*Technical Memorandum 33-531*

*Development and Testing of the Flight Command  
Subsystem for the Mariner Mars  
1971 Spacecraft*

*W. H. Chitty*

March 15, 1972

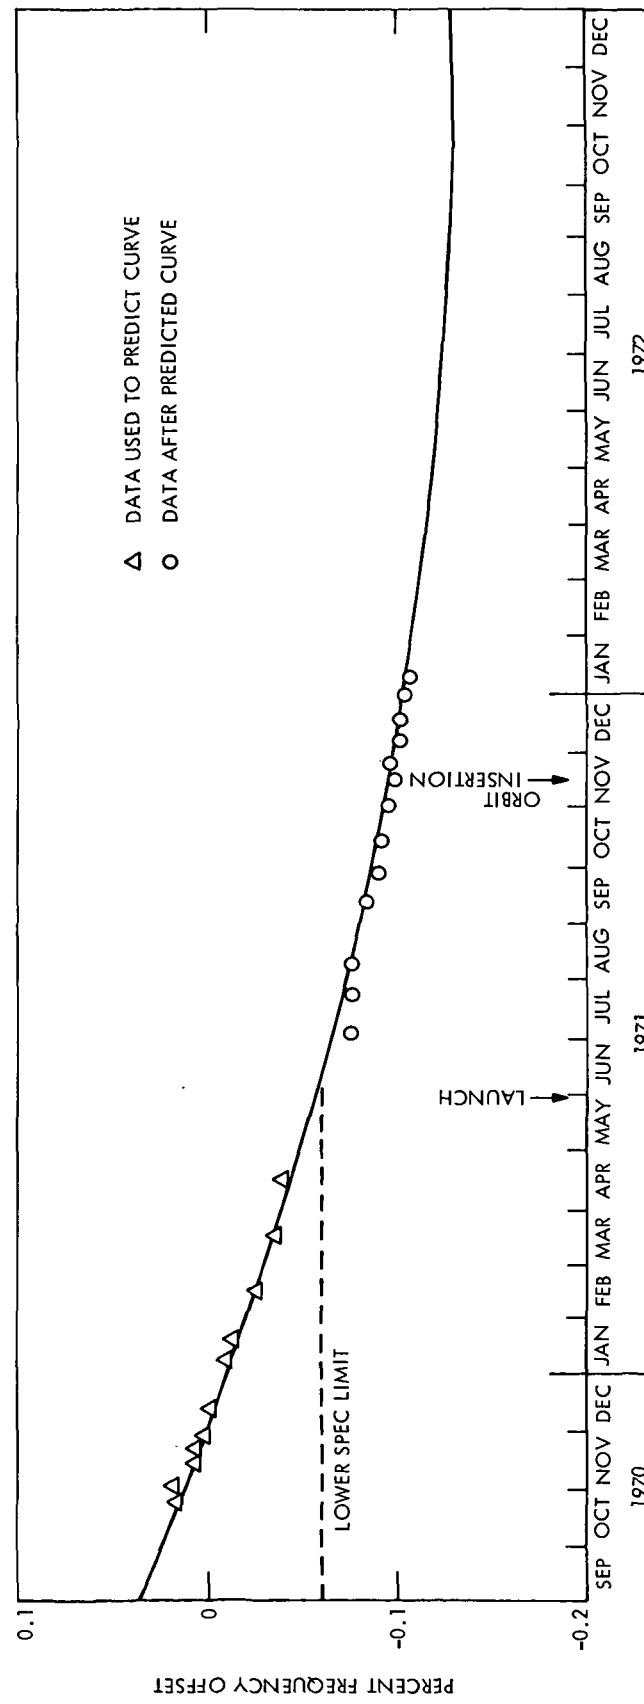
All MM '71 FCS VCO (used in the phase-locked loop) free-run frequencies had a tendency to drift negatively with time (Fig. 1), at an exponentially decaying rate. Although some of the drifts were actually out of specification, they were continuous, predictable, and not catastrophic. Furthermore, the FCS units are still able to meet system requirements when the ground sub-carrier frequency is adjusted a corresponding amount.

The frequency drifts were in the opposite direction and for a longer time period than for the MM '69 FCS VCOs. Although the MM '71 FCS VCO design was identical to that for MM '69, a change in vendors had to be made for the thin-film resistors in the timing circuit. The long-term resistance shift characteristic of the new resistor was determined to be the chief cause of the observed MM '71 FCS VCO drifts.

Fig. 1. Mariner 9 FCS VCO frequency drift curve
