APPLICATION OF BORON/EPOXY REINFORCED  
ALUMINUM STRINGERS AND BORON/EPOXY  
SKID GEAR FOR THE CH54B HELICOPTER  
TAIL CONE

PHASE II: FABRICATION, INSPECTION AND FLIGHT TEST

Final Report

Sikorsky Aircraft  
Division of United Aircraft Corporation ,

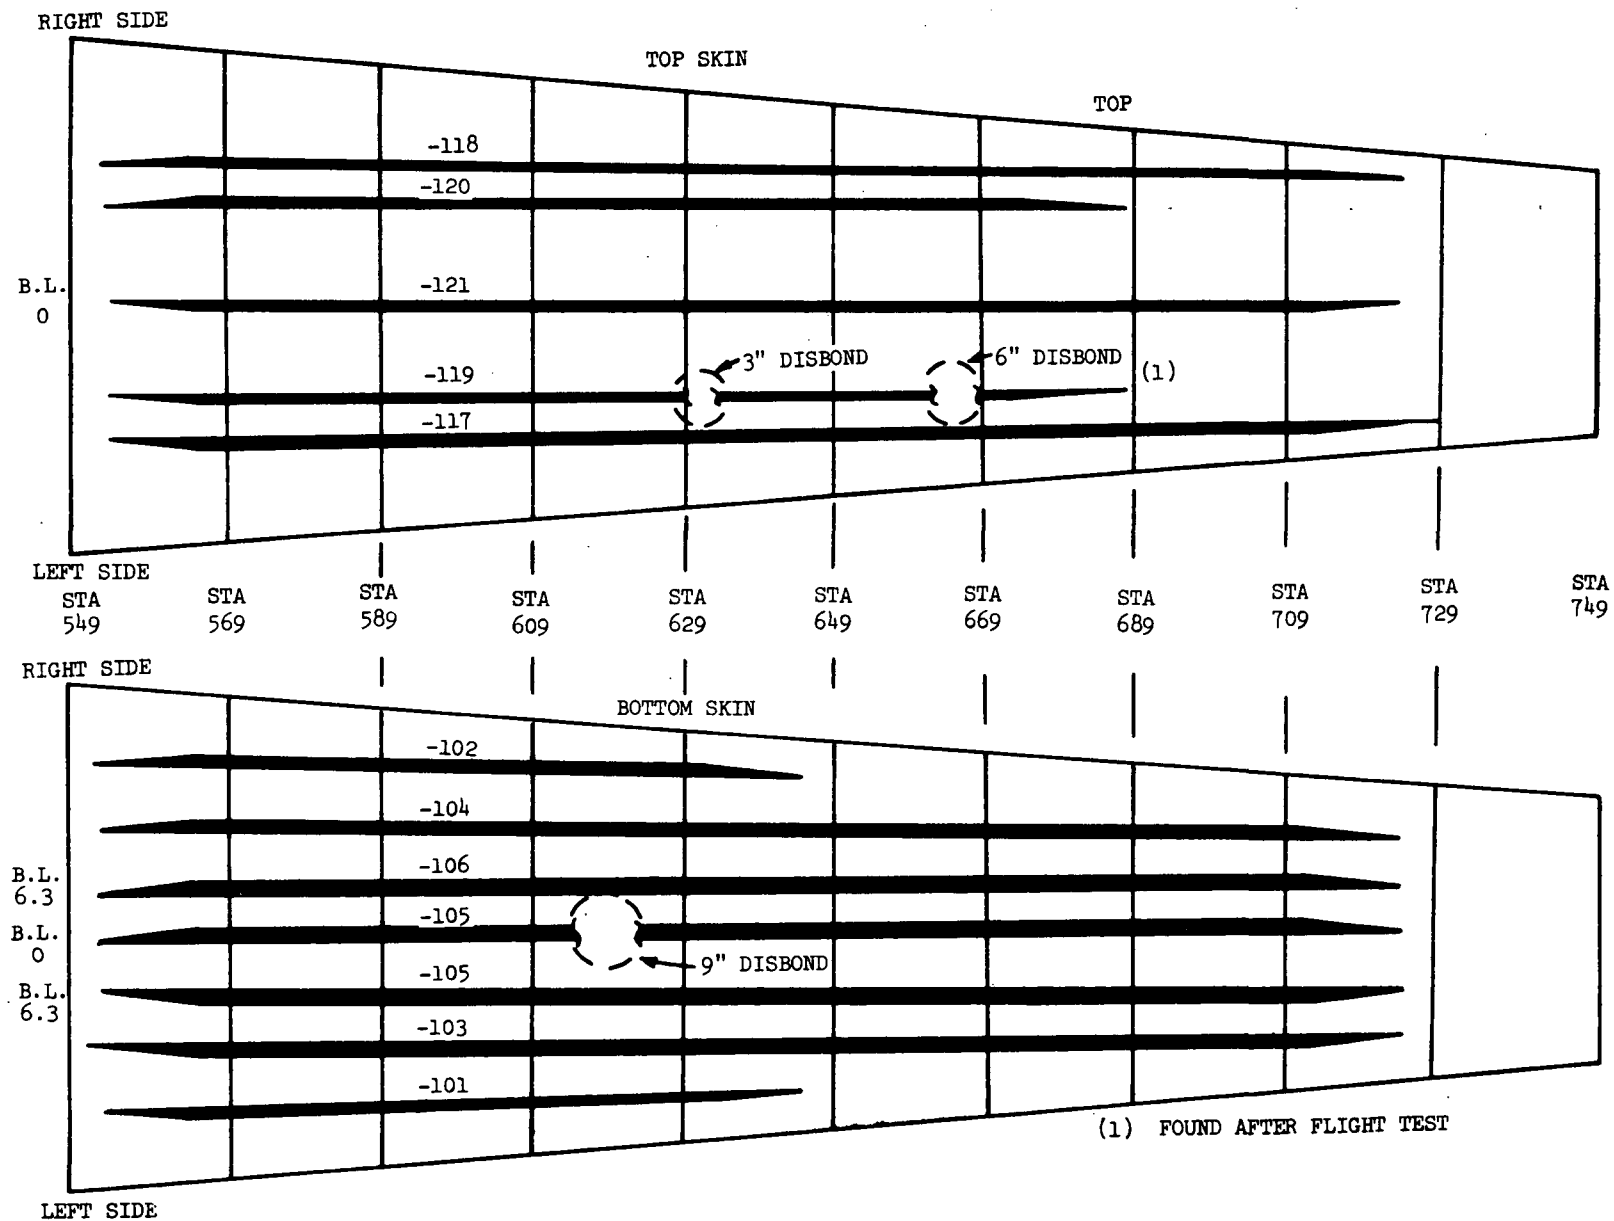
FIGURE 2-2. TAIL CONE BOND DEVIATIONS FOUND IN FABRICATION AND FLIGHT TEST INSPECTION.

Upon completion of all tail cone riveting, the bonding of the reinforced stringers were again inspected this time by the Fokker bond tester. At this time two bond deviations were found: a nine (9) inch partial debond on stringer -105, B.L.O at station 618; and a three (3) inch debond in the upper left hand stringer -119 at station 629. These areas are shown in Figure 2-2.

No physical problems were encountered in conducting this inspection and a six (6) inch disbond area was found in the upper left hand stringer -119 at station 669. This area is shown in Figure 2-2. The debonded area appears to be similar to those found in the fatigue test specimen, (Reference 7-1) which did not propagate after the initial disbond. It is adjacent to a stringer/frame clip and is not critical.

The coin tap method of inspection was unable to find the disbonded area around Hi-LOK fasteners that were noted in the fabrication phase, reference section 2.0. Apparently the Hi-LOK fasteners pull the boron reinforcement and aluminum stringers together such that when coin tapped, it resonates like a bonded structure. The periodic field inspections will monitor these areas and will be able to detect if the bond deviations propagate beyond the influence of the fasteners.

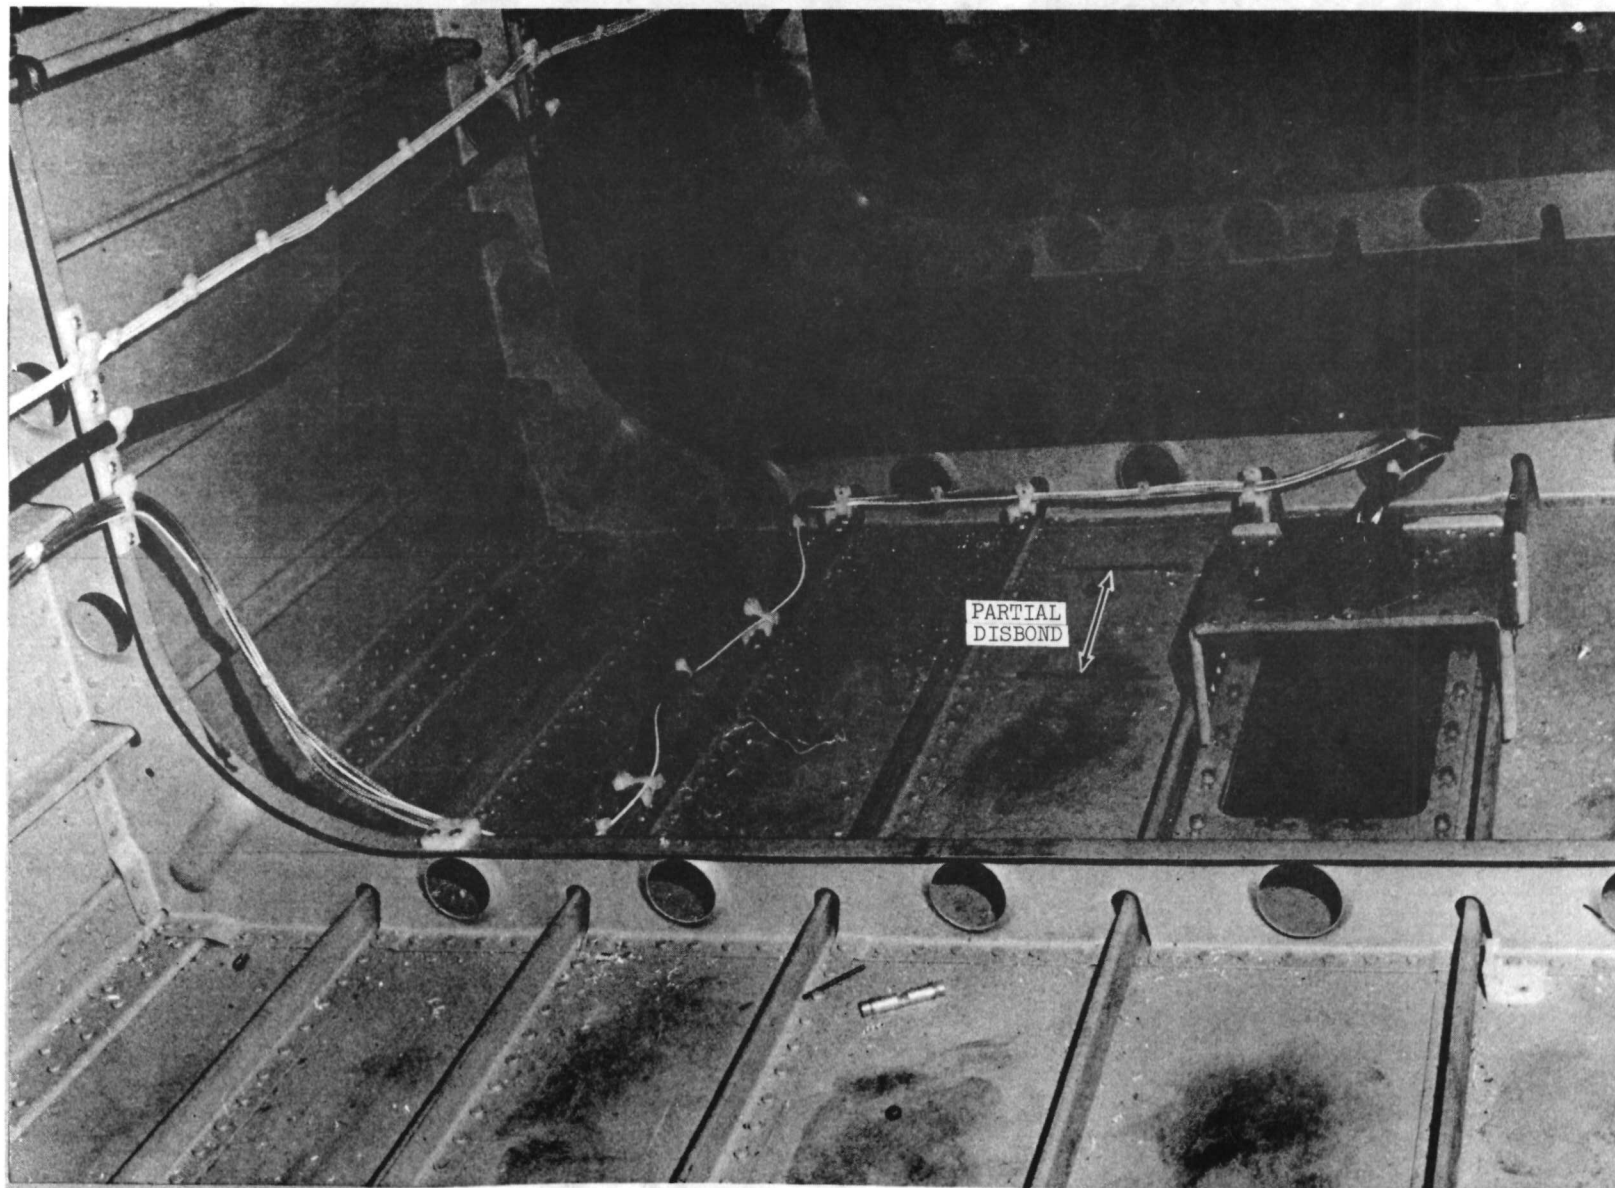
FIGURE 2-3. PARTIAL BOND DEVIATION UNDER COMPASS BRACKET.

The nine inch partial disbond was found in the vicinity of the compass bracket which is fastened by three (3) Hi-LOK fasteners, see Figure 2-3, while the three (3) inch disbond was found in the area of a stringer/frame clip and fasteners. It is felt that the disbonds were caused by the drilling of holes in the aluminum stringers through the predrilled holes in the boron/epoxy reinforcement strips.

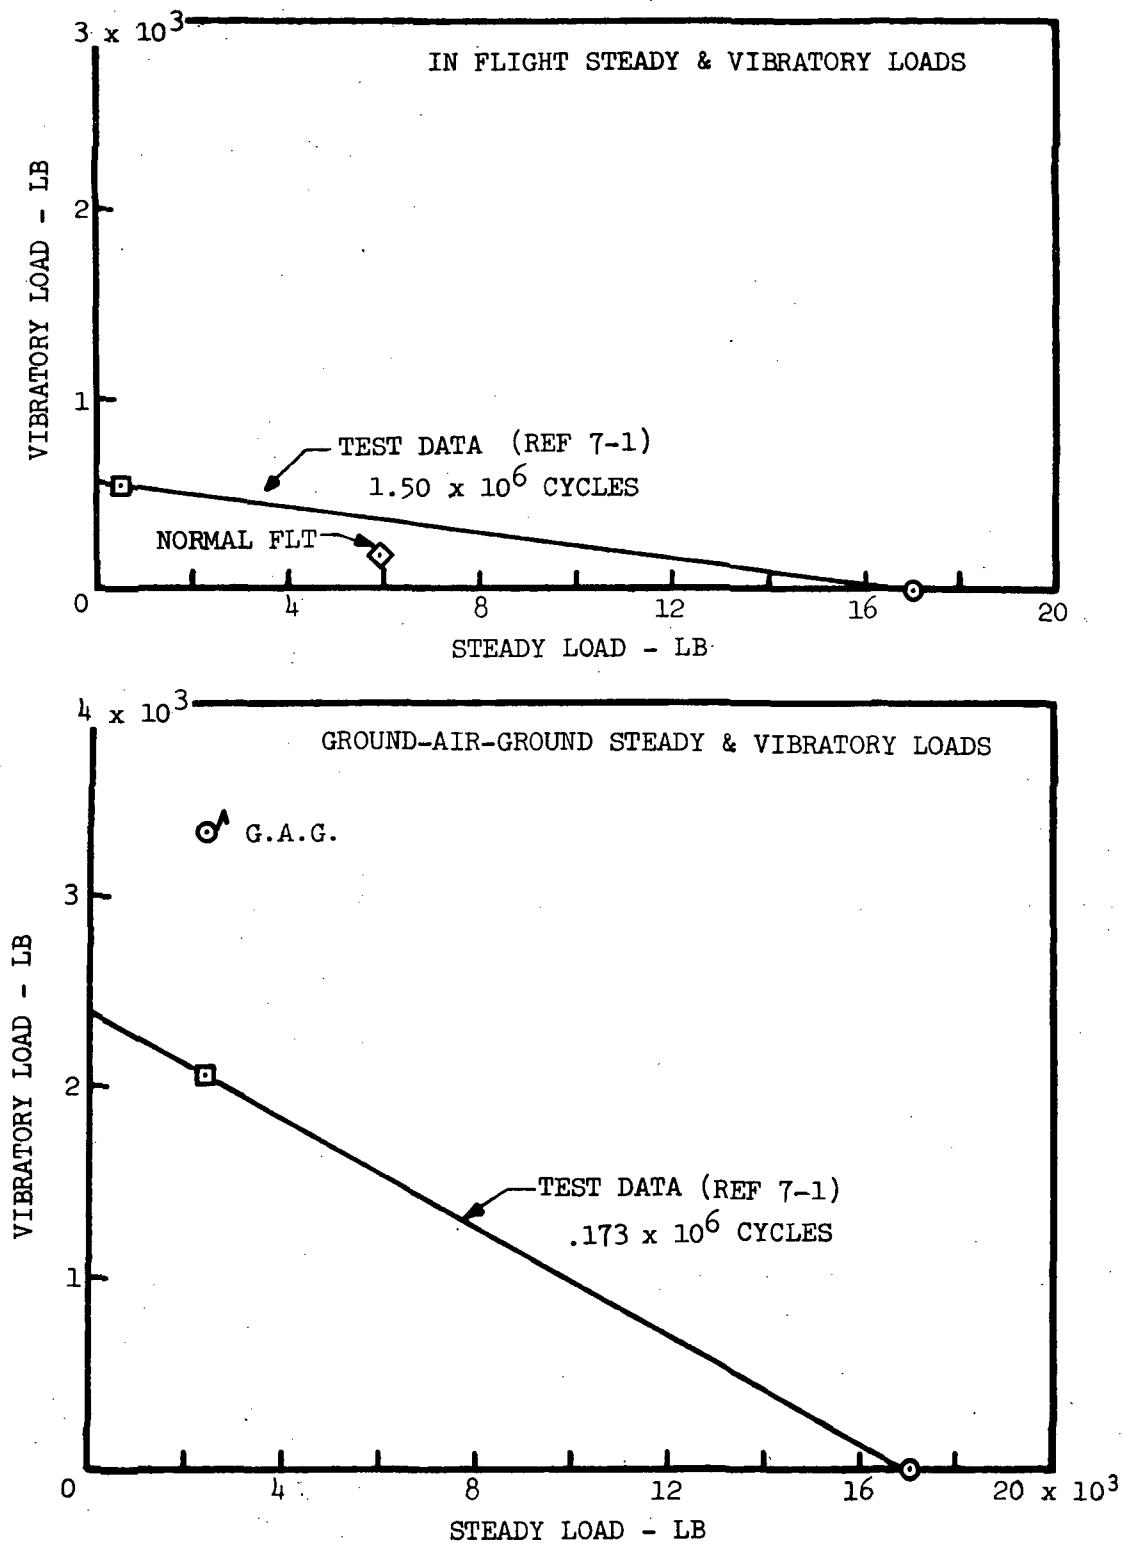
FIGURE 4- 1. FATIGUE LOADINGS FOR BORON EPOXY REINFORCED STRINGER.

The Goodman (constant life) diagrams shown in Figure 4-1 are based on test data from Reference 7-1. The constant life line of  $.175 \times 10^6$  cycles is derived from the fatigue testing of the stringer panel and the test point for static failure. As such, this line represents 10,000 hours or fifteen (15) years of aircraft usage with a factor of 7.3.

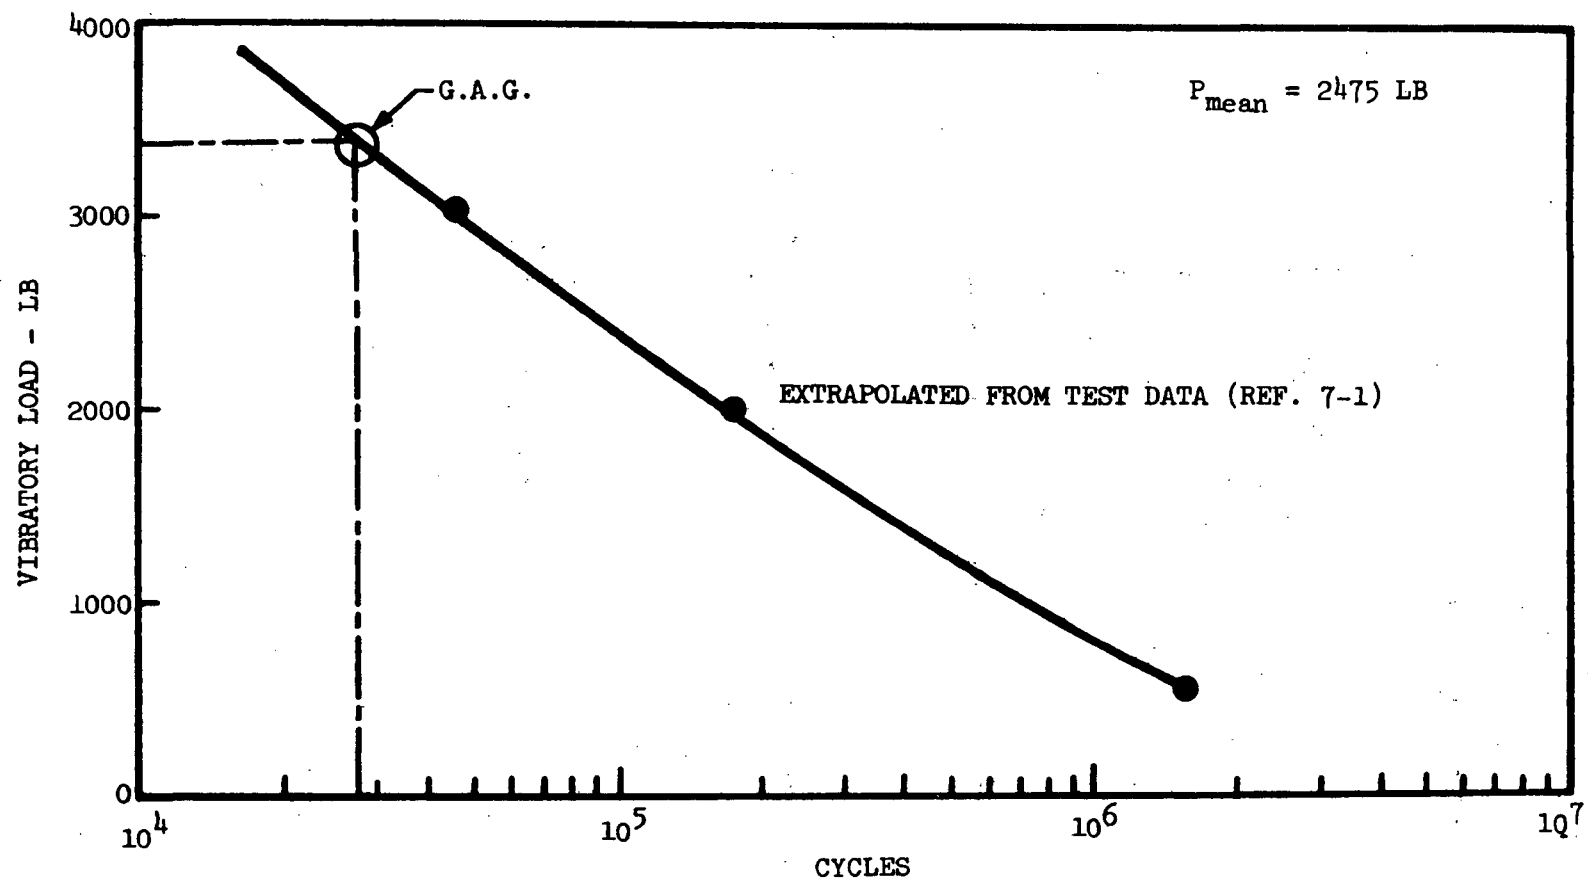
FIGURE 4-2. LOAD-CYCLE DATA FOR BORON/EPOXY REINFORCED STRINGER.

However, the GAG stresses observed in the flight and ground survey were above the constant line, and an extrapolation of life was made using the method shown in Figure 4-2. Using the mean stress of 2475 pounds, as shown in the Goodman diagram of Figure 4-1, the fatigue test data (Reference 7-1) was used to construct the S-N diagram of Figure 4-2. Extending the line to the GAG survey data shows the resulting cycles would be approximately 29,000 cycles mean life for the boron/epoxy reinforced stringers. Using the estimate of 2.38 GAG cycles, found from previous stress surveys (Reference 7-1), the projected usage would be limited to 3050 hours with a life factor of 4.0. However, no safety of flight is involved since the

failure mode is debonding of the boron reinforcement whereas the aluminum stringer by itself is capable of withstanding many more cycles. The bond integrity will be monitored during the inspection periods. It should also be noted that the 10,000 hours usage could be met with a reduced life factor of 1.2.

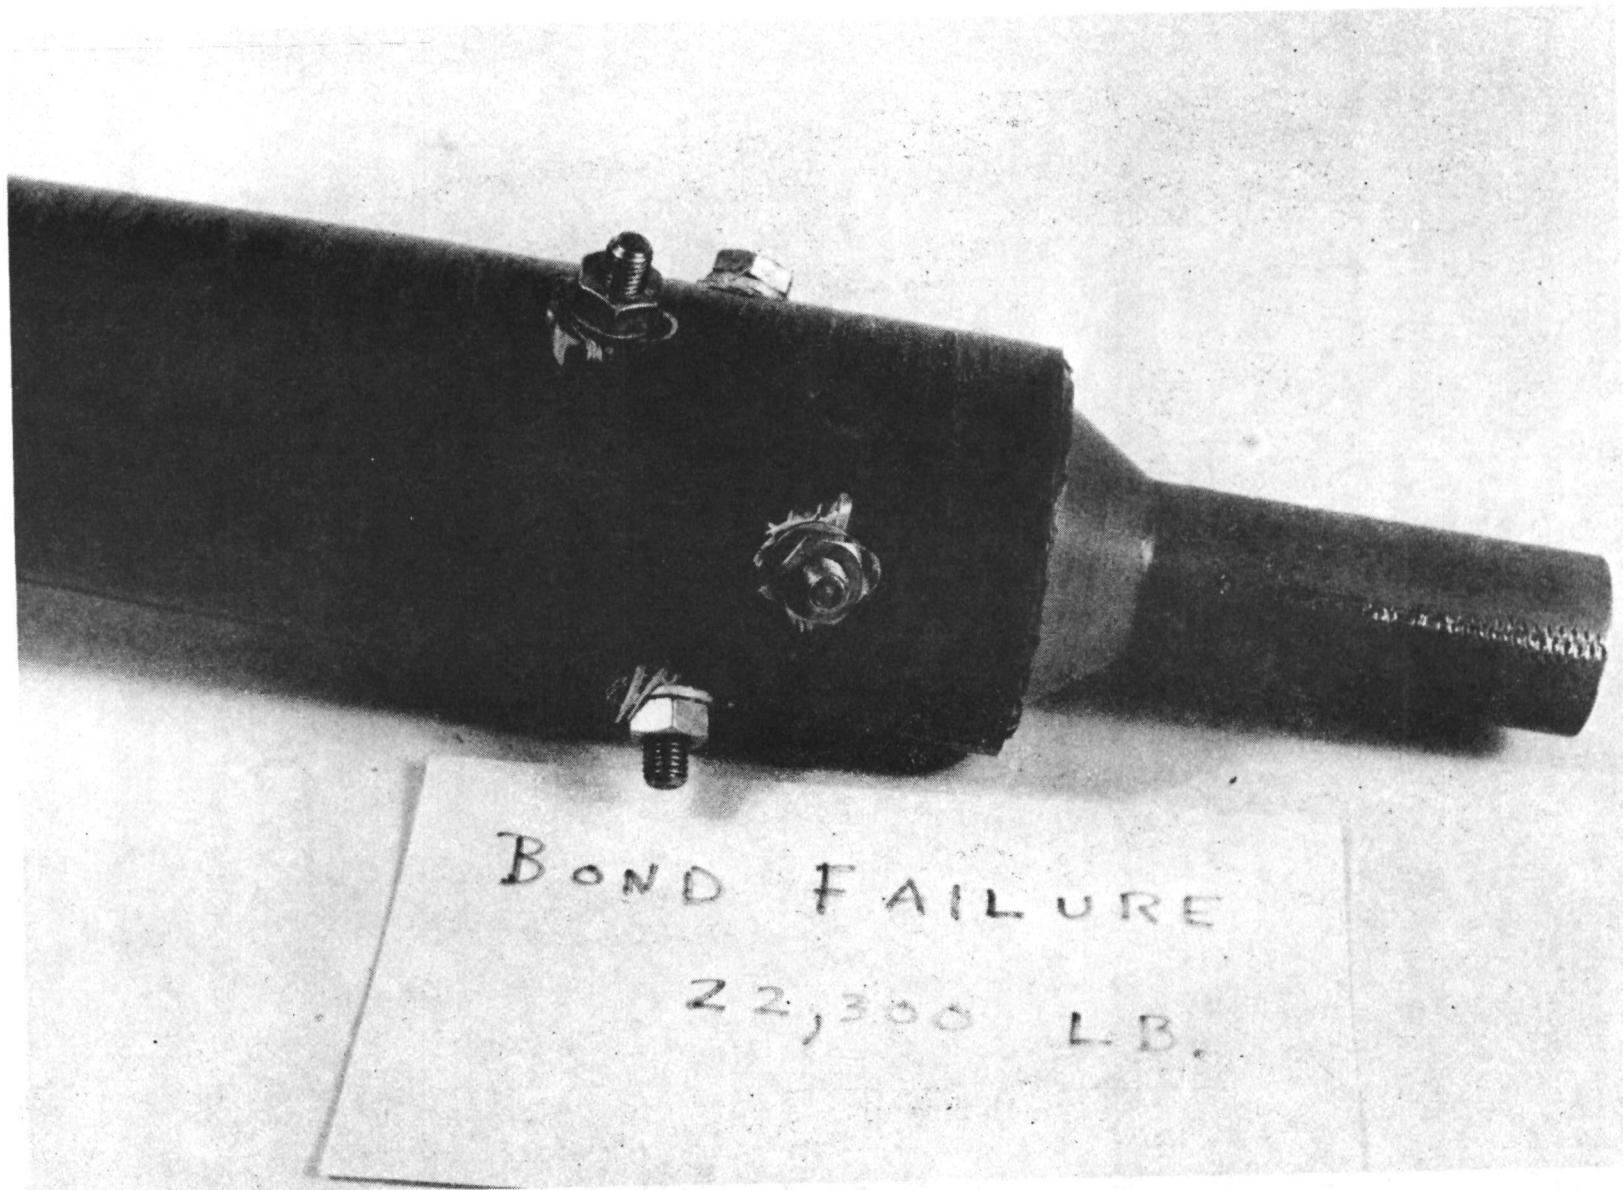
FIGURE 5-5. COMPRESSION END FITTING FAILURE IN BORON/EPOXY TUBE

In the compression test a boron/epoxy strut was strain gaged and installed in a Baldwin 100,000 pound universal test machine. The tube was loaded in compression with special care taken to assure the strut was centrally plumb in the machine. At 22,300 pounds, the bond between the end fitting and composite tube failed. The load dropped momentarily then was brought back up to 22,000 pounds. The composite tube then failed by local crushing at the bolt holes as shown in Figure 5-5. The maximum ultimate production design tube load is 9823 pounds (Reference Figure 5-4).

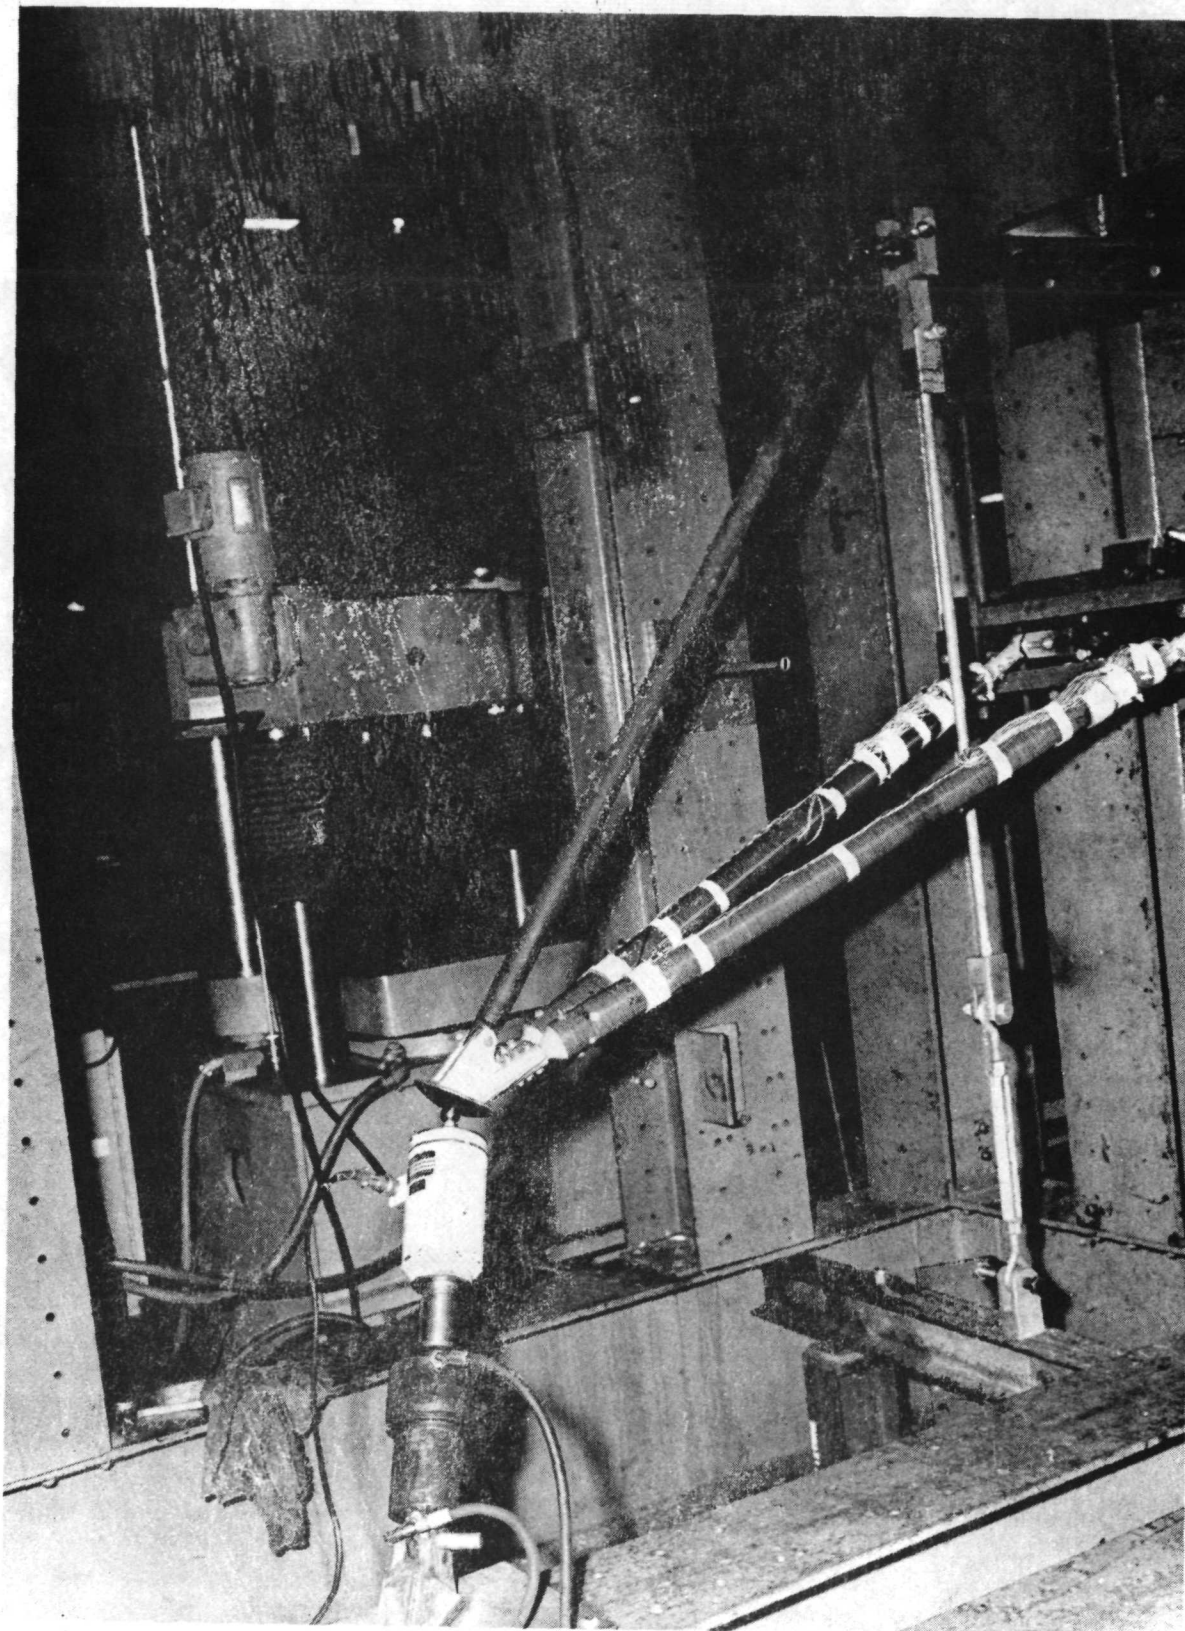
FIGURE 5-6. ASSEMBLY TEST OF SKID GEAR INSTALLATION

The proof test of the skid gear assembly is shown in Figure 5-6. During this test the transition fitting, at the lower attachment point, failed at an applied resultant load of 6600 pounds. The failing load was above the design limit load of 4450 pounds but below the design ultimate load, (Reference Figure 5-4). It was noted in this test that the individual strut loads changed from pure axial, in the undeformed condition, to a combination of axial and bending, as the assembly deformed. Strain gages on the assembly monitored the strains. Ultimate strut loads were generated by extrapolation of test data and were used in the design and analysis of the assembly end fittings. These loads are higher than the production ultimate design loads as shown in Figure 5-4. A new reinforced lower transition fitting was designed for the aircraft installation taking into account the moments as determined by test. A summary of margins of safety for the strut is shown in Table 5-2.

The composite tubes used in the skid gear assembly test were visually inspected for damage and none was detected. The bonded end fittings were carefully machined out and the new fittings bolted and bonded in place.
