MSC-07230

APOLLO 16 MISSION REPORT

MANNED SPACECRAFT CENTER

AUGUST 1972

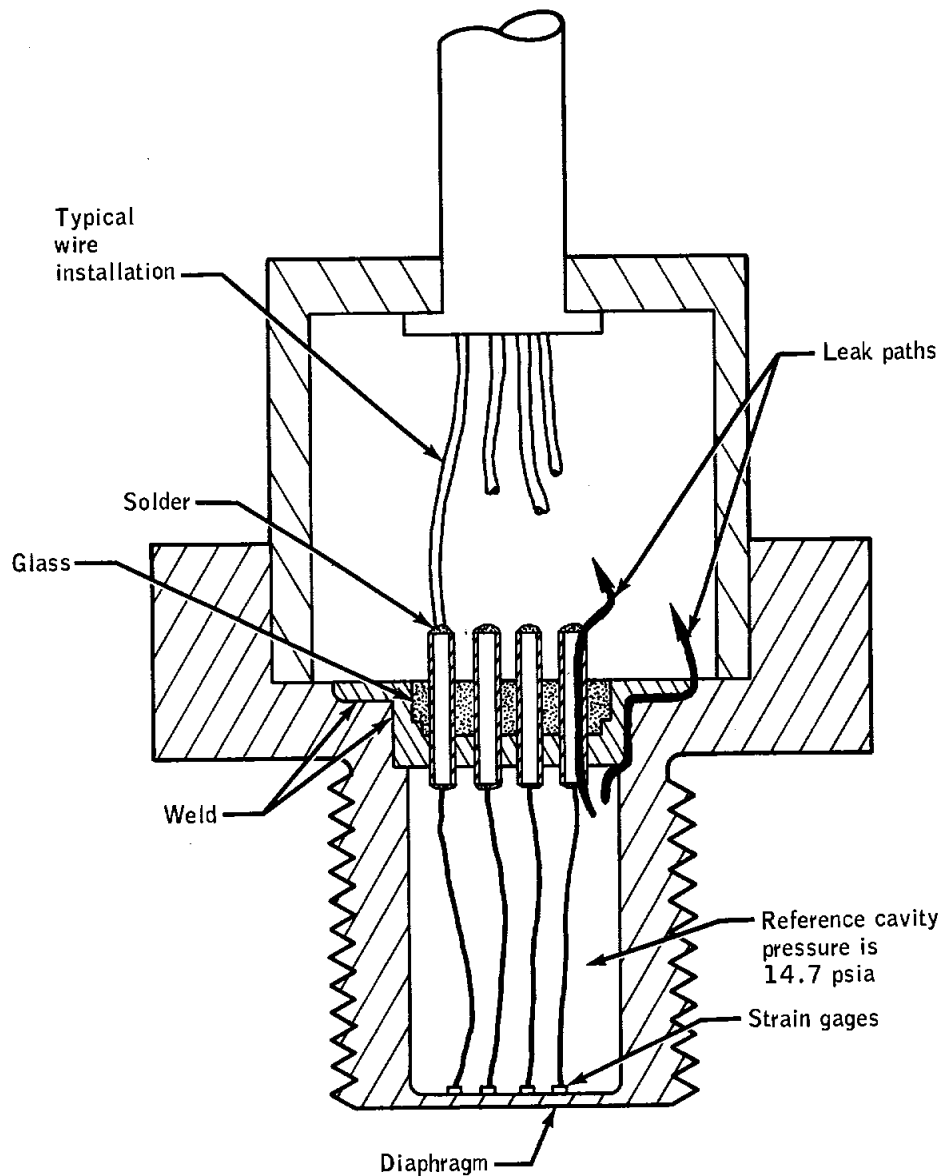
Figure 14-3.- Service propulsion system pressure transducer failure.

the header-to-case weld (fig. 14-3). During altitude chamber tests for Apollo 16 and during the Apollo 12 mission, a similar transducer showed the same type of failure. The Apollo 16 transducer (replaced after the altitude chamber tests) had not had a vacuum check since 1965 to verify that the reference cavity was leak tight. The altitude chamber test is adequate to verify the integrity of this type of pressure transducer.

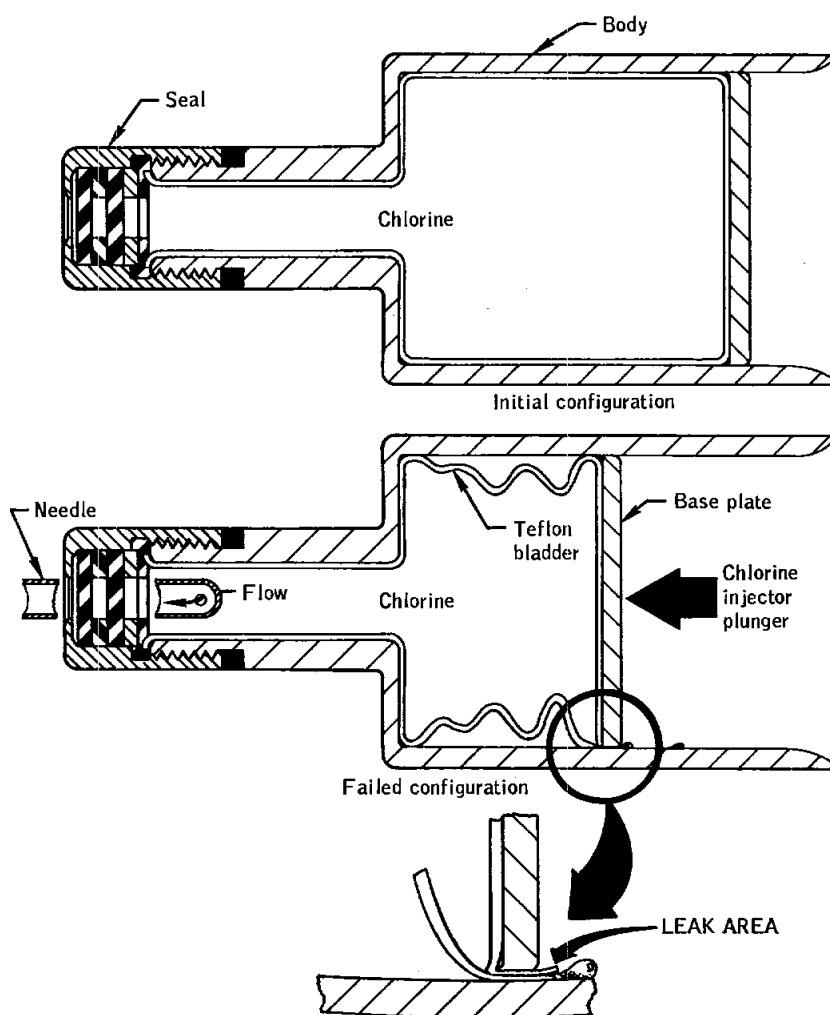
Figure 14-9.- Chlorine ampule failure.

Upon further examination by the crew, the chlorine ampule appeared to be broken (leaking) and the inner bladder was visible after having been extruded past the base plate. Inner bladder extrusion has been observed before but has not been associated with leaks. Figure 14-9 shows typically how the Teflon bladder can be forced past the injector base plate. The body sidewall is not sufficiently rigid to prevent the bladder from extruding around the base plate and being creased, which would be conducive to leaks. Subsequent chlorine injections were satisfactory. The specific ampule which caused the problem was later jettisoned with the lunar module and was not available for postflight inspection.

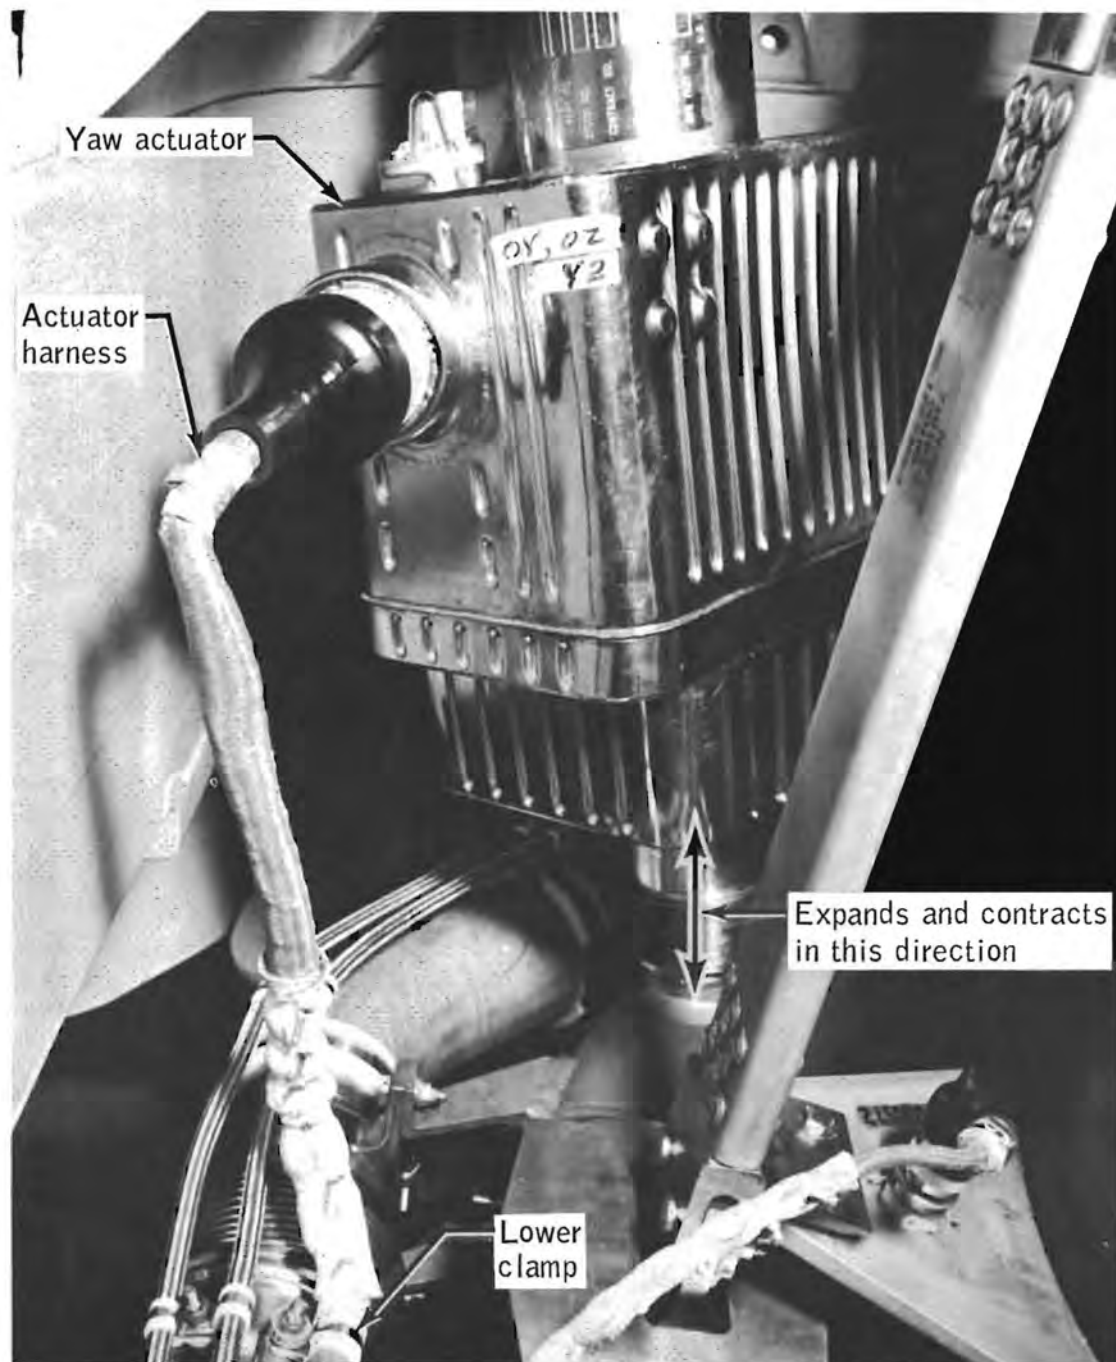
Figure 14-12.- Yaw actuator assembly and interconnecting wiring.

The cause of the failure was an open in the rate feedback loop of the secondary yaw servo system. Postflight testing of command module wiring and connectors and bench testing of the thrust vector servo assembly did not reveal any abnormalities. Therefore, the failure must have occurred in the service module wiring or connectors. Possible pin corrosion on the engine gimbal actuator wiring harness connectors or broken wires in the yaw gimbal wiring loop are the most probable causes of the flight problem. A broken wire would result from inadequate strain relief (see fig. 14-12) due to cable flexing. Wiring harnesses to the actuator assembly on three other vehicles were reviewed and found to move when the engine was gimballed. Motion of the actuator produced a strain on the harness at the lower clamp. The position of this clamp was changed for the remaining vehicles to provide strain relief.

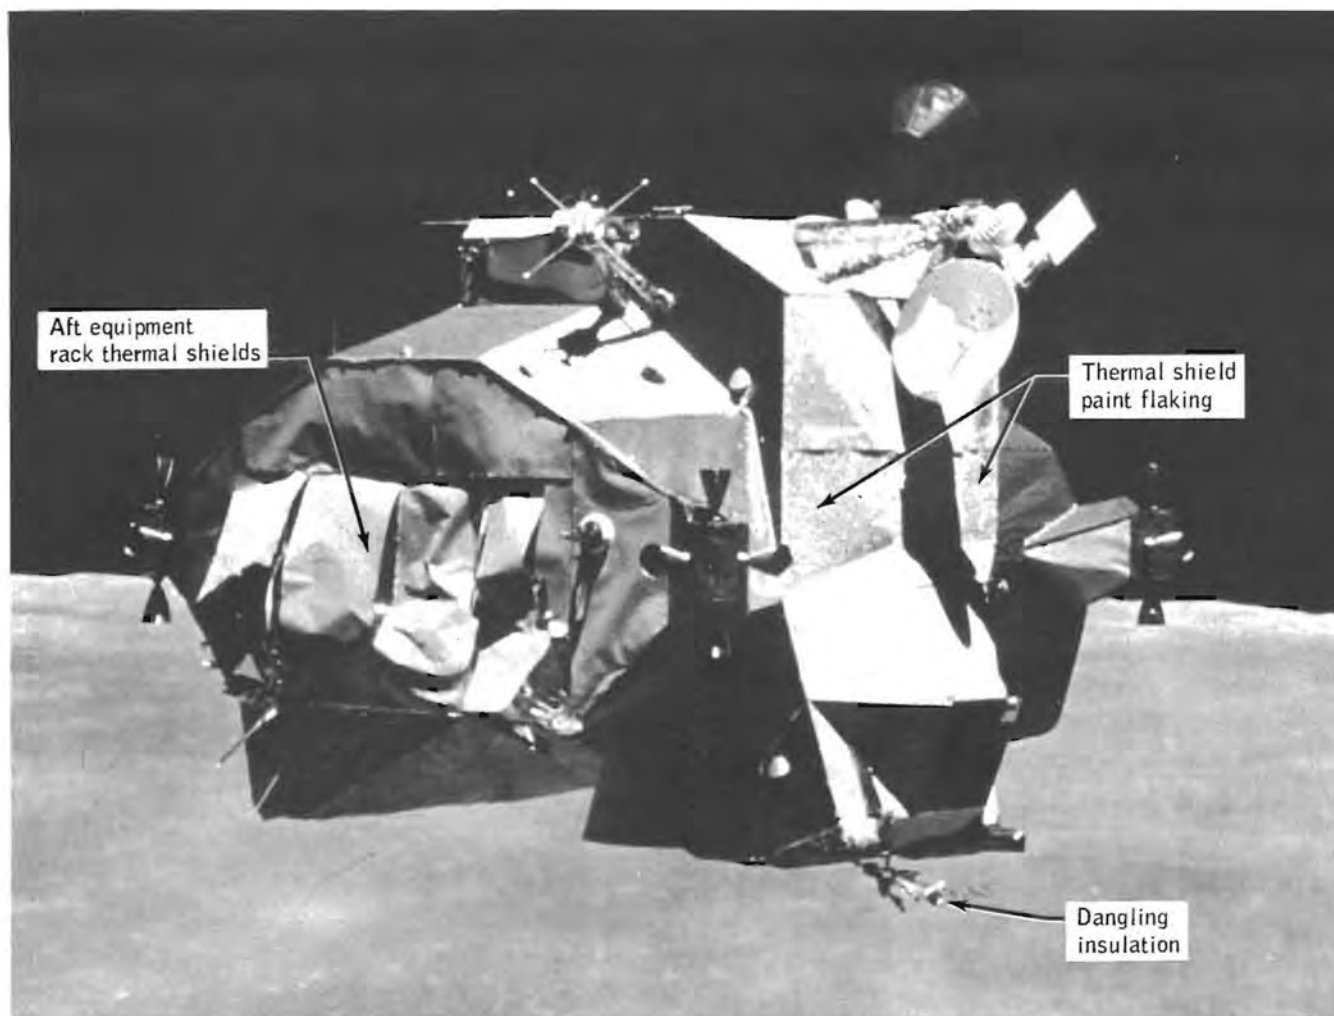
Figure 14-26.- Paint flaking and damaged thermal shield panels.

The most probable cause of the failure was ascent engine exhaust entering the cavity behind these thermal shields. A cross section of the lower edge of the shields is shown in figure 14-27. Analysis shows that the thermal shield which extends below the support tube allows a pressure buildup on the closure shield which exceeds its capability. Once the closure shield failed, the exhaust entered the cavity behind the shield, resulting in a pressure buildup exceeding the capability of the vertical thermal shields. The detailed flight configuration in this area was not tested.
