APOLLO 15 MISSION

TEMPORARY LOSS OF COMMAND MODULE TELEVISION PICTURE

ANOMALY REPORT NO. 4

MARCH 1973

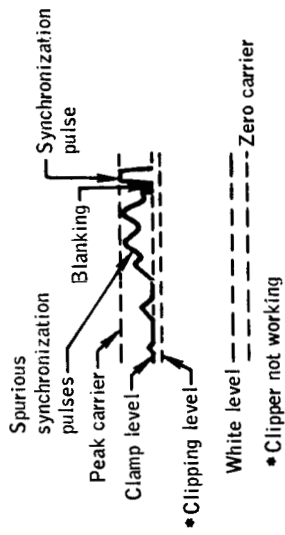
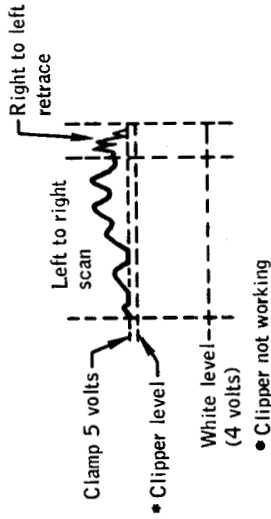
Postmission analyses and tests with the flight camera showed that when a high intensity light, like direct sunlight, came into the field of view, the normally black area under the mask on the video tube was effectively illuminated by charge spreading. When the beam crosses this area, a signal is generated that corresponds to the illumination level. This signal is clamped to the black-level voltage. As a result, wherever the image darkened during the ensuing sweep across the tube, the increase in voltage above the starting reference appeared "blacker than black" (above 5 volts) after clamping (figs. 3a and 3b).

Figure 3a.- Left to right scan signal before clamping.

Figure 3b.- Signal before blanking.

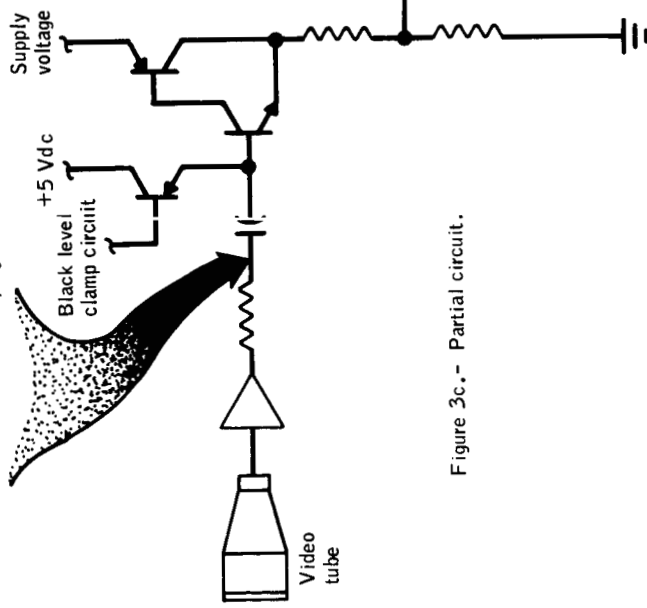
Figure 3c.- Partial circuit.

The large resulting voltage charged the clipper bias capacitor in the black-level clipping circuit (fig. 3c) and back-biased the clipping diode, preventing it from shorting the excessive signal to ground. As a result, high-amplitude excursions remained in the video signal output (fig. 3d) and were interpreted, by the ground signal converter, as synchronization pulses. The combination of the false synchronization pulses quickly followed by the normal signal synchronization pulse was rejected by the ground station converter and the picture was temporarily lost.

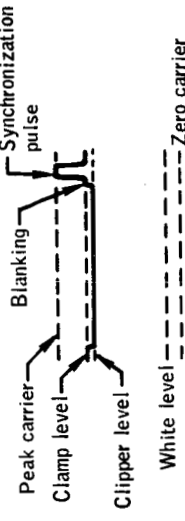
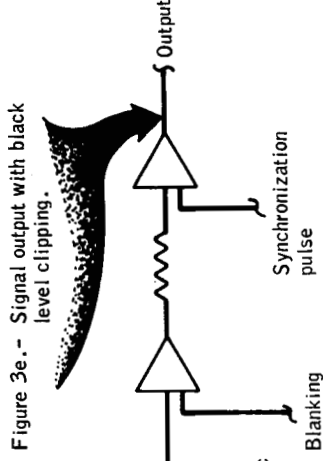
Figure 3d.- Signal output without black level clipping.

Figure 3e.- Signal output with black level clipping.

Figure 3.- Generation of typical video signal with direct sunlight in the field of view.

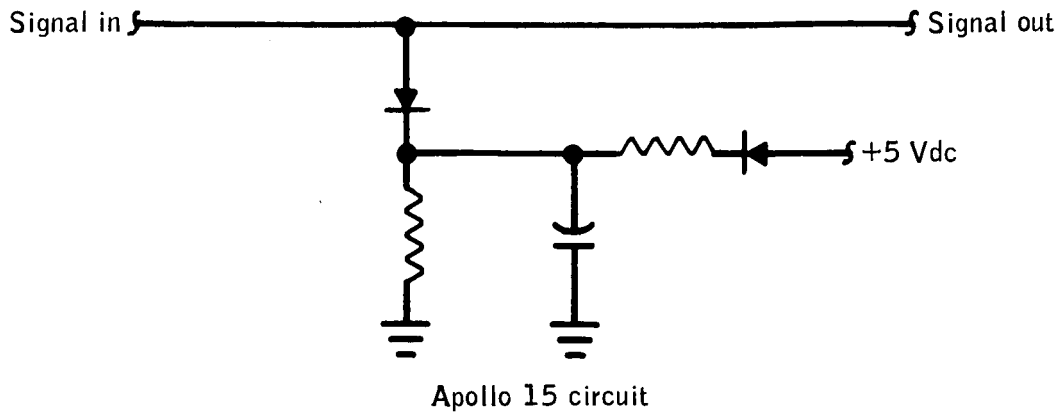
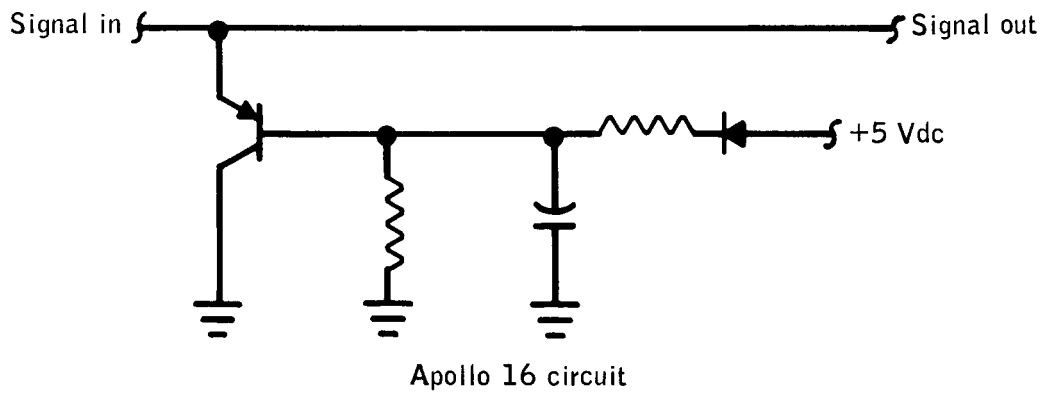
Figure 4.- Black-level clipping circuit modification for Apollo 16.

The temporary loss of the picture was caused by a false synchronization pulse that resulted from the inability of the black-level clipping circuit to respond adequately to the video signal when bright sunlight suddenly entered the camera's field of view. The clipper was not designed to operate with direct sunlight in the camera's field of view.

The black-level clipping circuit was modified to eliminate the diode which could be back-biased by a large charge on the bias network capacitor (fig. 4). The transistor which replaces the diode in the modified circuit isolates the bias capacitor so that it is not charged by the improper black level voltage. The transistor then continues to conduct the excess signal to ground, even in the case of high intensity light inputs to the video tube. In extreme cases (direct sunlight) the picture would go blank temporarily, with the modified circuit, but the normal synchronization pulse pattern would continue.

The black level clipping circuit has been modified and its performance on the Apollo 16 mission was satisfactory.
