APOLLO EXPERIENCE REPORT -THE CRYOGENIC STORAGE SYSTEM

by William A. Chandler, Robert R. Rice, and Robert K. Allgeier, Jr. Manned Spacecraft Center Houston, Texas 77058

NATIONAL AERONAUTICS AND SPACE ADMINISTRATION • WASHINGTON, D. C. • JUNE 1973

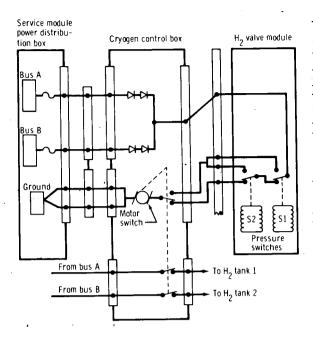
Figure 5. - Schematic of the hydrogen tank automatic pressure-control system. were "OFF." This failure could have been caused by either of the pressure switches or the motor switch failing to close. The tank 2 heaters then were placed in the AUTO position with no effect, and the tank pressures decayed to approximately 210 psia. At this time (95:43 g. e. t.), the tank 2 fans were turned on to arrest the pressure decay. The fans in tank 2 were then turned off at 100:13 g.e.t. When the lunar module was undocked (101:22 g. e. t.), the tank heaters came on and pressurized the tanks to approximately 270 psia. The automatic cutoff point was passed, and the crewmen were required to deactivate the heaters. This failure mode requires that both pressure switches fail closed or that the motor switch fail to open. It should be noted that this second failure mode is in conflict with the first failure mode.

Because there are three components in series (two pressure switches and one motor switch), there is no possibility to identify positively which component failed.

Because the second failure would have required that both pressure switches fail closed, there is reason to believe that there was a probable intermittent failure of the motor .switch or its circuitry.

As a result of the automatic-pressure-control-system failure, the hydrogensystem pressure was controlled by operating the fans in a manual mode throughout the remainder of the mission. This manual mode was the recommended contingency procedure, and no constraints to the mission resulted from this type of operation.

During the postflight investigation, a determination was made that terminal board number 9 (part number MD417-0018-0001) had 16-gage wire to supply the motor switch with power. There was a history of one intermittent-type failure using this type of terminal board with 16-gage wire. An intermittent open failure between selected pins could have been responsible for both the closed and the open modes of failure. During the investigation of the 16-gage-wire terminal boards, a discrepancy was found in the manufacturing process and corrective actions were instituted. Additionally, the suspect boards were removed from the program on a criticality basis, and this problem never recurred.

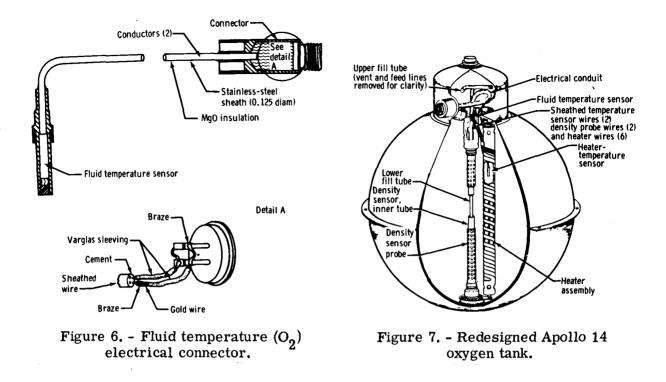
6. The bulk-fluid temperature sensor was relocated in the boss area (fig. 6).
