JSC-07954

**APOLLO 17 MISSION**

**ANOMALY REPORT NO. 2**

**MAPPING CAMERA EXTENSION MECHANISM  
OPERATED ERRATICALLY**

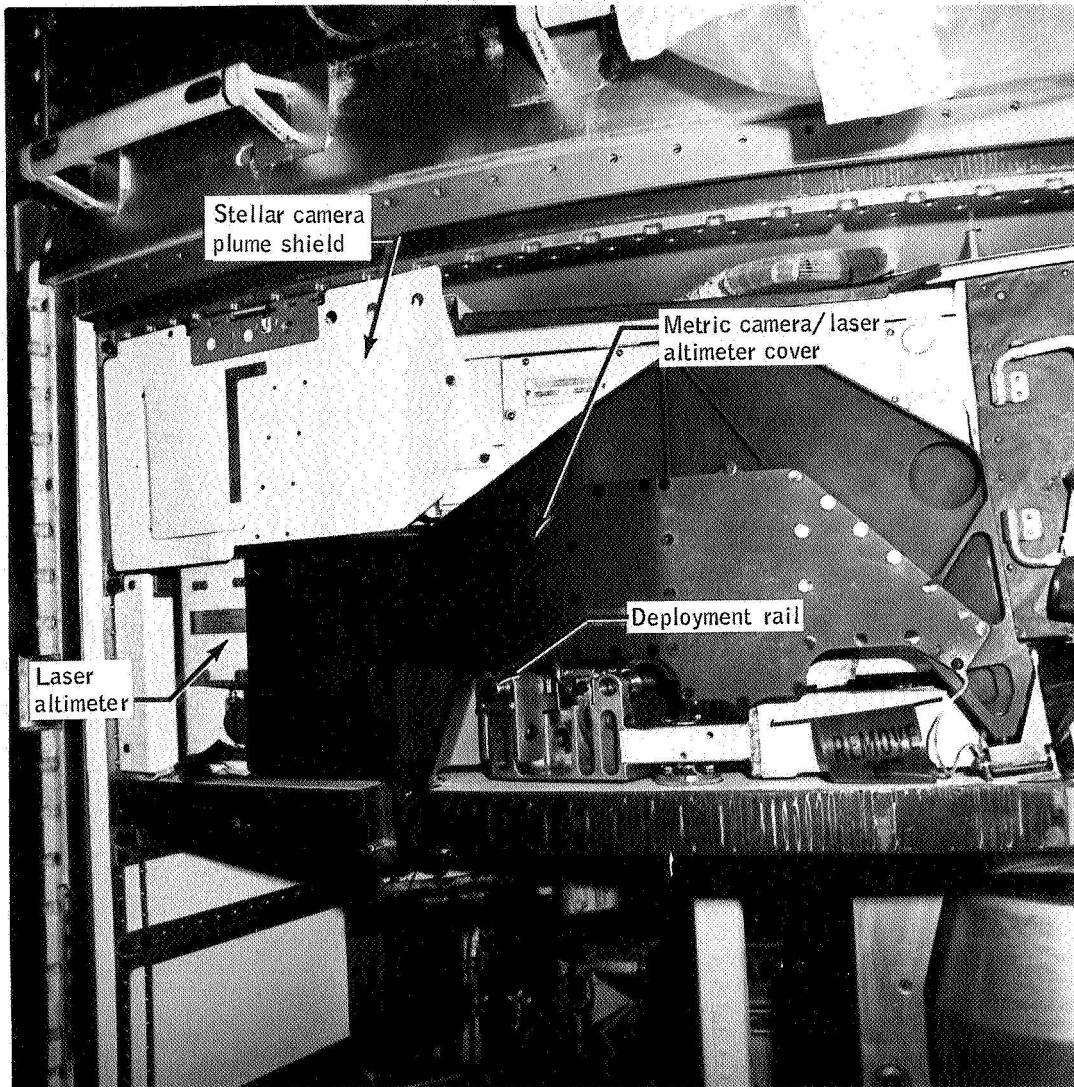
Figure 4.- Contamination covers.

Contamination covers (fig. 4) protected the camera and laser altimeter optics from the effects of waste water dumps, fuel cell purges, and reaction control system engine firings. The mapping camera/laser altimeter cover was controlled by a cabin switch. The stellar camera lens was protected by a spring-loaded plume shield. Camera motion during deployment opened the plume shield and held the shield open until the camera assembly was retracted.

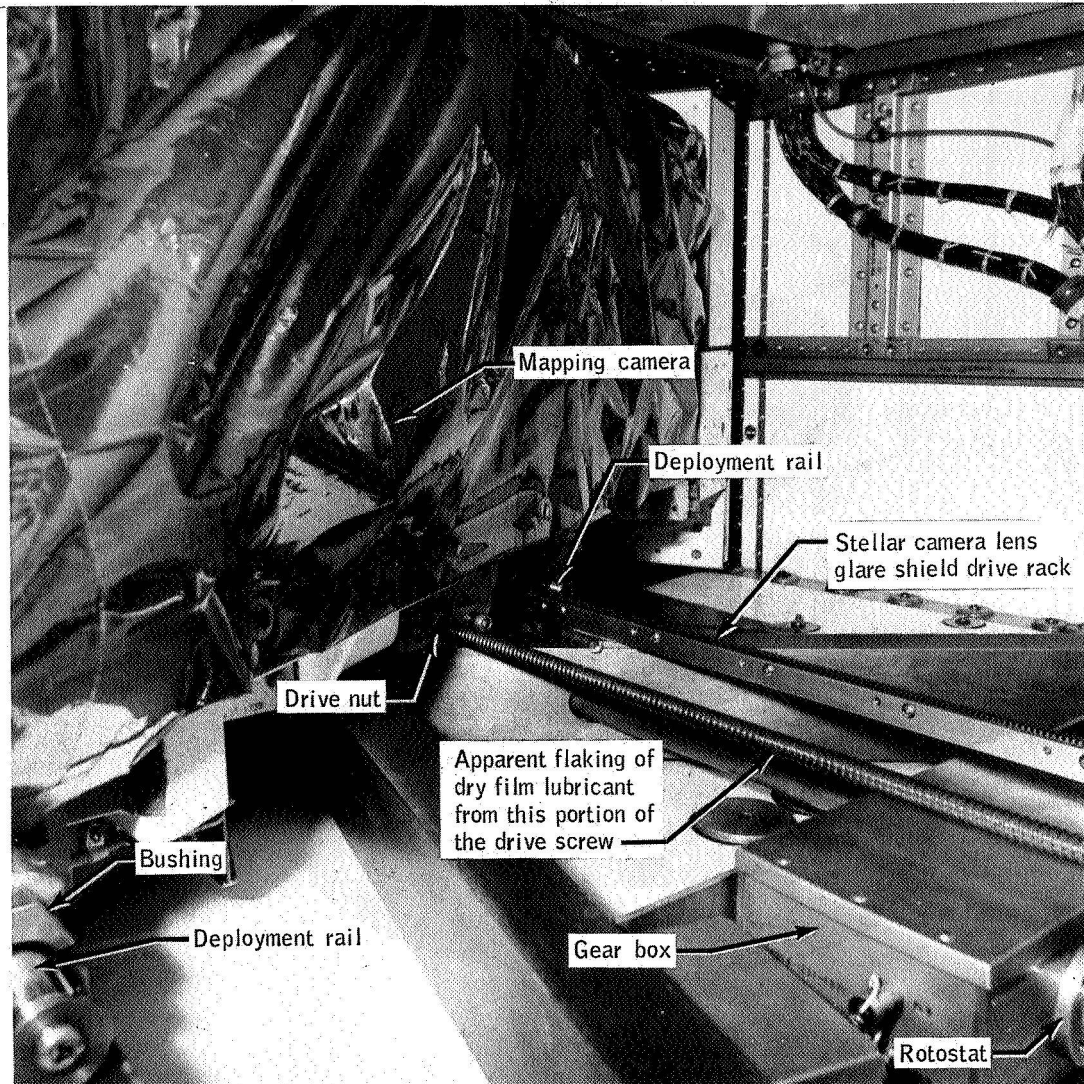
Figure 5.- Apollo 15 camera deployed during preflight checks (as seen from inside service module).

Testing also showed that the dry-film lubricant used on the Apollo 15 camera assembly drive screw flaked (fig. 5). As a result, the lubricant was changed to a wet film of versilube on the Apollo 16 assembly.

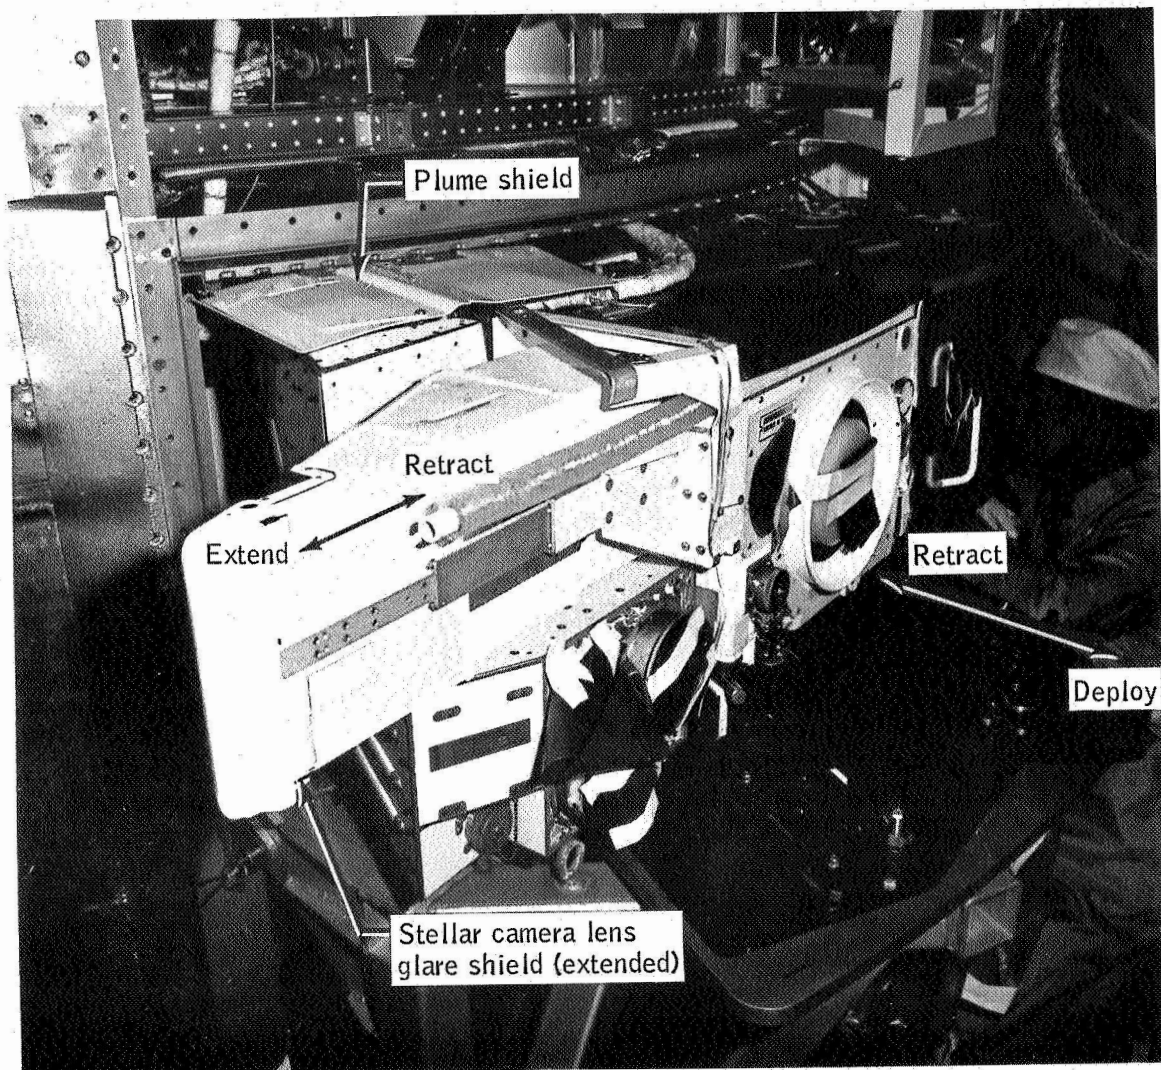
Figure 7.- Apollo 16 mapping camera during installation checks.

The stellar camera lens glare shield was extended and retracted as the mapping camera assembly was deployed and retracted (fig. 7). As the camera assembly was deployed outside the service module mold line, camera assembly motion caused a camera-mounted pinion gear to mesh with a stationary drive rack on the deployment frame (fig. 5). The pinion gear drove a gear train in the camera assembly that, in turn, extended the stellar camera lens glare shield approximately perpendicular to the deployment motion of the camera assembly. As the camera assembly was retracted, the pinion gear moved back along the drive rack, the gear train was driven in the opposite direction and the stellar camera lens glare shield was retracted. The glare-shield drive train contained a slip clutch to prevent the main assembly drive mechanism from jamming, should the glare-shield drive train jam. The stationary drive rack was installed in fittings on the deployment frame to permit alignment and gear engagement adjustments during camera assembly installation.

During the Apollo 16 extravehicular activity for film retrieval, the stellar camera lens glare shield was found in the extended position and jammed against the service module mold line and handrail. The jammed glare shield could have resulted from a loss of gear engagement between the drive rack and pinion gear when the camera assembly was fully deployed in zero gravity. This condition could occur if the camera assembly became misaligned when fully extended. The drive rack position was adjustable and the rack could have been slightly misaligned. During retraction, the rack and pinion re-engagement could then occur at a point where the glare shield would not have been sufficiently retracted to clear the vehicle

mold line. As a result of this problem on Apollo 16, the Apollo 17 drive rack was aligned for proper pinion gear engagement when the camera assembly was fully deployed. Zero-g conditions were approximated by supporting the camera assembly to remove the assembly weight from the rail/bushing interface.

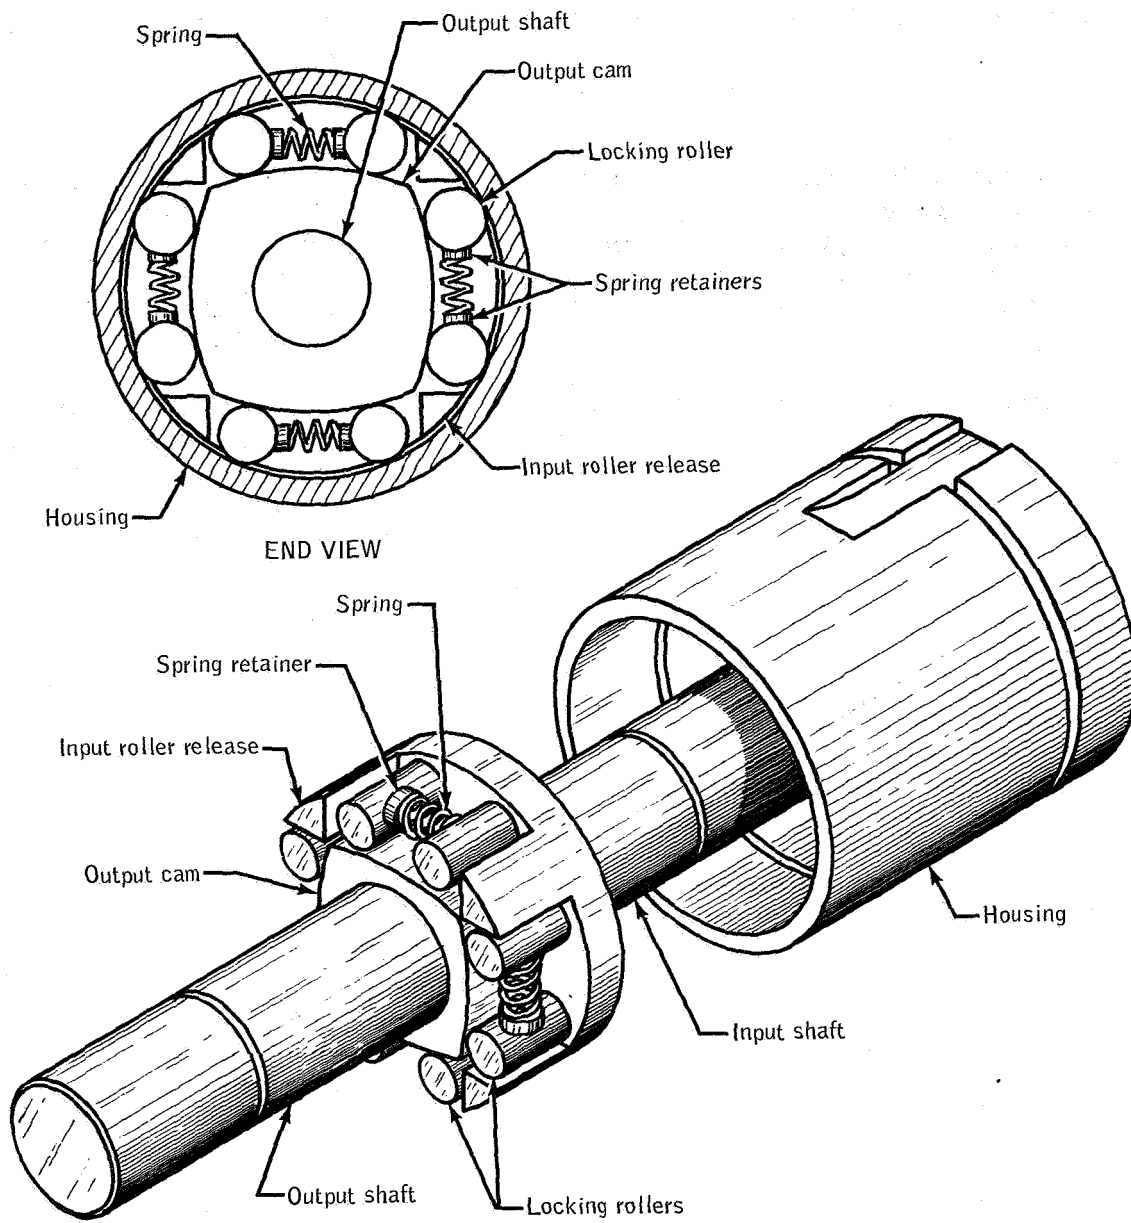
Figure 8.- Exposed view of rotostat.

Tests showed that power and signal cable tension could drive the rotostat output shaft faster than the input shaft during retraction. Under these conditions, the rotostat would periodically lock up, and release as the input shaft caught up, causing drive train chatter. Since the results of the chattering in zero-g conditions are unknown, the locking rollers (fig. 8) were removed from the rotostats on the remaining flight deployment mechanism. The chatter was eliminated, but the locking feature of the rotostat was also disabled. Tests conducted on the Apollo 17 camera assembly and two other units with the rotostat disabled indicated that sufficient friction was present in the drive train to preclude camera assembly movement after power was removed from the motors.

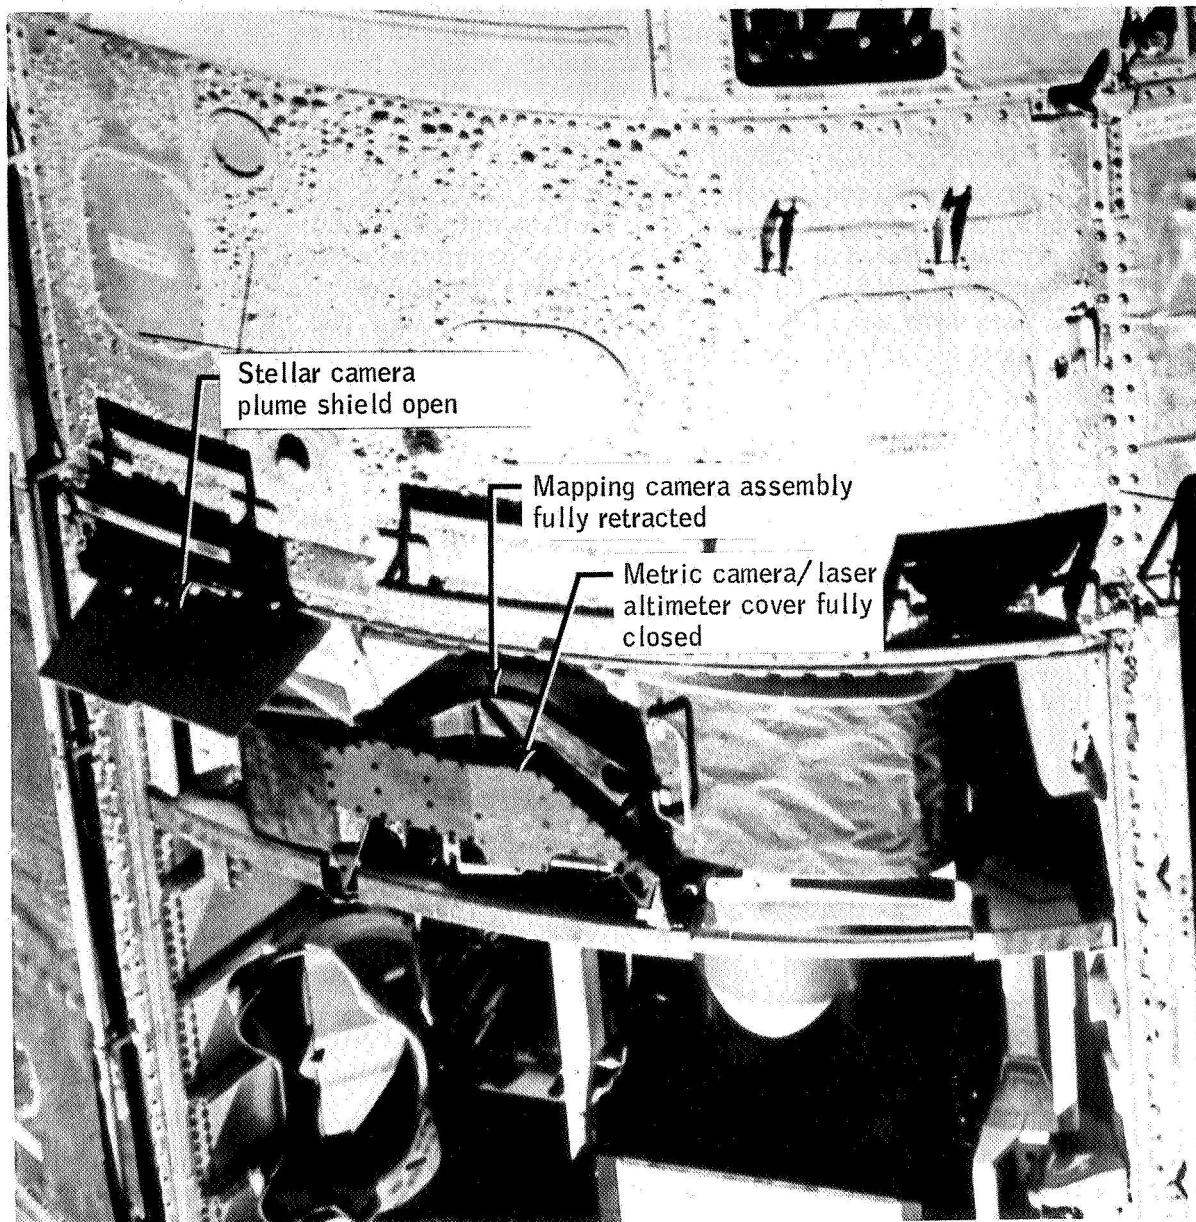
Figure 9.- Plume shield open during rendezvous on the Apollo 17 mission.

Deployment and retraction cycling was minimized during the Apollo 17 mission because of the problems experienced with the mapping camera assembly on the two previous missions. After a normal first deployment, the retraction time was a few seconds longer than normal. The second deployment and retraction time was 3 minutes and 20 seconds, and about 4 minutes, respectively. The third deployment time was normal. The final retraction again required a greater length of time than normal. In addition, photography of the service module taken during rendezvous operations (after the second deployment, but before the second retraction) showed that the stellar camera plume shield was either jammed or stuck open, even though the camera assembly was fully retracted (fig. 9). However, during the transearth extravehicular activity, the stellar camera plume shield was closed and all other visible equipment in and around the camera assembly appeared normal. The failure mode that caused the shield to remain open on the previous deployment cycle was apparently overcome during the final deployment cycle.

Because of the similarity of symptoms in the deployment/retraction times on the Apollo 15, 16, and 17 mission; the crushing of the stellar camera lens glare shield on Apollo 16 mission, and the unretracted plume shield on the Apollo 17 mission; a common cause is most likely. However, analyses and ground tests have failed to identify the exact cause of the problem.
