MSC-07571

APOLLO 16 MISSION  
ANOMALY REPORT NO. 3

INERTIAL SUBSYSTEM WARNINGS AND  
COUPLING DATA UNIT FAILURE INDICATIONS

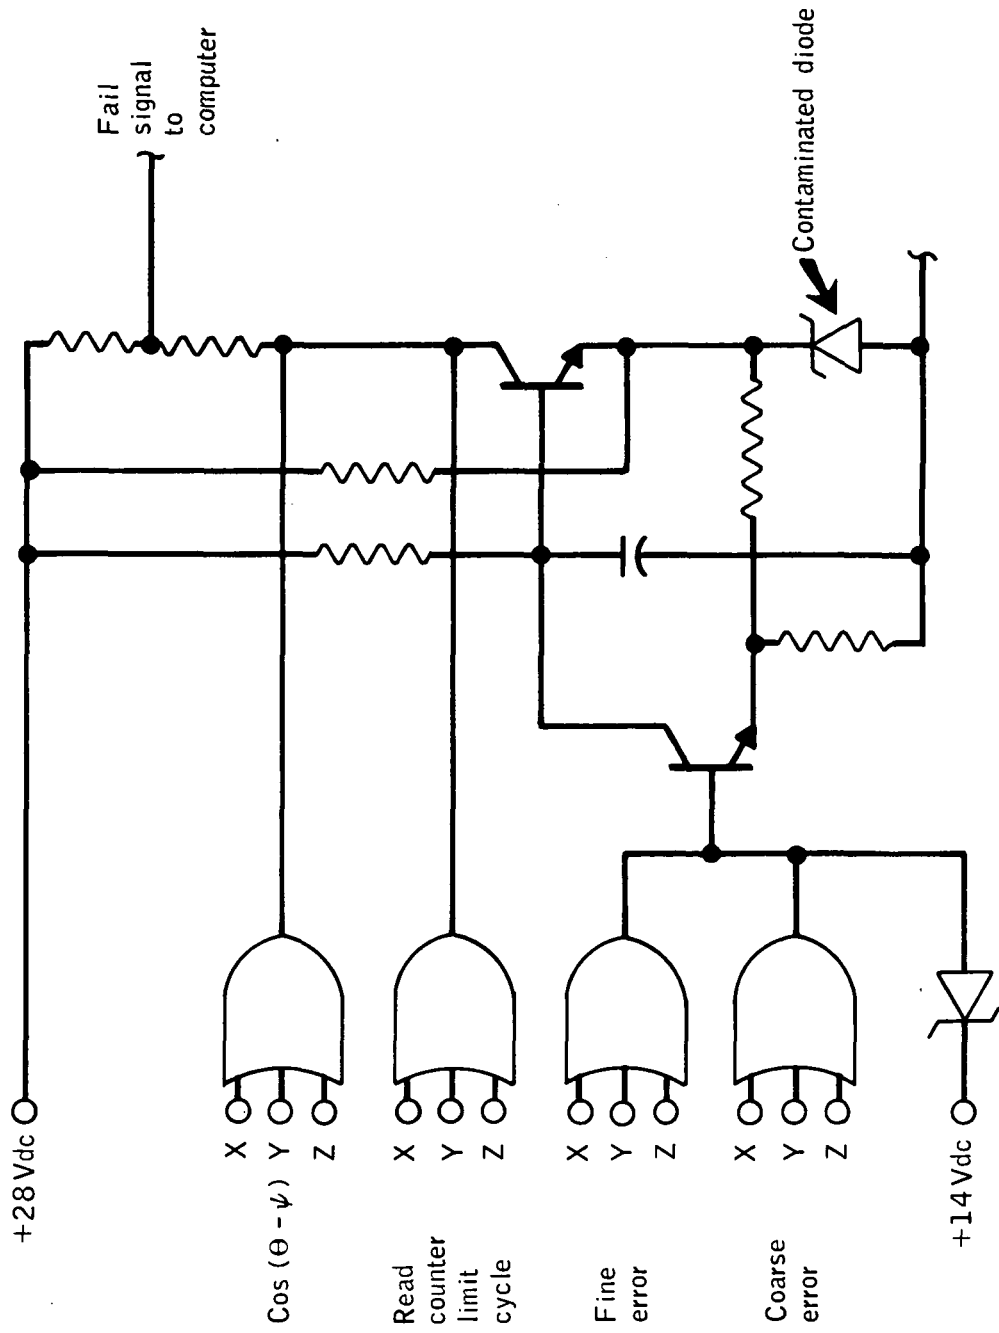
Figure 2.- Fail detection circuit.

Only one component defect was observed. A glass-body zener diode (fig. 2) contained a loose conductive silicon particle, approximately 1 mil by 5 mils, which was large enough to short the diode. Figure 3 shows the diode with the particle in it. If this diode shorted intermittently, the flight indications would result.

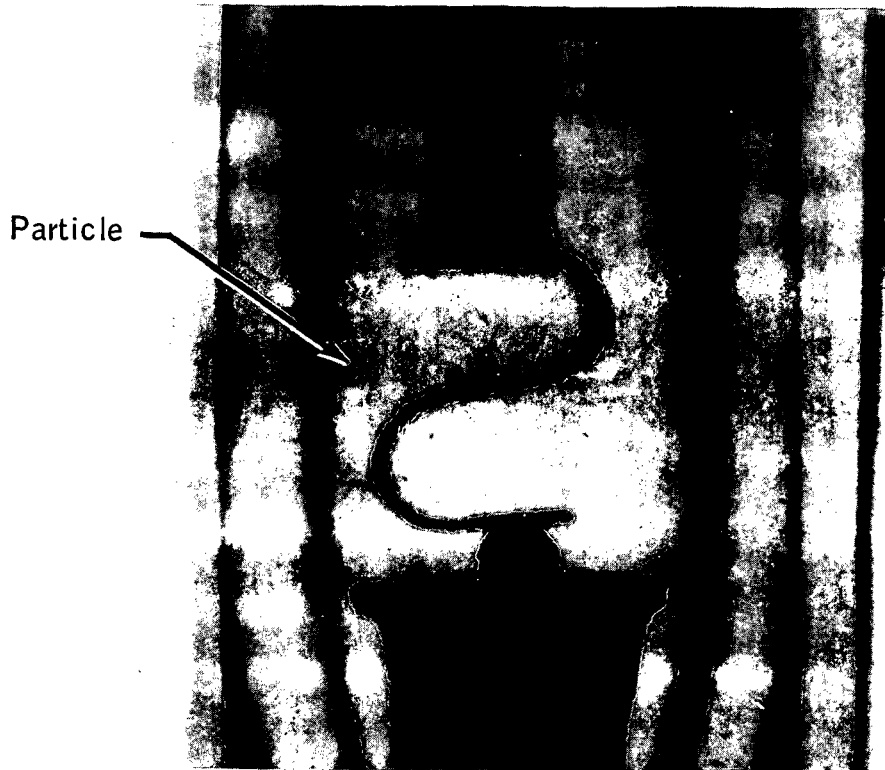
Figure 3.- Conductive particle in glass-body zener diode.

Conductive contamination in a zener diode in the failure-detect circuit of the coupling data unit assembly most likely caused the problem since the conductive contaminant was free to move and could have shorted the diode.

No corrective action will be taken because an intermittent short in any of the guidance system applications of this type of diode would not create a hazard to the crew. In any event, the cost of replacement of all the diodes of this type would be prohibitive.
