**NASA TN D-7437**

# APOLLO EXPERIENCE REPORT -EARTH LANDING SYSTEM

by Robert B. West Lyndon B. Johnson Space Center Houston, Texas 77058

NATIONAL AERONAUTICS AND SPACE ADMINISTRATION • WASHINGTON, D. C. • NOVEMBER 1973

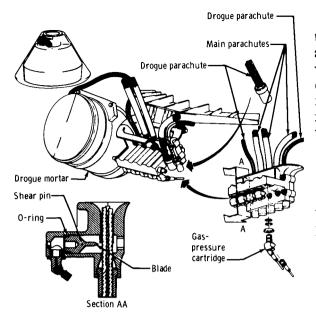
Figure 6. - Parachute attachment and disconnect fitting.

In several of the Block II aerial drop tests incorporating the flowerpot parachute attachment fitting, numerous cable strands were damaged on the drogue risers. This damage occurred in the portion of the cable riser that contacted the lip of the flowerpot fitting while the vehicle was oscillating and the parachute loads were high.

Laboratory tests were conducted to simulate the dynamics between the drogue steel-cable riser and the flowerpot fitting with loads applied to the riser. As the parachute loads were applied through the riser over the lip of the flowerpot, these tests revealed sufficient deflection in the flowerpot lip to cause a local misalinement between the two halves, resulting in a slight ridge over which the cable was abraded. Abrasion was also caused when the four strands of cable in a riser arranged themselves such that one cable would be loaded across another while bent over the lip of the flowerpot.

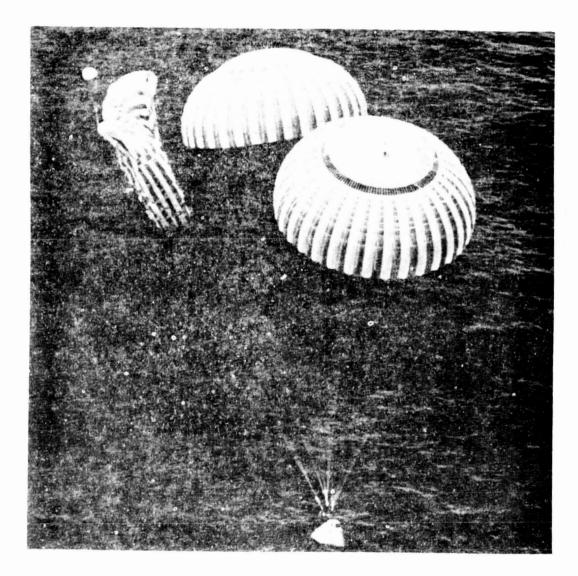
3. The most probable cause of the anomaly was burning monomethyl hydrazine (expelled from the CM RCS) coming in contact with the main-parachute fabric riser. A complete description of this anomaly and the subsequent findings and corrective actions are presented as appendix C.

Figure 1.- Spacecraft descending with one main parachute failed.

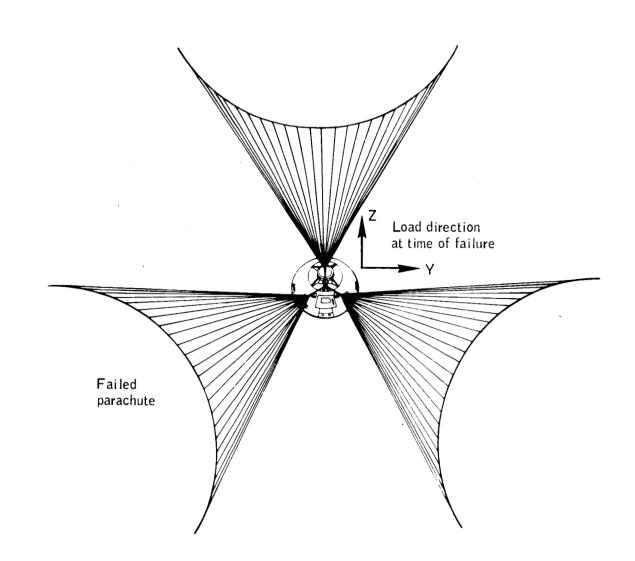
Figure 4.- Parachute location at time of failure.

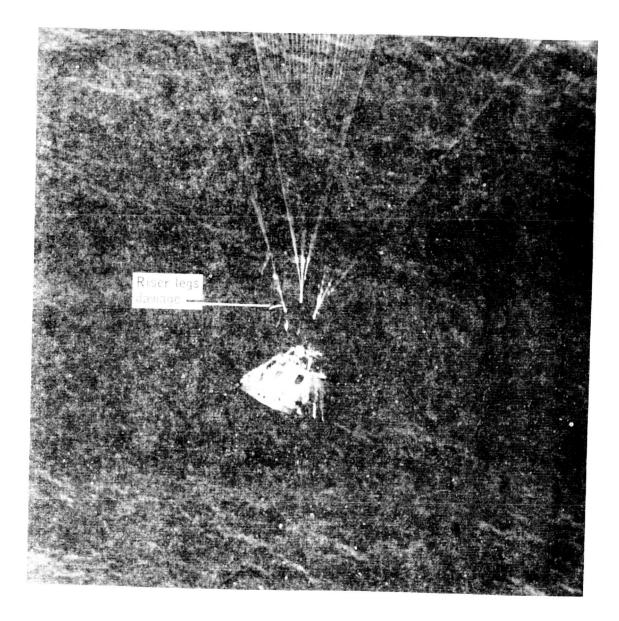
Figure 5 shows the spacecraft and lower parachute system when the spacecraft was relatively close to landing. The following observations resulted from study of this figure and other photographic data.

Figure 5.- Parachute riser damage during final descent.

a. Apparently three of the six legs of the fabric riser were taking the load.

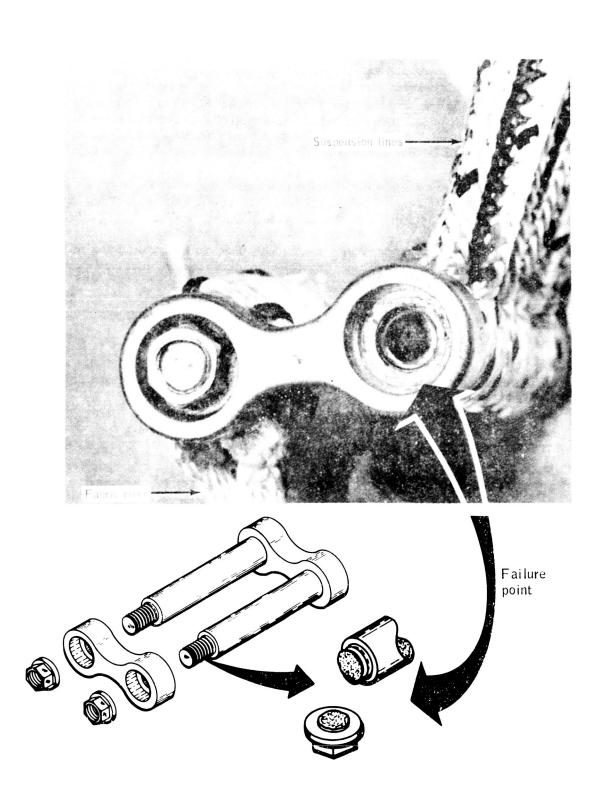
2. Although faulty connector links were found in the recovered main parachute, failure of connector links did not cause the main parachute to collapse.

Figure 7.- Main parachute connector link failure.

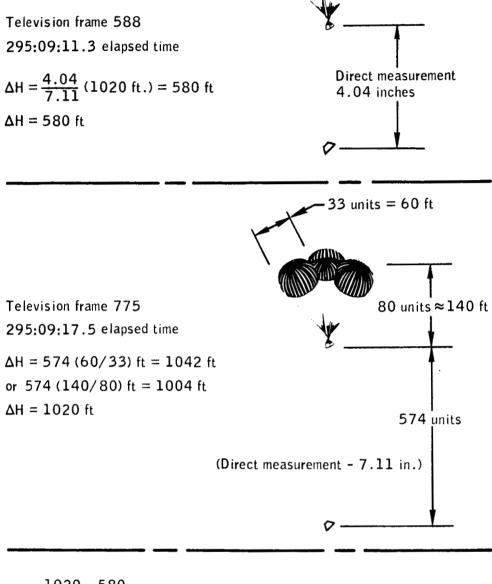
The position of the forward heat shield relative to the guidanceand-navigation-estimated trajectory is shown in figure 10. By extrapolating the forward heat shield trajectory, the forward heat shield would have intercepted the spacecraft at 295:09:03. This is 10.5 seconds before the spacecraft data indicate the anomaly occurred.

Figure 9.- Television frame and trajectory analysis.

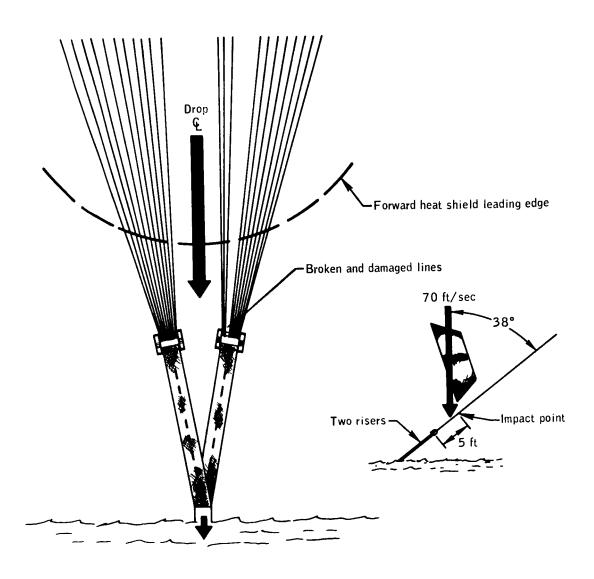
Figure 11.- Results of forward heat shield/suspension system impact test.

These tests showed that the forward heat shield contacting the parachute could damage some of the suspension lines, but would probably not cause a loss of riser legs.

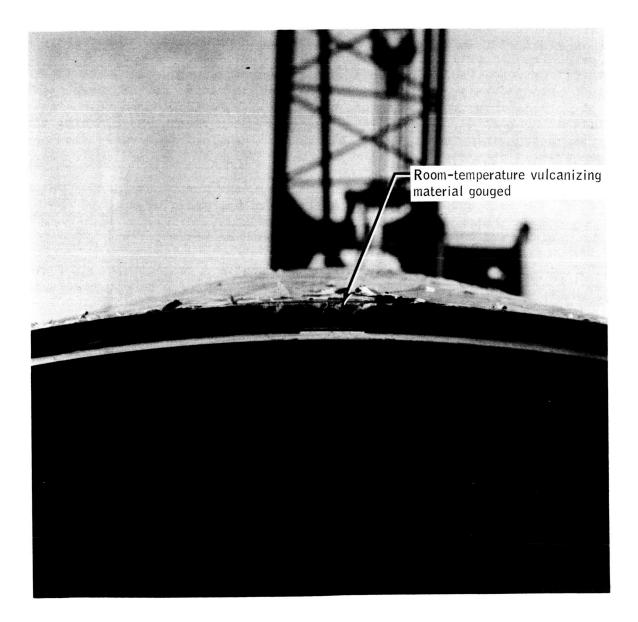
b. Parachute cable riser marks were present on the outside of the forward heat shield. These marks occurred as a result of the normal forward heat shield parachute deployment.

c. The forward heat shield mortar had fired and the ramp had its normal scratches. One pyrotechnic connector was bent, probably as a result of ground handling.

d. The handrail had been severely heated and approximately 7 inches of rail was missing. This condition was caused by reentry heating.

Figure 12.- Forward heat shield damage.

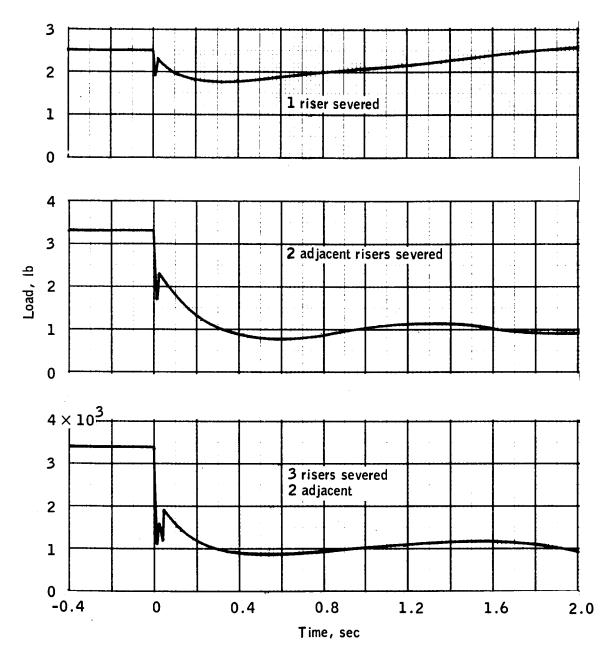
b. The damaged parachute held a position generally above the minus Y roll engines while the fuel expulsion was in progress.

Figure 13.- Parachute tow test loads.

c. Burning fuel can cause damage to the risers, suspension lines, or parachute canopy.
