NASA CR121238

Improvement Program
for
Polycarbonate Capacitors
by

TRW Capacitors

NASA LEWIS RESEARCH CENTER
Contract NAS 3-15688

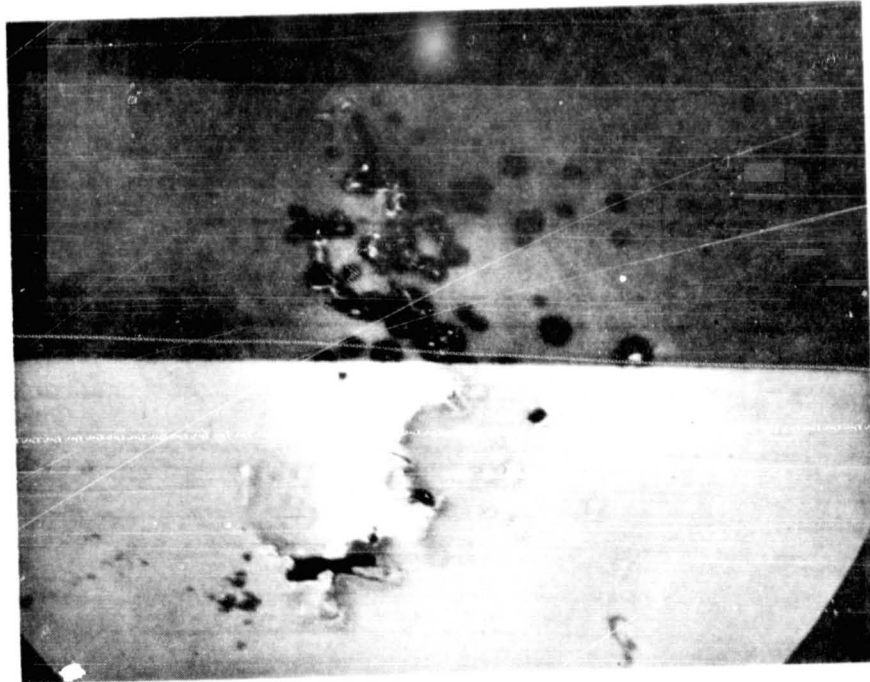
Ser. No. 27EXP04

The material used in the design was 4 layers of .0127 mm (.00050") thick metallized polycarbonate. The defect in the material was determined to be too much solvent in the film such that when the parts were exposed to test temperatures, the solvent outgassed. The production of gaseous molecules within the winding then set up conditions necessary in the presence of test voltage for ionization of the gaseous molecules to take place and the consequences of corona caused eventual failure of the capacitor. Samples of the dielectric were sent to outside sources for comment on the failure mechanism. One outside source suggested it was corona alone and suggested that we build some capacitors of the 0.25 uF metallized design and do not impregnate or enclose them so that we could see that corona would destroy them in rapid order. We built capacitors using raw material from the old contract plus other capacitors from the surplus material on hand for the current contract. They were wound, schooped, and terminated and were then subjected to 1000 hours at 368 volts rms at 400Hz and 125°C. Not a single failure occurred. Some of the parts were torn down and there was no evidence of any spots, holes, or corona. If outgassing had occurred, the gaseous molecules would have escaped since the windings were not encased. Therefore, ionization did not occur. On the regular NASA test parts, designs 3P and 3S, the gaseous molecules produced had no place to go since the windings were sealed and therefore ionization (corona) was initiated and led to capacitor failure.

Figure 17. Dielectric failure as a result of solvent outgassing and subsequent corona from ionization of gaseous molecules produced. Design 3P. Magnification 21X. Refer to Failure Analysis #8.

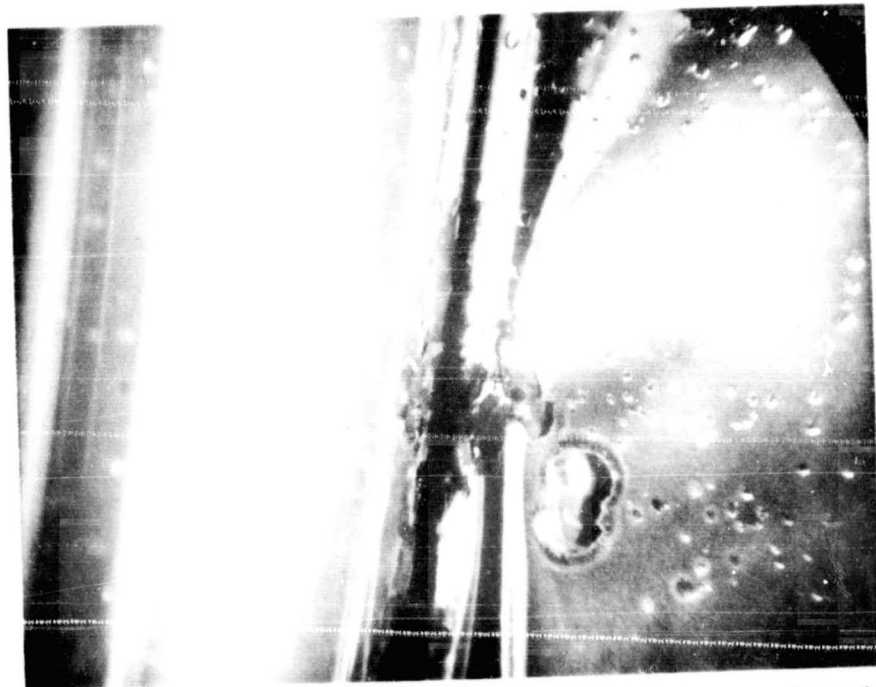
Ser. No. 26FXP03

Figure 18. Another example of outgassing and subsequent effects on design 3P. Magnification 7½X. Refer to Failure Analysis #10.

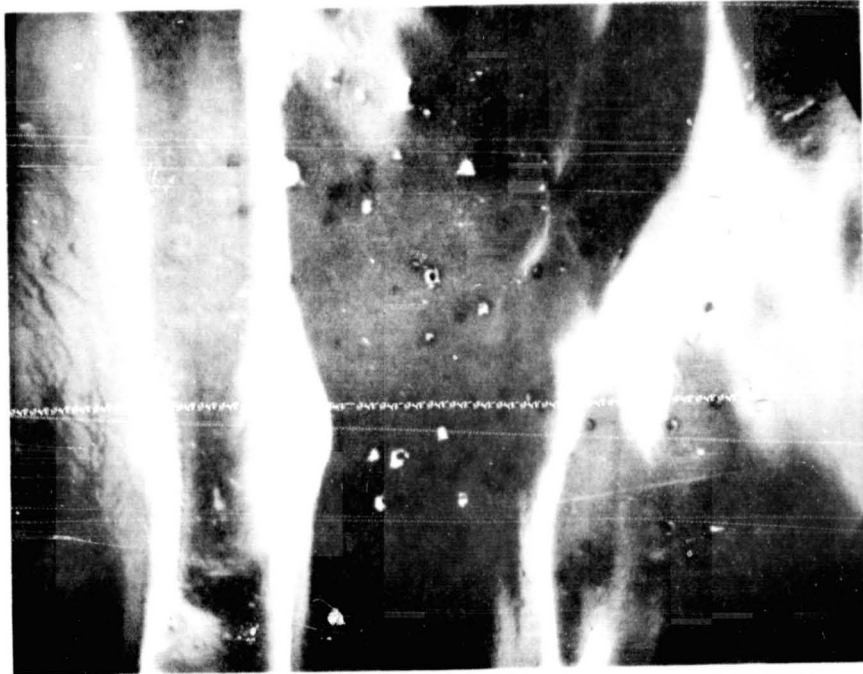
Ser. No. 26FXP01

Figure 19. Dielectric failure as a result of solvent outgassing and subsequent corona from ionization of gaseous molecules produced. Design 3P. Magnification is 13X. Refer to Failure Analysis #14.

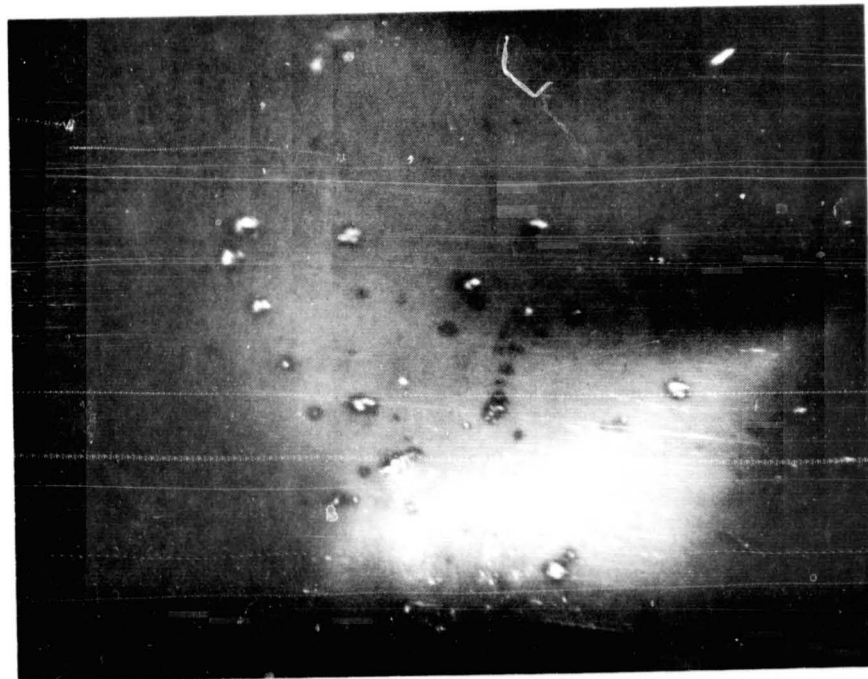
Ser. No. 27EXS07

Figure 20. Failure for same reason as on Figure 19 above but for a design 3S. Magnification 9X. Refer to Failure Analysis #16.

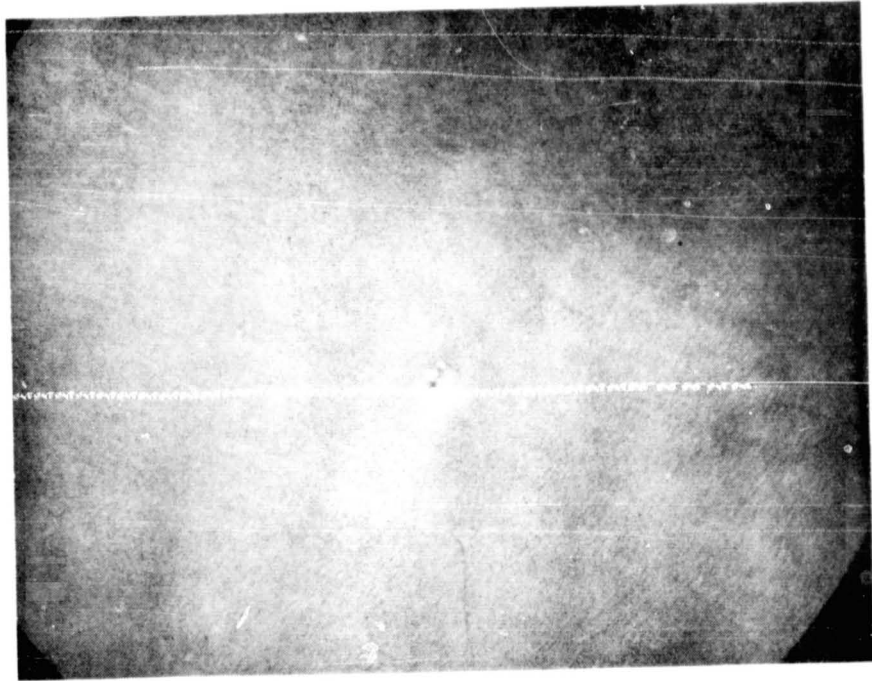
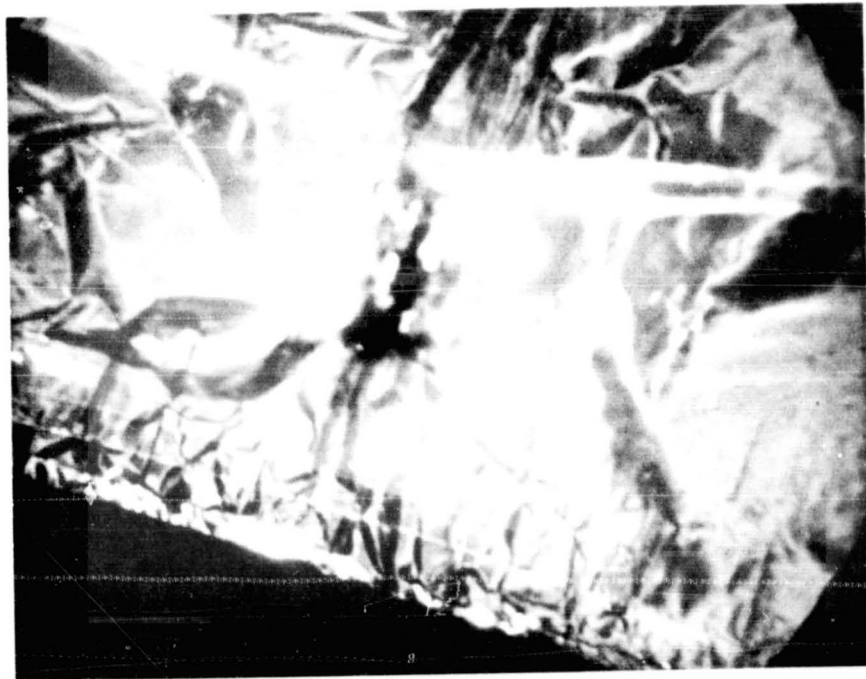
There was one failure - design 2S - in which there was scant evidence of why the capacitor failed but 2 or 3 particles similar to that photographed and shown in Figure 21 were found in the winding. See

Failure Analysis #31 in Appendix B. The particle could have been in the material when purchased or could have been trapped in the winding during manufacture. The latter seems unlikely since all parts were built in a clean room with operators wearing white non-linting type gloves.

Figure 21. Two or three small particles were found in a design 2S as in the top photograph and the main failure area is shown in the bottom photograph. Refer to Failure Analysis #31.

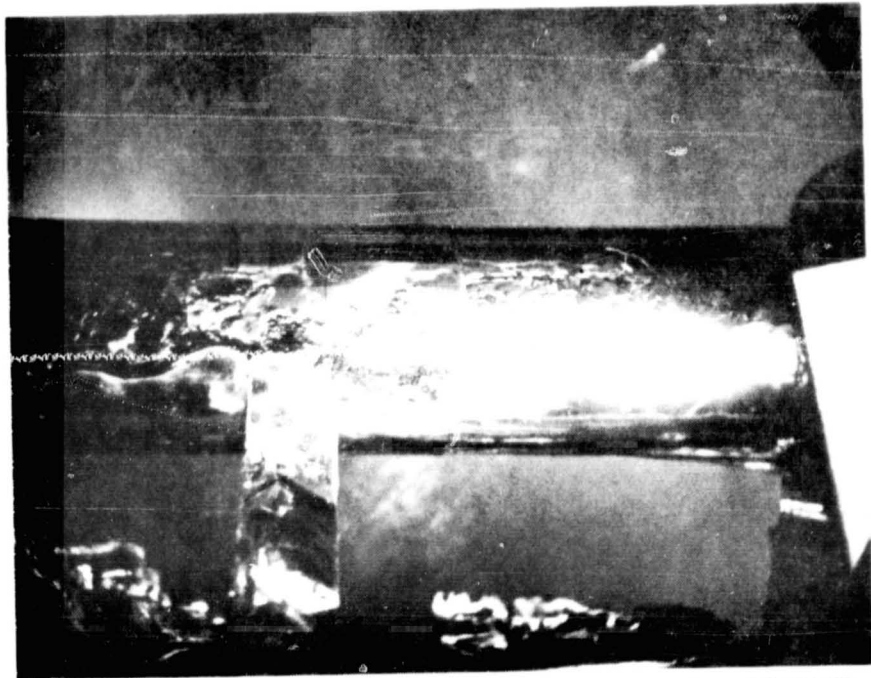
Ser. No. 26FXS05

Figure 22. An infantile failure which occurred within 8 hours. The winding is badly charred. Magnification $5\frac{1}{2}X$. Design is 3P. Refer to Failure Analysis #1.

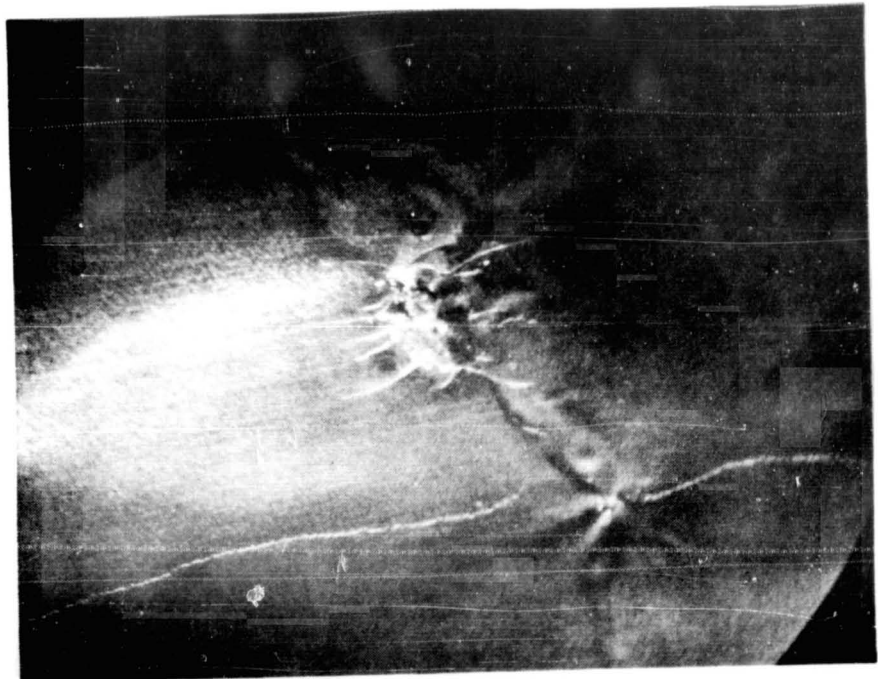
Ser. No. 24BFS14

There were 2 failures - one at 8 hours on design 3S and one at 1005 hours on design 2S in which no definite reason for failure could be determined other than a weakened area in the dielectric coupled with the oven temperature raising to 134°C for a short period of time could have been responsible. Figure 22 is of the design 3S which failed in 8 hours (an infantile failure) and Figure 23 is of design 2S. The detailed analyses are Failure Analysis #1 and #13 provided in the Appendix. It is highly probable that the infantile failure was due to the solvent outgassing mentioned previously since it had been subjected to 350 hours of burn-in at 125°C.

Figure 23. Failure attributed to weak dielectric and possibility of oven overheating contributing to a hot spot near the core. Magnification 22X. Design 2S. Refer to Failure Analysis #13.

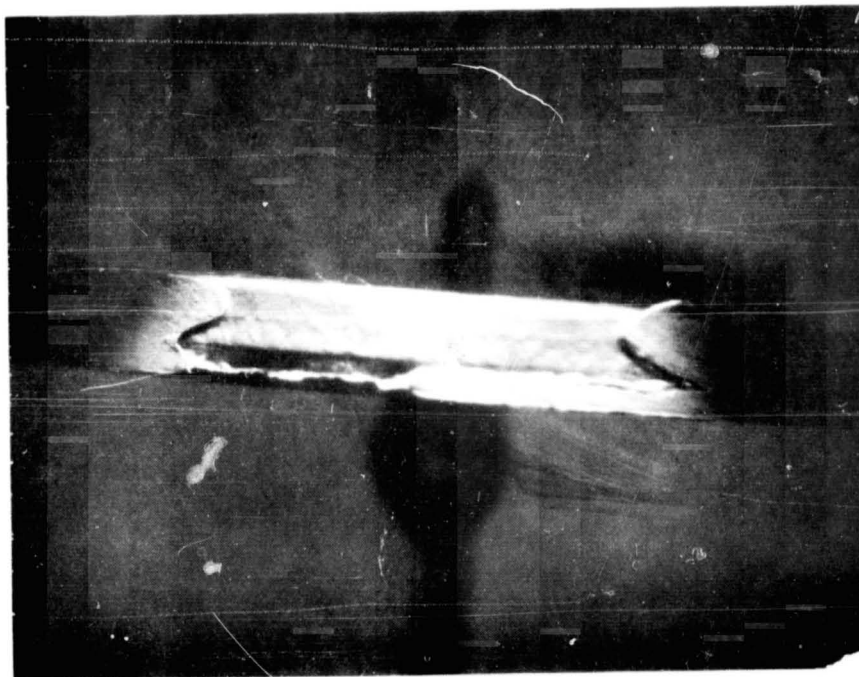
Ser. No. 17EXP03

- b. Insufficient solder bond - eyelet rim to tube. This failure mechanism was found in the previous study. Improvements were realized on this study but the problem was not completely eliminated. A photograph as shown in Figure 25 illustrates insufficient solder run-down along the circumference of the eyelet rim. Generally, the solder adhered very well to the brightly tin plated tubes. Part of the problem is human error since they were hand soldered and the capacitor was turned too fast for the amount of solder applied, resulting in insufficient solder run-down. The other problem is that any difficulty with insufficient bond of eyelet rim to tube almost always occurs on the second eyelet to be soldered. The impregnant and liquid fill present gets hot, attempts to push its way out, and may interfere with proper solder run-down. For details, see Failure Analysis #35 in the Appendix.

Figure 25. This photograph shows incomplete solder run down along eyelet rim resulting in a leaky seal such as described in Failure Analysis #35 as a cause of failure. Note - The photograph is of a design 3P which failed because of outgassing but the photograph served to illustrate the poor seal defined as the problem in Failure Analysis #35 on a design 1S.
