REVIEW OF HYDROGEN ACCIDENTS AND INCIDENTS IN NASA OPERATIONS

by Paul M. Ordin

Lewis Research Center

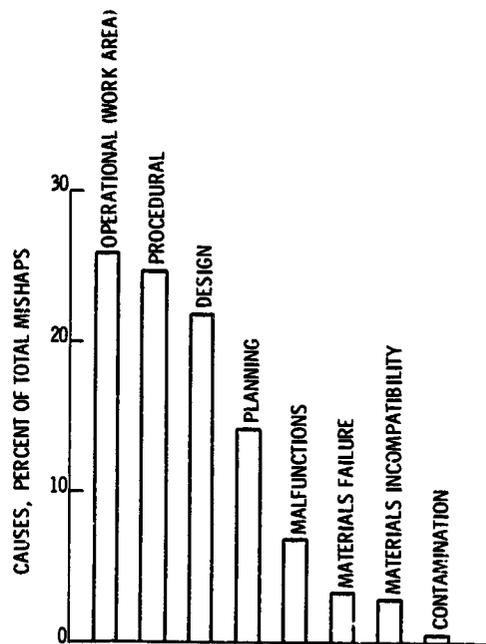
The largest number of mishaps (26 percent) was considered to be caused by work area deficiencies. Procedural deficiencies accounted for 25 percent. Design deficiencies were responsible for 22 percent. Planning deficiencies followed next with 14 percent. These four categories, which are basic to an overview of safety requirements for any type of engineering system, were responsible for 87 percent of the mishaps reviewed. Malfunctions were involved in about 8 percent of the accidents, while problems concerned with materials failures and materials incompatibilities were each factors in about 3 percent of the mishaps.

Figure 1. - General distribution of causes of mishaps with hydrogen - (more than one cause factor is involved with most mishaps).

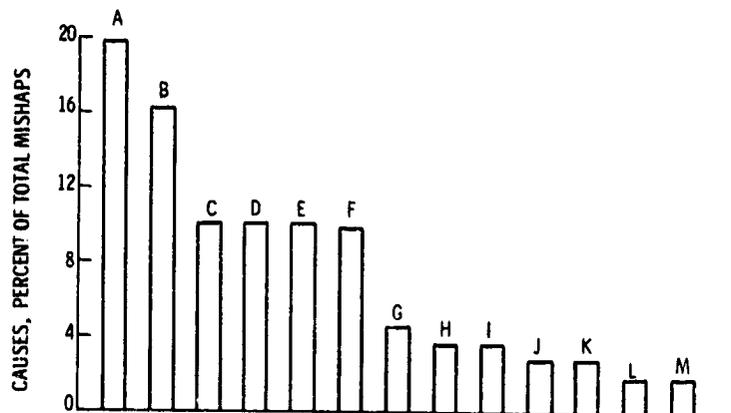
Valve malfunctions and/or valve leaks were considered as being responsible for 20 percent of the mishaps. These valve malfunctions and leaks, as well as a number of the other specific causes of mishaps, were due primarily to operational (work area), procedural, and design deficiencies. For example, valve malfunctions and valve leaks were caused by

Figure 2. - Detail distribution of causes of mishaps in which hydrogen was released (more than one cause factor is involved with some mishaps).

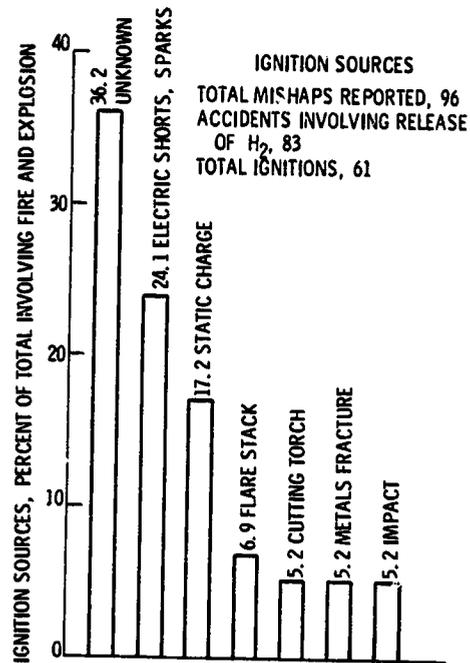
each considered to be responsible for about 5 percent of the ignitions. Ignition of hydrogen-air mixtures attributed to metal fracture involved tensile testing mishaps in which the fracturing of the specimens provided the ignition source. Also included are mishaps in which the cause of ignition was considered to be burst safety disks or metal failures. The specific ignition source was probably the static charges or hot spots that developed during material rupture. Ignitions attributed to impact include those considered to be caused by high-velocity fragments.

Figure 3. - Ignition sources - mishaps involving release of hydrogen.

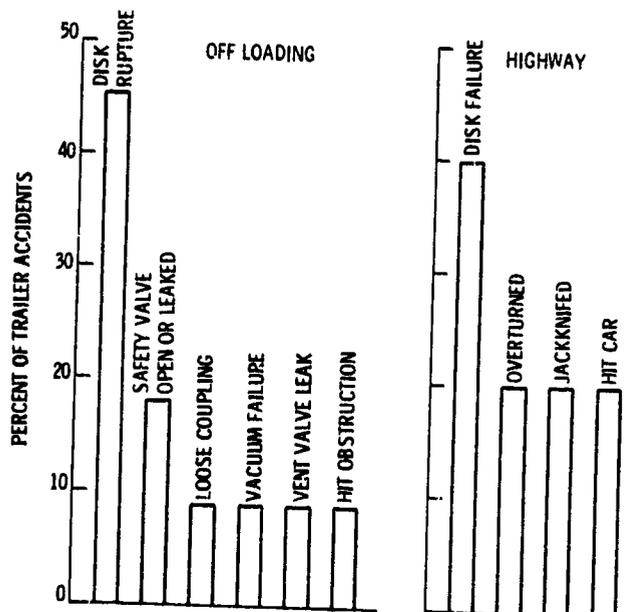
The causes of hydrogen tanker trailer mishaps are summarized in figure 4. Seventeen tanker trailer mishaps were included in the study with 71 percent (12) associated with off-loading operations (usually at the test facility) and 29 percent (5) occurring on the highway. In about 92 percent of the off-loading accidents (11), hydrogen was released, but in only 27 percent (3) did ignition take place. With respect to highway mishaps, 60 percent (3) involved a release of hydrogen, but no ignitions occurred. For both the off-loading and highway mishaps, disk rupture was the principal cause; other causes included open or leaking safety valves (18 percent), loose couplings, vacuum failures, and vent valve leaks. In several instances, positioning the trailer in preparation for connecting lines resulted in the driver hitting parts of the facility.

The safety record of over-the-road transportation of liquid hydrogen is quite evident in that only five tanker trailer highway accidents are included. These reports involved NASA operations. In three of these accidents the tractor was heavily damaged, but the trailer remained substantially sound. There was no damage in the other two highway accidents. In only one case was liquid hydrogen spilled on the ground, and there was no ignition of the hydrogen-air mixture.

Figure 4. - Liquid hydrogen trailer accidents.
