NASA TECHNICAL  
MEMORANDUM

NASA TM X-64825

MSFC SKYLAB CREW SYSTEMS  
MISSION EVALUATION

Skylab Program Office

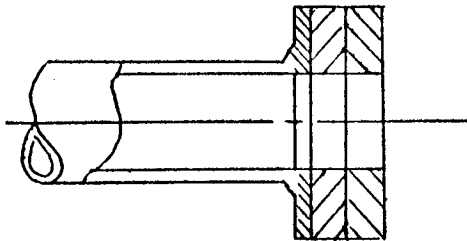
URINE COLLECTION DRAWER NO. 3

LAUNCH CONDITION  
SEALS BONDED TO SUCTION LINE  
FLANGE BECAME DEBONDED

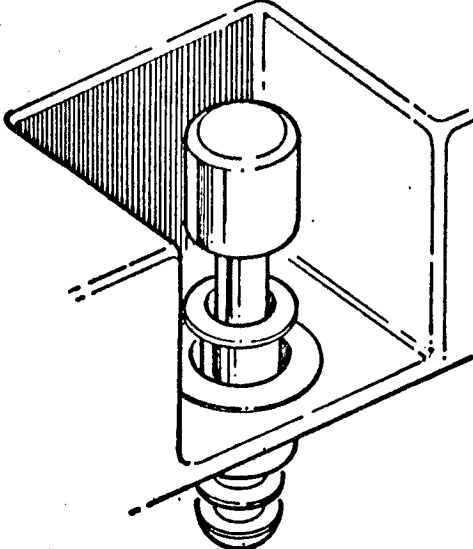
19 RANK	CREW CONSENSUS 2.00 MEAN RATE	DESCRIPTION Push Button Latch FASTENER
COMMENT:	Not positive locking - comes loose when bumped; sometimes jams requiring tool to release; tends to deteriorate with use.

SKYLAB USE: Food Tray lid to tray fastener.
