NASA TECHNICAL NOTE

NASA TN D-7775

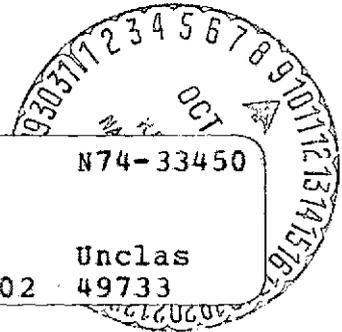
LIGHTNING DAMAGE TO A GENERAL AVIATION AIRCRAFT - DESCRIPTION AND ANALYSIS

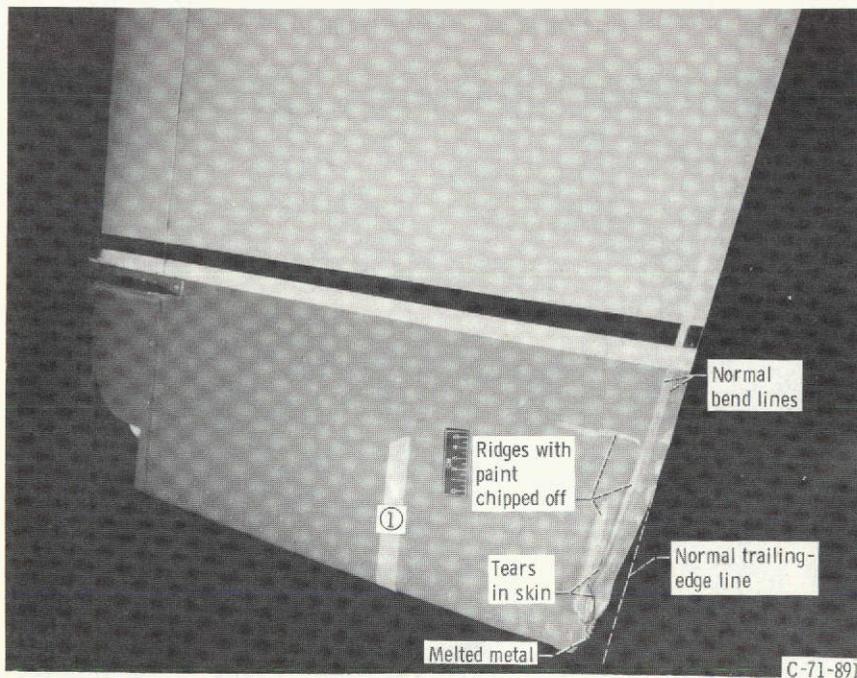
(b) Top surface of wingtip.

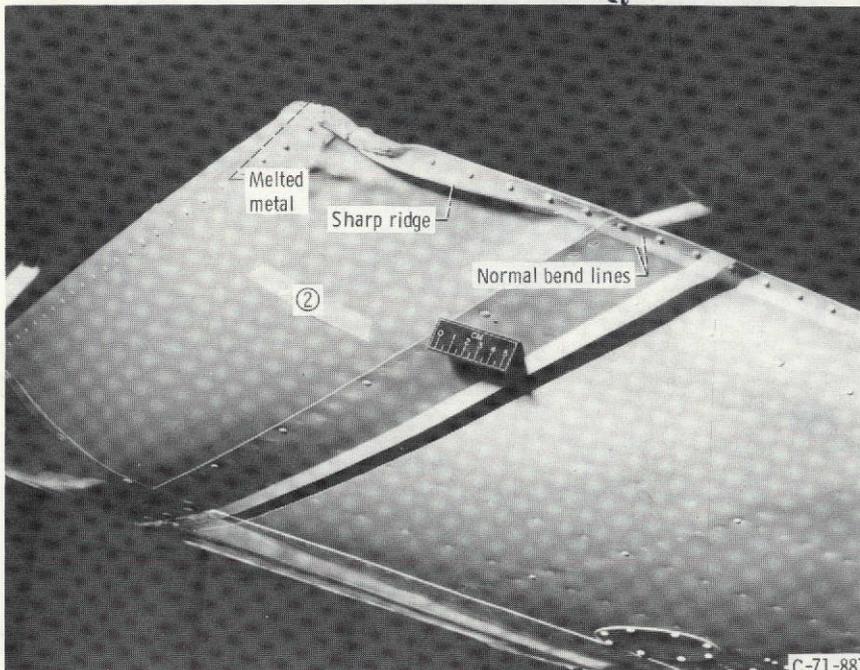
(c) Lower surface of wingtip looking forward.

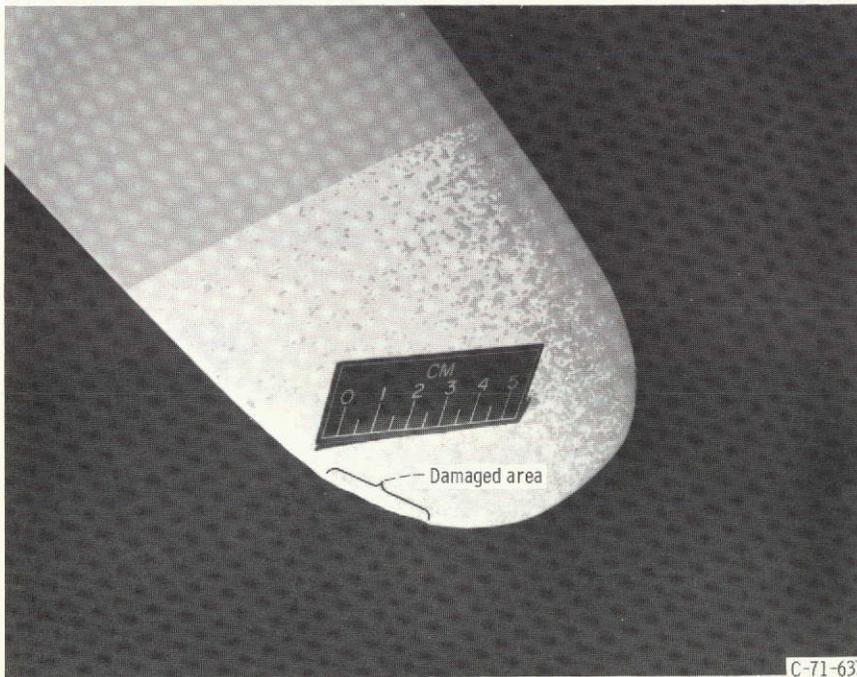
Figure 3. - Tip of blade on right propeller, showing lightning erosion damage.

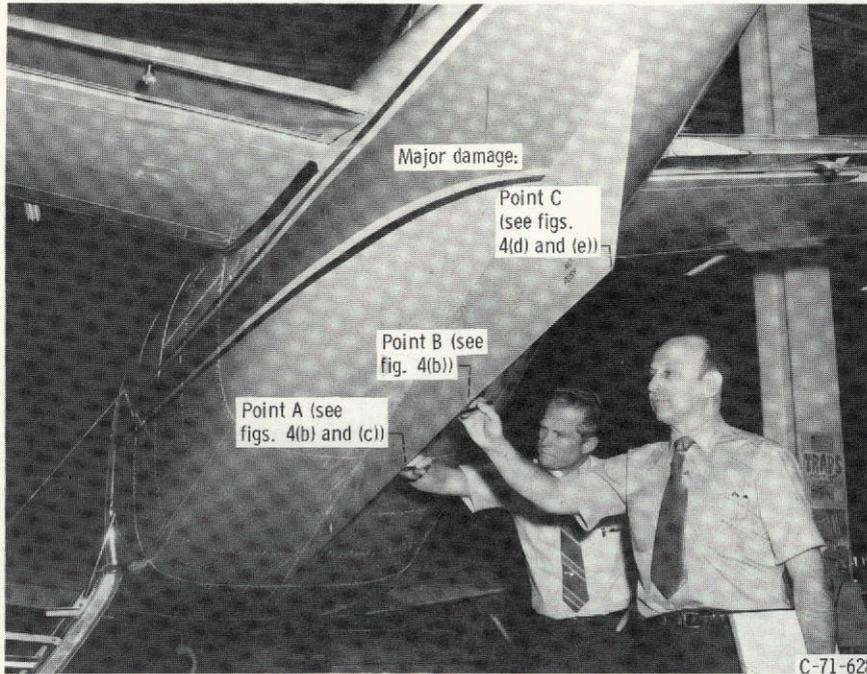
(a) General view indicating location of major damage.

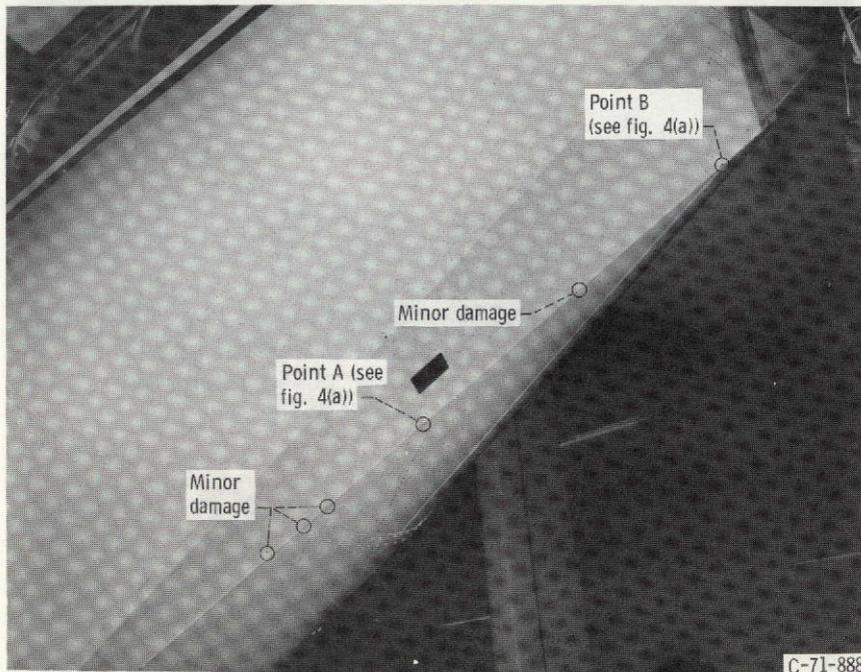
(b) Left side of forward section of fin.

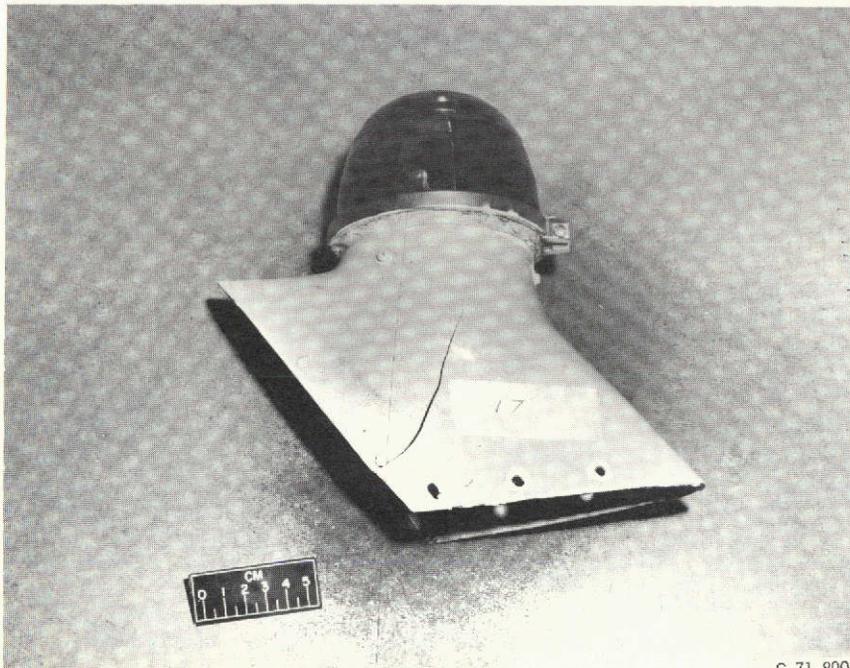
(b) Closeup of light removed from aircraft.

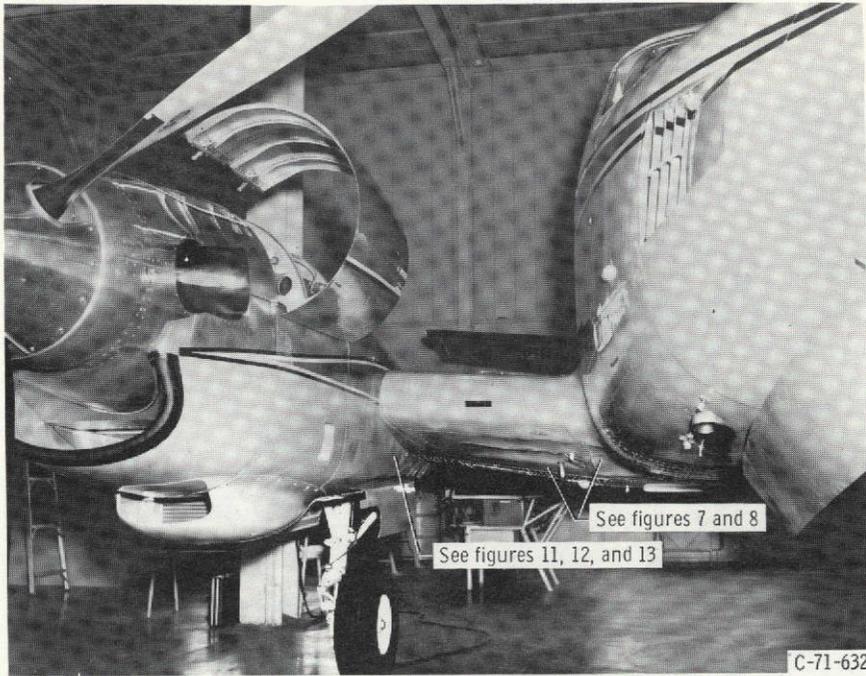
Figure 6. - General view of damage to lower surface of wing and inboard side of engine nacelle.

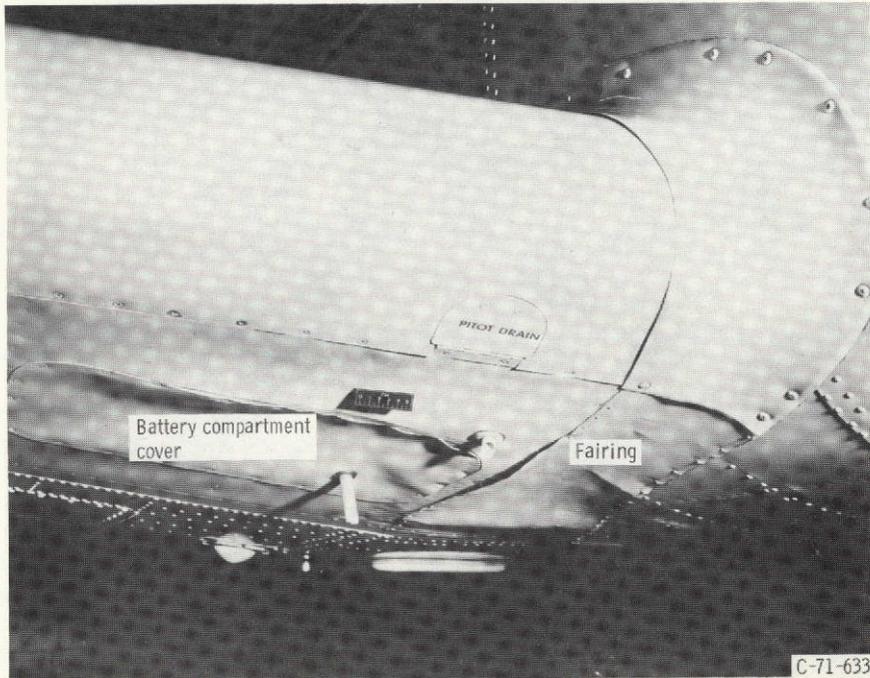
Figure 7. - Damage to battery compartment cover and wing-to-fuselage fairing.

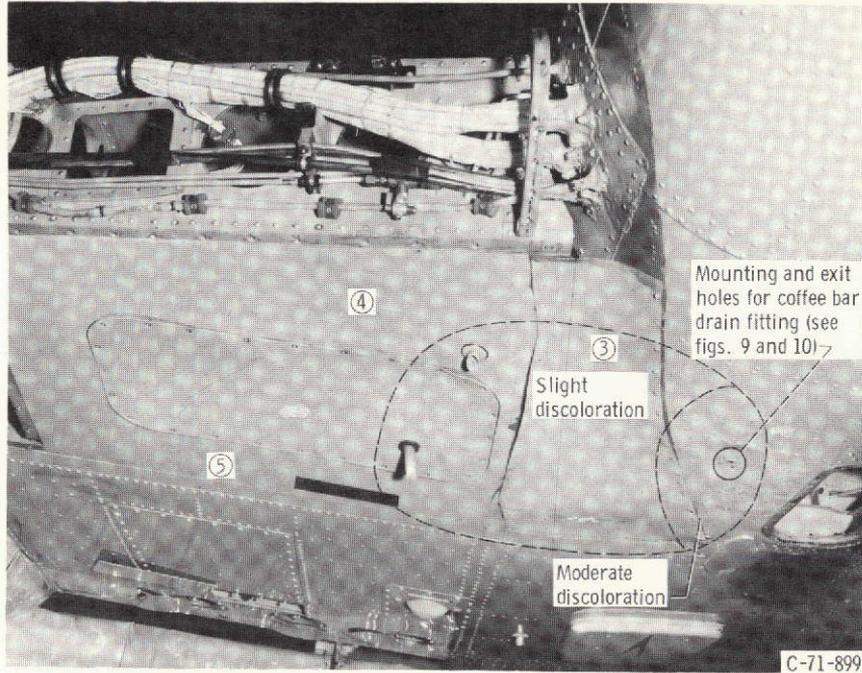
Figure 8. - Area of paint discoloration on wing and fuselage.

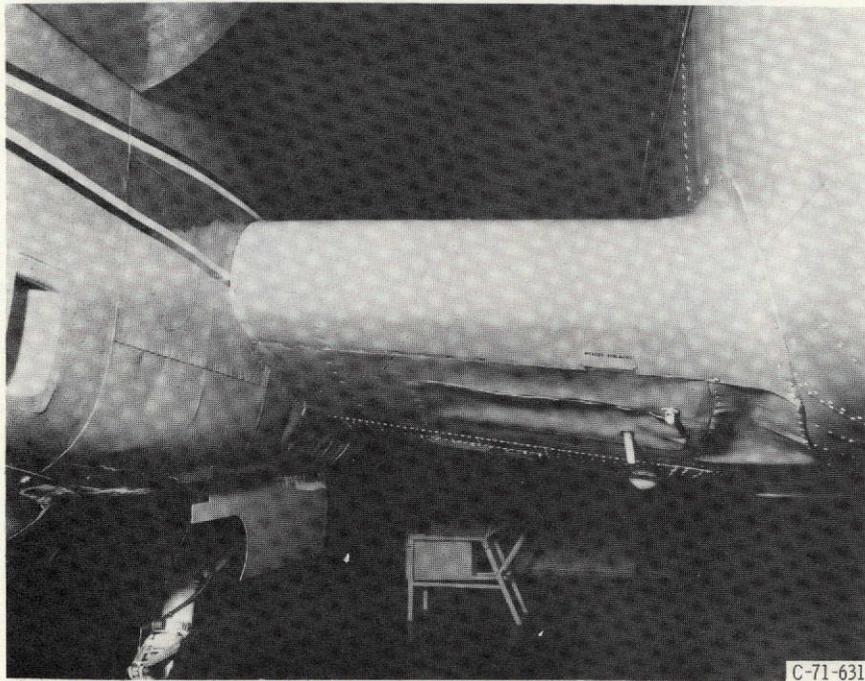
Figure 11. - Damage to lower inboard side of right engine nacelle and wing.

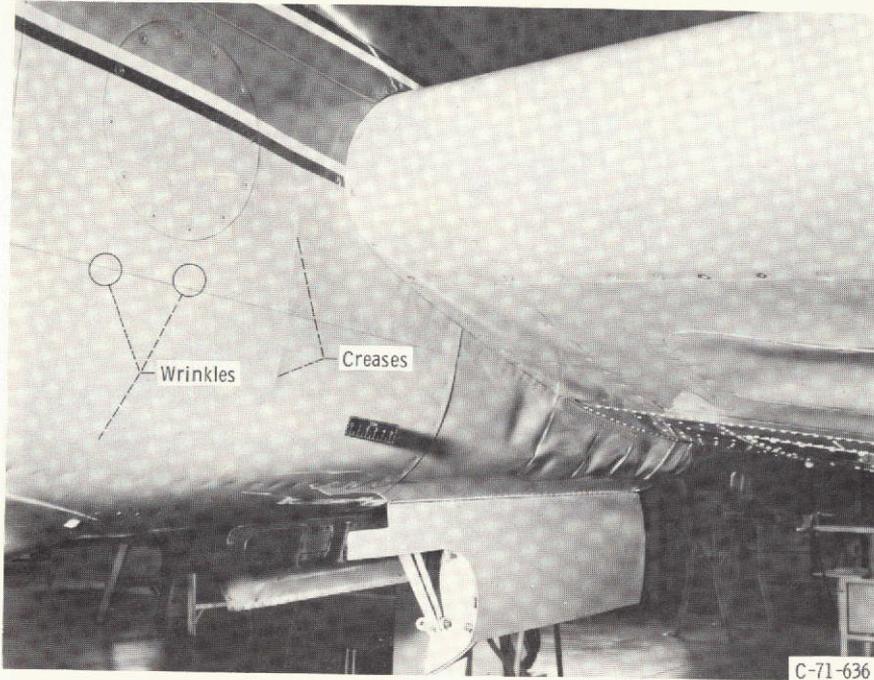
Figure 12. - Damage to lower inboard side of right engine nacelle.

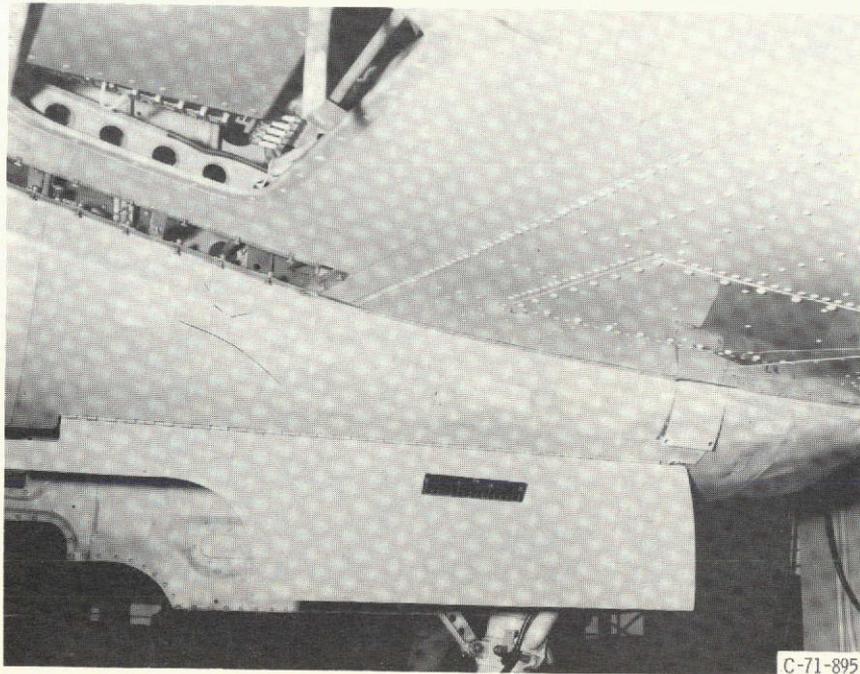
Figure 13. - Inboard view of damage at aft bottom of right engine nacelle. (See also figs. 15 and 16.)

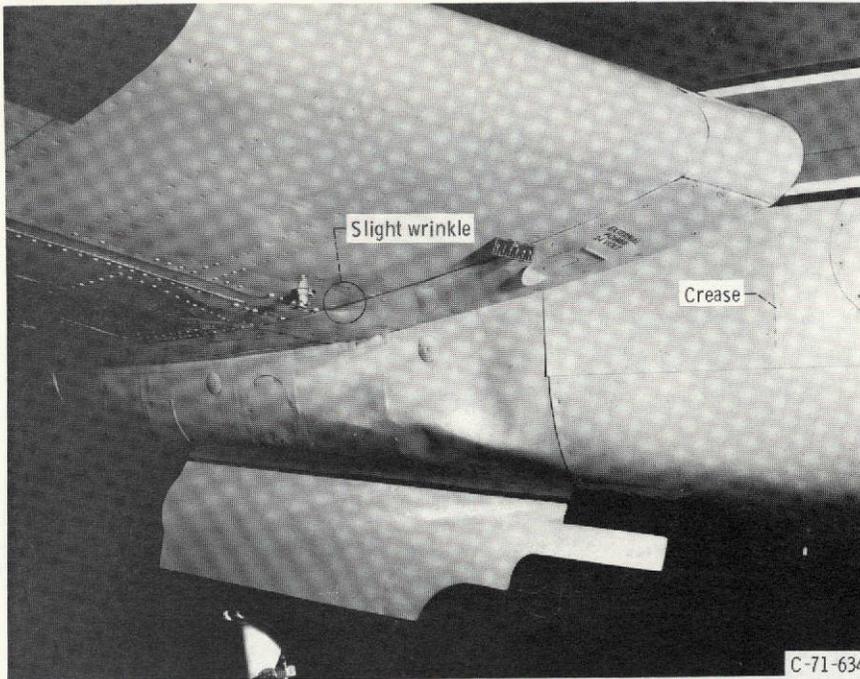
Figure 14. - Damage to outboard bottom side of right engine nacelle and lower wing surface.

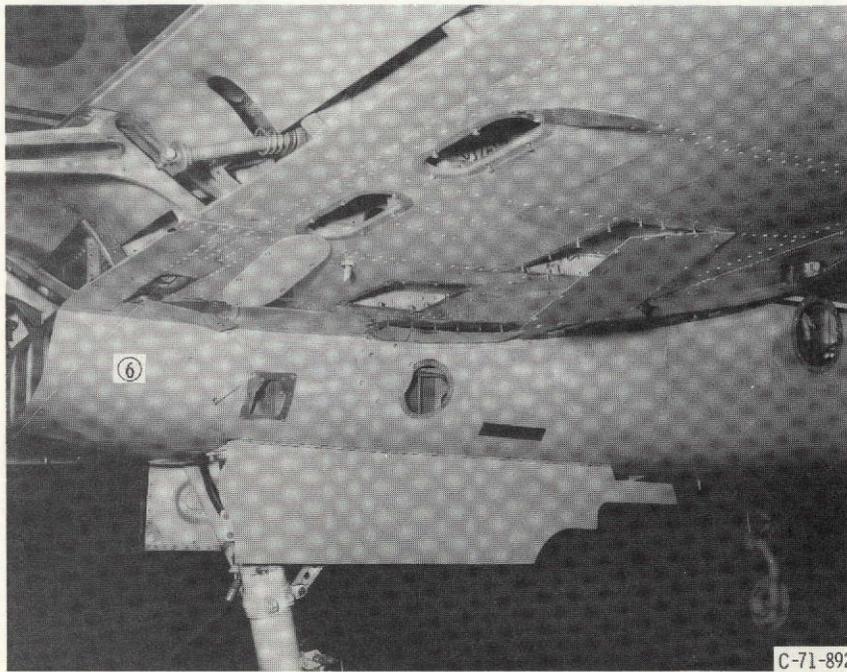
Figure 15. - Outboard view of damage at aft bottom of right engine nacelle. (See also figs. 13 and 16.)

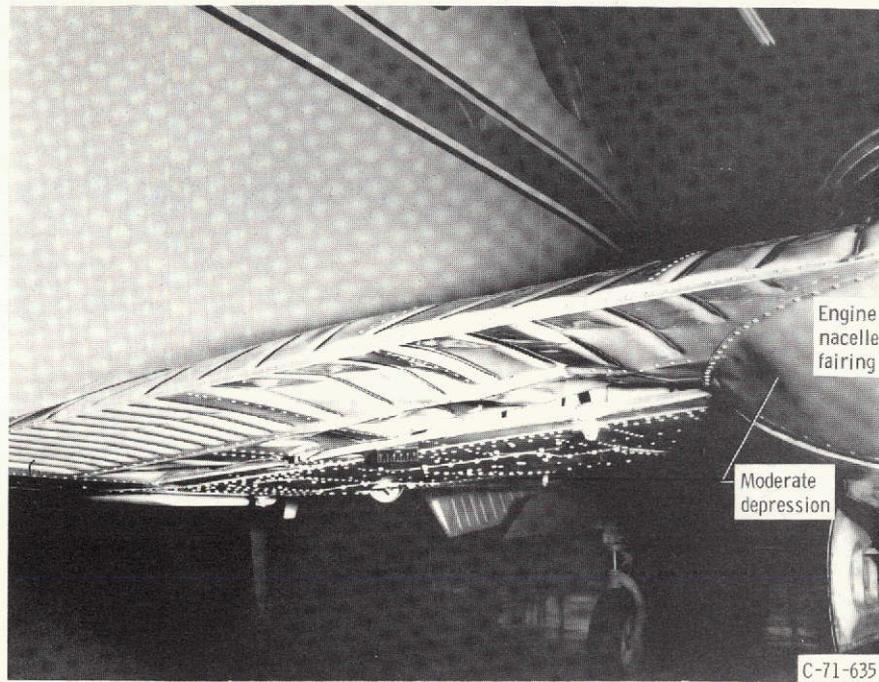
Figure 16. - Forward view of damage to lower surface of right inboard flap and engine nacelle fairing.

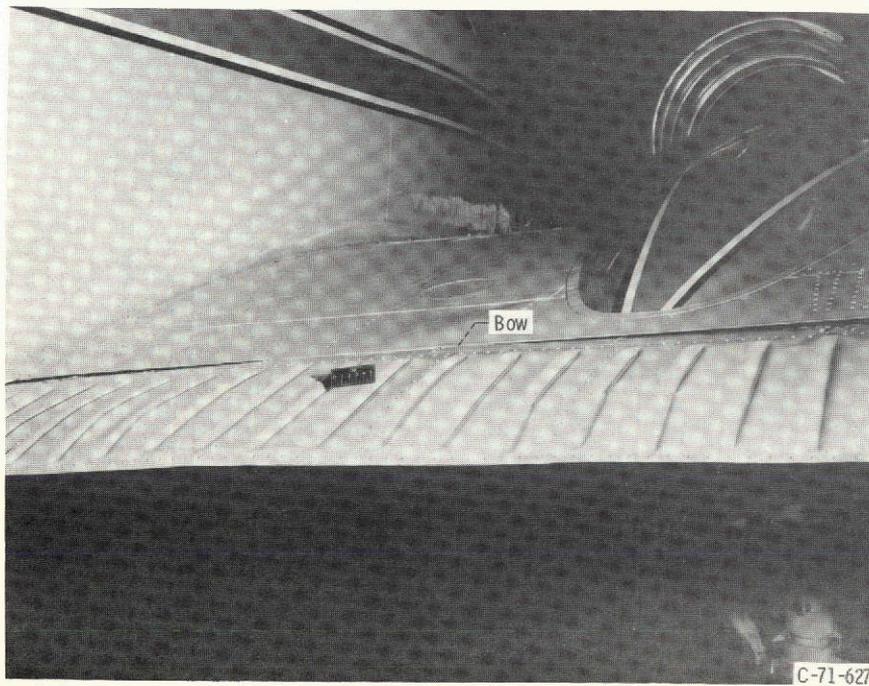
Figure 17. - Damage to top surface of right inboard flap.

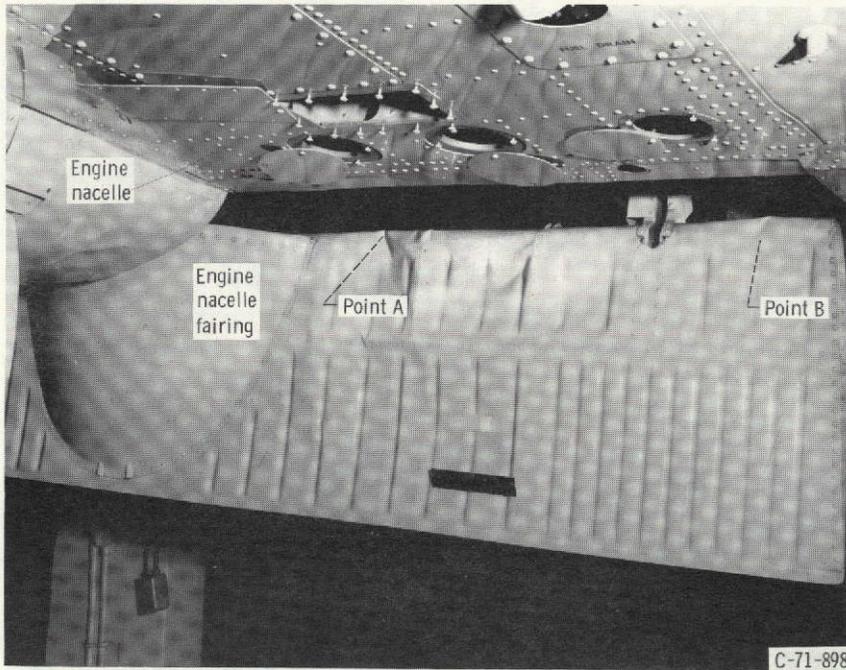
Figure 18. - Rearward view of damage to lower surface of right inboard flap and aft end of engine nacelle. Flap control rod disconnected with flap hanging from flap track. (See fig. 19.)

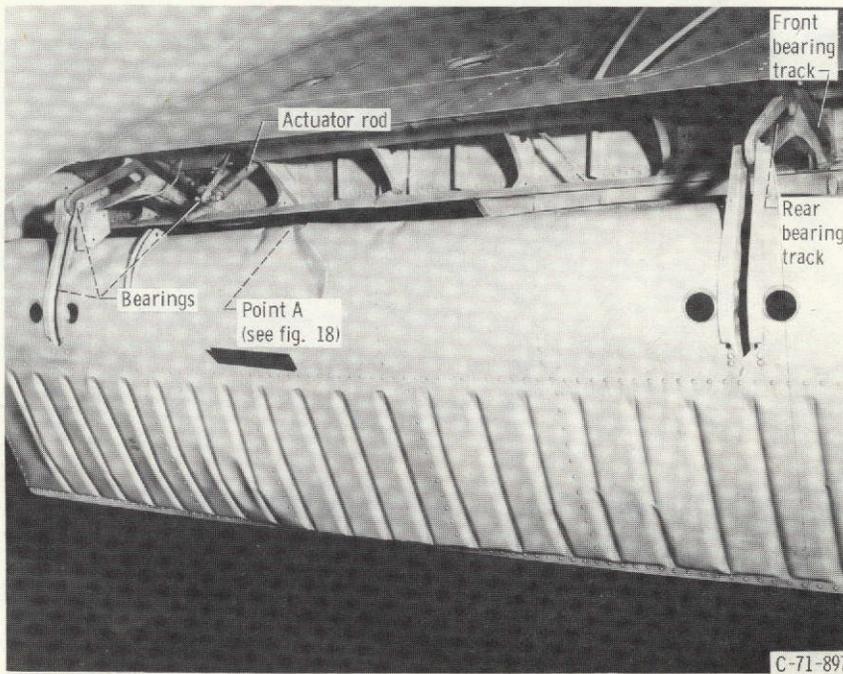
Figure 19. - Damage to top surface and leading edge of right inboard flap. Flap control rod disconnected with flap bearing normally in forward track supporting flap in rear track.

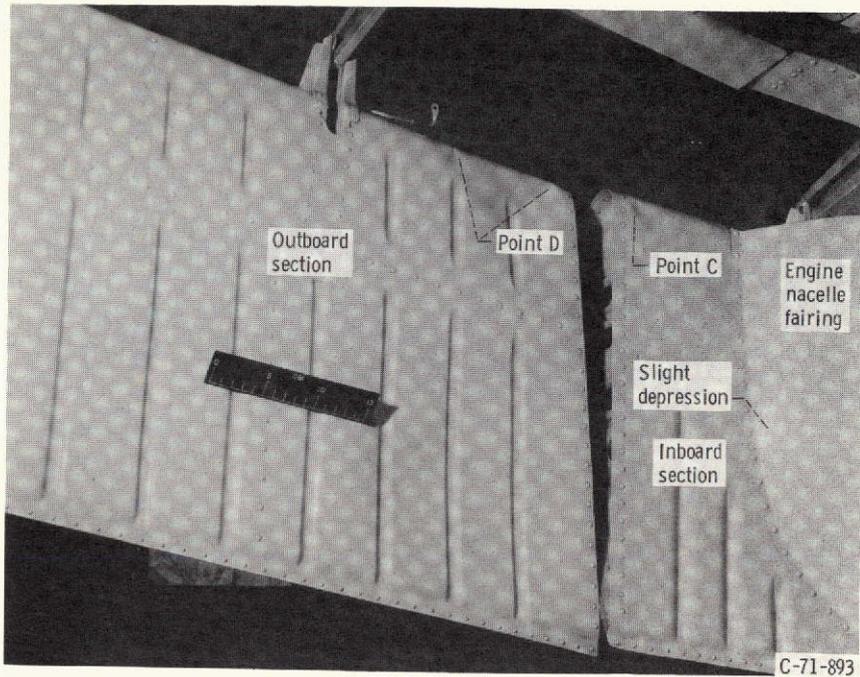
Figure 20. - Damage to lower surfaces of right inboard and outboard flaps. Flap control rod disconnected with flaps hanging from flap tracks.

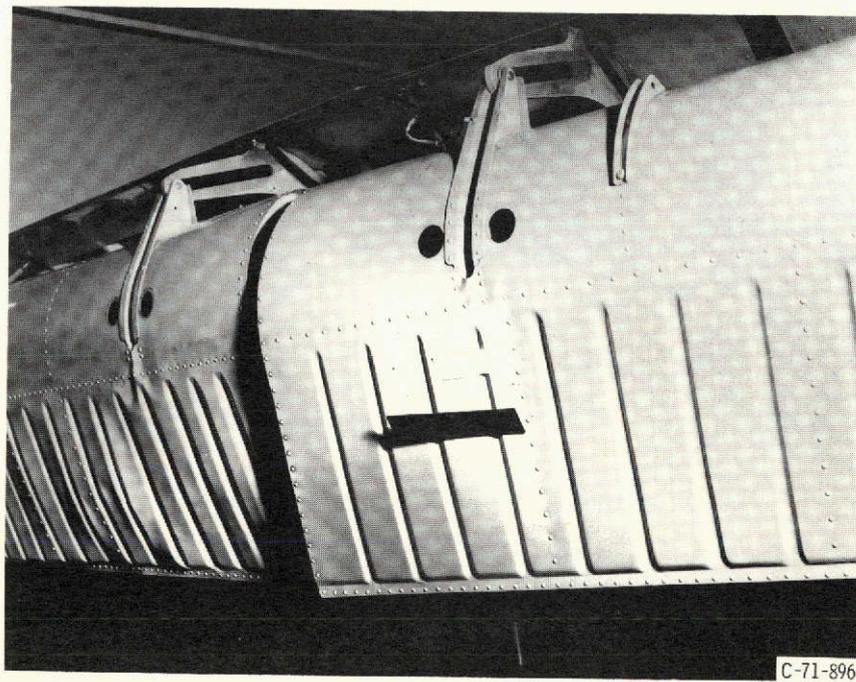
Figure 21. - Damage to upper surfaces of right inboard and outboard wing flaps. Flap control rods disconnected with flaps hanging from flap tracks.

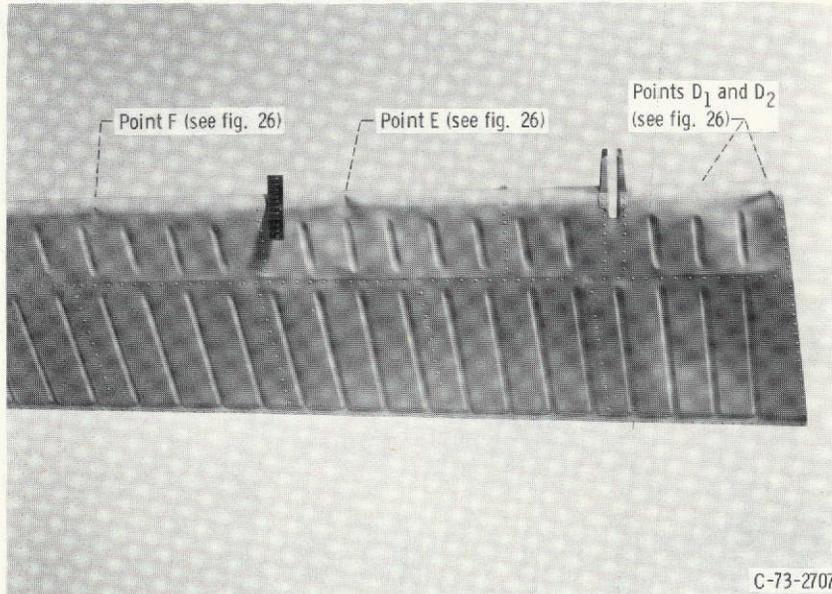
Figure 22. - Damage to lower-surface leading edge of right outboard flap.

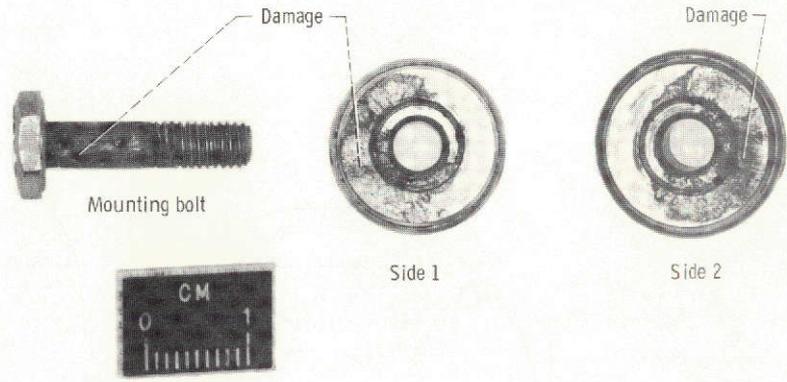
Figure 23. - Damage to outboard pair of bearings on left outboard flap.

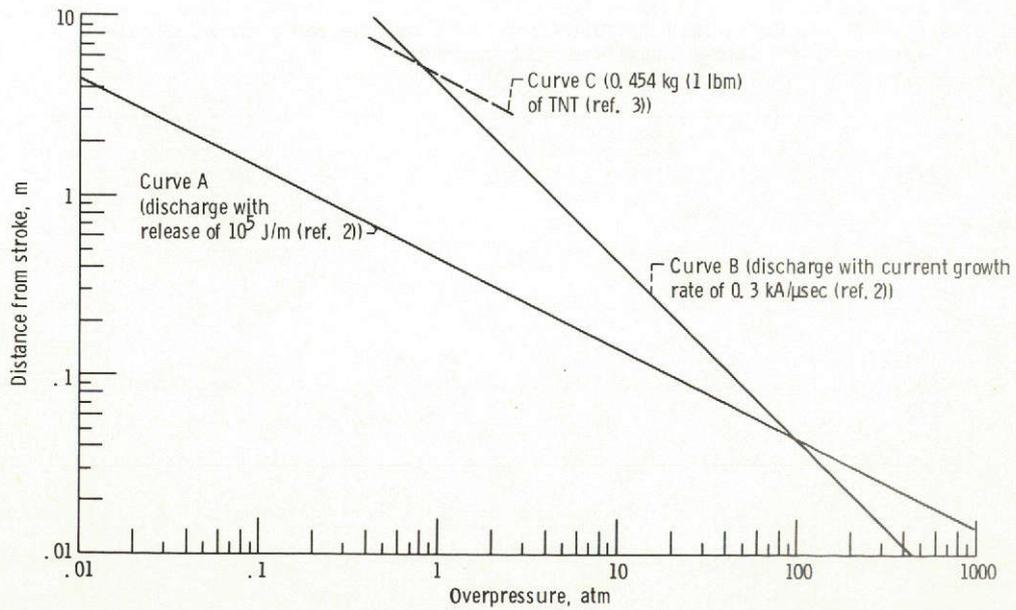
Figure 25. - Predicted shock wave overpressure generated by typical lightning discharge.

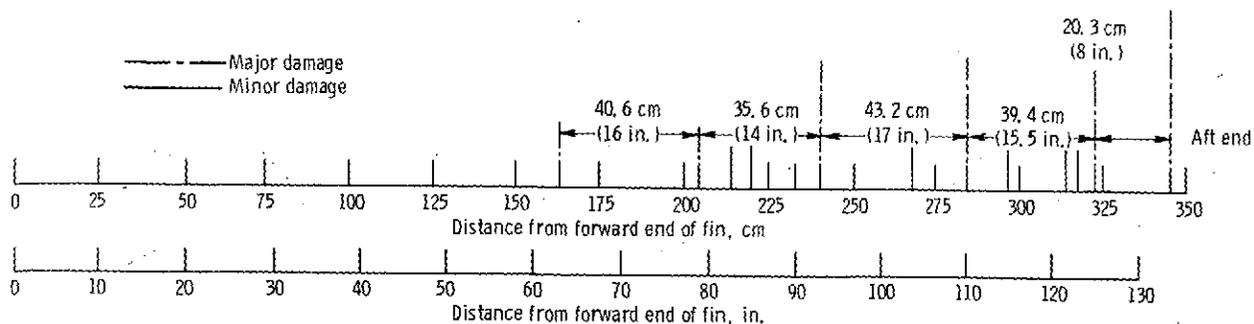
Figure 28. - Location of damage points along ventral fin due to swept stroke. (Length of line marking damage points indicates magnitude of damage.)

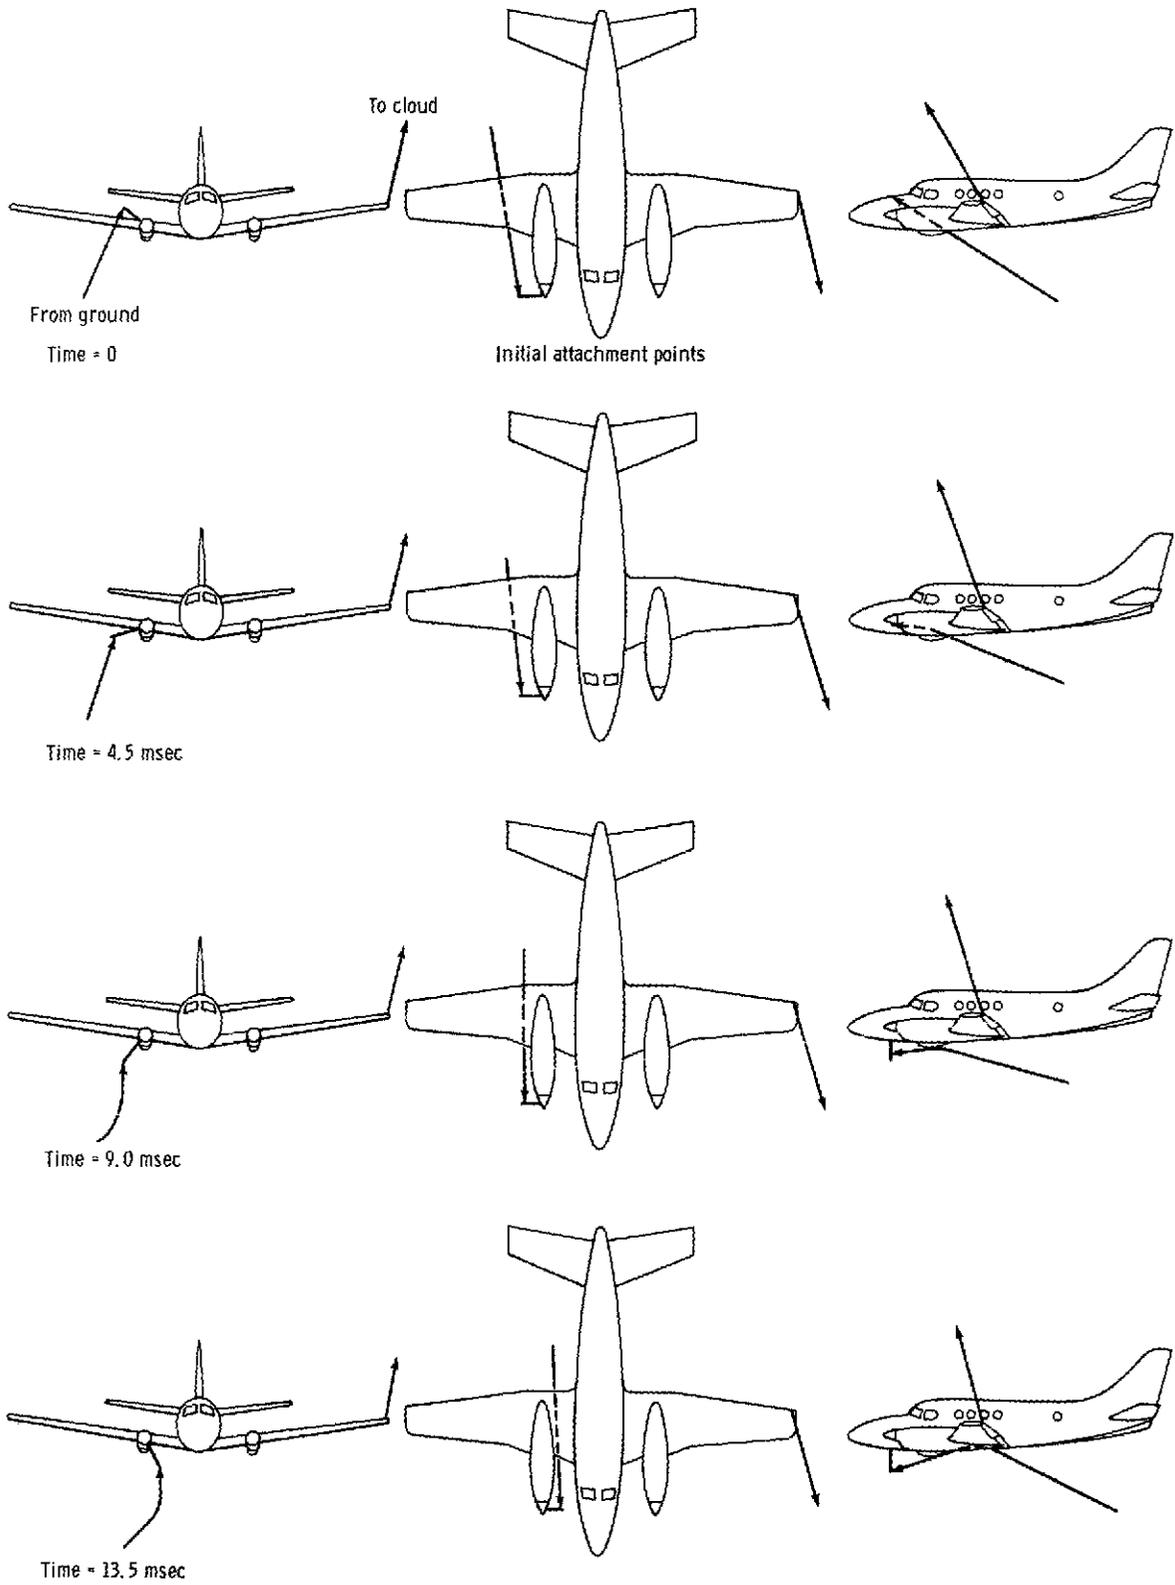
Figure 29. - Probable lightning path with respect to aircraft. (Indicated times are for high-current-stroke portions of discharge.)
