DESIGN, MANUFACTURE, DEVELOPMENT, TEST, AND EVALUATION OF BORON/ALUMINUM STRUCTURAL COMPONENTS FOR SPACE SHUTTLE

VOLUME IV + REPAIRABILITY

GENERAL DYNAMICS
Convair Division

August 1974

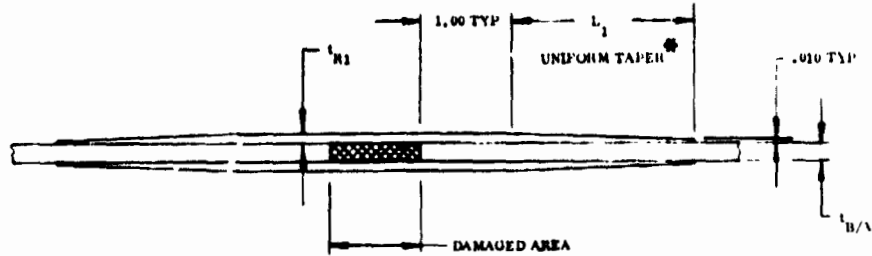
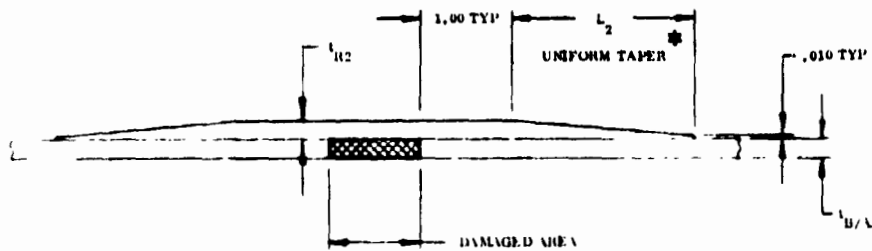
Figure 2-1. Guidelines for B/Al Patch Repair

As a general rule, the area of damage is not as critical as is the thickness of composite in which the damage is contained. General guidelines were prepared for patches (on skins) and straps (on beams) as given in Figure 2-1. The guideline could be used for repair on one or both sides of the damaged structure.

$$t_{R1} = \frac{1}{2} \times K_m \times t_{B/A}$$

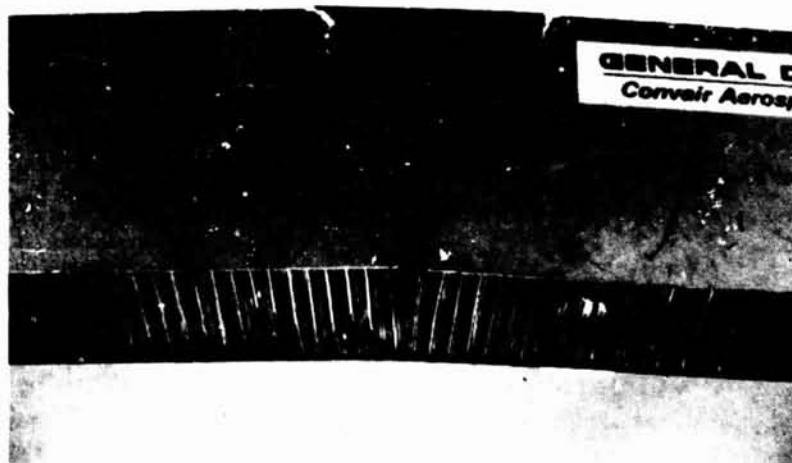
The specimen, shown in the damaged condition in Figure 3-2, was selected for this program because it represents a severely damaged skin section.

Figure 3-2. Failed Sandwich Beam Specimen. The Boron Aluminum tension skin failed at a stress of 1306 MPa (189.5 ksi). (136410)

The repair splice, consisting of a 0.76 mm (0.030 in.) thick section of 0.1 mm (4 mil) unidirectional B/Al, was adhesively bonded to the 0.51 mm (0.020 in.) thick B/Al skin with FM-123 adhesive. The splice section was 15.2 cm (6 in.) in length and conformed to the l/t ratio outlined in Section 2. The beam, prior to bonding, was straightened as much as possible at room temperature using a flat press. A capillary adhesive, Hysol 9313, was used on the honeycomb at crack surfaces and at the titanium/honeycomb interface. This adhesive was used to strengthen the honeycomb core and the titanium compression skin/aluminum honeycomb core interface where separation had occurred during initial testing. The repaired beam with the splice in place is shown in Figure 3-3.

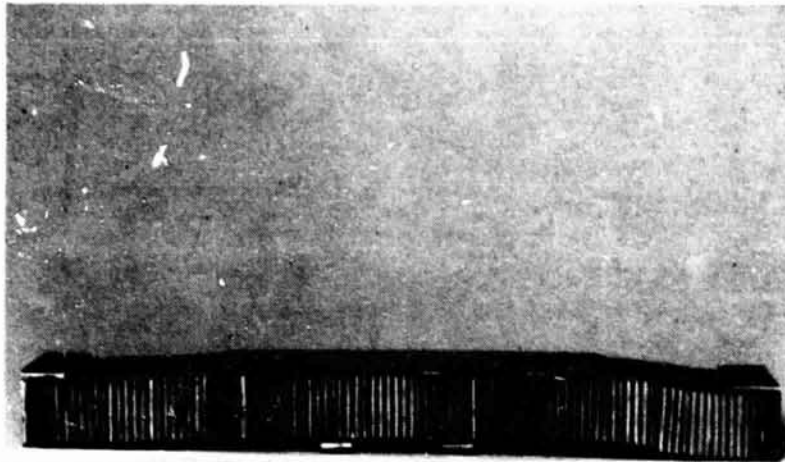
The repaired sandwich beam specimen was re-tested in an identical manner to the original test. The specimen failed at a load of 18.7 kN (4147 lb), which corresponded to a tensile stress of 1531 MPa (222 ksi), a 16.5% increase in strength over the original specimen. In addition, the failure, shown in Figure 3-4, was forced away from the initial failure. The actual cause for specimen failure was shearing of the aluminum core and subsequent tearing of the tension skin at one of the reaction points.

Figure 3-4. Retested B/Al Sandwich Beam Specimen.
The repaired beam failed at 1531 MPa (222 ksi), a strength increase of 16.5% over the initial structure. (136994)

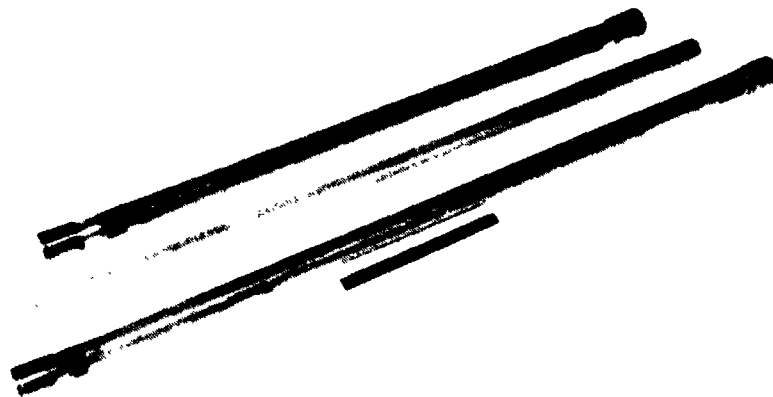
Figure 3-7 shows the two repaired test specimens as well as the repaired mid-fuselage tube.

Figure 3-7. Crushed B/AI Tubes Repaired by forming at 788K (950F) (137203)

The two damaged B/Al tubes were repaired by reforming the damaged portions at 788K (950F). The re-forming die consisted of two steel blocks, each with a groove 1.27 cm (0.5 in.) in radius, machined on facing surfaces. The blocks were sufficiently long to completely cover the damaged area of the tubes. Originally, aluminum dies were tried; however, they were not sufficiently strong to reform the tubes, but instead yielded under pressure.

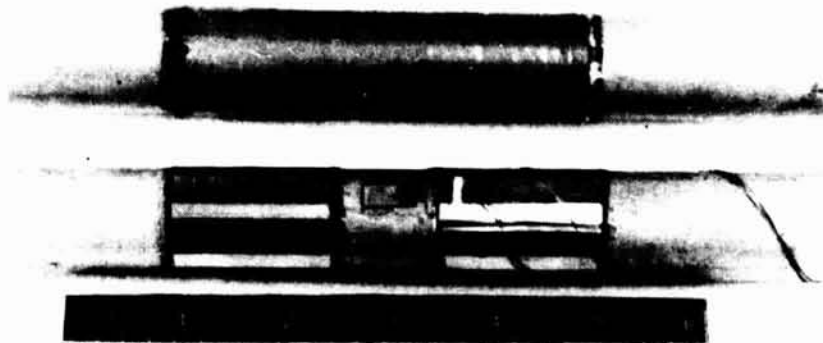
wide by 0.15 mm (0.006 in.) thick stainless-steel foil wrapped around the tube twice and adhesively bonded and cured at 333K (140F) for one hour. The foils were separated by 2.54 cm (1.0 in.) as shown in Figure 3-8.

After the stainless-steel wrap repairs were made, the tubes were again re-tested for buckling strength; the results are reported in Table 3-3. The stainless-steel wrap repair resulted in an additional improvement in the buckling strength capability of the B/AI tubes; however, the buckling strength is still less than was initially obtained for the undamaged tubes (by 10 to 13%). It is believed that with minor modifications the wrap repair method is capable of restoring full buckling strength capabilities to damaged B/AI tubes.

Figure 3-8. Foil Reinforced B/Al Tubes (138226)

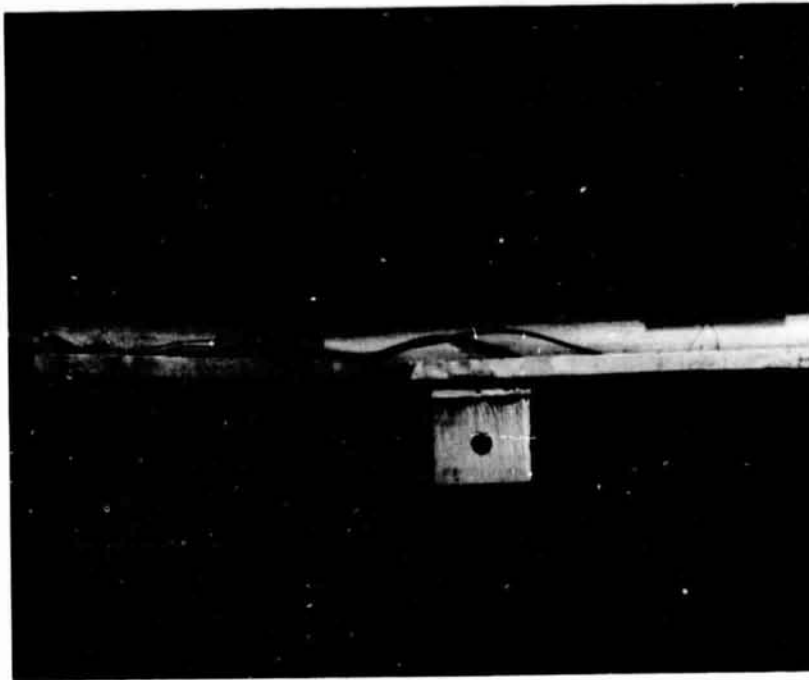
The subcomponent test specimen was initially loaded to produce tension on the B/Al stringer to evaluate horizontal shear capability, which was design critical. The specimen was loaded in increments to failure, which occurred at 1730 newtons (386 pounds). The initial failure mode was horizontal shear calculated to be 5.65 MN/m^2 (8170 psi) at the skin radius on one side of the specimen. The skin failure was not catastrophic; therefore, the specimen was reversed and loaded again, this time to produce compression in the curved top of the B/Al hat section. Loading progressed in increments, with some evidence of yielding in the failed area, to 1770 newtons (399 pounds) load, at which time the shear upright collapsed and the top cap was forced to buckle as shown in Figure 3-10. The ability of the stringer to carry nearly limit loads after an initial shear failure was highly encouraging and again illustrated the post-buckling capability of B/Al composite material.

Figure 3-10. Failed Hat Crippling Specimen (13 7951)

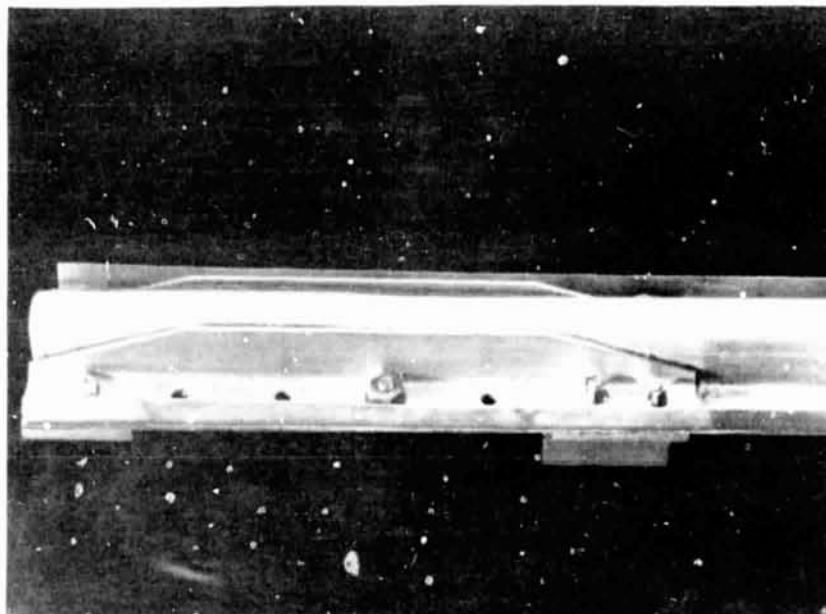
Figure 3-12. Repaired Sheet Stringer Specimen Prior to Riveting (139287)

The stiffener angles were made from 7075-T6 aluminum and the 2.54 cm by 5.08 cm by 6.3 mm (1.00 by 2.00 by 0.25 in.) aluminum pad was made from 2024 ST. The part was then bonded with Hysol 394.1 adhesive. After bonding, the 2.4 mm (3/32 in.) holes were brought to size and rivets installed. The repaired B/Al sheet stringer specimen is shown in Figure 3-12.

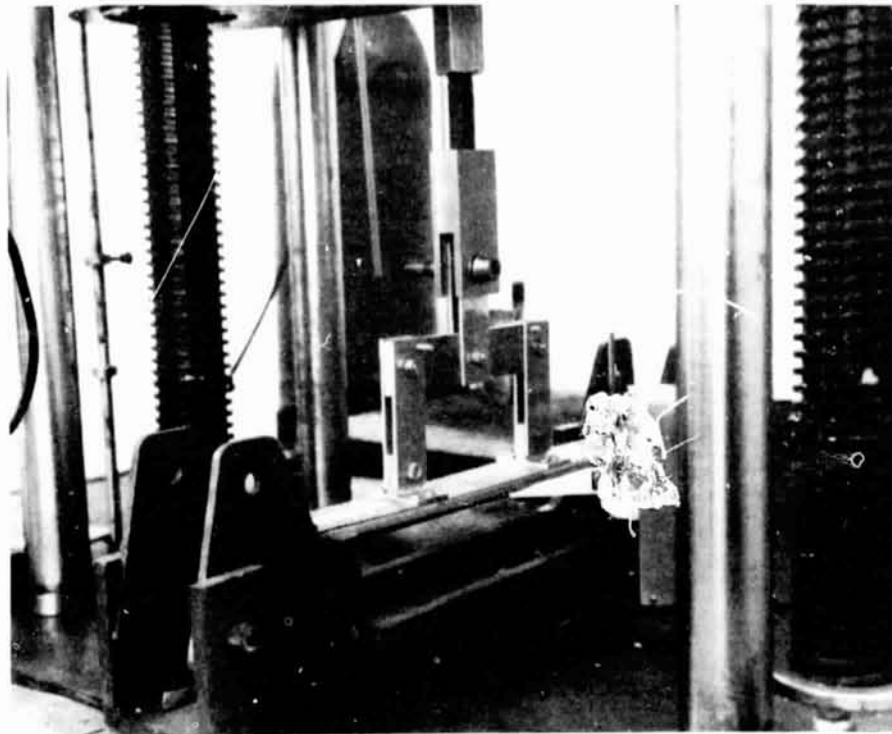
The repaired sheet stringer specimen was then retested using the same fixtures and test method as was used in the initial testing (Figure 3-13). The specimen was first loaded to produce tension on the B/Al stringer. Failure occurred at 1766 newtons (398 pounds), which is 3% higher than the original failure load. Again the failure was not catastrophic, and the specimen was reversed and loaded again, this time to produce compression in the B/Al hat section. Failure occurred at 2120 newtons (477 pounds), which is a 20% higher load than obtained in the initial test. The test data are summarized in Table 3-4, and Figure 3-14 is a photograph showing failure of the repaired specimen. The repair of the B/Al sheet stringer was obviously very successful.

Figure 3-13. Testing of Repaired B/Al Sheet-Stringer Specimen (139369)

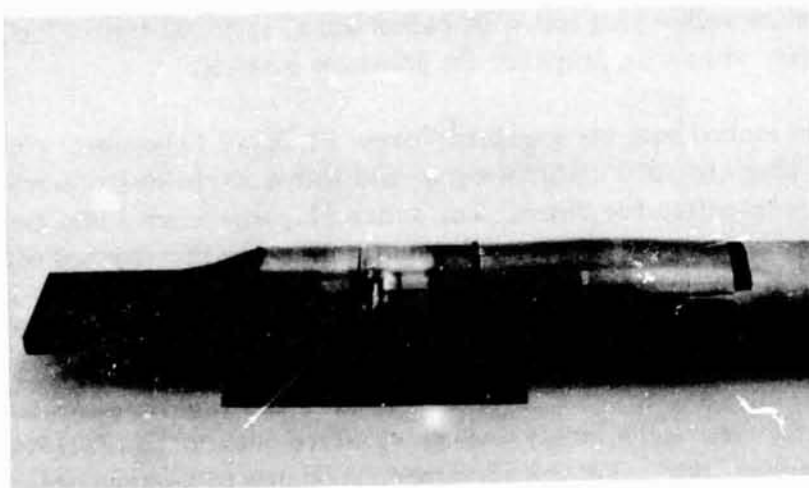
Figure 3-17. Repaired End of B/Al Tube (13 9633)

The B/Al tube was etched with the standard Forest Products Laboratory aluminum etch. The splice plug and split collar were etched with a nitric/hydrofluoric mixture, followed by a phosphate/fluoride rinse. The splice plug was bonded into the tube with Hysol E.A. 394.1 and allowed to cure. The split collar was then bonded with American Cyanamide's FM-123 adhesive for one hour at 393K (250F). Figure 3-17 is a photograph of the repaired B/Al tube.

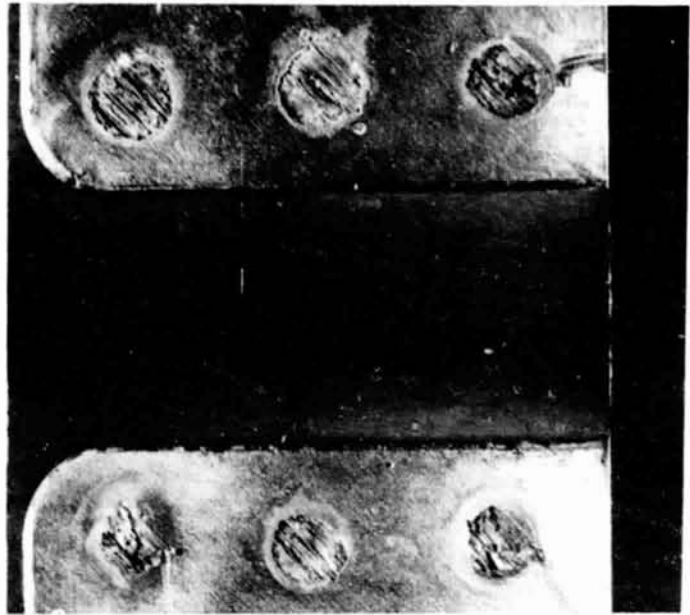
Two B/Al web splice test specimens were installed in test fixtures (one of which is shown in Figure 3-19) and tested in tension (double shear of the spotwelds). Failure of one specimen occurred at 100,085N (22,500 lb) of load. The failed test specimen is shown in Figure 3-20.

Figure 3-20. Failed Spotwelded Web Splice Test Specimen (136409)

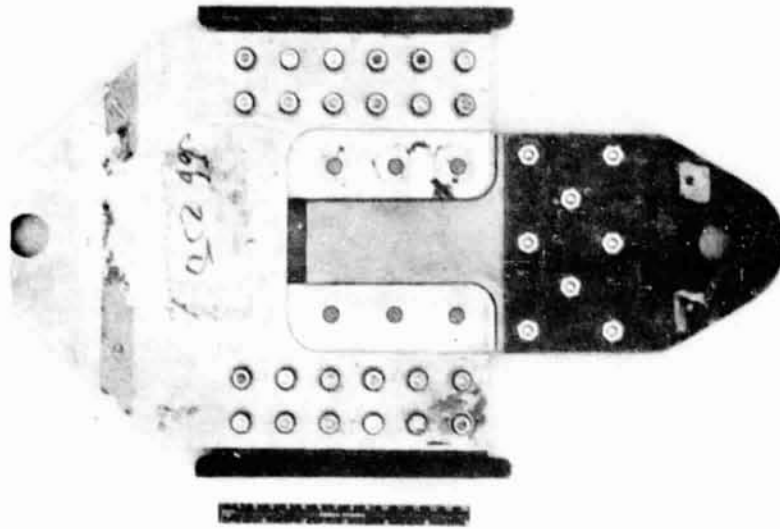
Figure 3-21. Photograph of Bolted Repair of Web Splice Specimen (140262)

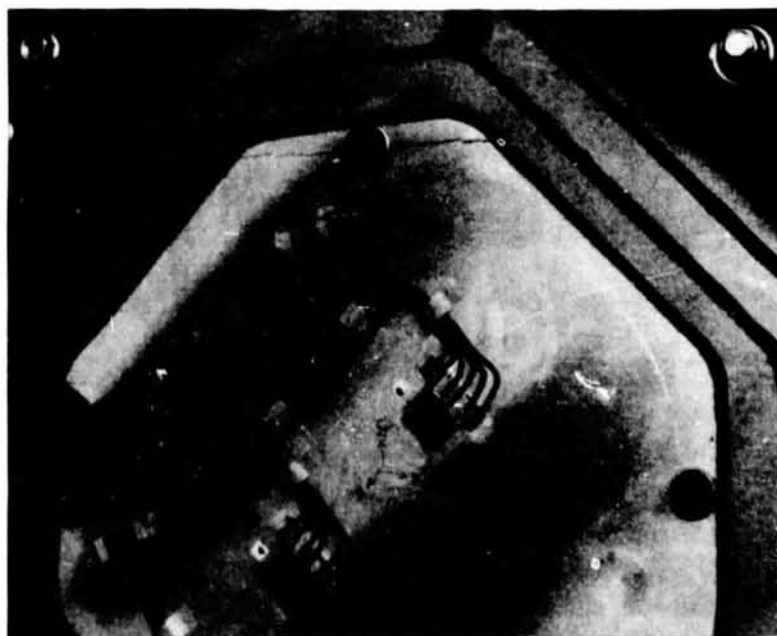
The failed $\pm 45^\circ$ B/Al tension field specimen selected for repairs is shown in Figure 3-24. Primary failure was a crack through one of the bolts tying the Z-section stiffener to the web. The proposed repair procedure (Figure 3-25) was to resistance weld a series of titanium sheets together in a mirror image of the damaged area (and the surrounding test fixture) and to then adhesively bond this doubler to the specimen.

Figure 3-24. Failed Tension Field Panel (12 2588B)

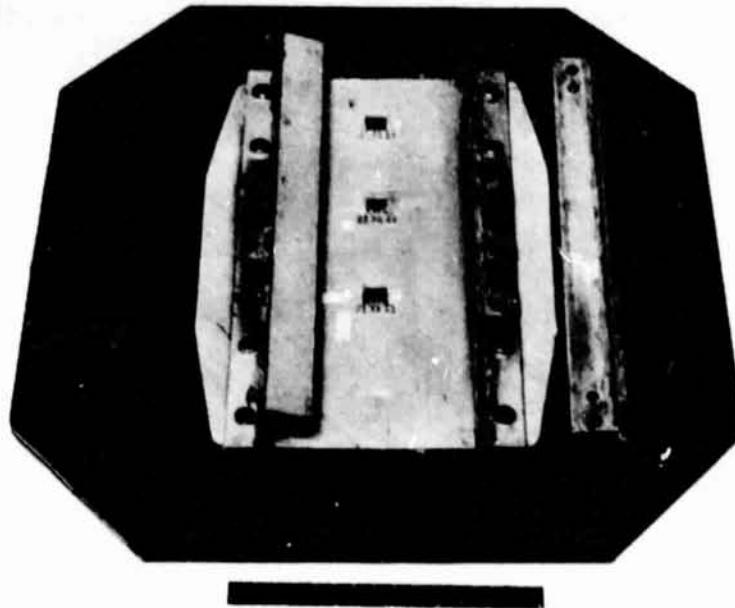
Figure 3-26. Damaged B/Al Tension Field Specimen (140311)

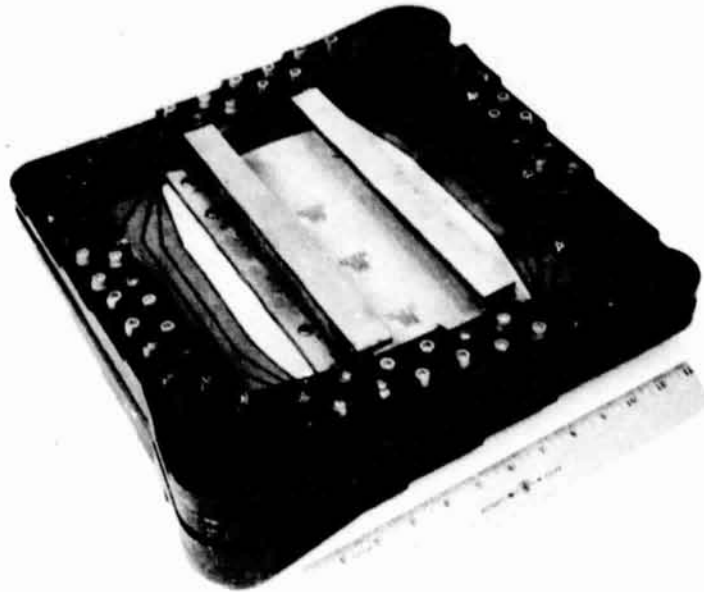
Figure 3-27. Repaired B/AI Tension Field Panel (140691)

The stiffeners were subsequently repaired by straightening of the unfailed stiffener [by forming in a closed die fixture at 533K (500 F)] and adhesively bonding an aluminum doubler onto the failed stiffener. Figure 3-27 is a photograph of the repaired tension field panel.

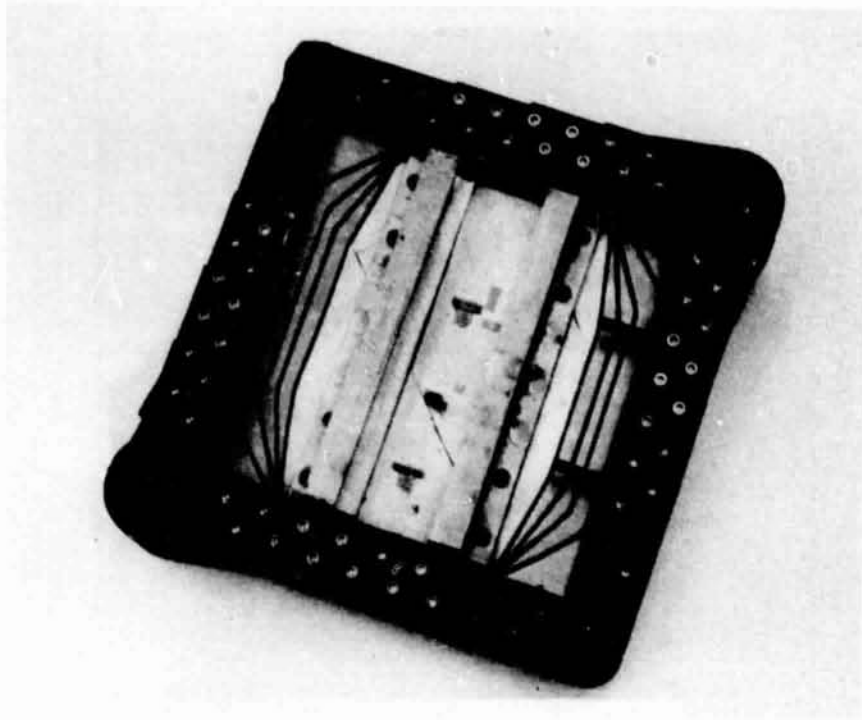
The repaired panel was then installed into the same universal testing machine and tested in the same manner as was used in the initial test. The results are summarized in Table 3-7, which indicates a very satisfactory repair was achieved. The failure was docile in nature, consisting of splitting of the B/Al web material, as is shown in Figure 3-28.

Figure 3-28. Failure of Repaired B/Al Tension Field Panel (140708)
