MSC-PT-R-68-22

APOLLO 6
ANOMALY REPORT NO. 6

ABNORMAL STRUCTURAL PERFORMANCE
DURING LAUNCH PHASE

February 1969

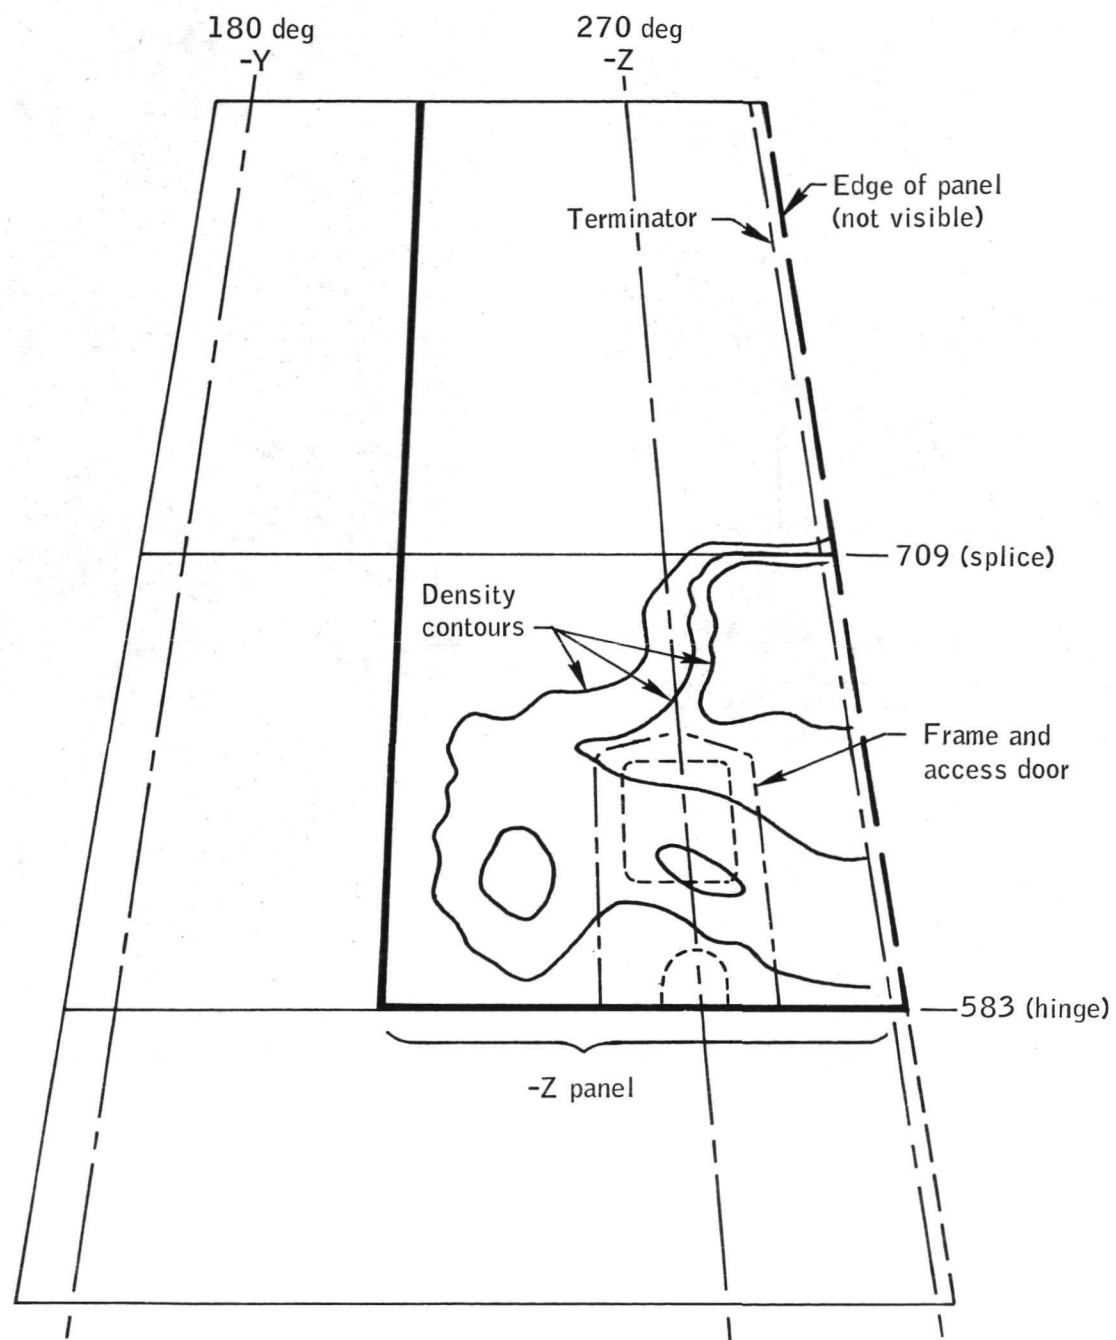
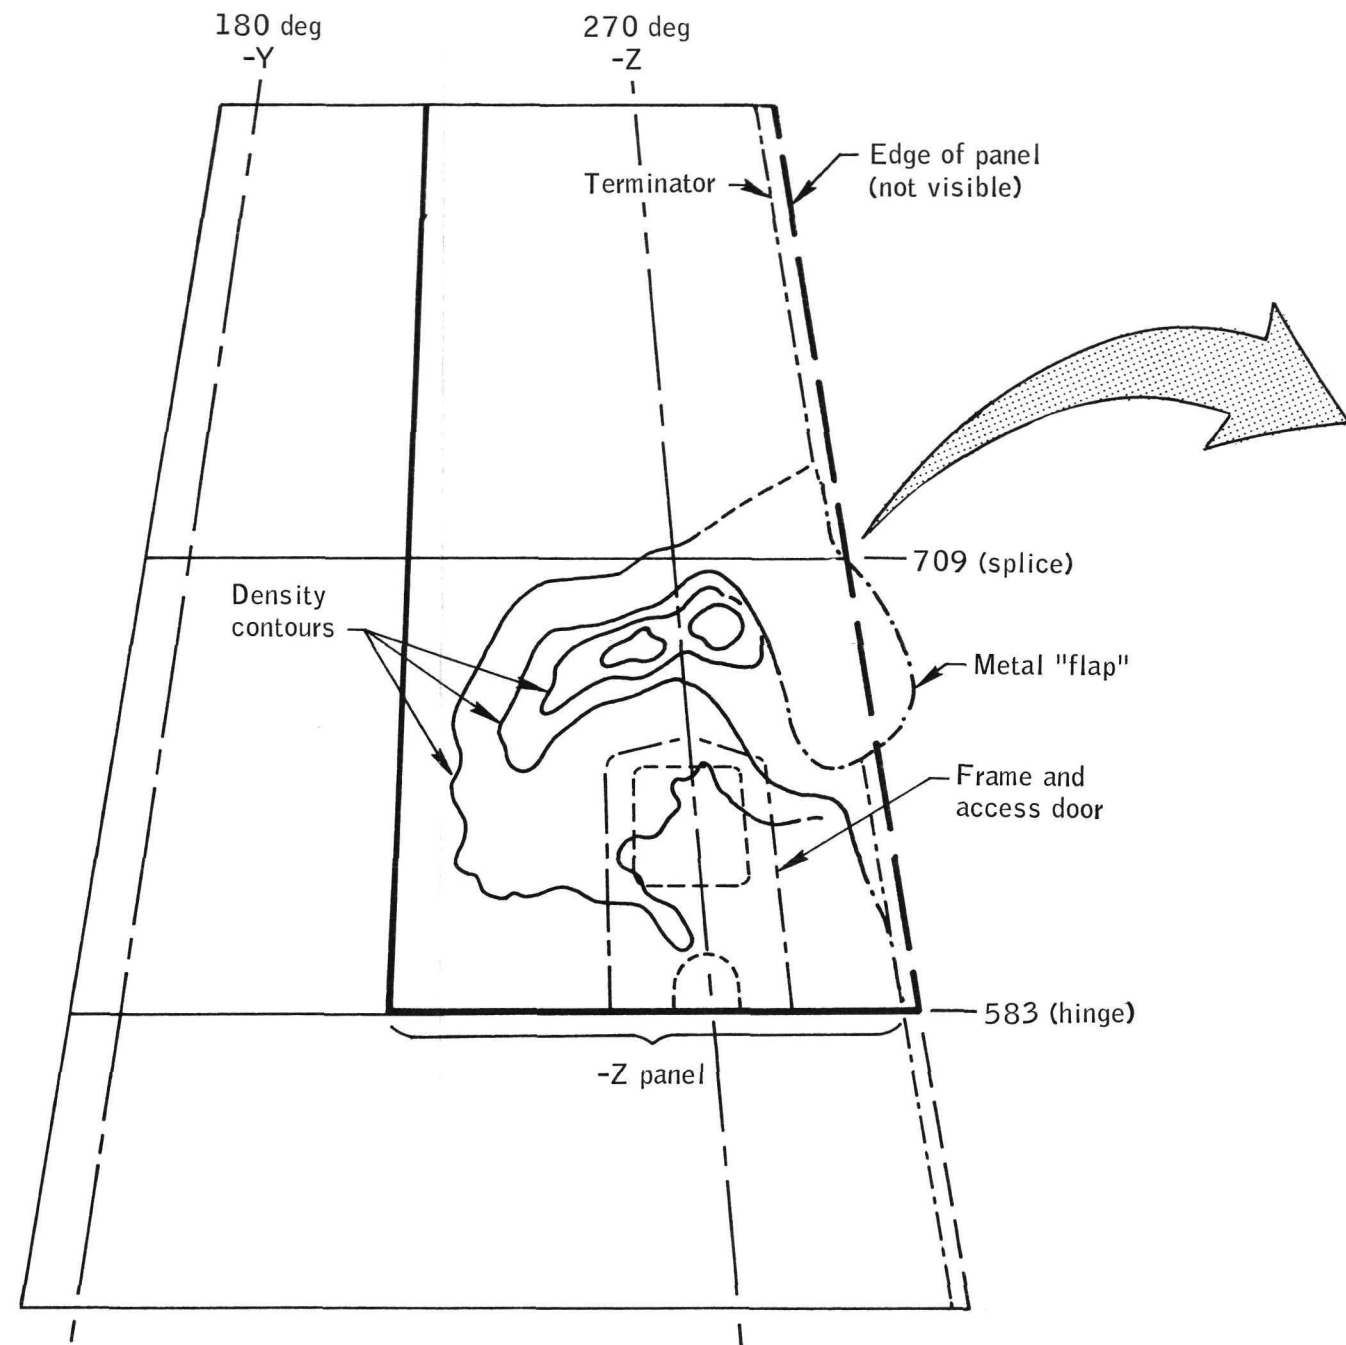
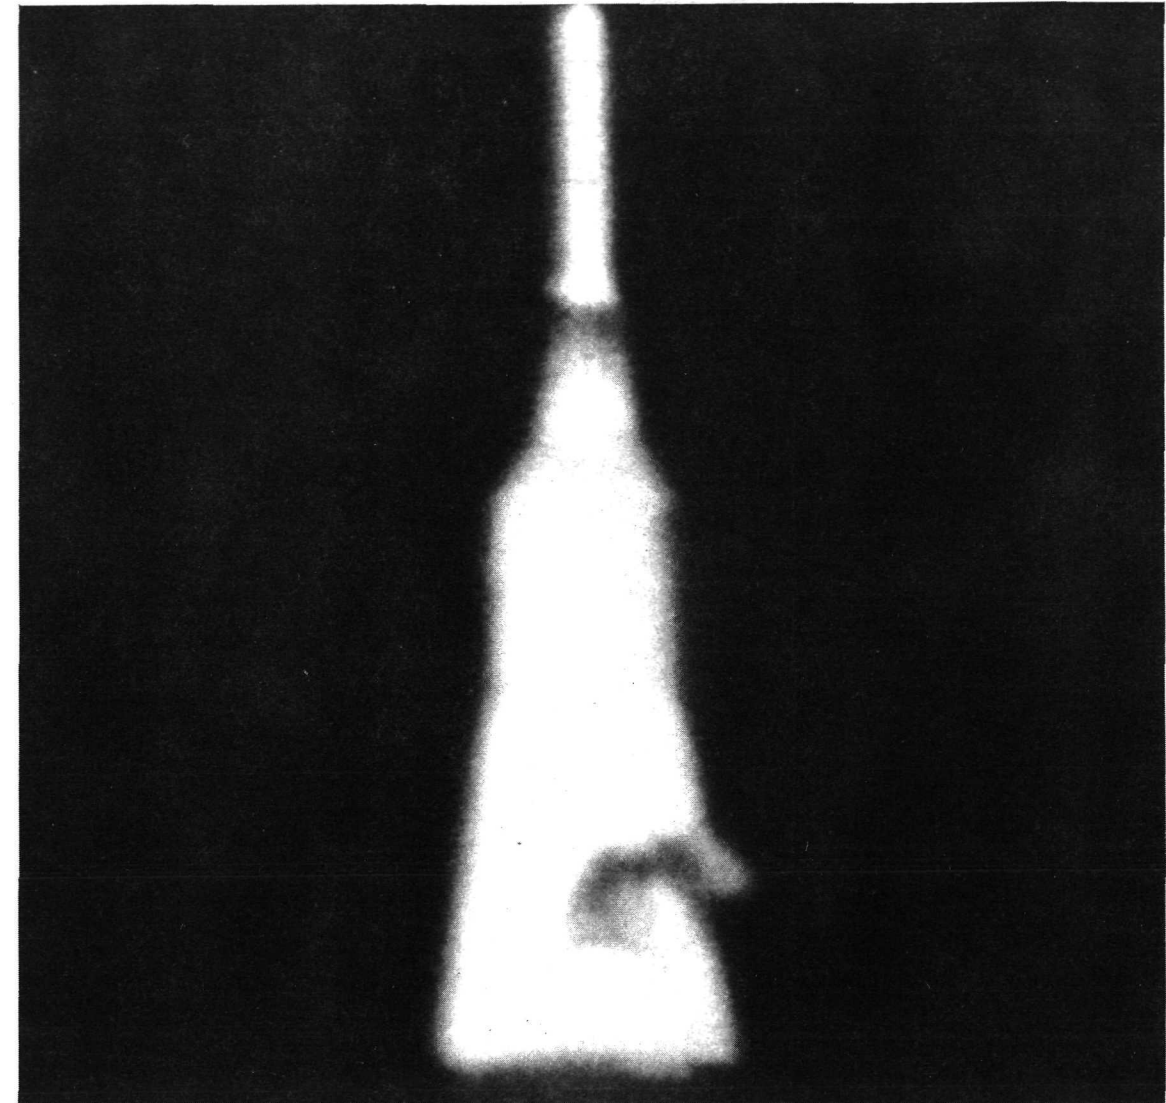
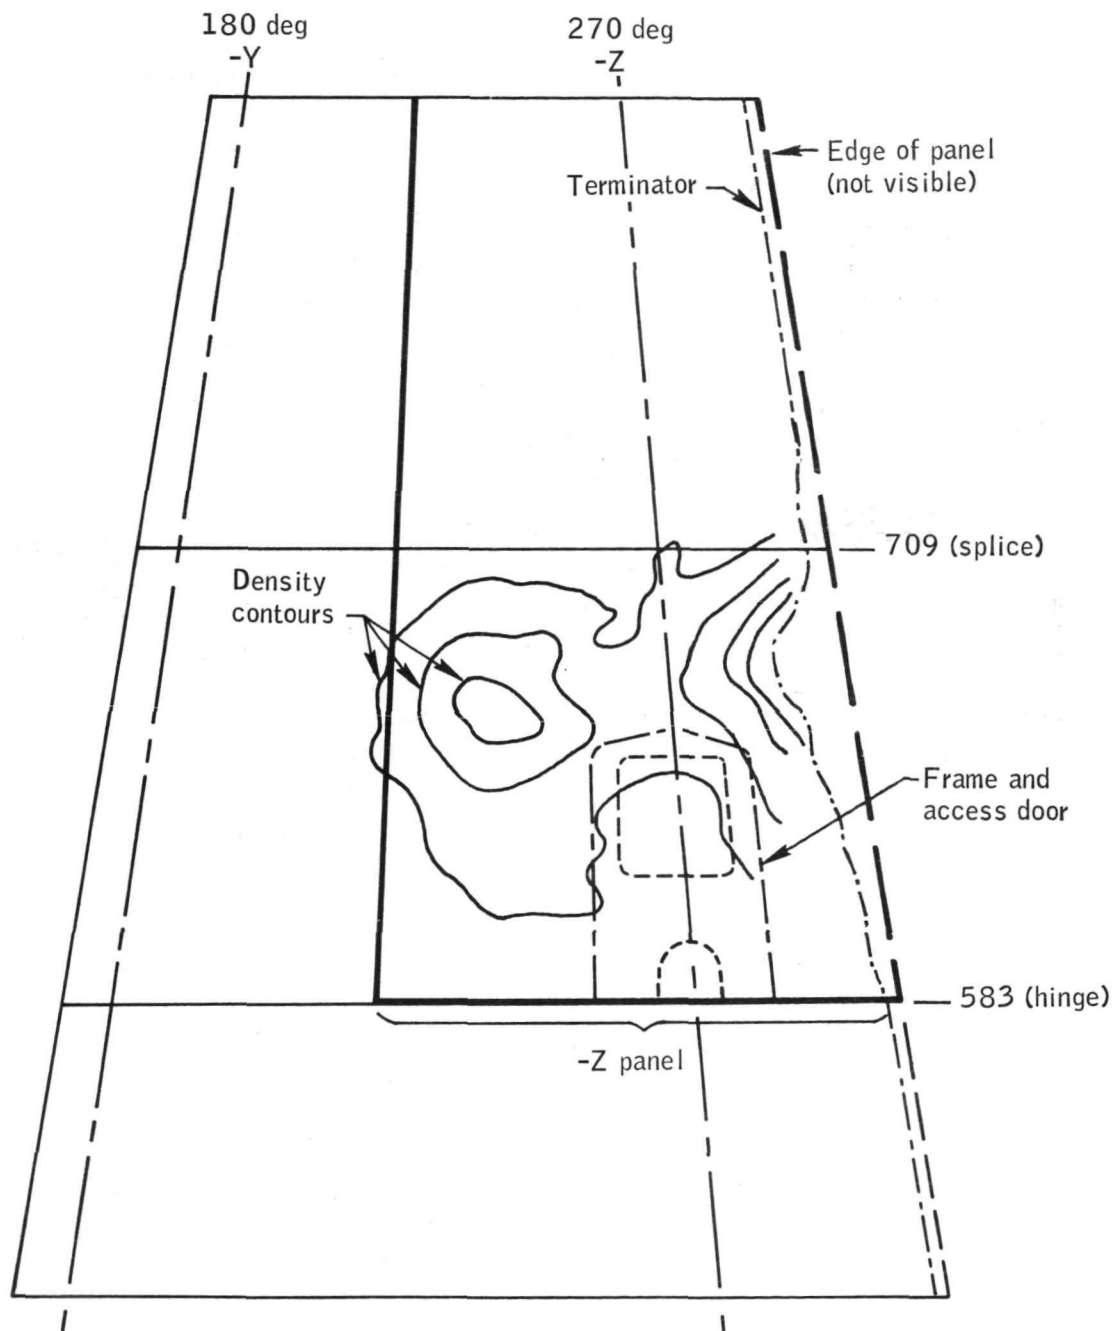
Figure 1.- Densitometer traces at time of anomaly.

Figure 1 shows the results from 3 of the 39 frames processed. The anomalous area suddenly appeared on the frame taken at 2:13.287, the preceding frames having shown nothing unusual. In subsequent frames, the density pattern changed from frame to frame and returned to the original color in some areas; these data have been interpreted as inward deflection of the surface and subsequent return to the original curvature. It has been concluded from the terminator line of the right side of the adapter that these deflections were quite large, on the order of 6 to 12 inches. An undamaged panel (1.7-inch-thick honeycomb sandwich) cannot deflect to these magnitudes and subsequently return to the original shape. Therefore, the data have been further interpreted as indication that the deflecting area is outer facesheet only, possibly with some fragments of core attached but with no inner facesheet.

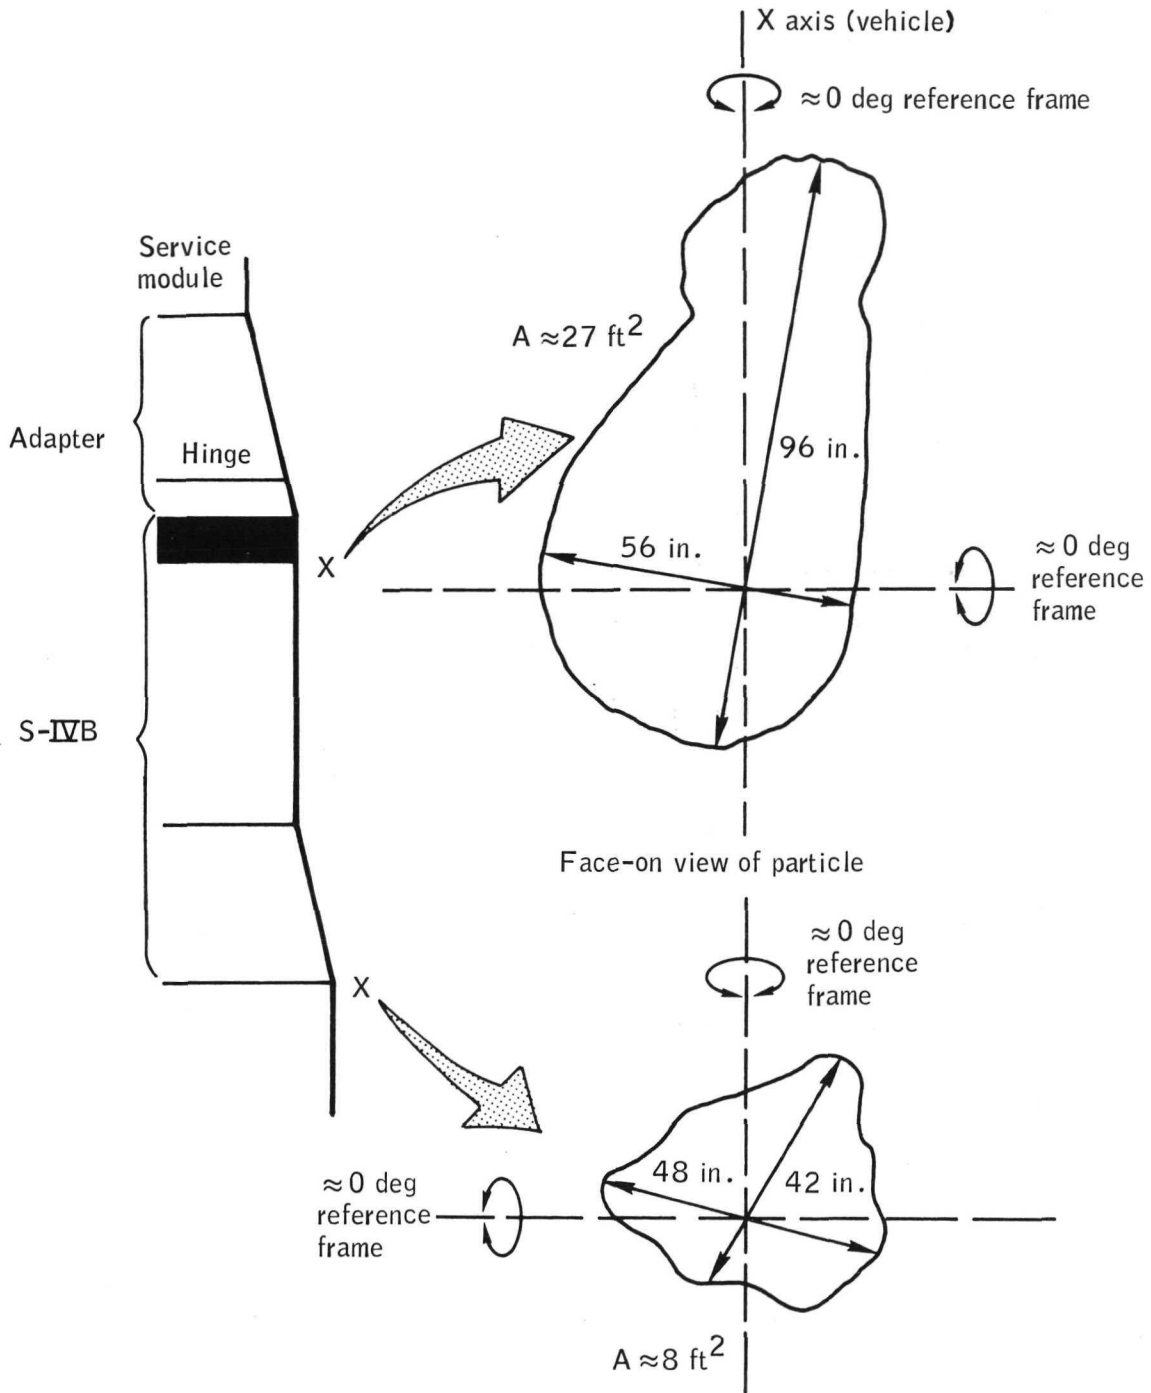
Figure 2.- Pieces observed at 2:13.587.

The isodensitracer was also used to determine orientation and size of the fragments seen in the photographs. Out-of-plane (shutter plane) orientation of a particle was determined by the grouping of the constant-density contour lines across the face of the particle. Closely spaced lines on one side and broadly spaced lines opposite indicated the direction of out-of-plane tilt; the degree of contour compaction showed the amount of tilt. The frame at 2:13.587 (fig. 2) captured an in-plane view of the two large pieces that came from the adapter at 2:13.420. These pieces total about 35 square feet in area.

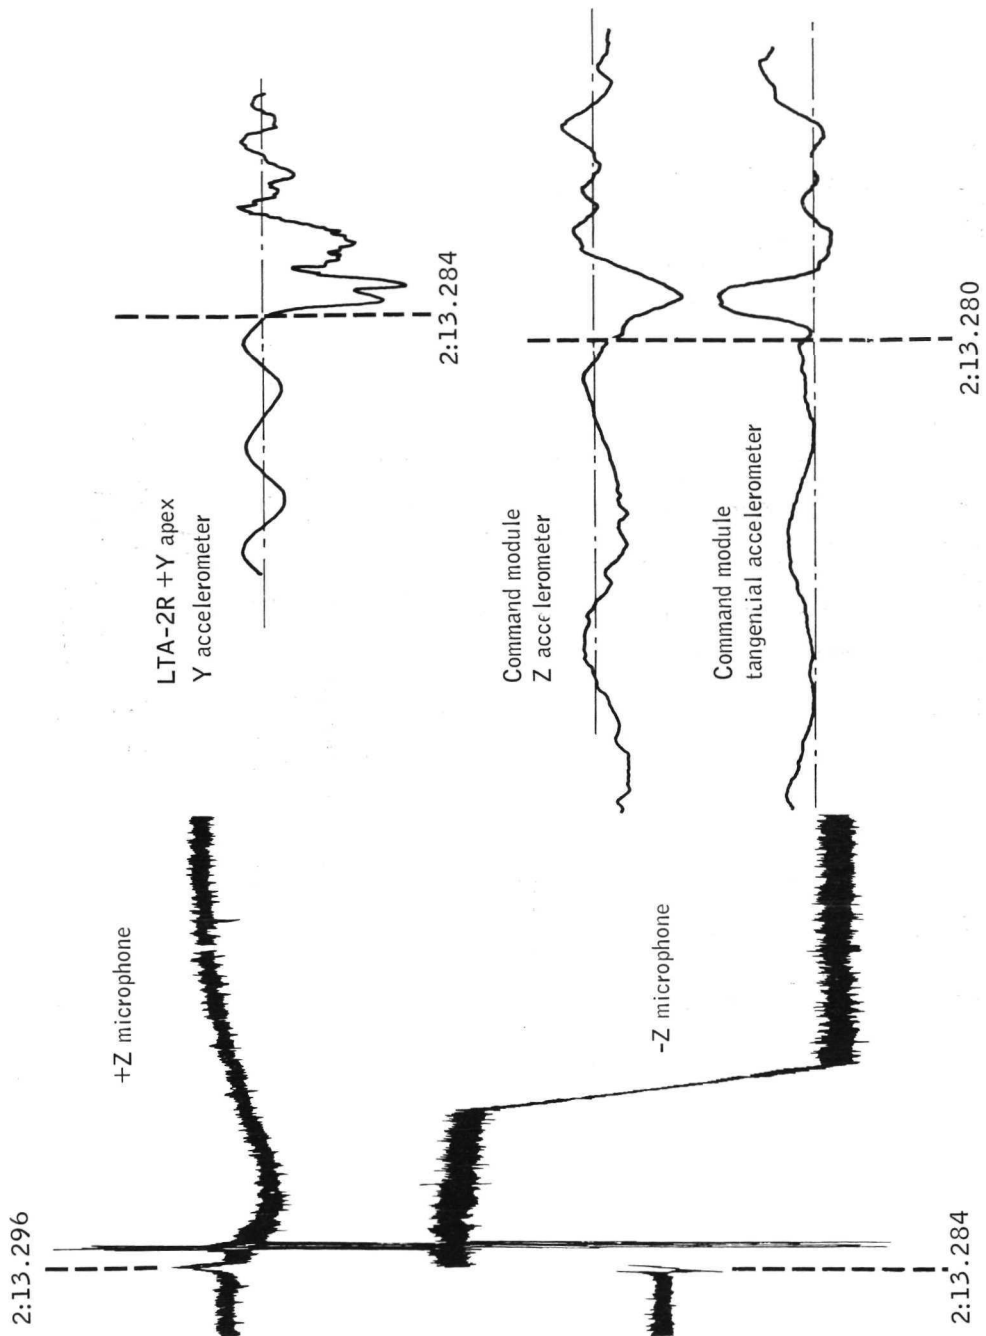
Figure 4.- Instrumentation changes at time of anomaly.

The lunar module +Z microphone registered sound beginning at 2:13.296 (fig. 4). This is consistent with sound having been generated on the -Z panel, approximately 16 feet away, at about 2:13.281. The command module pitch and tangential accelerometers tended to confirm this time, showing what might be interpreted as the beginning of a change at 2:13.280 (fig. 4).

The lunar module -Z microphone and +Y apex radial accelerometer, both near the -Z panel, show pronounced changes at 2:13.283 (fig. 4). The disturbance saturated the amplifier of the microphone and allowed the +Y apex fitting to accelerate radially outward at a rate about six times that experienced one-half cycle earlier. The -Z microphone was about 2 feet from the -Z panel surface; this location is consistent with sound originating at the panel surface at 2:13.282.

Because the -Z microphone change can be interpreted relatively well and because the microphone was close to the anomalous area, the time of the failure must have been very near 2:13.282.

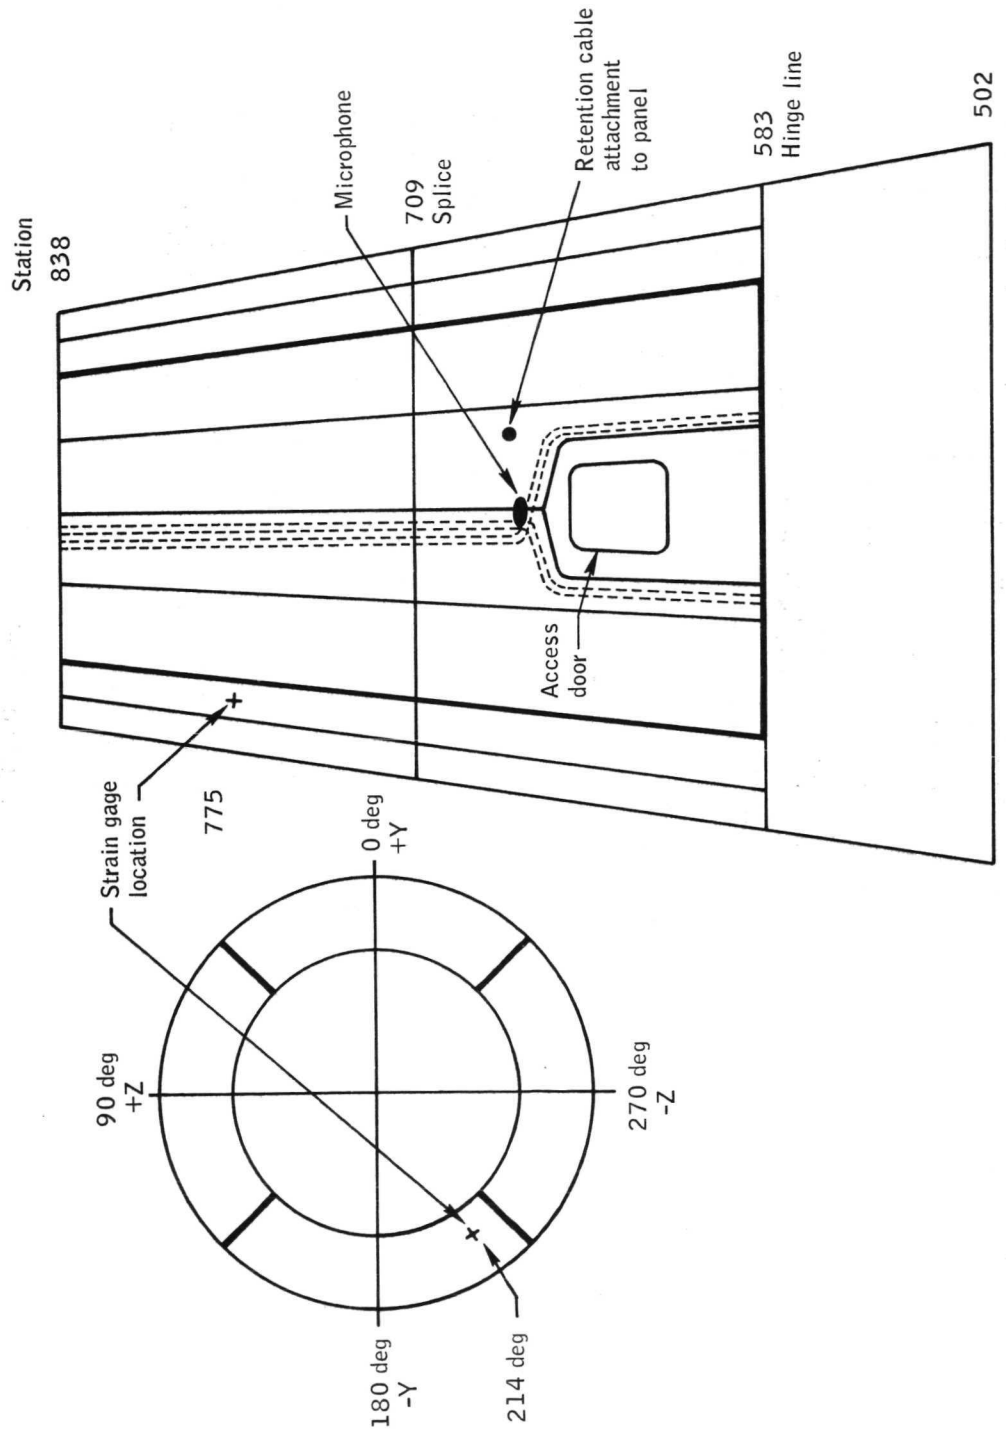
Figure 5.- Adapter general arrangement and strain gage location.

Ten of the 14 adapter strain gages were rendered inoperative by the anomaly. The four remaining measurements, located at station 775, $\theta = 214$ degrees (fig. 5), indicated longitudinal and circumferential strains for the outer and inner facesheets of the -Y panel. Power for the gages that failed was received through a wire harness routed up the inside wall of the -Z panel. The four gages which remained operative received power through a separate wire harness.

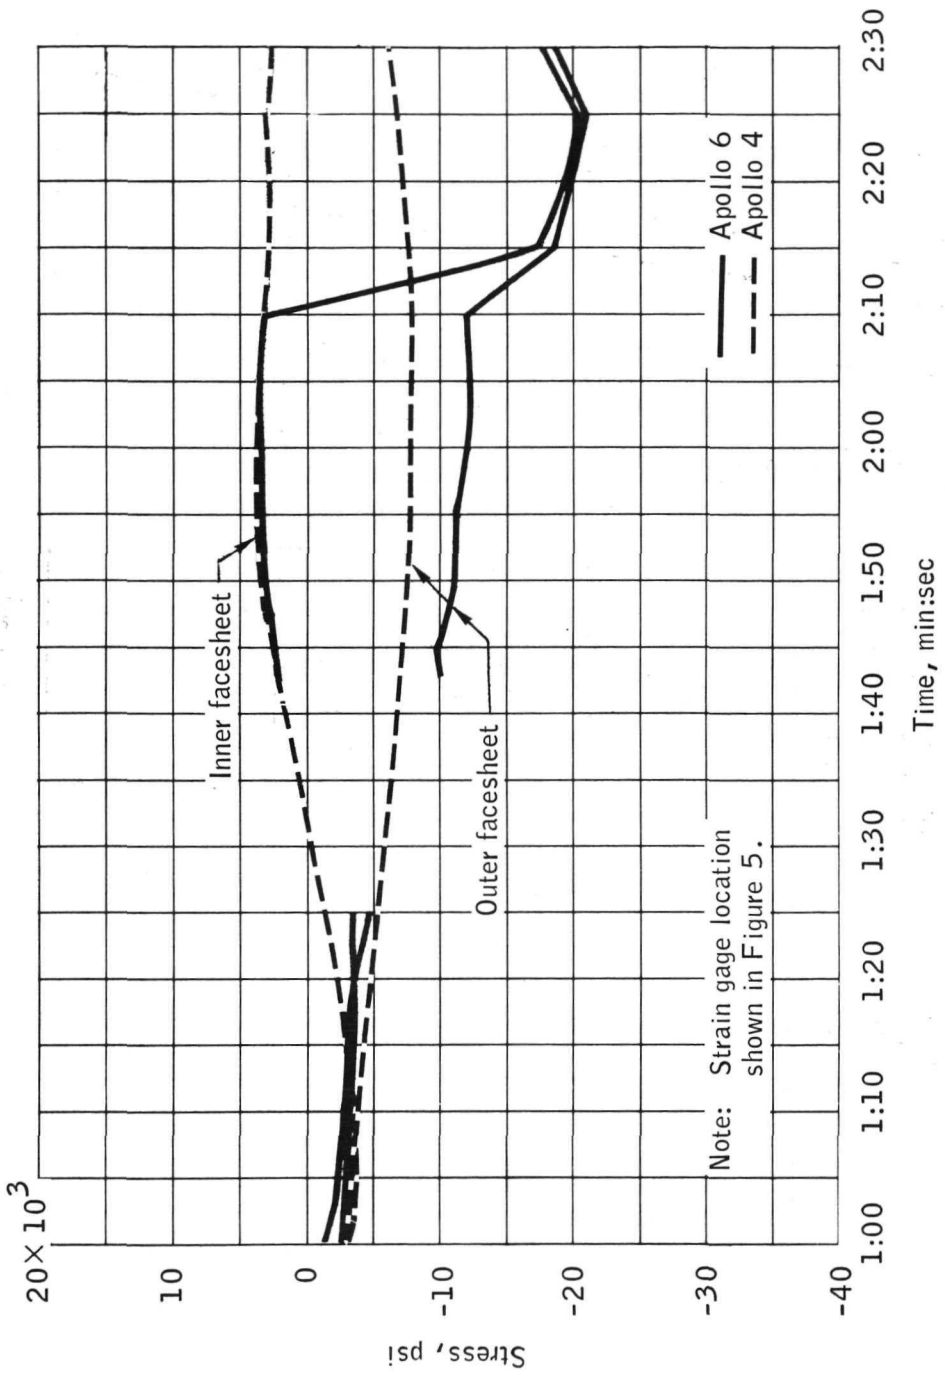
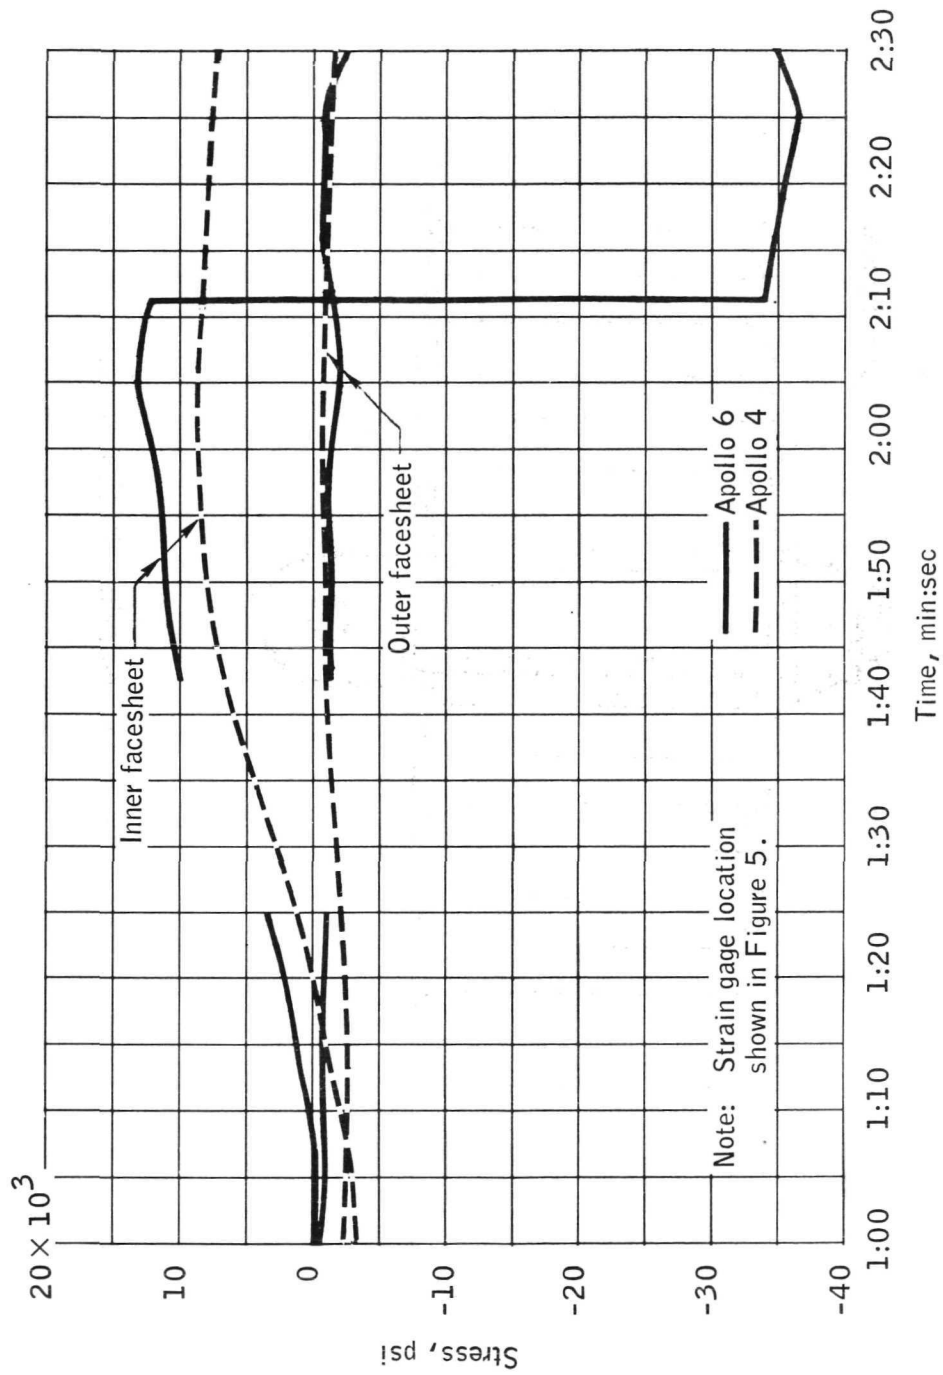
Figure 6.- Stresses at time of anomaly.

Prior to the anomaly, all the gages were measuring strains similar to those experienced on the Apollo 4 mission. At the time of the anomaly, the longitudinal compression stress in the -Y panel increased in both facesheets; the circumferential stress increased in compression on the inner facesheet but remained essentially unchanged on the outer facesheet (fig. 6). One possible cause is that the -Z panel lost effectiveness for carrying longitudinal loading and imposed high circumferential loading upon the upper half of the -Y panel.

The increase in longitudinal stress on the -Y panel can be approximated by complete removal of the -Z panel (station 838 to station 584), with a resulting shift of neutral axis toward the +Z side for the remaining structure. However, removal of the panel does not explain the high increase in circumferential stress on the -Y panel; this shift would have necessitated a circumferential loading of 525 lb/in. compression near station 775. Thus, the nature of damage in the upper half of the -Z panel may have been such that longitudinal stiffness was drastically reduced while circumferential rigidity was unaffected, and since the circumferential loading on the -Y panel increased sharply, the -Z panel must have been locally deformed. The foregoing suggests that the facesheets on the upper half of the -Z panel were intact, but the panel may have sustained longitudinal failure and some deformation along the -Y/-Z edge member.

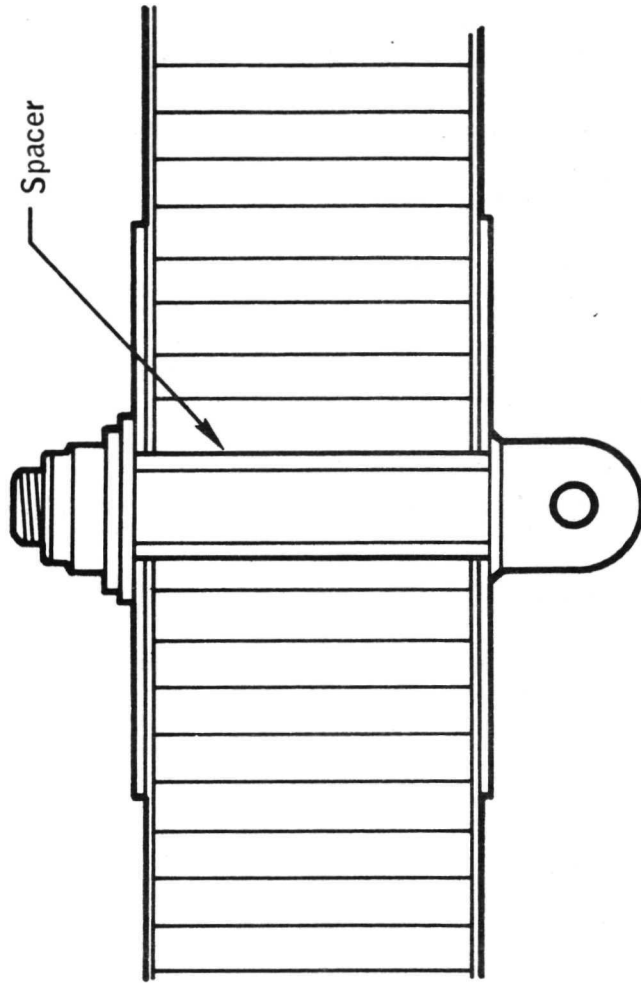
Figure 7.- Retention cable attachment bolt.

The assembly tolerances for the retention cable attachment bolts to the panels permitted an undesirable situation. The bolt was tightened on two 3-inch-diameter doublers on each side of the honeycomb panel; a spacer was provided to prevent excessive forces from being applied to the core (fig. 7). However, drawing tolerances permitted the spacer to be as much as 0.030 inch undersize; thus, of the 105 in-lb torque normally anticipated with a 7/16-inch-diameter bolt, only 25 percent would have been sufficient to crush the core. This is not especially serious but is undesirable and has been corrected on the drawing.

The retention cable attachment bolt is not a strong suspect because the bolt installation had to be intact to permit the panel to withstand the closing forces generated by the orbital tumbling. Photographic evidence substantiates that the panel did resist these forces. This mode of failure is improbable.

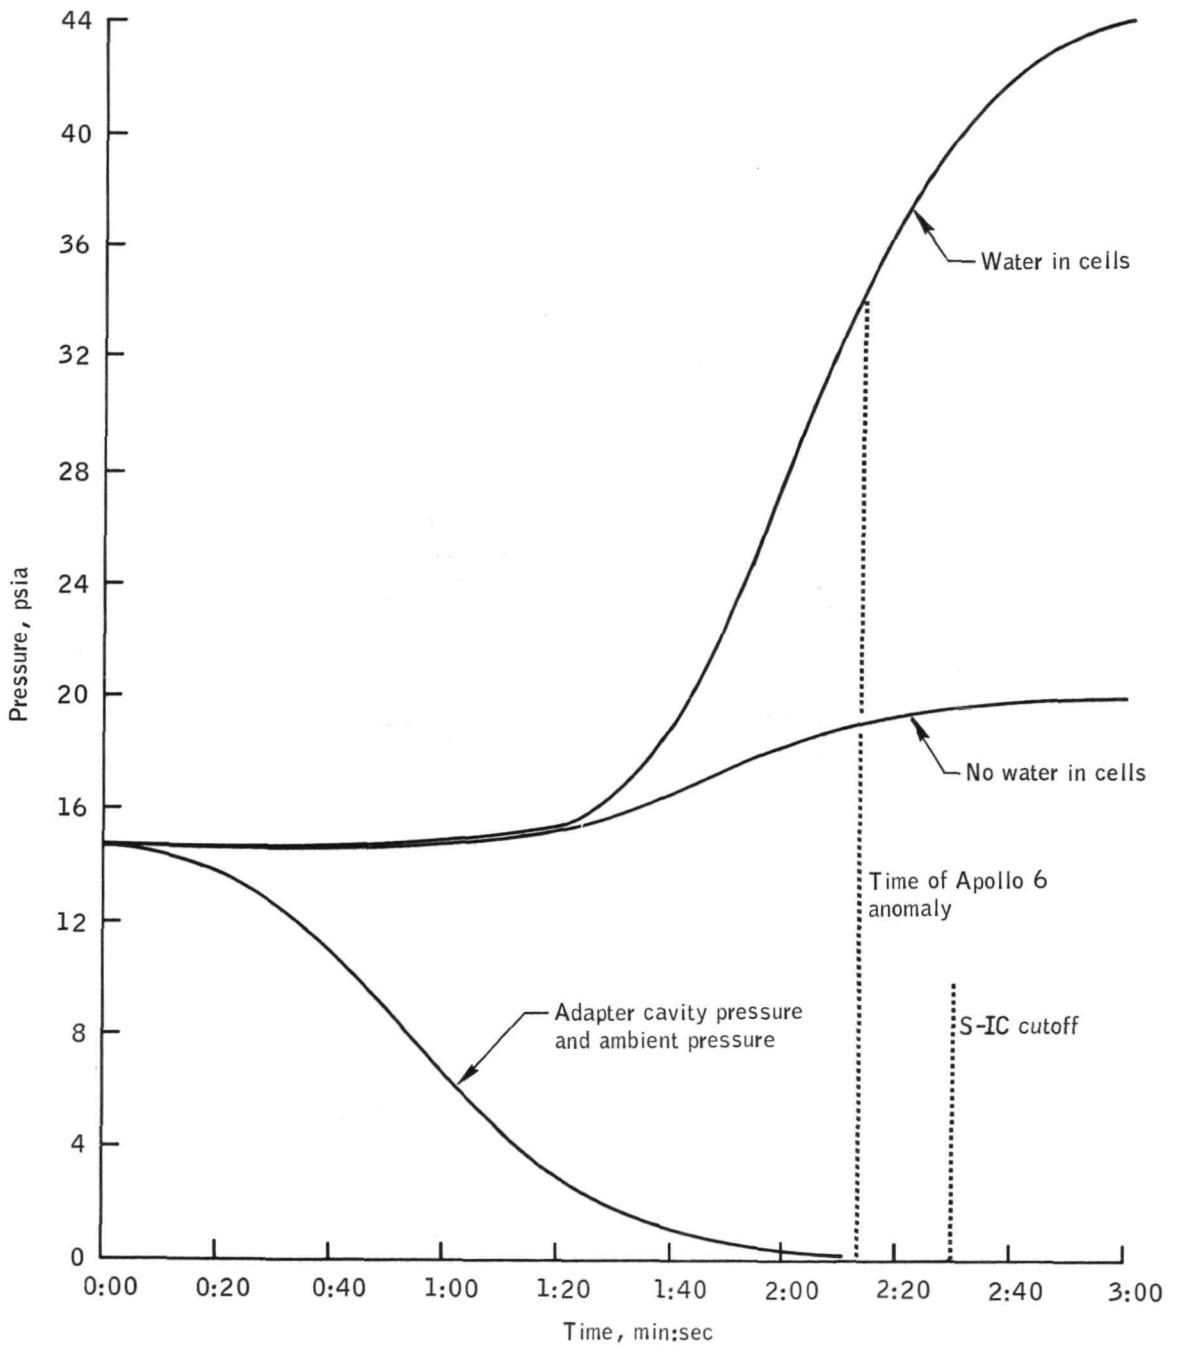
Figure 8.- Innercell pressure on Apollo 6 during launch.

The honeycomb core of the Apollo 6 adapter panels was vented cell-to-cell but not to the atmosphere. Consequently, a differential bursting pressure would develop during launch. The 14.7-psi atmospheric pressure of air trapped in the core at lift-off would be increased by aerodynamic heating of the adapter surface. The temperatures on Apollo 6 were high enough that any water in the panel would have been converted to steam.

To bracket the range of pressure the Apollo 6 honeycomb core could have experienced, an analysis was performed both with and without water in the cells. The results (fig. 8) indicated that a maximum pressure of approximately 33 psig could have been attained at the time of the anomaly, when the outer and inner facesheets were at temperatures of 297° F and 202° F, respectively.

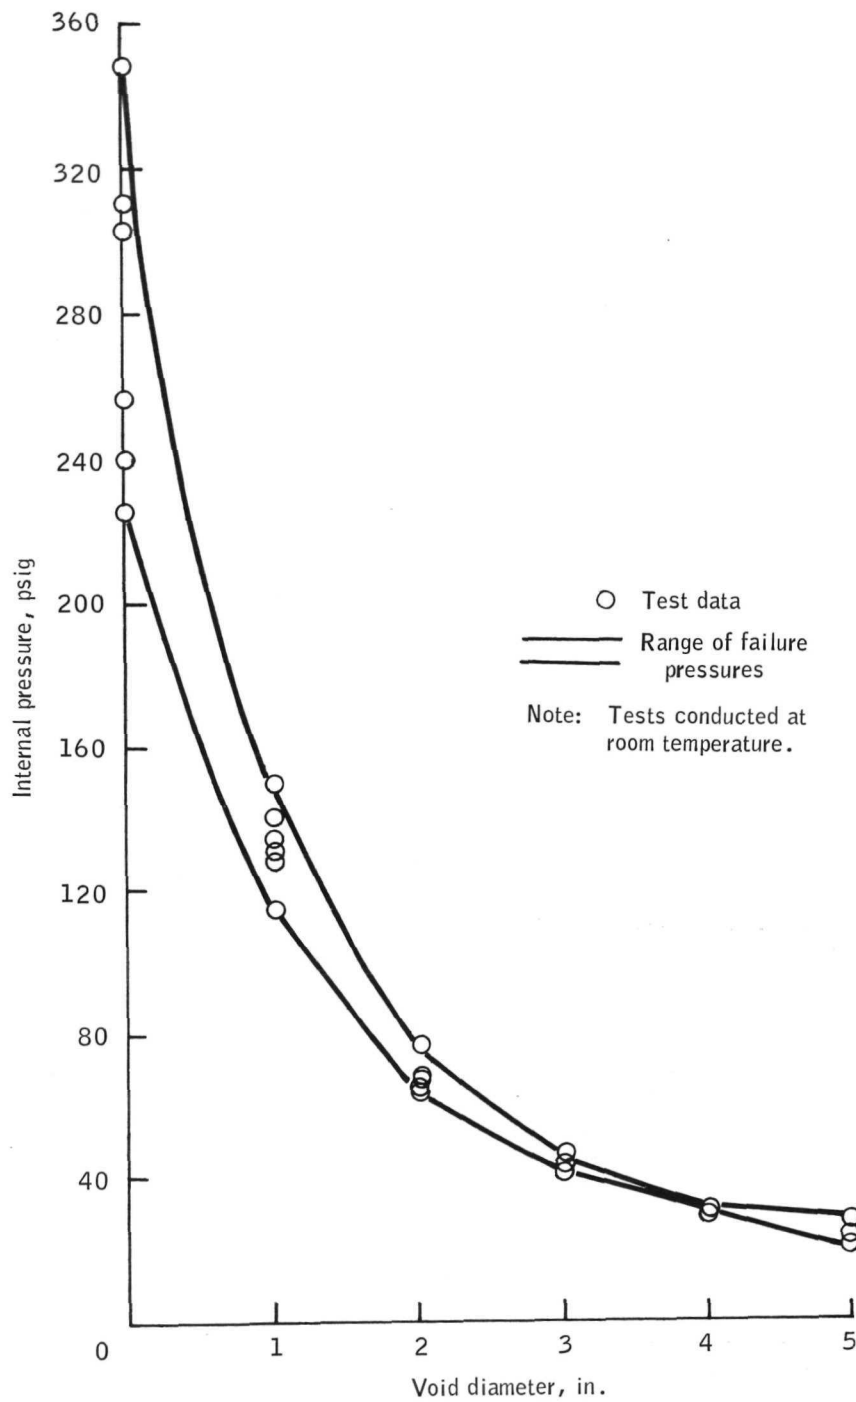
Figure 9.- Effects of sheet-to-core bond voids.

Tests to establish how sheet-to-core bond voids affect pressure containment capability are summarized in figure 9. These tests were performed on 15- by 15-inch panels with 0.029- and 0.015-inch aluminum facesheets and 1/4- by 0.001-inch aluminum honeycomb core. The test specimens were sealed by edge frame members so that high pressures could be applied to the core without leakage. The test consisted simply of pressurizing the specimen until failure, noting the failing pressure. No load or heat was applied.

These specimens failed by the mechanism of the built-in void permitting the facesheet to bulge to a curvature such that the peel strength of the adhesive was exceeded. Once started, the entire facesheet came off explosively. The data from these tests indicate that the relationship between pressure containment capability and void size is fairly predictable.

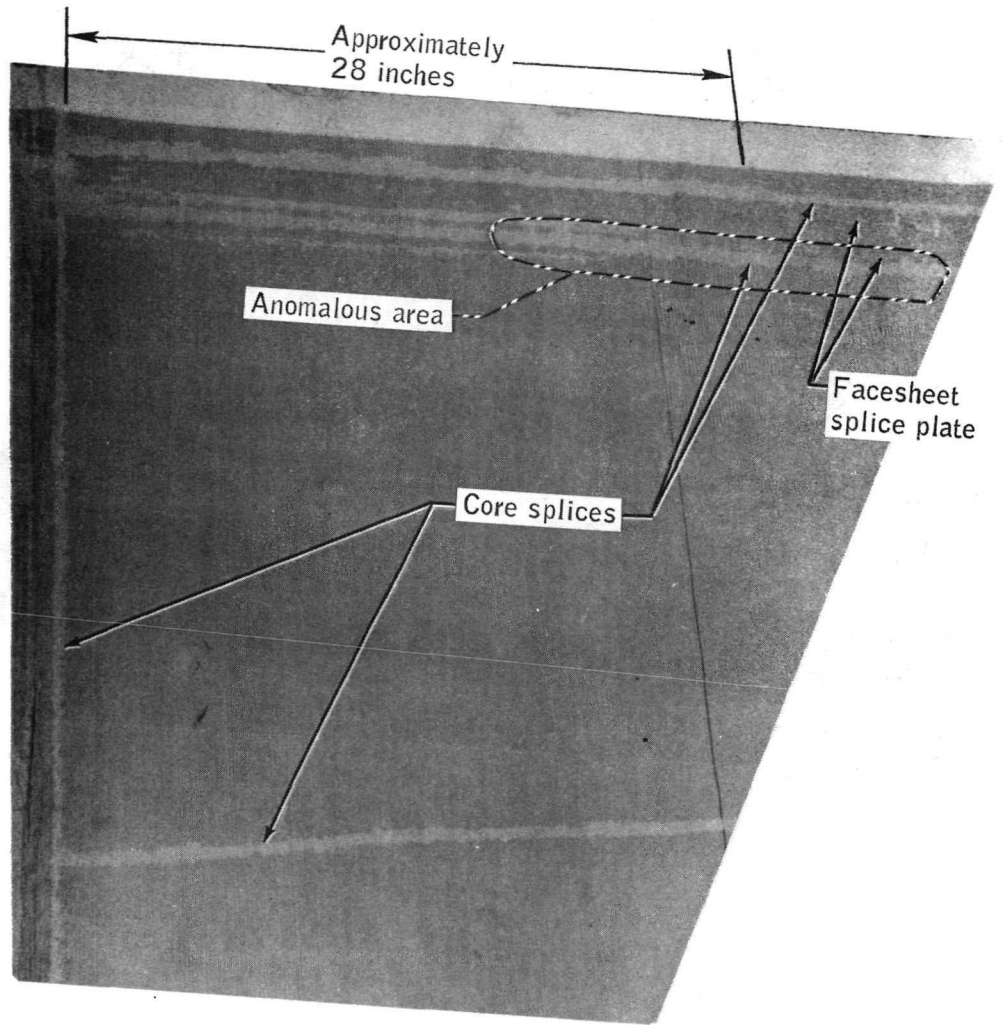
Figure 10.- Anomalous area of C-scan.

The C-scan from the -Z panel of the Apollo 6 adapter contained an anomalous area (see fig. 10), approximately 2 feet long at the station 709 butt splice near the +Y edge of the panel. However, no X-rays were taken in this area. Subsequently, inspection of C-scan and X-ray records for adapters 12, 13, 14, 15, and 16 revealed that deficient assembly techniques of the adapter at station 709 have consistently resulted in abnormalities in the structure at this station. With the additional knowledge gained by comparison of the C-scan and X-ray records on the same structure, the C-scan record for the adapter of Apollo 6 was reviewed recently, and it was concluded that voids were present in the -Y panel and that very likely the anomalous area in the -Z panel contained intermittent voids.

Hence, a deficiency associated with the large anomalous area of the C-scan is highly suspected as being the initiator of the failure. The station 709 abnormalities found consistently in later adapters substantiate this suspicion.

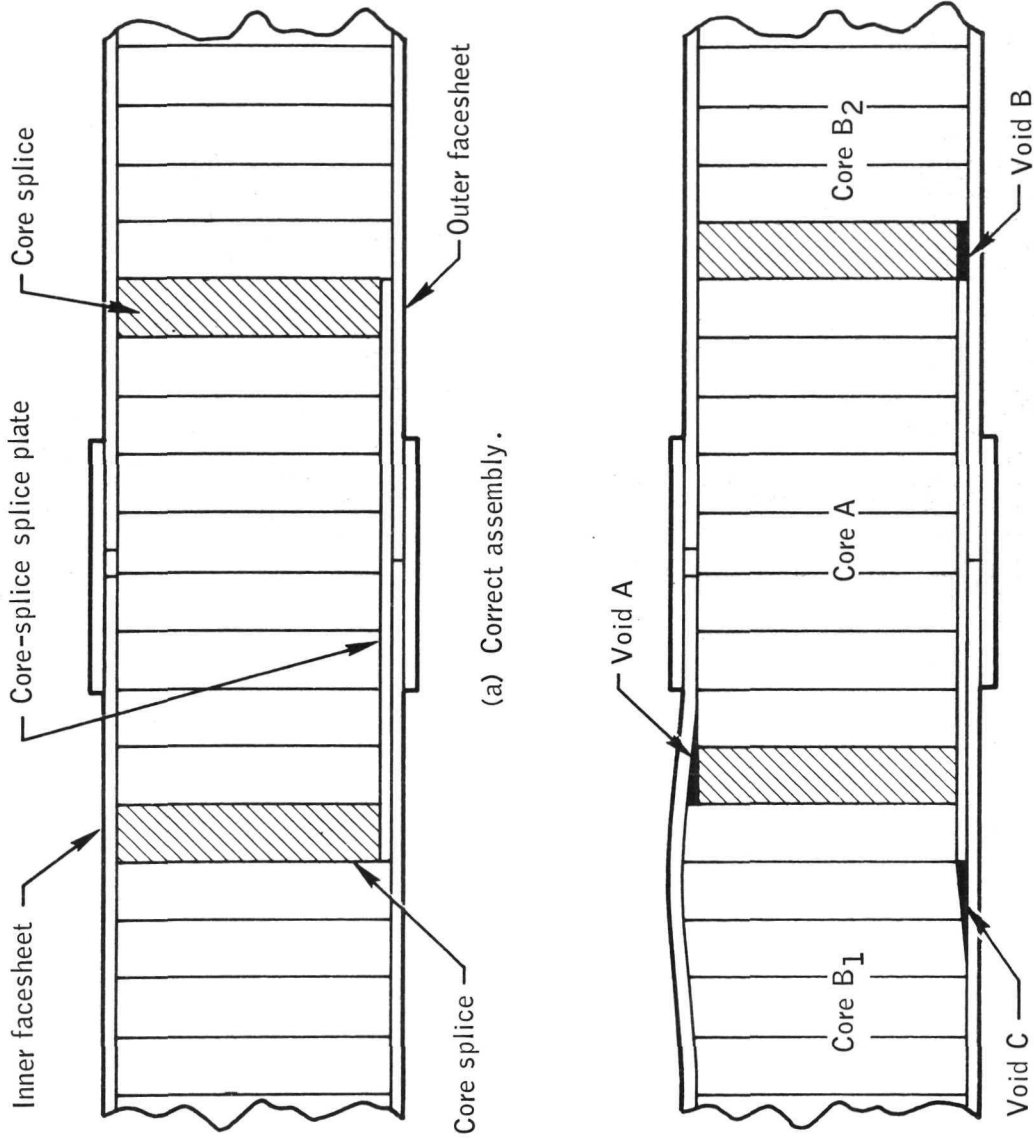
Figure 11.- Splice abnormality found in adapters 12, 13, 14, 15, and 16.

Figure 11 illustrates the deficient assembly at the 709 splice of adapters 12 through 16. The outside doubler, the outside facesheets, and the internal doubler are assembled in the relative positions shown and are placed on a "glide" sheet which has the curvature of the adapter quarter panel. These four elements cannot move with respect to each other because they are tack-riveted. On the assembly of facesheets and doublers are placed three honeycomb core elements (A, B1, and B2 in the figure). Honeycomb core A is approximately the width of the internal doubler, is placed over the doubler, and is shallower than cores B1 and B2 by an amount equal to the thickness, 0.032 inch, of the internal doubler. Cores B1 and B2 should rest on the facesheets.

The deficiency identified in the adapters is caused by core B1 being misplaced onto the internal doubler, as shown in the lower left of figure 11. The misplacement of core B1, or of core B2, then produces a bump in the internal face sheet, displaces core A, and creates the three voids shown. If adequate adhesive is provided for the core splicing operation, void A and B will be filled by the foaming adhesive. However, void C may

not fill because the core overlap on the internal doubler can prevent passage of the adhesive into this void. If the quantity of adhesive supplied for the core splices is inadequate, voids A and B may also exist. Void C was found on adapters 13, 14, and 15 and has been repaired by injection of adhesive.

The most probable cause of the Apollo 6 adapter failure was an abnormal splice assembly at station 709, resulting in a facesheet bond too weak for the internal panel pressures achieved.

The above actions were taken prior to the recently flown missions. Since the splice abnormalities have been identified, the affected regions have been repaired by adhesive injection. The Structures and Mechanics Division has determined that the core-splice splice plate (fig. 11) is not required. Consequently, the contractor has been directed to revise the design to not have this internal splice plate and thus avoid abnormal assemblies in the panels yet to be bonded.
