MSC-PT-R-68-22

APOLLO 6
ANOMALY REPORT NO. 6

ABNORMAL STRUCTURAL PERFORMANCE
DURING LAUNCH PHASE

February 1969

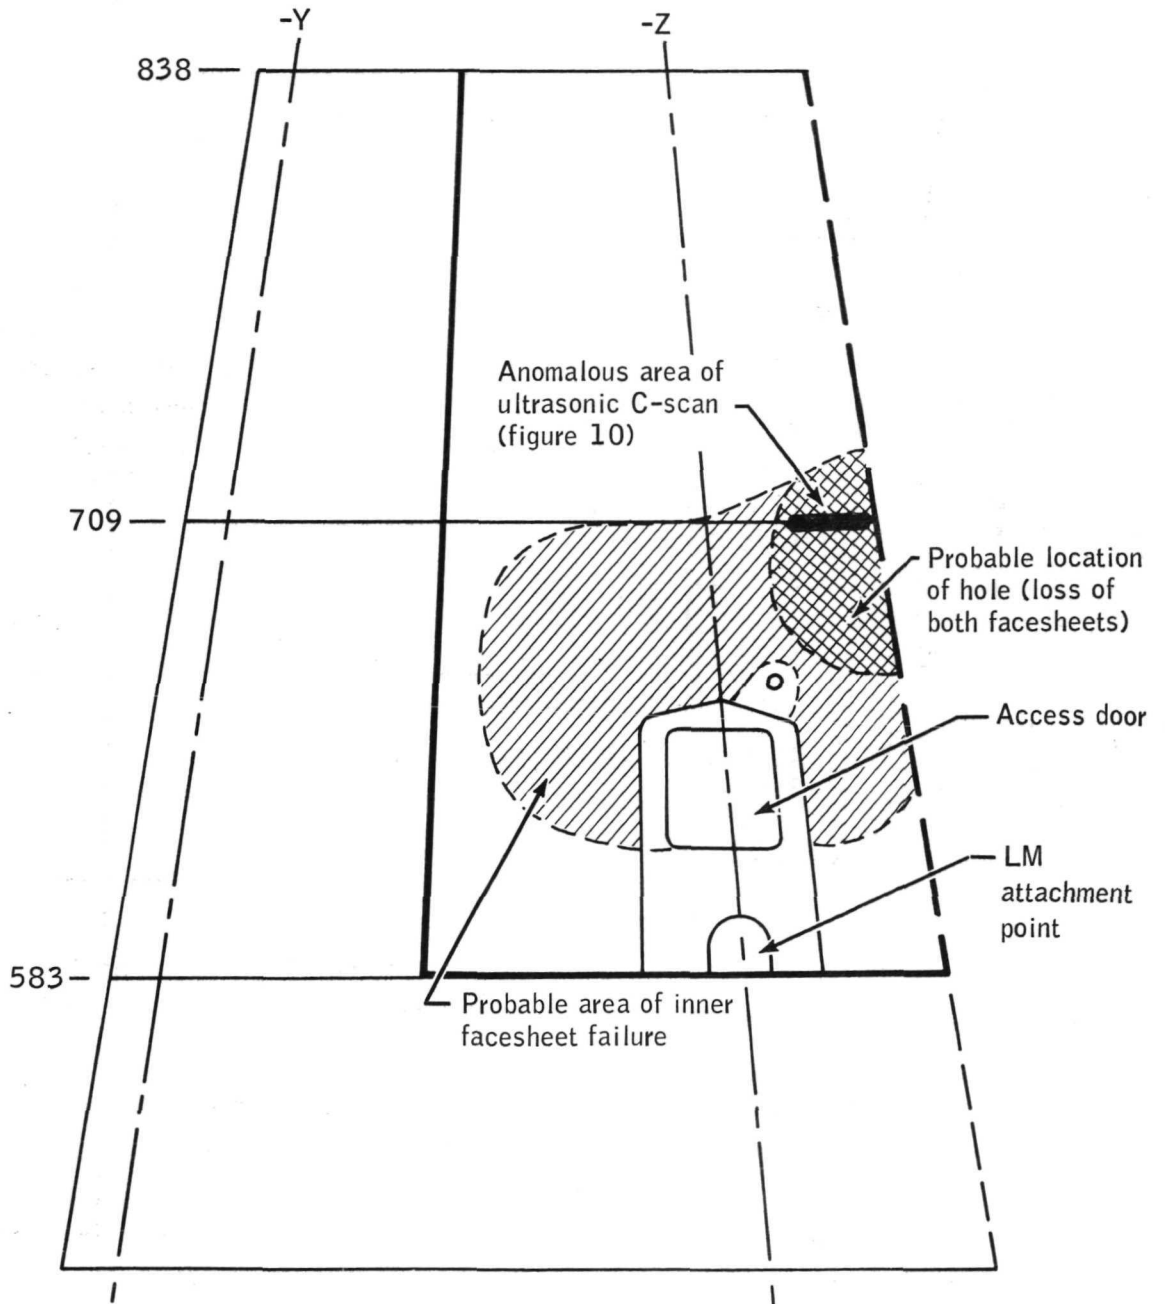
Figure 12.- Probable areas of inner face sheet failure.

To verify that a large amount of inside sheet can come off without taking the outside sheet with it, a test was performed using a full circular section of an adapter (SLA 2). A pressure of 77 psi applied to the core removed the entire inner facesheet from one panel and split the outer facesheet longitudinally as a result of the excessive hoop tension. The core had been deliberately crushed in a 3-inch-diameter area to precipitate failure. (A bond void would have lowered the failing pressure, but this was impractical to accomplish on the existing test specimen.) All the evidence, in combination, establishes that differential pressure in the honeycomb core was the mechanism that produced the large extent of panel failure of the Apollo 6 adapter. The estimated failed area is shown in figure 12.
