Document No. QTR-72-1039
Revision _____
Release Date DEC 5 1972

QUALIFICATION TEST REPORT
BUMP PROTECTION HAT
(SUBASSEMBLY OF
T020/M509 HEAD PROTECTIVE ASSEMBLY)

CONTRACT NAS 9-11905

ABSTRACT

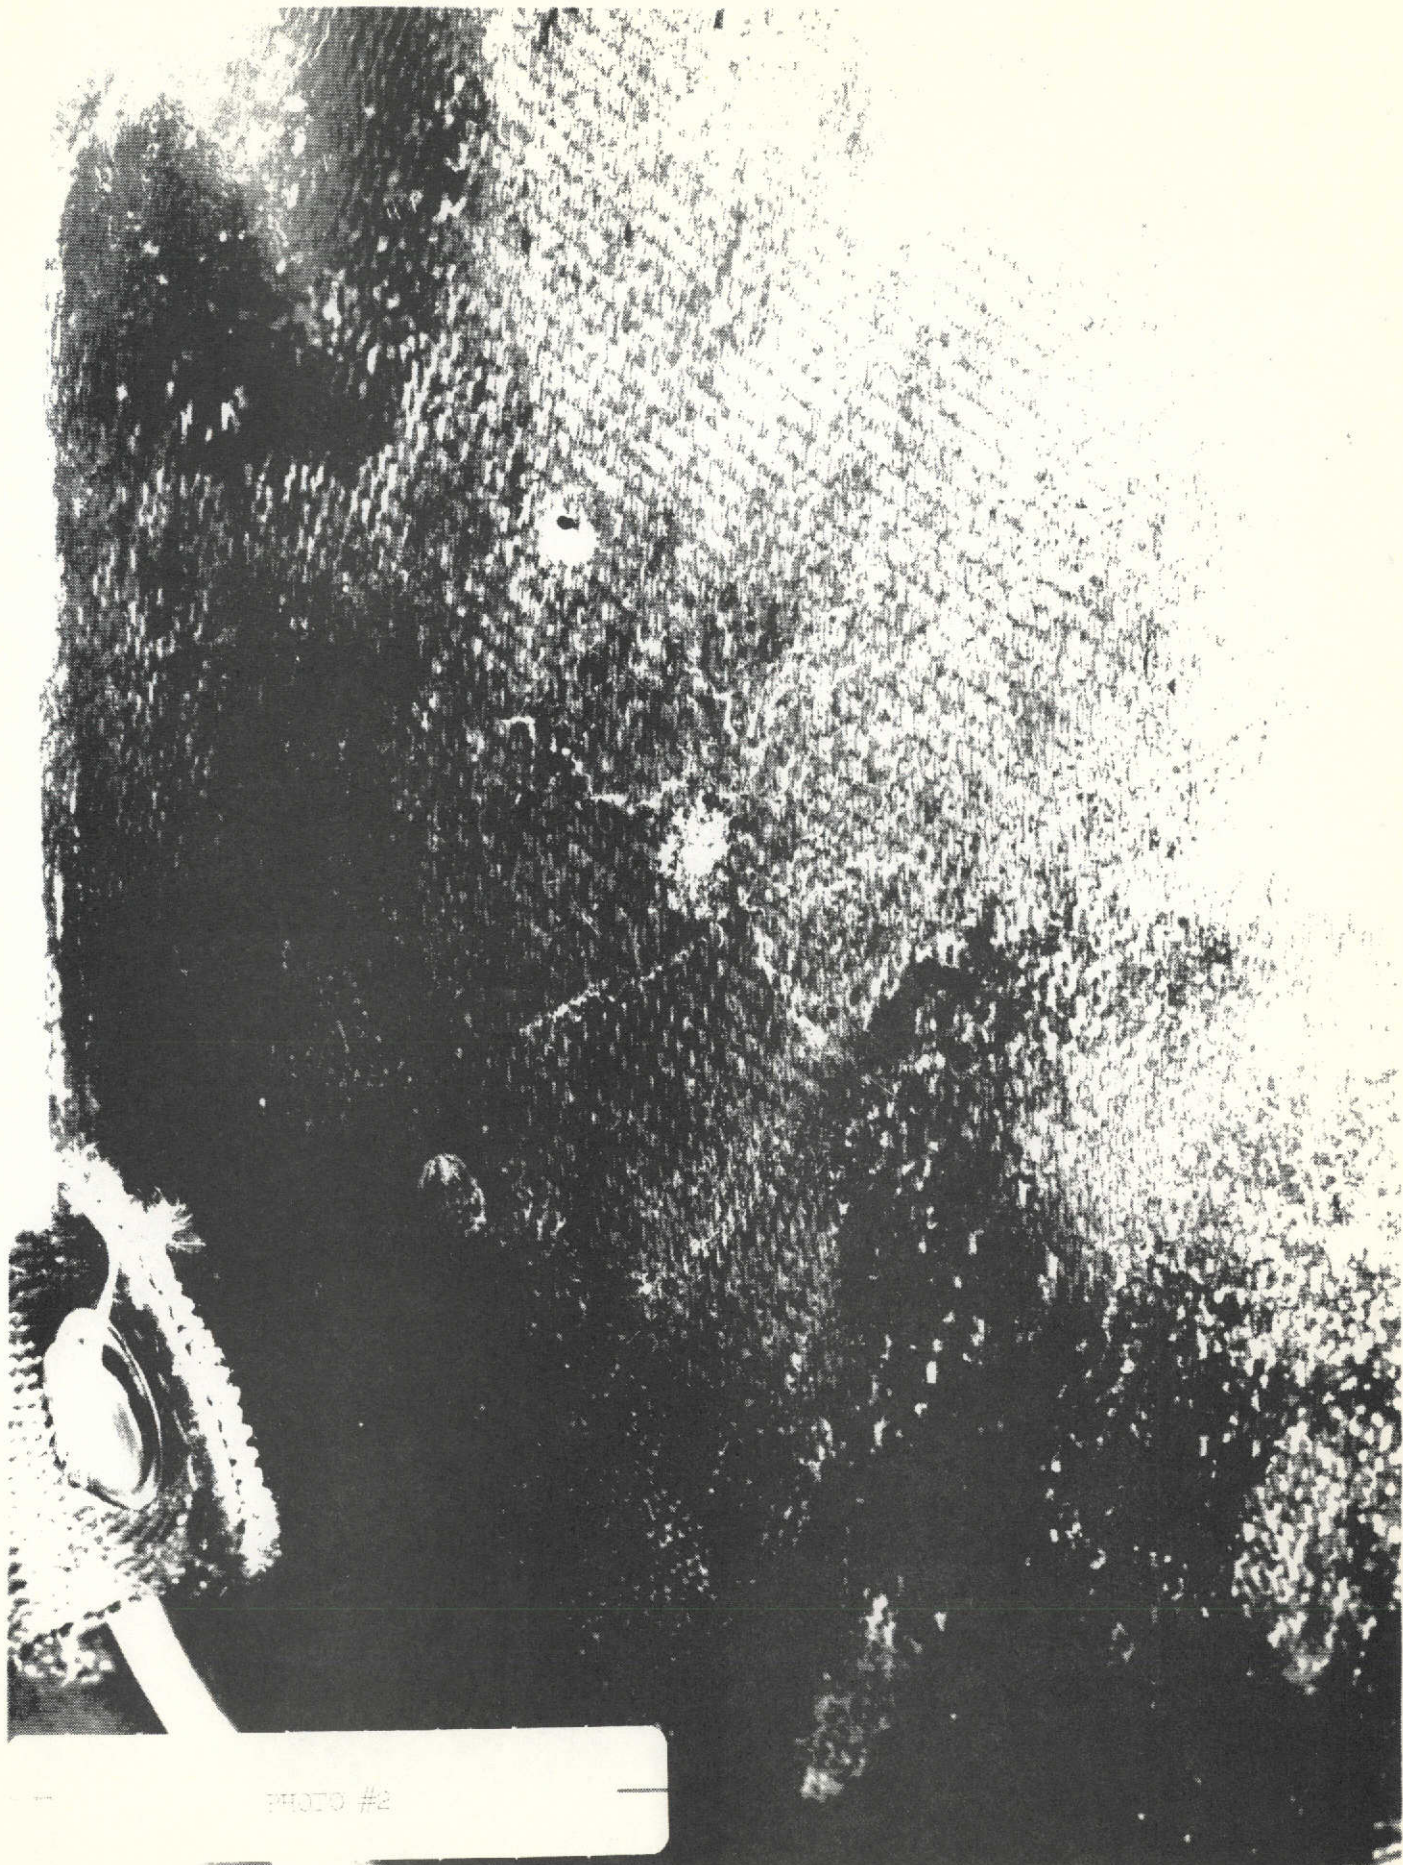
PHOTO #2

All three impacts caused stress cracks on the outside of the BPH. The side impact also caused stress cracks on the inside of the BPH. There were no stress cracks on the inside of the BPH for the top and front impacts. Analysis of the side impact cracks showed that the outside stress cracks were not the same as the inside cracks, hence, there was no penetration of the helmet. All cracks were acceptable according to the pass-fail criteria of QTP-72-1026.

1. Test Setup for Side Impact
2. Side Impact Viewed from outside helmet
3. Side impact viewed from inside helmet
4. Test setup for top impact
5. Top of helmet viewed prior to impact
6. Top of helmet after impact (magnified 3 times)
7. Top inside of helmet after impact
8. Test setup for front impact
9. Front of helmet viewed prior to impact
10. Front of helmet after impact
11. Front inside of helmet after impact

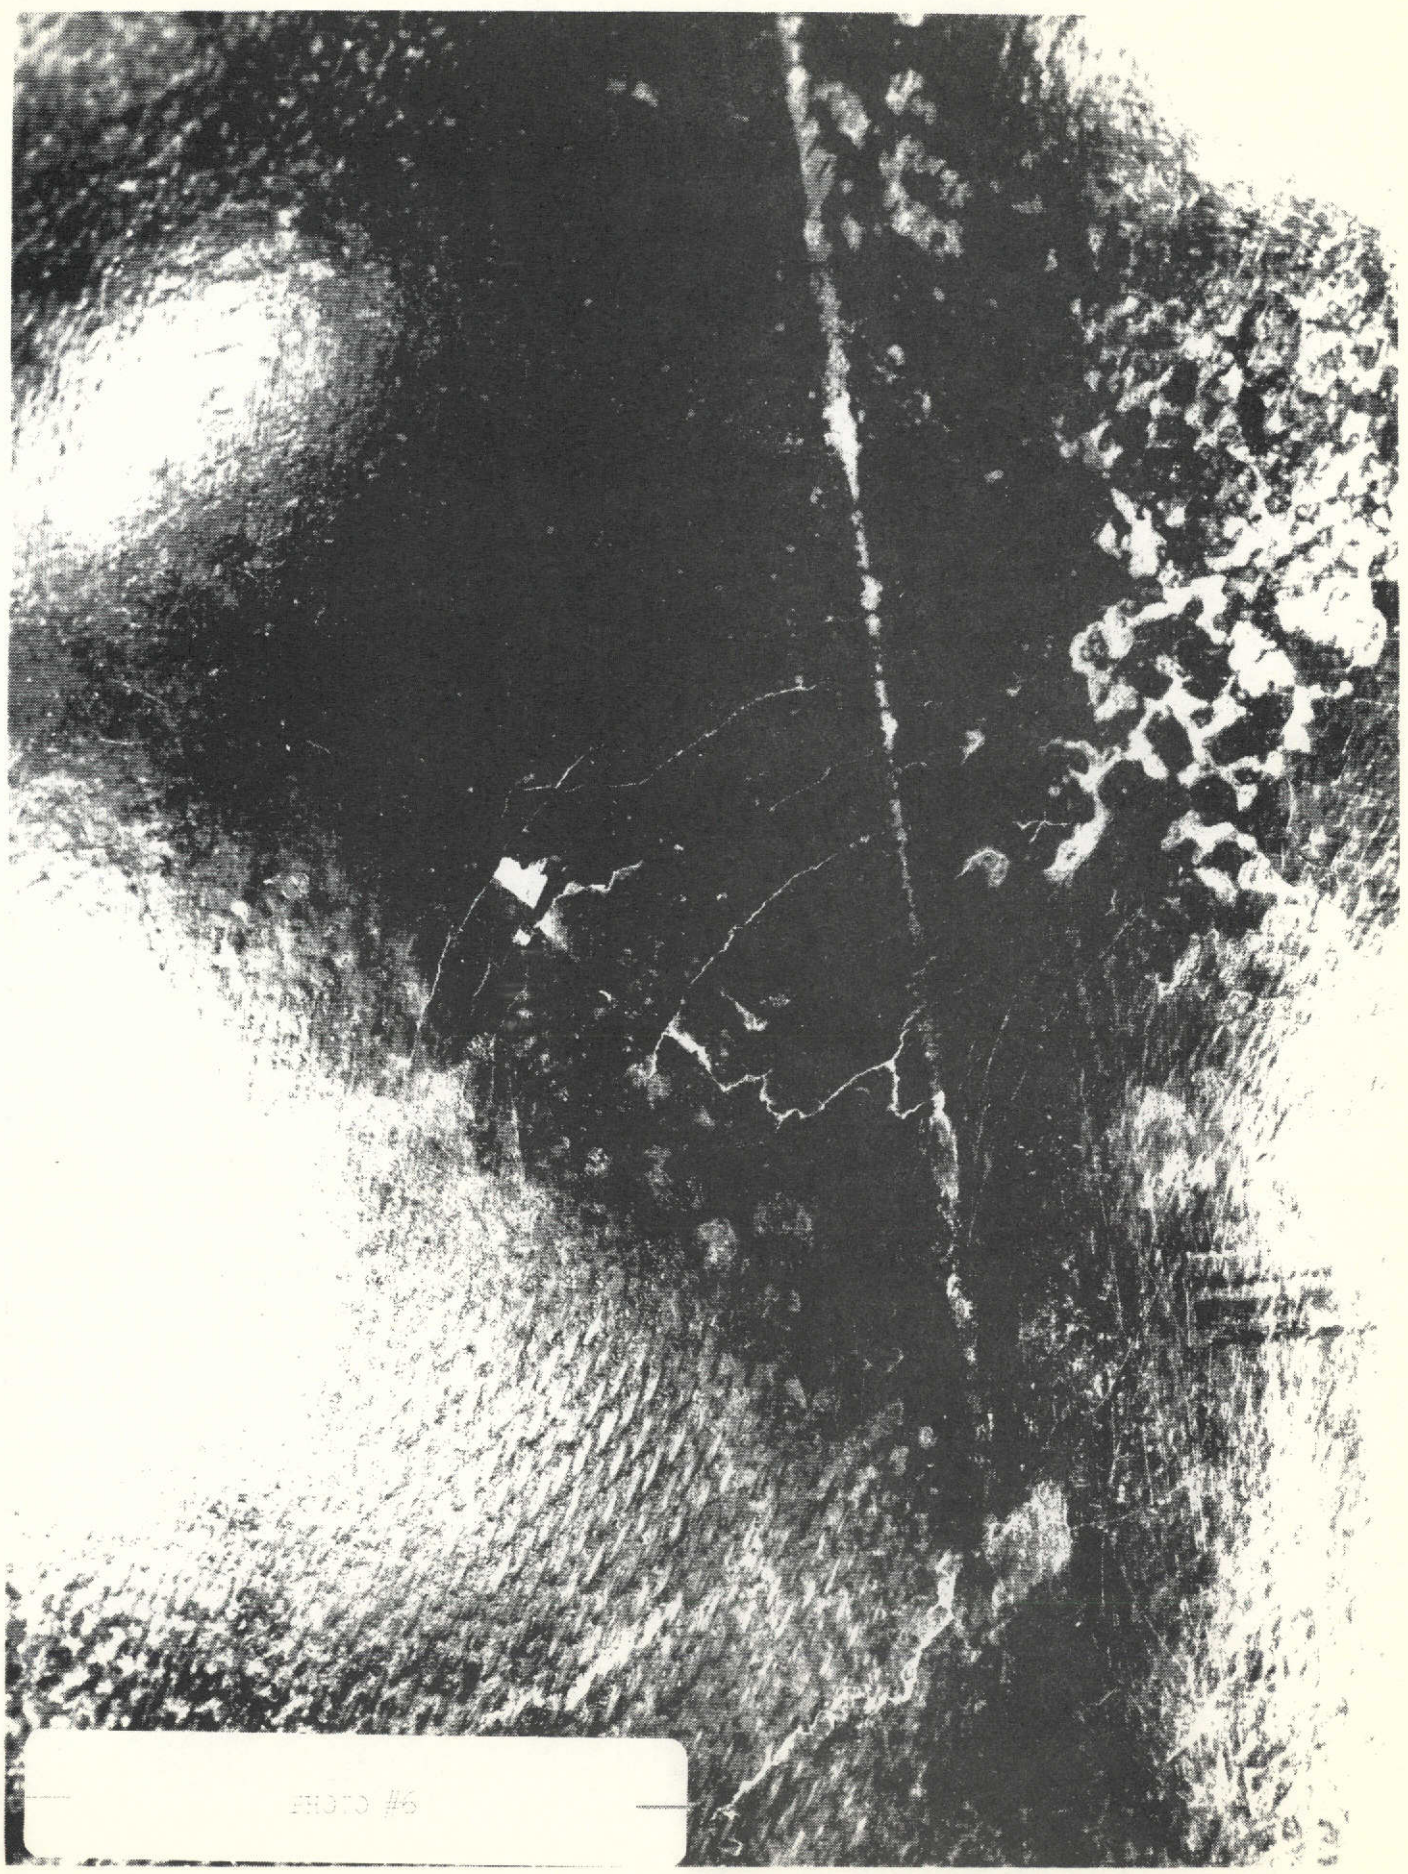
PHOTO #6

- a. Side Impact - Less than $3/8$ " deflection, though the exact amount could not be determined.
- b. Top Impact - Approximately $3/8$ " deflection.
- c. Front Impact - Less than $1/2$ " deflection, though the exact amount could not be determined because the impact was a glancing blow.
