ANALYSIS OF TURBOFAN ENGINE PERFORMANCE DETERIORATION  
AND PROPOSED FOLLOW-ON TESTS

G. P. Sallee, H. D. Kruckenberg, and E. H. Toomey

AMERICAN AIRLINES, INC.

CONTRACT NAS 3-18537

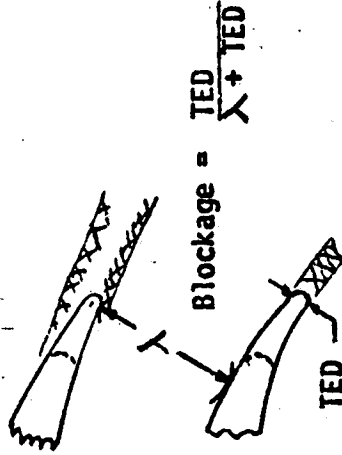
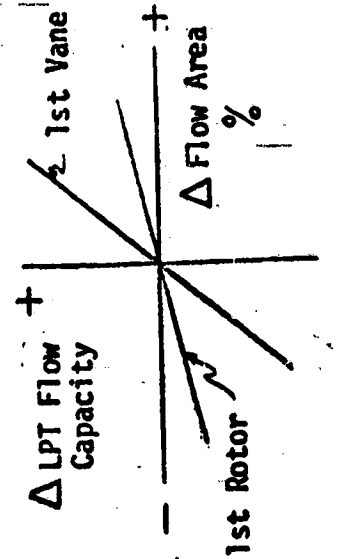
Figure 22. Turbine Shadowgraph Analysis of JT8D

- o ALL AIRFOIL CONTOURS WERE WITHIN THE ALLOWABLE TOLERANCE BAND.
- o TRAILING EDGE BLOCKAGE WAS GREATER THAN NOMINAL.

- o FLOW AREAS WERE CLOSED RELATIVE TO NOMINAL.

STAGE NUMBER	BLOCKAGE %	EFFICIENCY PENALTY %	FUEL FLOW PENALTY PPH
1	+0.73	Ni1	+5
2	.06	Ni1	0
3	+0.30	-.05	+5
4	+0.03	Ni1	0

STAGE NUMBER	ROM FLOW AREA %	TURBINE FLOW CAPACITY %	FUEL FLOW PENALTY PPH
1	-.84	Ni1	0
2	-.85	-.26	+3
3	-.84	-.10	+1
4	-.52	-.06	+1

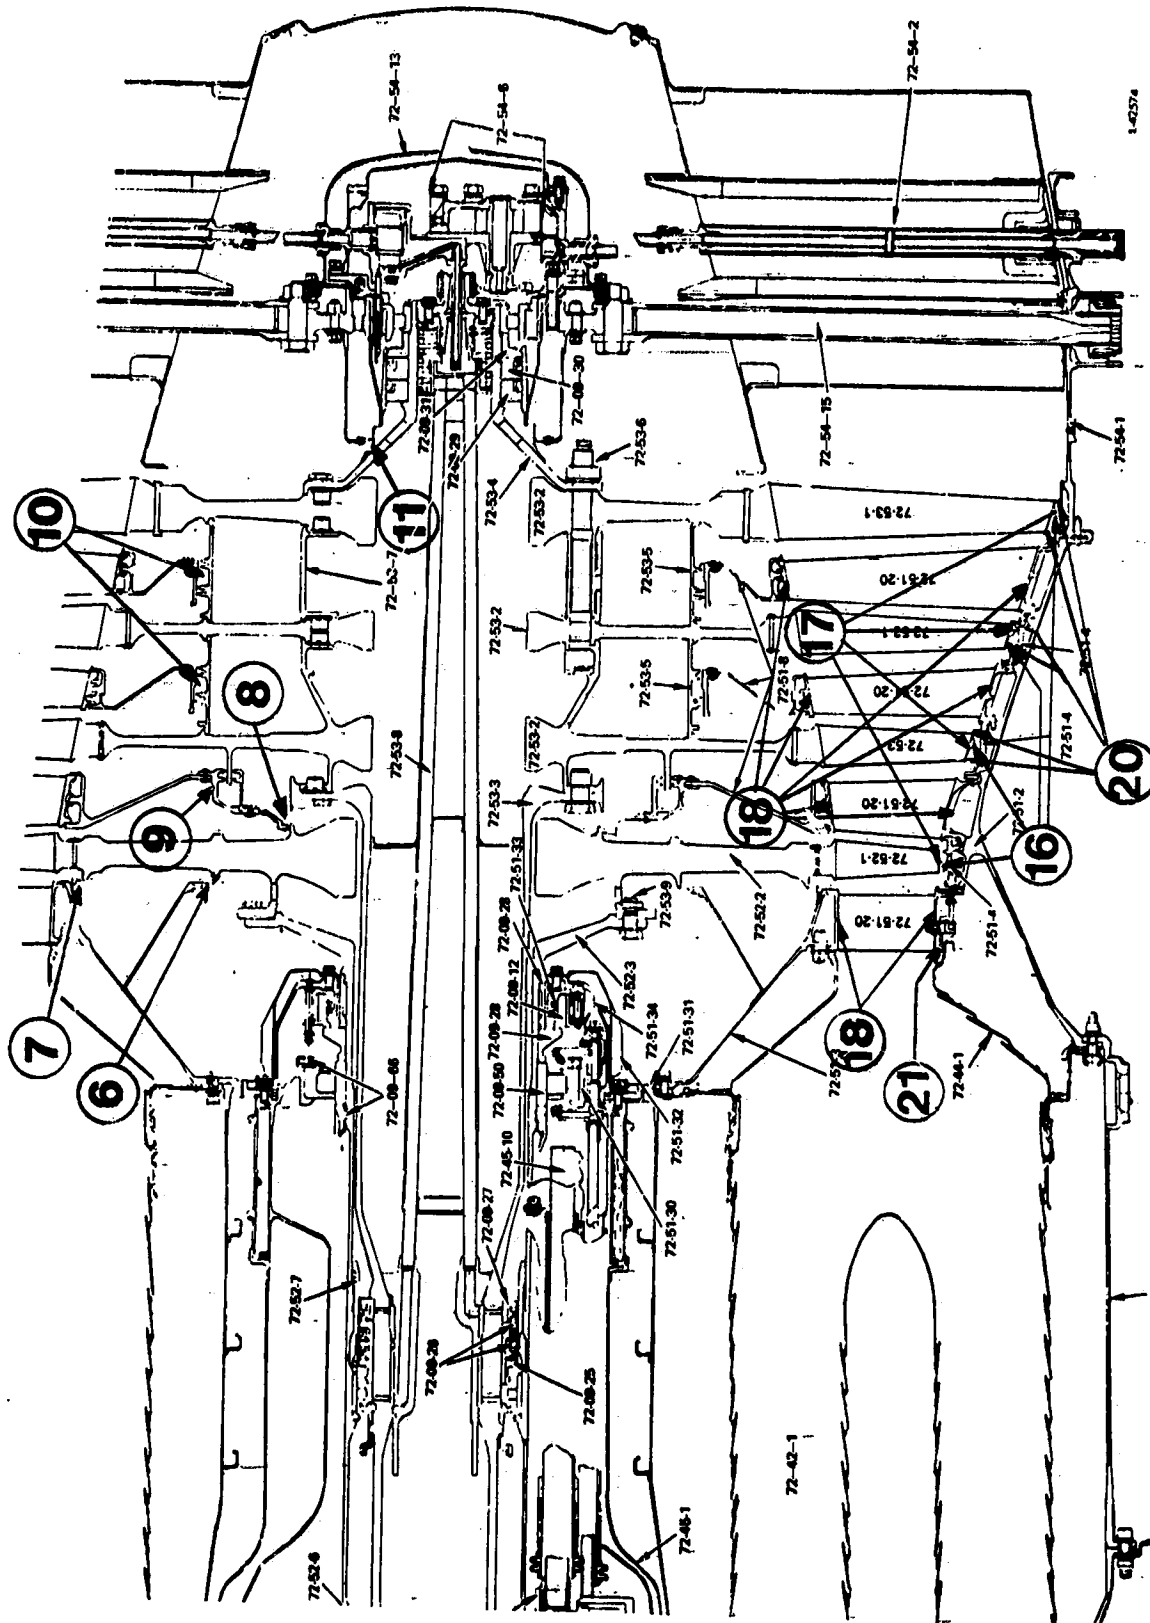
FIGURE 45 - JT3D HIGH & LOW TURBINE AREAS OF MEASURED SEAL & BLADE TIP TOLERANCES

The seals in the turbine area as indicated by numbers 6 through 11, 17, 20, and 21 were found to be within the P&WA check and repair limits. Approximately 50% of the tolerances fell within the check and repair limits while the remainder were within P&WA reference dimensions (manufacturing limits). Both the first and second stage turbine tip blade clearances (number 16) were found to exceed both the minimum and maximum limits for some of the blades. However, the average tip clearance for the 1st and 2nd turbine blades was found to lie within the P&WA manual limits. The third stage rear turbine tip blade clearance was exceeded by some blades, but the average value for all the blades was within P&WA manual limits. The fourth stage turbine blade tip clearances were found to be okay.

In summary, engine S/N 667783 exceeded the P&WA manual limits concerning individual blade tip clearances for the 1st and 2nd fan blades and for the 1st through 3rd turbine blades. The various seal areas in Figures 43 through 45 were found to be within manual limits with exception of the 7th to 8th stage fwd seal land diameter and the 15th and 16th stage aft seal land diameter which exceeded manual limits. The performance data for this engine is given in the main report.
