NASA TN D-7992

APOLLO EXPERIENCE REPORT -
GUIDANCE AND CONTROL SYSTEMS:
MISSION CONTROL PROGRAMMER FOR
UNMANNED MISSIONS AS-202,
APOLLO 4, AND APOLLO 6

Gene F. Holloway
Lyndon B. Johnson Space Center
Houston, Texas 77058

NATIONAL AERONAUTICS AND SPACE ADMINISTRATION • WASHINGTON, D. C. • JULY 1975

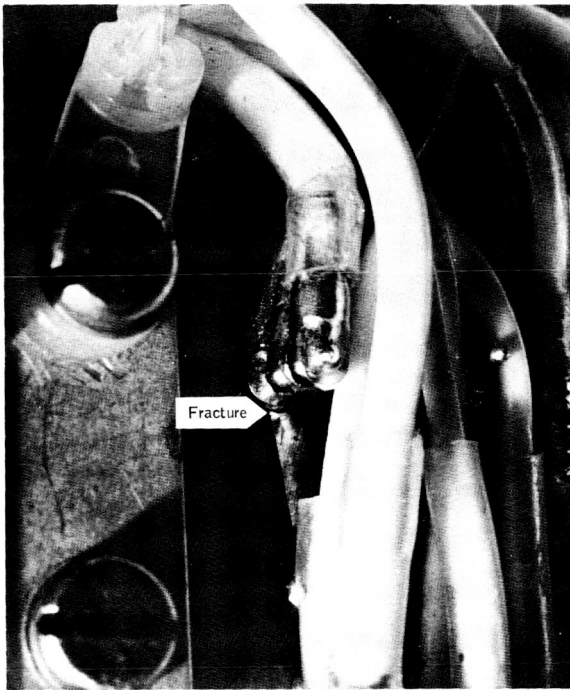
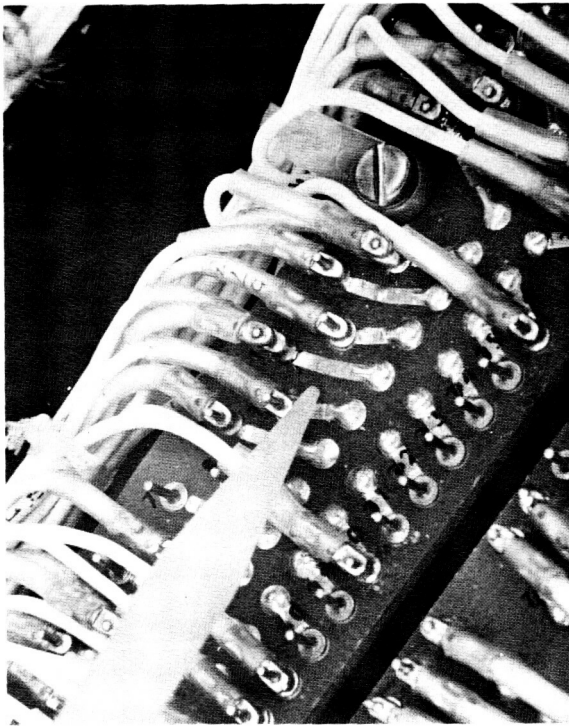
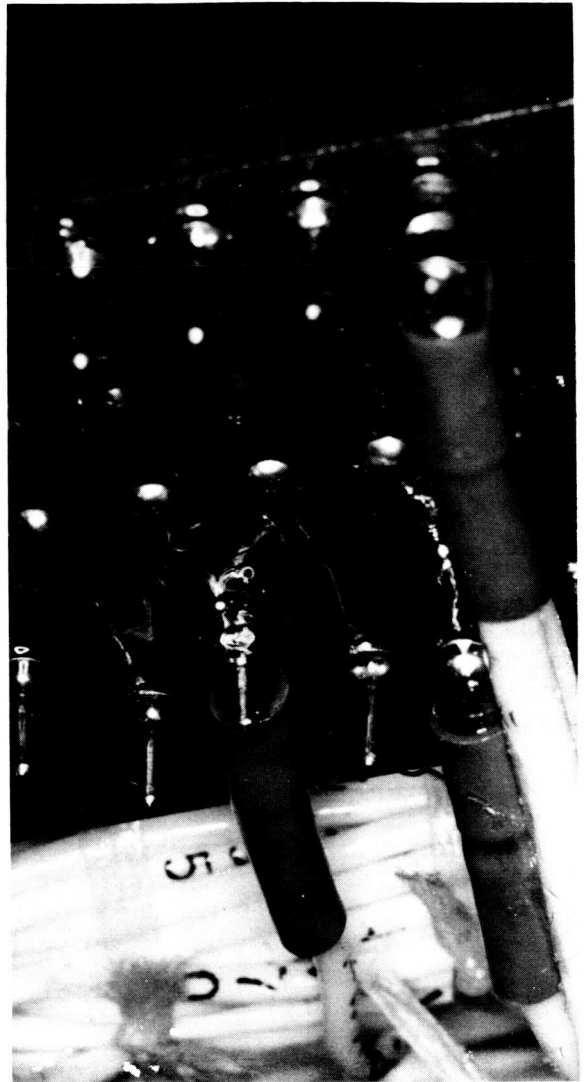
Figure 14.- Fractured solder terminals.

The MCP production unit 3 (qualification test unit 1) entered the vibration environment portion of the qualification test on April 2, 1966. The vibration effects to be investigated were the resonances of each package (resonance search) and the susceptibility of the MCP to random vibration. The postvibration physical inspection of the MCP indicated 35 instances of fractured solder joints on the pins of the SCC control assembly connector boards (fig. 14). The GCC had 10 loose or broken solder joints around similar pins. However, no functional test failures were attributed to the solder fractures around the pins. The corrective action for the cracked-solder-joint problem included soldering the terminals on both sides of the circuit strip (fig. 15) and adding a bracket to improve the wire-bundle routing. The corrective action was successful, and the problem did not recur during future vibration tests.

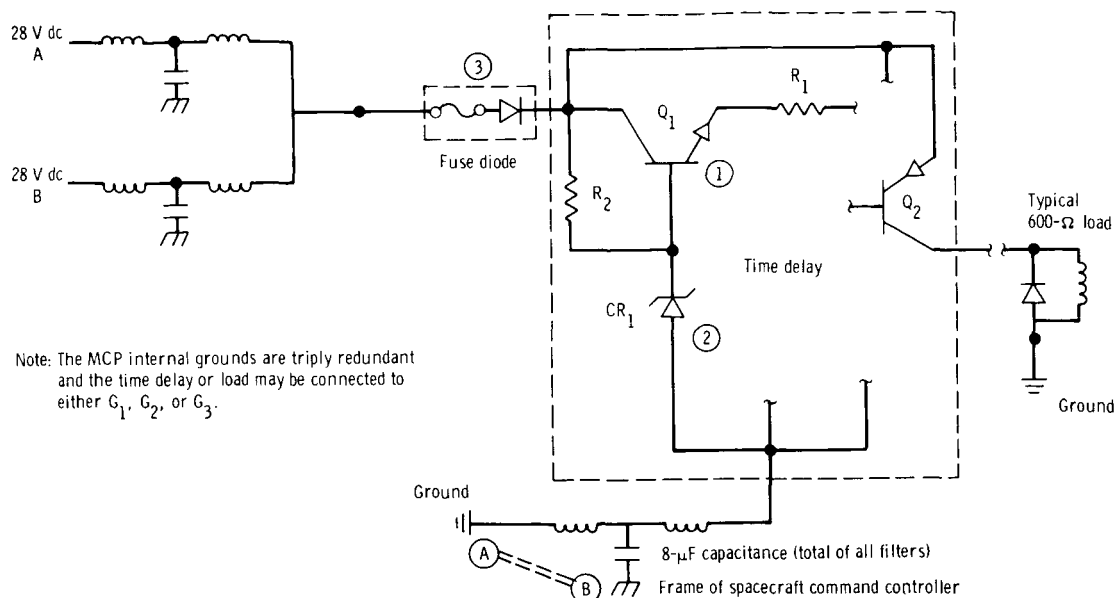
Figure 17. - Time-delay circuit schematic.

For a 14-month period ending in April 1967, NASA and various aerospace industry representatives combined their efforts to resolve the MCP time-delay and fuse-diode failures. The failure mode was readily established shortly after the first time-delay circuit failed. Transistor Q_1 (fig. 17) of the time-delay circuit shorted (collector to base) causing zener diode CR_1 to overload, exceed the thermal rating, and fail, so that

the fuse diode on the time-delay input was overloaded and failed (open circuit). Numerous attempts were made to establish the cause of the failure. The following list of significant events in the investigation indicates the amount of study on this problem.

18. In February 1967, the insulation-resistance megohm test used during acceptance testing was determined to be the cause of the failures. After the megohm test was eliminated and a multimeter was used to check the insulation resistance, no more time-delay failures occurred.

The extensive engineering investigation to resolve the time-delay failures revealed that this failure, as well as several others, resulted from the transients caused by the 500-V dc megohm portion of the unit-level test at the vendor's facility. Failure of 8 diodes, 4 capacitors, 22 fuse diodes, and 14 time delays could be attributed directly to these transients. The listed failures were of an induced nature. During factory test, components were stressed beyond their capacity by an action of the test operator, who was not aware of the consequences. The action consisted of shorting an internal ground (G_1 , G_2 , or G_3) to the frame of the SCC after the megohm test. (Refer to points A to B in fig. 17.) This action was taken by the test operator to avoid electrical shock from filter capacitors that had been charged to several hundred volts when the megohm test voltage was applied to the frame of a control assembly in the SCC. The control assemblies were insulated from the frame, and this insulation was tested each time by the megohm test unit. The test specification required that 500 V dc be applied across a test point on the control assembly to the SCC frame for 2 minutes, then the insulation resistance would be read. During this 2-minute period, the filter capacitors were charged through the multitude of relay, time-delay, and differentiator paths.

Laboratory tests of transistor Q_1 , used in the time-delay circuits (fig. 17), were performed to determine the collector-to-base breakdown strength under pulse conditions. The test consisted of superimposing a positive pulse on a 28-V dc signal on the collector of transistor Q_1 in a time-delay circuit. The circuit was repeatedly pulsed, increasing amplitudes in 10-volt increments to 228 V dc (maximum pulse amplitude plus 28 V dc) or until failure, whichever occurred first. Fifty-six transistors were tested in the laboratory under these conditions, and 35 transistors failed. Each time a transistor failed, zener diode CR_1 was also overstressed and failed. The failed

transistor and zener diode had degraded or shorted junctions that were essentially the same as the failed parts in the SCC units of the MCP. During the laboratory test, the lowest pulse input to cause failure was at 108 V dc (28 V dc plus an 80-volt pulse). Six failures occurred at input signals of less than 150 V dc, 10 at less than 170, 20 at less than 198, and 35 at less than 228. Thirty of the transistors failed on the first voltage pulse at the failure level, five transistors failed by the fifth pulse. The 21 transistors that did not fail were ultimately pulsed 170 times at 228 V dc. After the cause of failure had been determined, it remained to be proved that the components that had not failed were not degraded by the megohm tests, even though they seemed to function satisfactorily. Three of the 21 transistors were selected at random and were pulsed for a minimum of 43 000 cycles without a failure. Therefore, the misapplication of the megohm test could cause immediate failures but would not cause the components to be degraded and susceptible to subsequent failure.

On the basis of the vendor's successful isolation of the cause of the failures, its proper corrective action to prevent future occurrences, and its demonstration that existing time-delay transistors in the MCP were not degraded, the problem was closed on April 6, 1967.

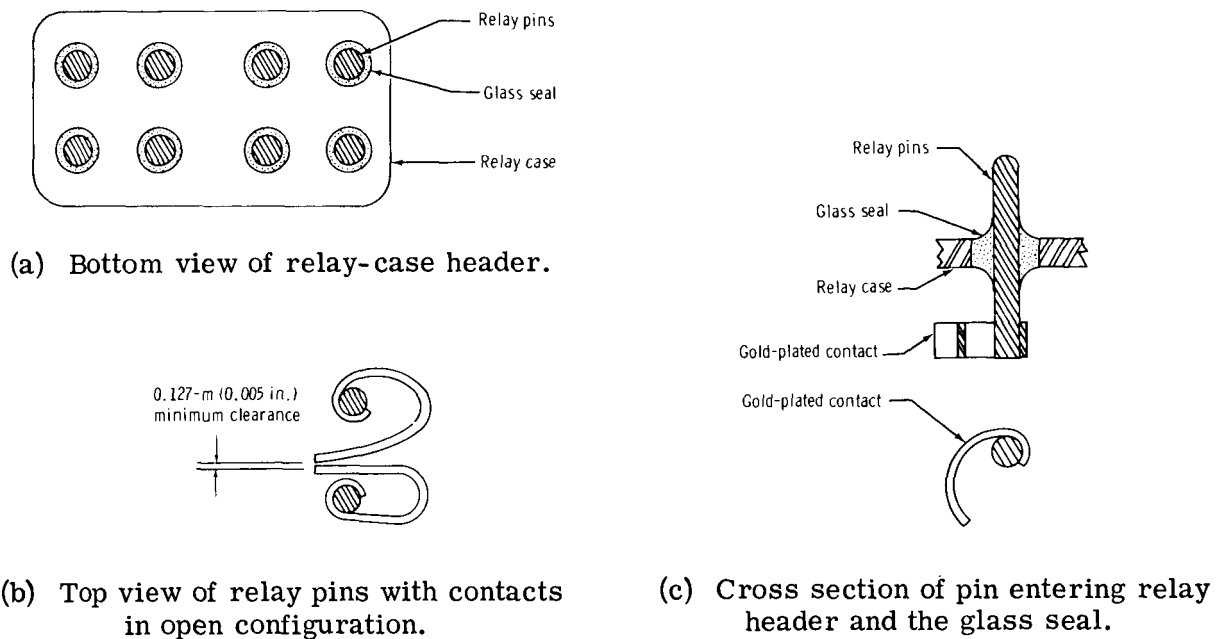
Figure 18. - Relay schematics to describe glass-seal problem.

The problem involving cracked glass seals did not adversely affect a program or a spacecraft, because the only two failures occurred in qualification unit 1 during the postflight test of spacecraft 011. The specification required that all component leads that mount on printed circuit boards shall not protrude through the board more than 0.76 millimeter (0.030 inch). The relays, diodes, transistors, and other electrical components using glass-to-metal seals around their leads (or pins) were discovered to be subject to a shock wave during the process of clipping the pin. This shock wave was transferred down the pin and could possibly crack the glass seals. (The wire cutters, diagonal-cutting pliers, or side-cutting pliers use a wedge or chisel effect to separate the wire.) At the instant of final metal separation, rather severe forces (or shock waves) were transferred along the wire.

The problem with the MCP relays was a result of the vendor's fabrication techniques, which required the leads to be clipped. The relays, including the pin seals, were first inspected and then inserted in the circuit boards; the leads were clipped, the cut pins were soldered, and the solder was inspected. (At this time, the relay-pin seals could not be seen.) The clipping operation mechanically stressed the relay pins and cracked some of the glass seals.

Whenever a glass seal cracked or the relay pin became loose in the glass seal, the pin was free to rotate; merely the wrist action of the technician clipping the pin could rotate the pin and alter the critical relay contact alinement (fig. 18). The manufacturing alinement procedures required that the contacts first be set at a minimum 0.127-millimeter (0.005 inch) clearance. An overtravel adjustment was then checked and established at 0.0635 millimeter (0.0025 inch) to effect the proper wiping action of the relay contacts and then the proper electrical transfer. Alinement of the contacts had to be within $\pm 3^\circ$. A projected viewgraph, which magnifies the contacts many times

their actual size, was used by the manufacturer to inspect and check these adjustments. Failure or improper action of the relays could occur for insufficient contact gaps or for contact gaps with too great a clearance. To prevent future problems, the vendor eliminated the relay clipping during the manufacturing process. An NASA Flight Safety Information Bulletin was published to notify all Apollo Program participants of the hazards of clipping terminals with glass-to-metal seals.
