NASA CR - 145167
(SER - 50983)

**STUDY TO INVESTIGATE DESIGN ,
FABRICATION AND TEST OF LOW COST CONCEPTS
FOR LARGE HYBRID COMPOSITE
HELICOPTER FUSELAGE - PHASE II**

April 1977

Sikorsky Aircraft

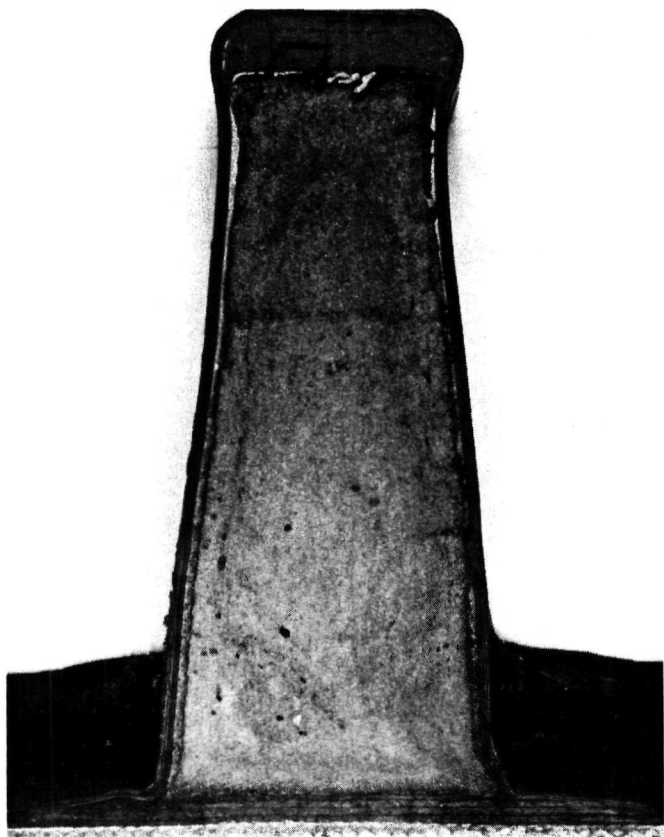
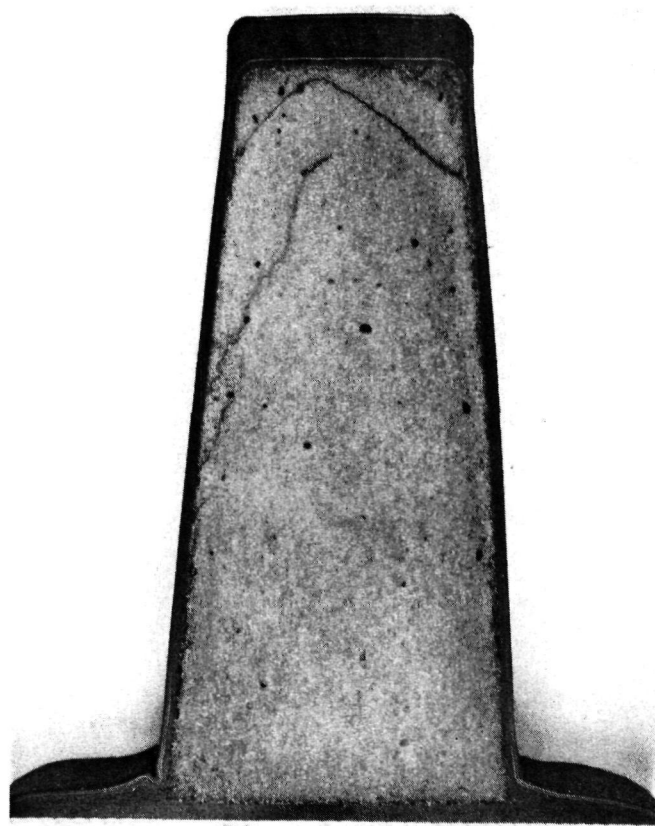
(a) ORIGINAL FRAME SECTION. POOR DEFINITION AND COMPACTION OF UPPER CAP.

(b) IMPROVED FRAME SECTION. EXCELLENT DEFINITION OF CROSS SECTION AND COMPACTION OF UPPER CAP.

FIGURE 24. SECTION VIEWS OF ORIGINAL SHELL SECTION FRAME AND IMPROVED FRAME.

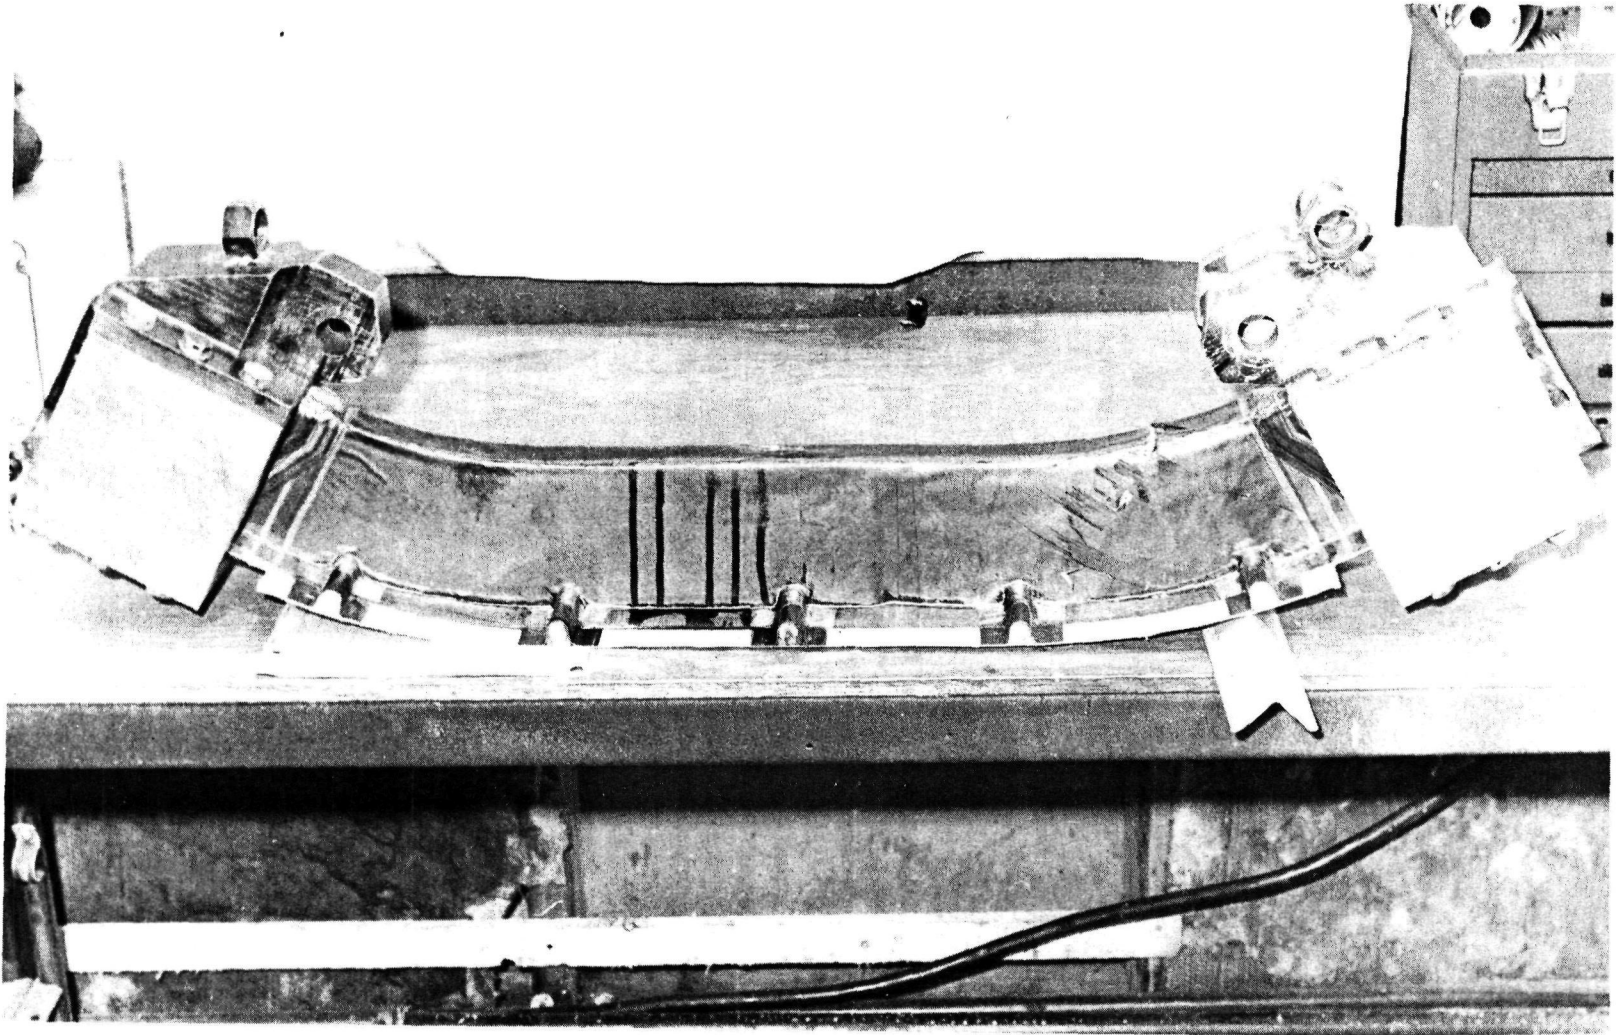
The first EWR 32381 frame fatigue specimen, Figure 30, was installed in the test fixture and loaded with the upper cap in compression. Load was applied in 4.45 kN (1000 lb) increments to determine the spring rate of the specimen. At 43.6 kN (9800 lb) or approximately 60 percent of design ultimate load, the specimen failed suddenly and catastrophically in the area of the 50.8 cm (20 in.) radius adjacent to the built up test fixture doublers as shown in Figure 32. The frame specimen was separated at the fracture to inspect the damage which had occurred. Sections were cut from the specimen as shown in Figure 33 to determine the extent of damage. Figure 34 shows the fracture surface (Figure 34a) and the damage at a point 5.08 cm (2 in.) away from the fracture surface (Figure 34b). In the area of fracture, the upper cap laminate was completely separated from the web laminate, and forced downward approximately 2.54 cm (1.0 in.) into the foam core causing localized crushing of the foam. The web laminate was buckled on both sides of the frame section and had completely separated from the stabilizing foam core. Examination of sections cut from the frame specimen in areas C&D (Figure 33) shows a separation of the shear webs from the stabilizing foam core and indications of cap/web separation. No damage was apparent in the center portion of the frame specimen (Sections E, F, G, H, I (Figure 33)). In Sections J, K, L (Figure 33), the curved area opposite the primary fracture area of the specimen, a separation of the shear web from one side of the foam core was found. A longitudinal crack extending from the shear web to foam separation was discovered in the upper cap laminate extending to the cap to web interface. From these preliminary observations, no conclusions to determine the mode or sequence of failure could be established. To provide the information necessary to thoroughly understand the premature failure of this first specimen, five separate areas of investigation were established.

FIGURE 32. TEST #1, FRAME S/N 1; FAILURE OCCURRED IN CURVED AREA BETWEEN 4TH AND 5TH STRINGER, RIGHT HAND END.

An unexpected static failure of the number one frame fatigue specimen in the curved portion of the specimen during limit load application and the subsequent failure analysis, as discussed further in Section 6.2, indicated certain design modifications were required to be incorporated into the present composite frame design. To verify the effects of these projected improvements, a decision was made to fabricate an additional frame specimen, incorporating all of the calculated design improvements. In addition to the changes made in the design of the frame section, suggested fabrication improvements were also evaluated. Semi-flexible caul plates were fabricated and utilized to improve surface definition and contours on the frame outer surfaces.

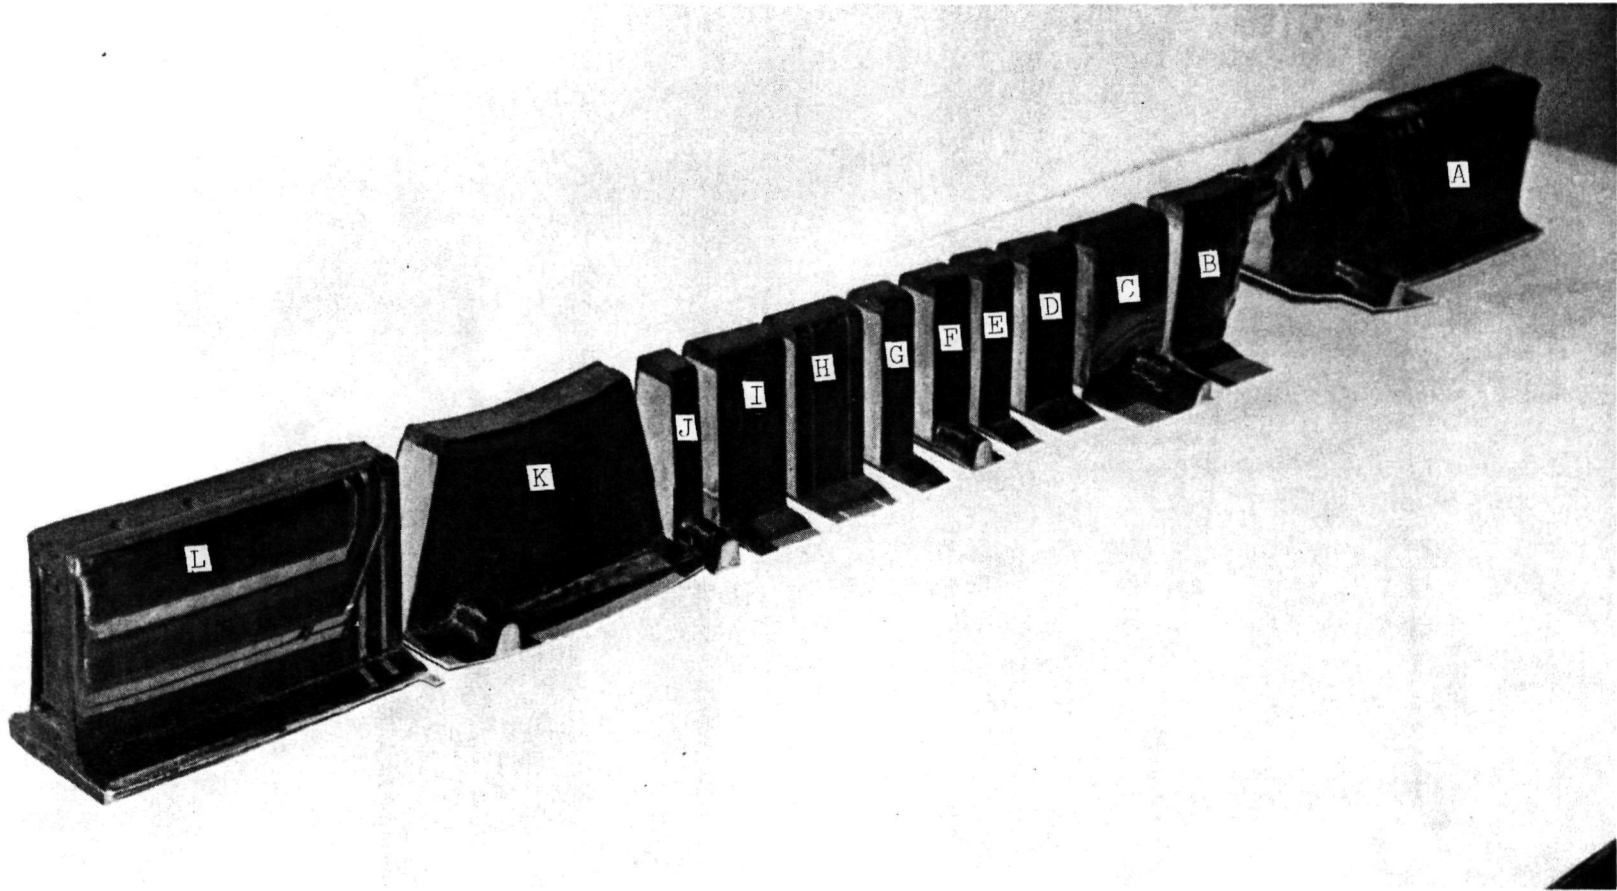
FIGURE 33 . FAILED FRAME SPECIMEN #1; SECTIONED FOR FAILURE ANALYSIS AND MATERIAL PROPERTY IDENTIFICATION.

To determine the quality of the first frame test specimen, materials evaluation specimens were removed from the areas where no damage was apparent. These areas represented by letters F and K in Figure 33 were further machined to provide short beam shear and photomicrograph specimens of the upper cap laminate and foam compression specimens of the frame core. Shear properties of the upper cap laminate were found to average 87.5 MPa (12,700 psi), which is above the calculated minimum acceptable value of 86.2 MPa (12,000 psi). Examination of the upper cap photomicrographs revealed small voids running longitudinally, but not of sufficient size or magnitude to be considered a contributory factor in the static failure of the frame specimen. Foam compression samples prepared from area F (Figure 33) were within the nominal density range of 221 Mg/m³ (8.0 lb/ft³) and produced an average room temperature compression strength of 1.38 MPa (200 psi) at 10 percent deflection, which is above the design requirement for the core material.

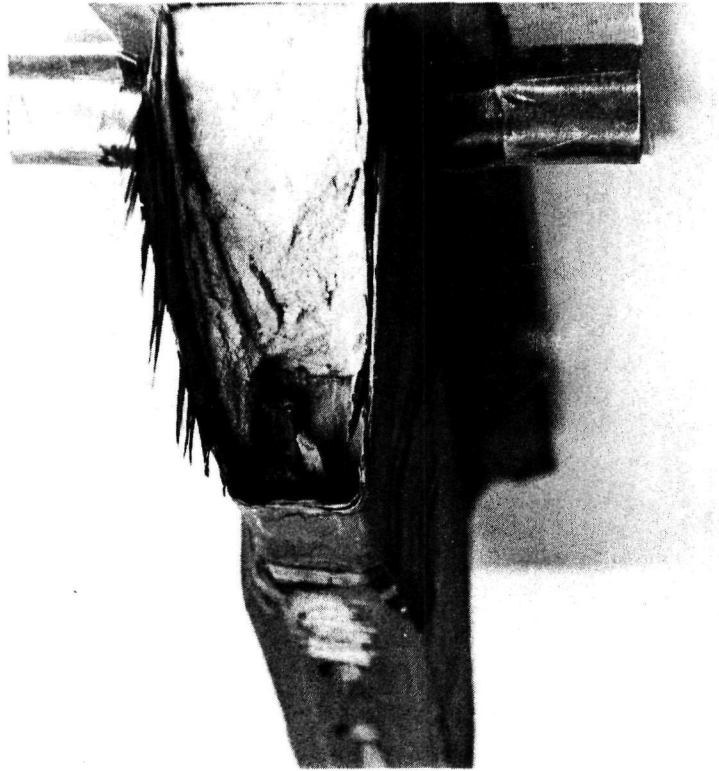
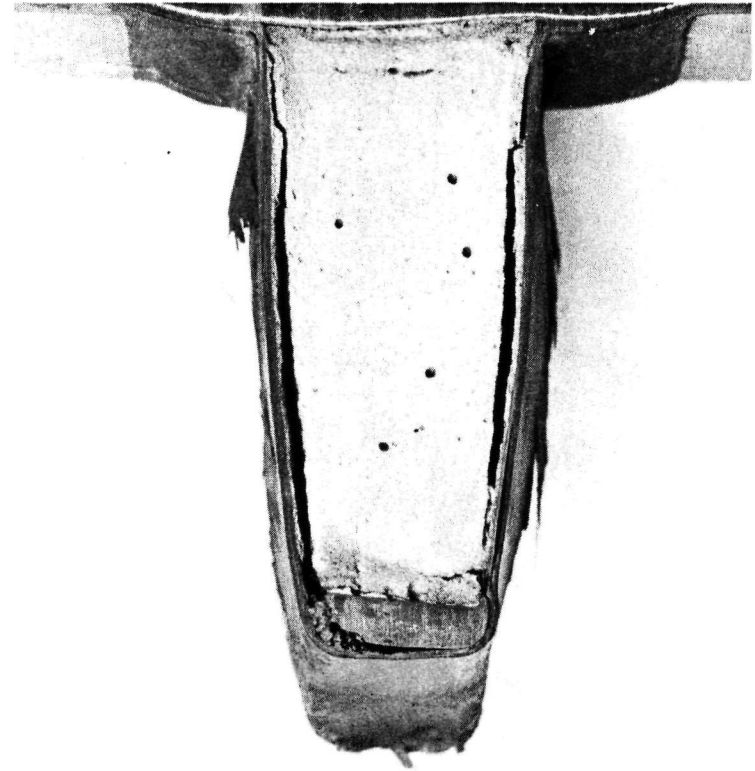
(a) SECTION 5.08 CM (2 IN.) AWAY FROM
FRACTURE SURFACE

(b) FRACTURE SURFACE

FIGURE 34 . FAILED FRAME SPECIMEN #1; VIEWS OF THE INTERIOR FAILURE.

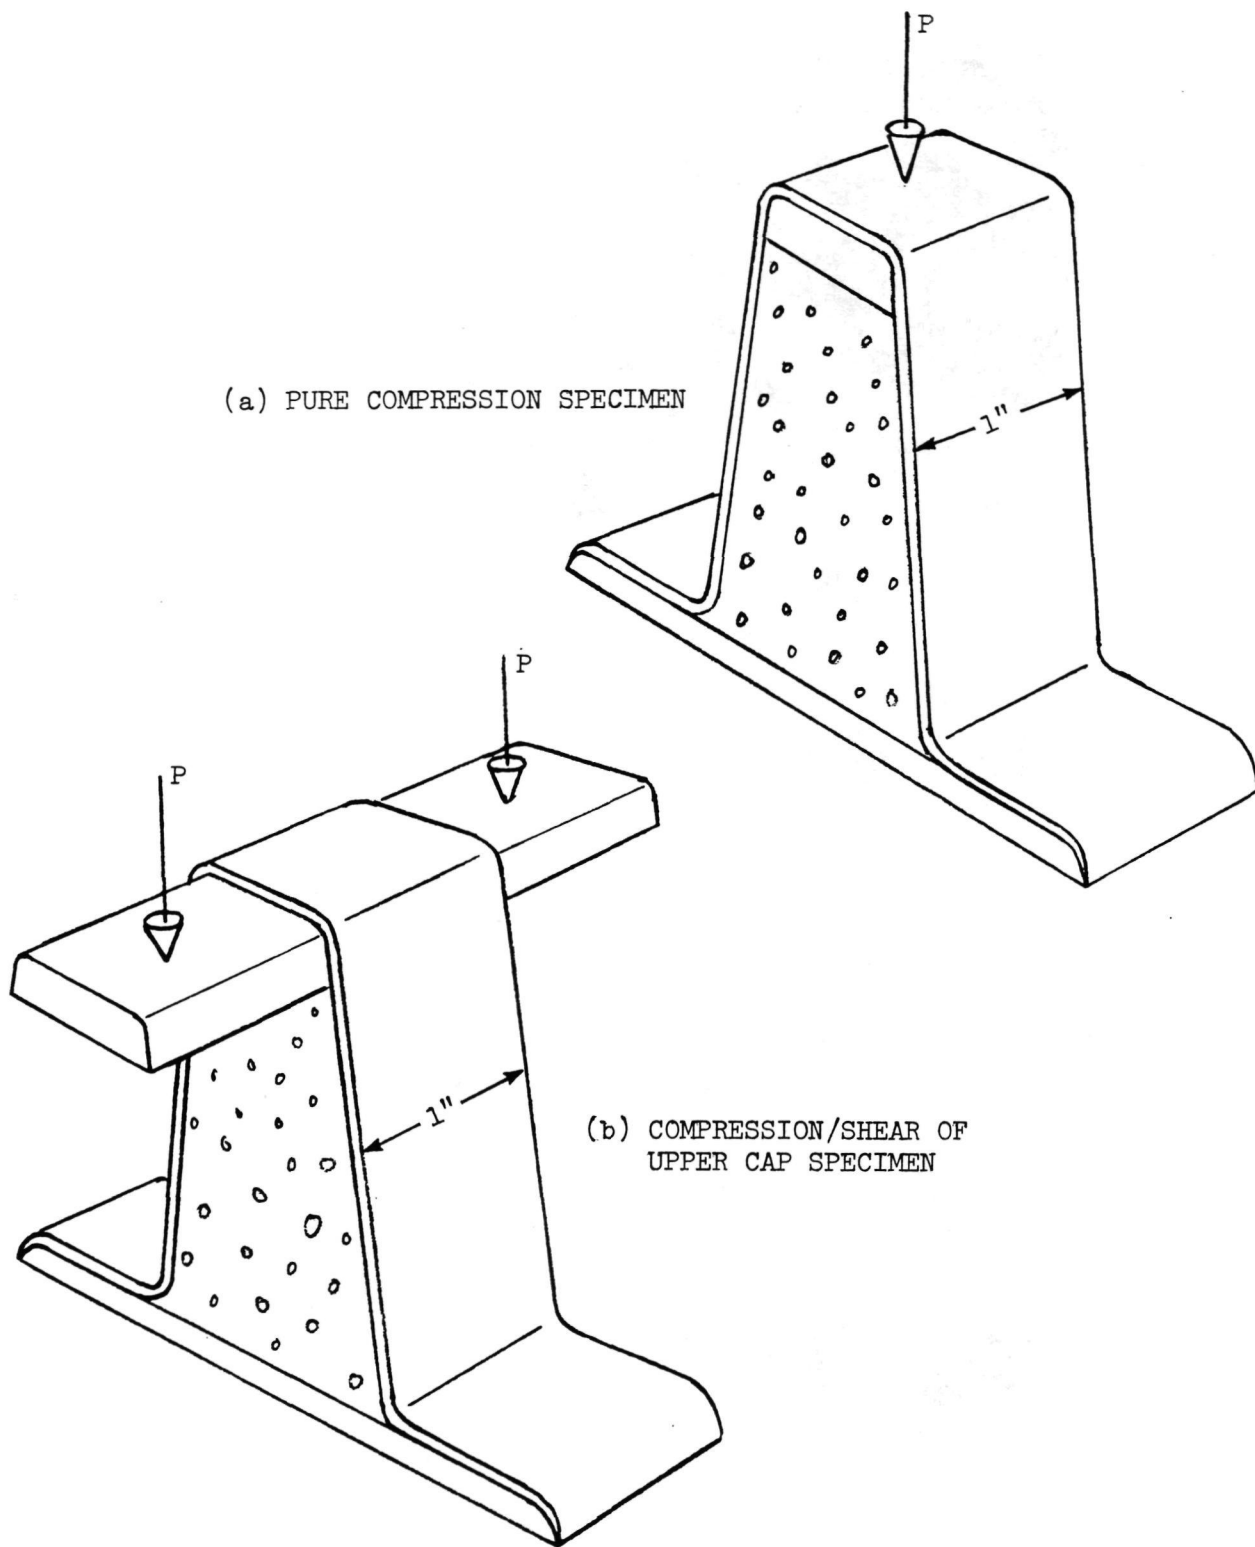
To determine the cap/web interface integrity, two specimens shown in Figure 35b prepared from areas H and I Figure 33 were tested. The first specimen failed at 2.82 kN (634 lb), a load substantially below the 10.67 kN (2400 lb) achieved by the pure compression specimens, but approximately equal to the calculated radial load of 1.4 mN/m (800 lb/in.) in the curved section of the first frame specimen at the actual static failure load. The failure observed in this specimen also originated at the junction of the web, cap and foam core, and propagated along the foam interface until the web buckled. The crack also propagated upwards into the 0° cap laminate. Inspection of the second specimen revealed pre-existent damage sustained during the static loading of the full-scale frame specimen. The damage appeared as a slight separation of the shear web from the side wall of the foam stabilizing core. When tested to determine its residual load carrying capabilities, the specimen would not sustain load above 1.56 kN (350 lb) because of the significant deflection of the pre-existing separation. Comparison of the pre-existent failure observed in this specimen under load with the generated failure in the first specimen tested reveals an identical failure pattern and location as shown in Figure 36.

FIGURE 35. COMPRESSION TEST SPECIMENS REMOVED FROM FIRST FRAME SPECIMEN.

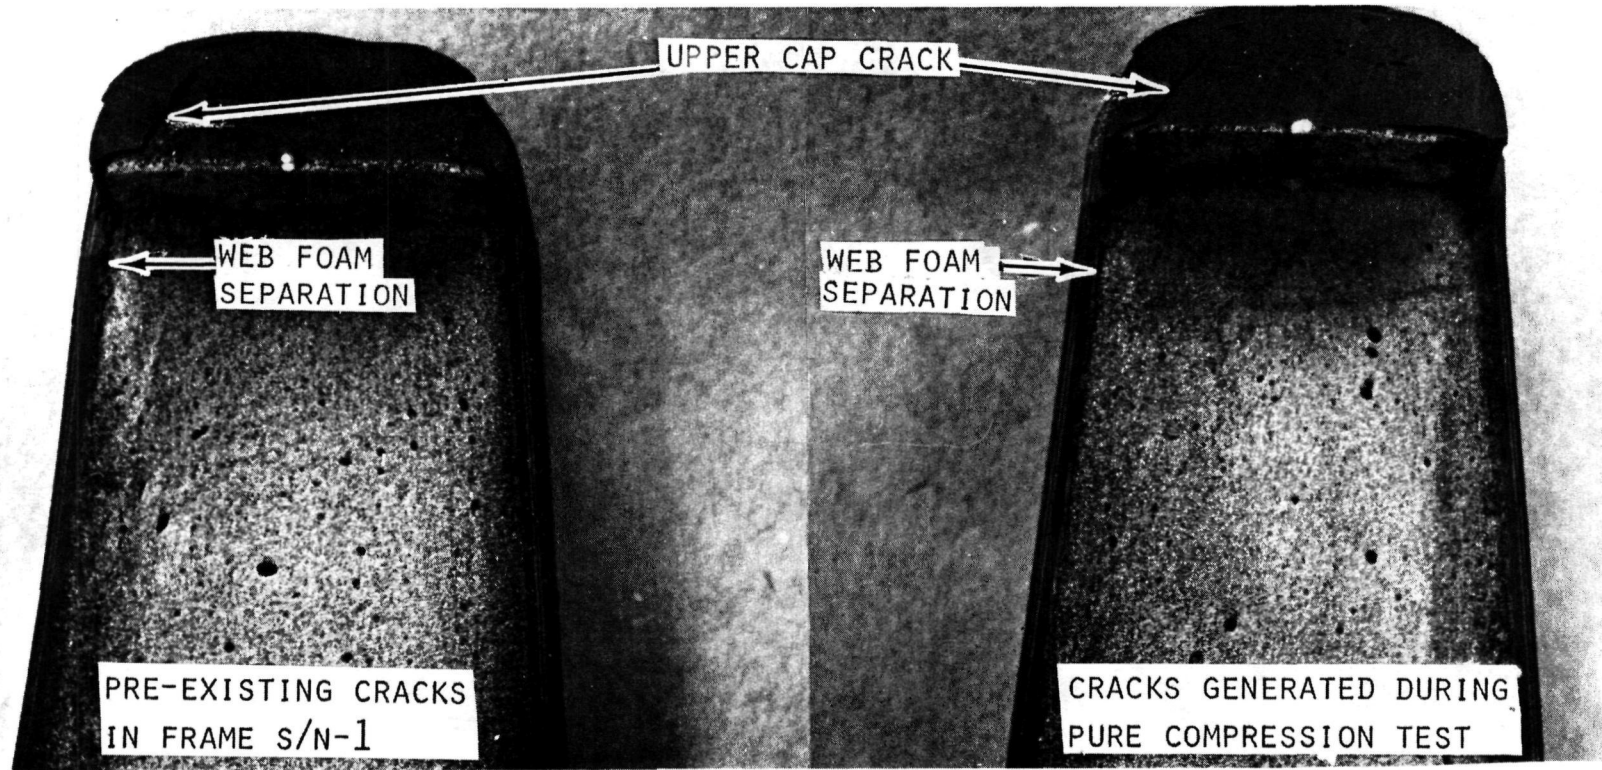
FIGURE 36 . FULL SCALE FAILURE MODE DUPLICATED BY SPECIMEN TESTS.

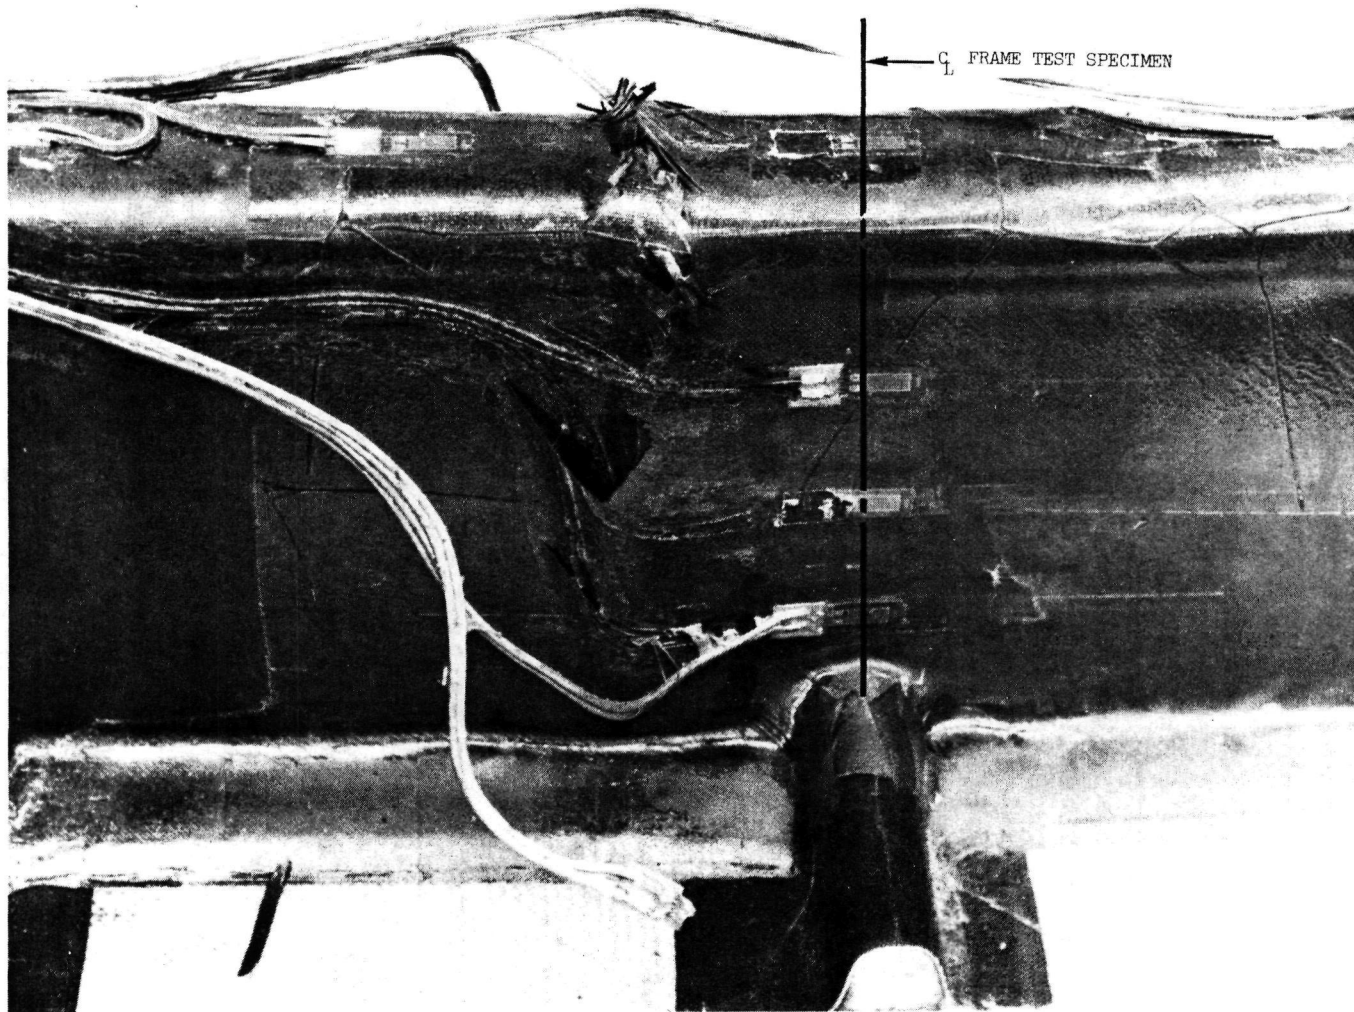
FIGURE 37. TEST #2, FRAME S/N 4; VIEW OF STATICALLY INDUCED FRACTURE,
AFTER SUCCESSFUL COMPLETION OF 4000 HOUR SPECTRUM FATIGUE TEST.

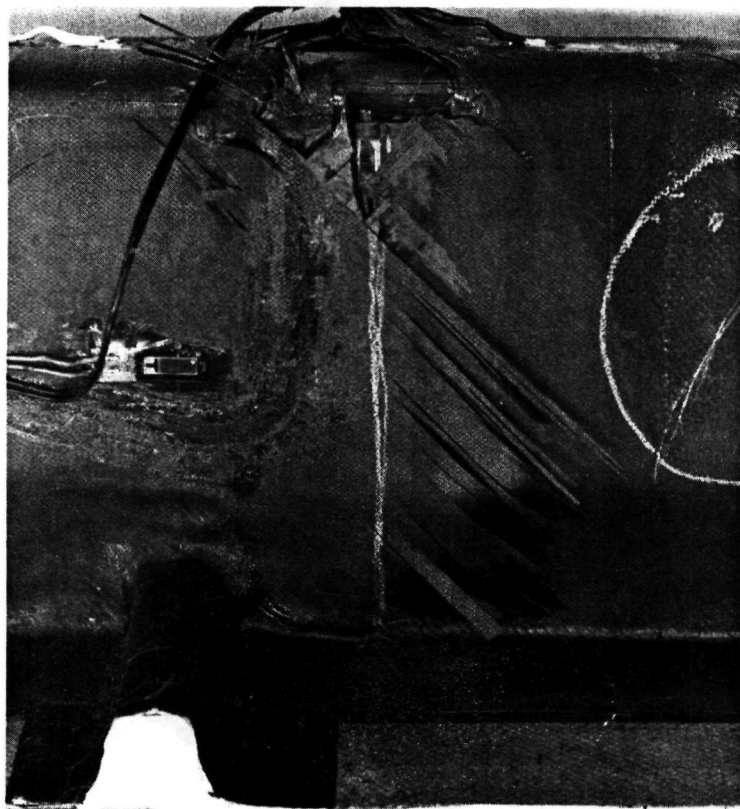
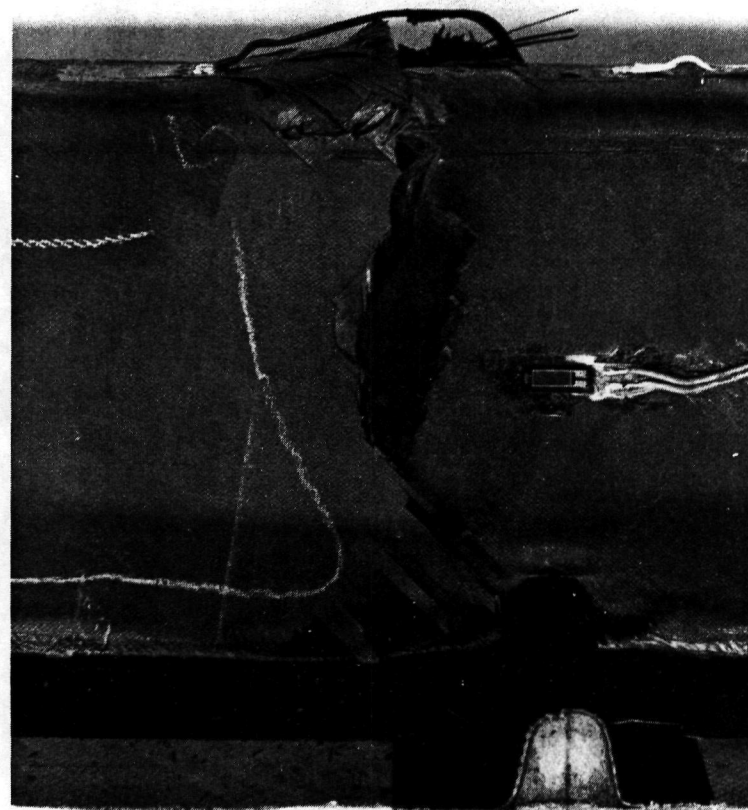
/// (a) FRACTURE SURFACE, RIGHT SIDE.

(b) FRACTURE SURFACE, LEFT SIDE.

FIGURE 38. TEST #3, FRAME S/N 3; FAILURE OCCURRED IN CENTER TEST AREA.

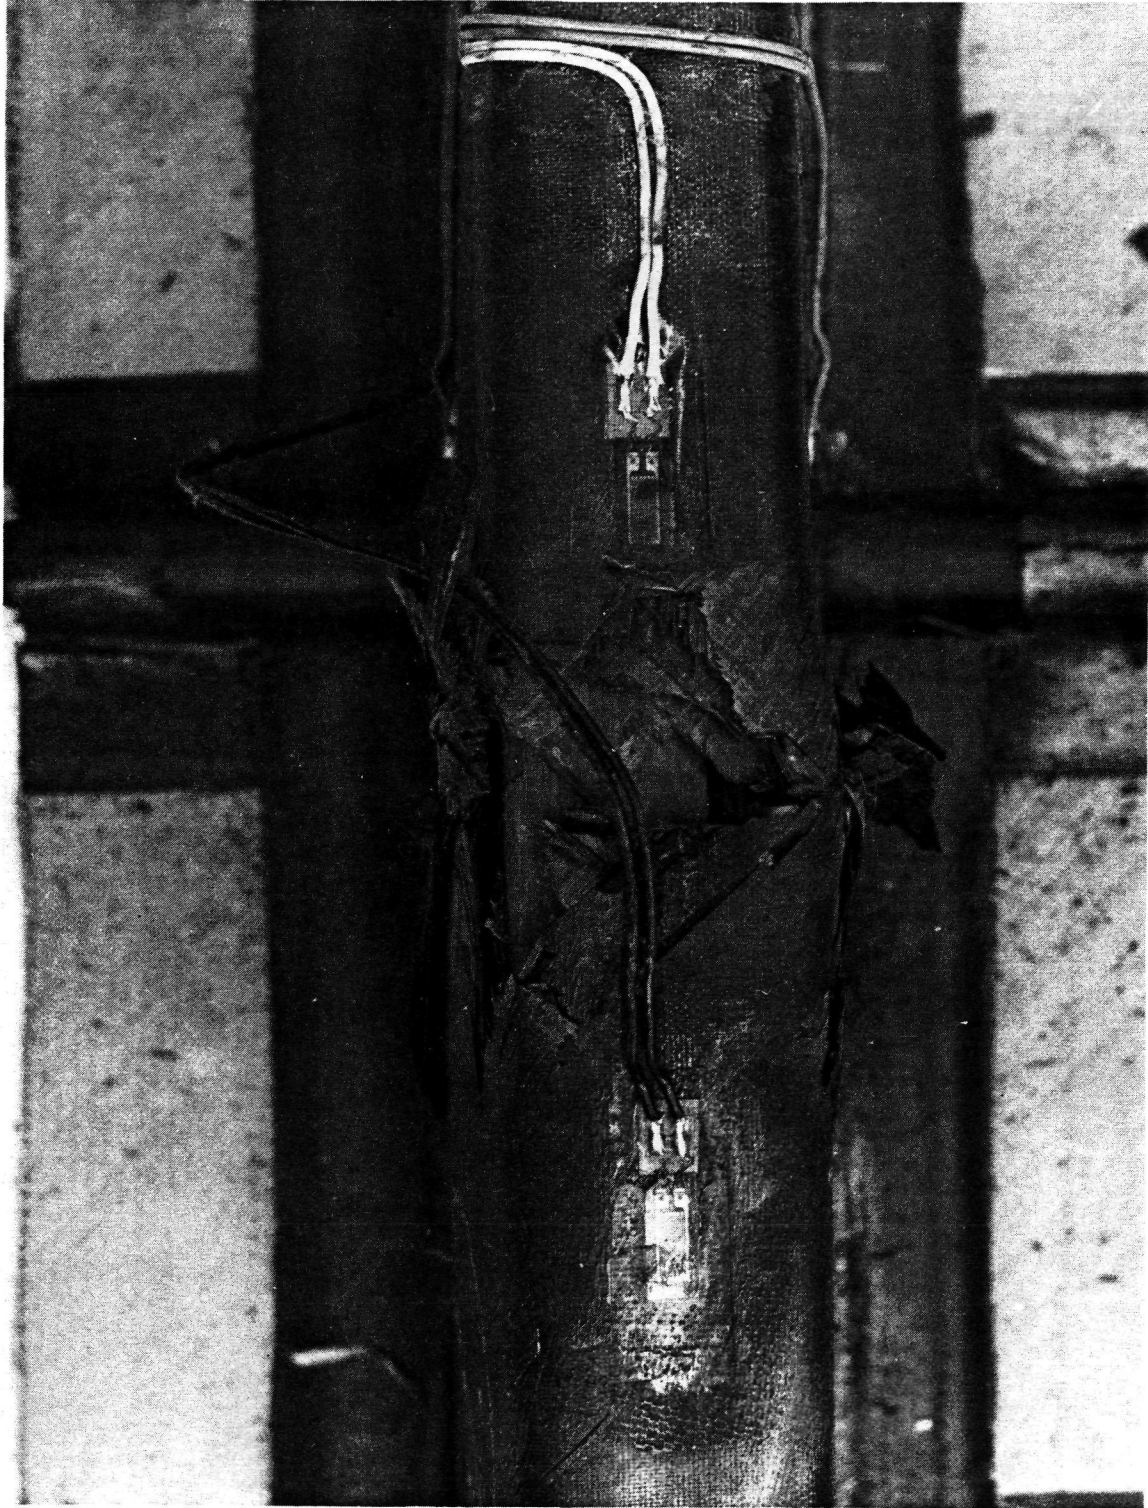
FIGURE 39. TEST #3, FRAME S/N 3; TOP VIEW OF FATIGUE FAILURE SHOWING FRACTURE OF SHEAR WEB AND UPPER CAP.

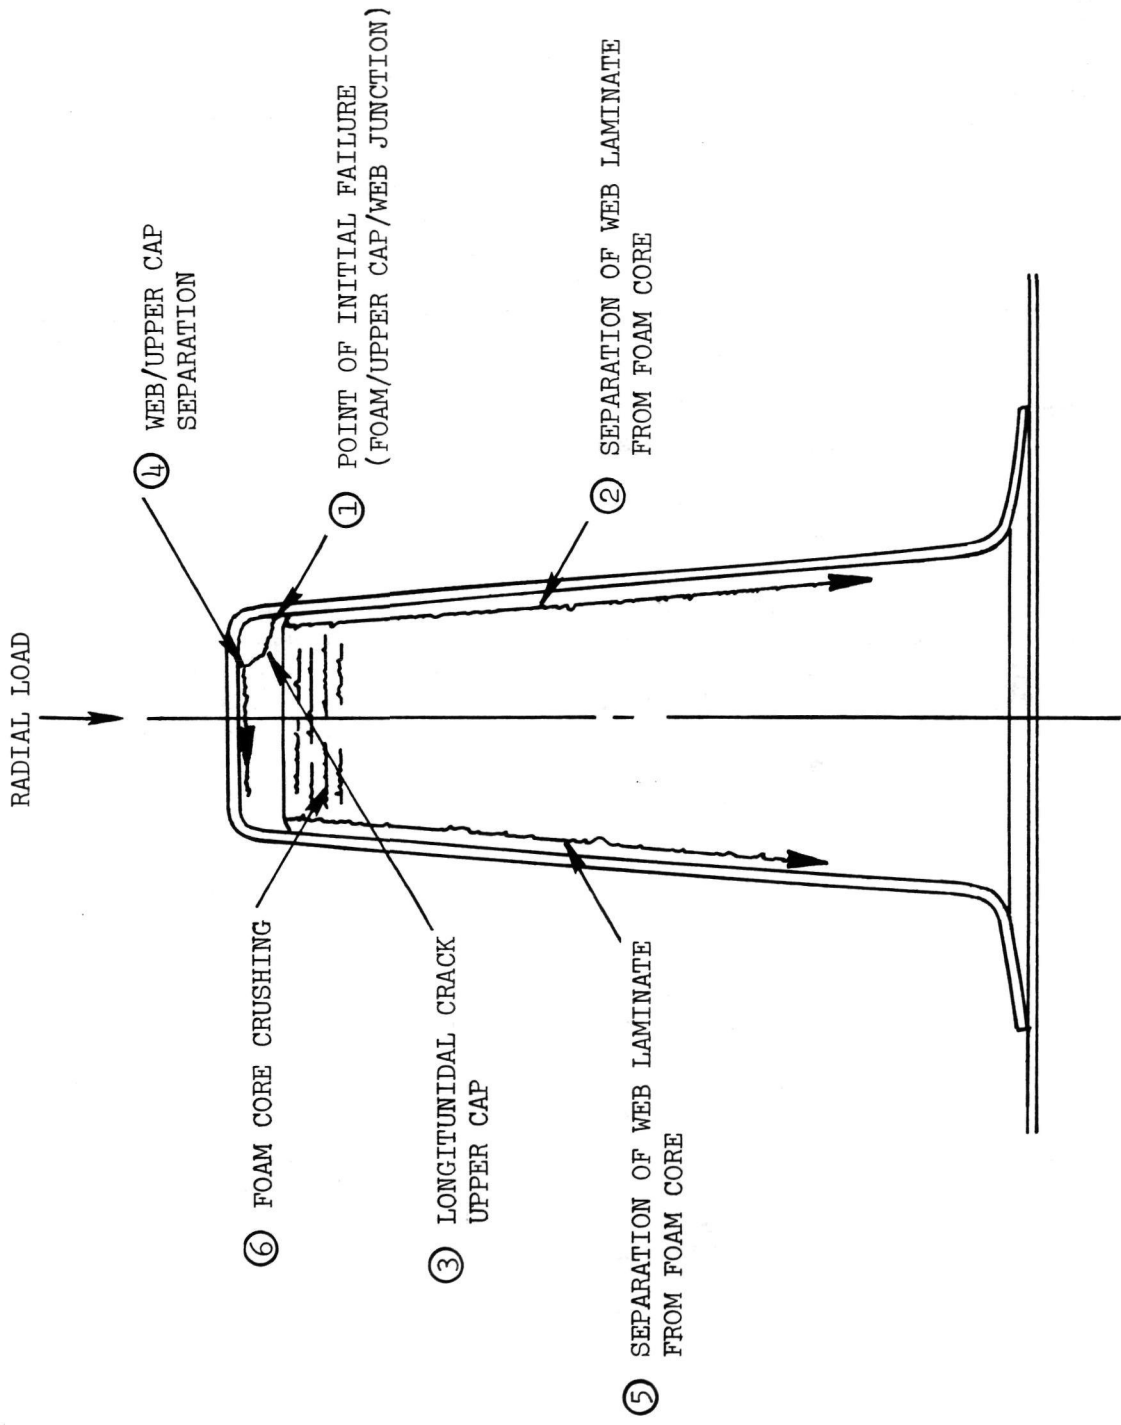
FIGURE 40. CROSS SECTION OF FRAME SPECIMEN, POINT OF INITIAL FAILURE, AND SEQUENCE OF FRACTURE.

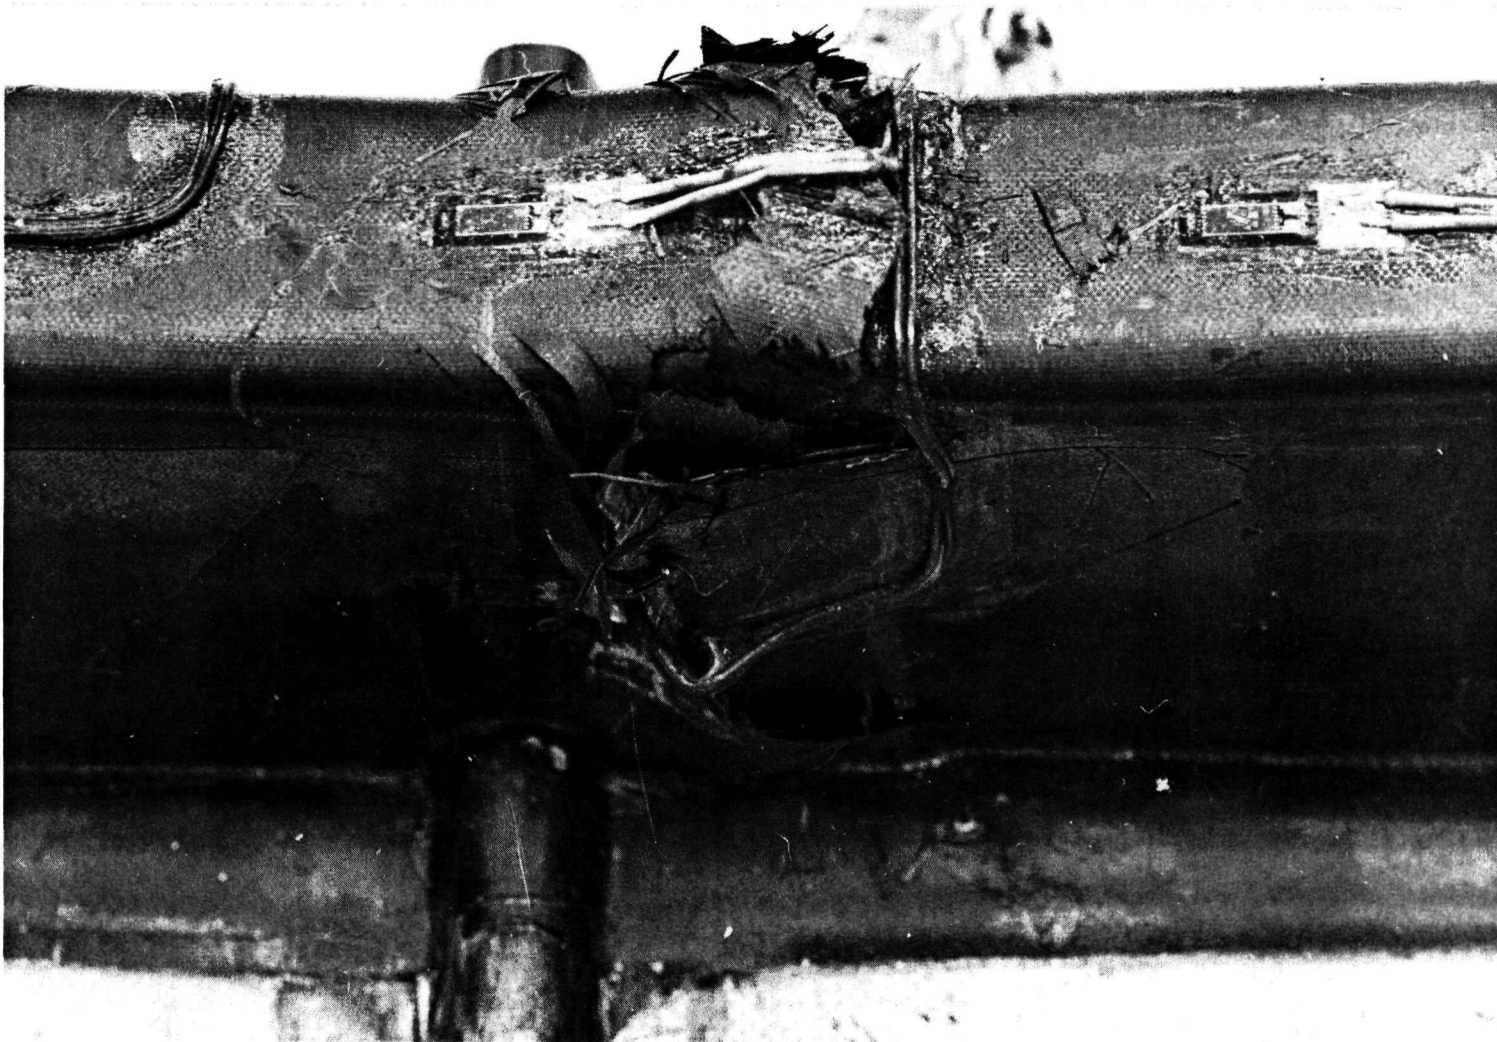
Primary failure of the fourth frame fatigue specimen occurred 40 percent into the spectrum fatigue test in the curved section at the left hand side of the frame specimen. At that time the upper cap separated from the shear web. Buckling of the shear web in the curved portion of the specimen was prevented by the additional stabilization provided by the extended doublers in that area. With each additional cyclic loading, the upper cap no longer restrained from independent deflection by the web to cap bond was driven into the supporting foam core until complete separation into small fiber bundles had occurred. Failure of the upper cap proceeded as individual fiber bundles fractured with each load application until a point 51 percent through the cyclic fatigue

FIGURE 41. TEST #4, FRAME S/N 2; VIEW OF FRACTURE OF SHEAR WEB AND UPPER CAP.

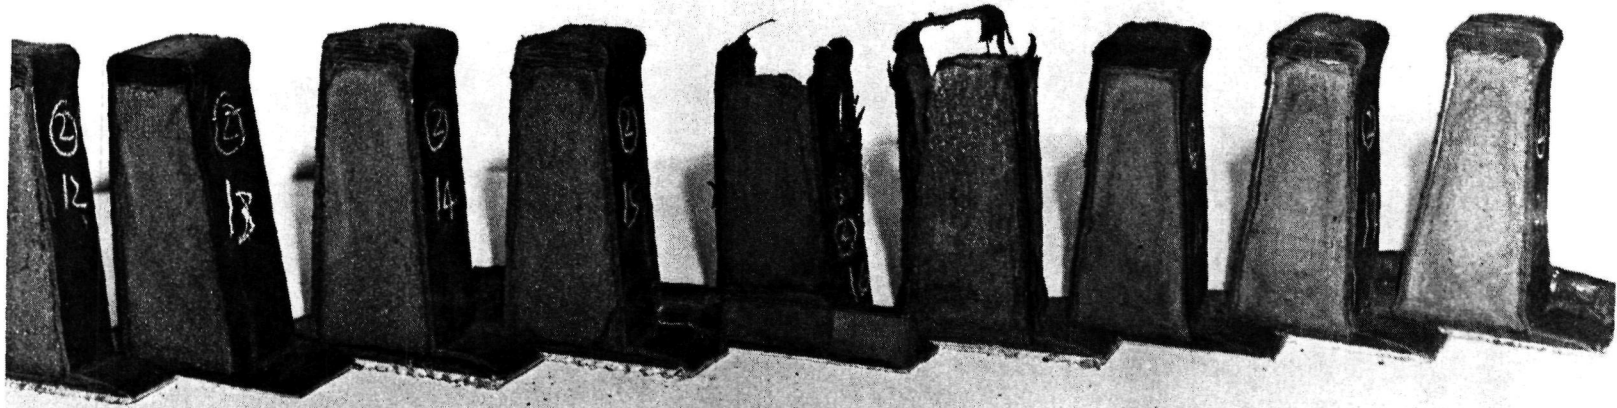
FIGURE 42. TEST #4, FRAME S/N 2; FRACTURE ANALYSIS SECTIONS CUT FROM CENTER TEST AREA OF FRAME.

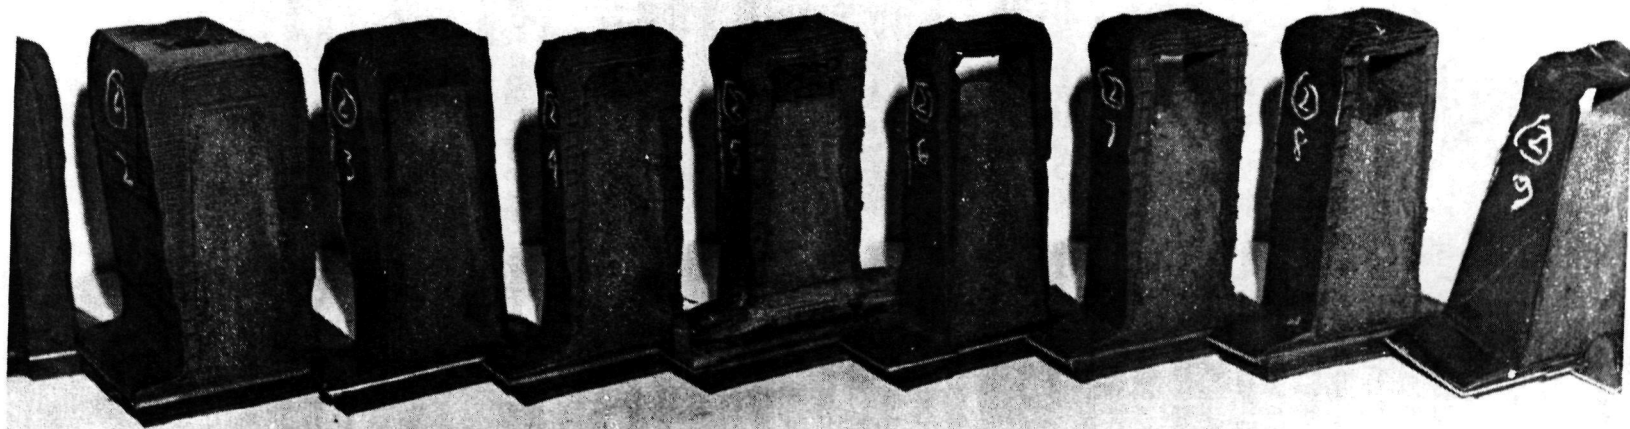
FIGURE 43. TEST #4, FRAME S/N 2; FRACTURE ANALYSIS SECTIONS CUT FROM LEFT CURVED AREA OF FRAME.

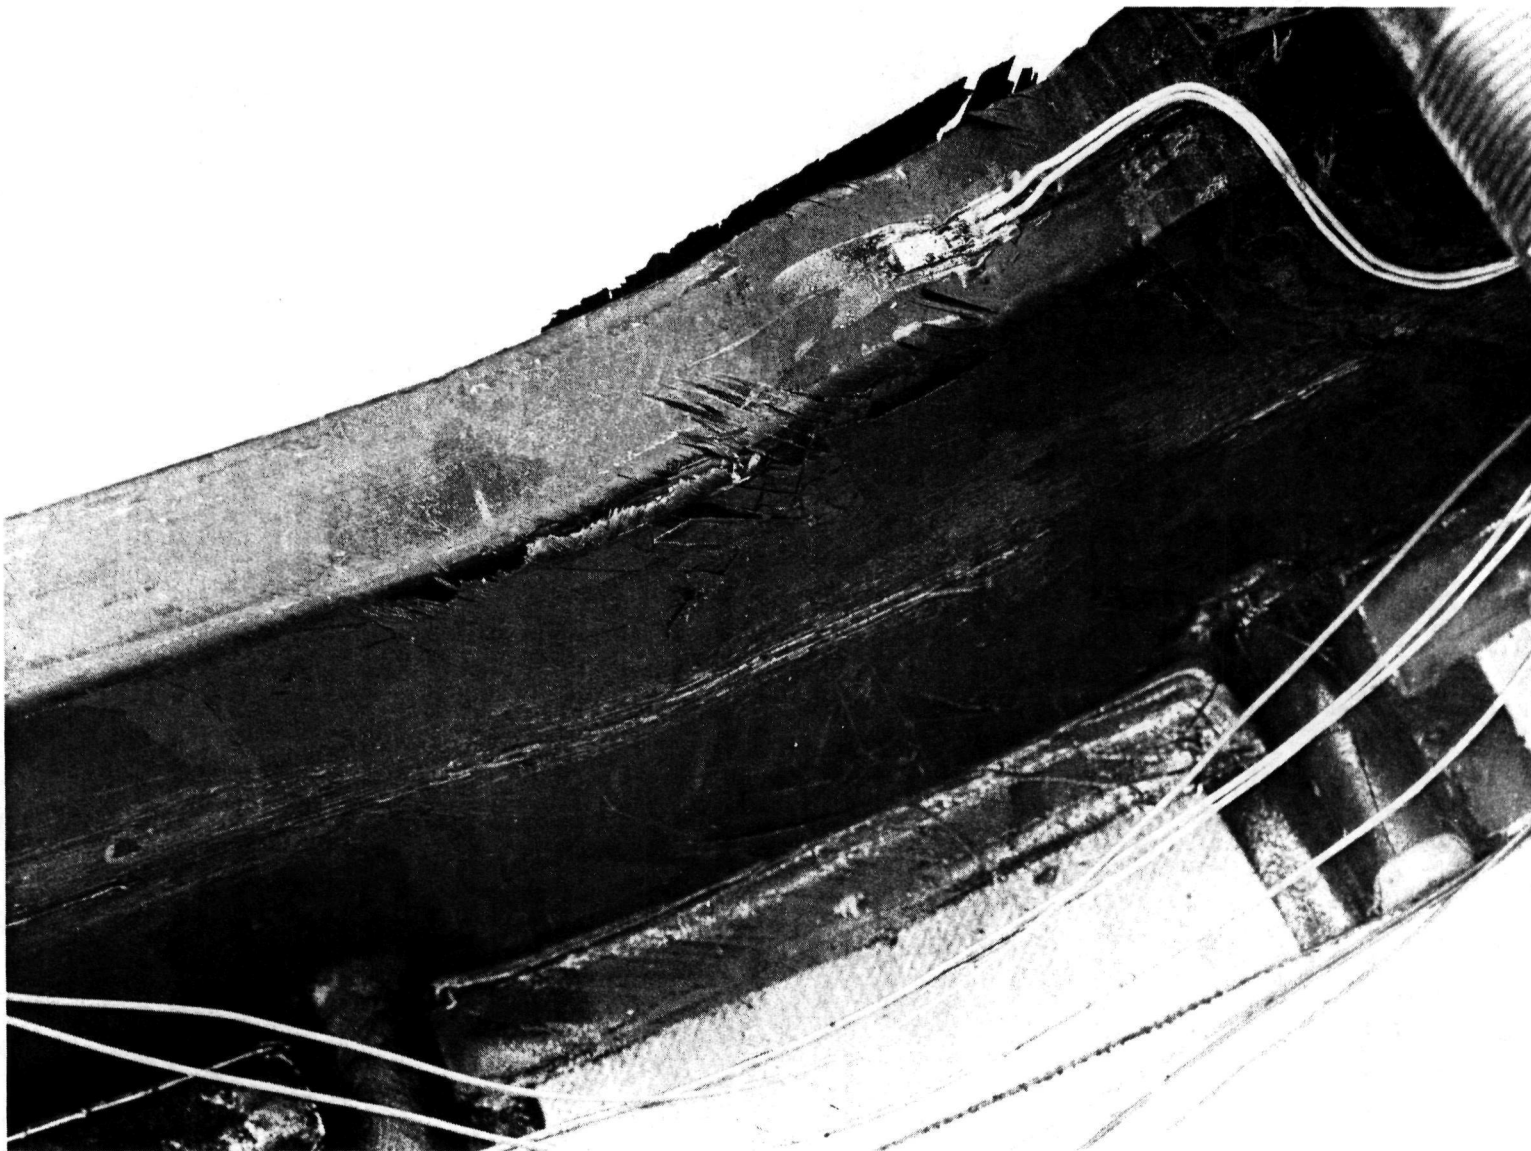
FIGURE 44. IMPROVED FRAME SPECIMEN, FAILURE AREA BETWEEN FOURTH AND FIFTH STRINGER RIGHT CURVED AREA OF FRAME.

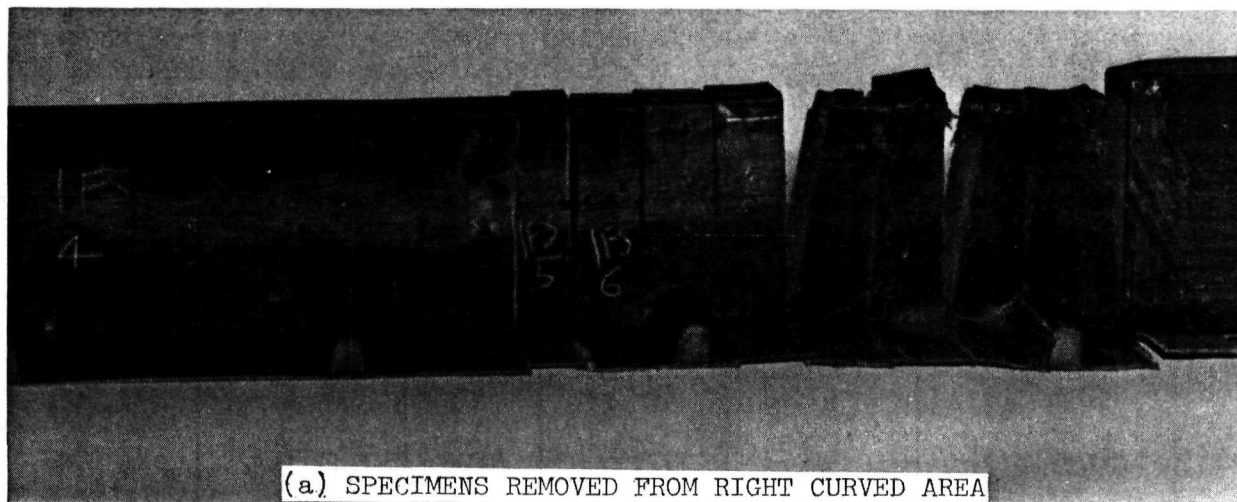
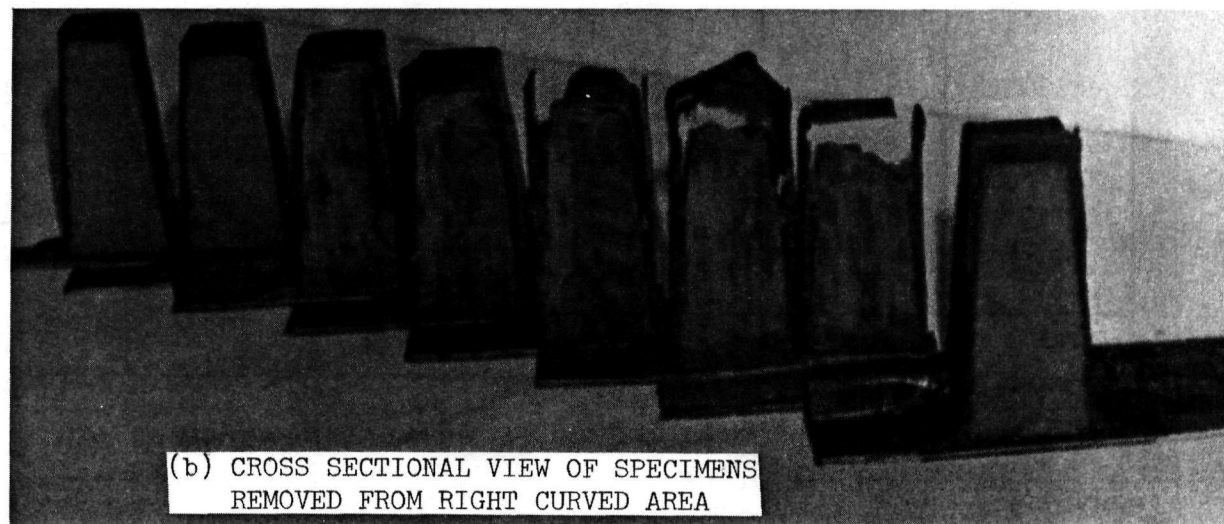
FIGURE 45 . FAILURE ANALYSIS SPECIMENS CUT FROM IMPROVED FRAME SPECIMEN .
