NASA CR - 145167
(SER - 50983)

**STUDY TO INVESTIGATE DESIGN ,
FABRICATION AND TEST OF LOW COST CONCEPTS
FOR LARGE HYBRID COMPOSITE
HELICOPTER FUSELAGE - PHASE II**

April 1977

Sikorsky Aircraft

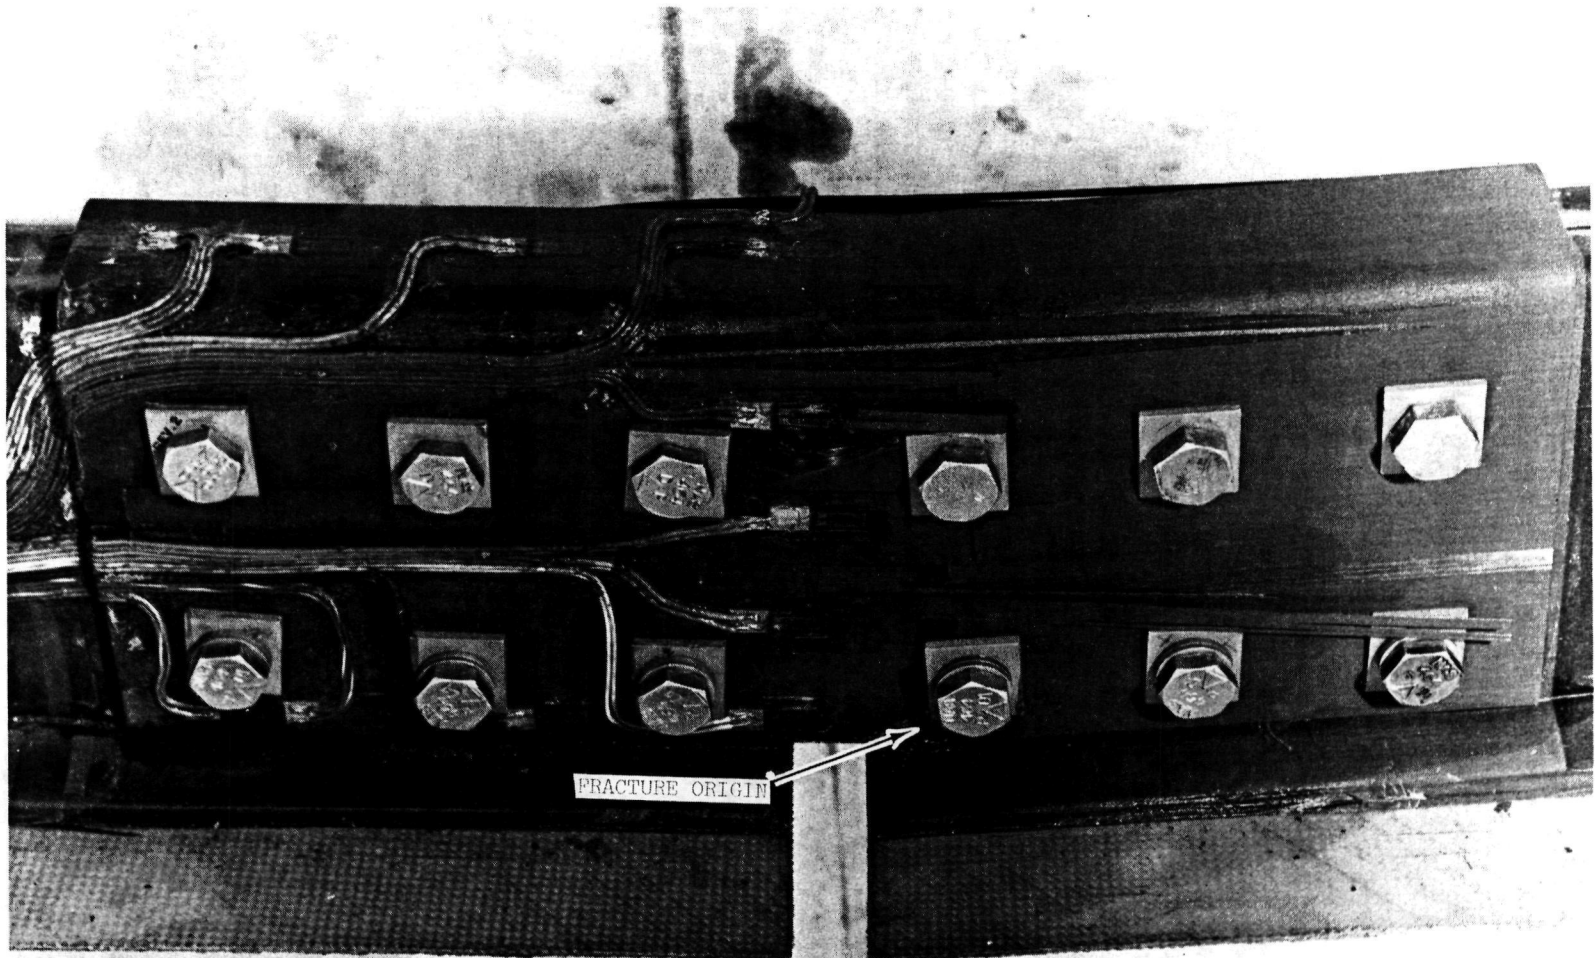
The first frame splice joint specimen was prepared for test with strain gauges bonded to the splice channel in areas of maximum anticipated strain. The specimen was installed in the test fixture and the simulated 4000 hour spectrum fatigue test initiated. Cyclic loads were applied to the specimen in accordance with the 4000 hour loading spectrum shown in Table II. No visual or acoustic indications of damage were apparent at the completion of the 4000 hour test. Fracture occurred during the residual strength test at a compression load of 32.47 kN (7,300 lbs). Fracture initiated at the lower or free edge of the splice channel, immediately below the bolt hole closest to the centerline of the splice channel, as shown in Figure 46. The fracture extends from the lower edge of the splice channel to the upper bolt hole closest to the centerline of the channel on both sides of the channel. The lower bolt hole through which the fracture propagated was incorrectly drilled. When the specimen was set up for drilling the first hole drilled was at right angles to

FIGURE 46. #1 FRAME SPLICE JOINT FATIGUE SPECIMEN, STATIC FRACTURE OF SPLICE CHANNEL INITIATED AT FREE EDGE BELOW BOLT HOLE CLOSEST TO SPECIMEN CENTER LINE.

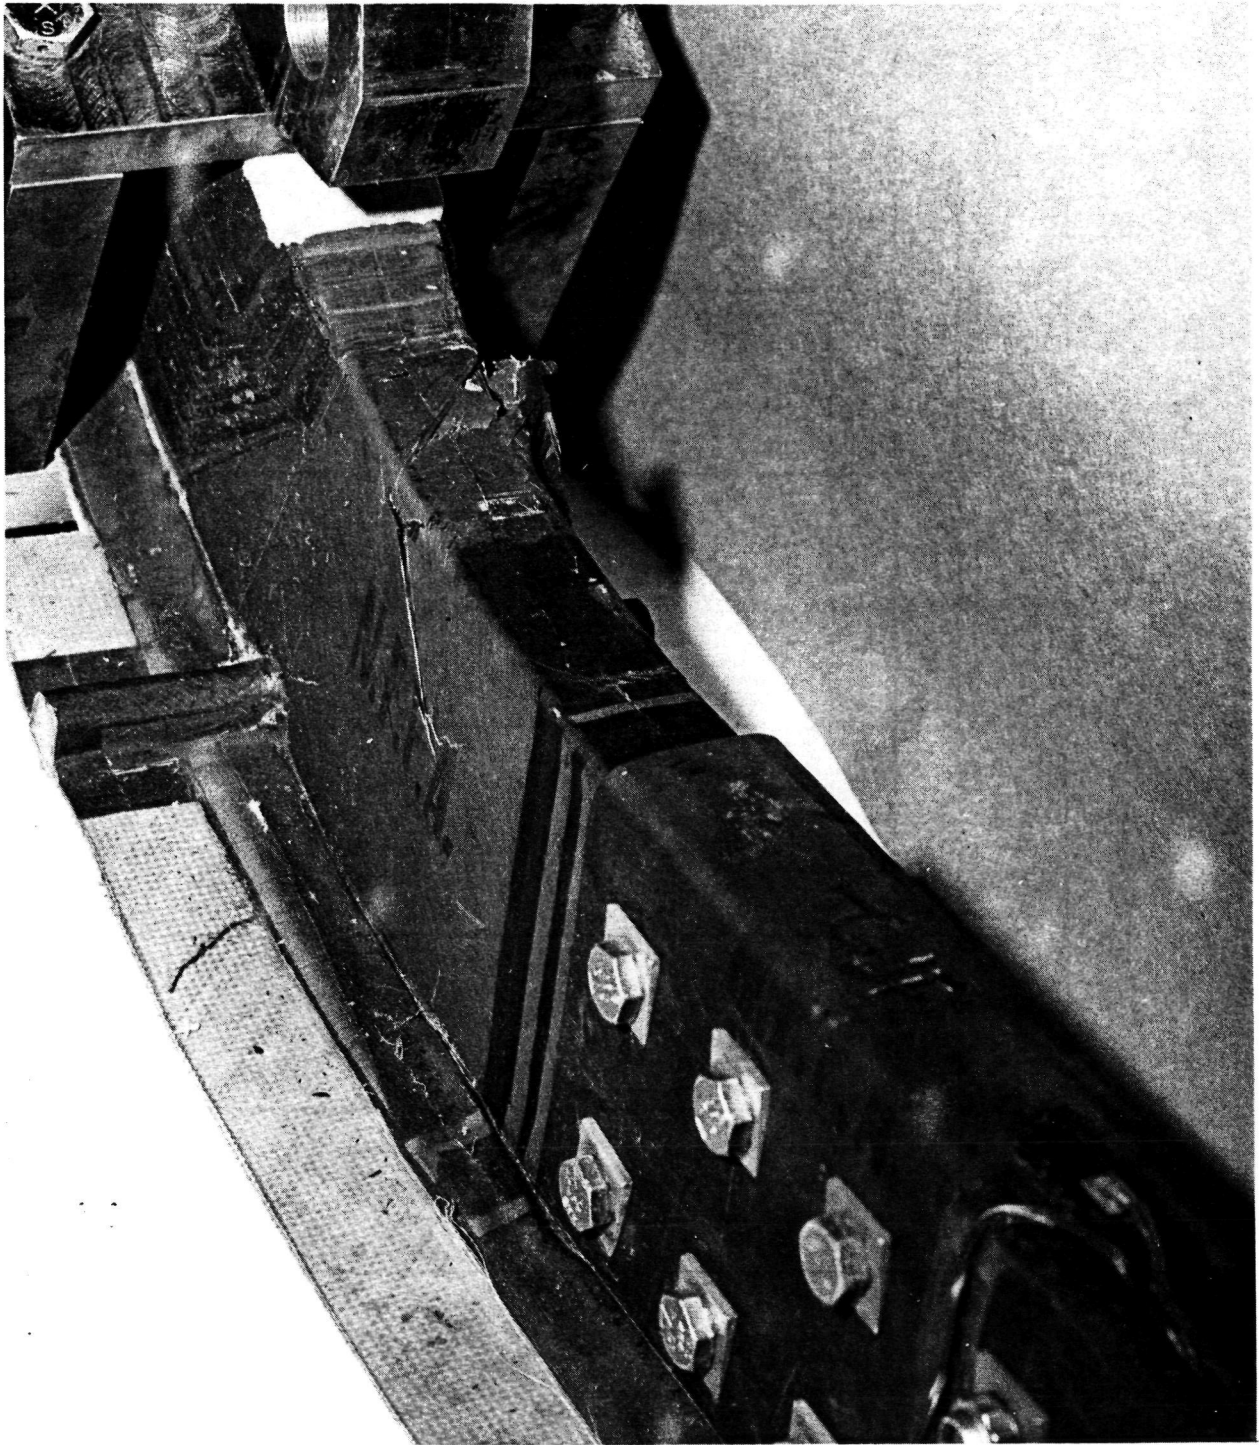
FIGURE 47 FRACTURE OF THE #2 FRAME SPLICE JOINT FATIGUE SPECIMEN OCCURRED IN THE CURVED AREA OF THE FRAME SECTION.

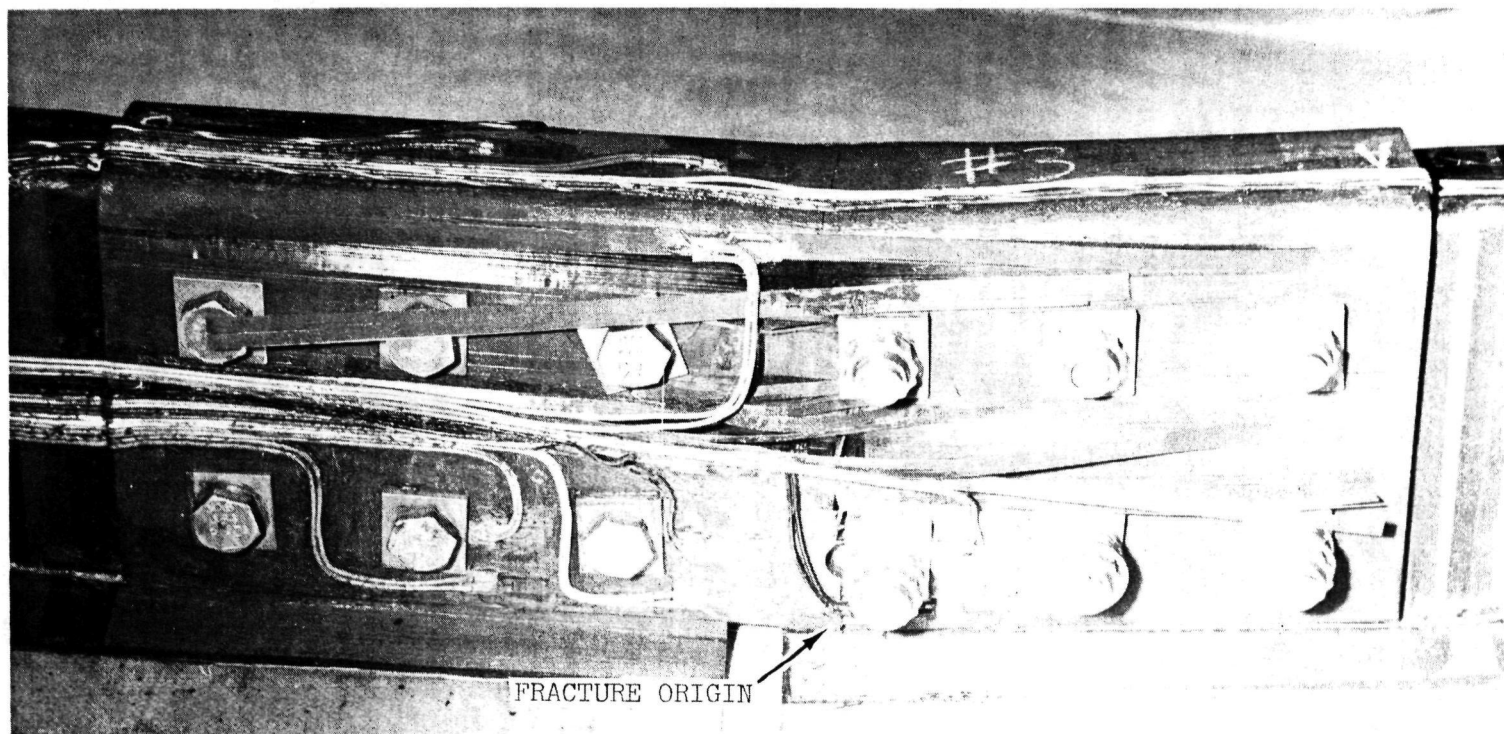
FIGURE 48. #3 FRAME SPLICE JOINT FATIGUE SPECIMEN, STATIC FRACTURE OF SPLICE CHANNEL INITIATED AT FREE EDGE BELOW BOLT HOLE CLOSEST TO SPECIMEN CENTER LINE.
