# 737 GRAPHITE COMPOSITE FLIGHT SPOILER FLIGHT SERVICE EVALUATION

**THIRD ANNUAL REPORT  
APRIL 1976 THROUGH APRIL 1977**

**Prepared under contract NAS1-11668 by  
BOEING COMMERCIAL AIRPLANE COMPANY  
P.O. Box 3707  
Seattle, Washington 98124**

**August 1977**

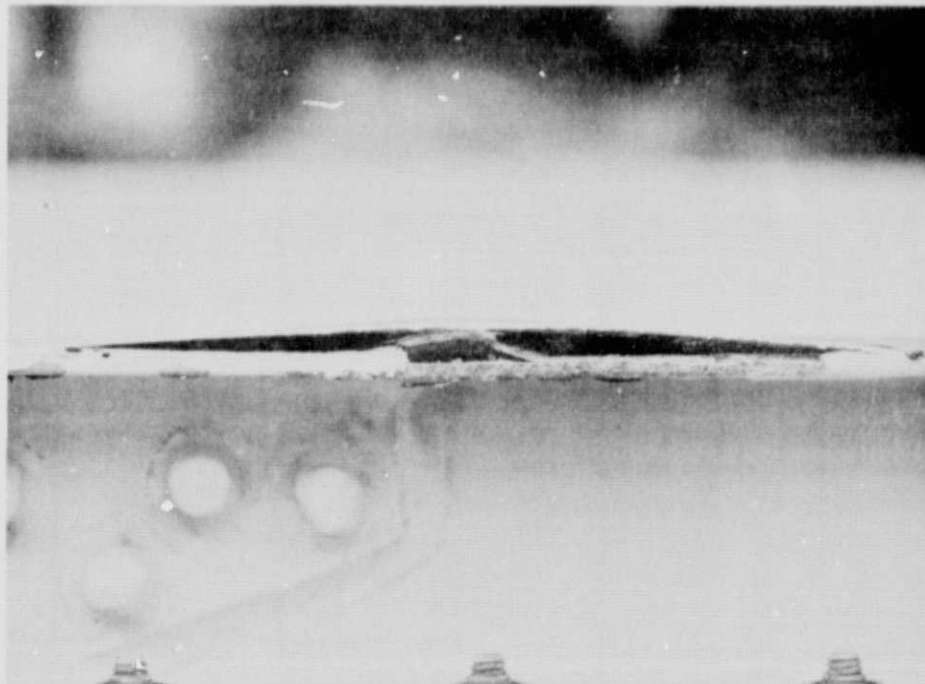
No additional examples of exfoliation corrosion were reported from the completed fleet survey (ref. 2, p. 11). One additional case of exfoliation corrosion in the aluminum (7075-T6) spar element (fig. 3) was observed during the recent annual spoiler examination activity. This spoiler, S/N 0049 and operated by Aloha, was removed and returned to Boeing for examination. This spoiler has been committed to the repair cycle for refurbishment.

*Figure 3. — Exfoliation Corrosion in Spar of S/N 0049*

| Spoiler serial number | Airline | Date removed | Reason for removal | Action taken | Final disposition |
|---|---|---|---|---|---|
| 0049 | TS | 4/13/77 | Spar exfoliation corrosion | NDT | Repair in process |

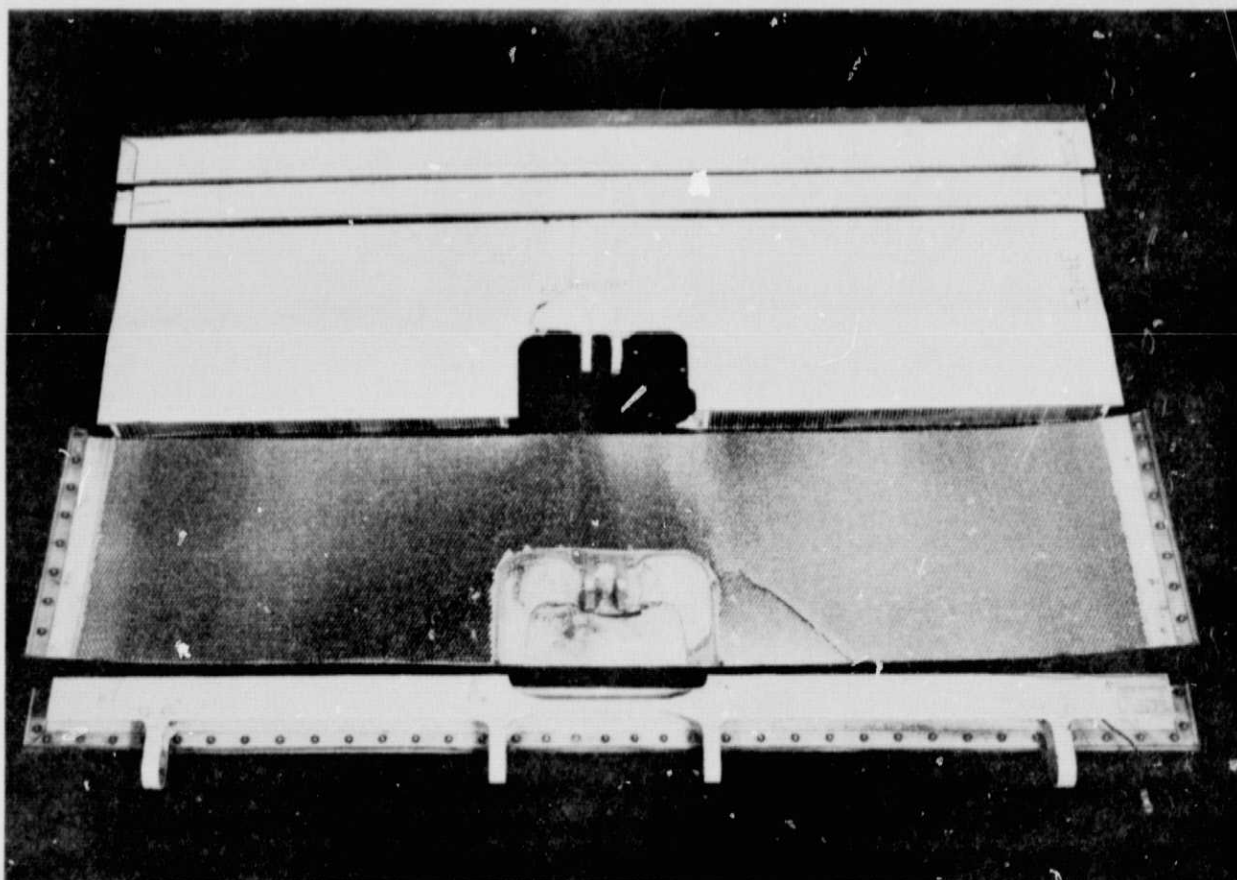
The examination technique for honeycomb core corrosion has been expanded to encompass all units that are tested in the static test laboratory. Each spoiler assembly is completely sectioned to enable visual observation of both bond lines in virtually all portions of the panel. Figure 4 shows a typical example of the degree of dissection achieved. A total of five static test spoilers (S/N 0057 and 0109 from the second year testing and S/N 0026, 0054, and 0116 from the third year testing) have been sectioned in this manner. Not only has there been a complete absence of corrosion in the honeycomb, but the physical appearance of both the honeycomb and the cured EA9628 adhesive compares favorably with newly manufactured assemblies.

*Figure 4. — Dissection of S/N 0054 for Corrosion Inspection*

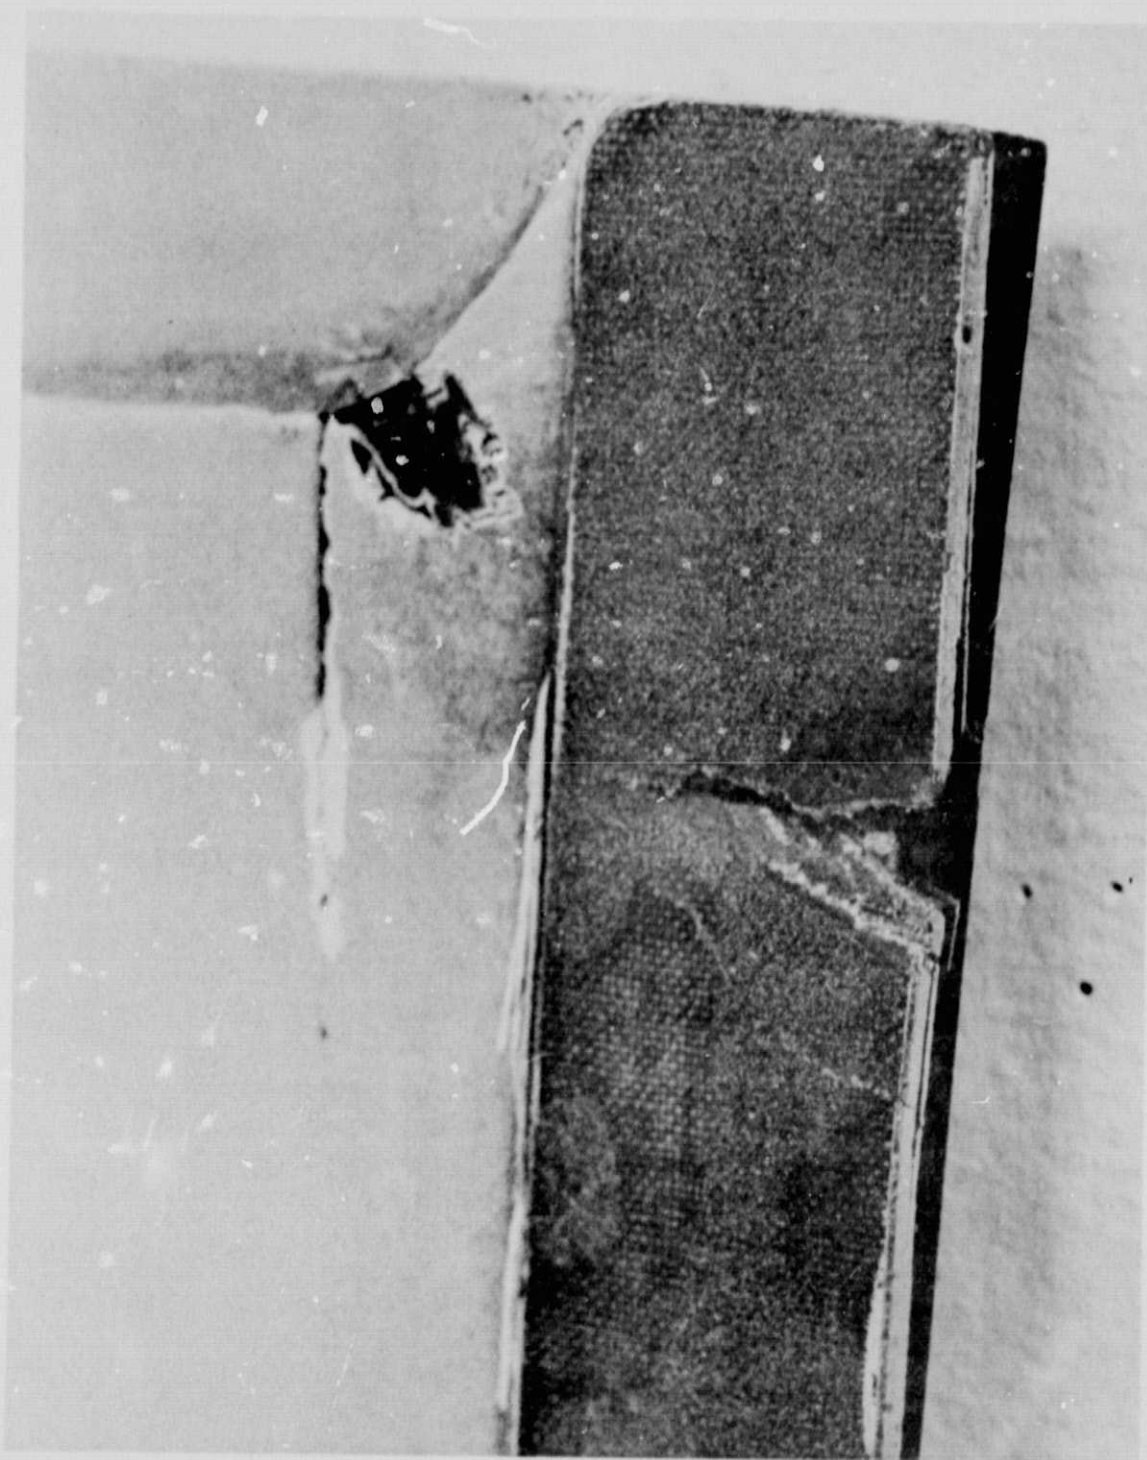
The three cases of maintenance damage are illustrative of the ever-present risks associated with maintenance operations. Each instance of maintenance damage occurred inside the maintenance hanger area and was a result of activity involving aircraft components in the vicinity of the spoilers themselves. Two incidents resulted in damage to the trailing edge (figs. 7 and 8) and one panel received handling damage to the leading edge spar (fig. 9). The rate of maintenance damage approximates that of the previous year of operation.

| Spoiler serial number | Airline | Date removed | Reason for removal | Action taken | Final disposition |
|---|---|---|---|---|---|
| 0089 | NZ | 11/22/76 | Maintenance damage | NDT & repair | Reinstalled |

Figure 7. - Trailing Edge Damage - S/N 0089

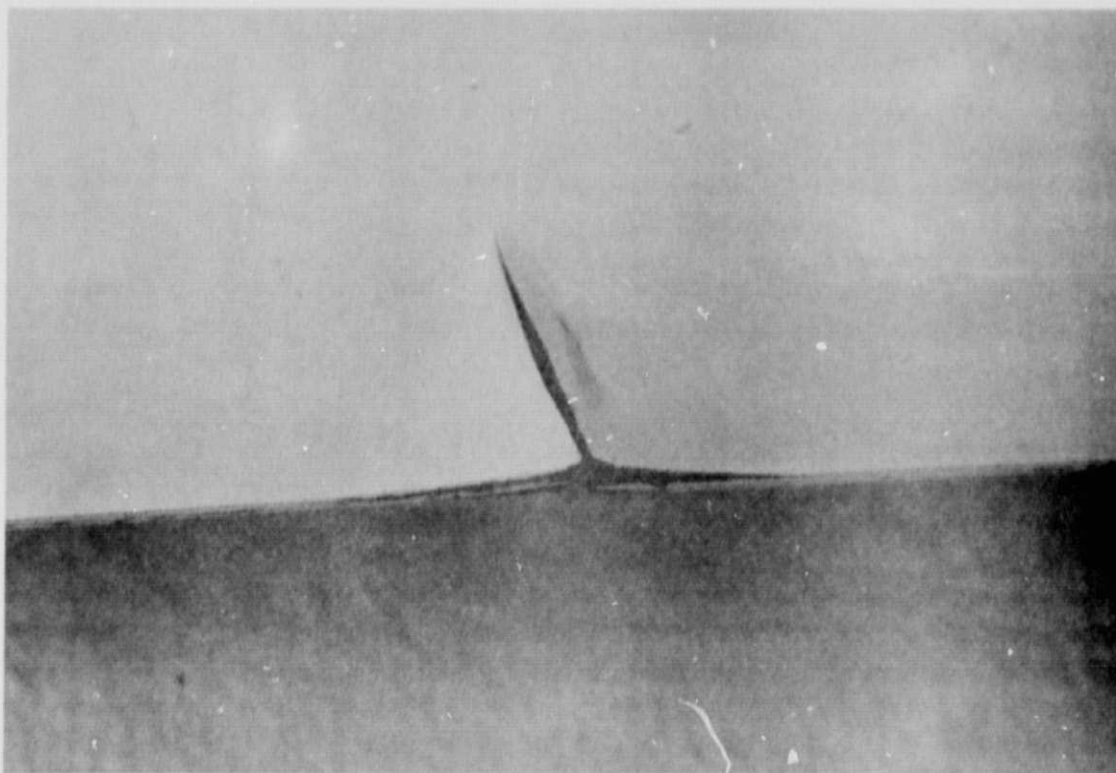
| Spoiler serial number | Airline | Date removed | Reason for removal | Action taken | Final disposition |
|---|---|---|---|---|---|
| 0108 | VP | 11/17/76 | Maintenance damage | NDT & repair | Reinstalled |

*Figure 8. — Trailing Edge Damage — S/N 0108*

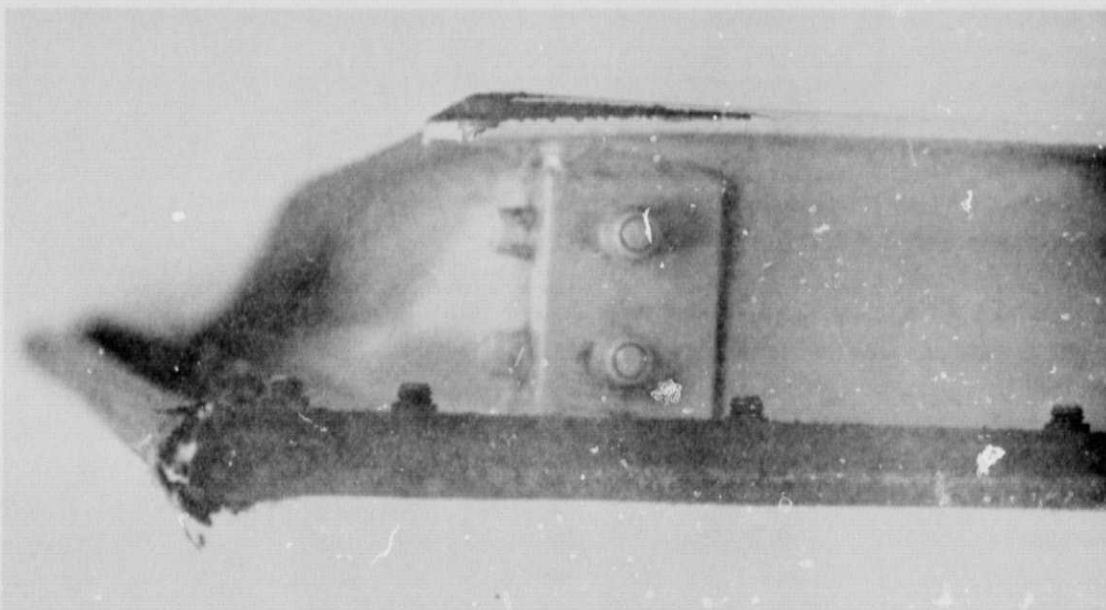
| Spoiler serial number | Airline | Date removed | Reason for removal | Action taken | Final disposition |
|---|---|---|---|---|---|
| 0088 | NZ | 11/22/76 | Maintenance damage | NDT & repair | Reinstalled |

*Figure 9. — Leading Edge Spar Damage — S/N 0088*

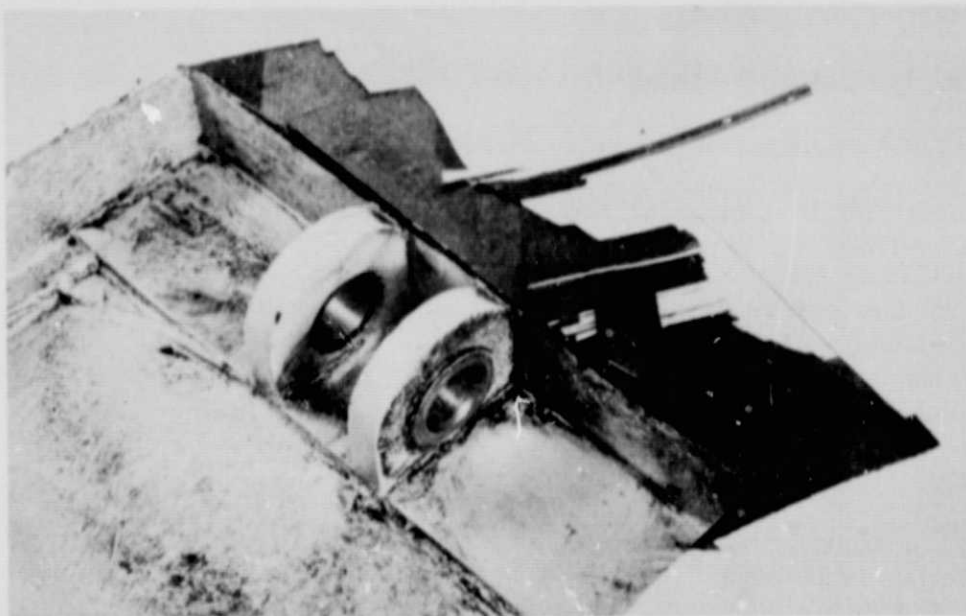
Figure 10. — Lower Surface Delamination—Aloha Spoiler S/N 0306
