JSC-13045

# **Space Shuttle Orbiter Approach and Landing Test Evaluation Report**

Captive-Active Flight Test Summary

September 1977

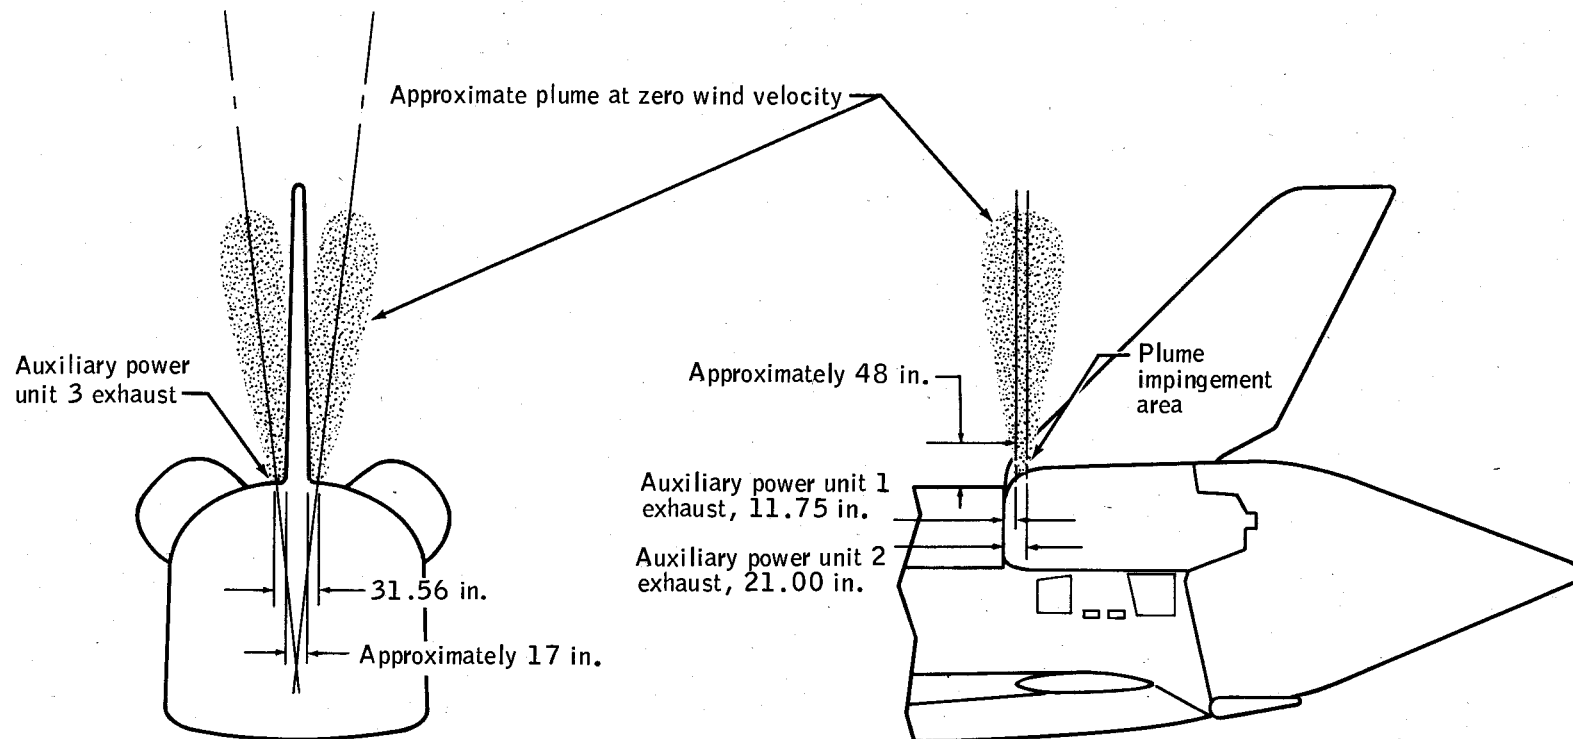
Following the first flight, ground personnel reported seeing a flame in the exhaust plume from auxiliary power units 1 and/or 2 after landing. Inspection of the exhaust impingement area (fig. 3-1) revealed only minor effects. After the vehicle turned off the runway following the second flight, ground personnel again observed flame in the exhaust plume of auxiliary power units 1 and/or 2. Limitations for operating the auxiliary power units preflight and postflight were established for the third flight; however, no flame was observed during ground operations.

Figure 3-1.- Auxiliary power unit exhaust plumes.

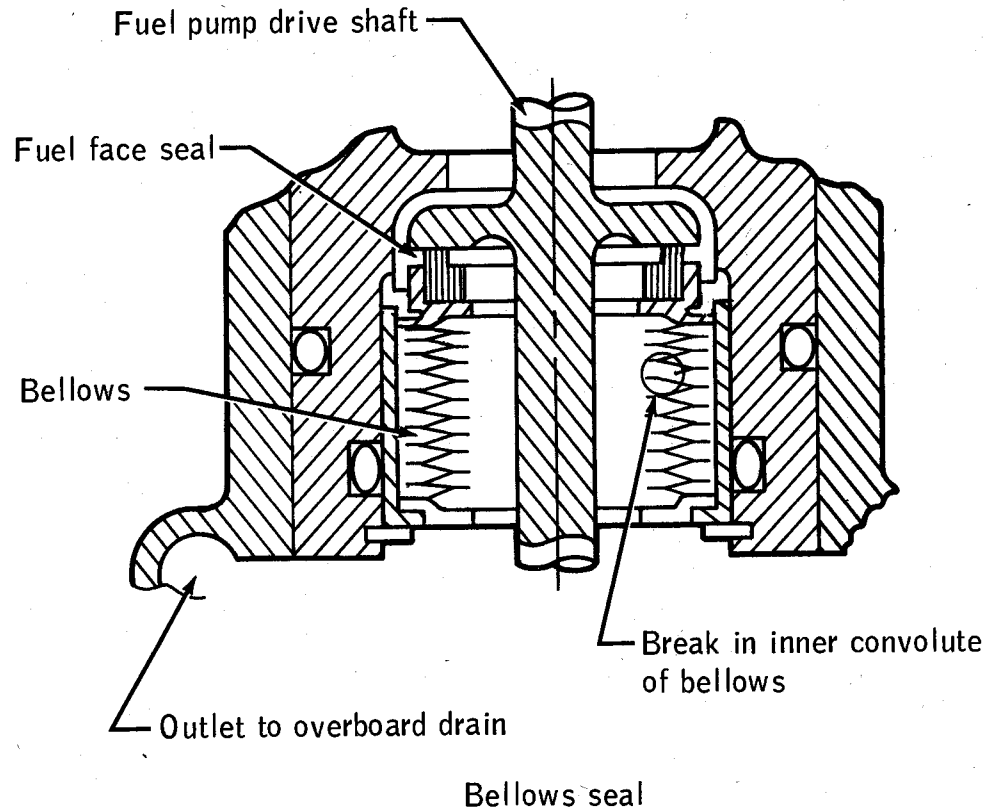
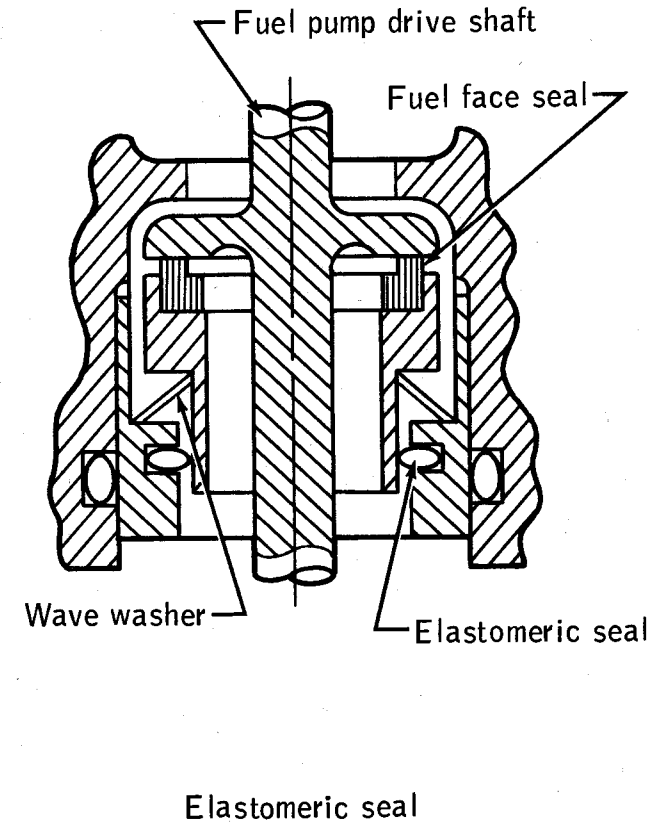
Approximately 18 minutes into the flight, auxiliary power unit 1 was activated as planned. There was an increase in the rate of fuel usage for the unit about 25 minutes after activation. It was determined postflight that failure of the auxiliary power unit 1 fuel pump bellows seal had caused extensive hydrazine leakage.

About 30 to 45 minutes after auxiliary power unit shutdown following the second flight, the pump inlet pressure of unit 1 decayed to 34 psi, indicating fuel (hydrazine) leakage. This indication was supported by an increased rate of unit 1 fuel usage about 25 minutes after activation. Postflight inspection revealed that there had been excessive leakage from the auxiliary power unit 1 fuel cavity drain. This anomaly is discussed in paragraph 6.4.

Figure 6-2.- Auxiliary power unit fuel pump seals.

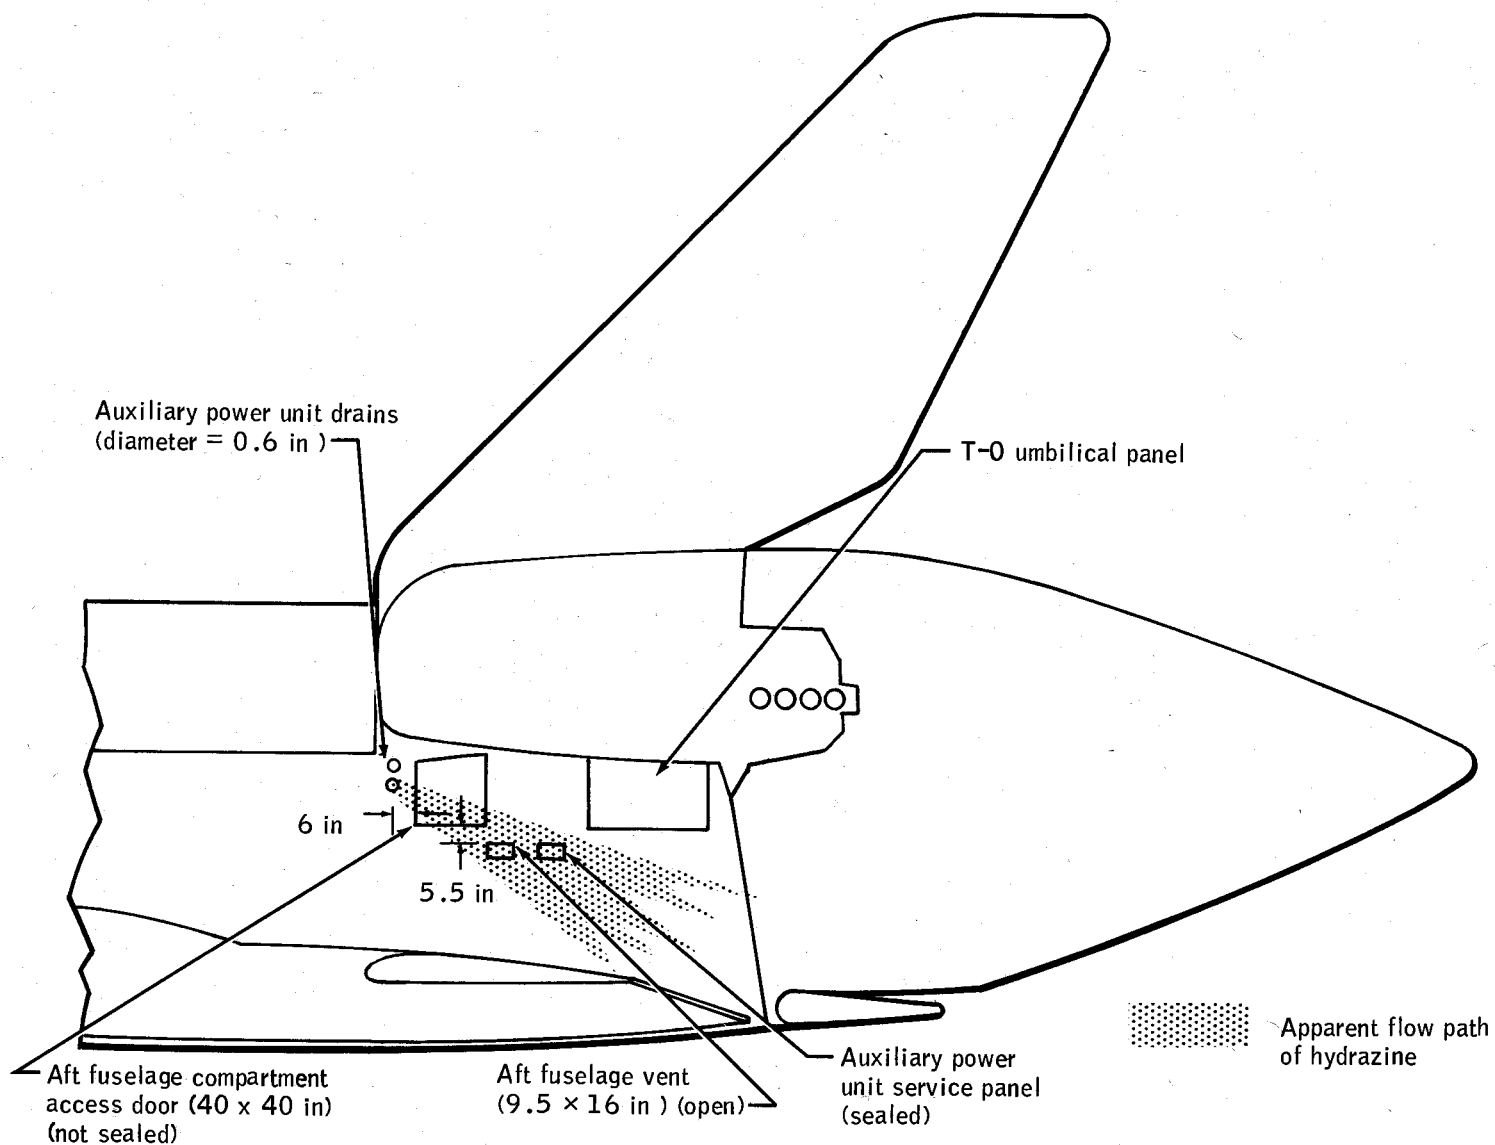
Figure 6-3.- Hydrazine flow on aft fuselage left-hand external surface.

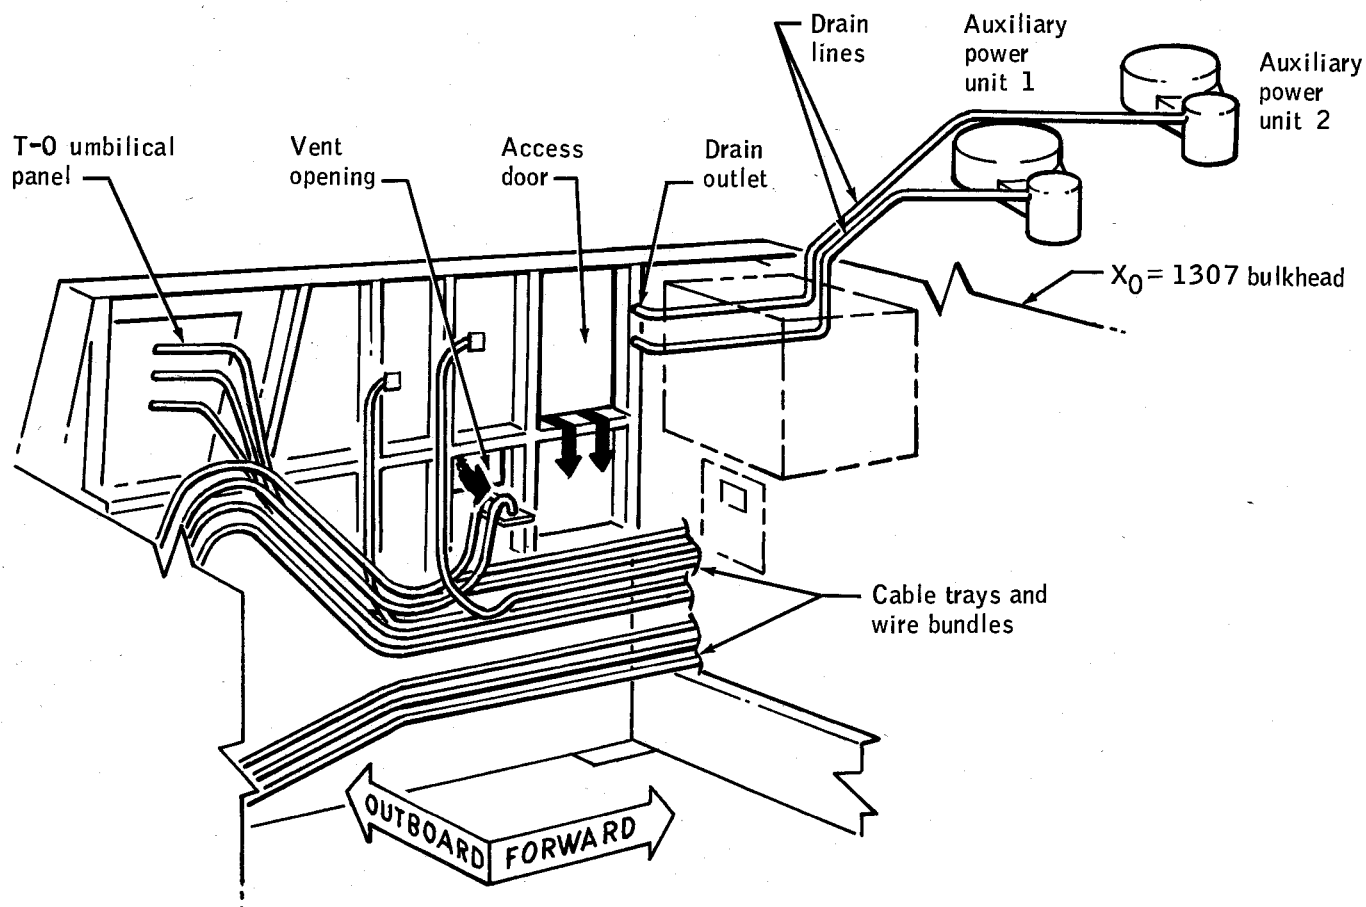
Figure 6-4.- Aft fuselage interior, left-hand side wall looking outboard.

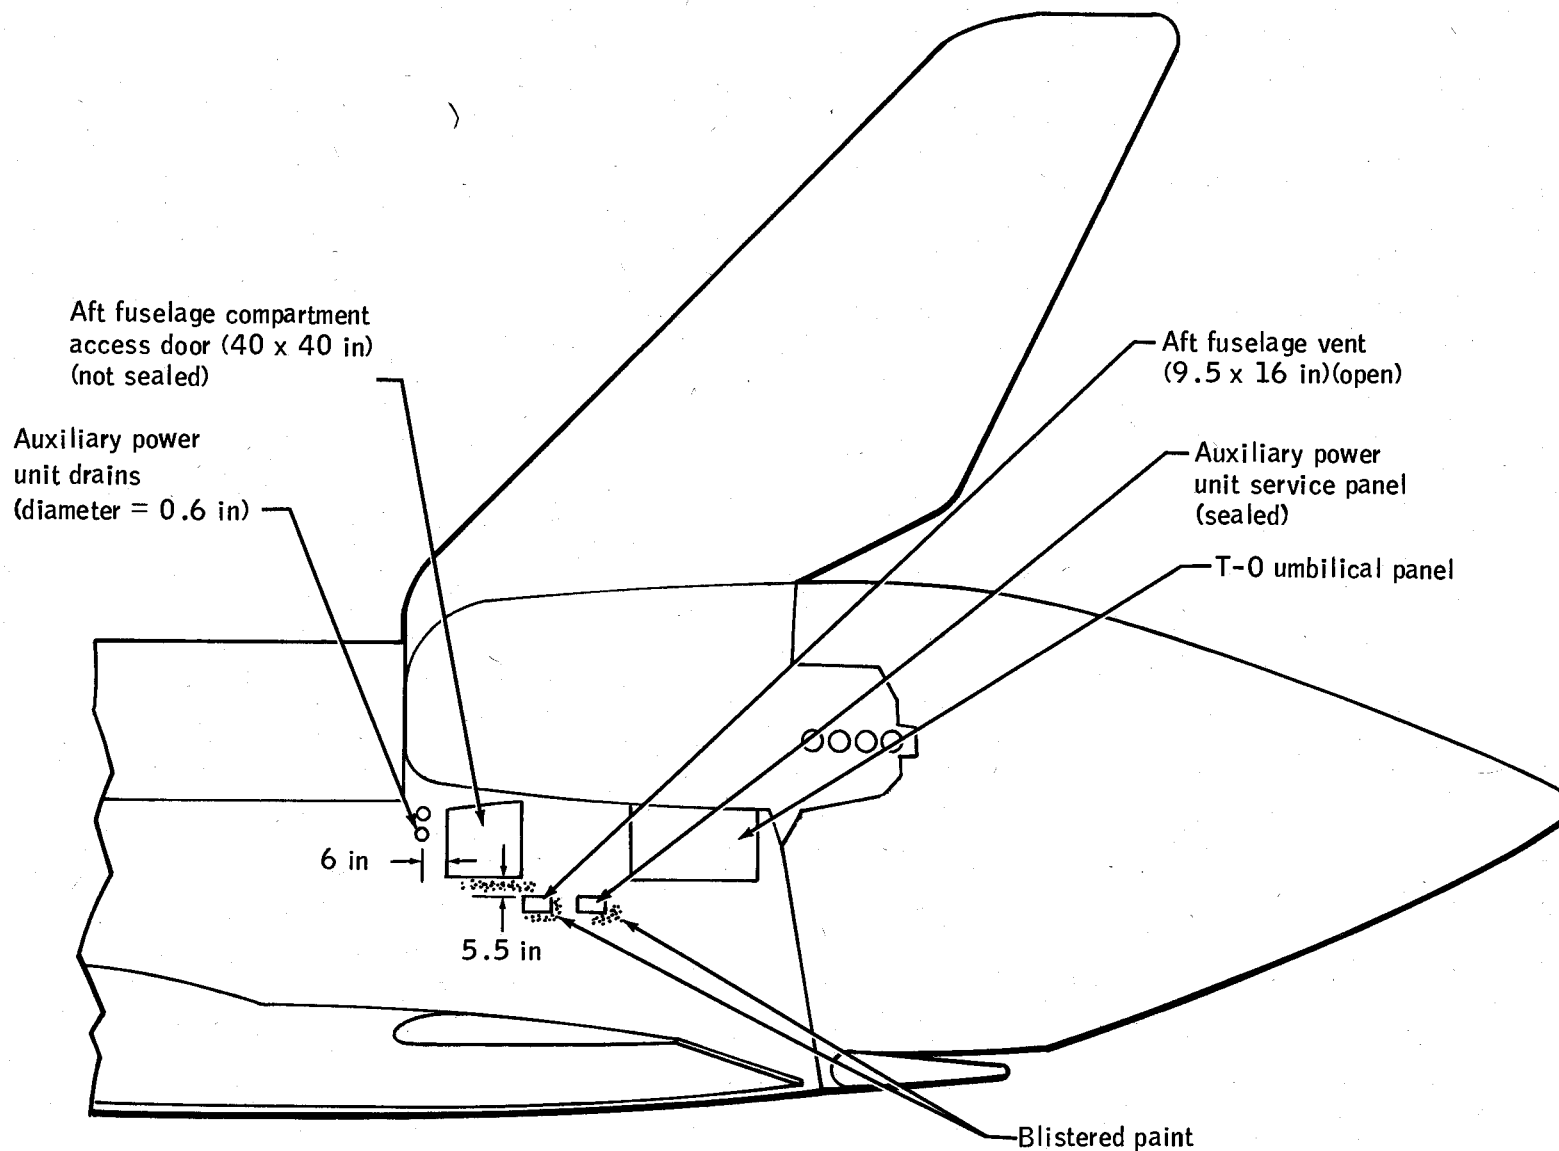
Figure 6-5.- Hydrazine on aft fuselage left-hand external surface.

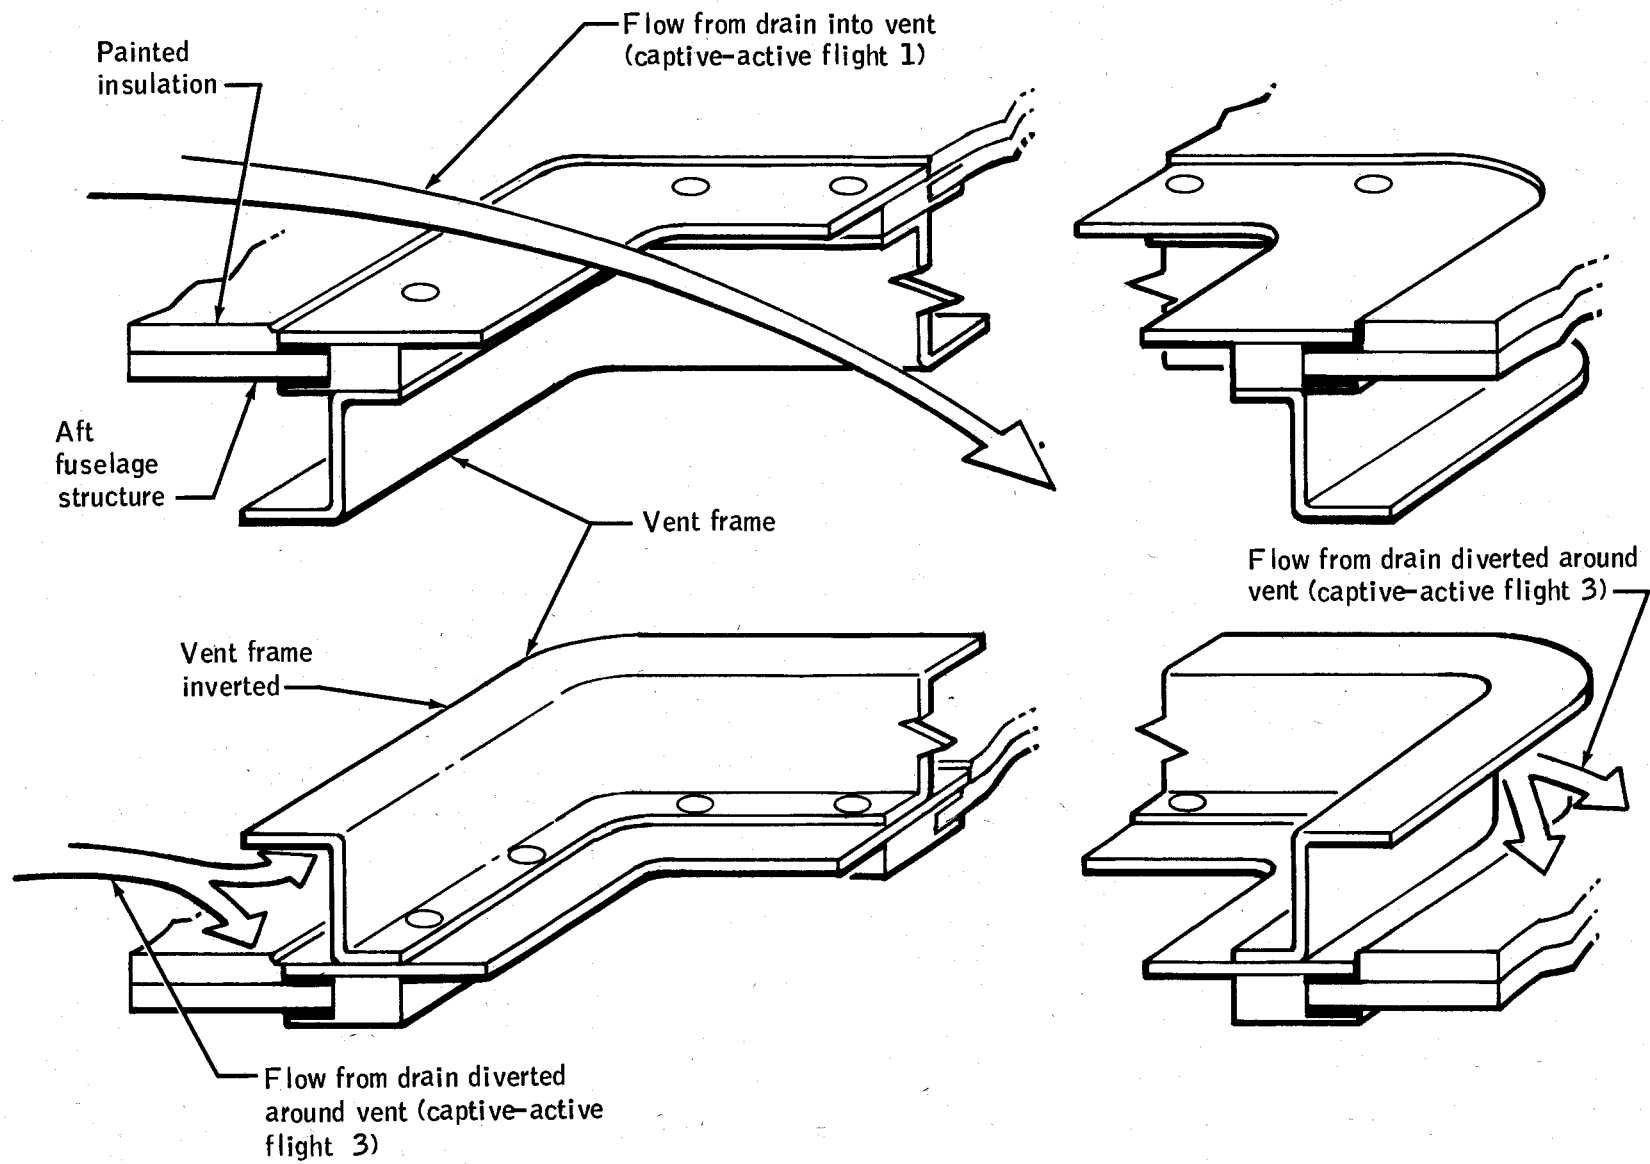
Figure 6-6. - Vent protection for captive-active flight 3.

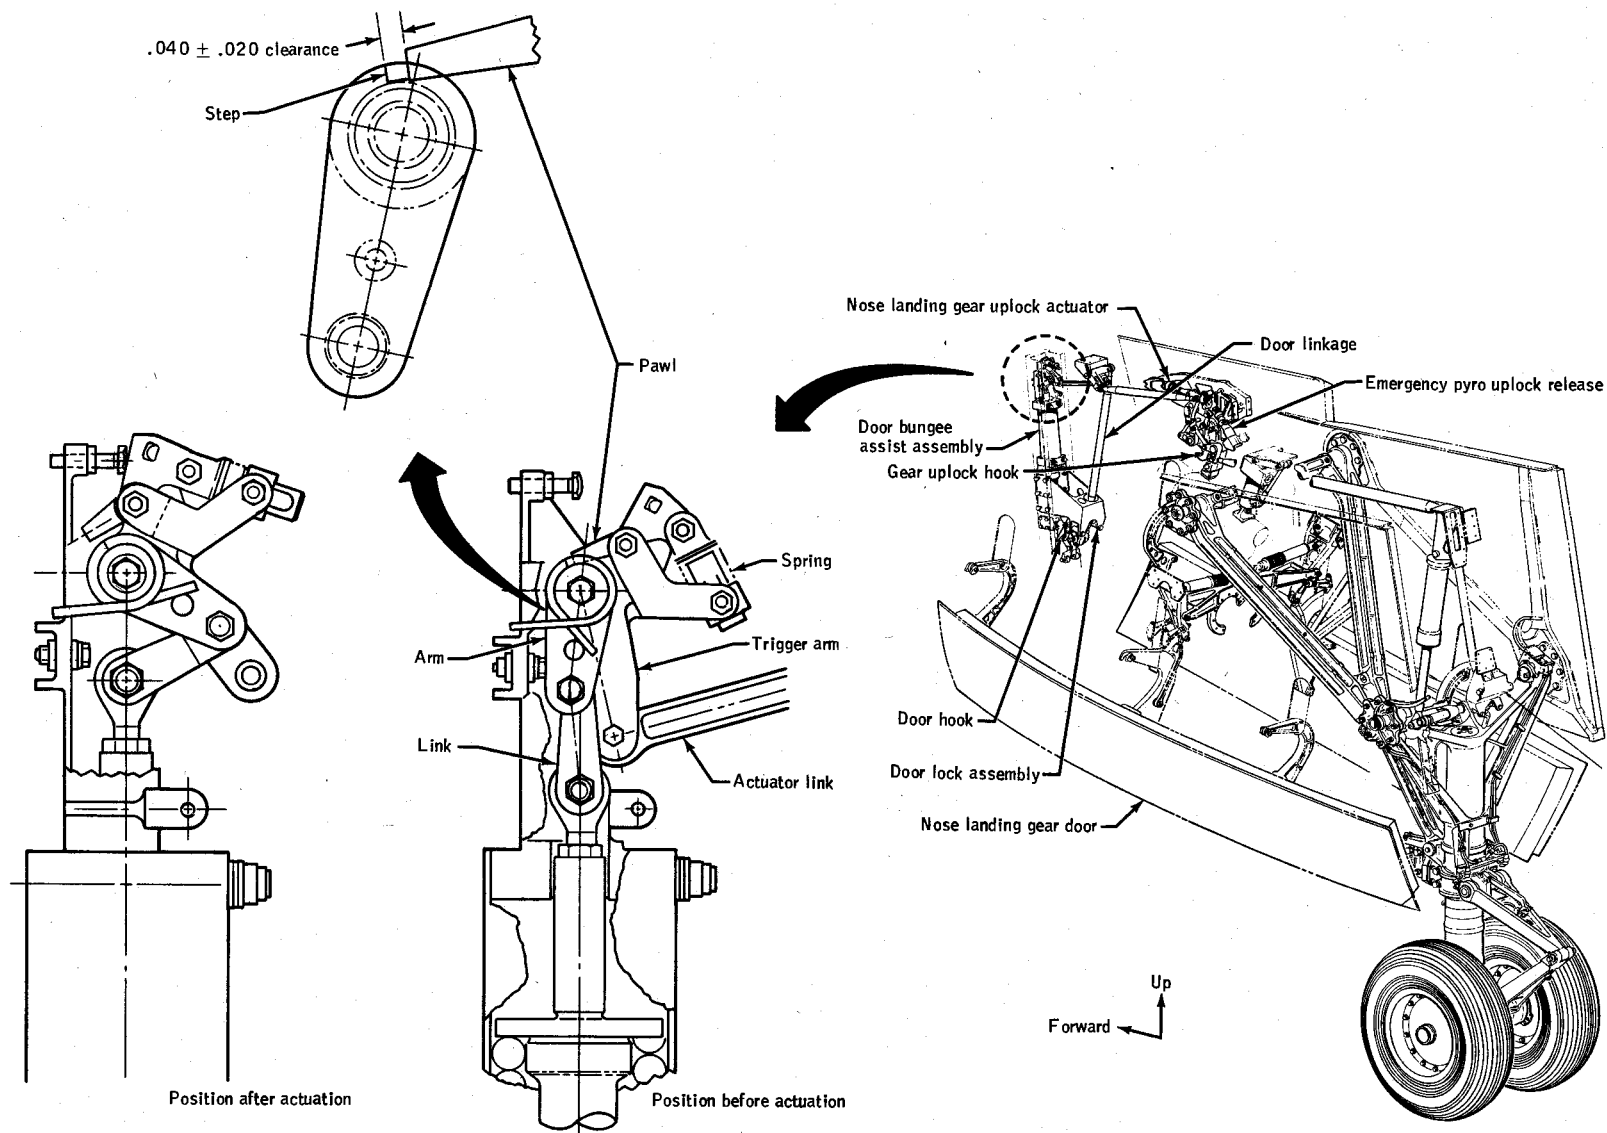
Operation of the spring bungee is not required for proper nose landing gear operation for the Approach and Landing Test Program. The system is being redesigned for Orbital Flight Test.

Figure 6-8.- Nose landing gear mechanism.

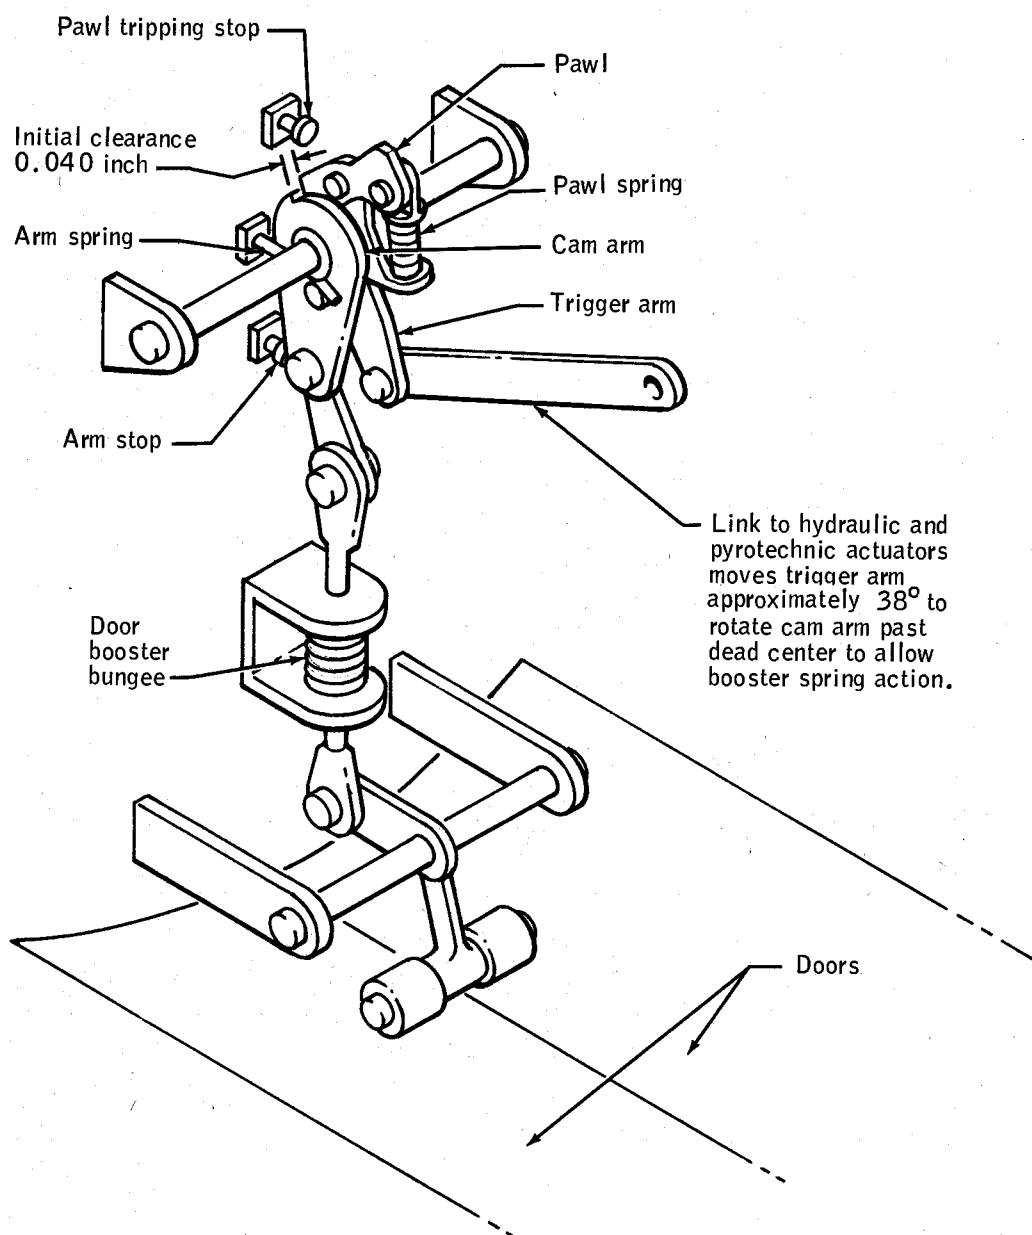
Figure 6-9.- Forward landing gear door booster bungee.

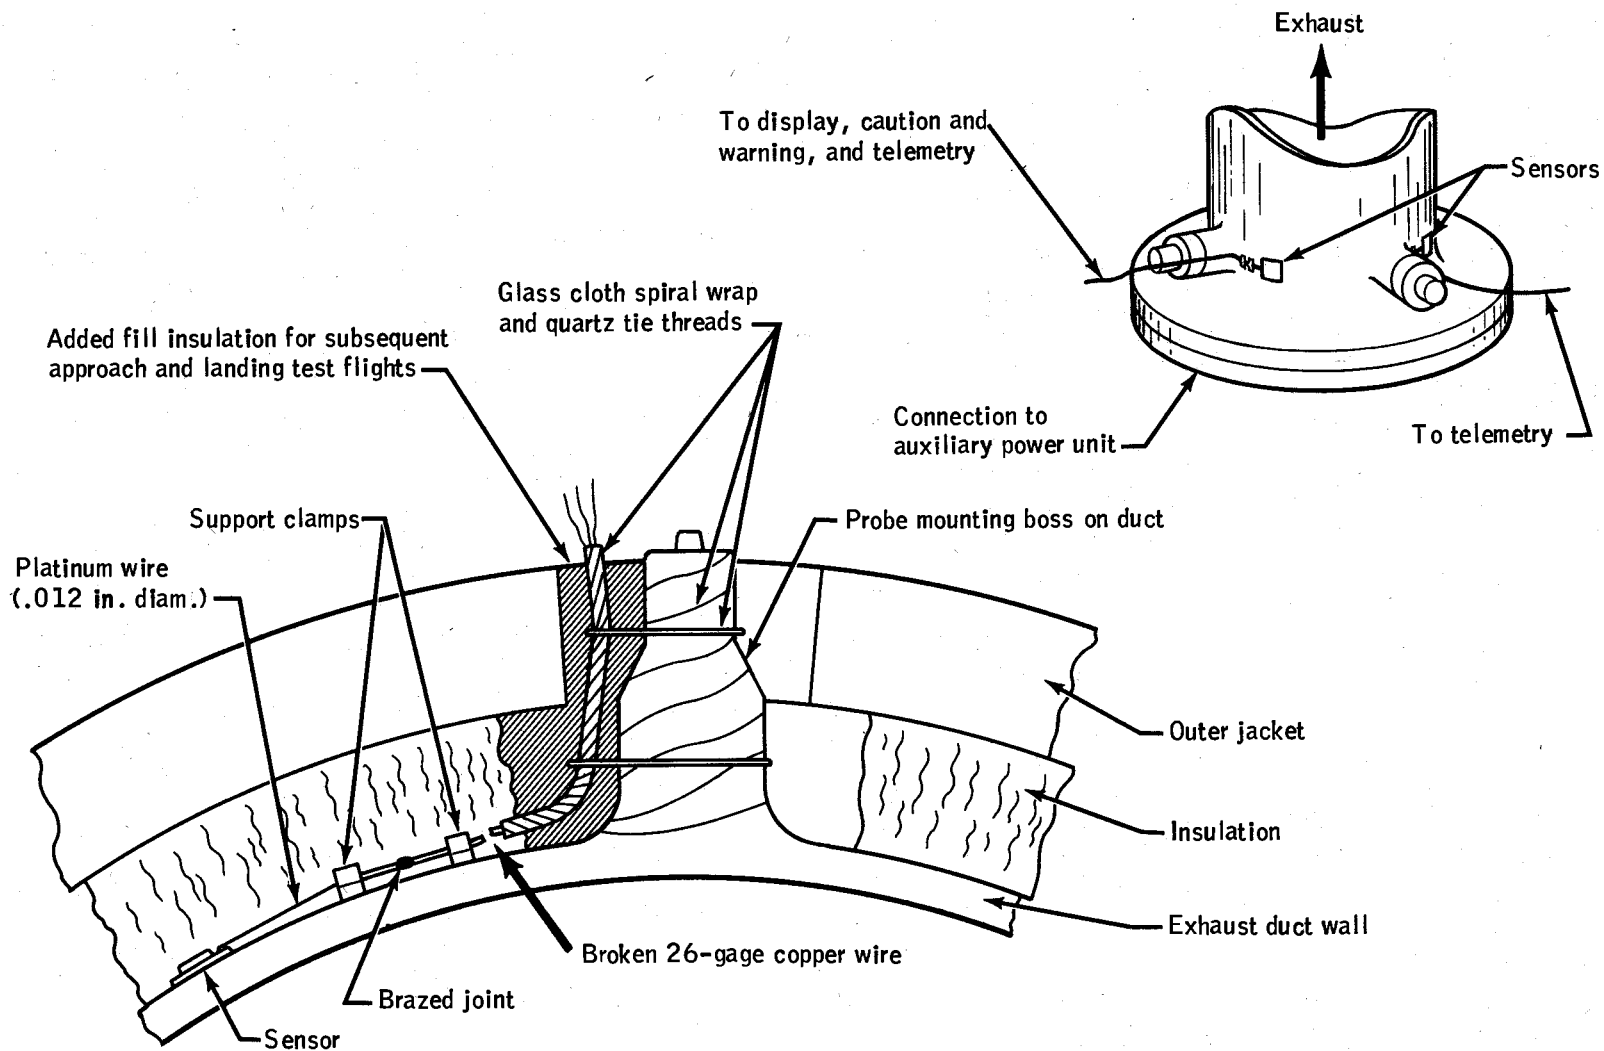
Figure 6-10.- Auxiliary power unit exhaust duct temperature measurement.

Corrective action taken for the remainder of the Approach and Landing Test flights includes (1) the addition of fill insulation (fig. 6-10) to better protect the copper lead from the high temperature of the boss and provide support to dampen lead movement and minimize flex stress by the hold-down clamp and (2) provide readout of the redundant temperature measurement in the cabin for crew monitoring. A probe-type sensor in the boss is being considered for Orbital Flight Test.
