1. Report No. <b>NASA CR-144984</b>	2. Government Accession No.	3. Recipient's Catalog No.	
4. Title and Subtitle <b>737 GRAPHITE COMPOSITE FLIGHT SPOILER FLIGHT SERVICE EVALUATION</b>		5. Report Date <b>May 1976</b>	6. Performing Organization Code

## 737 GRAPHITE COMPOSITE FLIGHT SPOILER FLIGHT SERVICE EVALUATION

Robert L. Stoecklin  
Boeing Commercial Airplane Company

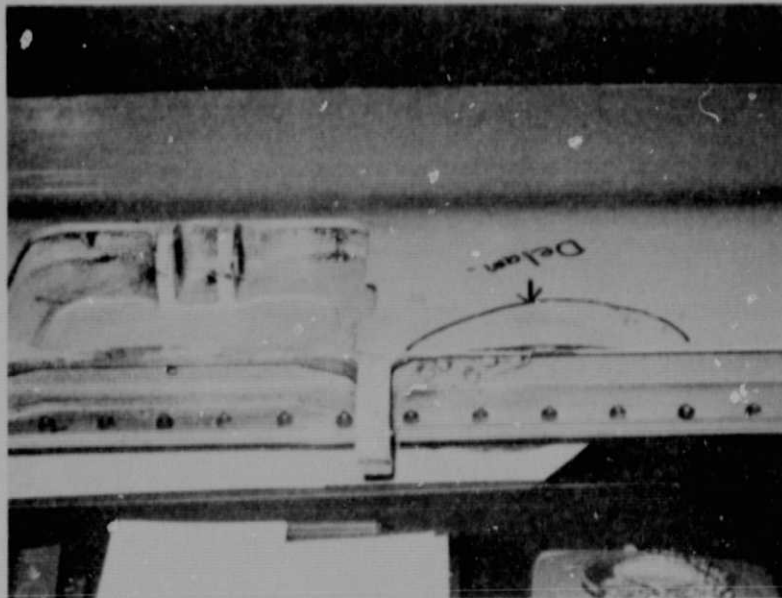
On January 28, 1976 New Zealand National Airways (NZNAC) reported a problem of delamination along the front spar/skin interface of spoiler S/N 0050 (fig. 2). The panel was removed from the aircraft. Additional inspection activity at NZNAC identified another spoiler, S/N 0009, which exhibited a similar though less severe delamination. Both panels were returned to Boeing for evaluation.

Figure 2.—Delamination Resulting from Exfoliation Corrosion Under Skin

Detailed examination of both units revealed that the fundamental problem was one of exfoliation corrosion of the aluminum spar element. The corrosion commenced at the hinge fitting/spar butt joint and progressed outboard within the spar chord. Expansion of the corroding aluminum generated the expanding force which precipitated the skin delamination. The corrosion was contained entirely on the spar side of the adhesive bondline and no evidence was found to suggest that the presence of the graphite skin accelerated the corrosion. No corrosion was found in the center hinge fitting nor in the aluminum core adjacent to the corroding spar. The corrosion is attributed to intrusion of moisture through a crack in the sealant material and through a suspected defect in the BAC 5555 surface preparation. Spoiler S/N 0050 has been removed from the program; S/N 0009 is being evaluated further.

A fleet survey was initiated to look for additional examples of exfoliation corrosion. To date, responses covering 63% of the spoilers in service have not uncovered additional corrosion problems.

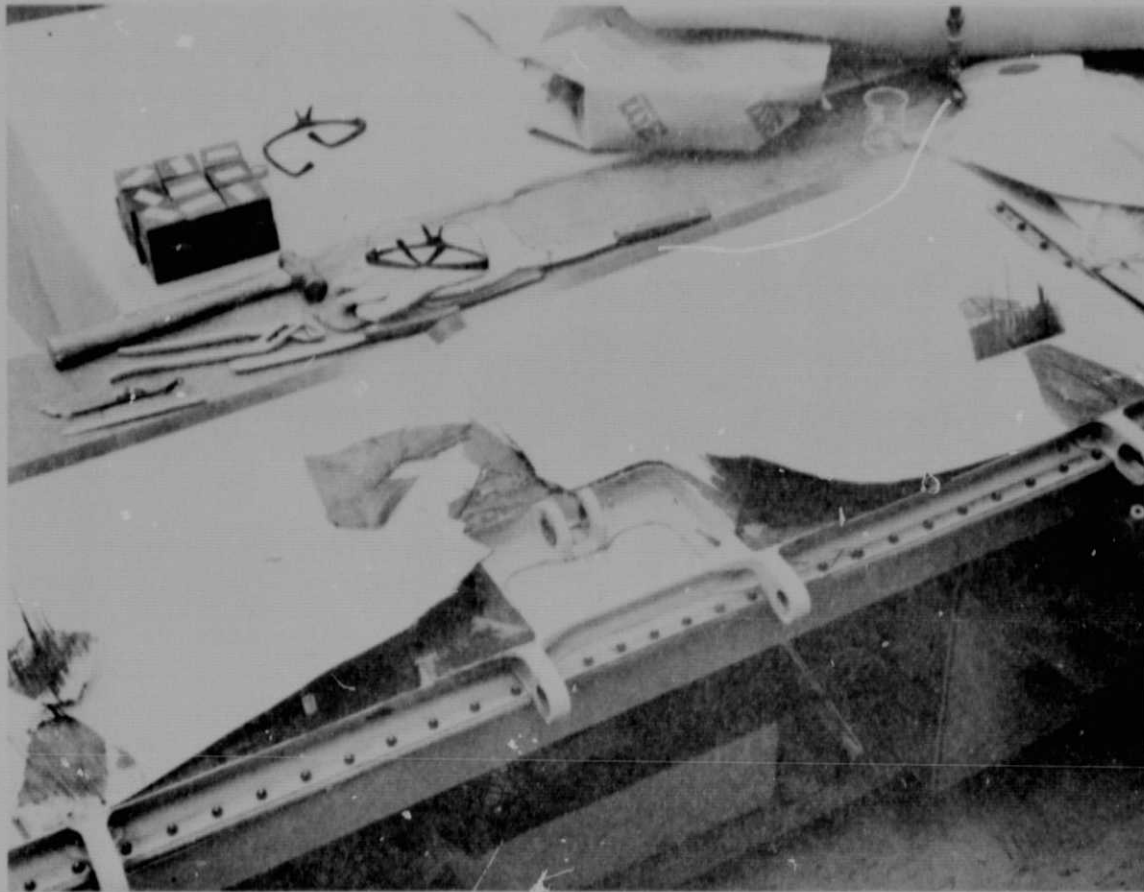
An additional moisture/corrosion investigation was undertaken following the discovery of corrosion in the aluminum spar elements. Spoiler S/N 0025, having been tested to destruction following 2 years of flight-service in Hawaii, was selected for core corrosion exploration. The lower skin element was peeled extensively, beginning in the vicinity of the center hinge fitting (fig 3). Minute examination of the core cells failed to identify any corrosion of the internal structural elements.

*Figure 3.—Core Corrosion Examination of Static Test Spoiler S/N 0025*

S/N 0025 had accumulated 3757 flight-hours and 10 233 landings over a period of 2 years flight service.

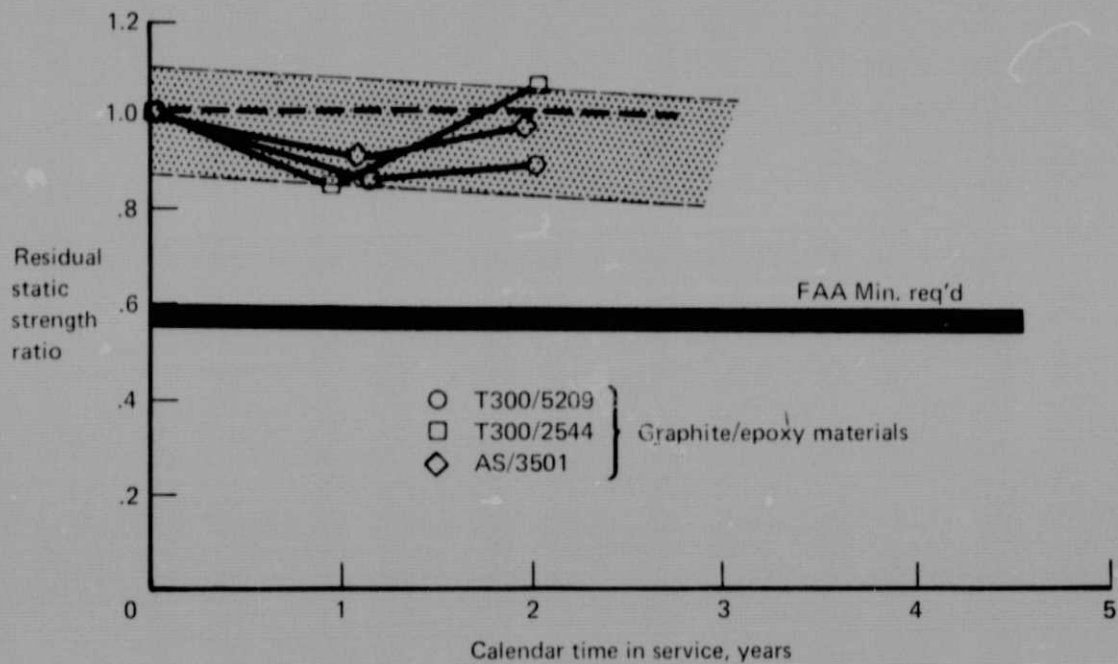
It is significant to note that all three spoilers destructively tested yielded residual static strengths greater than the corresponding part-numbered units tested after 1 year of

service. Figure 4 shows a plot of all test data plotted as a function of time. This data points out the potential scatter in the strength data being collected, and at the same time defines a degradation with time significantly lower than was indicated following completion of the first years testing. The test failures of the second year specimens are shown in figures 5 through 10.

Figure 4.—Residual Static Strength of Graphite-Epoxy Spoilers After Removal From Flight Service

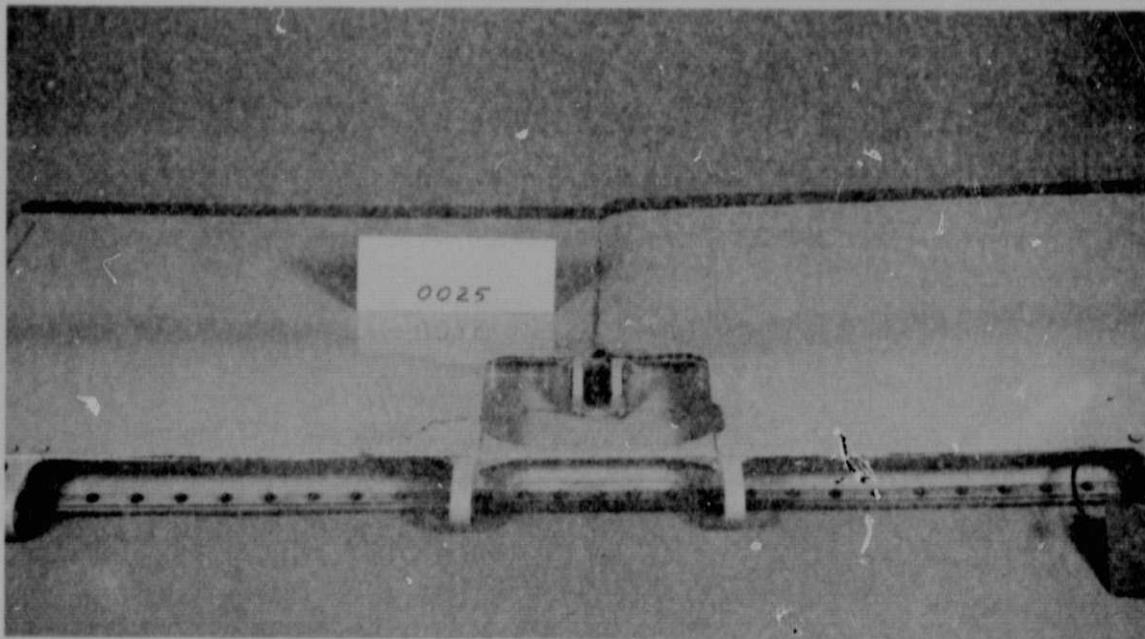
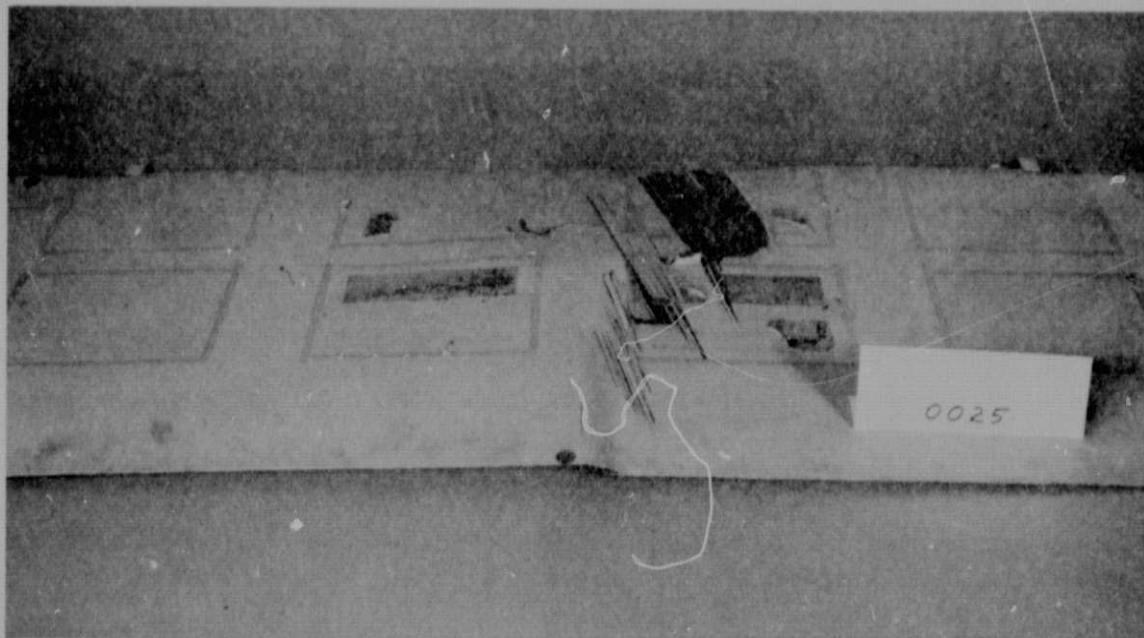
Figure 5. — Failed Static Test Specimen S/N 0025

Figure 6. — Failed Static Test Specimen S/N 0025

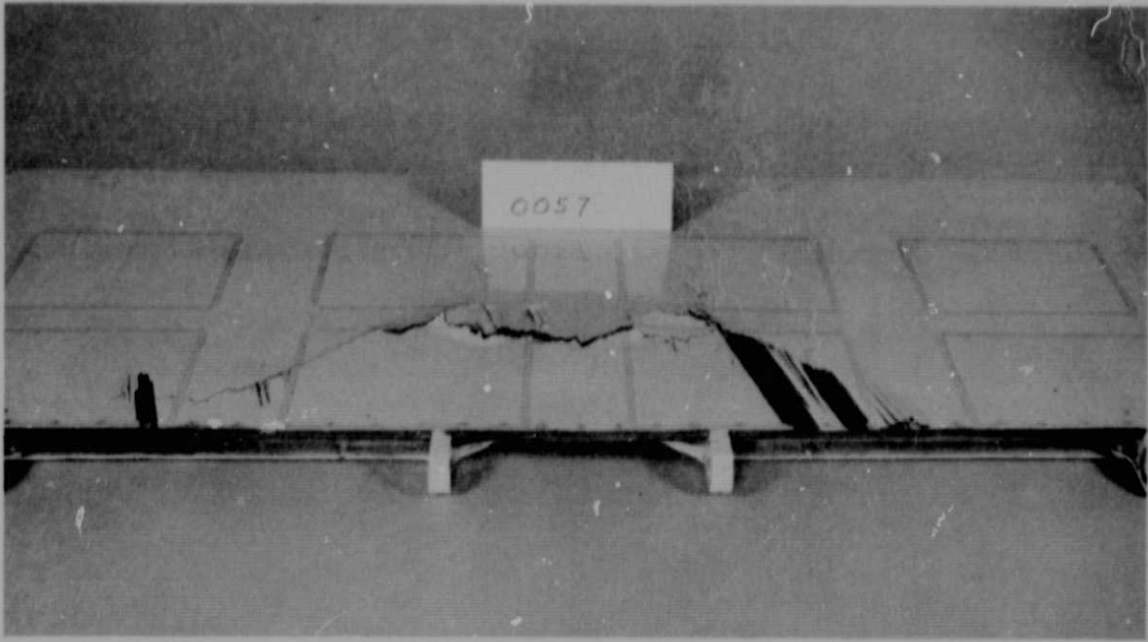
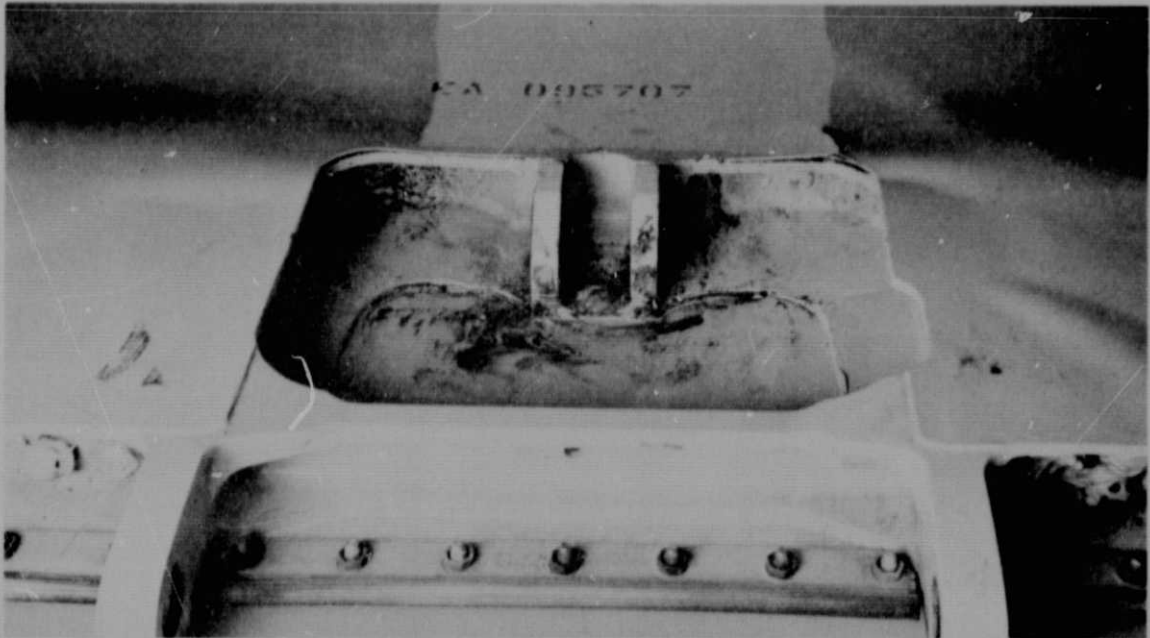
*Figure 7.—Failed Static Test Specimen S/N 0057*

*Figure 8.—Failed Static Test Specimen S/N 0057*

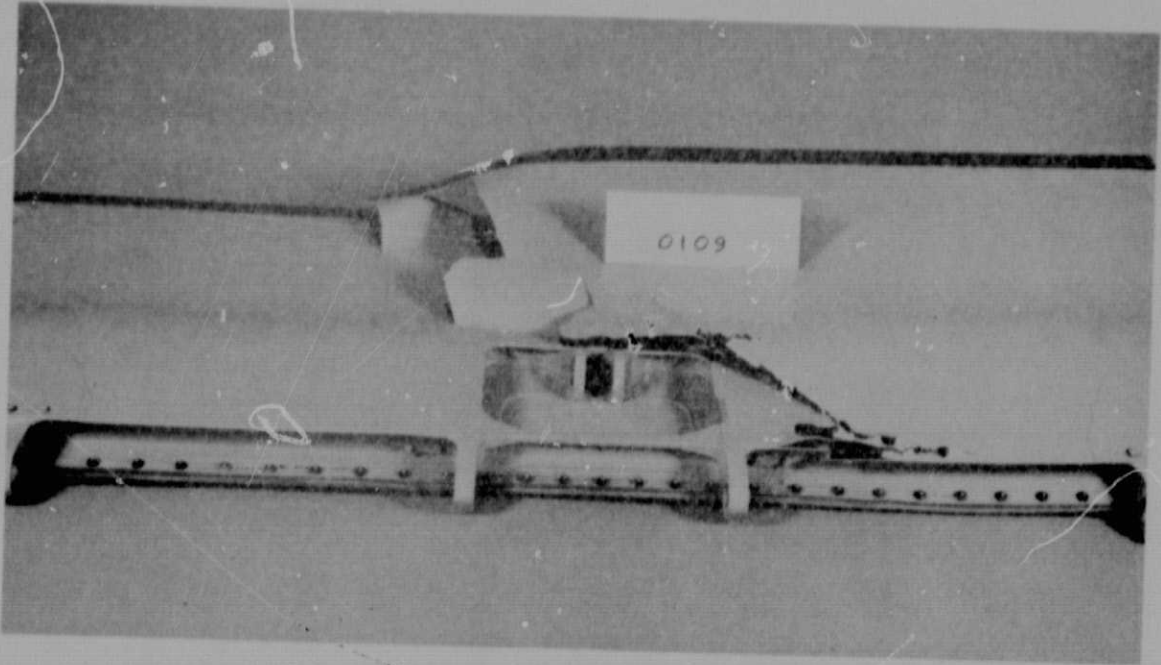
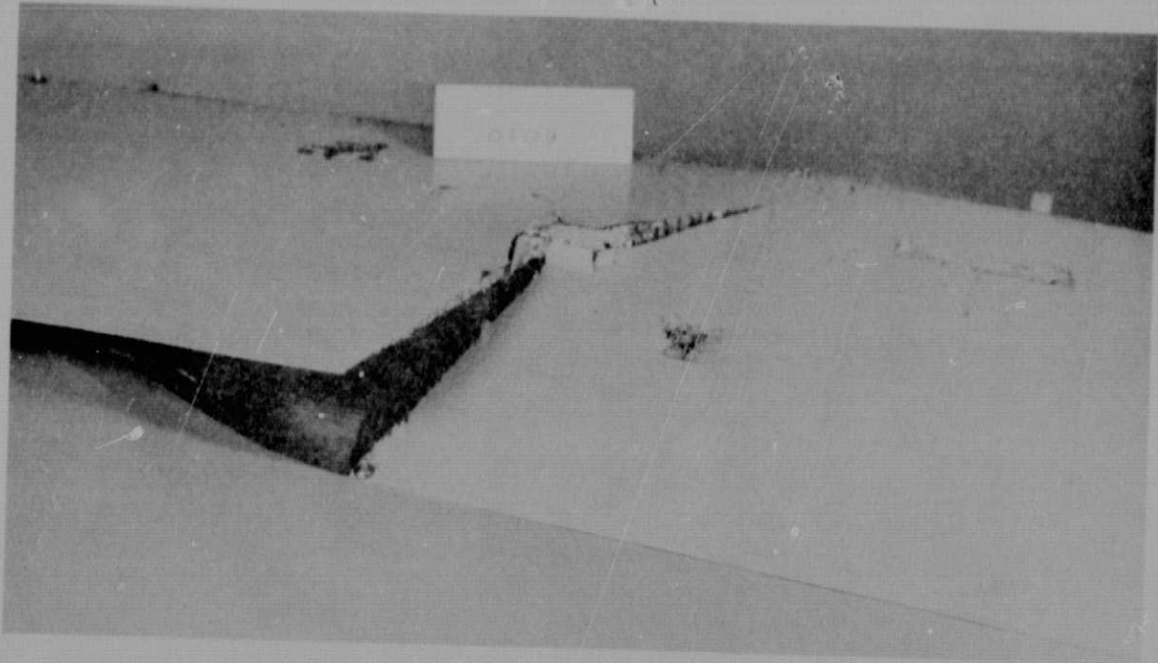
Figure 9.—Failed Static Test Specimen S/N 0109

Figure 10.—Failed Static Test Specimen S/N 0109

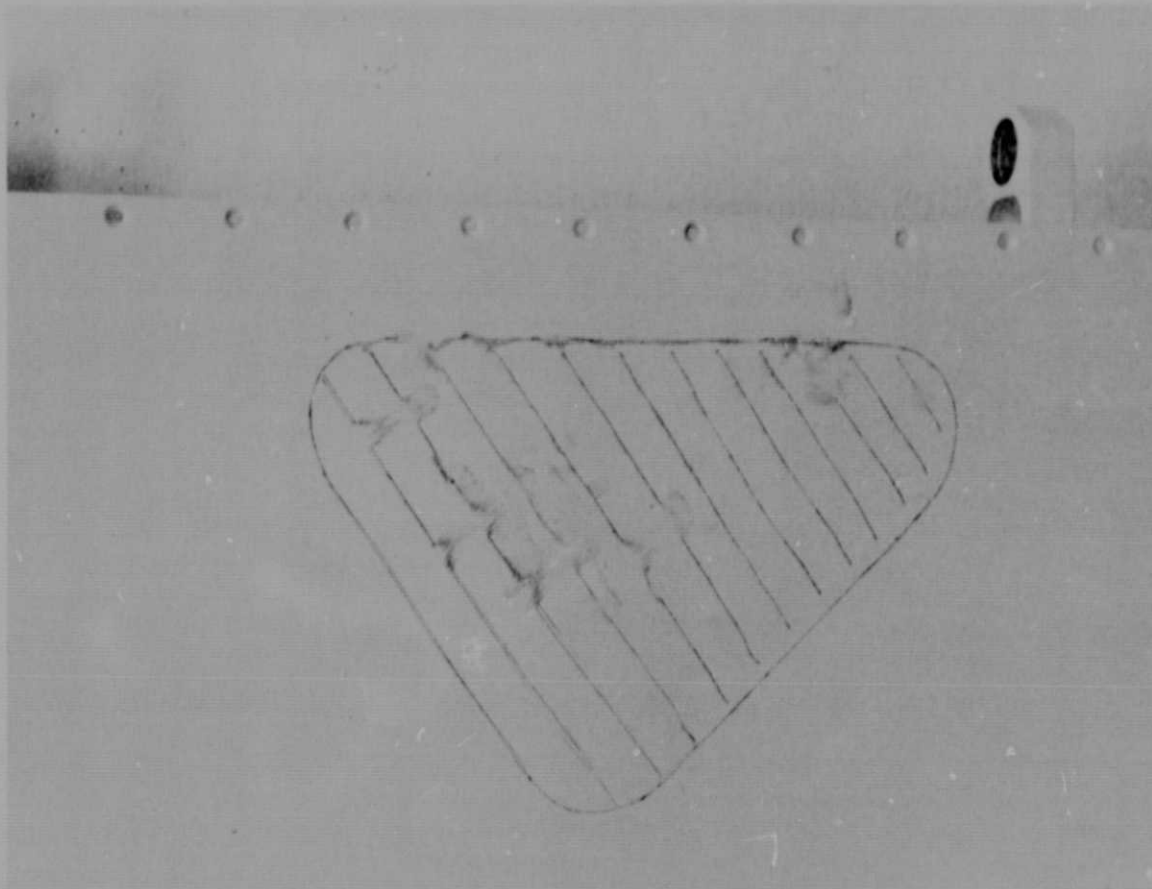
An interesting situation developed on spoiler S/N 0105, P/N 65-76327-3. This unit was returned by Aloha Airlines for repair of a second occurrence of a rod-end blister above the center hinge fitting. The repair was accomplished via the previously developed and now routine repair procedure. During the oven-drying cycle for the epoxy enamel finish (limited to 180° F (82° C)) a triangular skin blister occurred outside the center hinge fitting area, the outline of which is shown in figure 11. The blistered skin area subsequently removed and the part opened up as shown in figure 12. The extent of the damage to both the skin, the core, and the subsurface -11 aluminum doubler precluded further repair and the assembly was scrapped. Investigation of the circumstances of drying the epoxy enamel finish ruled out the possibility that the assembly had become overheated locally. The maximum temperature recorded in the drying room was 180° F (82° C). Flatwise tension tests were run on successive cures of EA9628 to establish any degradation as a result of reexposure of the adhesive to repeated curing cycles. The tests showed little change in tension properties.

*Figure 11.—Skin Blister—Upper Surface of S/N 0105*

The failure hypothesis advanced for these circumstances is that the original adhesive cure produced a smaller than normal filleting between the skin and the core within the area of the triangular blister (fig. 12). These fillets were sufficient to produce an acceptable response in the ultrasonic C-scan recordings produced as part of the normal manufacturing sequence. Subsequent heating and cooling strains were sufficient to eventually produce a failure in the fillet bonds.

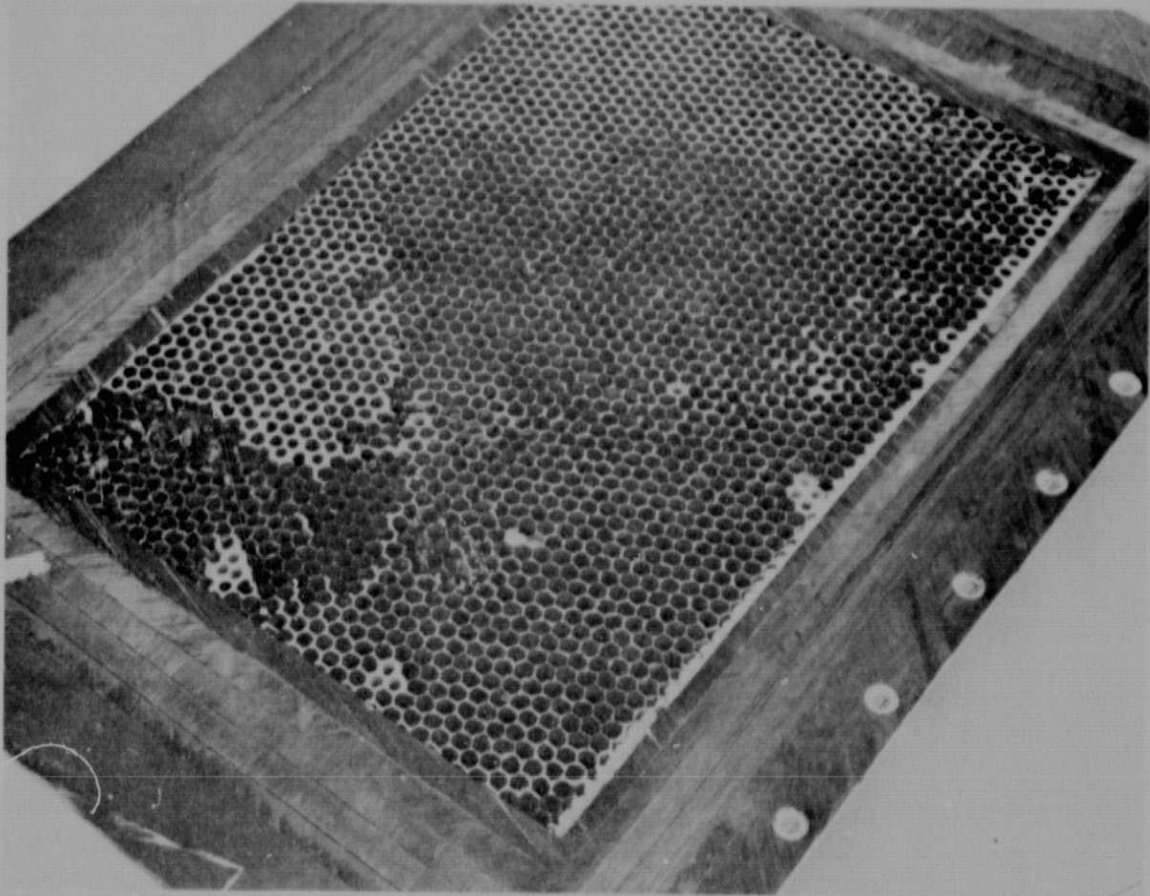
Figure 12.—Spoiler S/N 0105 With Section of Upper Skin Removed

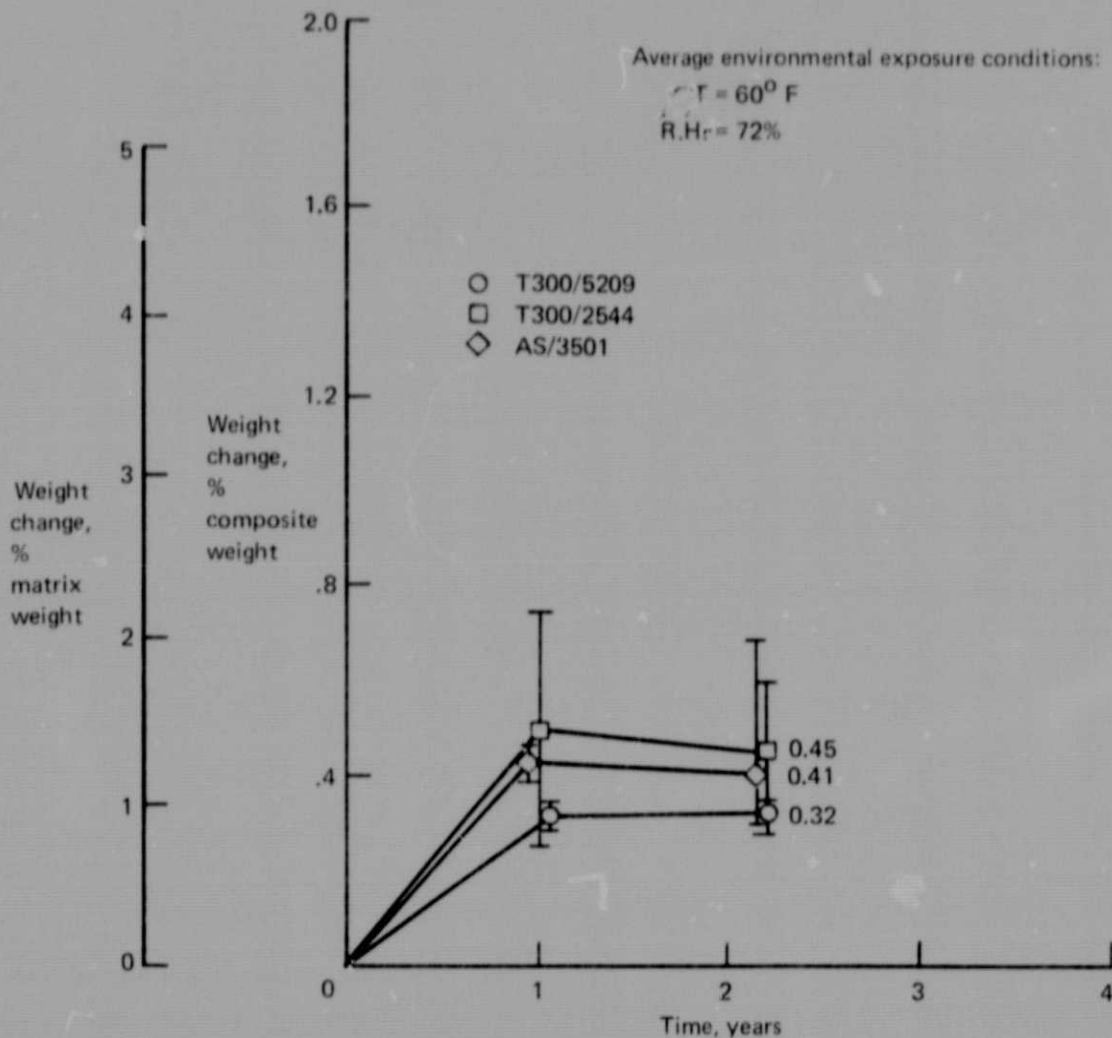
Specimens were removed from the NASA-Langley exposure rack following 2 years of exposure, weighed and returned to the rack. The weight change data acquired from these specimens has been plotted with the data acquired from the 1-year specimens and is plotted in figure 14. The data is quite significant and shows a strong trend toward stabilizing the change of composite weight due to moisture absorption. This trend should be further defined when the 3-year data is assembled late in 1976.

Figure 14.—Moisture Pickup in Exposed Epoxy-Matrix Laminates (Langley Research Center)

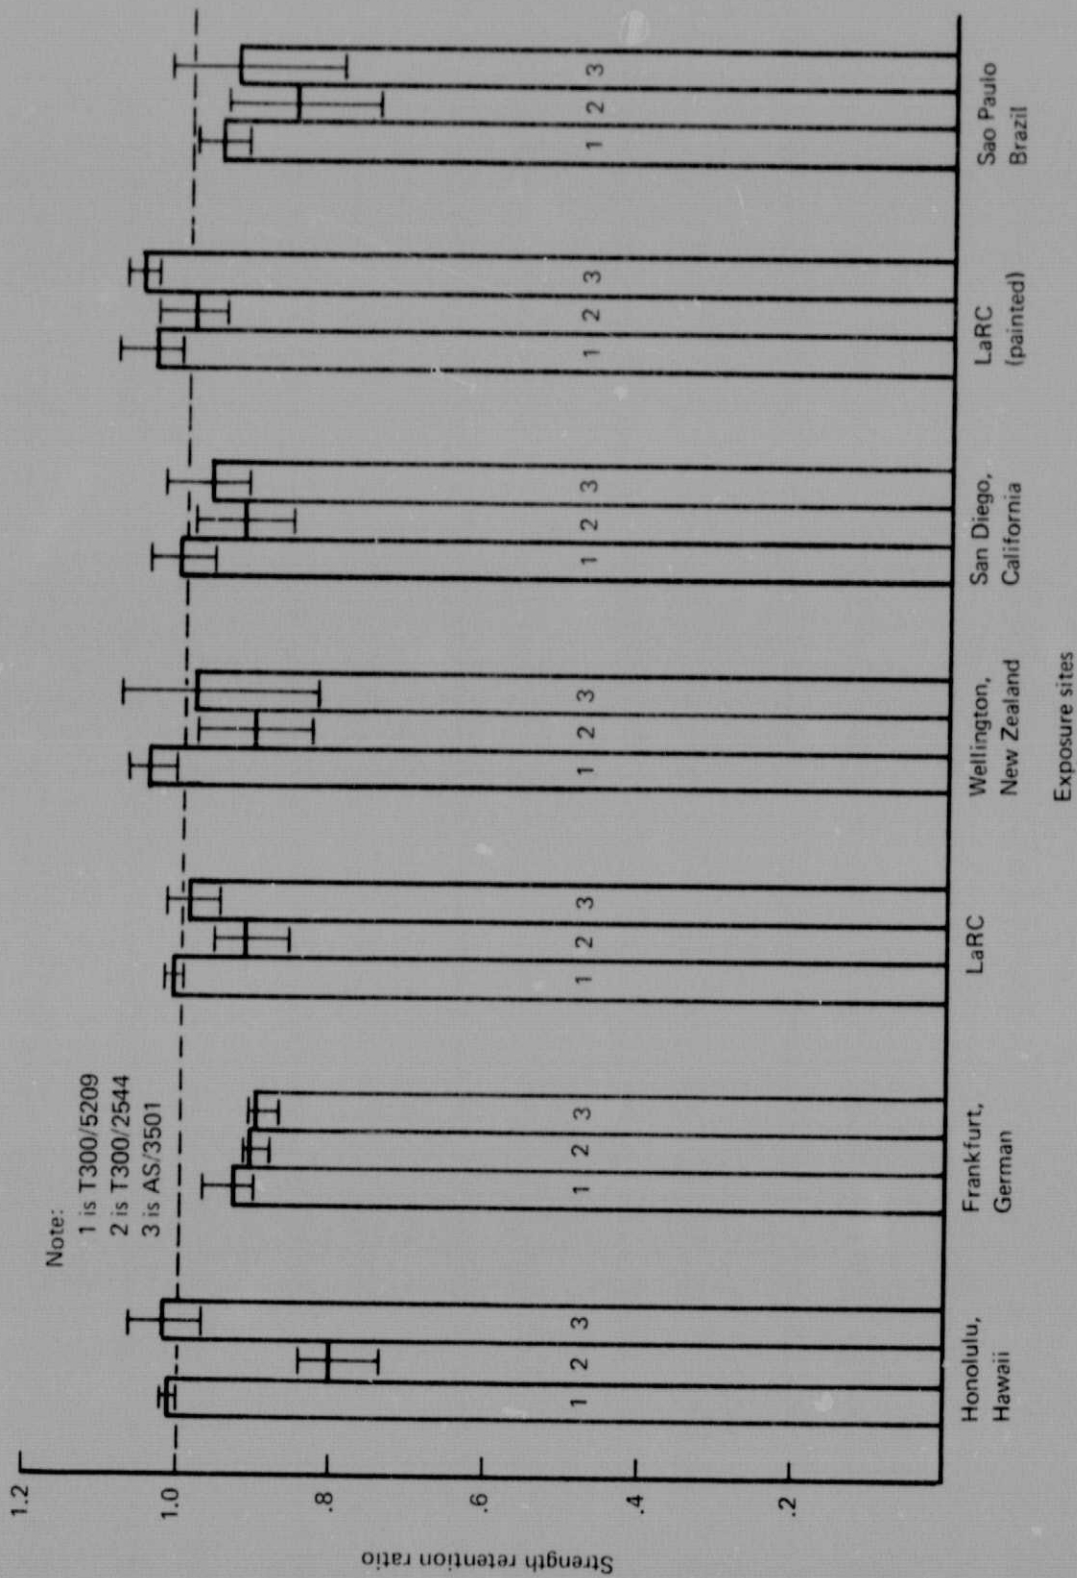
Figure 15.—Interlaminar Shear Strengths of Graphite-Epoxy Composites After 1-Year Outdoor Ground Exposure

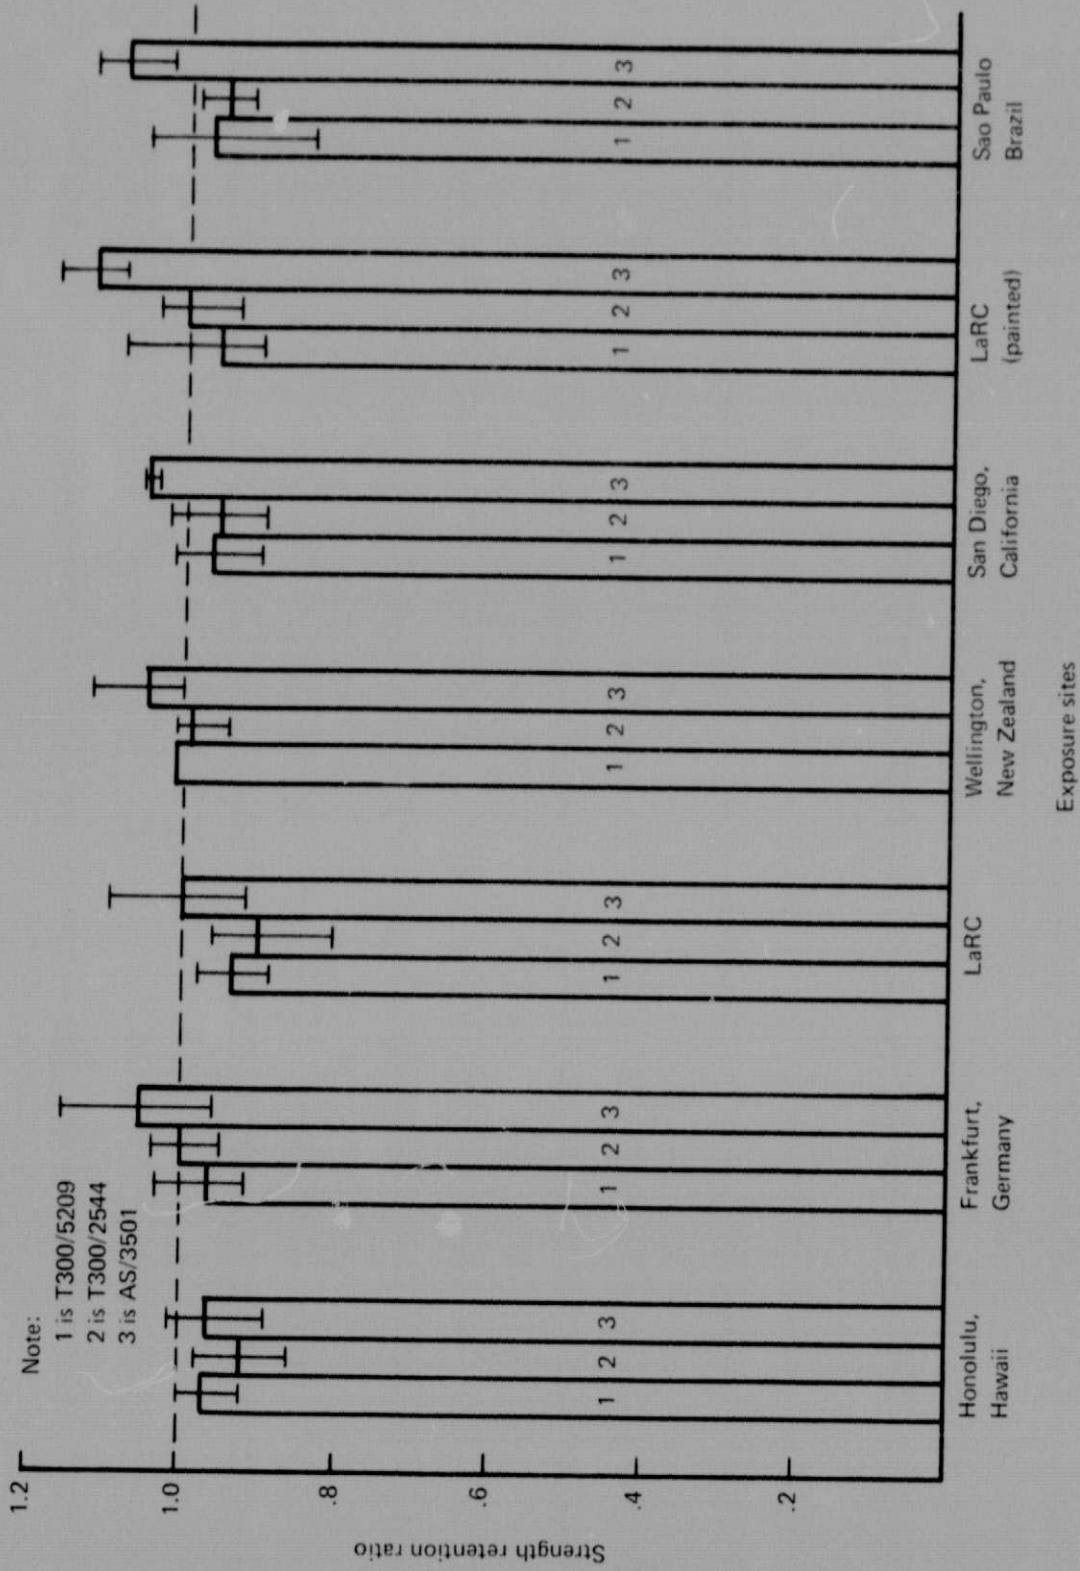
Figure 16. - Flexure Strengths of Graphite-Epoxy Composites After 1-Year Outdoor Ground Exposure

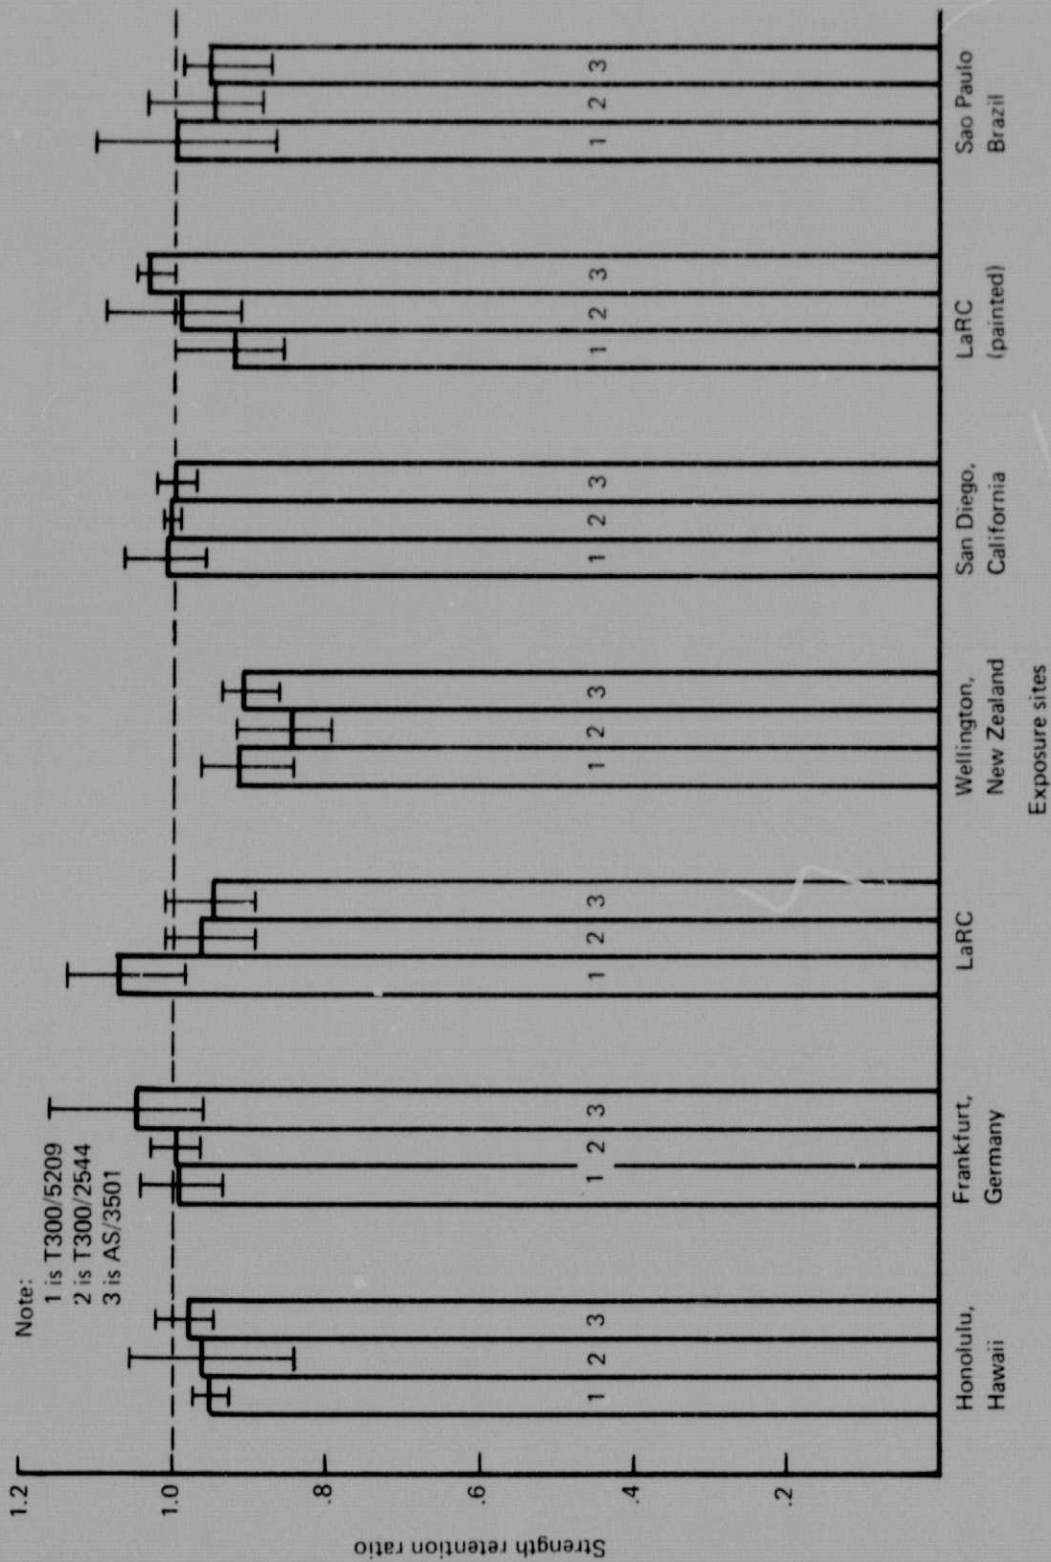
Figure 17.—Compression Strengths of Graphite-Epoxy Composites After 1-Year Outdoor Ground Exposure
