Space Shuttle Orbiter Approach and Landing Test

Final Evaluation Report

February 1978

Lyndon B. Johnson Space Center
Houston, Texas

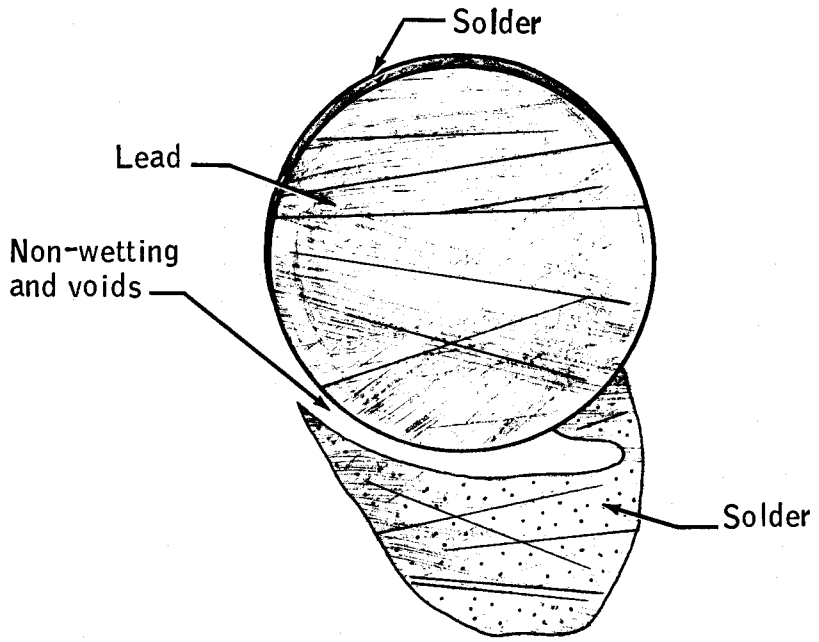
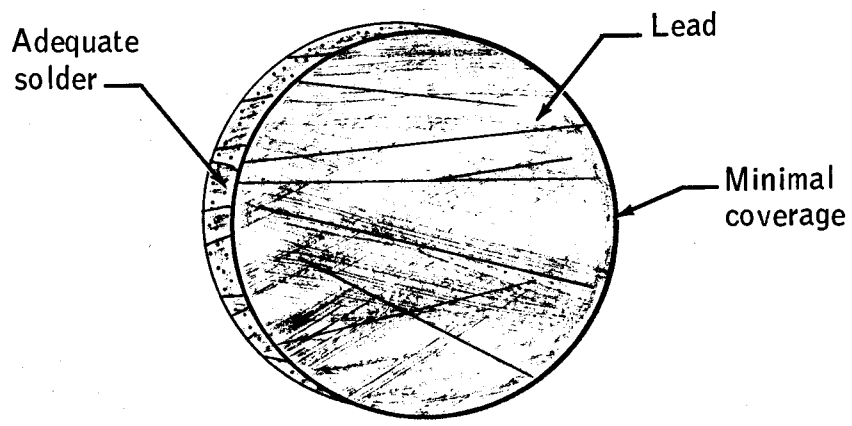
Figure 7-1. - Sections of solder joint and pretinned lead (magnified 100 times).

During operation of auxiliary power unit 1 on captive-active flight 3, the exhaust duct temperature reading went off-scale high and triggered the caution and warning signal. The redundant measurement, not displayed in the cabin, showed normal temperature readings which indicated that the off-scale high reading was probably the result of an open circuit. Postflight examination confirmed that the sensor lead had broken at the flex stress joint adjacent to the brazed joint support clamps.

(a) Solder joint

(b) Pretinned section

Corrective action taken for the remainder of the Approach and Landing Test flights included (1) the addition of fill insulation to better protect the copper lead from the high temperature of the boss and provide support to dampen lead movement and minimize flex stress by the hold-down clamp and (2) provide readout of the redundant temperature measurement in the cabin for crew monitoring.

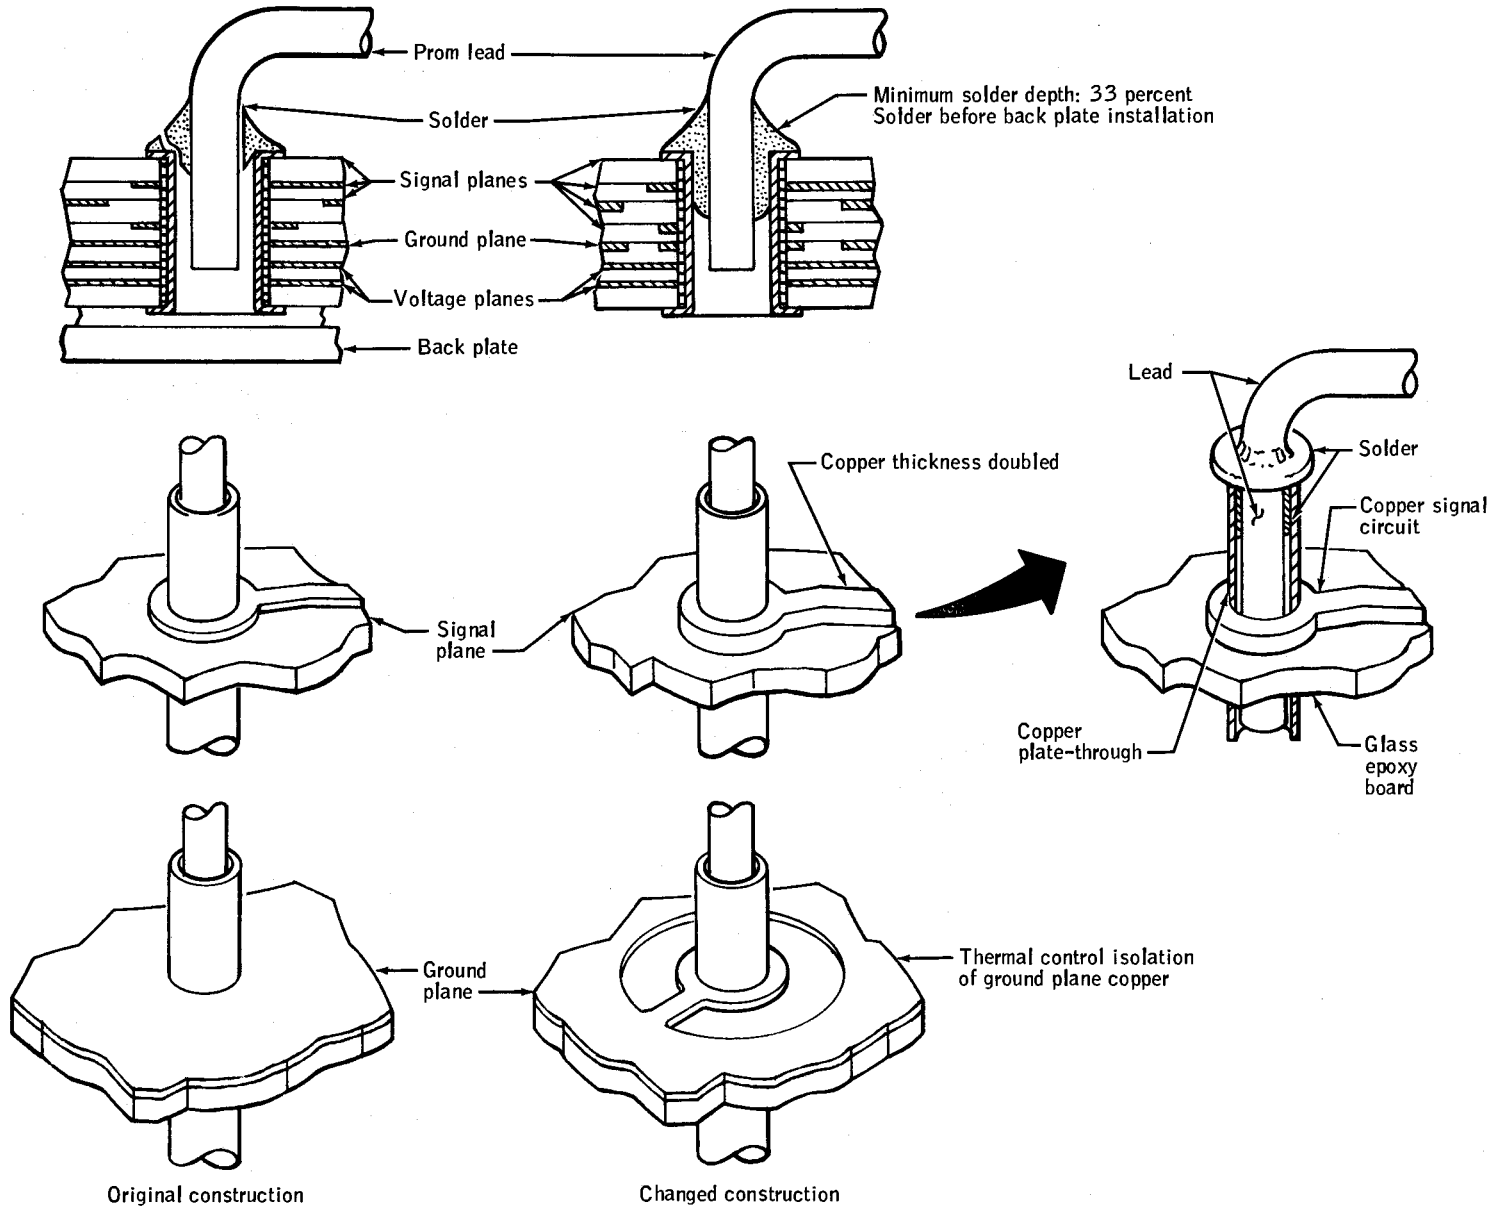
Figure 7-3.- Change in computer page lead connections to improve solder wicking.

In-line changes had been implemented to circumvent this kind of problem, but not in time to be applied to system F8. Using the old verification procedure, the crowded page configuration made even oblique X-ray examination of some solder joints unsatisfactory for verification of the complete page. To correct this situation, the procedure was modified so that component X-ray inspection of solder wetting is accomplished before back-plate installation. Other changes

consisted of doubling the copper thickness of the signal planes to increase physical strength during solder heating and providing thermal relief around the ground plane junction, reducing thermal conductivity away from the solder connection (fig. 7-3). The thermal relief modification provides a smaller, controlled heat path between the solder connection and the rest of the ground plane, slowing the heat sink rate and allowing flow, filling, and bonding of solder to at least 33 percent of full depth.

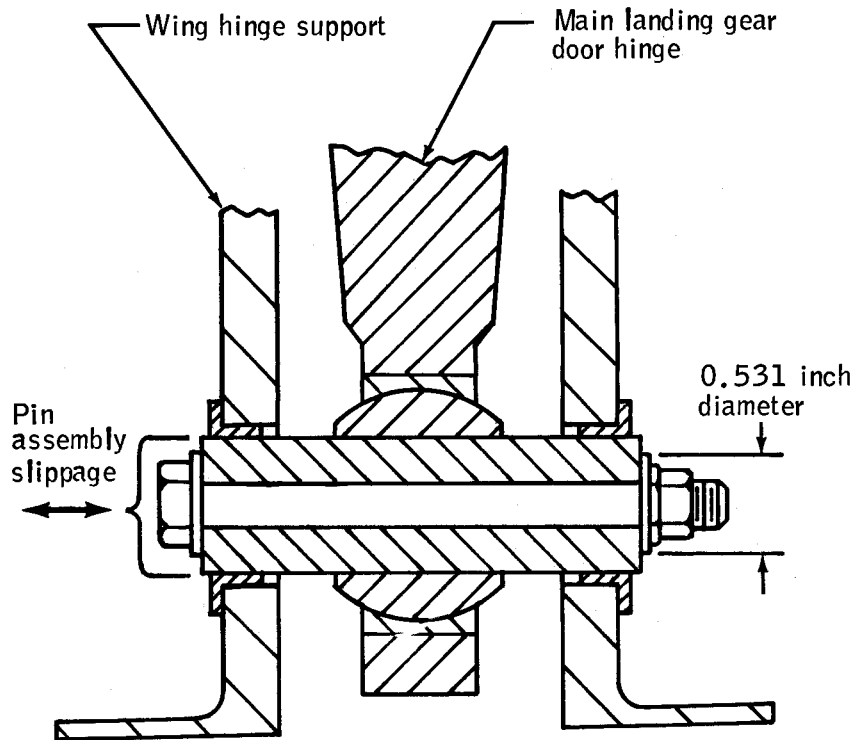
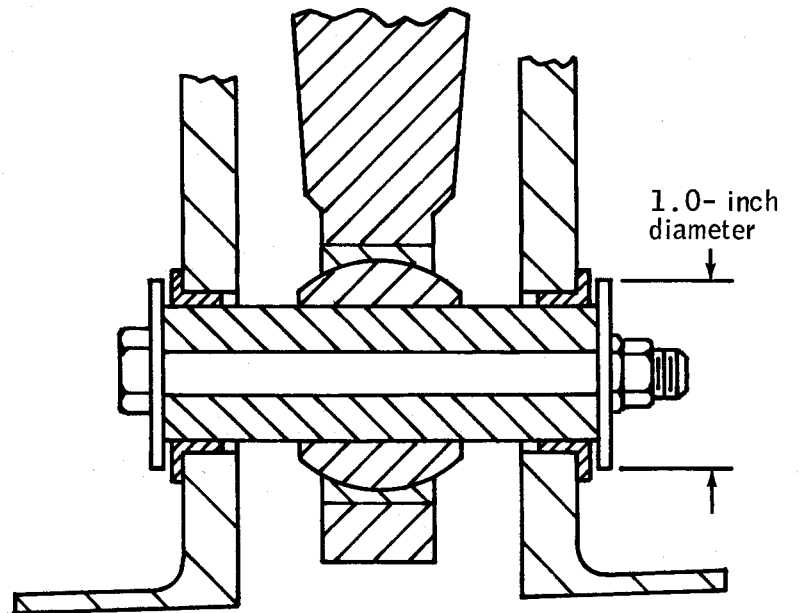
Figure 7-4.- Main landing gear door hinge assembly.

Main landing gear door hinge pin assembly: A main landing gear door hinge pin assembly was found missing after free flight 1. This anomaly is discussed in paragraph 7.2.3.

Washer too small to retain pin on forward and aft hinges

Washer diameter increased

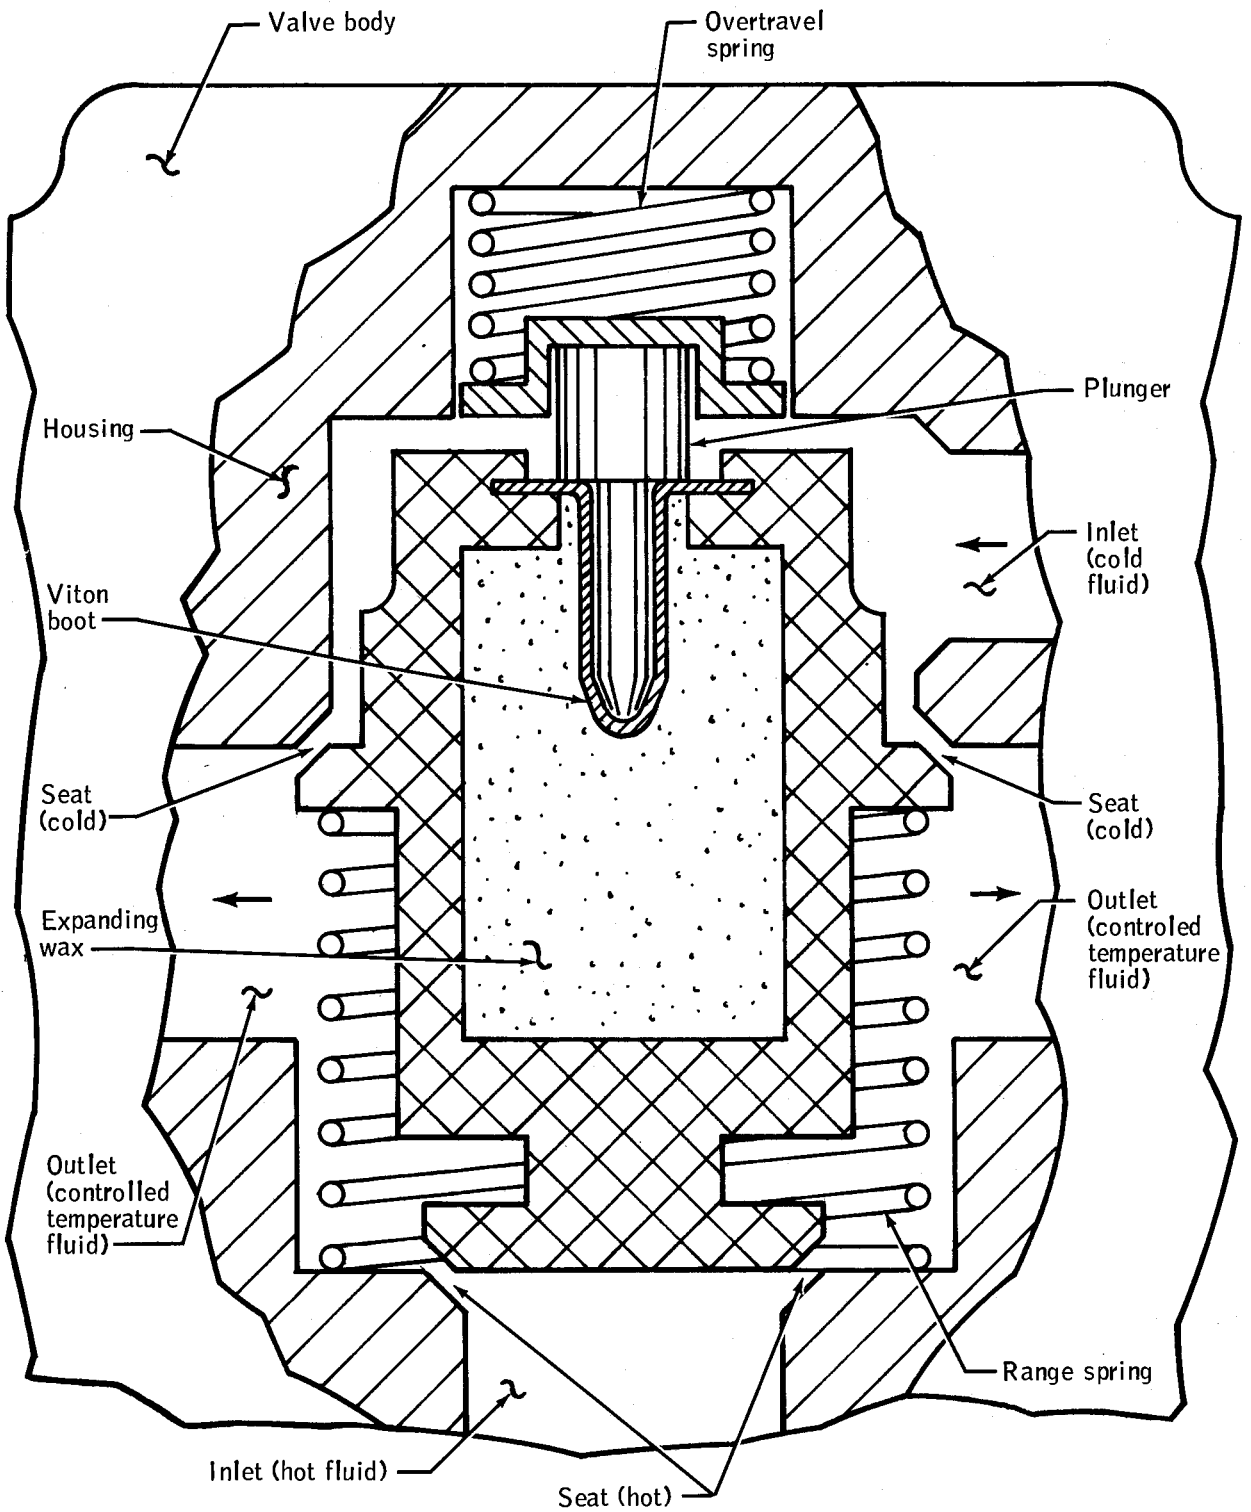
Figure 7-7.- Typical fuel cell thermal control valve (simplified).

The condenser exit temperature is controlled by selective mixing of hot and cold coolant by the condenser exit temperature control valve. The mix position of the valve (fig. 7-7) is directly controlled by the plunger and the sensor medium (expanding/contracting wax) assembly, which is mounted in the flow stream of the condenser exit line (fig. 7-8). The temperatures at the hot and cold inlets to the valve are controlled by the hot premixing valve and the cold premixing valve. An off-nominal condition in either of these three valves could result in abnormal condenser exit temperatures.
