# LONG-TERM CF6 ENGINE PERFORMANCE DETERIORATION - EVALUATION OF ENGINE S/N 451-479

W. H. Kramer and J. J. Smith

General Electric Company  
Aircraft Engine Group  
Cincinnati, Ohio 45215

Prepared for  
NATIONAL AERONAUTICS AND SPACE ADMINISTRATION  
Lewis Research Center  
Cleveland, Ohio 44135  
February 1978  
Contract NAS3-20631

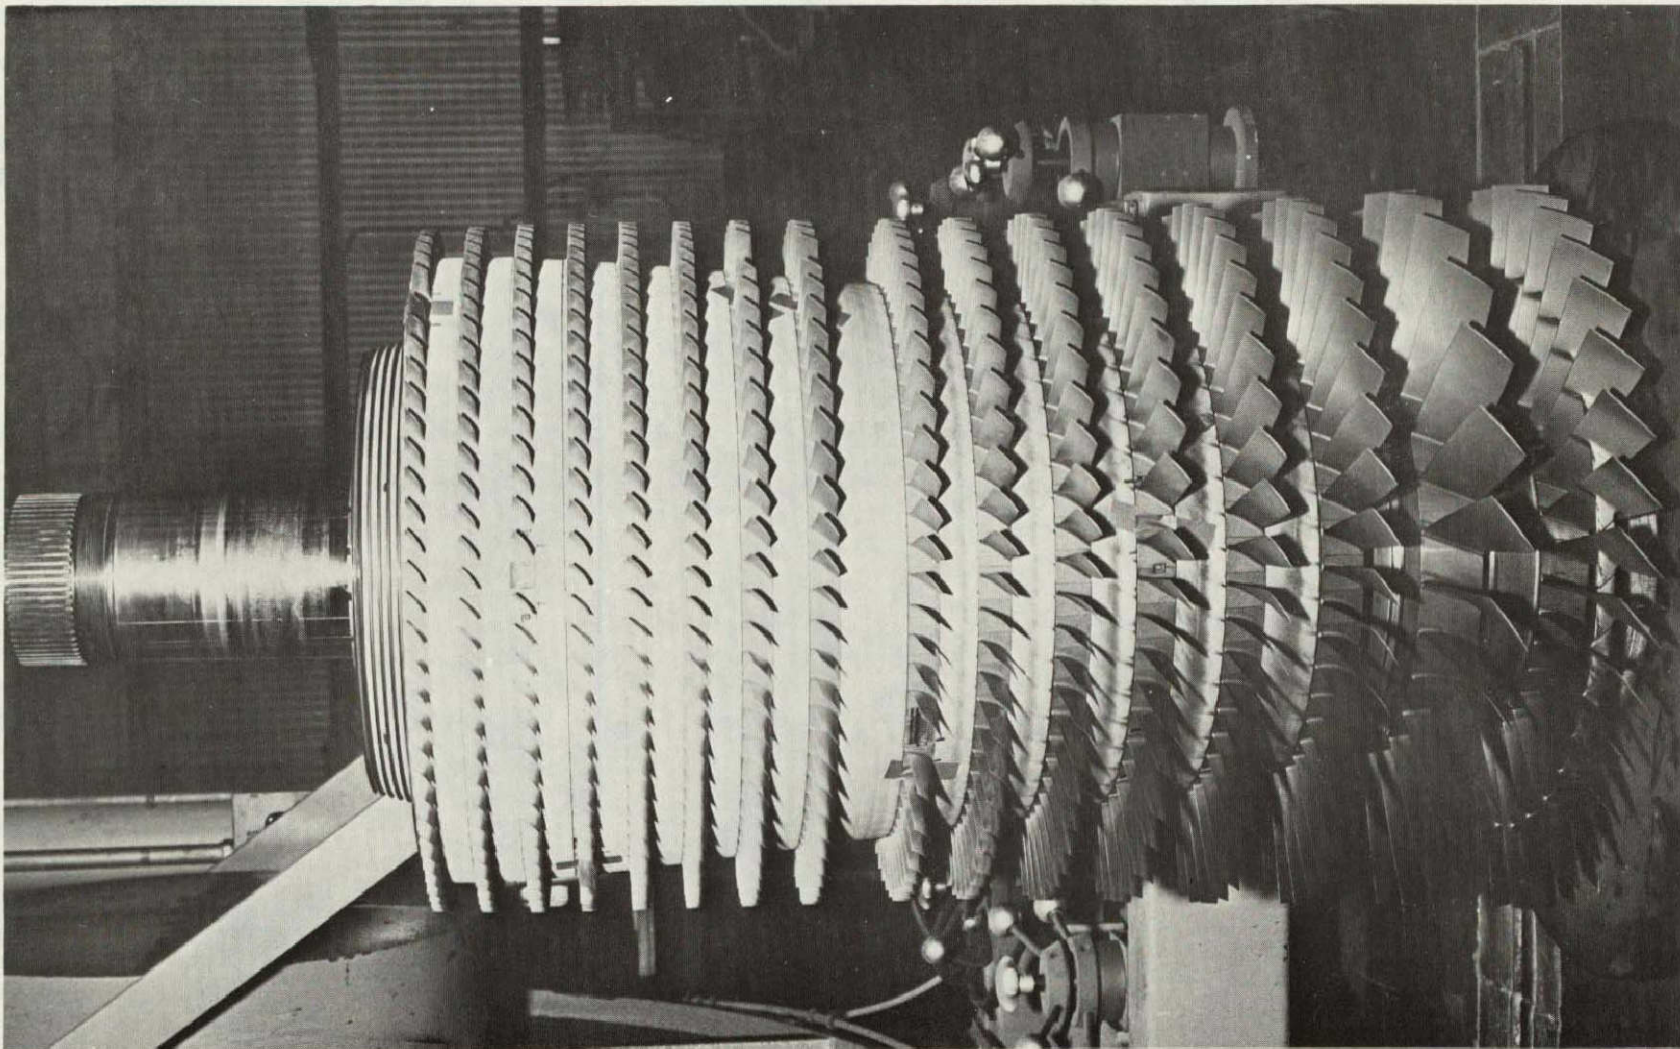
Figure 8-1. High Pressure Compressor Rotor (Cleaned), Missing Blades  
at Surface Finish Check.

Inspection of the HP compressor rotor revealed the spool and blades to be extremely dirty throughout, with a heavy deposit of oil mixed with the dirt in the forward end (through Stage 6). Some very mild aluminum splatter was noted on blades in Stages 12 and aft. A photograph of the rotor assembly was taken (Figure 8-1); however, it was not taken until after the rotor had been prematurely cleaned, erasing all evidence of the dirty condition.

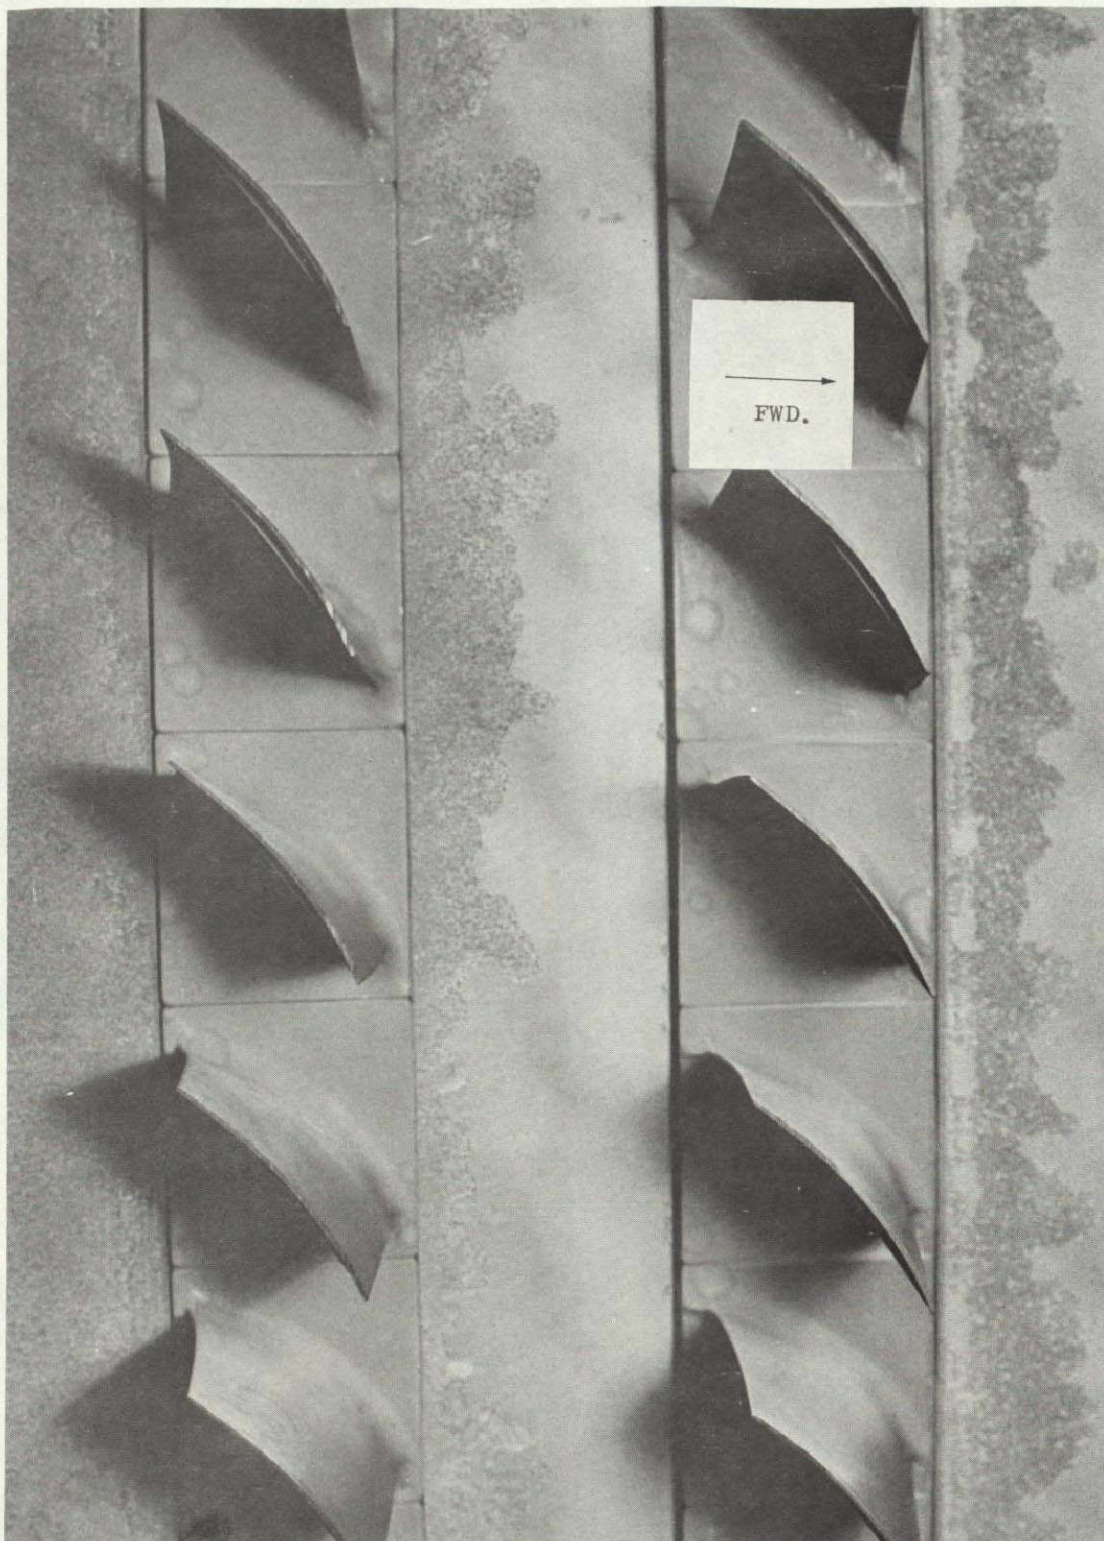
Figure 8-2. HP Compressor Rotor Stages 13 to 15 Land Coating.

The coating of the compressor rotor lands was inspected with the following discrepancies noted (Figure 8-2 in Appendix B):

| <u>Stage</u> | <u>Conditions</u> |
| 15 and 16 | 100% missing |
| 14 | 20/30% missing |
| 13 | 30/40% missing |

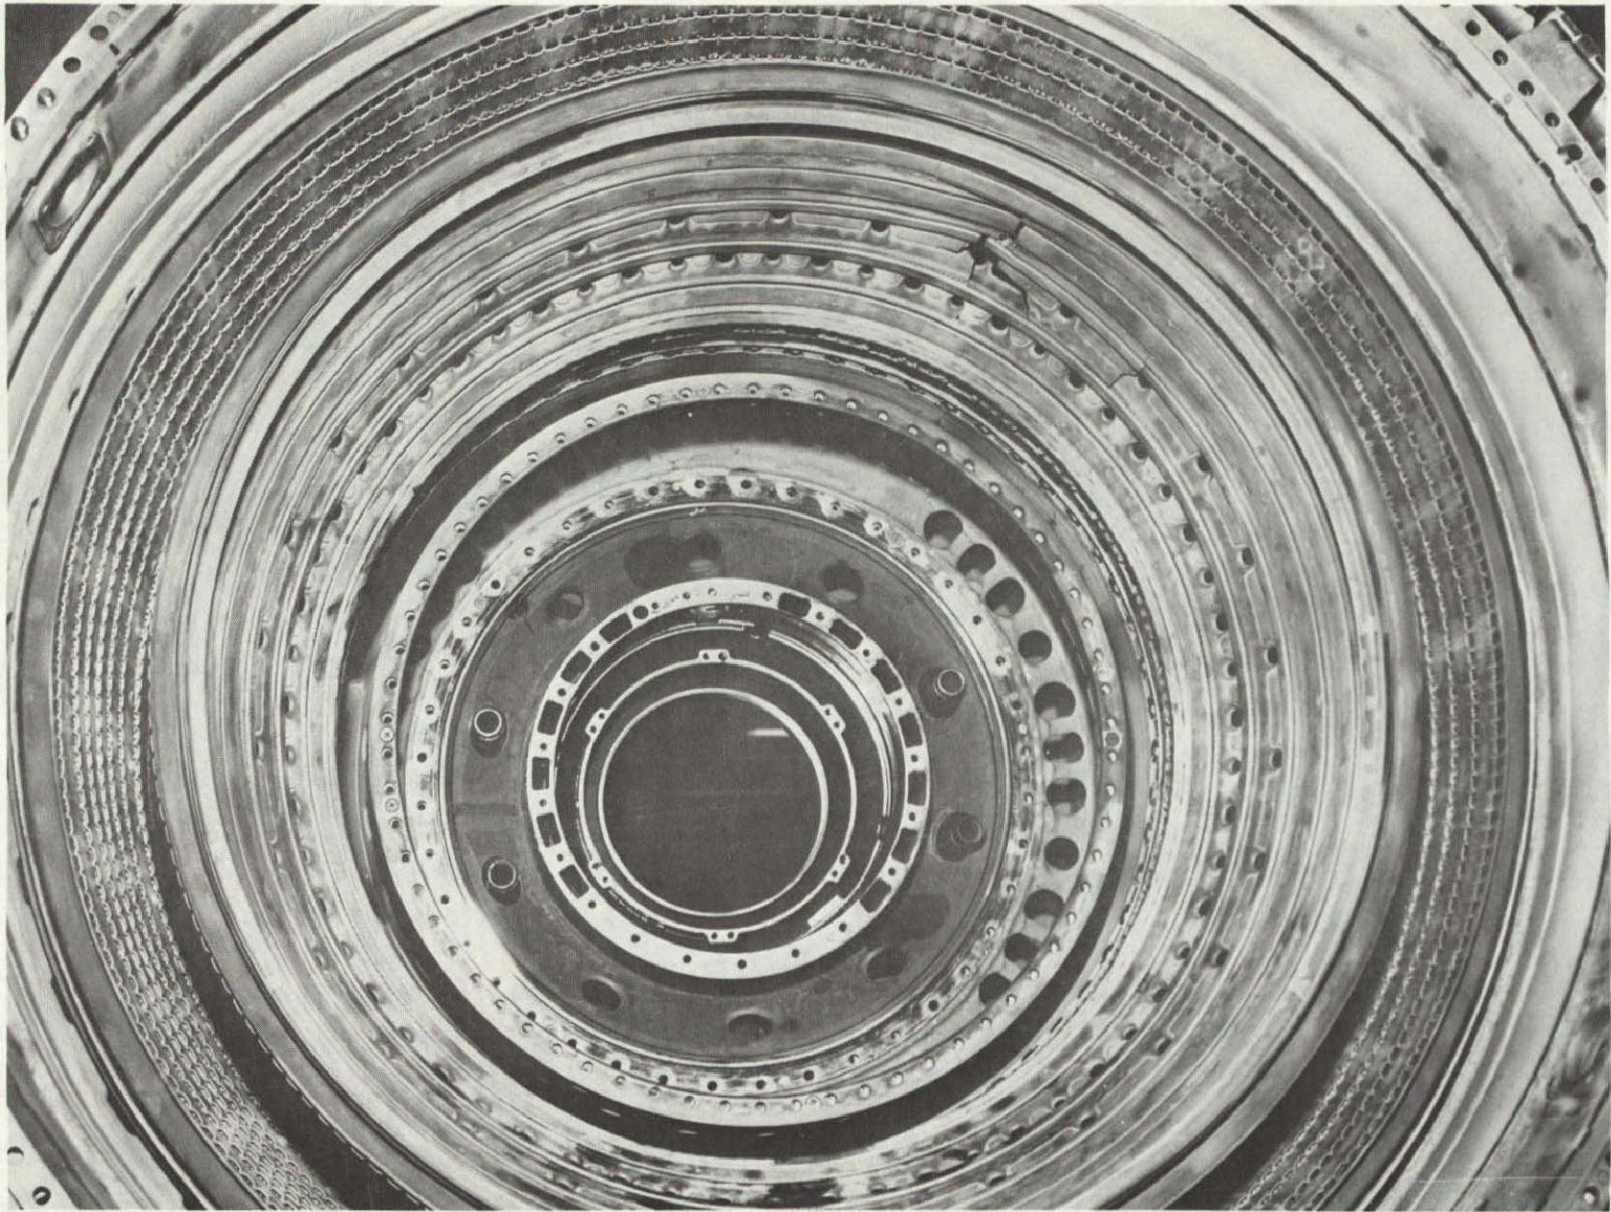
Figure 8-6. Combustor, Overall Cracks.

To expedite the work scope, the combustor was not removed from the rear frame, but rather visually inspected as installed. The combustor had its typical 1/4" to 1/2" cracks, inner and outer liners. The most noteworthy fault was the cracks originating at the inner liner's aft thimble louver at approximately the 7 o'clock location. This particular louver had cracked in four different directions of varying lengths (Figures 8-6 and 8-7 in Appendix B). The cracks were approximately 5/8", 1", and 2-1/2" in length and another about 2-1/4" long connecting with a 4-1/2" circumferential crack. The whole piece was bulged into the airstream approximately 5/8". There were six more of these thimble louvers with cracks ranging from 1/2" to 1-1/4" but these are considered insignificant with regard to performance.

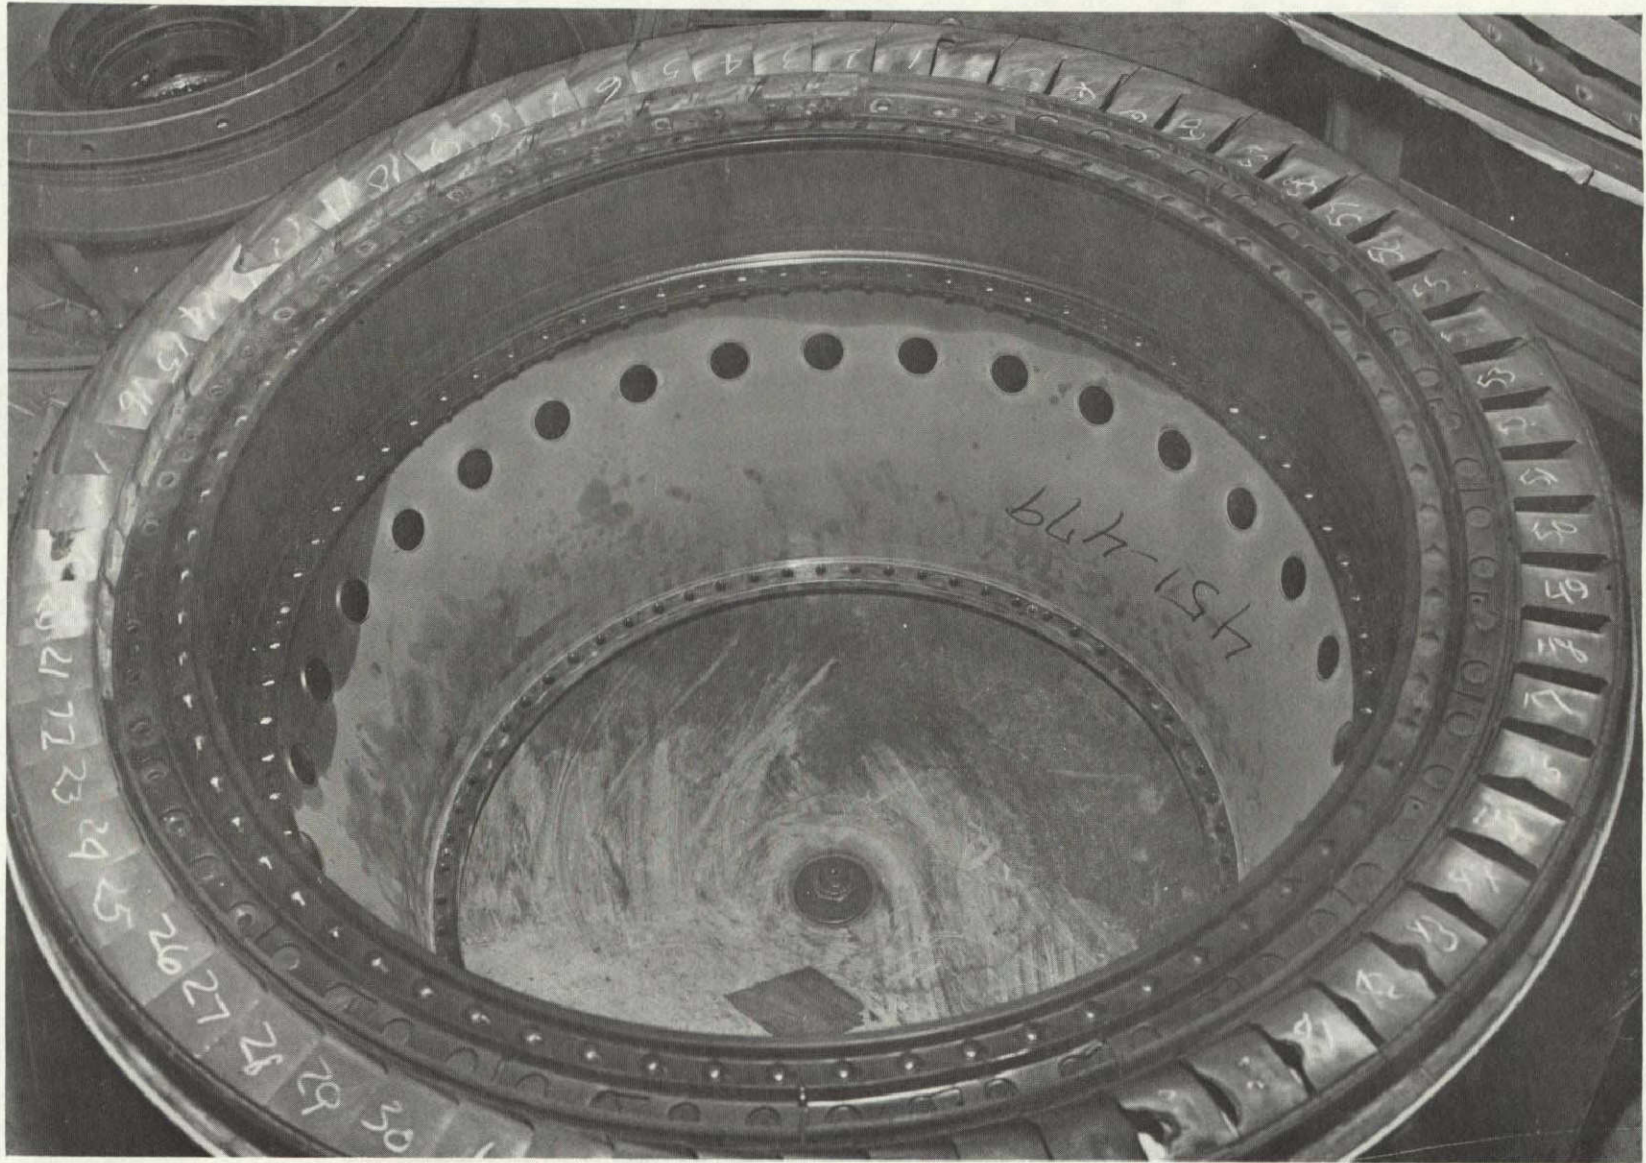
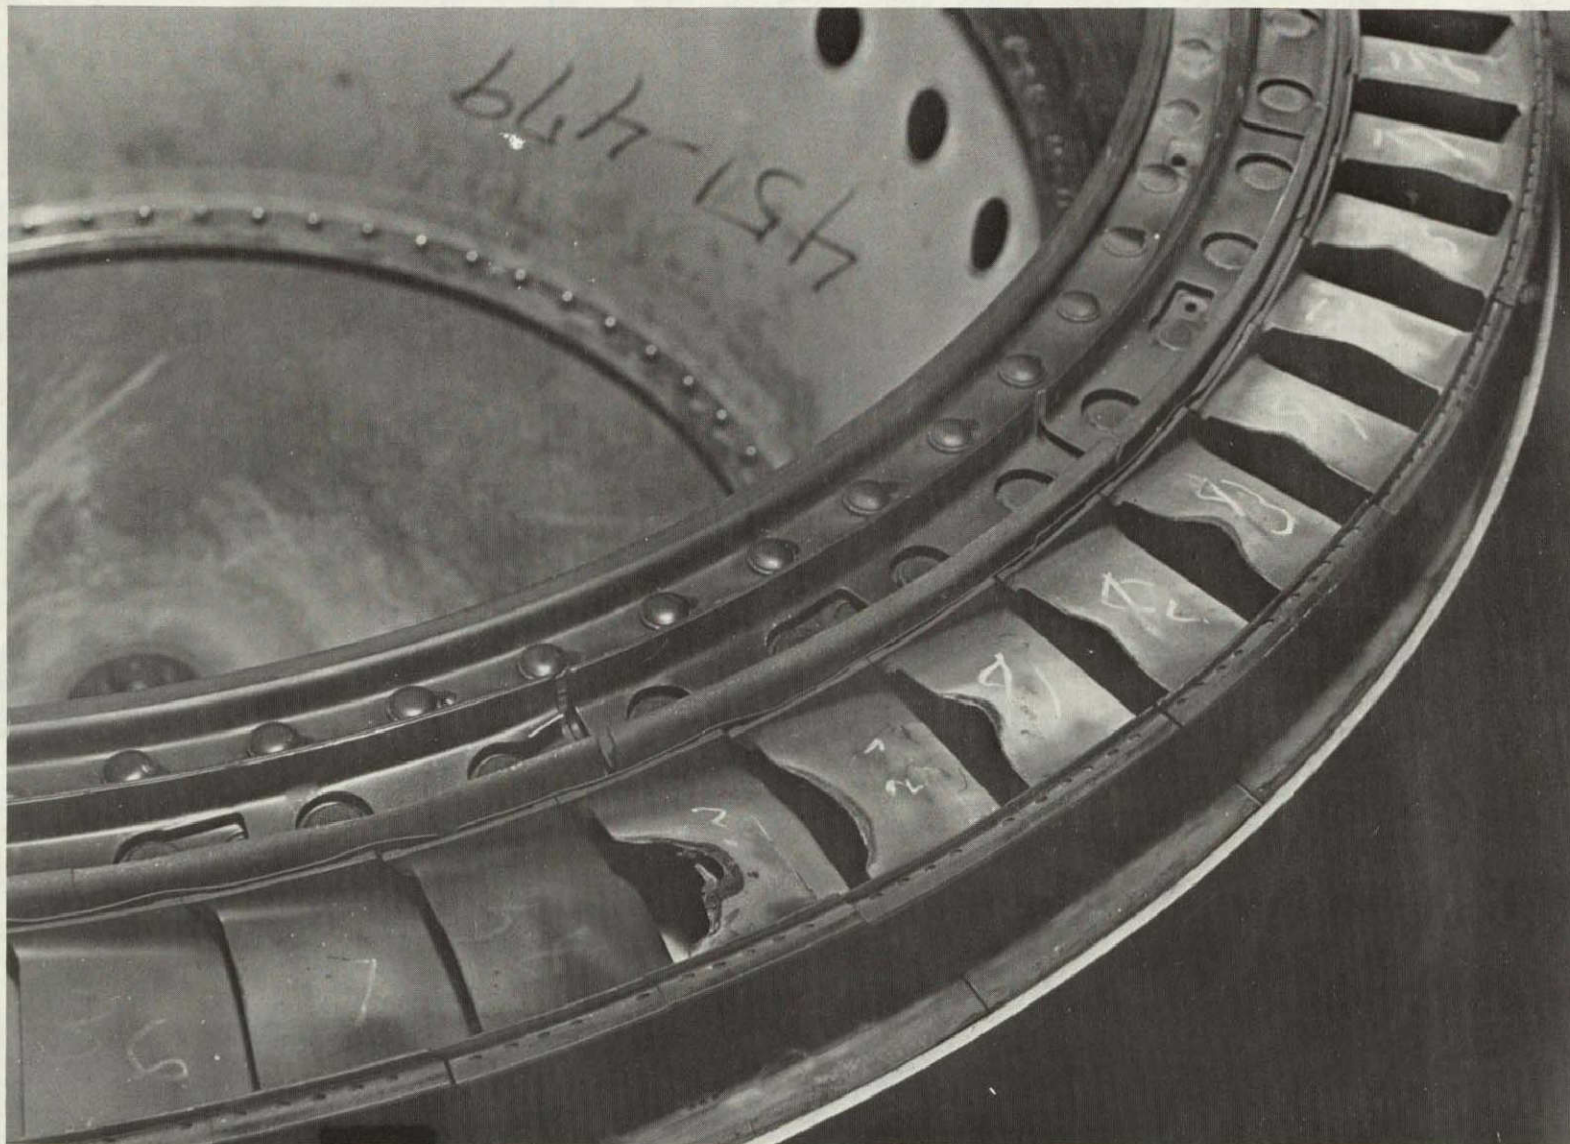
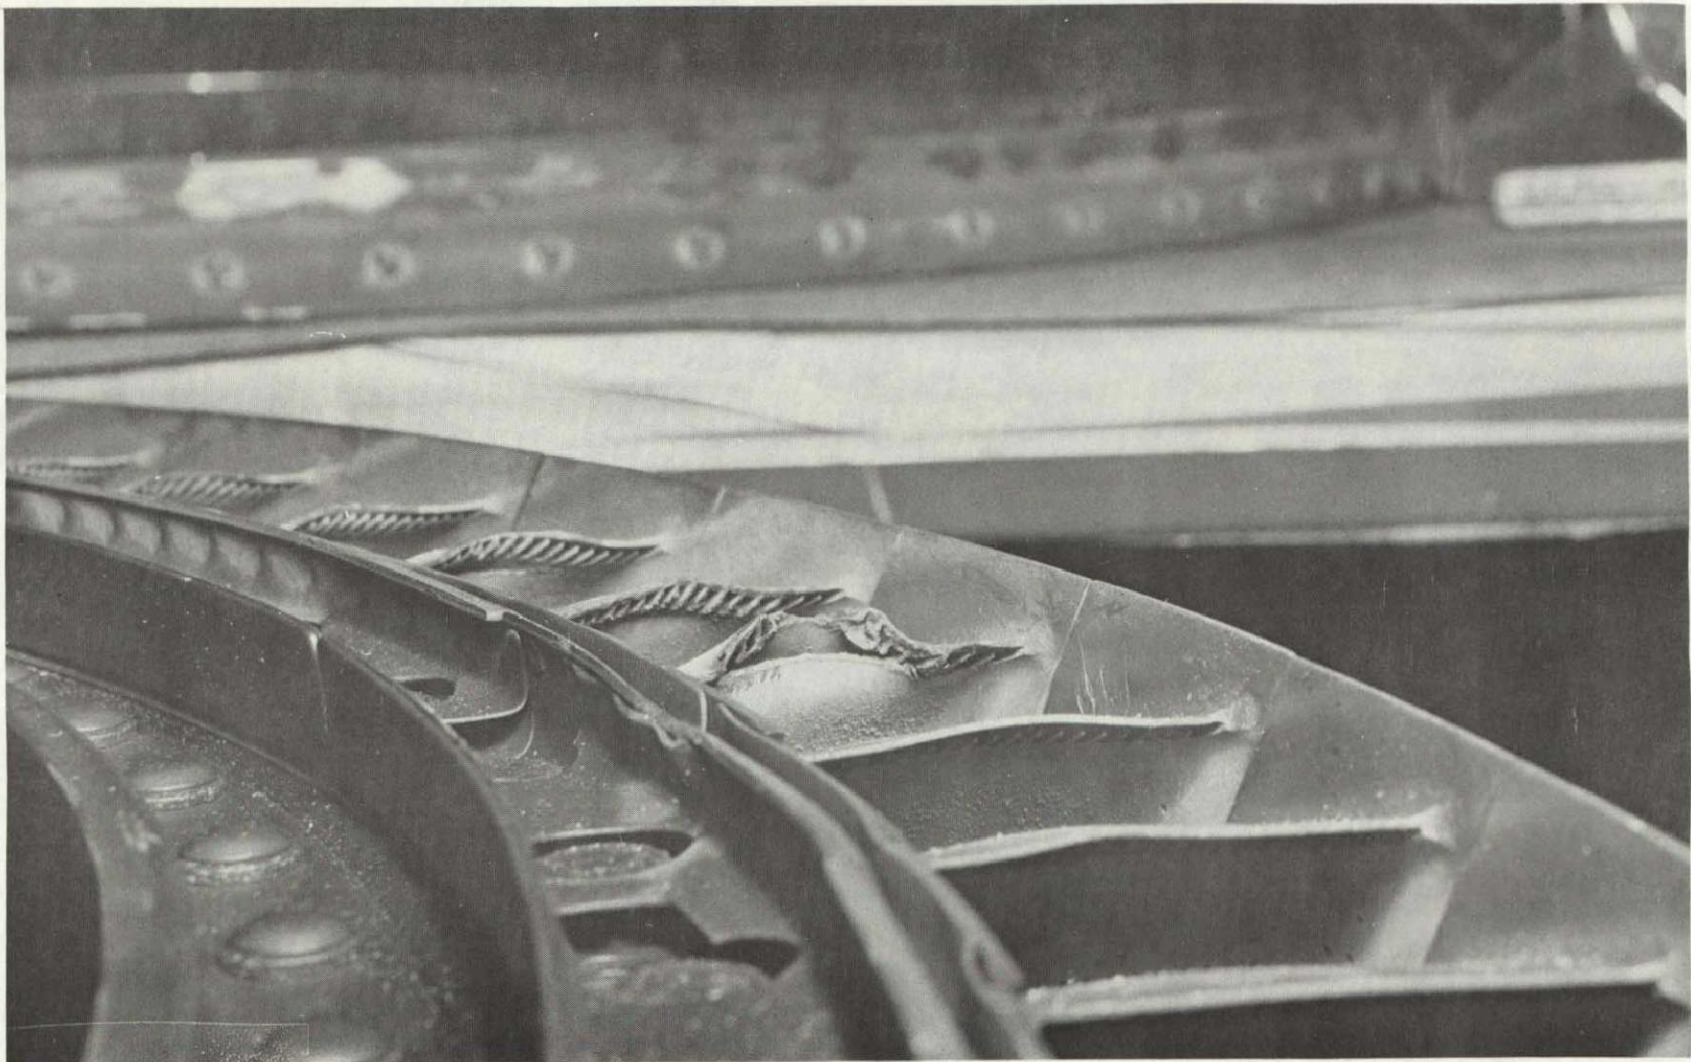
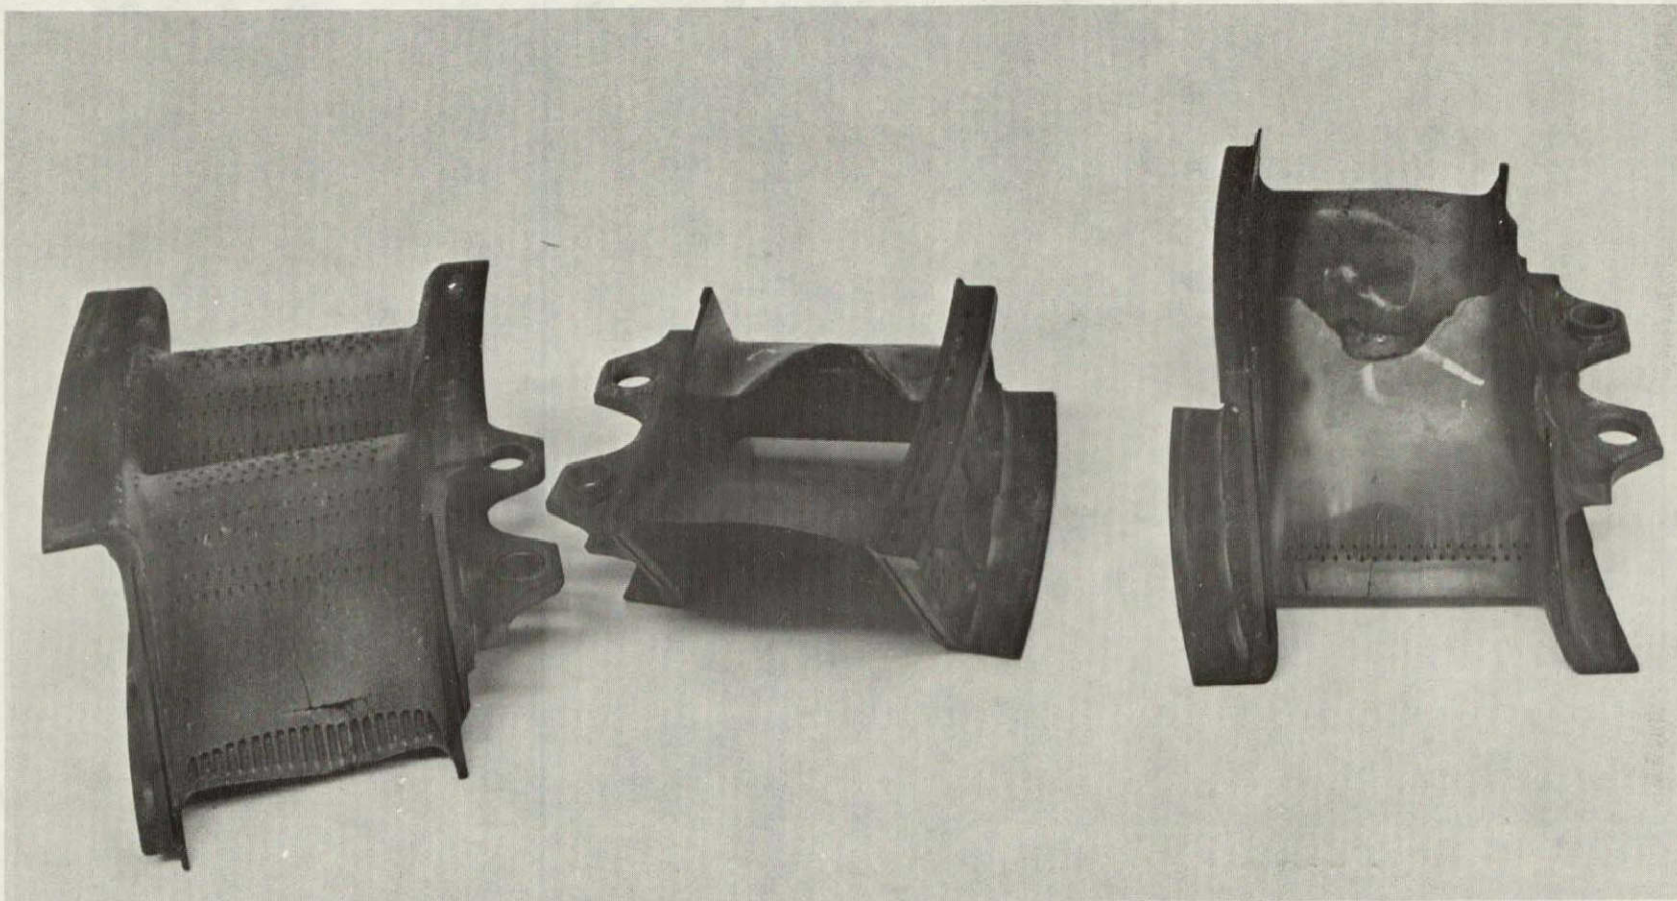
Visual inspection of the Stage 1 HPTN assembly revealed 13 vanes with some degree of burning on the trailing edge, while some 10 other vanes were bowed in the same area. (See photographs in Appendix B, Figures 8-10 through 8-13. Note that the position markings as viewed in the photographs are incorrect. Per B/P, the vane marked No. 18 is really Vane No. 1. From that point, the vanes should be marked in clockwise order. For orientation purposes, all references to vane position numbers in this report are per the actual position and not as depicted in the pictures.) As can be seen in the photographs, all vane distress emanated approximately from the center of the airfoils at the trailing edge, and continued radially outward and inward about the same amount for each particular vane.

All of the vanes that experienced the burning/distortion showed radial cracks of varying lengths on the concave side, depending on the severity of the distress. These cracks were located  $3/8$ " to  $1/2$ " forward of the trailing edge.

Figure 8-11. Stage 1 HP Turbine Nozzle Assembly, Trailing Edge, Burnt/Distorted Vanes.

Figure 8-12. Stage 1 HP Turbine Nozzle Assembly Distress, Aft End.

Figure 8-13. Stage 1 HP Turbine Nozzle, Typical Vane Distress.

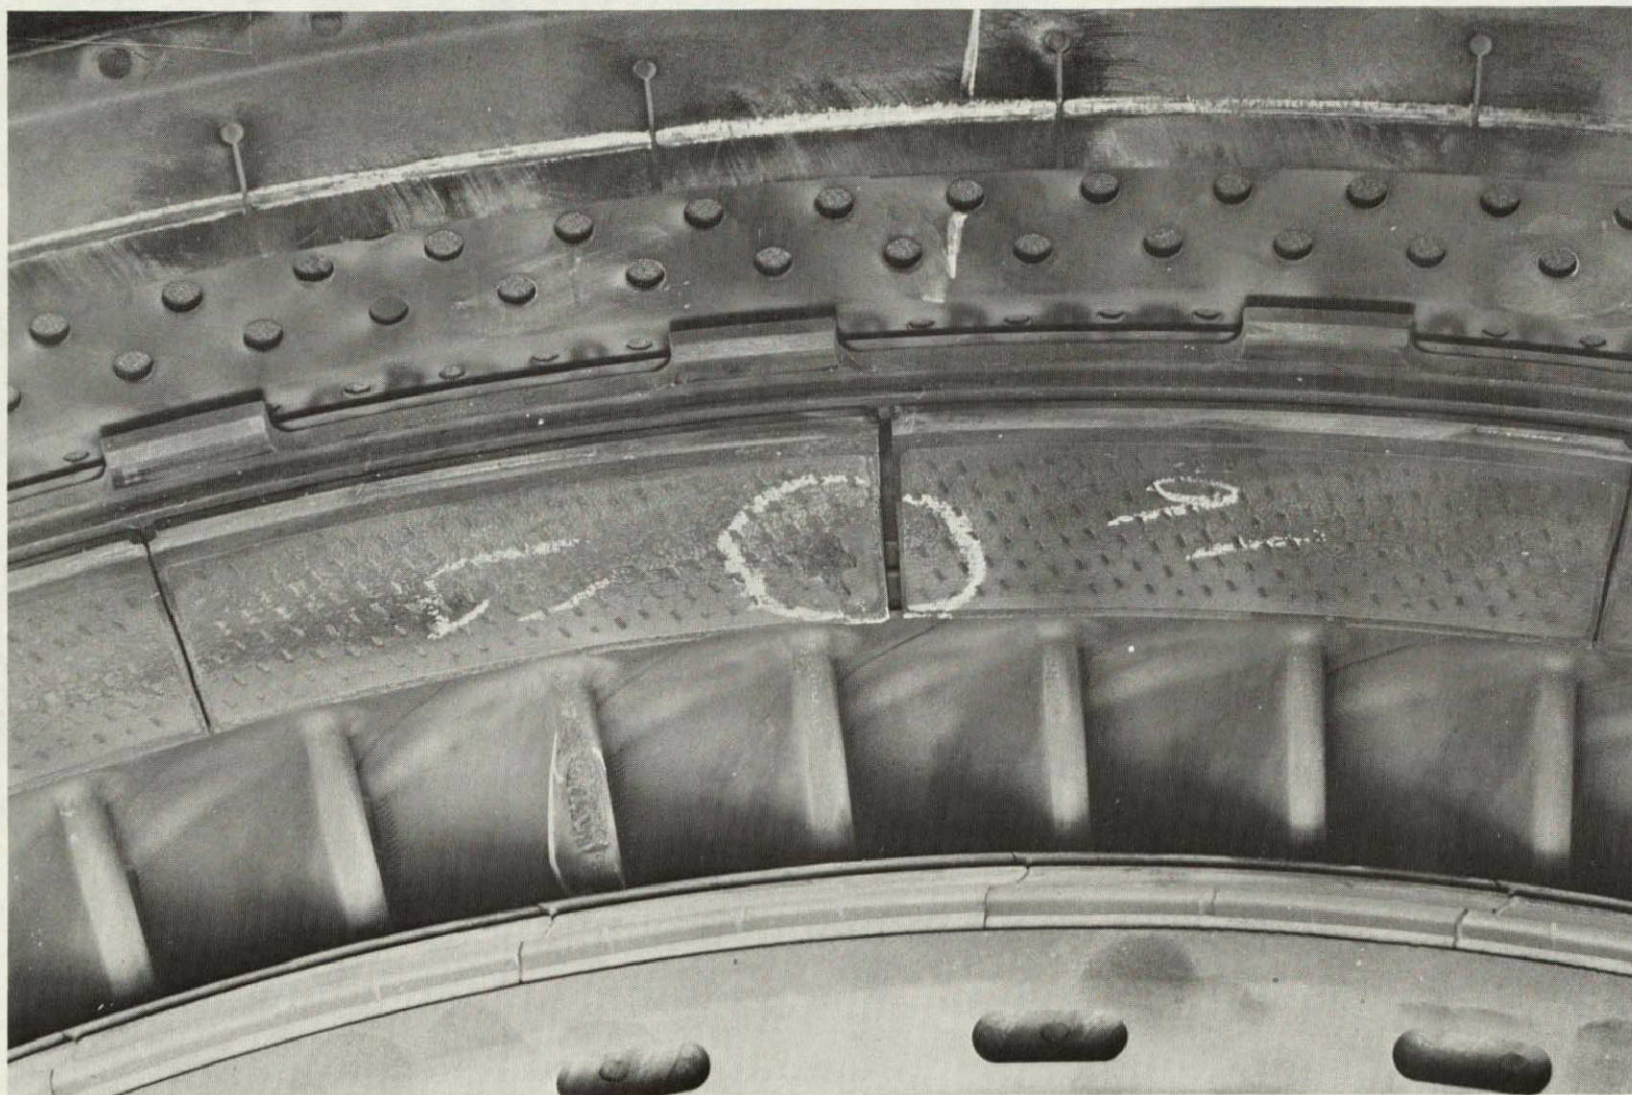
Figure 8-15 . Stage 2 HP Turbine Nozzle, Damage Vane/Stage 1 Shroud.

The Stage 1 shrouds were very rough and eroded/oxidized. One shroud (No. 17) had an irregular shaped piece missing, approximately 1" x 1-1/2" (see photograph in Appendix B, Figure 8-15). This was the only missing section.

The vanes were in excellent condition with no burning noted on any of them. One vane, immediately behind Stage 1 Shroud No. 17, did show some type of impact damage in the center third of the leading edge (see photograph,

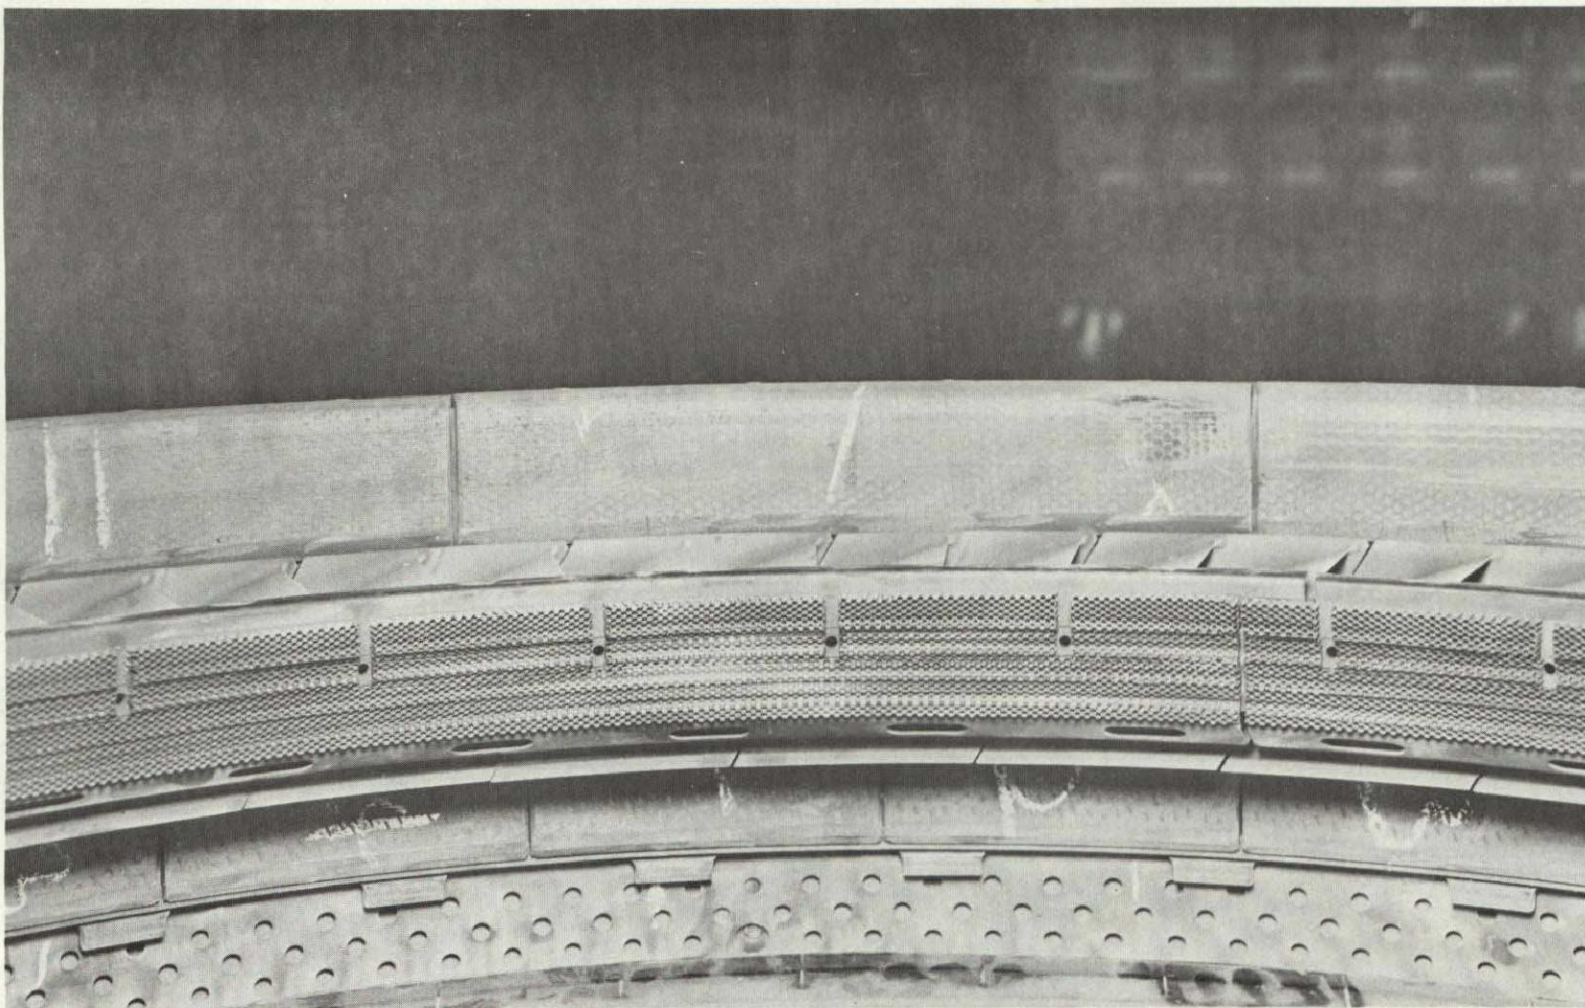
Figure 8-16. Stage 2 HP Turbine Nozzle Stage 2 Shroud Rub.

The Stage 2 shrouds had light erosion/oxidation, with no missing pieces. All shrouds were heavily rubbed, with a more recent rub, approximately 1" x 1-1/2", noted on shroud No. 1 (see photograph, Figure 8-16, in Appendix B).

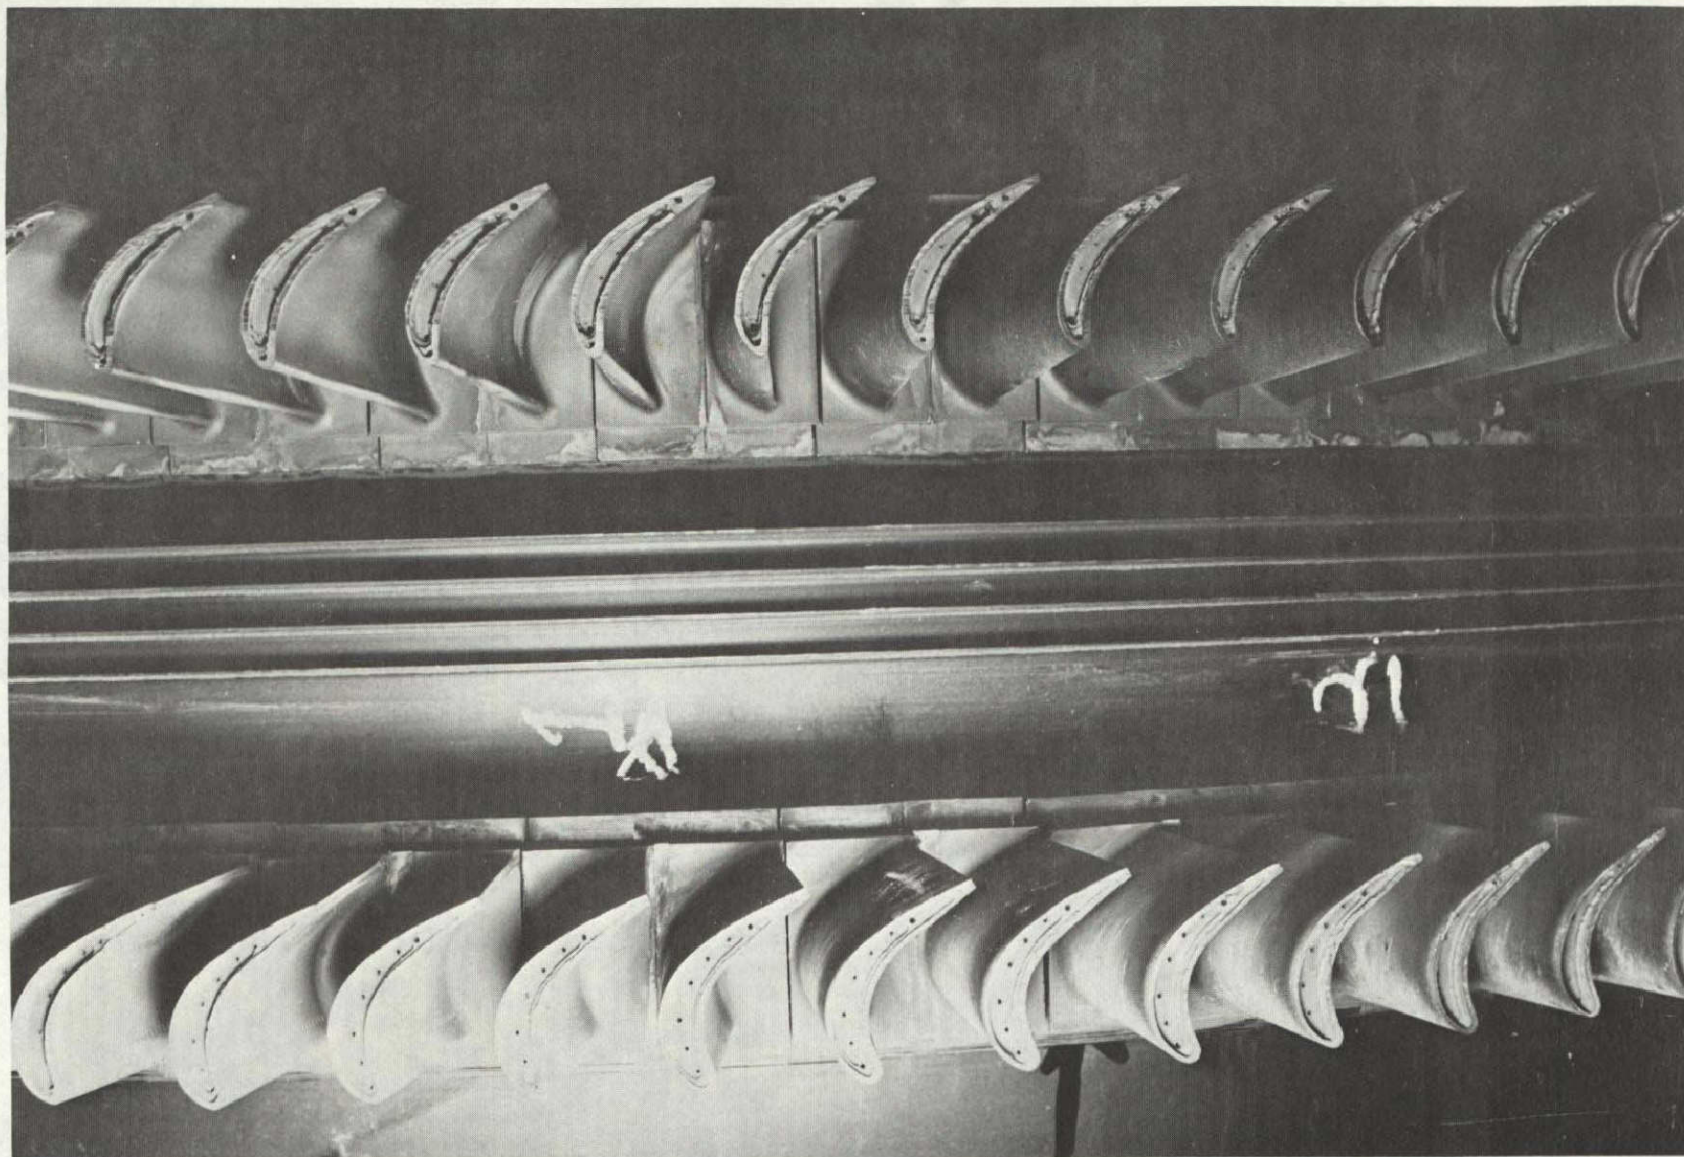
Figure 8-18. HP Turbine Rotor, Blade Tip Rubs.

An overall visual inspection of the HTPR assembly showed it to be in good condition. No discrepancies were noted in any of the spool parts (disks, shafts, seals, etc.). There appeared to be a heavy Stage 2 blade-to-shroud rub, as evidenced by the discoloration at the tips of all blades, accompanied by tip burrs the full blade width. Except for the slight deposit buildup at the leading edge, convex side, the Stage 2 airfoils were smooth.

Stage 1 blades also exhibited some rubbing, but not as much as Stage 2; no burrs were noted on the blade tips. The typical heavy deposits and roughness were seen on the concave surface of the airfoil, with the convex side being smooth.

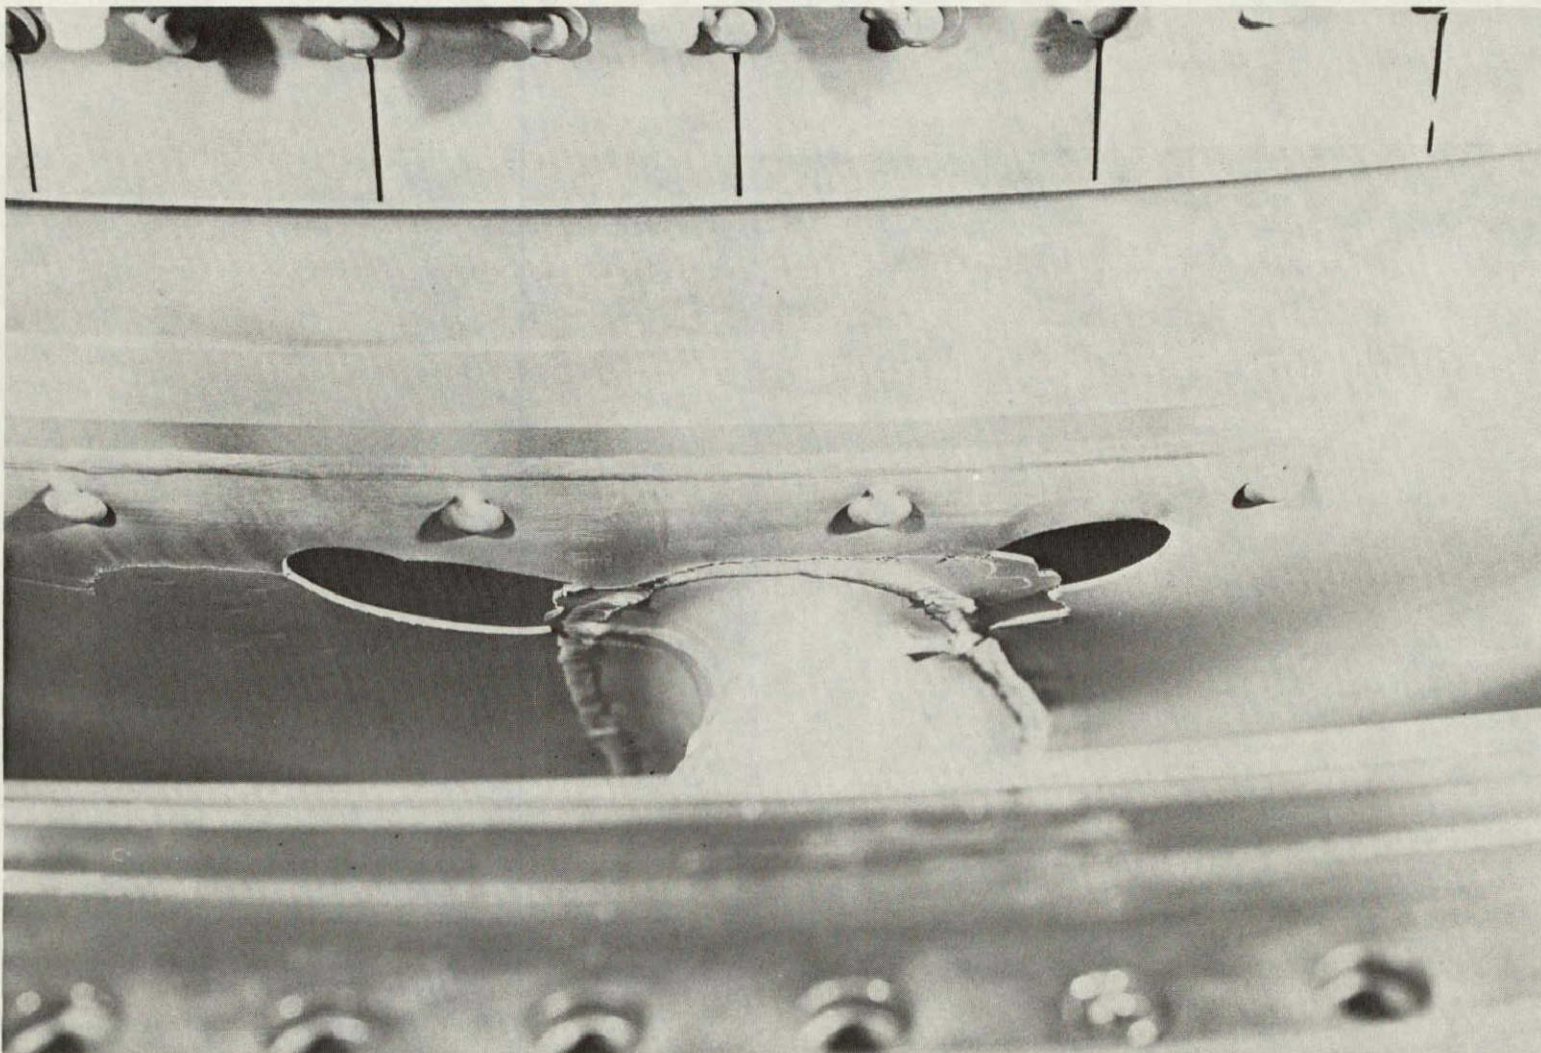
Figure 8-19. Turbine Mid Frame Liner Distress.

Visual inspection of the turbine midframe revealed two holes (3/4" dia. and approximately 1" x 2-1/2") in the inner liner aft of Strut No. 2; one hole on each side of the strut (see photograph, Figure 8-18 in Appendix B). Aft of Strut No. 2, there was a 4" circumferential crack in the liner, and another circumferential crack approximately 9" long was observed in the liner

After removal of the LPT module during the core analytical teardown, the TMF liner was visually inspected, as viewed from the forward end, and no further crack progression was noted. It was noted during this inspection that the buckling of the liner had caused one EGT T/C probe aspirator hole to be immersed in the cooler TMF liner cavity. Another was partially immersed. Possibly this could have been the reason for the inconsistent EGT indicated readings, recorded during the several tests conducted.

No attempt was made to repair or to replace any of the discrepant parts. Any change of hardware at this time could have clouded any subsequent data taken to analyze the LP system per the test plan.

It was the consensus of opinion that none of the noted faults were serious enough to imperil the engine during the remaining planned tests. Therefore, after all the inspection checks were complete, the TMF was re-assembled to the package together with all the original hardware "as is." The test program was completed without incident.

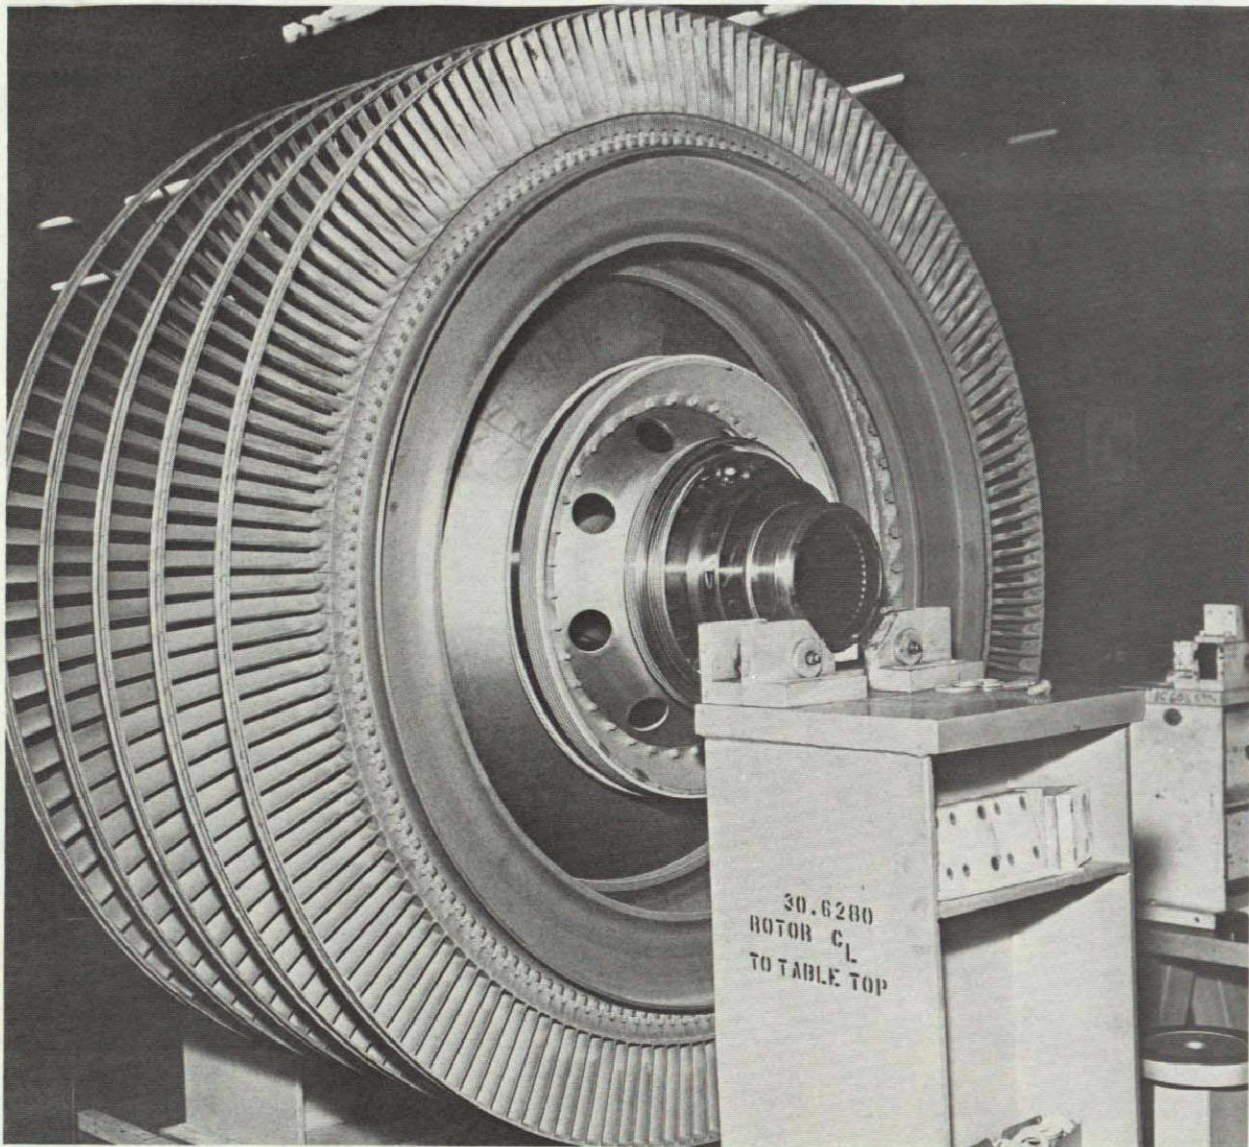
Figure 8-22. LP Turbine Rotor, Overall View.

A visual inspection of the LPT rotor assembly showed it to be in excellent condition. No discrepancies were observed on any of the spool parts. Blades were rough and dirty, typical of blades which have this amount of running time. A photograph of the rotor assembly can be found in Appendix B, Figure 8-22, showing it mounted in the lathe bed for the inspection checks.
