# LONG-TERM CF6 ENGINE PERFORMANCE DETERIORATION - EVALUATION OF ENGINE S/N 451-479

W. H. Kramer and J. J. Smith

General Electric Company  
Aircraft Engine Group  
Cincinnati, Ohio 45215

Prepared for  
NATIONAL AERONAUTICS AND SPACE ADMINISTRATION  
Lewis Research Center  
Cleveland, Ohio 44135  
February 1978  
Contract NAS3-20631

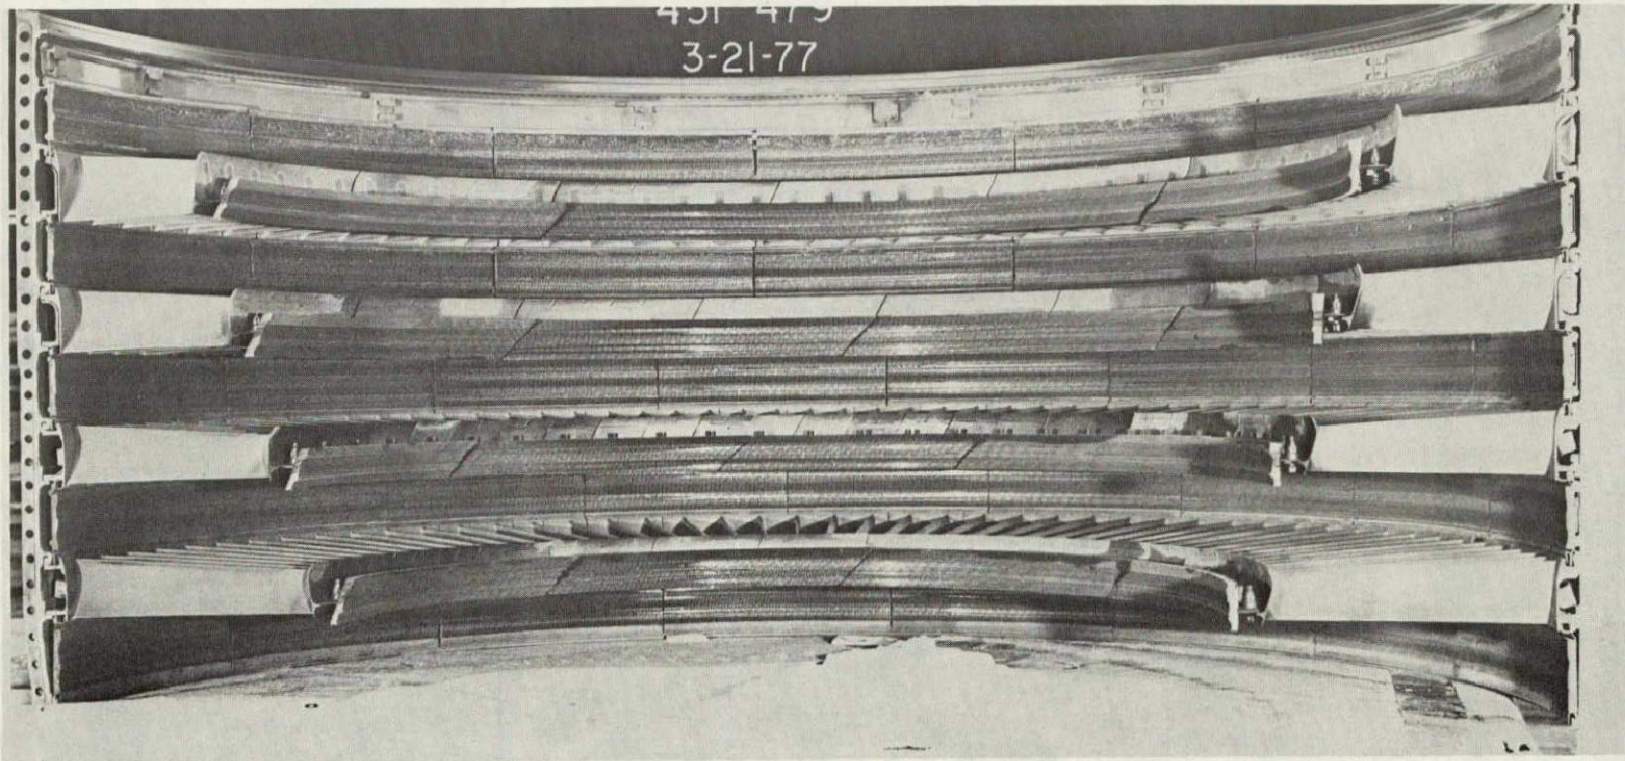
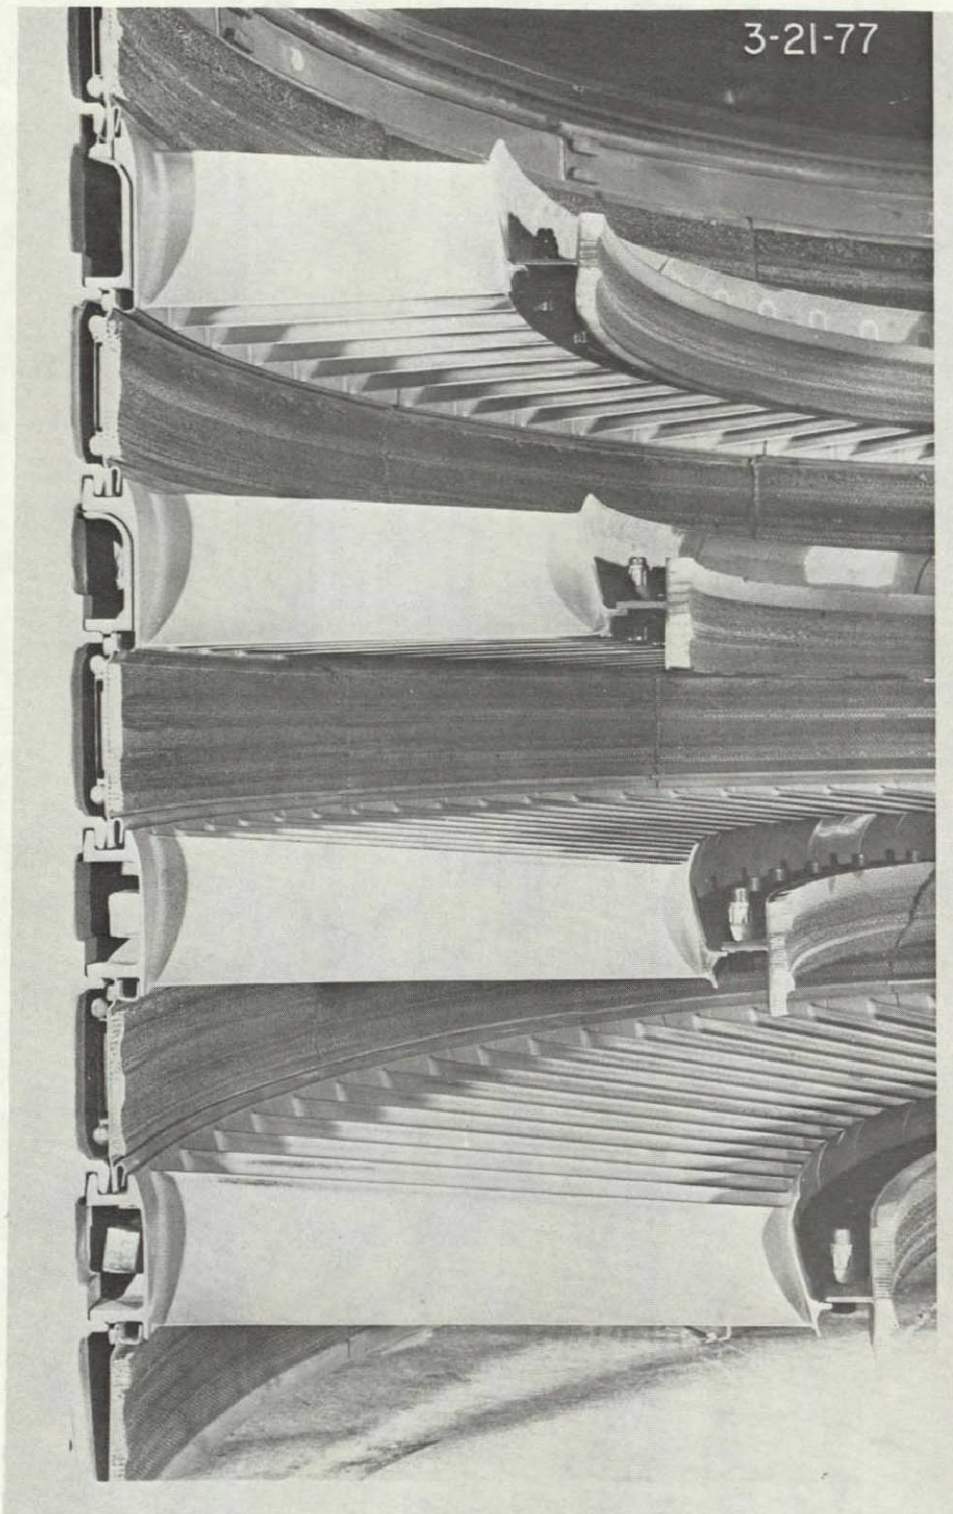
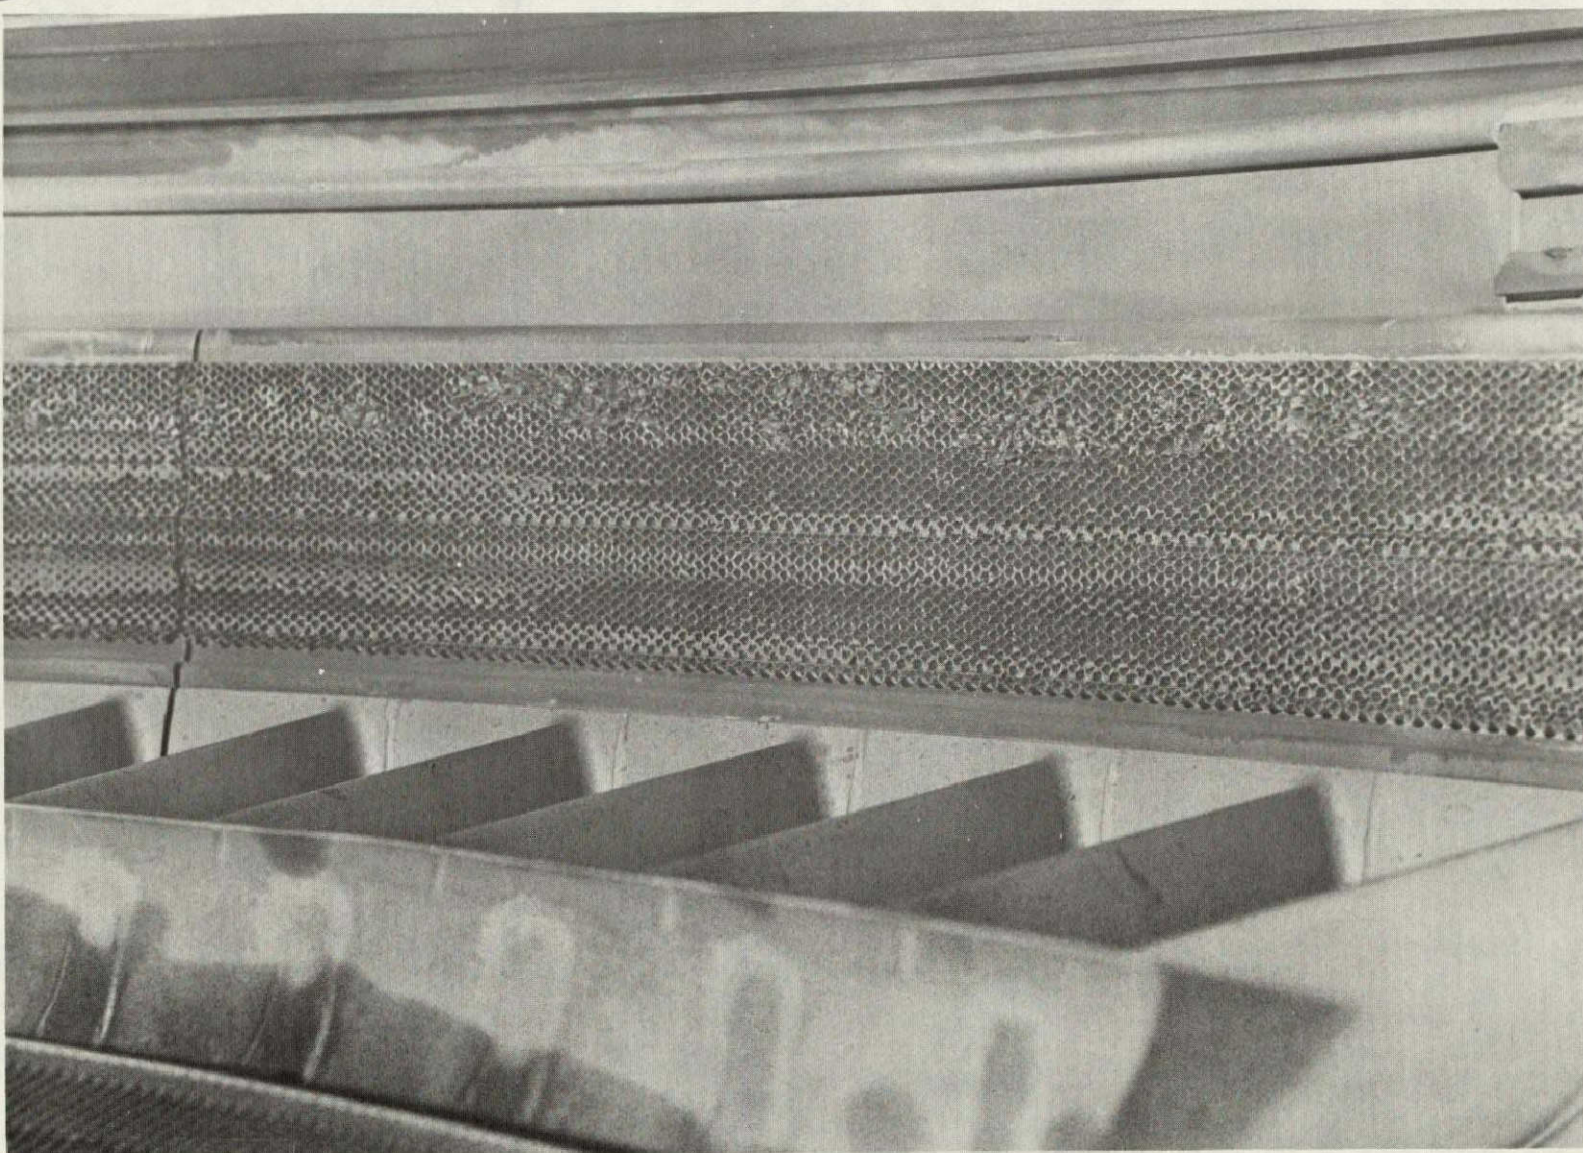
Visual inspection of the LP turbine stator assembly showed it to be in good condition. Rub patterns on the shrouds and seals were typical of those observed in the past. (See photographs in Appendix B, Figures 8-23, 8-24, and 8-25.) Casteone impressions were made of the maximum depth rub pattern visually observed in each casing half for all shrouds and interstage seals. A sketch of each of these is shown in Figure 6-1.

Figure 8-24. LP Turbine Stator Assembly, End View of Shroud and Seal Rubs.

Figure 8-25. LP Turbine Stator Assembly, Stage 1 Shroud Rub Pattern.

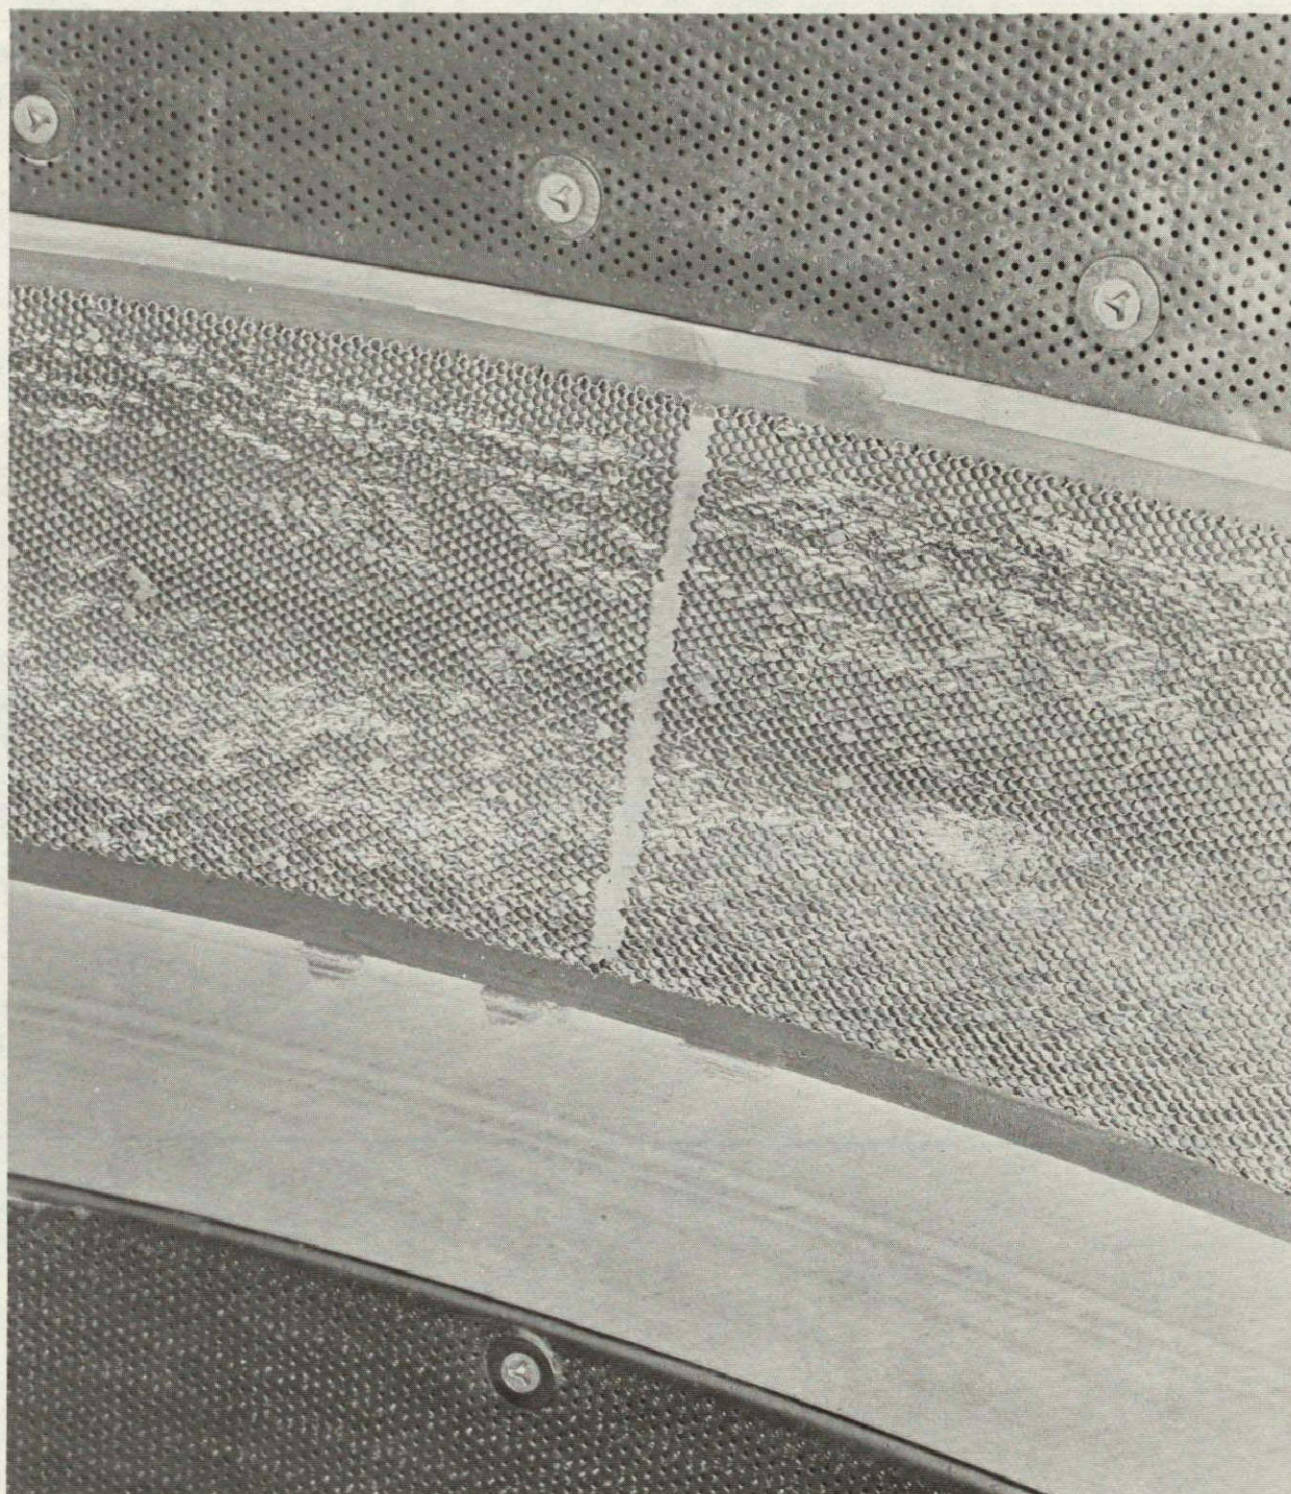
Figure 8-27. Stage 1 Fan Shroud Ice Damage.

The Stage 1 open faced, aluminum honeycomb shroud exhibited typical ice damage. There were approximately 30 pock marks distributed through the full 360° circumference and located in the path of the blades. The typical size indentation was approximately 3/8" x 1-1/2", with the honeycomb mashed to a depth of 0.050"/0.080". In addition, there were many superficial markings the full width and circumference of the shroud. See photograph, Figure 8-27 in Appendix B, which shows a typical section of the damaged shroud.

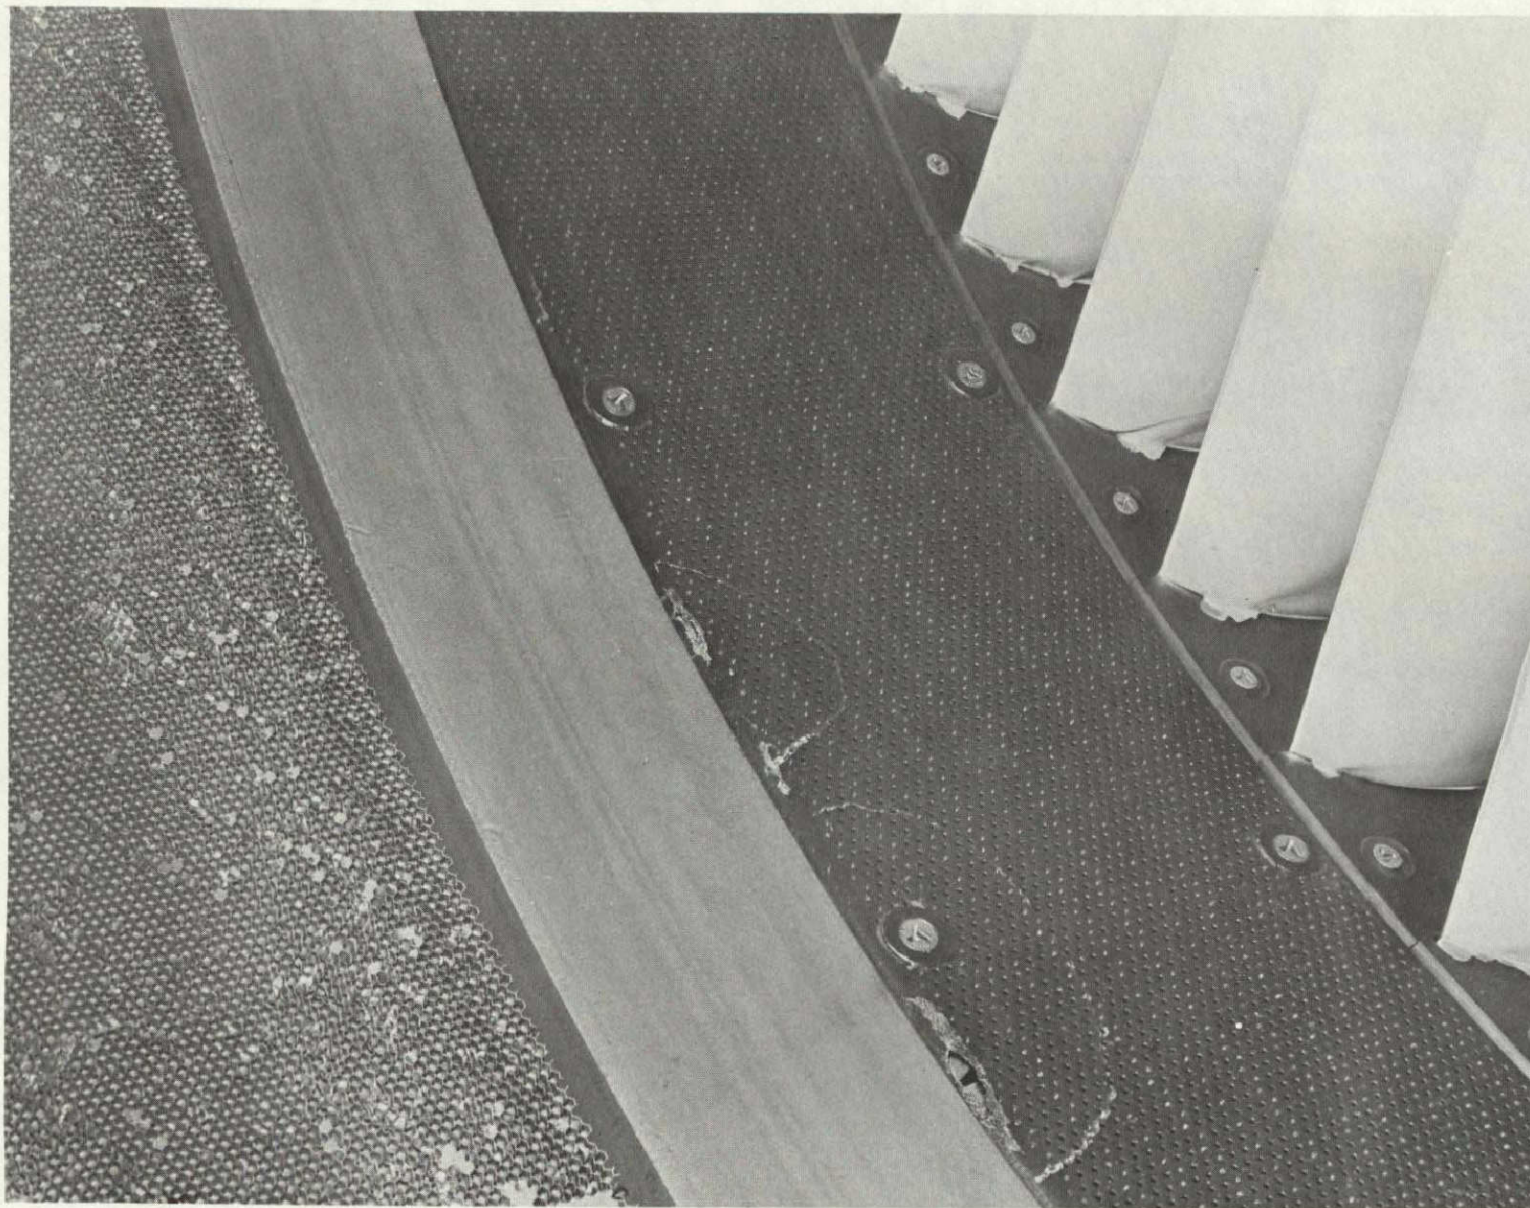
Figure 8-28 . Fan Stator Aft Liner Ice Damage.

Stage 1 fan blade OGV's also were in excellent condition. There was some slight damage on the leading edge of the aft stator case linings. This too can be attributed to ice damage. A photograph showing the worst observed damage can be found in Appendix B, Figure 8-28.
