# DOE/NASA TECHNICAL MEMORANDUM

DOE/NASA TM-78163

## OWENS-ILLINOIS LIQUID SOLAR COLLECTOR MATERIALS ASSESSMENT

By R. L. Nichols  
Materials and Processes Laboratory

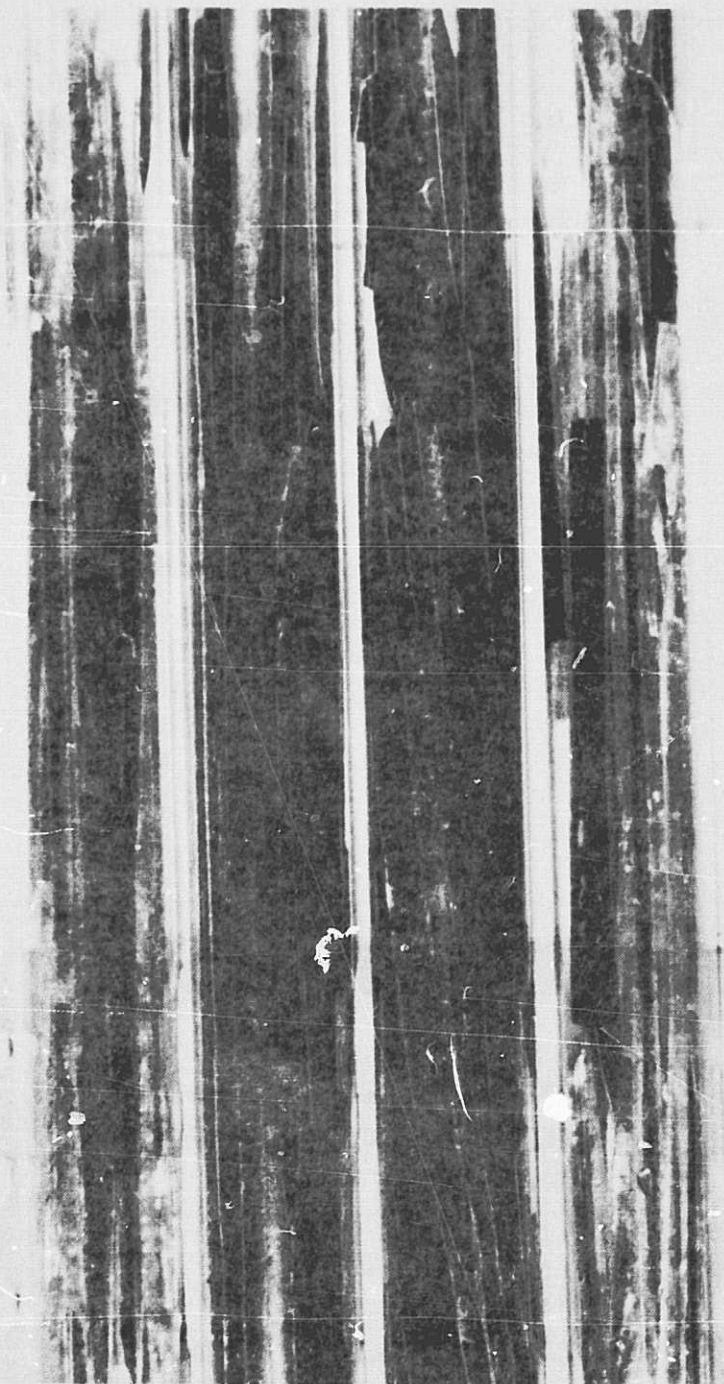
Figure 4. Typical fracture pattern.

The fracture initiation site on any fractured glass appears as a straight, mirror surface surrounded by a distinct, gray-colored area, termed the stippled area. The fracture will then branch and propagate in both axial directions, creating long spiraling slivers of glass. These slivers typically point to the initiation surface. Figure 4 shows a typical fracture pattern created by pressurization of a tube.

Fracture studies of the complete collector tubes which broke during proof testing consistently indicated that the fracture initiated at a defect or scratch on the internal surface of the absorber tube. These defects are attributed to scratches and checks generated during manufacturing and inspection processes. Similar studies on the bare absorber tubes, which were pressure tested to failure, show that the fracture initiation site was consistently on the outside surface of the tube and that, again, an observable defect such as a scratch or check was present at the initiation site.

939-1	937-1	935-1	937-2
415 psi	430 psi	500 psi	305 psi
TOP			BOTTOM

In the case of the bare absorber tubes tested to failure, the fact that these tubes were not subjected to the normal measuring, inspection, and fabrication processes of collector tube manufacture undoubtedly accounts for all initiation sites appearing on the external surface (i. e., the internal surface has not been rubbed or scratched by any jigs or fixtures while the external surface has been subjected to some abuse, producing the scratches, checks, or rubs that are failure initiation sites). In testing complete collector tubes to failure, potential initiation sites on the exterior surface of the absorber tube are inhibited from slow flaw growth to failure by the vacuum in the annular gap between tubes. This moves the initiation site to the interior surface of the absorber tube because the water hydrotest fluid causes the stress corrosion induced slow flaw growth, entirely consistent with the experimental results of flaw growth studies.<sup>1</sup> It is also indicated that the magnitude of the flaws produced on the interior surface of the absorber tube during collector tube manufacture is similar to those on the exterior of the tube. Thus, minimizing the production of these defects on the internal surface would reduce the losses during proof pressure testing.

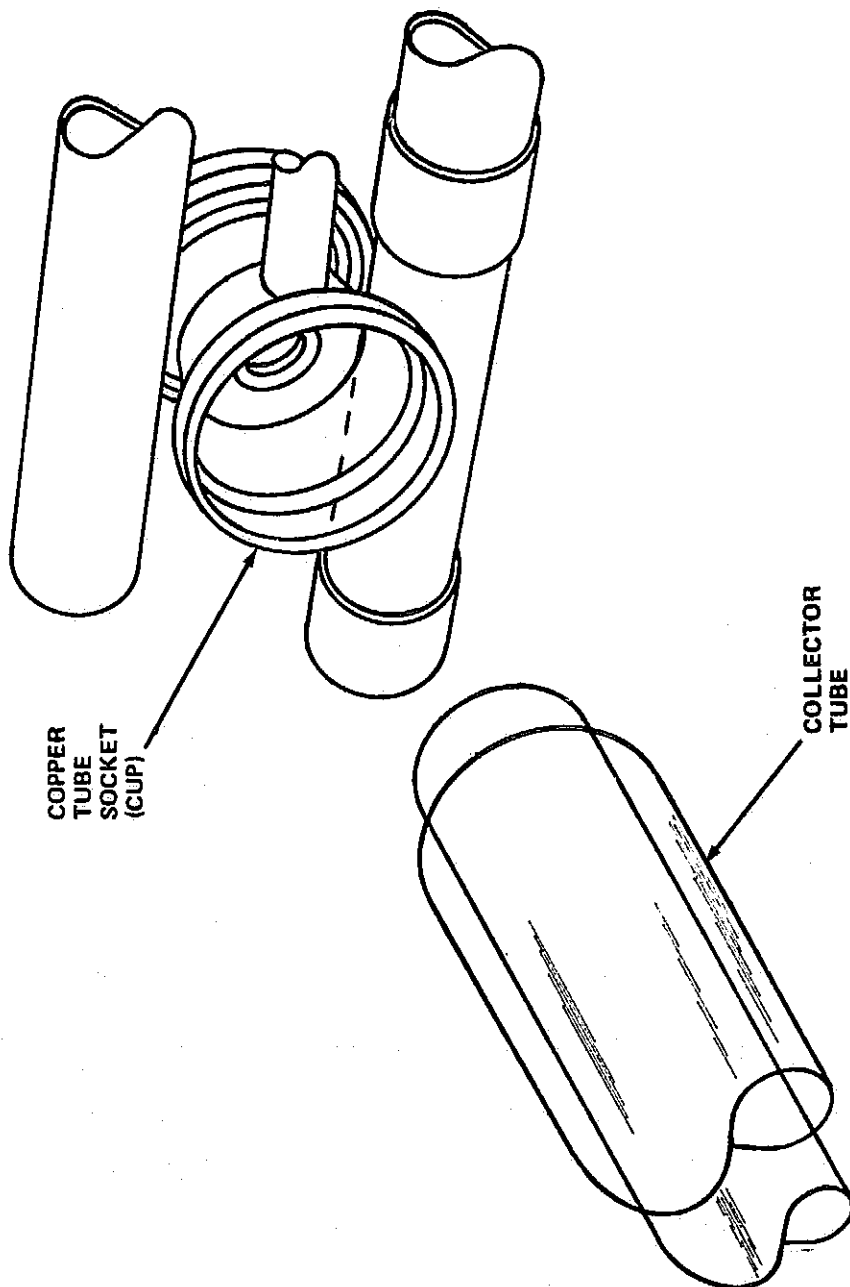
Figure 5. Copper tube socket.

The liquid flow in the collector is channeled from one tube pair to the next by copper tubing and cups shown in Figure 5. These individual components are soldered together with Welco No. 5 solder (95 percent tin, 5 percent silver) which melts at approximately 435°F (224°C). The maximum temperature observed near a soldered component during boilout and stagnation on the solar simulator was 495°F (257°C) at the cups.

Soldering does not appear to be an adequate process for fabricating the cup assemblies. The flow of the solder, due to gravitational force, does not fill the joint as desired; the surface area in the joint is relatively small for a soldered assembly carrying loads; and the melting point of the solder is too low for the temperatures observed in stagnation/boilout.

The solder used to assemble the manifold softens at a temperature very close to those observed during boilout conditions. The components should be brazed together provided the copper is not fully annealed during the process. The optimum manifold system would be one which is a monolithic casting. This would eliminate seal leakage and improve the tolerance achievable on the manifold.

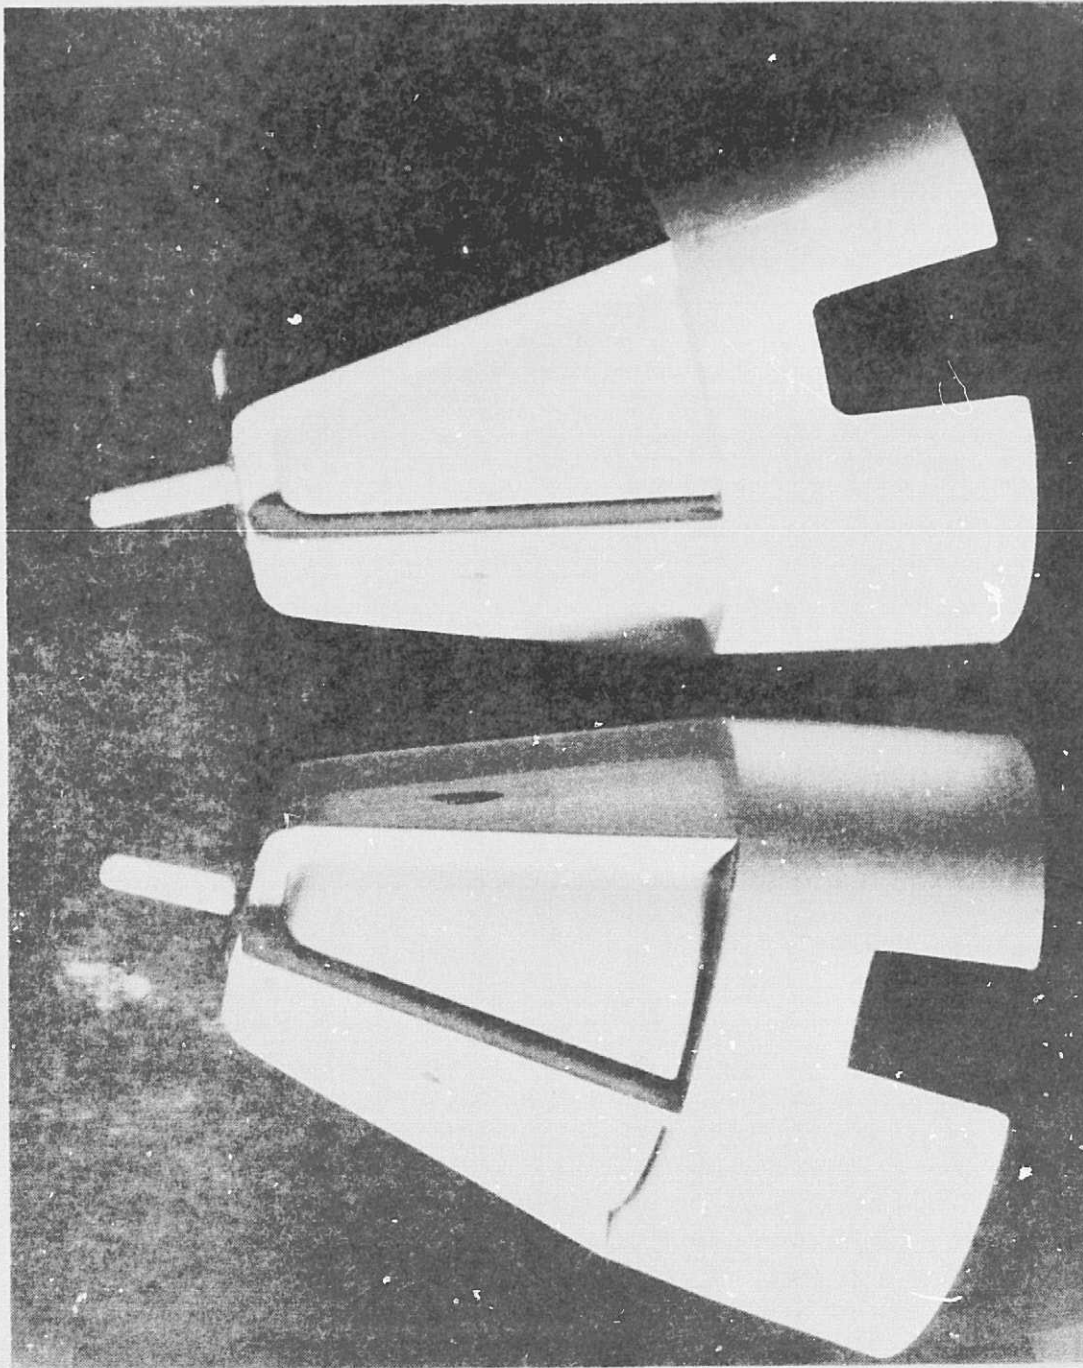
Figure 6. Tube support cap insert.

The tube support cup insert (Fig. 6) is the only plastic component identified as a potential problem area. A maximum temperature of 205°F (96°C) was observed at the position of this part. The problem encountered is deformation of the cup insert due to thermal softening during the boilout mode of collector operation. This component could be redesigned to a conical shape to improve distribution of the load transferred to it from the collector tube's closed end. Fabricating this part from a higher temperature material than acrylic-butadiene-styrene (such as polycarbonate or polysulfone) should alleviate this problem.
