LONG-TERM CF6 ENGINE PERFORMANCE DETERIORATION - EVALUATION OF ENGINE S/N 451-380

PREPARED BY: W.H. Kramer
J.J. Smith

General Electric Company
Aircraft Engine Group
Cincinnati, Ohio 45215

August 1978

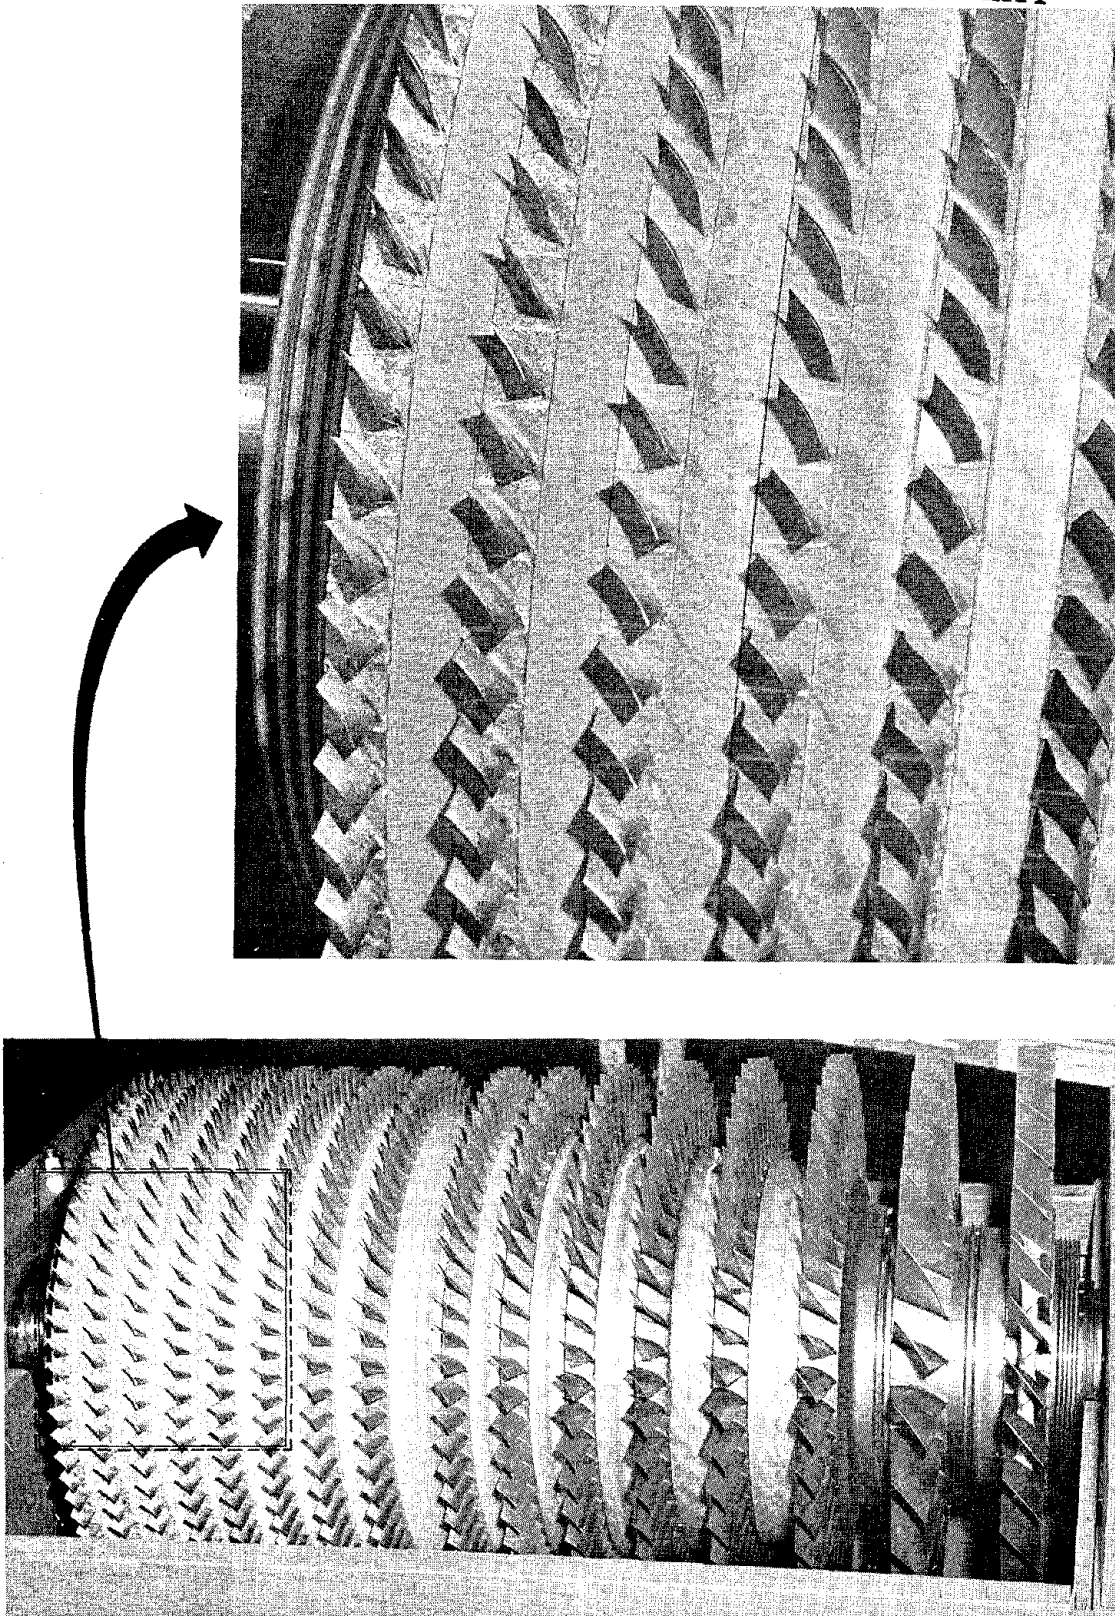
Inspection of the aluminum coating on the compressor rotor lands revealed discrepancies as noted below. (See Figure 1.)

Stage	Land Condition
14 and 15	100 percent missing
12 and 13	Approximately 50 percent missing
10 and 11	Intermittent chipping, aft end of land
7 - 9	Intermittent chipping, forward end of land
3 - 6	Satisfactory

Figure 1. HP Compressor Rotor Coating.

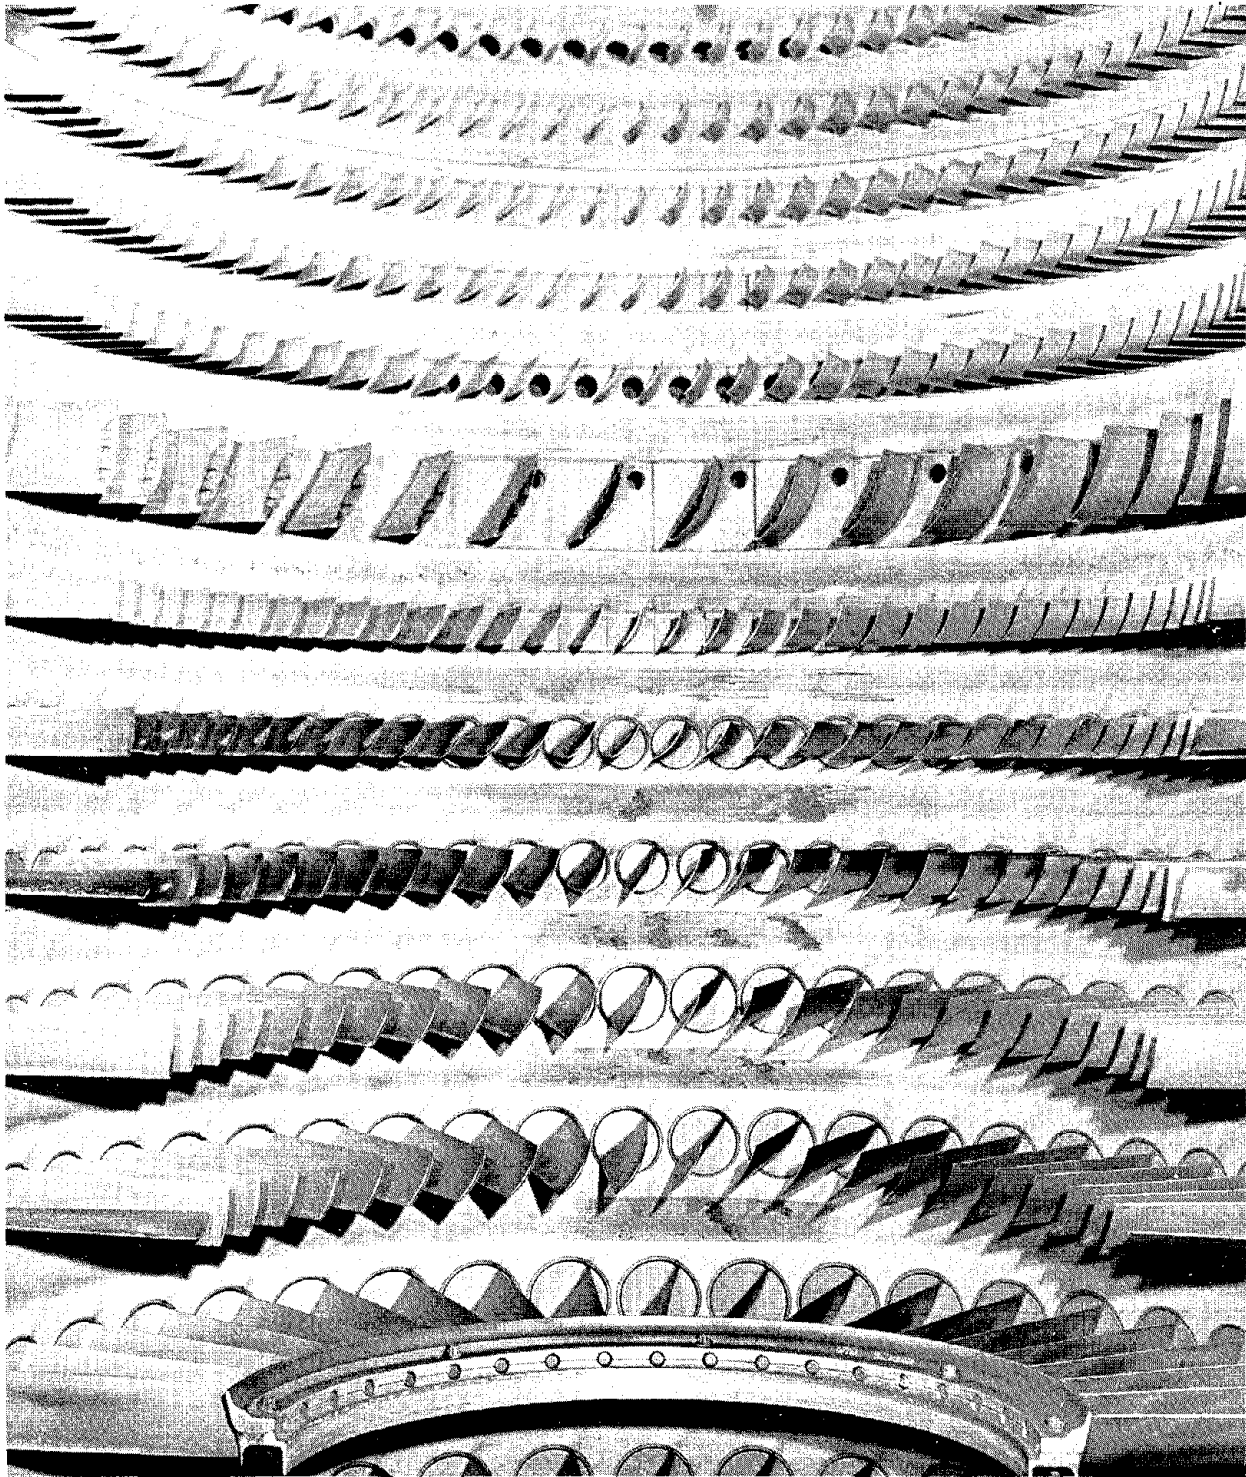
Figure 2. HP Compressor Stator Case, Upper Land Rubs.

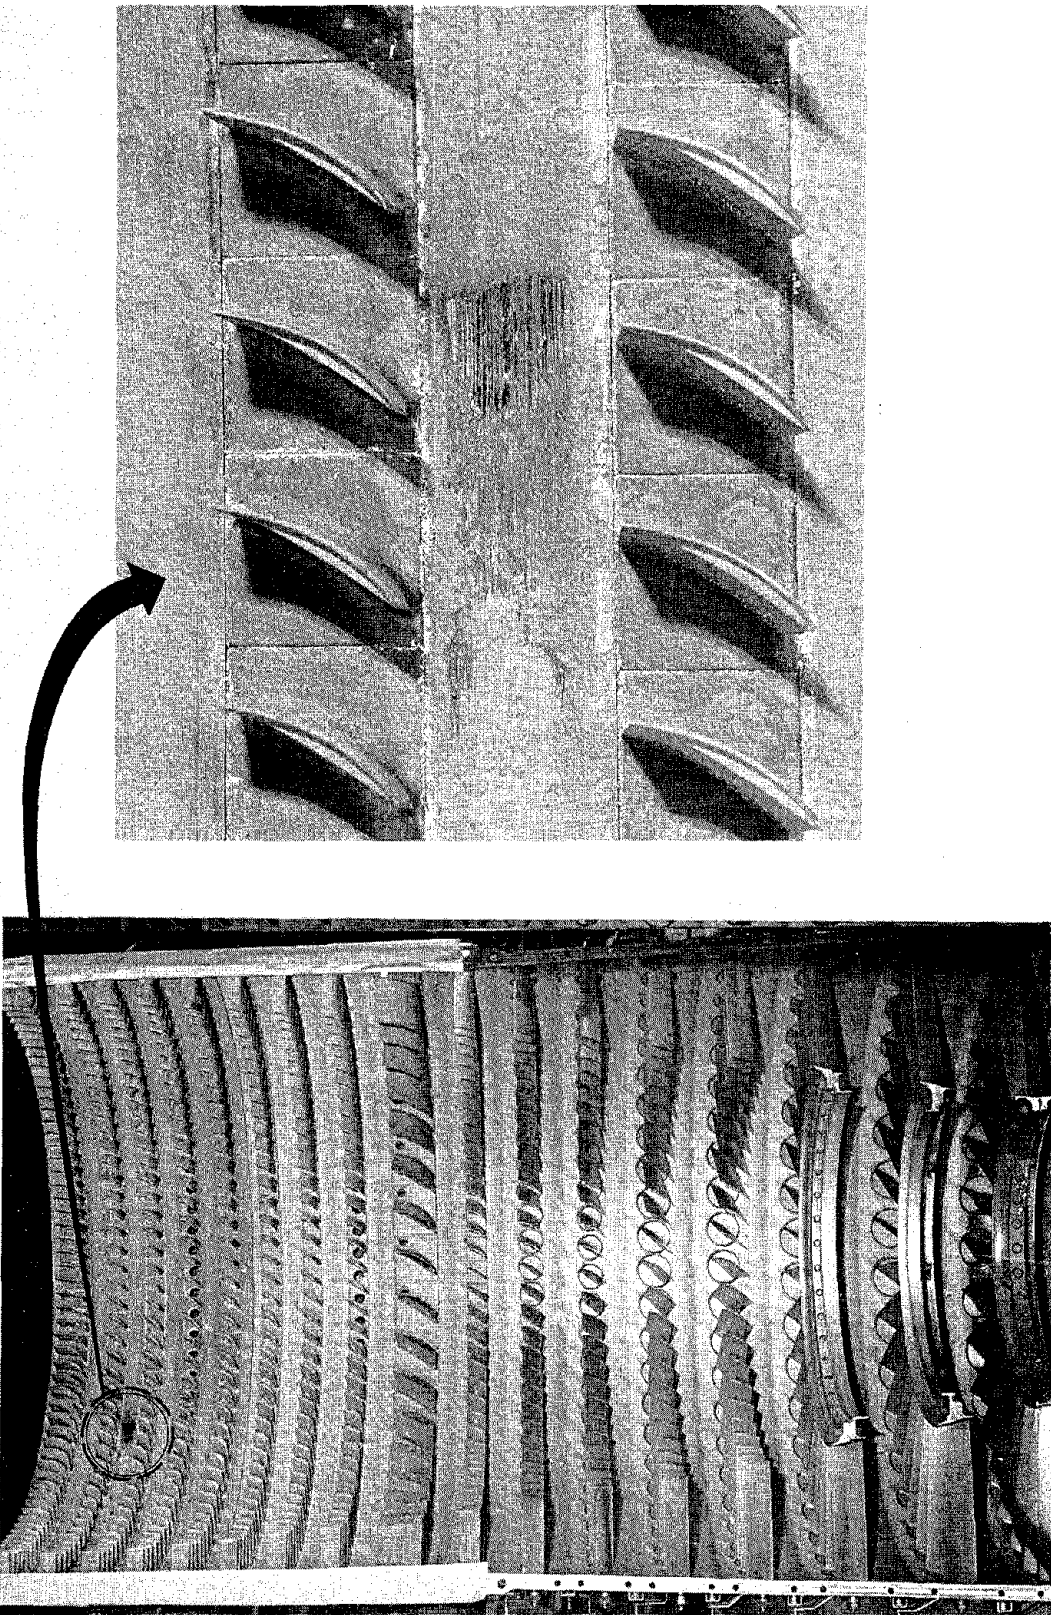
The airfoils were in excellent condition, except for the dirt and the oxidized appearance of the Stage 15 and 16 blades. The blades contained no nicks (FOD) or other damage. Stage 15 blades exhibited a very mild tip rub which was substantiated by the rub noted on the compressor stator land, lower case (See Section 6.1.2.4).

Figure 3. HP Compressor Stator Case, Lower 15th Stage Rub.

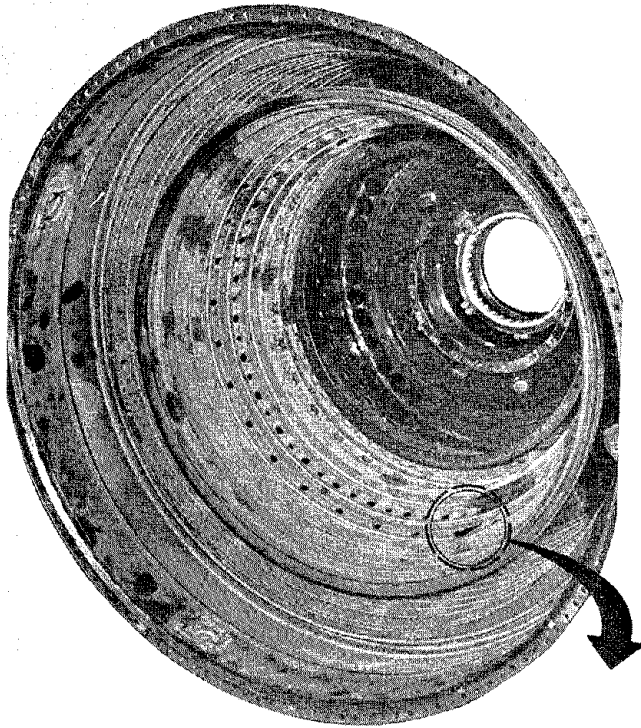
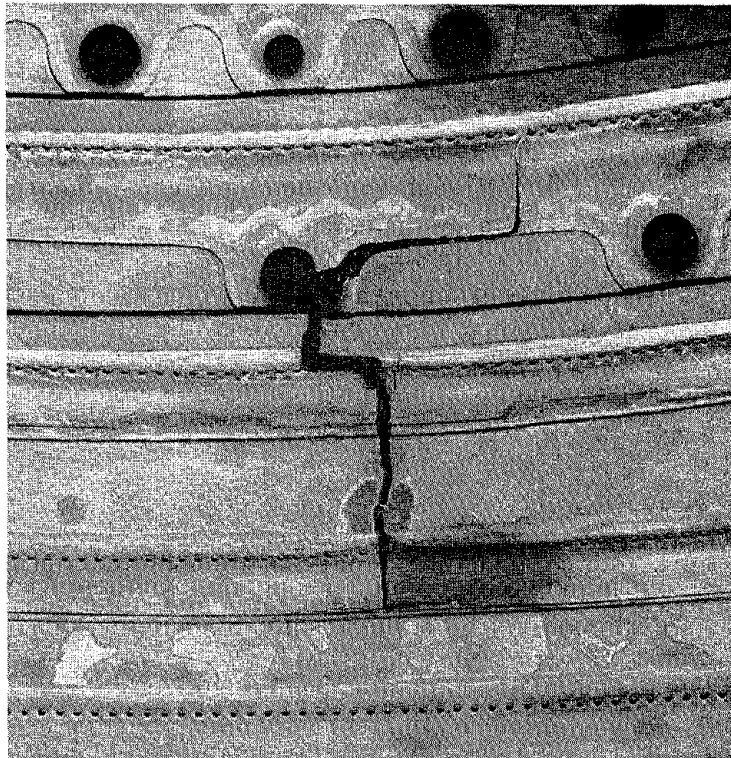
A visual inspection of the combustor was made as-installed in the compressor rear frame. The most notable observation was the distress seen in the inner liner, which was the same condition noted in the previous Task IV engine, S/N 451-479; i.e., cracks originating at the aft thimble louvers. From the louver located at approximately 6 o'clock, a crack progressed aft approximately 2-1/4 inches, then circumferentially about 3/4 inch. Another crack, originating at the same louver, progressed circumferentially approximately 1-1/2 inches, then forward about 9/16 inch.

The louvers at 11 and 12 o'clock had circumferential cracks on each side ranging from 3/4 to 1 inch in length. Other louvers were similarly cracked, but to a lesser degree. Figure 4 shows a photograph of the combustor depicting the various cracks.

Figure 4. Combustor Inner Liner.

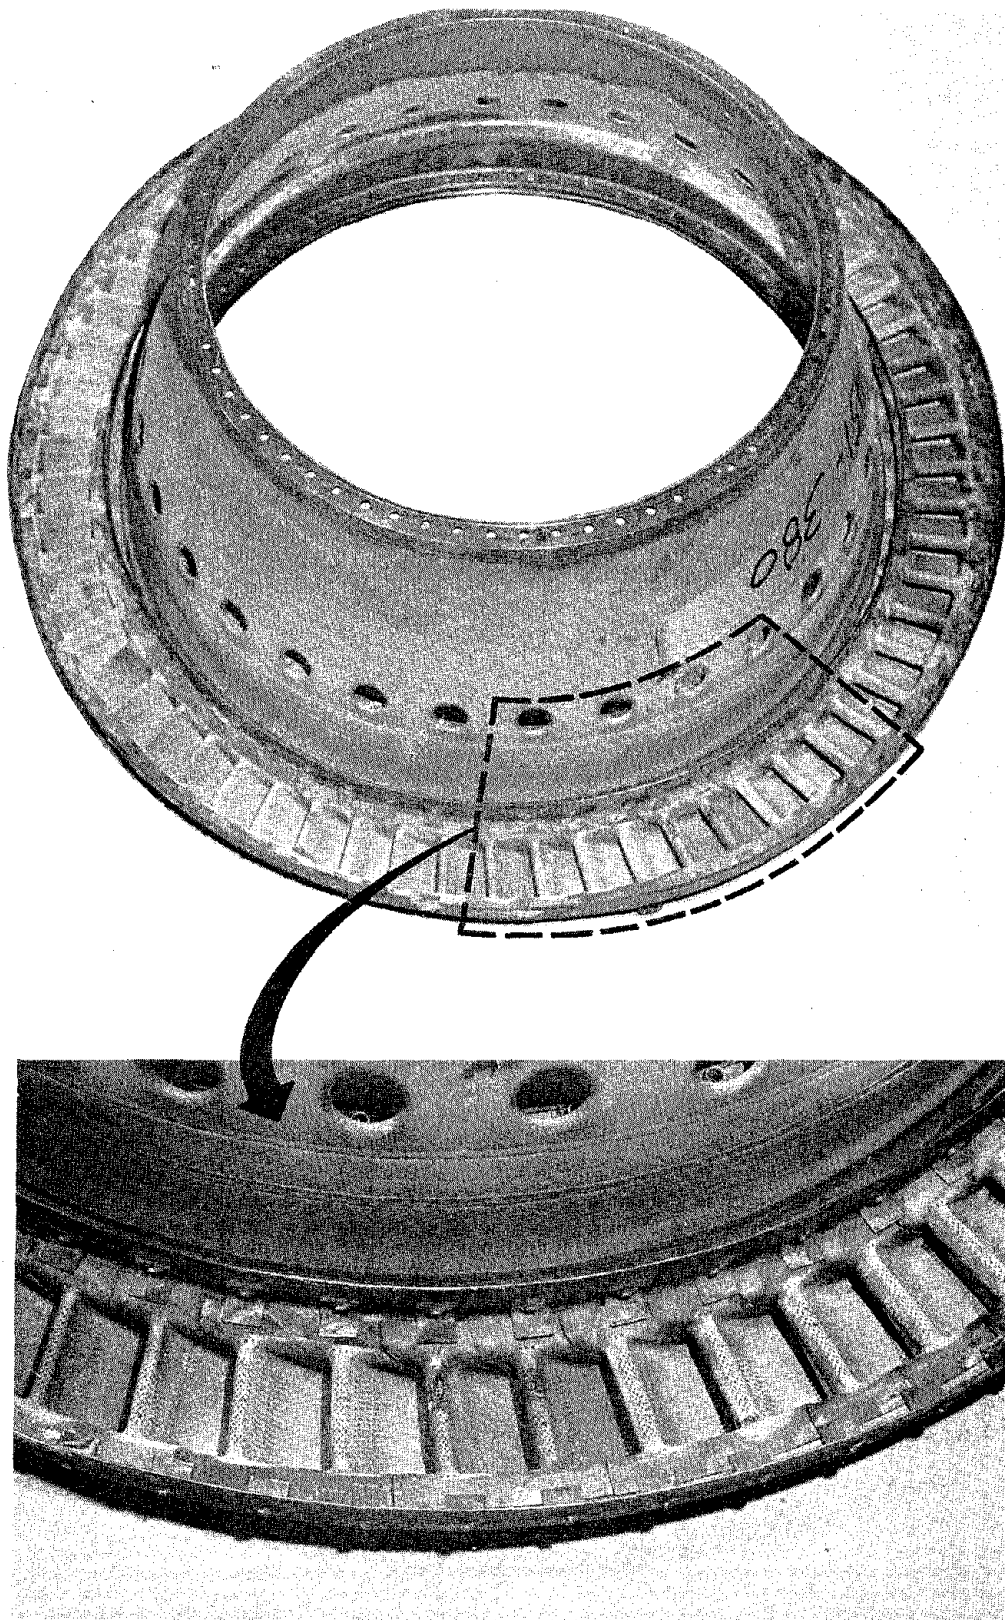
There were the normal minute cracks on the leading edge of the vanes, together with the common splatter buildup, but all cooling holes were open. Five vanes were mildly burned on the leading edge, but they had not burned through. One vane, vane No. 20, did burn through, leaving a hole approximately 7/16 inch x 1/4 inch. Its insert was exposed, but was intact with no signs of burning.

Figure 5. Stage 1 HPTN Vanes, Leading Edge.

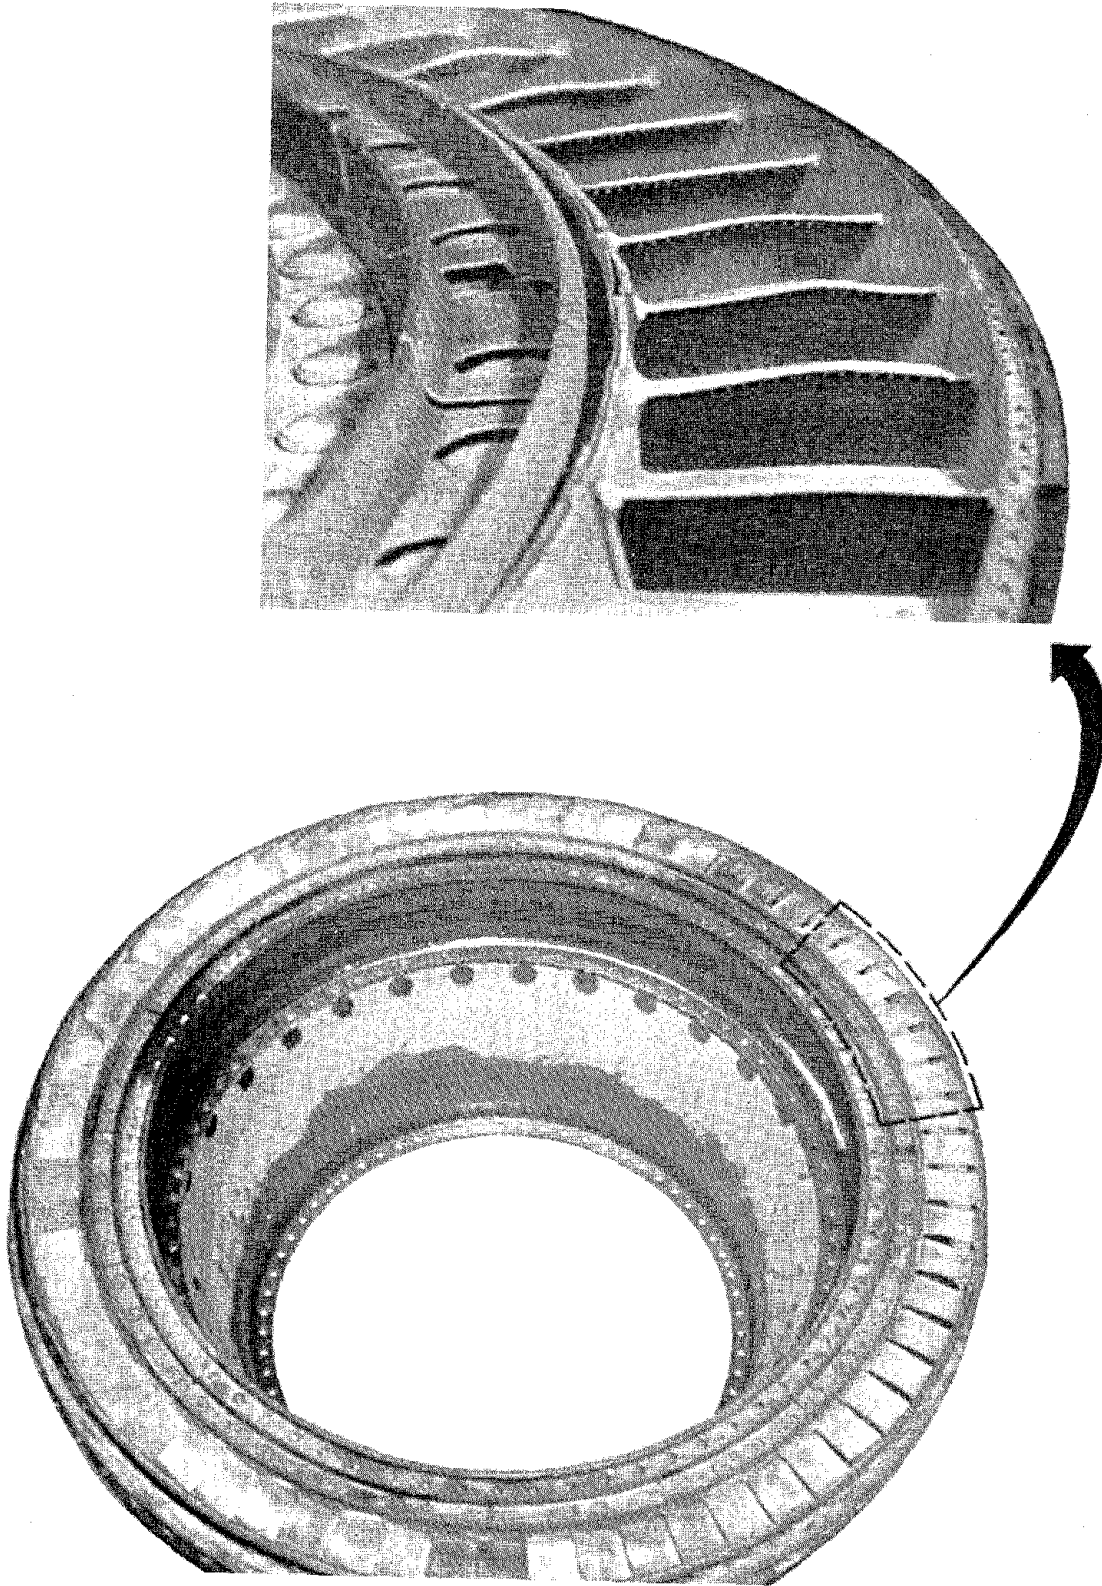
Visual inspection of the Stage 1 HPTN assembly showed it to be in a less deteriorated condition than the assembly from the first Task IV engine (NASA-CR-135381, "Long-Term CF6 Engine Performance Deterioration - Evaluation of Engine 451-479"). Photographs of the assembly are shown in Figures 5 and 6. No burning of the vane trailing edge was in evidence, which was in sharp contrast to what was seen on the previous engine, and, although there were 10 vanes which were bowed on the trailing edge, none were as severe as those seen on the 451-479. As before, the bowing caused radial cracks just forward of the aft cooling holes on the concave side. The lengths of the cracks were proportional to the severity of the bowing.

Figure 6. Stage 1 HPTN Vanes, Trailing Edge.

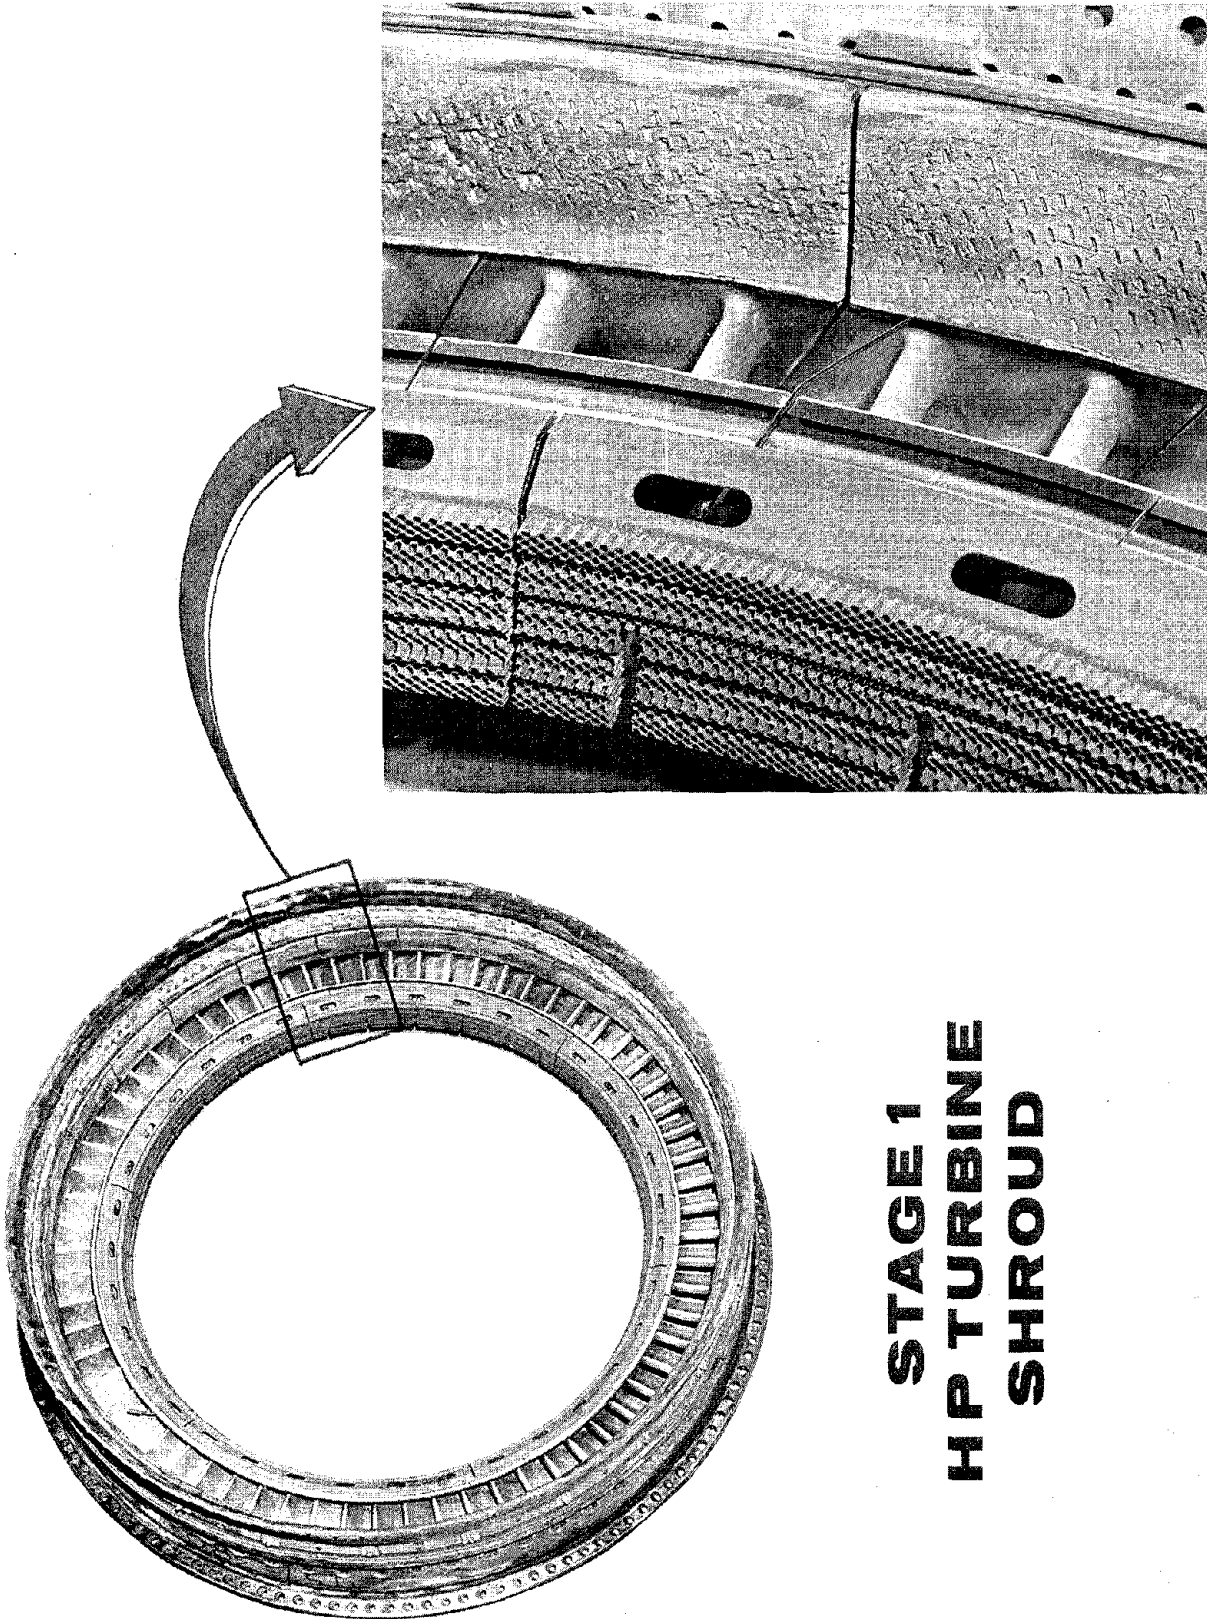
The Stage 1 shrouds were very rough due to oxidation/erosion. The majority of the shrouds revealed local hot spots with a considerable amount of Bradelloy missing between the pins which were recessed, probably due to pin oxidation.

Figure 7. Stage 1 HP Turbine Shroud.

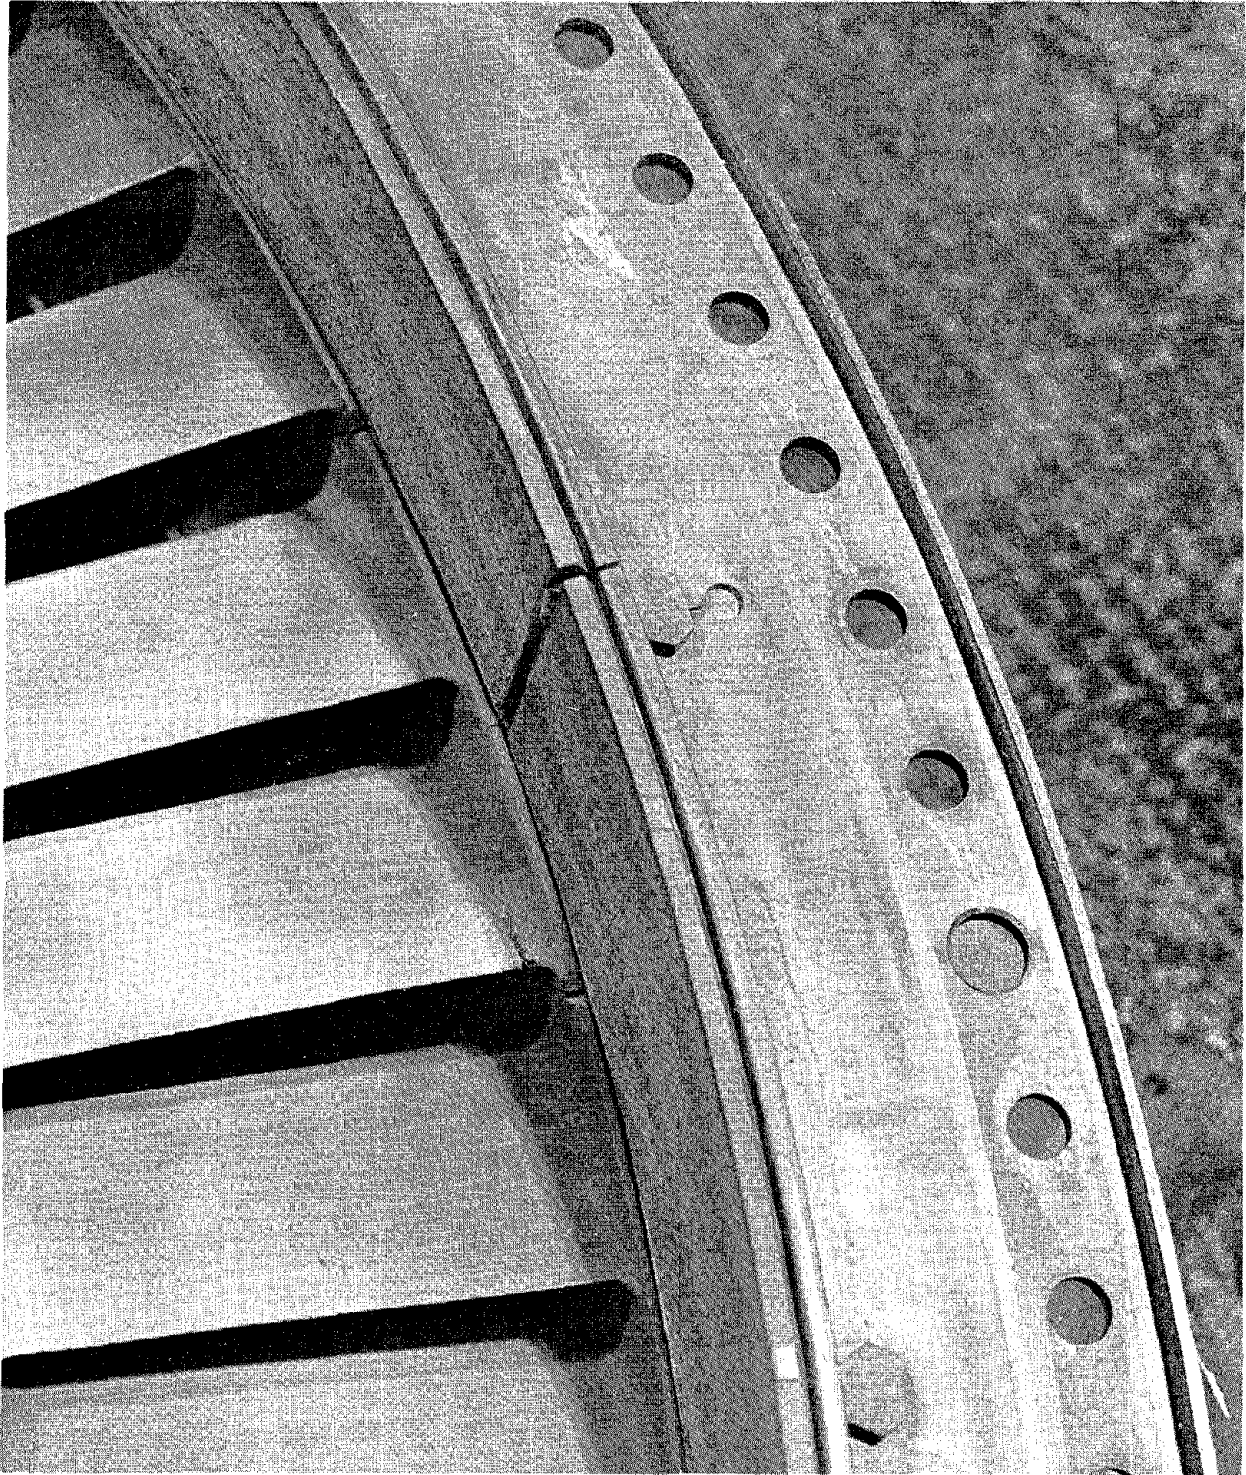
Overall, the vanes were in good condition. There were six vanes with minor leading edge burning, but none burned through. Six other vanes exhibited small cracks just below the outer platforms on the trailing edge.

Figure 10. Stage 2 HP Turbine Nozzle Vane, Trailing Edge Crack.

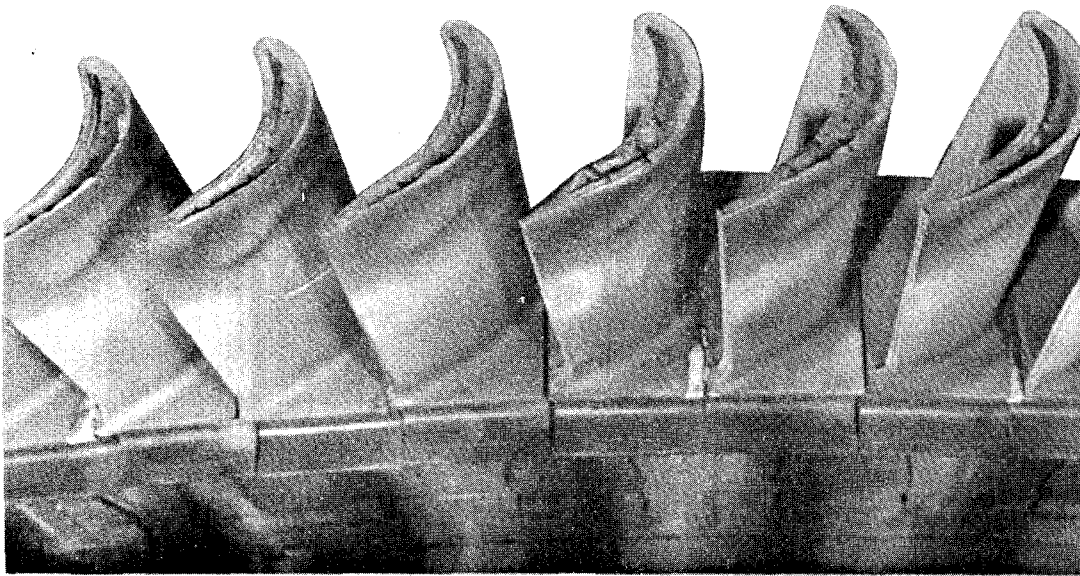
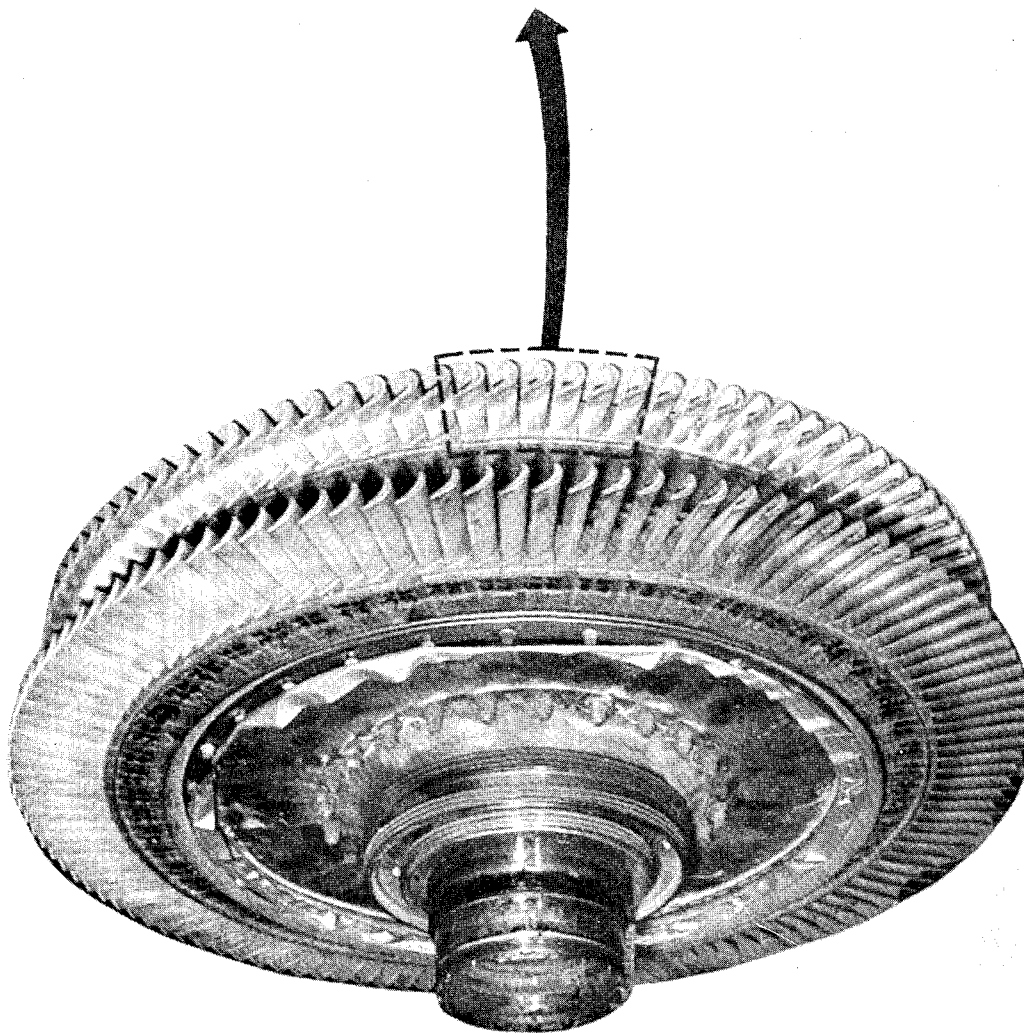
Except for the Stage 1 blades, a visual inspection of the high pressure turbine rotor assembly revealed it to be in good condition. Most of the Stage 1 blades exhibited tip cracks and burning, as depicted in Figure 11. The concave surface of the airfoils revealed heavy deposits and roughness, while the convex sides were smooth.

Figure 11. HP Turbine, Stage 1 Blade Tip Cracks and Tip Burning.

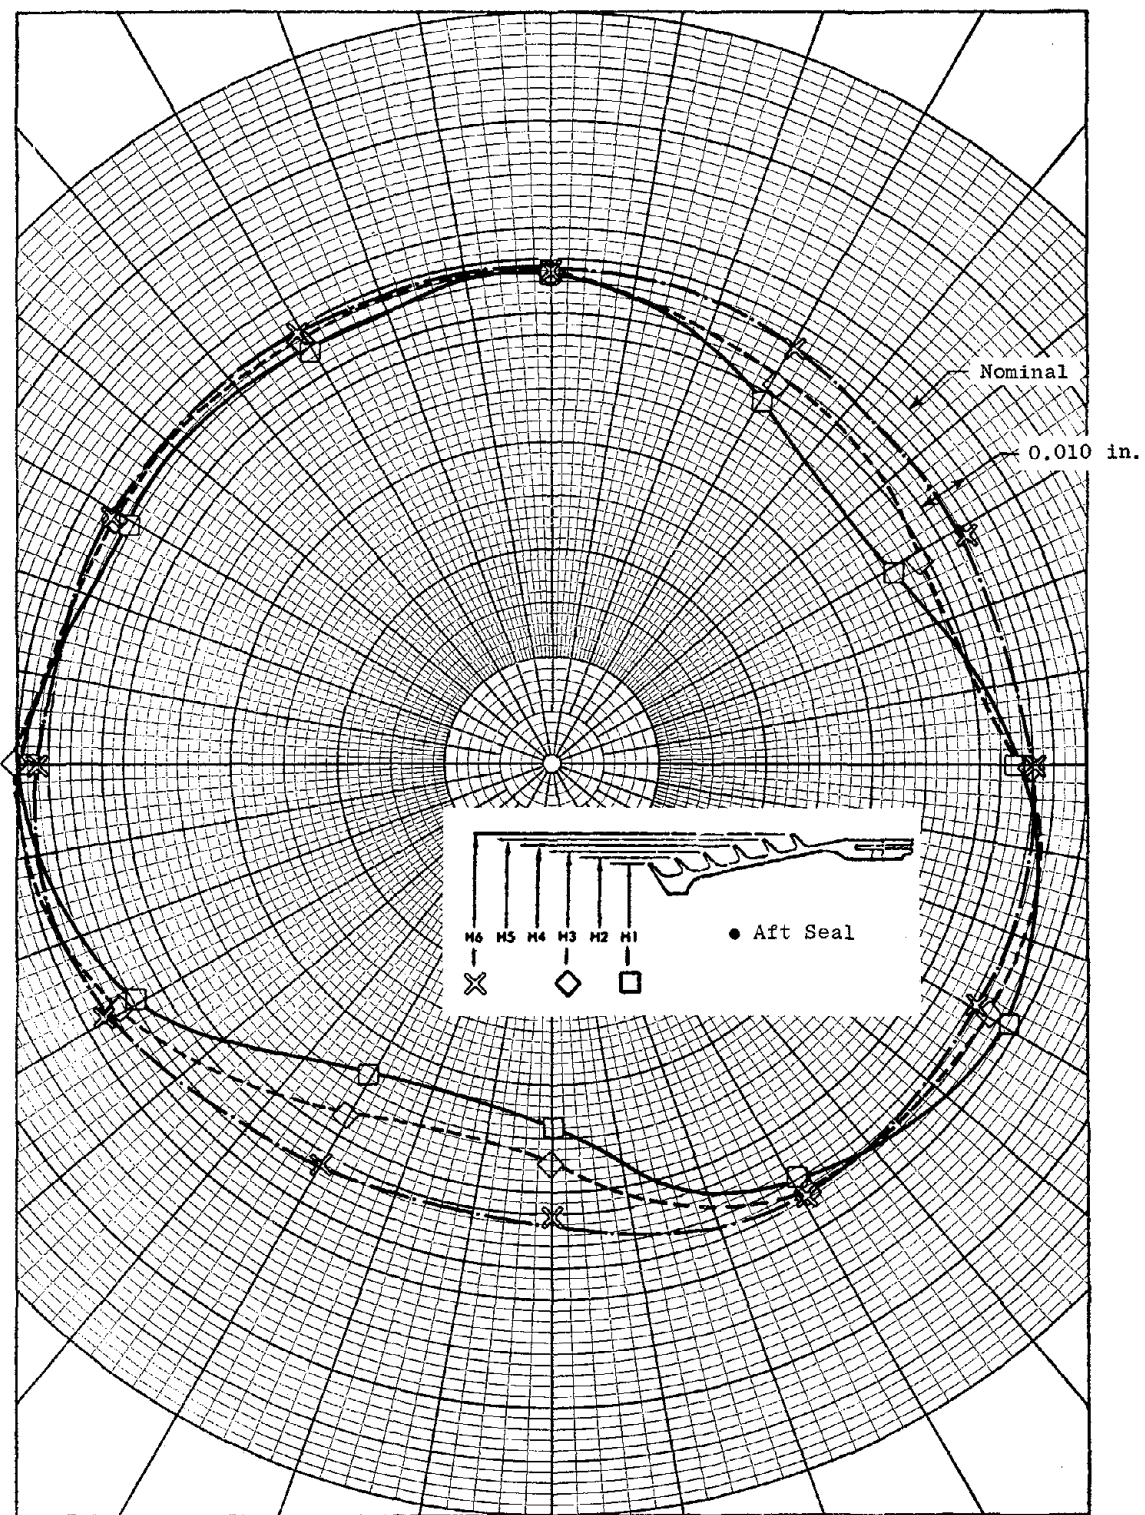
A review of the dimensional inspection checks revealed a large amount of circumferential warping of the aft air seal (see Figure 12 which depicts the runout of the seal teeth, H1, H3 and H6). Experience has shown that this condition is the result of thermal ratcheting caused by nonuniform heating of the seal journal, resulting in distortion of the seal teeth diameters, unequal wear, increased seal leakage and, therefore, reduced performance. To alleviate this condition, a six-pin retention system was introduced for each of the seals, but rework of existing hardware was left to the convenience of the operators.

Figure 12. HPTR Forward Shaft Aft Seal Teeth Runout.

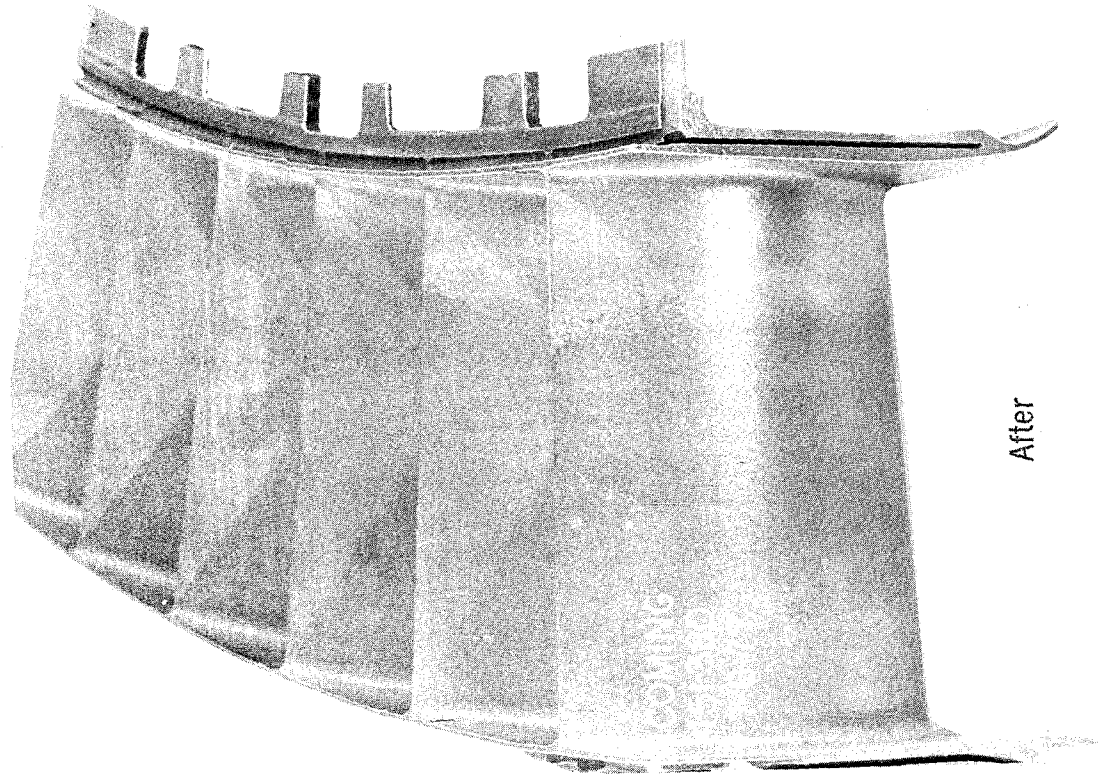
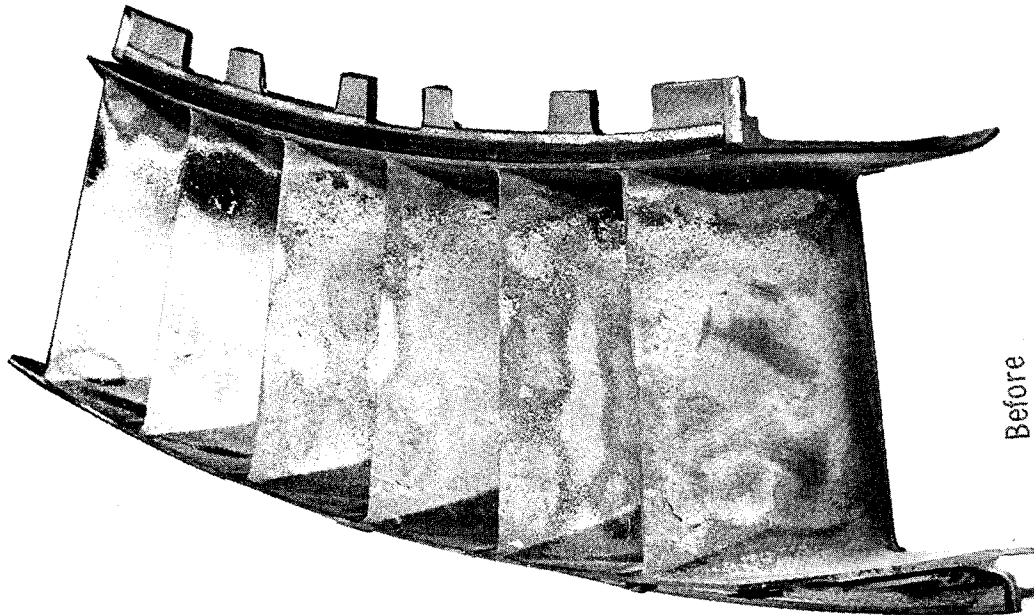
Following the inspection checks, these vanes, together with all of the other Stage 1 vanes, were SWECO cleaned for two hours (see Figure 14 which exhibits one of the vane segments before and after cleaning). The same previously inspected airfoils were then remeasured to assess the amount of performance loss attributable to airfoil surface finish changes.

Figure 14. Stage 1 LP Turbine Nozzle Vanes Before and After SWECO Cleaning.

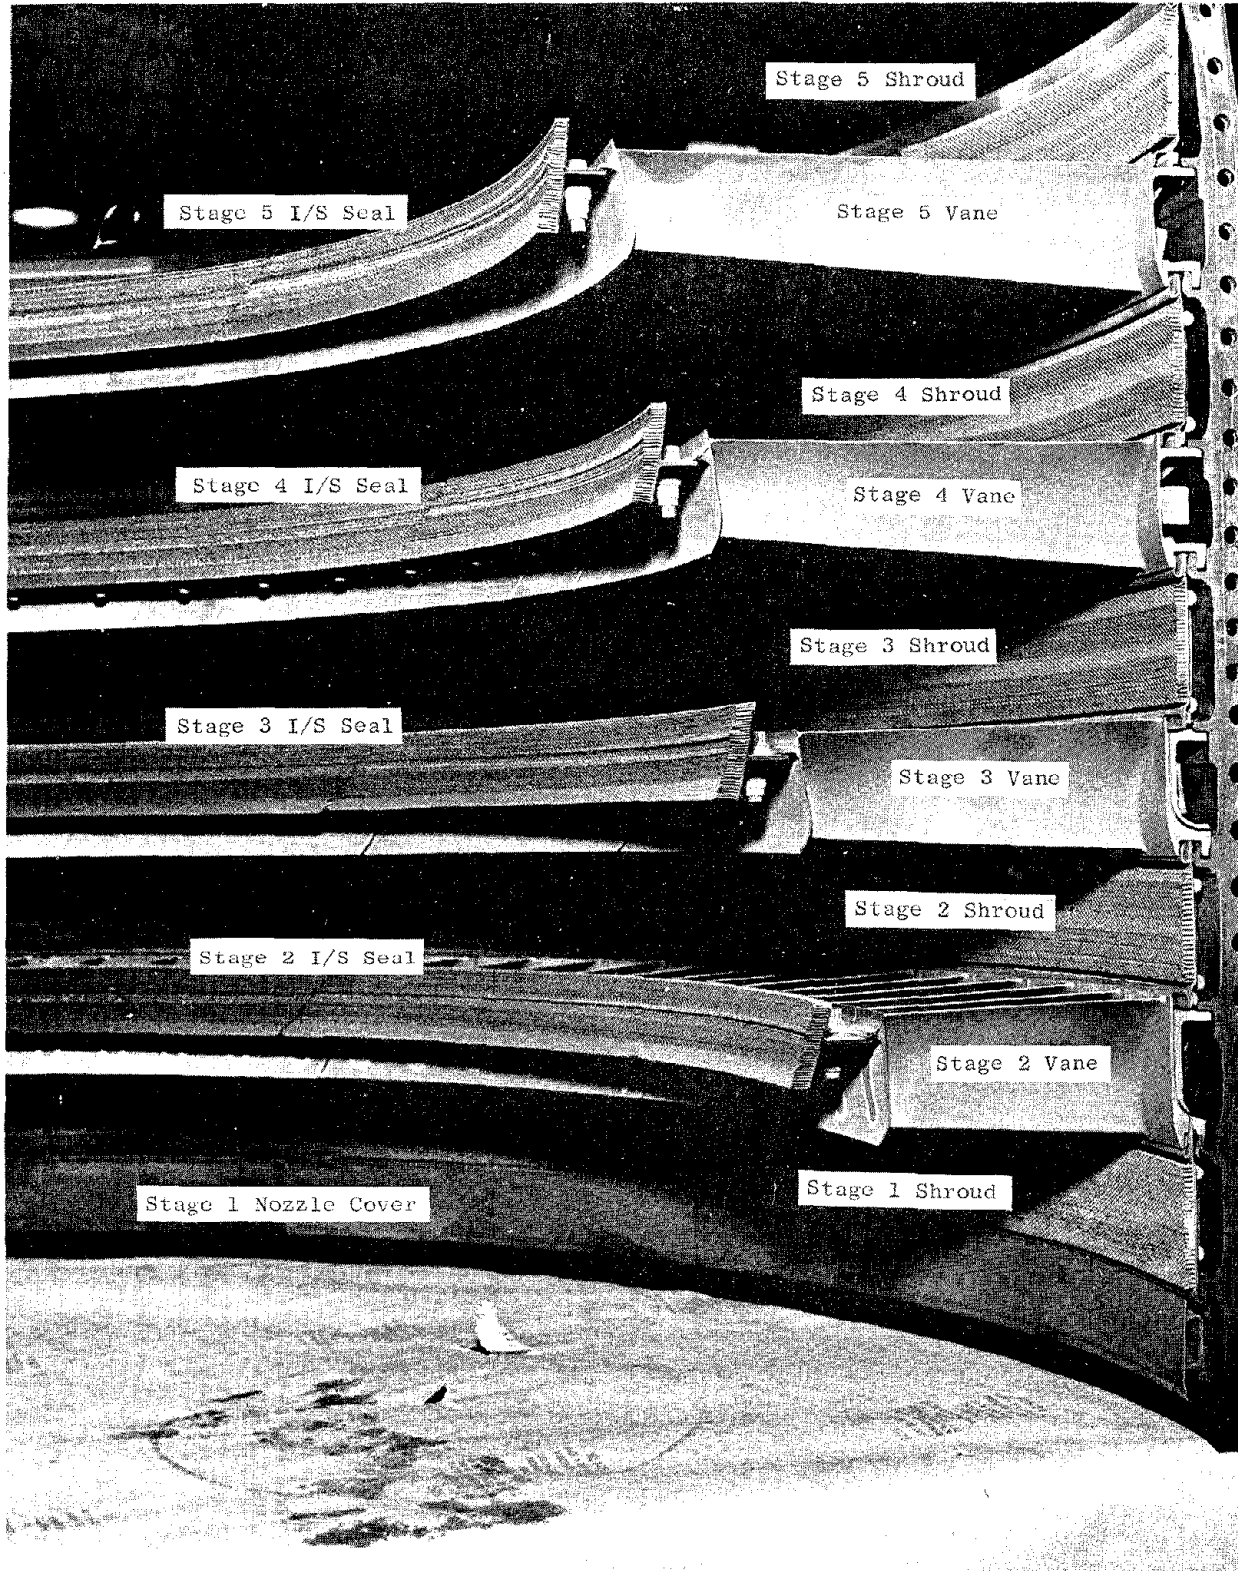
A visual inspection showed the LP turbine stator assembly to be in good condition. Vanes were dirty and rough, as expected, with the worse conditions in the forward stages. Rub patterns on the shrouds and the interstage seals were about the same as seen on the first Task IV engine, S/N 451-479. (see Figure 15). Castone impressions were made of the maximum depth rub pattern visually observed in each stage of shrouds and seals, all being in the lower case. A sketch of each of these is shown in Figure 16. The impressions are in the files of ASE Engineering and no further action is planned for them, unless some future activity in the program indicates a need for further study.

Figure 15. LP Turbine Stator Assembly, End View of Shroud and Seal Rubs.
