LONG-TERM CF6 ENGINE PERFORMANCE DETERIORATION - EVALUATION OF ENGINE S/N 451-380

PREPARED BY: W.H. Kramer
J.J. Smith

General Electric Company
Aircraft Engine Group
Cincinnati, Ohio 45215

August 1978

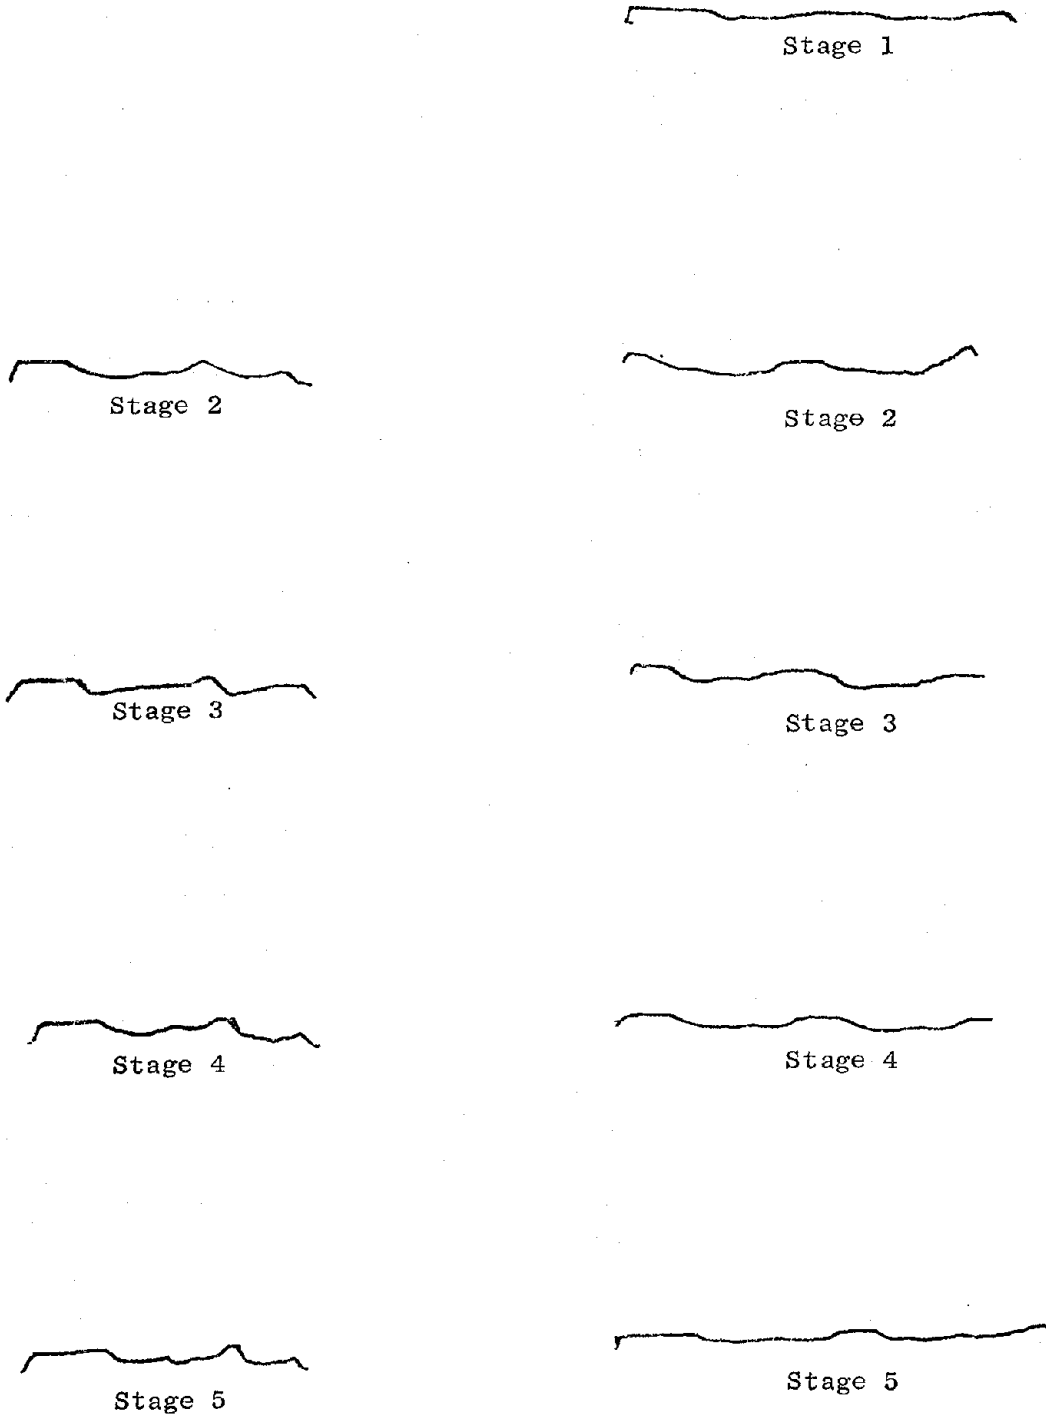
A visual inspection showed the LP turbine stator assembly to be in good condition. Vanes were dirty and rough, as expected, with the worse conditions in the forward stages. Rub patterns on the shrouds and the interstage seals were about the same as seen on the first Task IV engine, S/N 451-479. (see Figure 15). Castone impressions were made of the maximum depth rub pattern visually observed in each stage of shrouds and seals, all being in the lower case. A sketch of each of these is shown in Figure 16. The impressions are in the files of ASE Engineering and no further action is planned for them, unless some future activity in the program indicates a need for further study.

Figure 16. LPTS Shroud and Interstage Seal Rub Impressions.

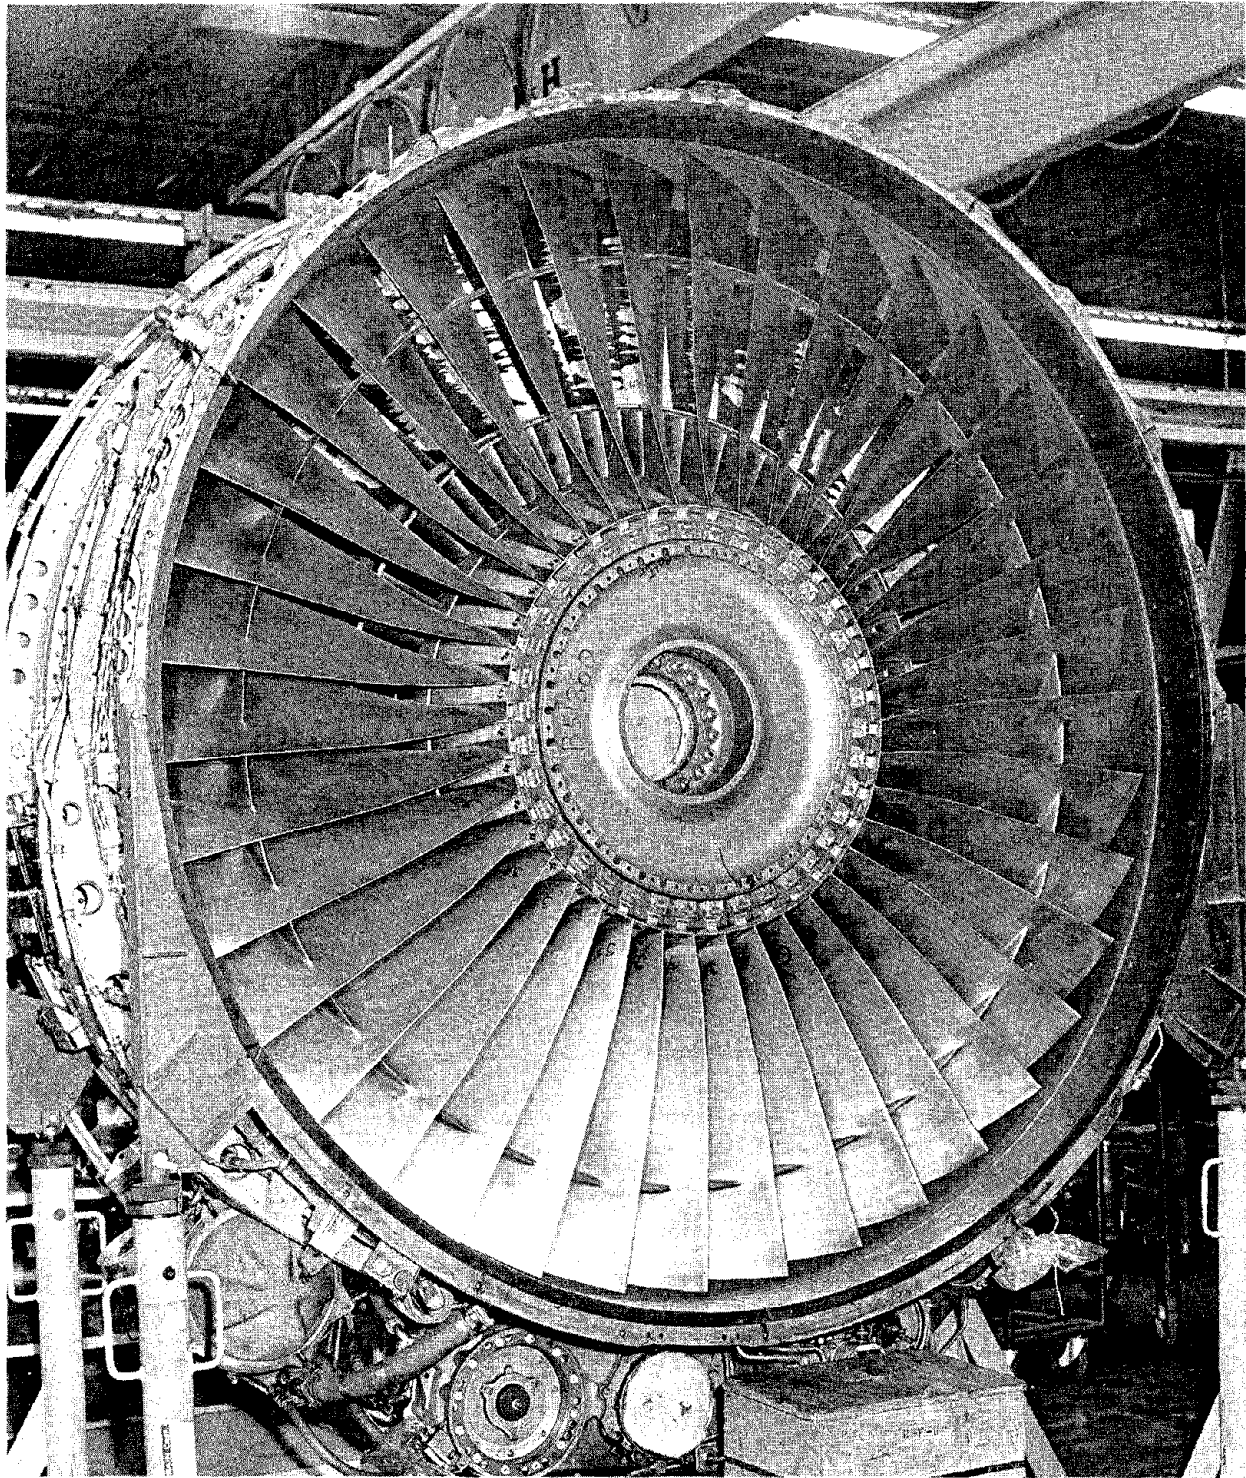
Figure 17 shows the fan section after the test cell runs. Note the missing coating on the outer OGV's as viewed through the blades at the top. A view of these vanes from the aft side can be seen in Figure 18.

Much of the urethane coating on the Stage 1 fan outer OGV's was missing on either or both sides of the vanes (see Figures 17 and 18). Visual inspection revealed no other discrepancies.

Figure 17. Fan Section, Overall View - Forward Looking Aft.

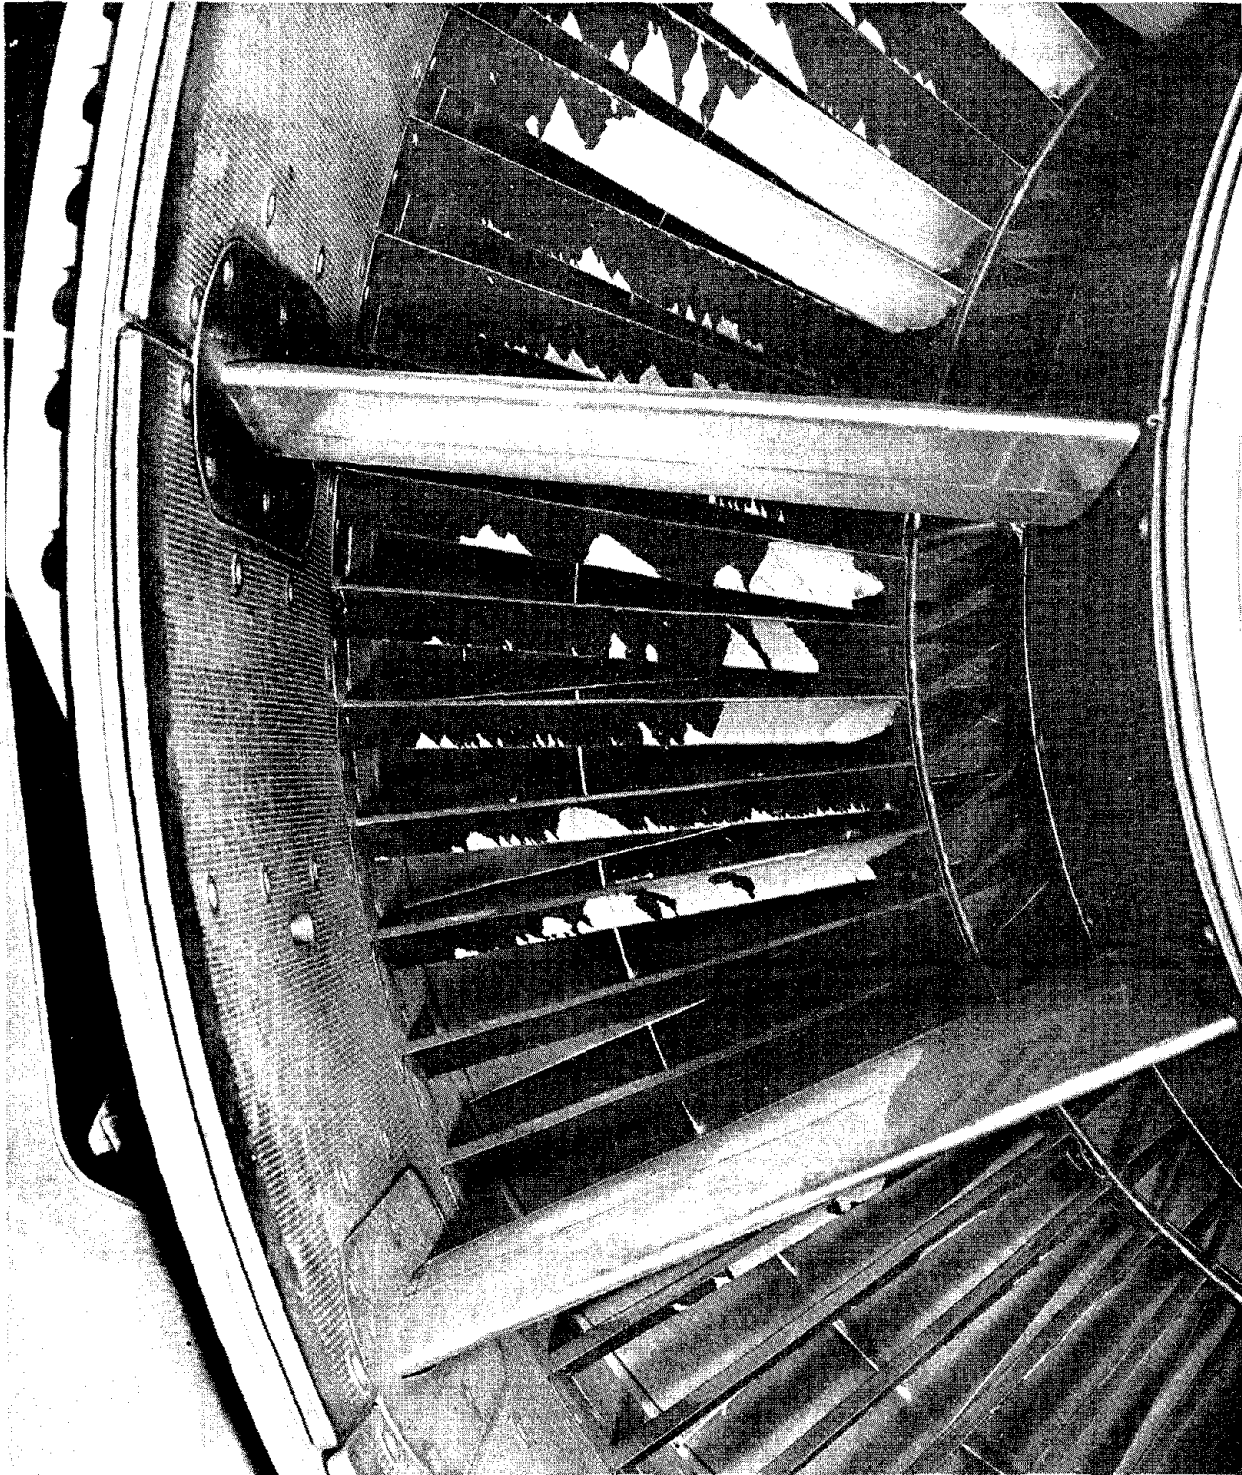
Figure 18. Stage 1 Fan Outer OGV's, Trailing Edge Coating Peeling.
