CHEVRON CUTTING--EXPERIMENT WITH NEW  
RUNWAY MIXTURES

K. Tyran

Translation of "CHEVRON CUTTING--Versuch mit  
neuen Laufflachenmischungen," Swissair, Dept. ....  
Technik, Versuchsbericht, Publ. No. 72'758  
Dec. 22, 1977, 20 pages..

K. Tyran  
Swissair-Technical Department

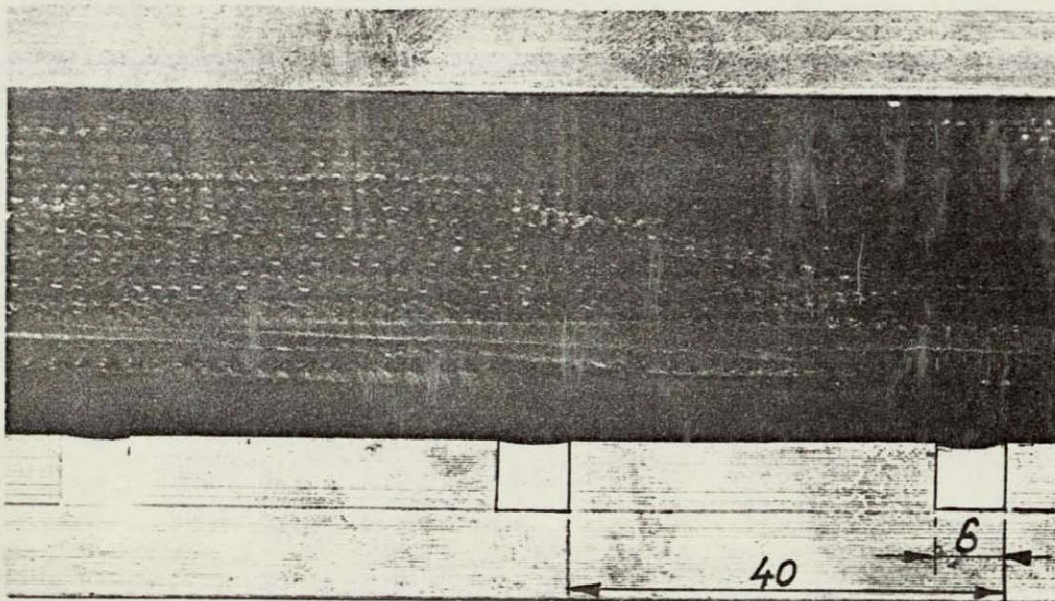
These damages occur upon landing when the stationary tire touches the grooved runway and slides over the groove edges. Chevron Cutting is influenced by tire pressure, touchdown velocity and mass moment of inertia of the wheel (Figs. 1, 2, 3).

Fig. 2 Runway profile. A B-747 tire with  $13.35 \text{ kp/cm}^2$  tire pressure is pressed about 1.4 mm deep into the groove.

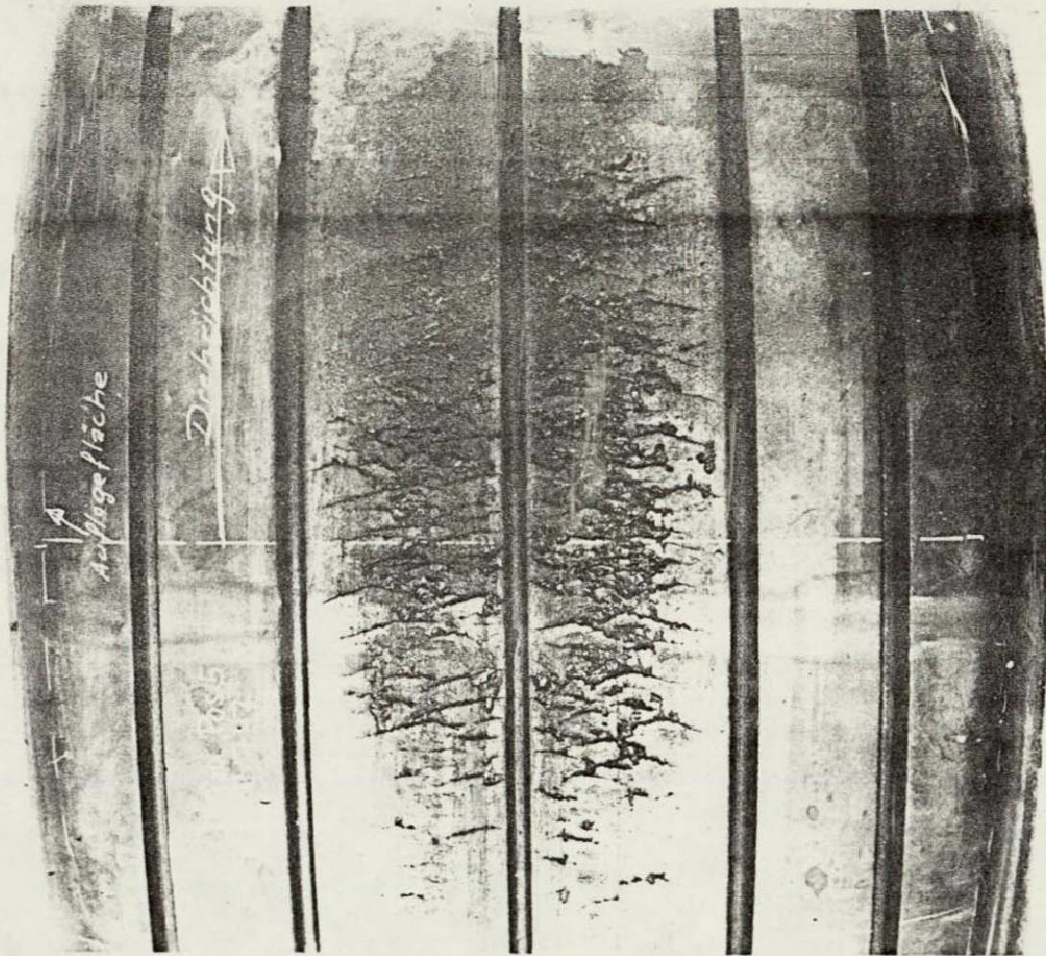
Fig. 3 Chevron Cutting occurs at the touchdown surface when the stationary tire glides over the groove edges.

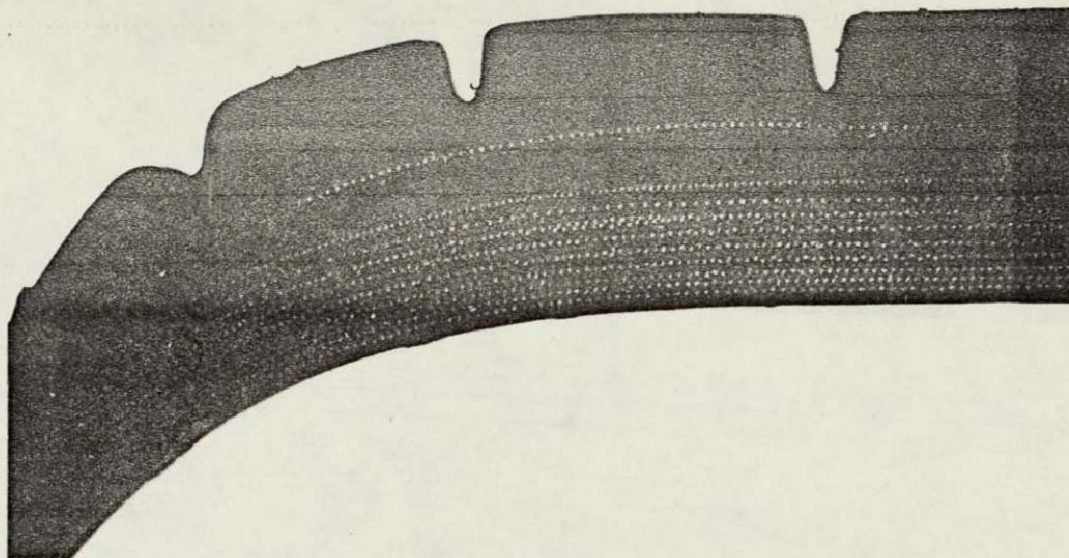
A so-called "spiral wrap" running surface construction was developed by the Goodyear Company. This is a reinforcement of the running surface through cord threads in the rubber of the running surface. The threads are applied with the unvulcanized rubber strip, circumferential in spiral-form, through a special rubbercapping process (Orbitread). Tires of such construction have been made in the USA for the past 5 years. Fig. 4 shows the distribution of the cord threads in the running surface.

Fig. 4 "Spiral wrap" construction contains cord threads in the running surface rubber which are wound in the direction of the circumference.

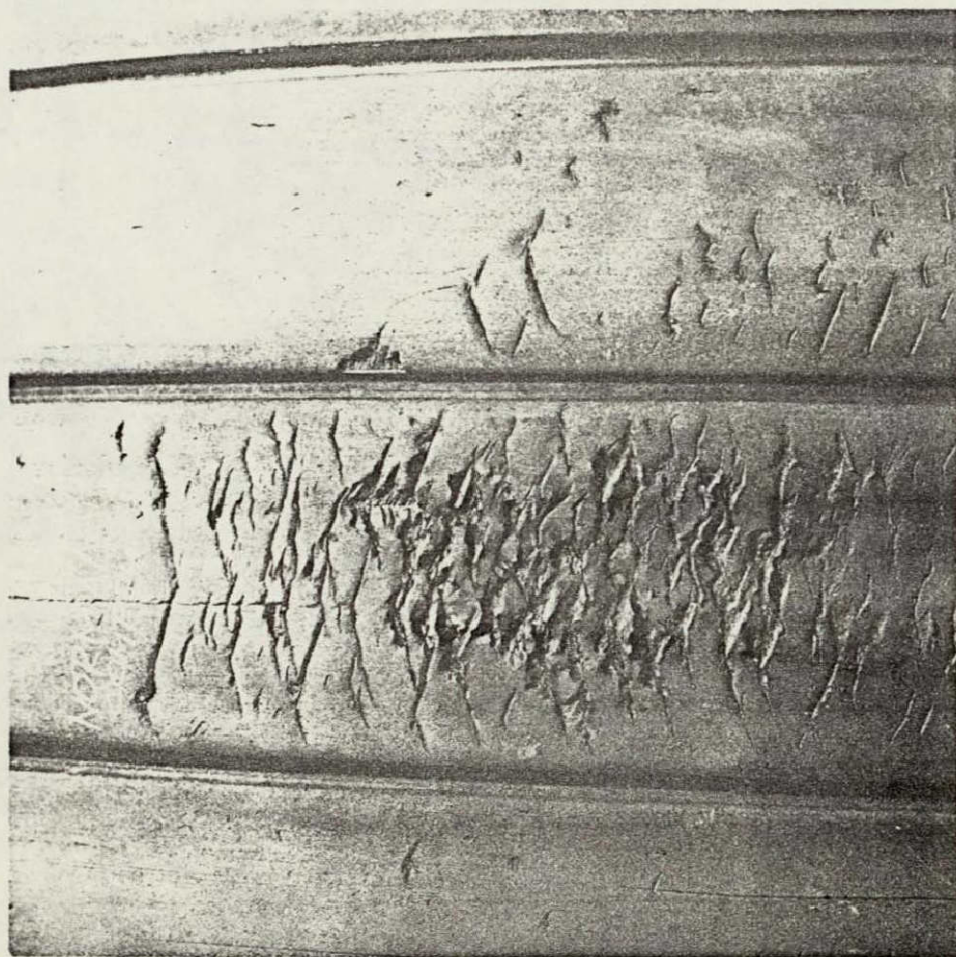
There were no Chevron Cuts on two of the nine test tires. They did appear on the remaining seven test tires but to a much smaller extent than for the previous running surface mixture. The breaks are up to 8 mm long and about 0.8 mm deep. For the previous mixture breaks were as much as 40 mm long and 3-4 mm deep (see Figs. 5, 6, 7 and 8). Two of the tires capped with natural rubber showed better performance with regard to Chevron Cutting than those with the previous running surface mixture.

Fig. 5 THOMPSON--normal mixture with typical Chevron Cuts.

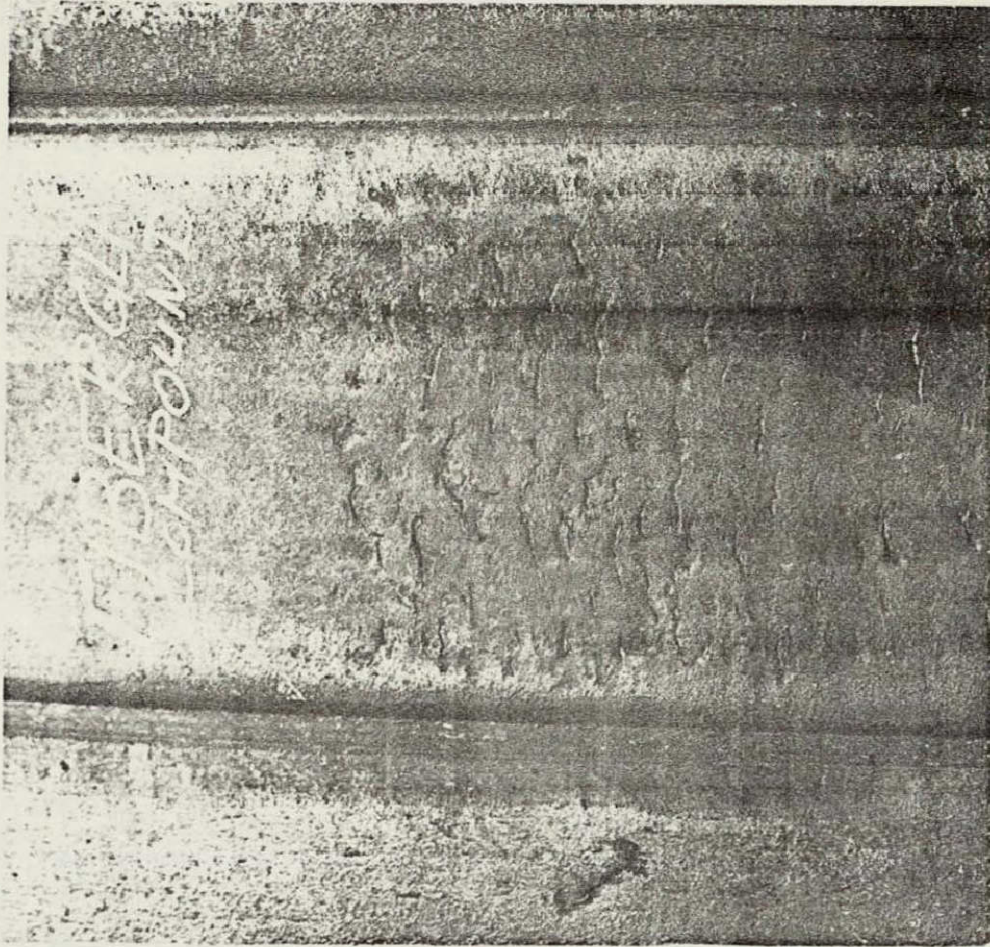
Fig. 6 THOMPSON--Fiberglass compound with typical Chevron Cuts.

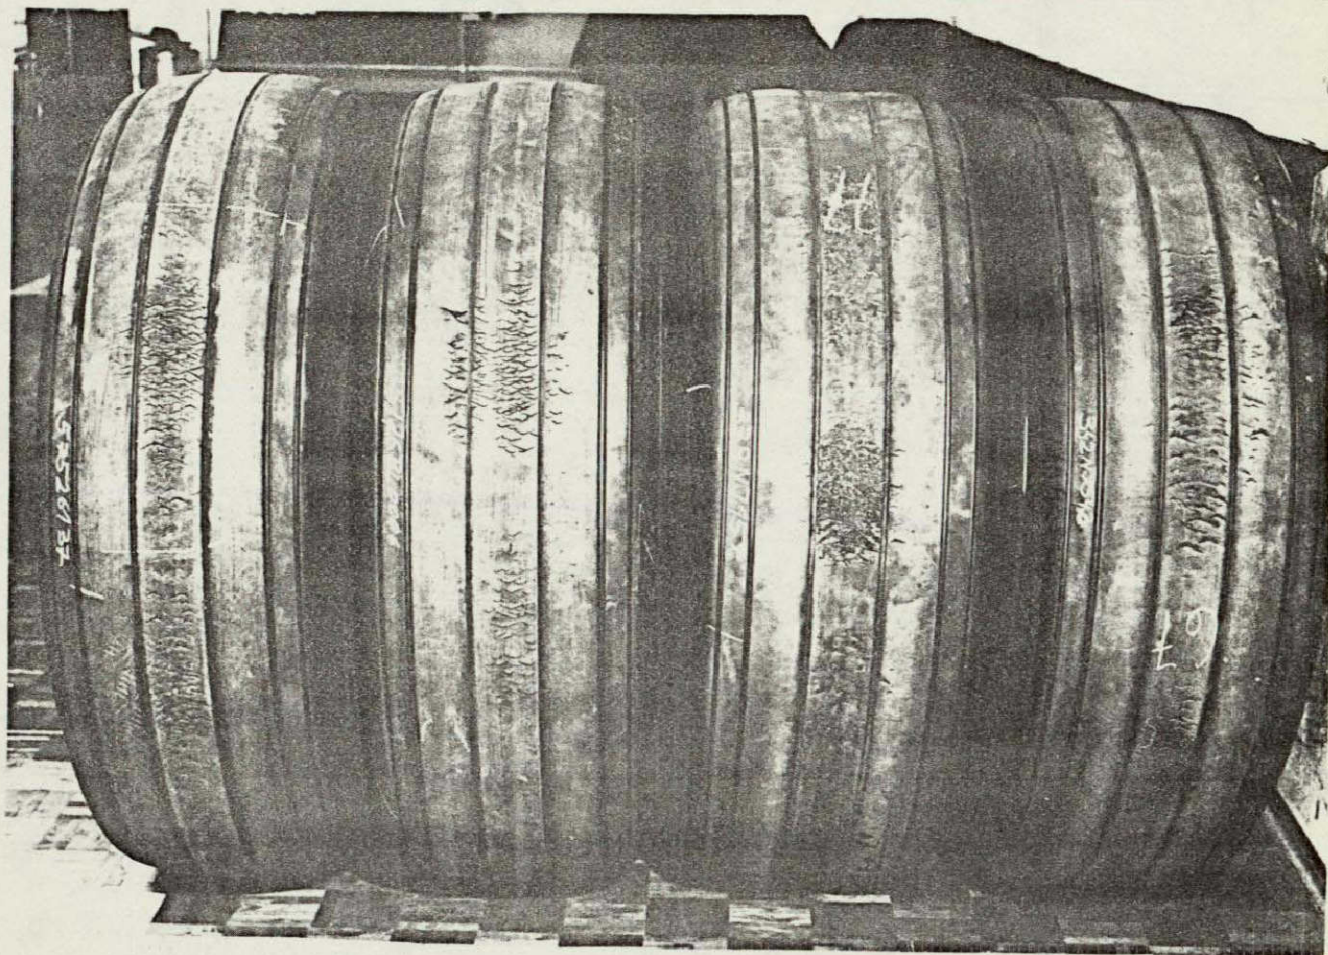
Fig. 7 THOMPSON--Normal mixture typical appearance.

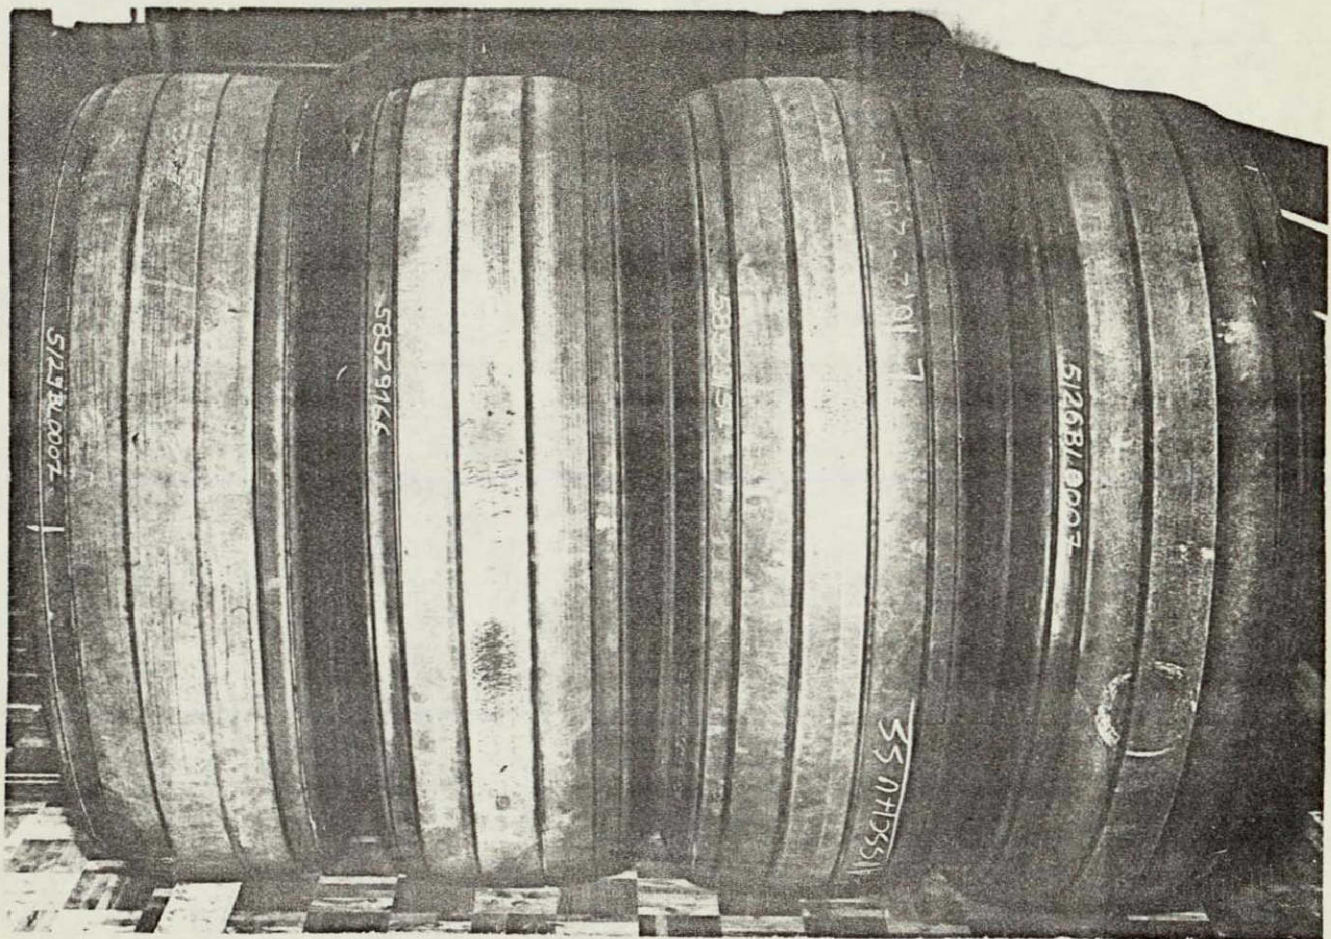
Fig. 8 Fiberglass compound typical appearance.

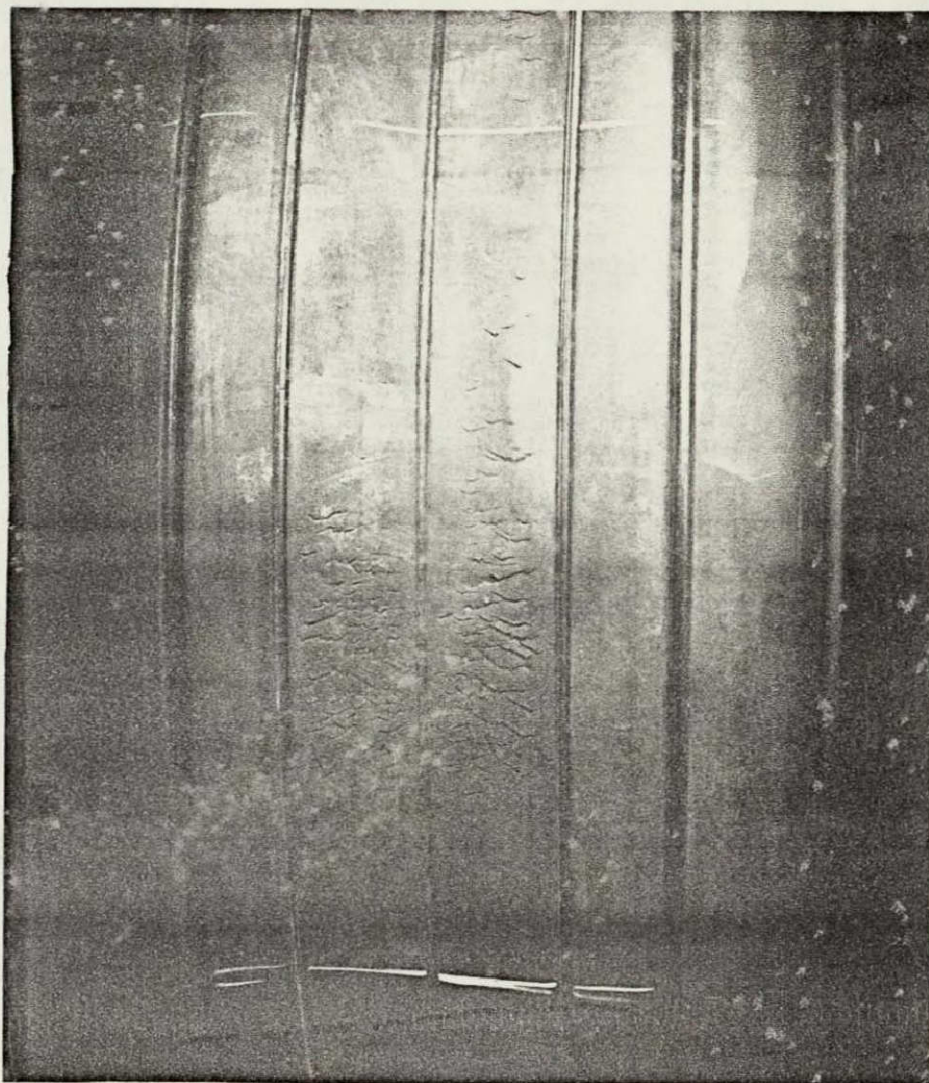
Fig. 9 shows Chevron Cutting on a normal running surface construction. Fig. 10 shows a worn-out "spiral wrap"-tire.

Fig. 9 GOODYEAR--normal construction with typical Chevron Cutting.

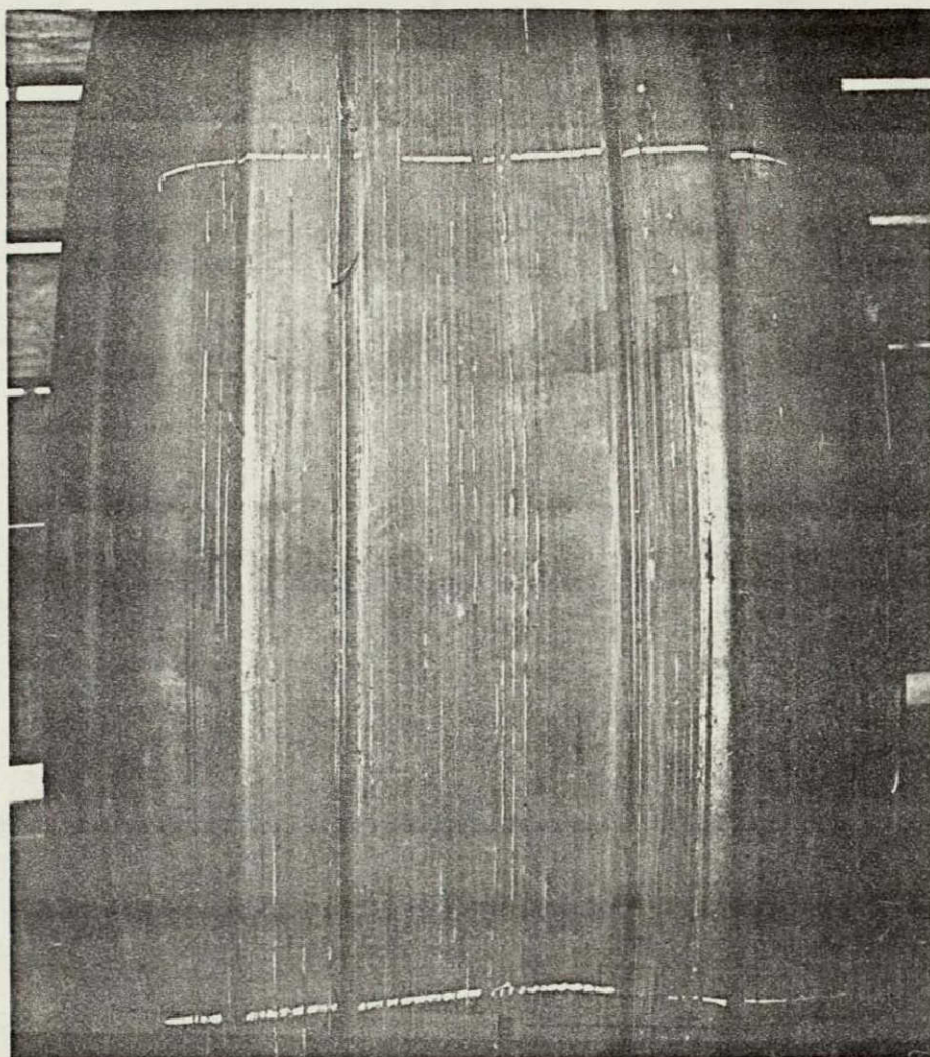
The "spiral wrap" construction of the running surface has shown the best performance of all tested fabrics with regard to Chevron Cutting. No Chevron Cuts appeared on the tires tested.

Fig. 10 "Spiral Wrap" construction, typical appearance of a worn-out tire. No Chevron Cutting appears on this tire.

--Because positive results have been achieved with the spiral wrap tires and no price increases are expected for the moment, it is suggested that this construction be continued for the B-747. After sufficient experience with it the introduction of this construction may be considered for other types of aircraft.

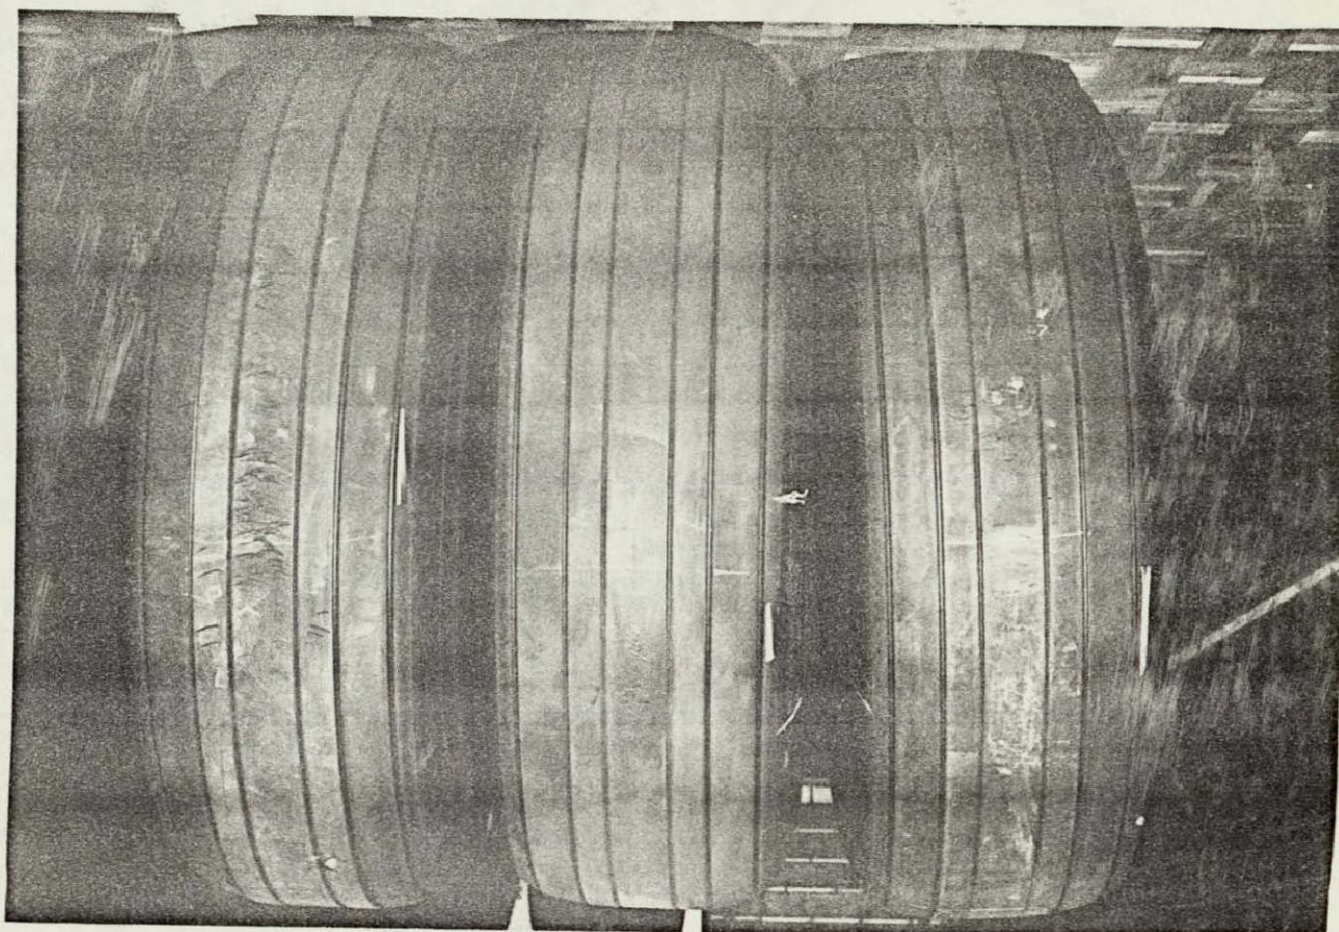
The softer rubber mixture showed no difference from the previous normal running surface mixture with regard to susceptibility to Chevron Cutting. Length and depth of the breaks is also about the same for both mixtures. Figs. 11 and 12 show the extent and Figs. 13 and 14 the characteristic of Chevron Cuts on Mader rubber cappings.

Fig. 11 MAEDER--normal mixture typical appearance of worn-out tires.

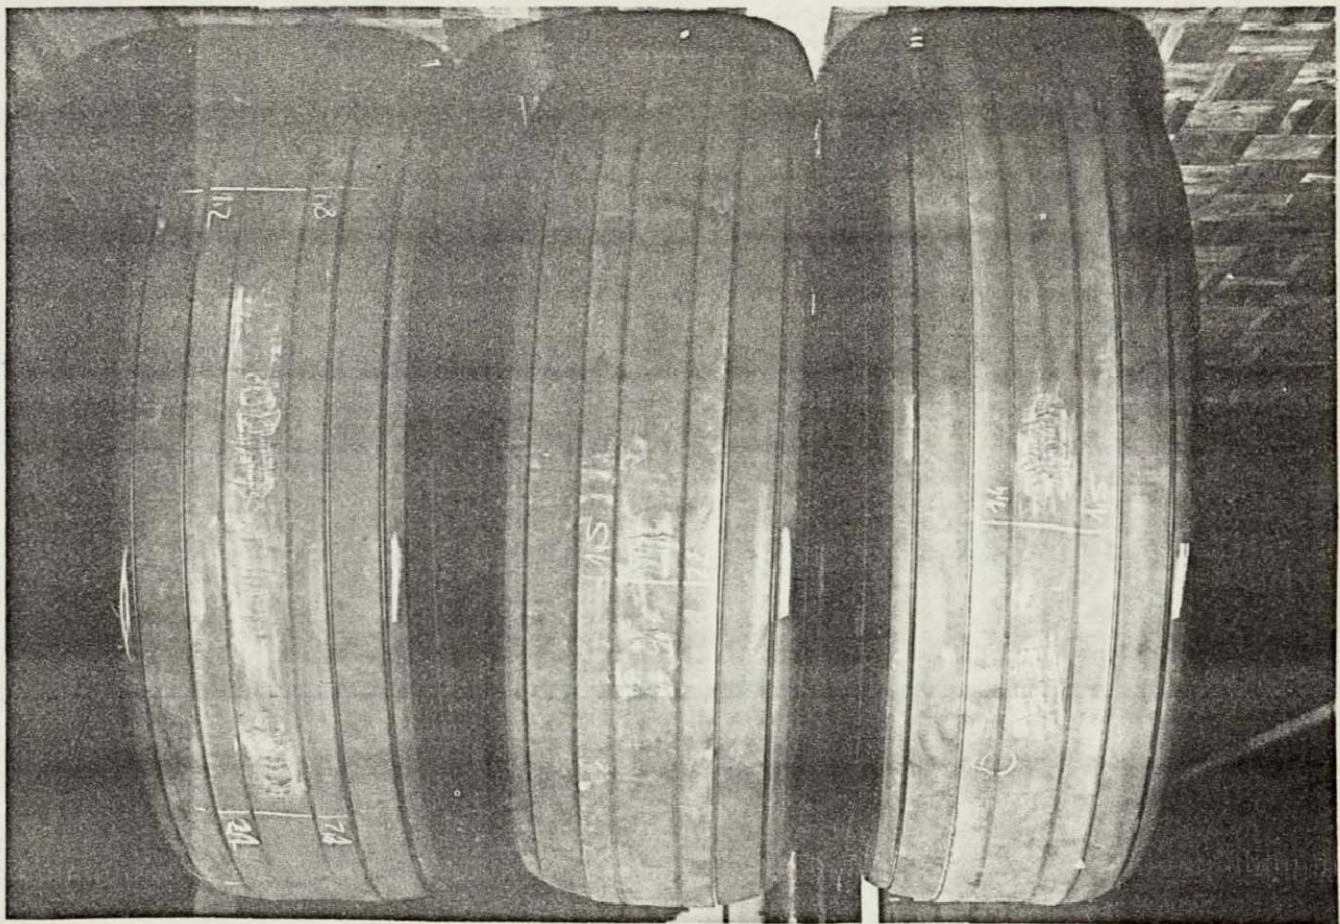
Fig. 12 MAEDER-soft rubber mixture typical appearance of worn-out tires.

--Since no better results were achieved with the soft rubber mixture it is suggested that this mixture not be introduced.

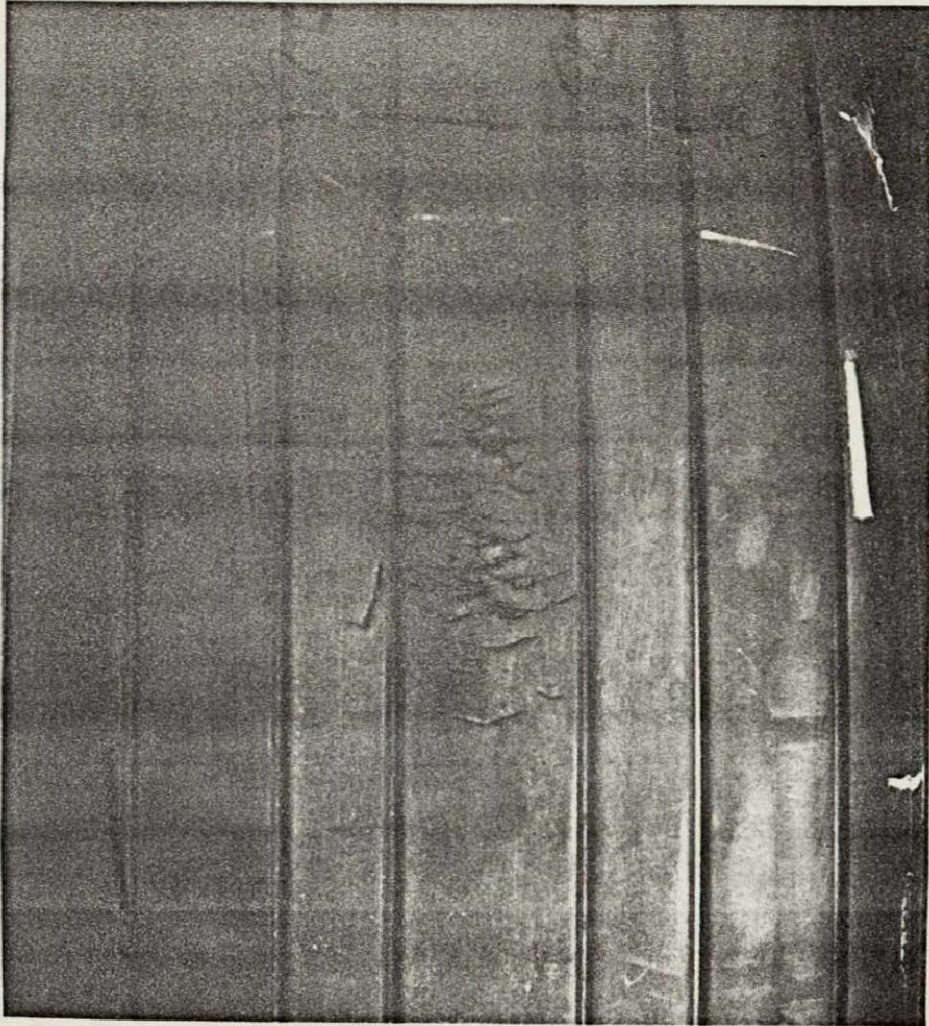
Fig. 13 MAEDER--normal mixture with typical Chevron Cuts.

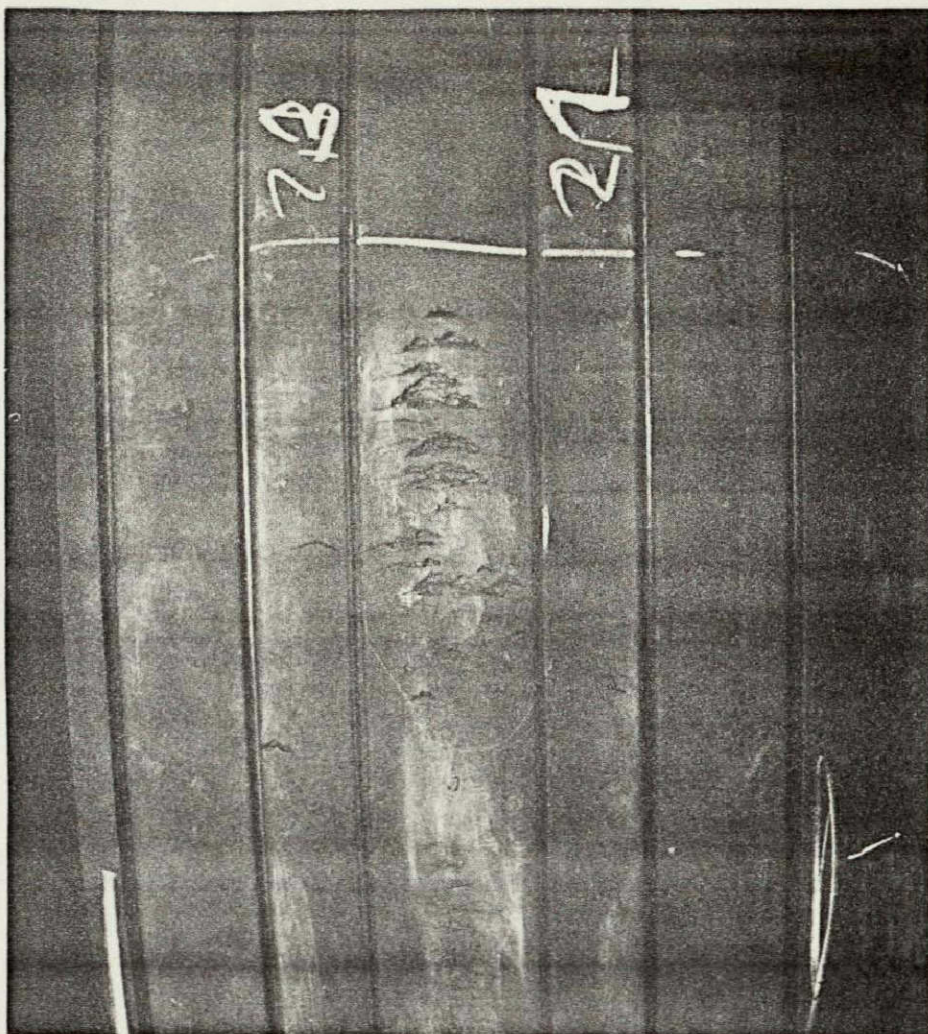
Defects that are caused by Chevron Cutting are relatively harmless. No complete separations from the running surface or blowouts will result. Only breaking off of rubber or rib separations above the reinforcement layers can happen (see Fig. 14).

Fig. 14 MAEDER--soft rubber mixture with typical Chevron Cuts.

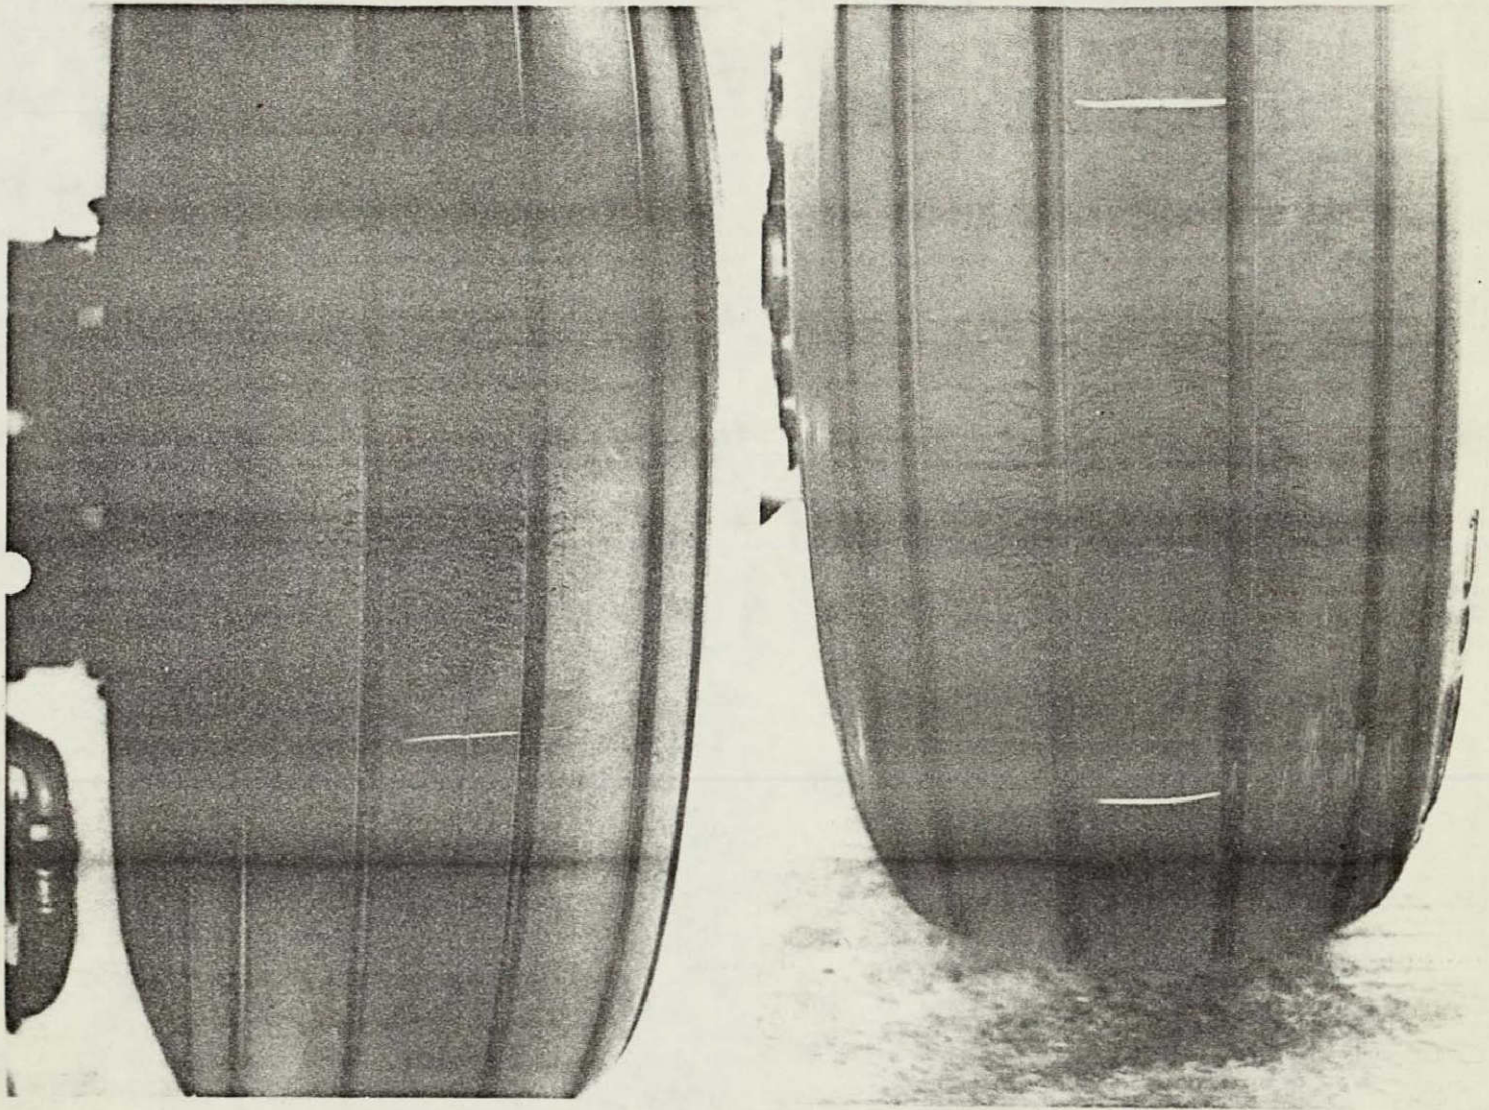
During the first phase of operation of this runway the previous "Chevron Cutting" characteristic changed for one of the rubber-capping fabrics (Thompson). The breaks become closer, shorter and shallower (see Fig. 15). This effect was not observed any longer after a few days had passed. It is assumed, therefore, that the brush finish texture is quickly filled by the worn rubber and thus loses its effect.

The extent of Chevron Cutting differs for the various rubber capping fabrics according to the different rubber mixtures. It could be observed, for instance, that breaks at the running surfaces are shorter for natural rubber mixtures than for synthetic mixtures (Fig. 15). Chevron Cutting occurs with different intensity at all types of aircraft, resp. tire dimensions.

Fig. 15 This form of Chevron Cutting could be observed during the run-in phase of runway 16/34, which had been equipped with a brush-finish surface texture, but only on Thompson cappings.

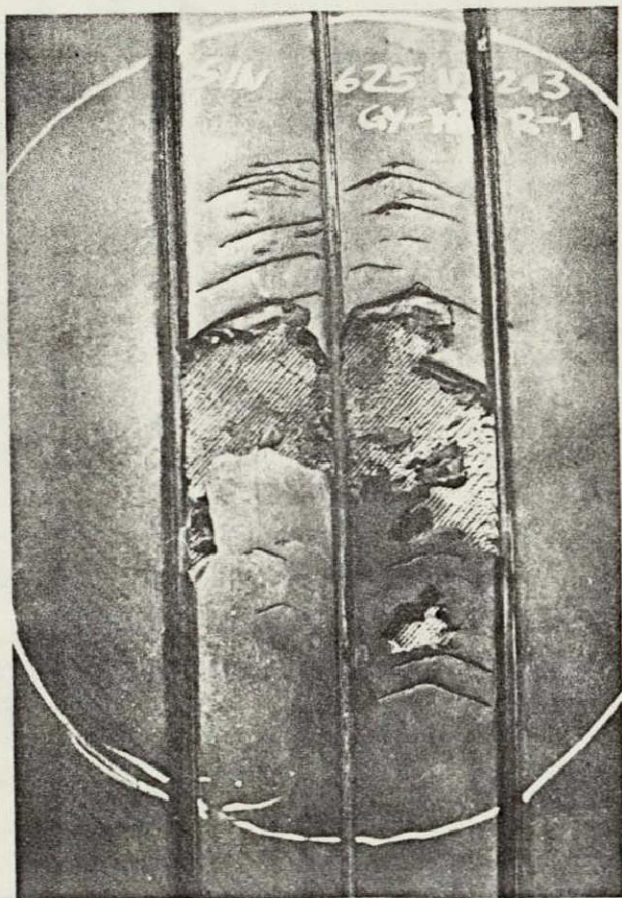
Fig. 16A (DC-10 NLG)

| <u>A/C</u> | <u>L-<br/>Gear</u> | <u>Fabric</u> | <u>Description of Defect</u> |
|---|---|---|---|
| DC-10-30 | NLG | Mader | Rubber breaking off (Fig. 16A) |

Three defects occurred on DC-10-30 tires that were capped by the Mäder Company (Figs. 16A, 16C). One defect occurred on a new B-747 tire from the Kleber Company (Fig. 16B).

Rubber breakouts caused by Chevron Cutting

--It is suggested that the Mäder Company make some changes in the rib configuration of the rubber mixture on this type of tire since only Mäder-capped DC-10-30 NLG-tires suffered defects from Chevron Cutting.

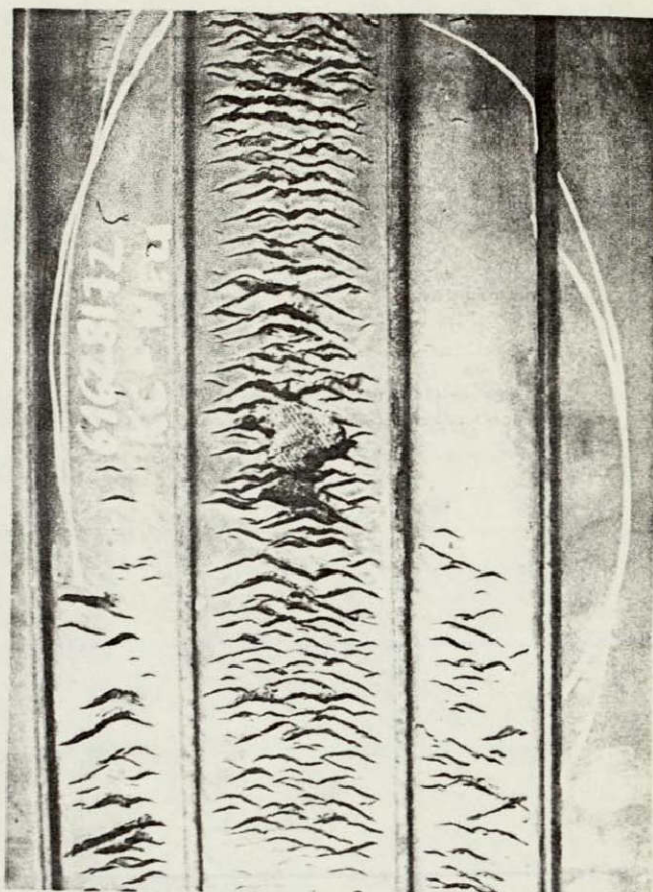
Fig. 16B (B-747)

| <u>A/C</u> | <u>L-<br/>Gear</u> | <u>Fabric</u> | <u>Description of Defect</u> |
|---|---|---|---|
| B-747 | MLG | Kleber | Rubber breaking off (Fig. 16B) |

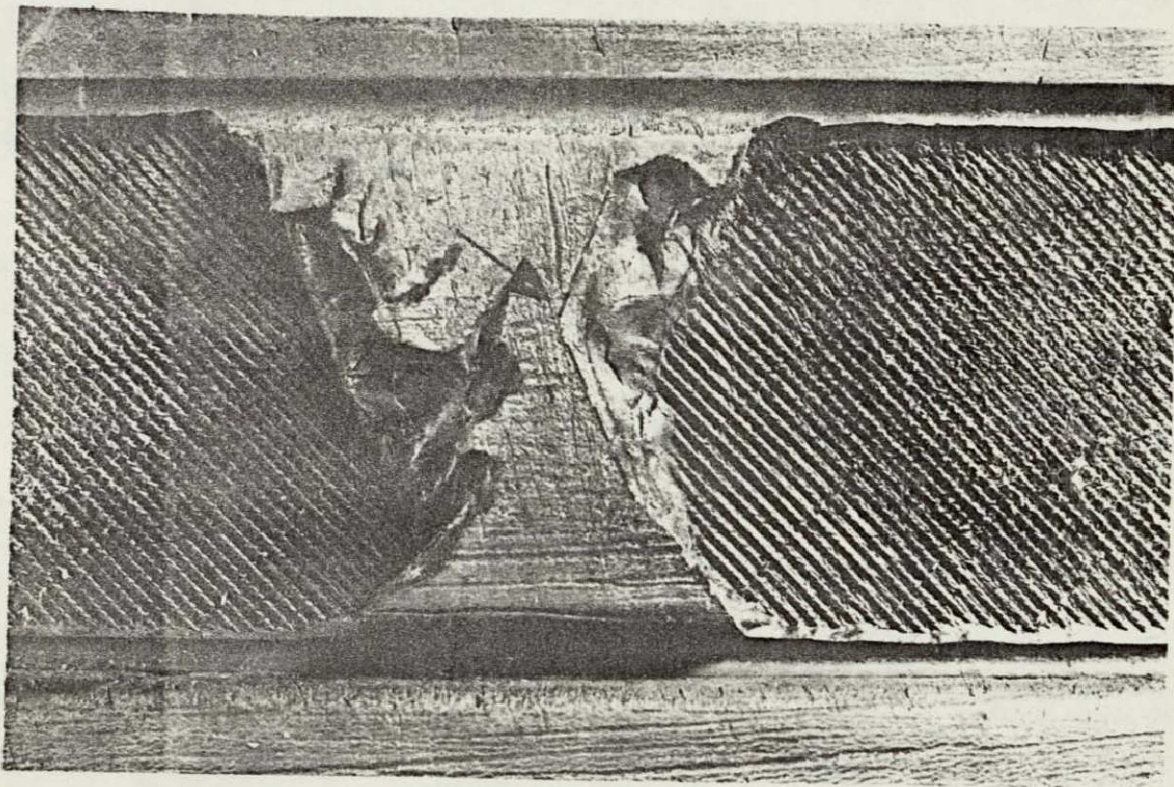
| <u>A/C</u> | <u>L-<br/>Gear</u> | <u>Fabric</u> | <u>Description of Defect</u> |
|---|---|---|---|
| DC-10-30 | NLG | Mader | Rib separated by 60 cm (Fig 16C) |

Fig. 16C Chevron Cutting is the point of origin for a rib separation (DC-10 NLG).

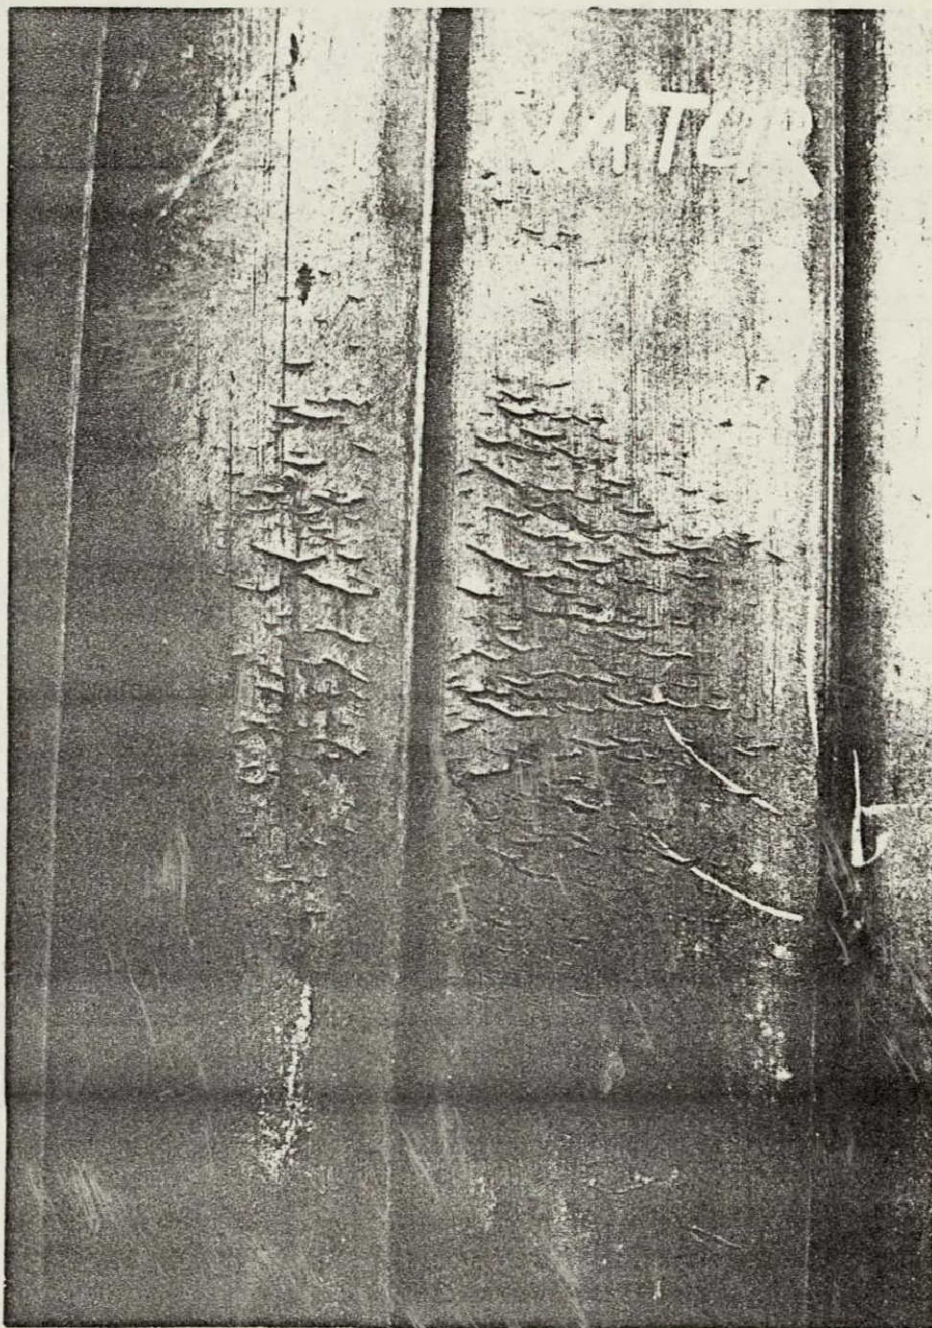
Fig. 17 THOMPSON--natural rubber mixture mit shorter breaks.

aircraft tires and capping fabrics used the B-747 running surfaces by Thompson are the most seriously affected by Chevron Cutting. It is suggested that this type of tire be capped with natural rubber or some improved rubber mixture, for the time being.
