DOE/NASA/1892-78/1  
NASA CR-159393  
WQEC/C 78-224

# **BLOCK II SOLAR CELL MODULE ENVIRONMENTAL TEST PROGRAM**

Kevin L. Holloway  
Naval Weapons Support Center

**October 1978**

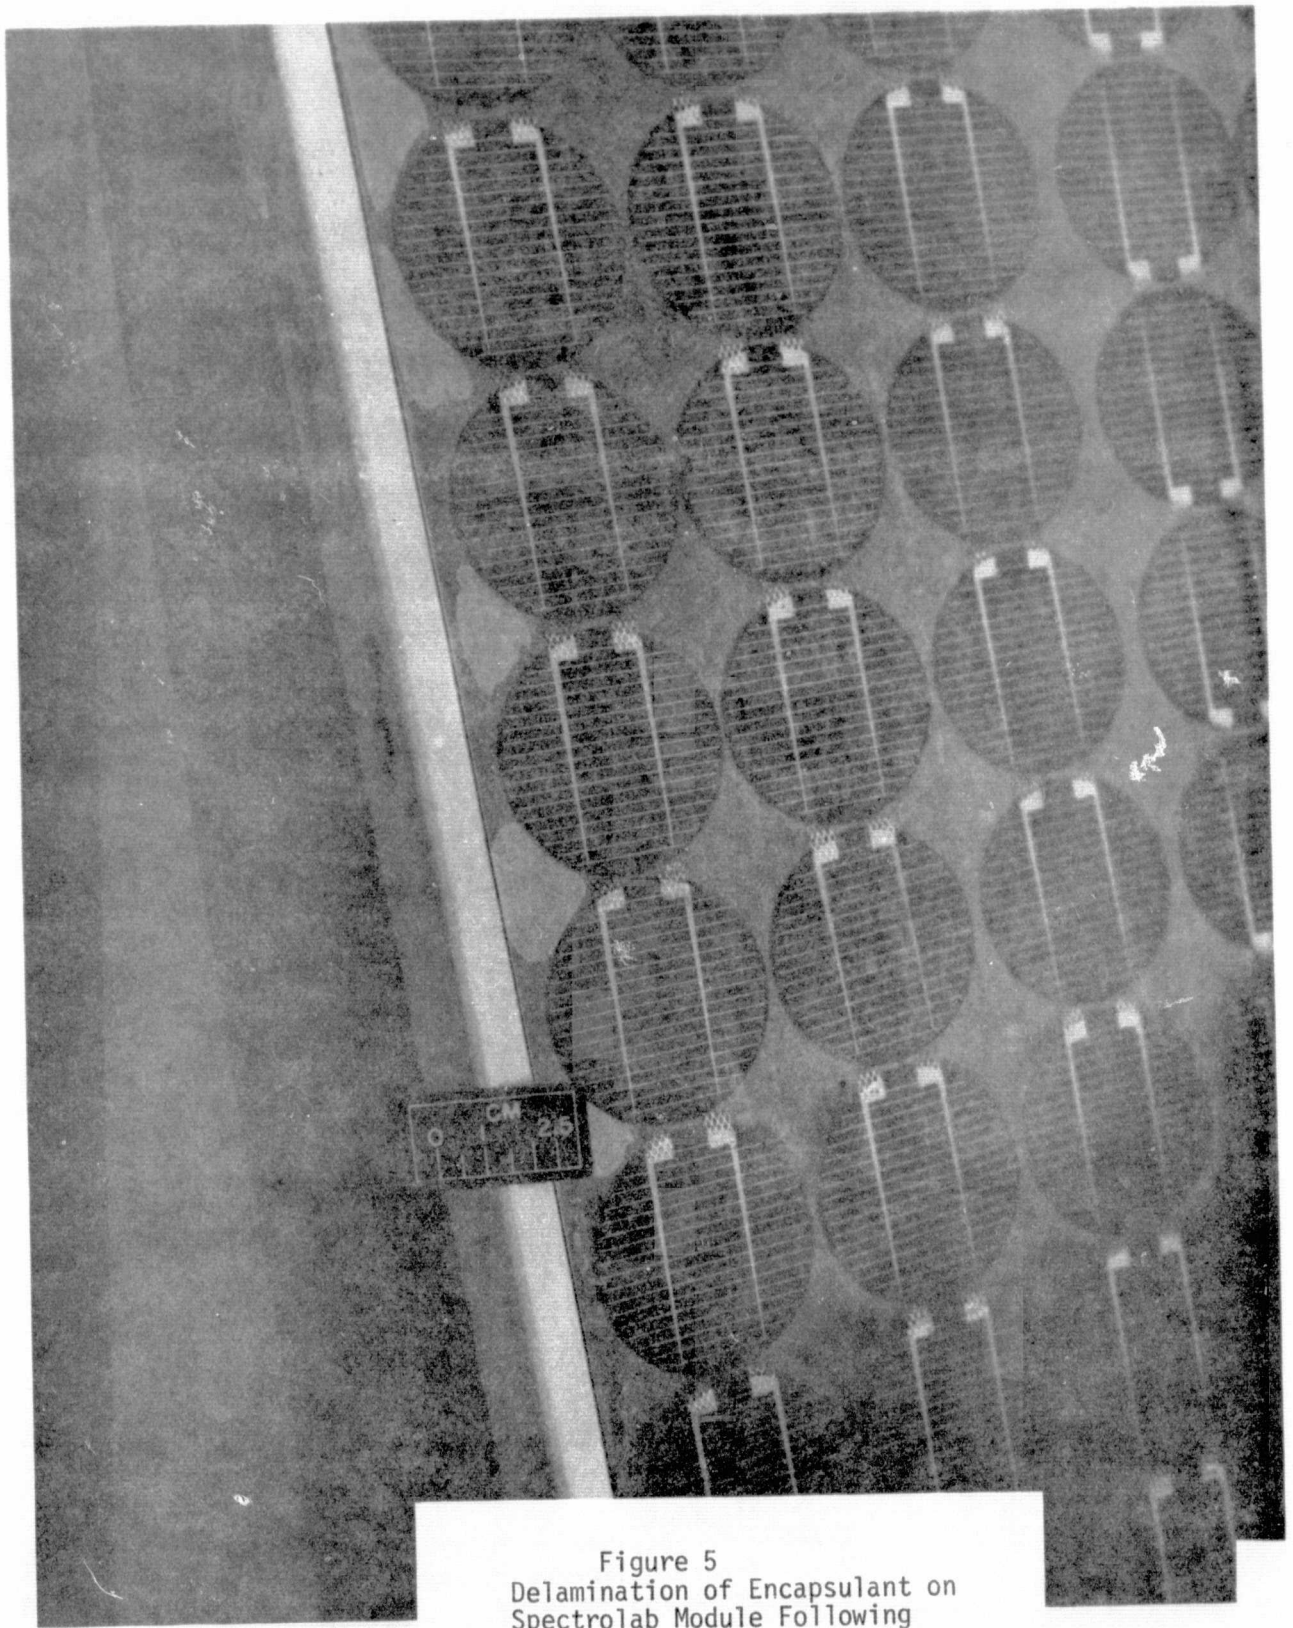
Spectrolab - all modules showed some delamination of the encapsulant where it is fastened to the glass as shown in Figure 5. The cells showed no visible defects.

Figure 5  
Delamination of Encapsulant on  
Spectrolab Module Following  
28-Day Temperature and Humidity

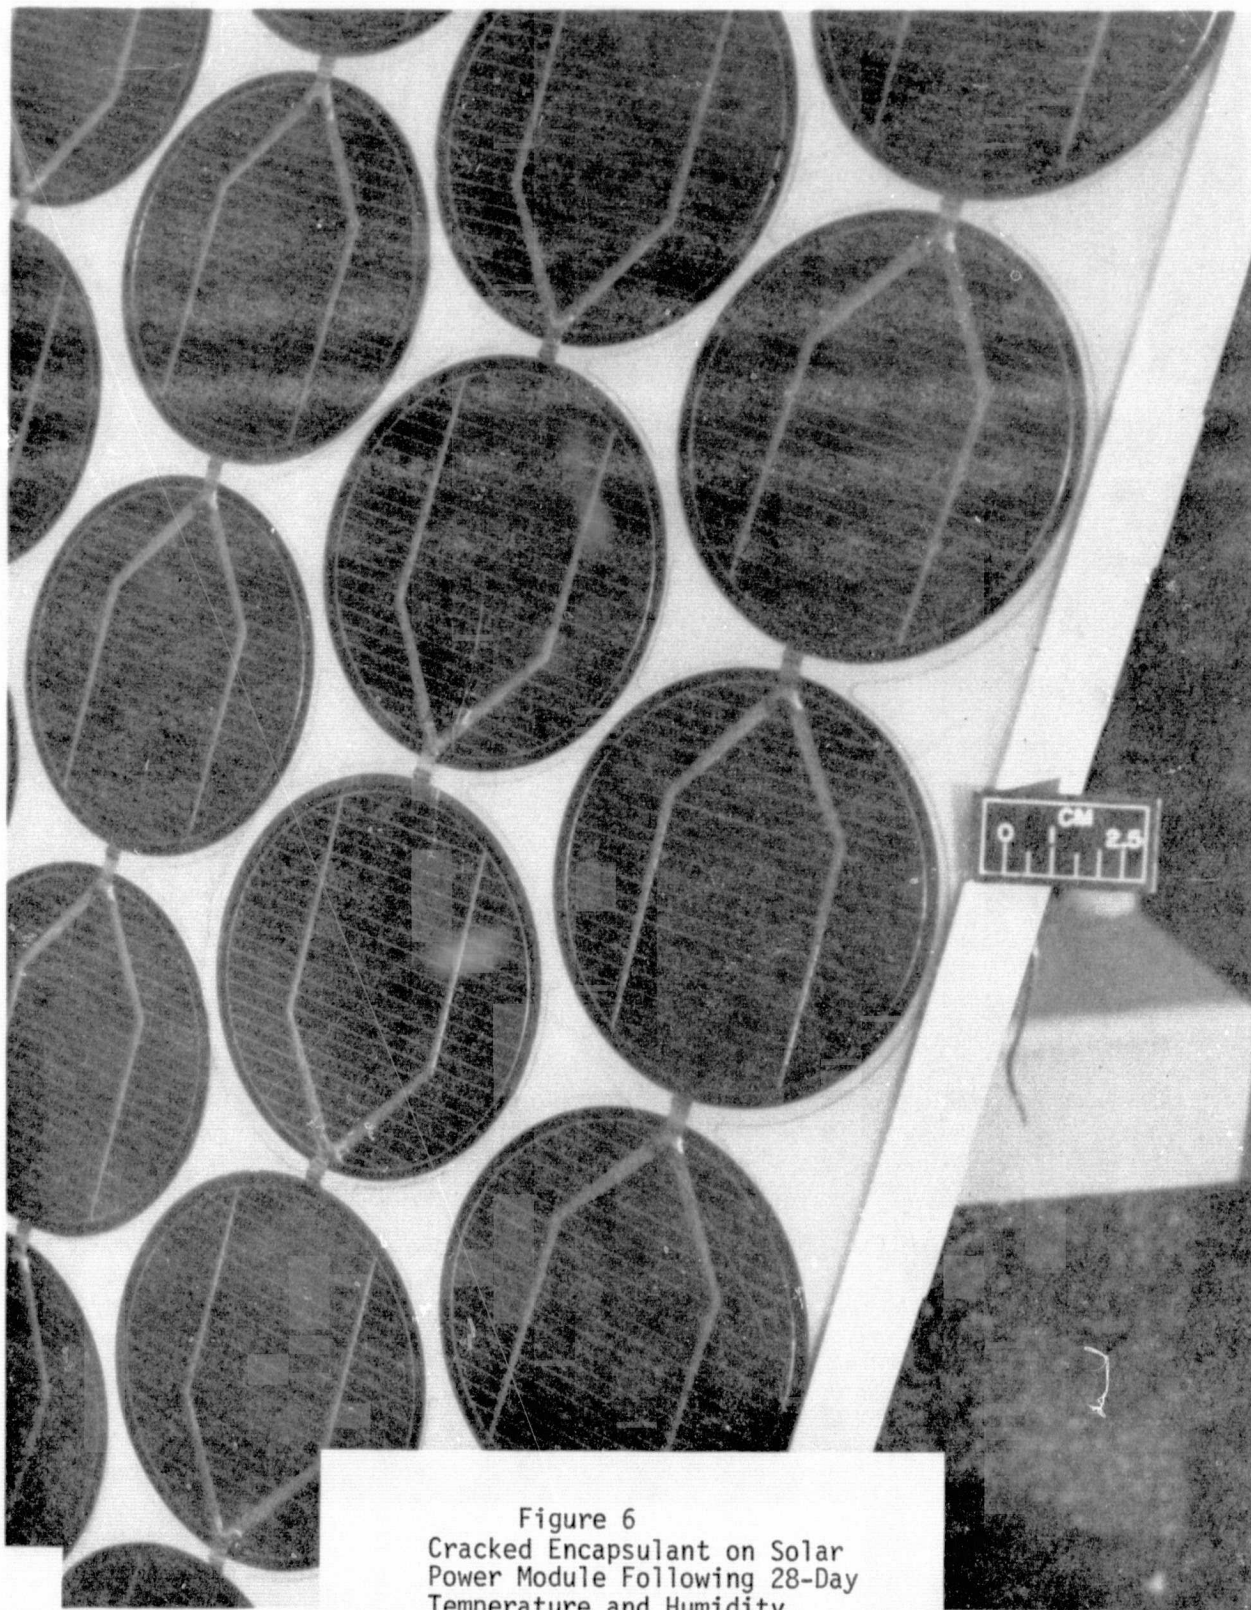
Solar Power - The encapsulant on all modules was cracked, some in the upper layer and some through both layers as shown in Figure 6. Some cells were corroded.

Figure 6  
Cracked Encapsulant on Solar  
Power Module Following 28-Day  
Temperature and Humidity

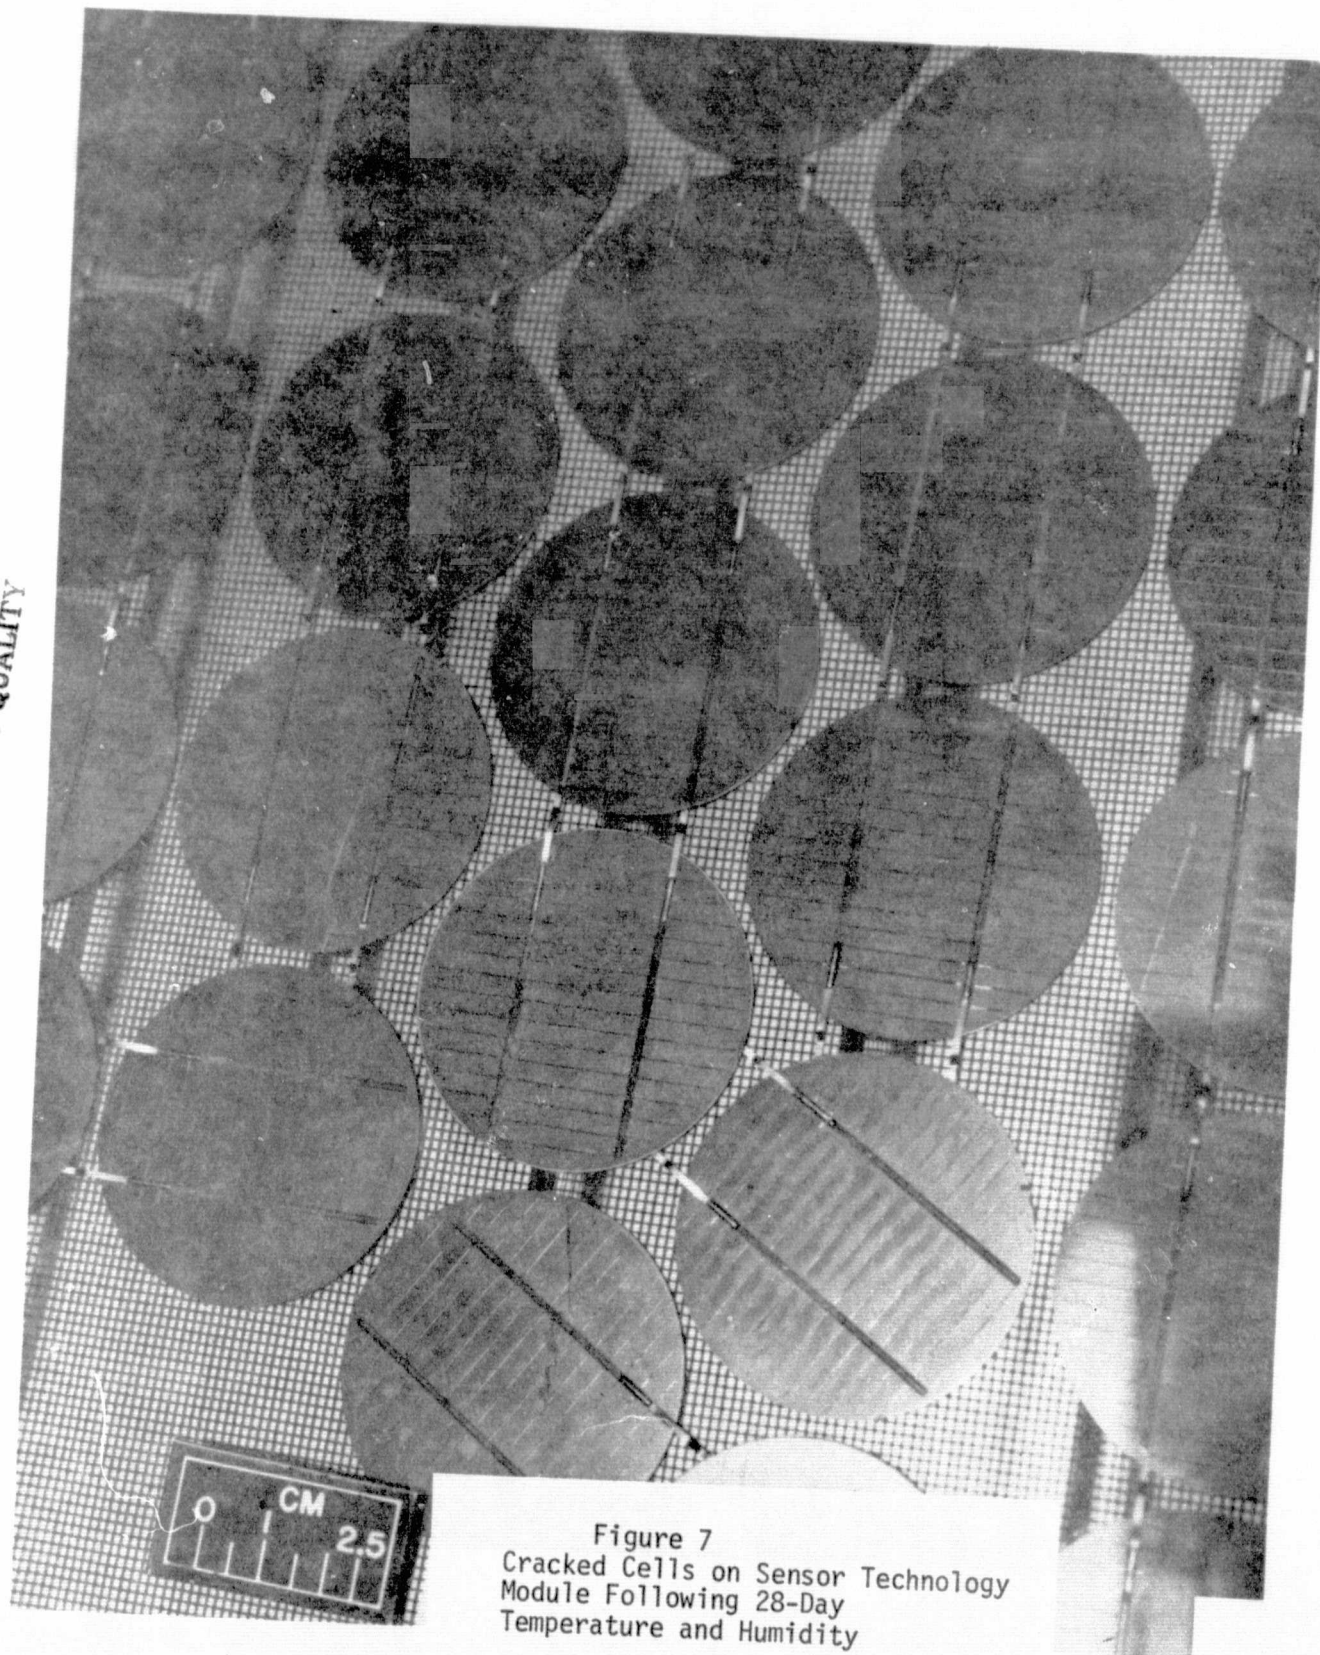
Sensor Technology - cells in all modules showed fading and corrosion. S/N 0143 had several cracked cells as shown in Figure 7.

Figure 7  
Cracked Cells on Sensor Technology  
Module Following 28-Day  
Temperature and Humidity

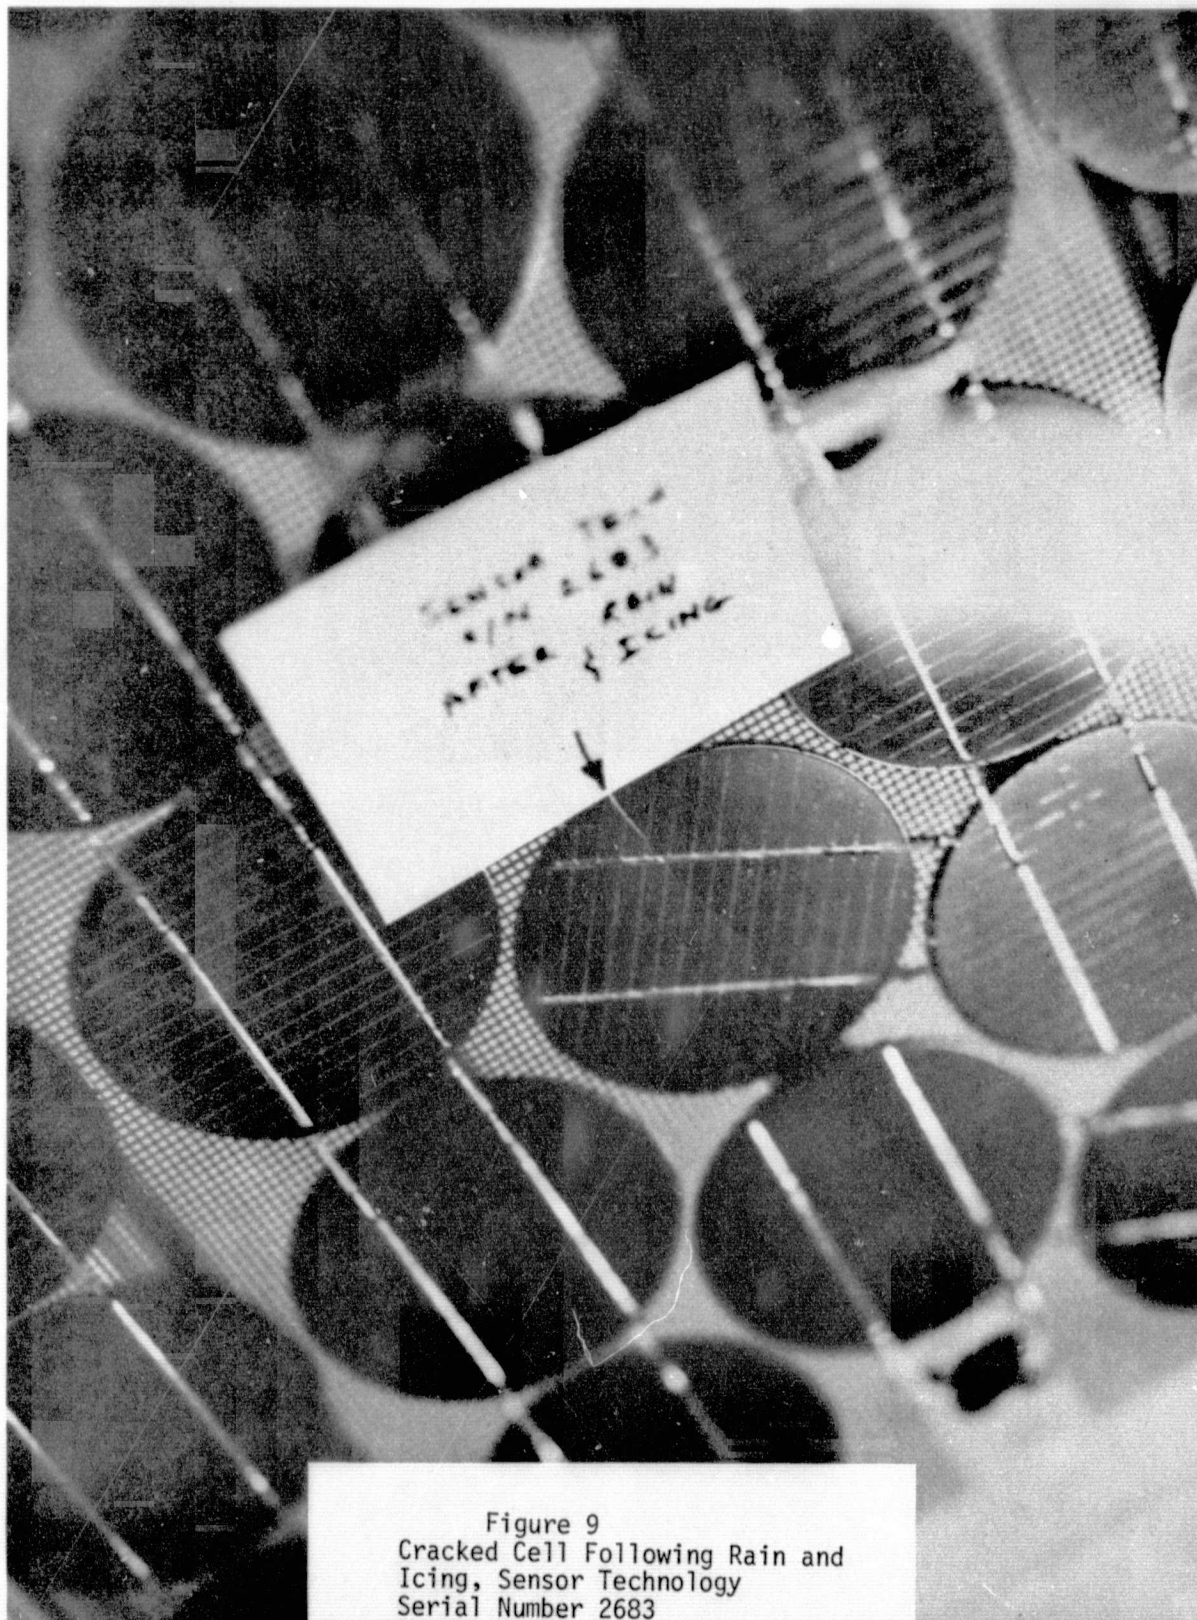
A visual check of the modules following rain and icing showed that Sensor Technology S/N 2683 had one cracked cell, shown in Figure 9. Figure 9 is typical of cracked cells occurring throughout the test program. All other modules showed no visible defects. A visual check was not made between the rain test and the icing test.

Figure 9  
Cracked Cell Following Rain and  
Icing, Sensor Technology  
Serial Number 2683

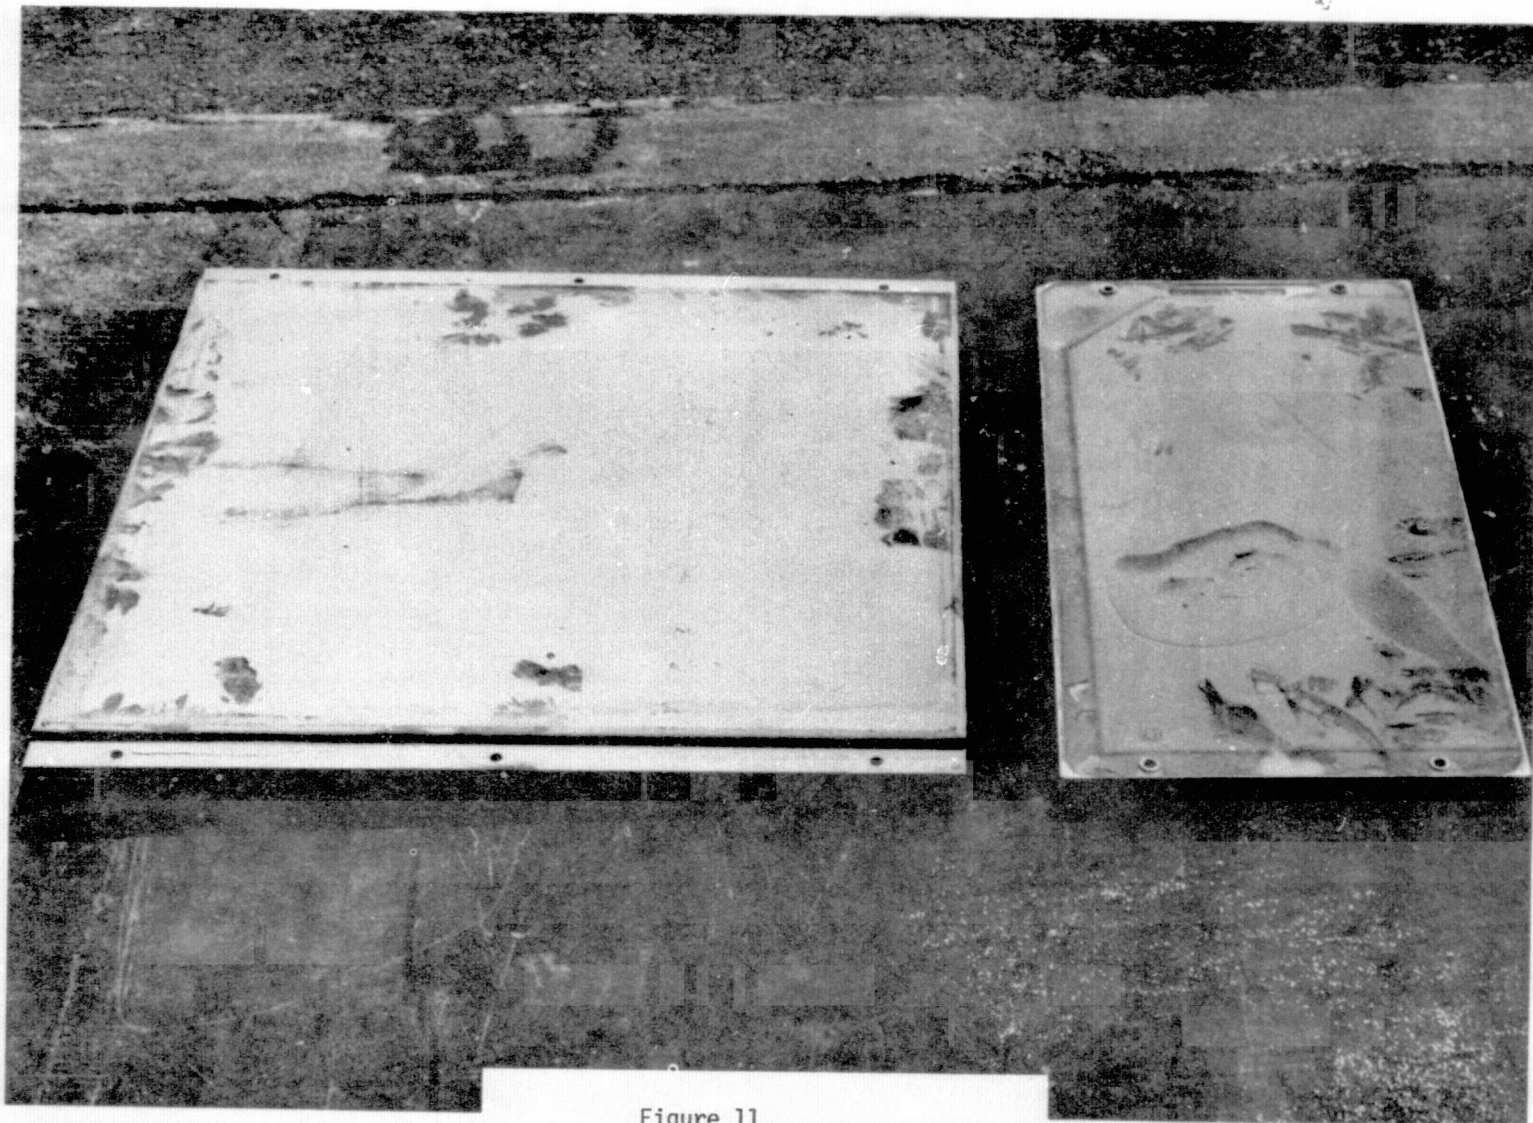
A visual examination following the sand and dust test showed that the Solarex and Sensor Technology modules were extremely dusty making it impossible to see the cells or encapsulant to check for material damage. Figure 11 shows one Solarex module and one Sensor Technology module following sand and dust. The Spectrolab and Solar Power modules were also dusty but the dust film was light enough that the cells and encapsulant could be seen. There was no visible damage to the Spectrolab and Solar Power modules. The modules were returned to NASA Lewis Research Center for post-test analysis without being cleaned so it is not known if the dust was embedded in the encapsulant or just lying on the surface.

Solarex and Sensor Technology  
Modules Following Sand and Dust

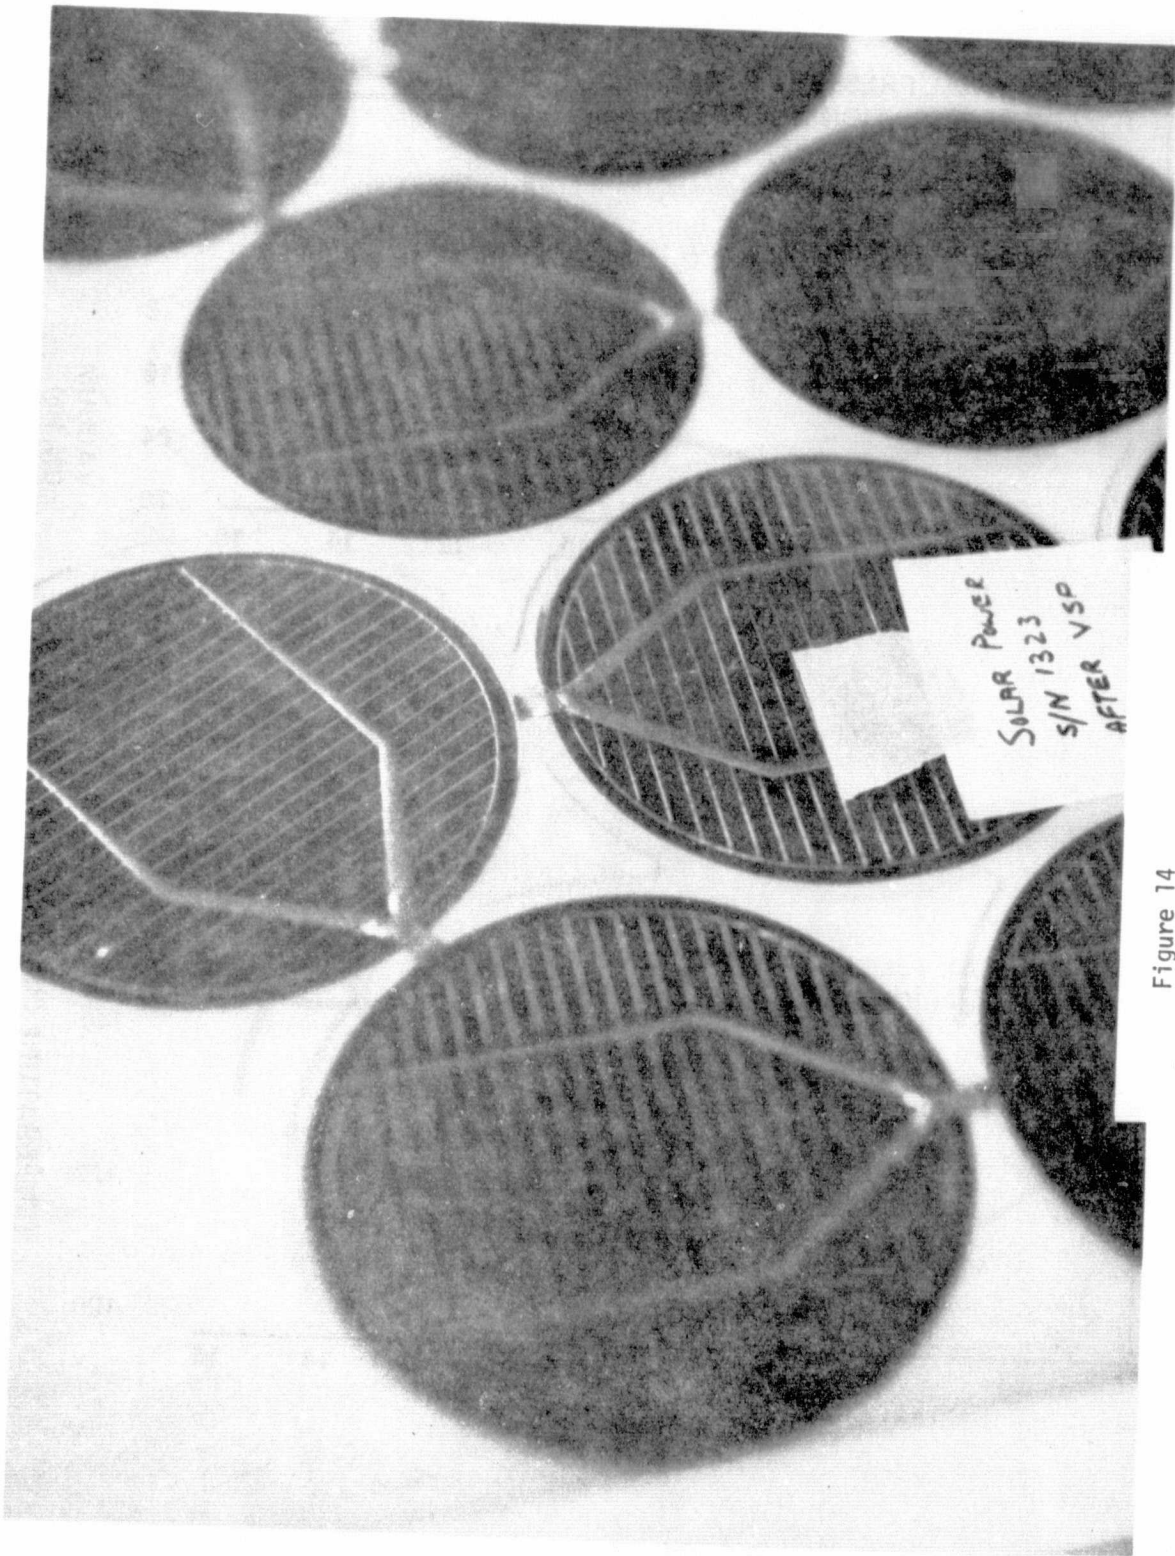
Solar Power - There were numerous cracks in the encapsulant (approximately 15 places on S/N 1287, 21 places on S/N 1307 and 15 places on S/N 1323). The encapsulant had delaminated from the backing in several spots on all modules. Figure 14 shows the delaminated and cracked encapsulant on S/N 1323. Figure 14 is typical of cracked and delaminated encapsulant occurring during VSP and other environmental tests for all types of modules. S/N 1287 had one cracked cell (row 3, cell 1). S/N 1307 showed signs of corrosion on two cells (row 4, cells 5 and 6) as shown in Figure 15.

Figure 14  
Cracked and Delaminated Encapsulant  
Following Vacuum/Steam/Pressure,  
Solar Power Serial Number 1323

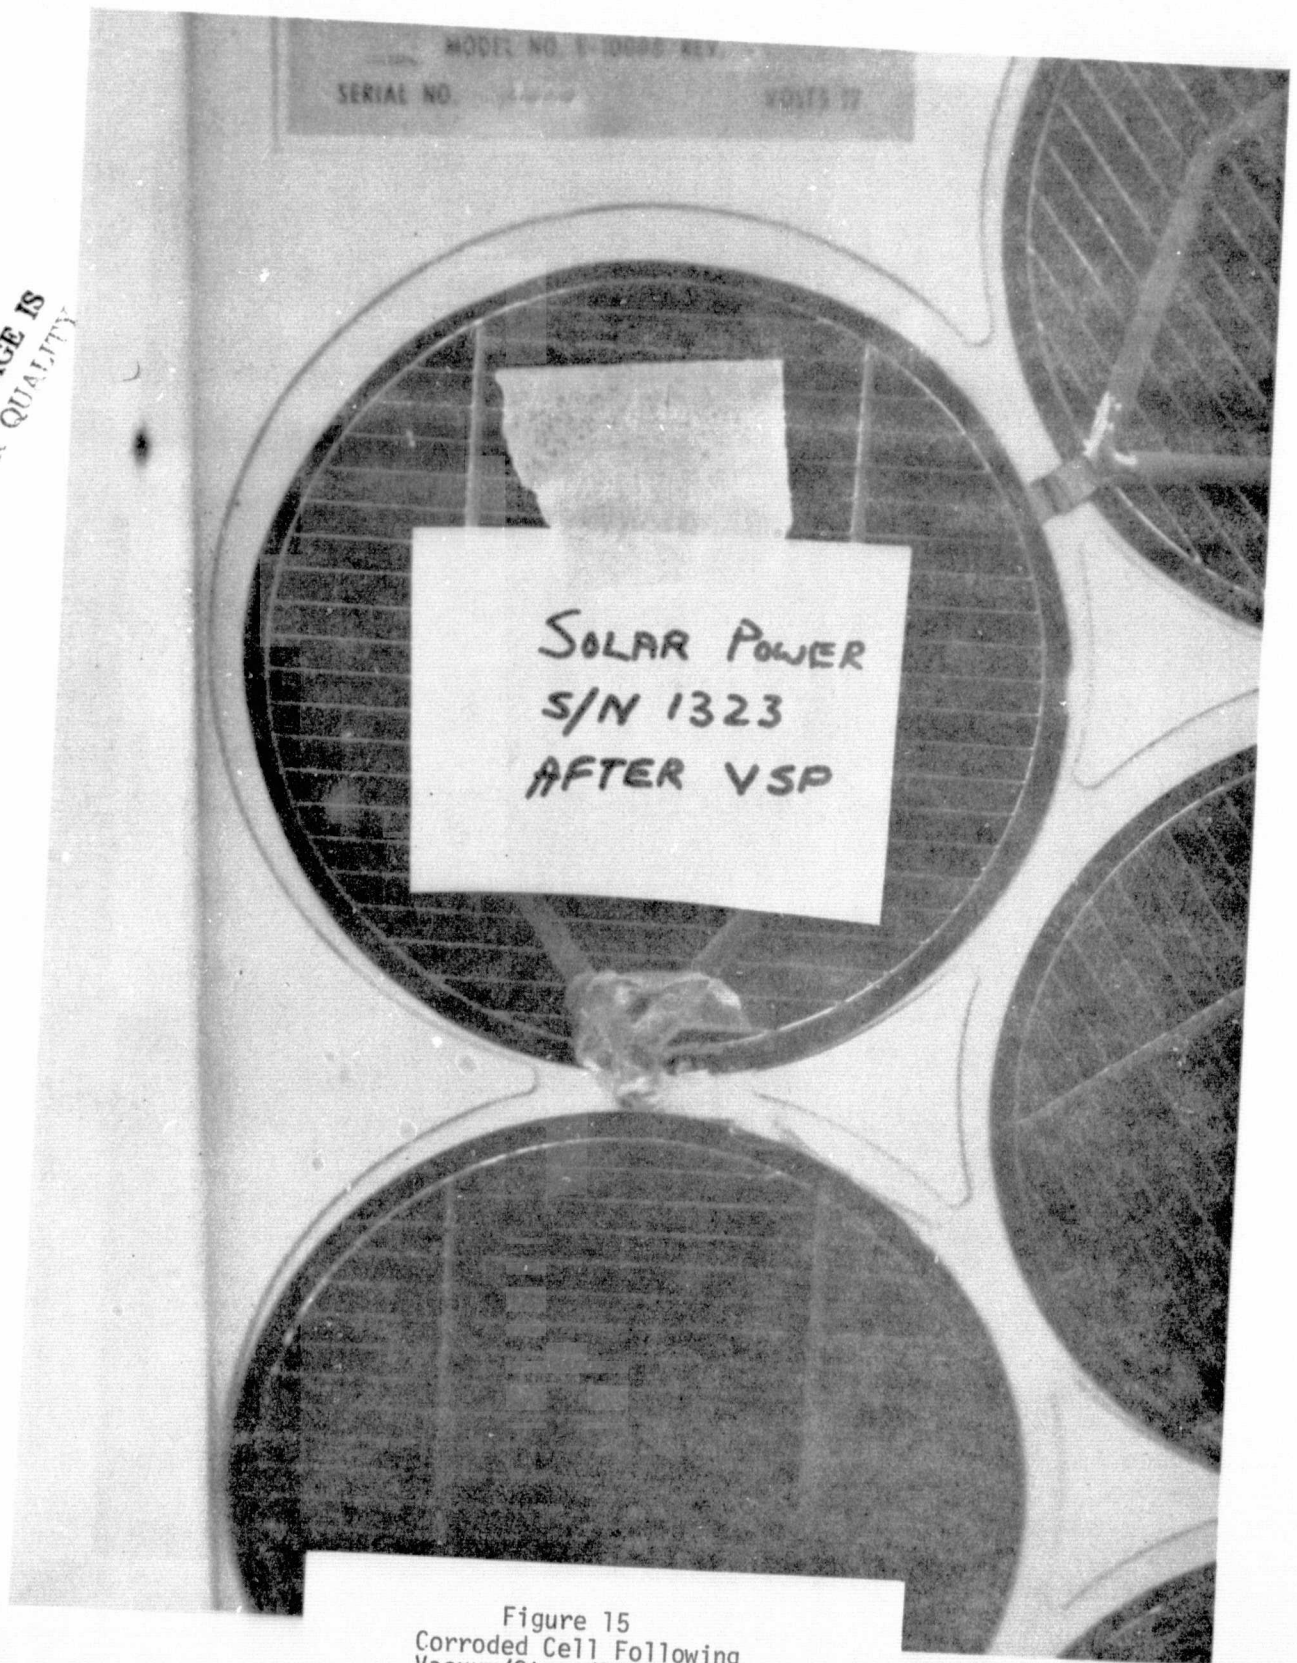
Figure 15  
Corroded Cell Following  
Vacuum/Steam/Pressure, Solar  
Power Serial Number 1323

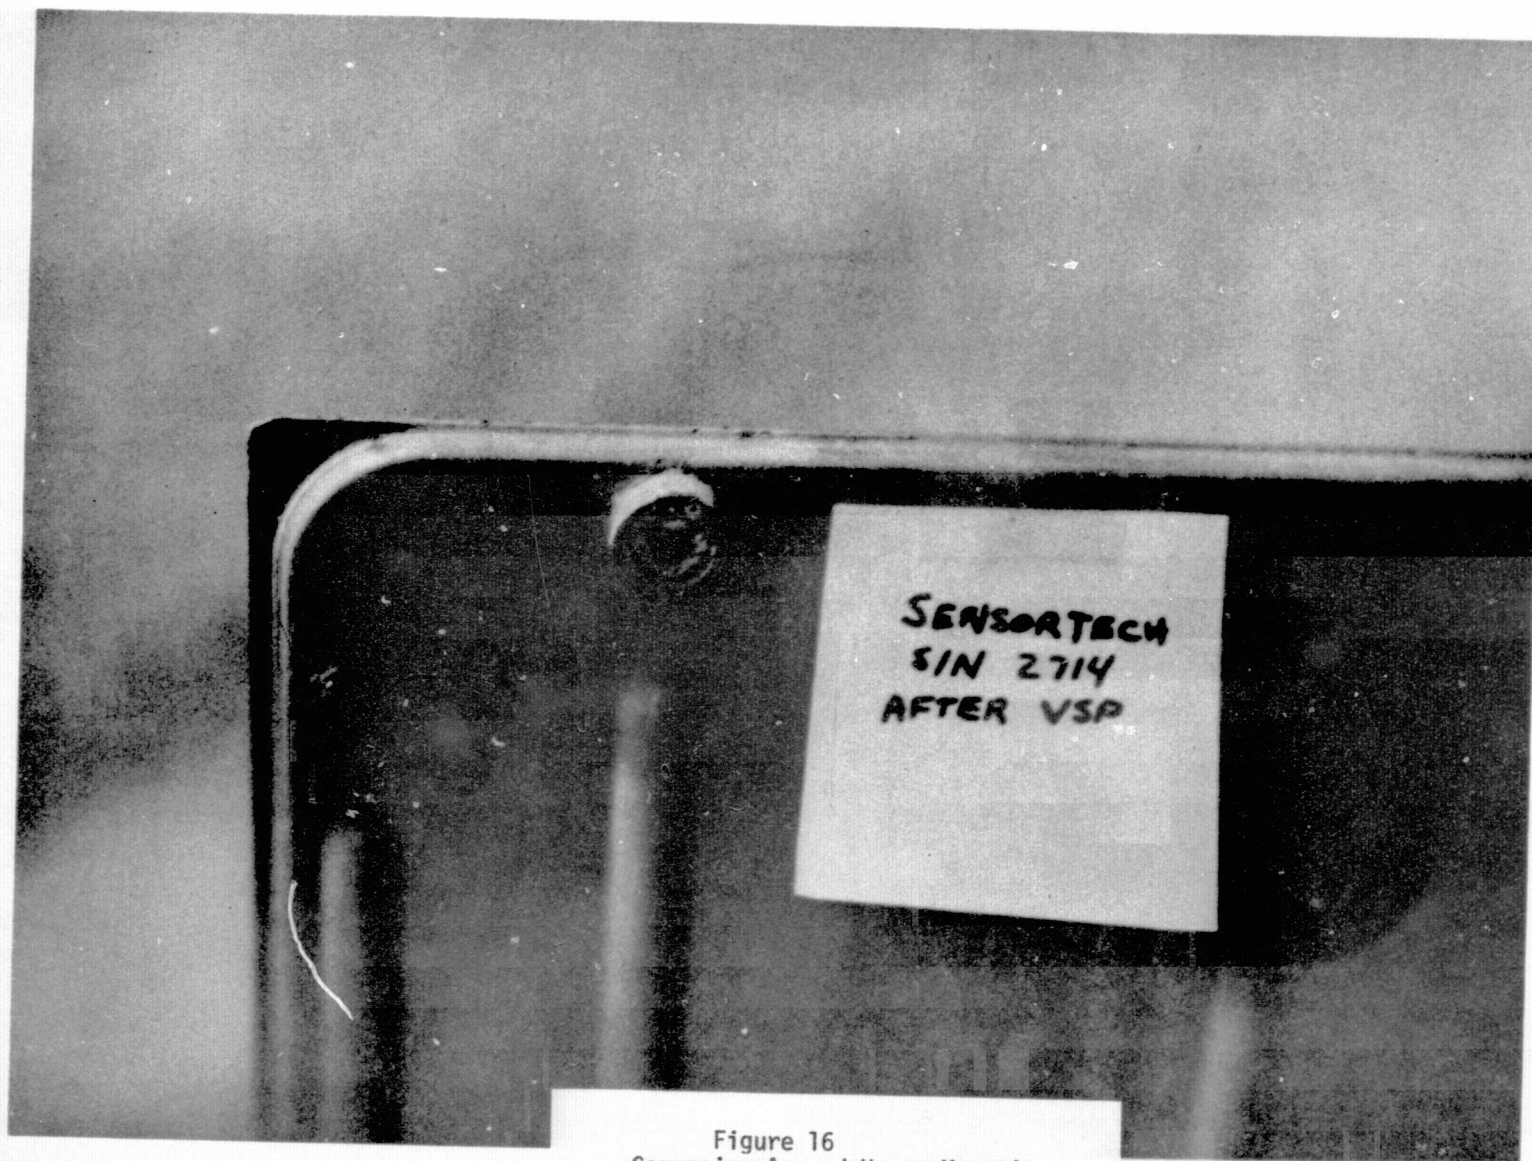
Sensor Technology - There were numerous cracks in the encapsulant (approximately 25 places on S/N 1786, 17 places on S/N 2671 and 24 places on S/N 2714). Some cells were discolored near the cracks. S/N's 1786 and 2714 had corrosion around the upper mounting holes as shown in Figure 16.

Figure 16  
Corrosion Around Upper Mounting  
Hole of Sensor Technology  
Module Following Vacuum/Steam/  
Pressure

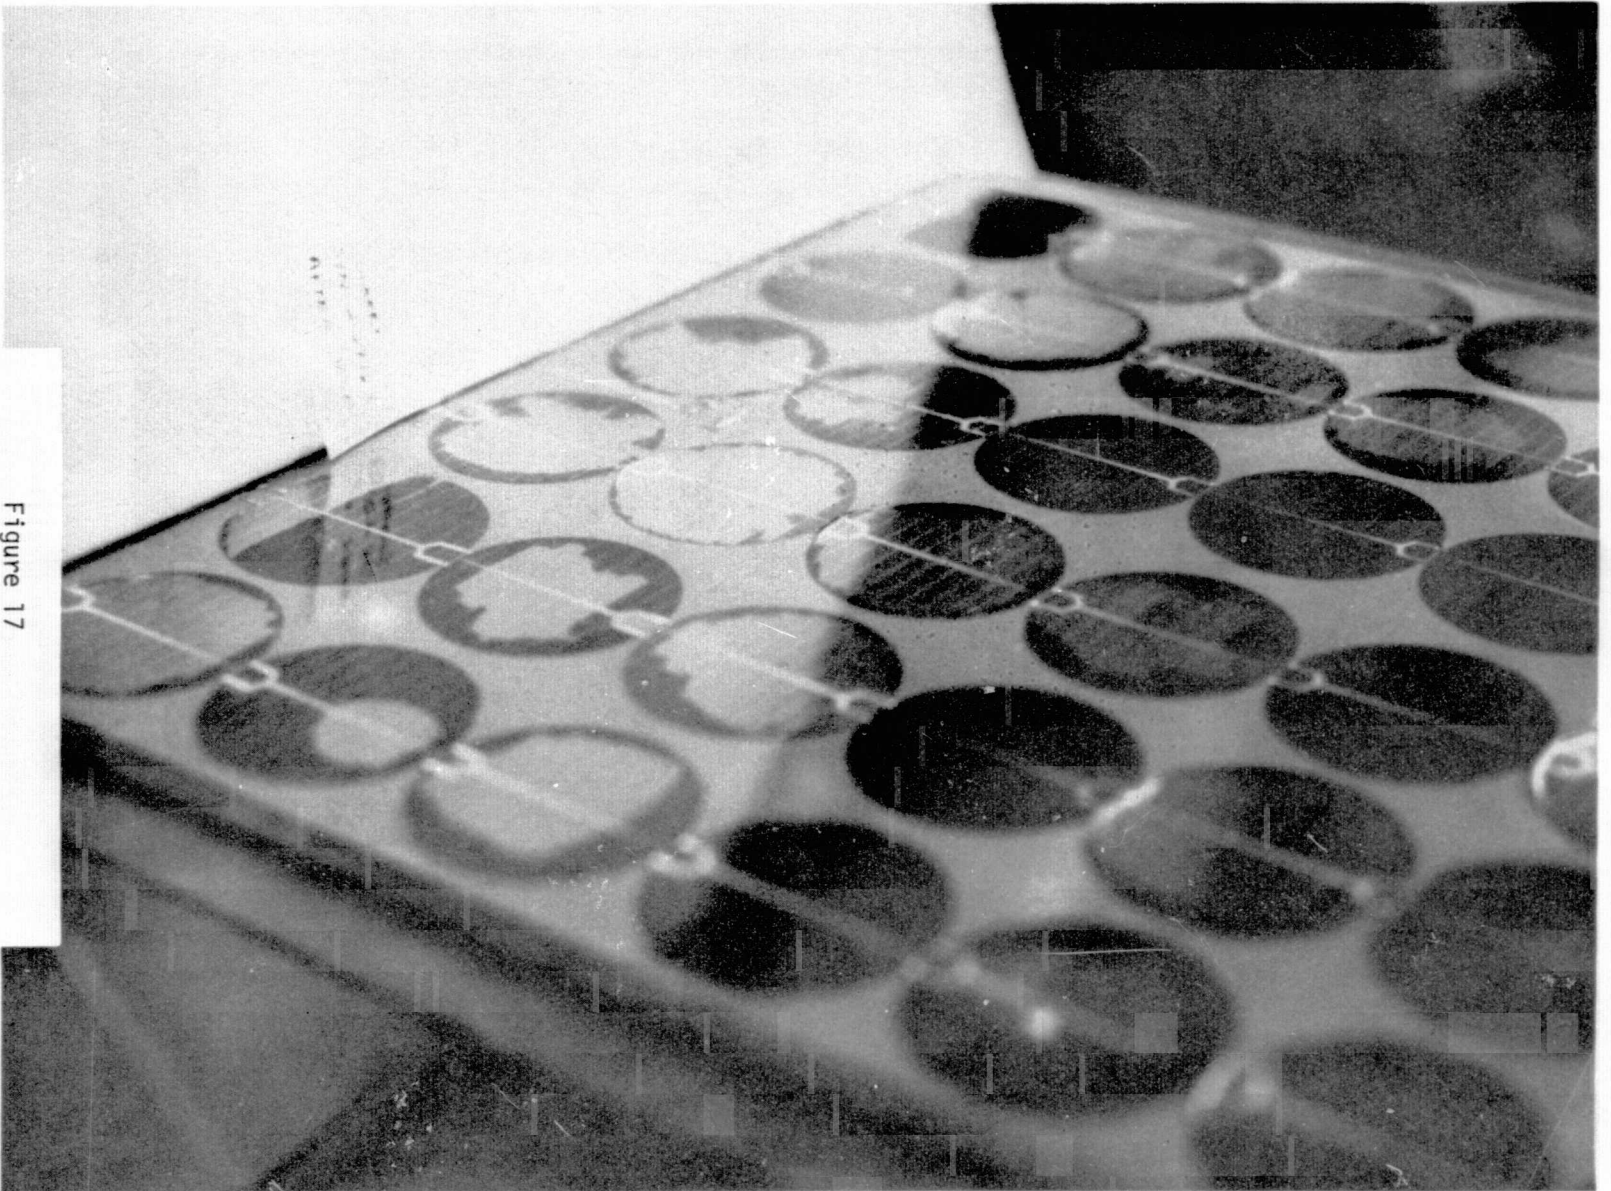
Solarex - There were numerous cracks in the encapsulant (approximately 14 places on S/N 229156, 18 places on S/N 228138 and 17 places on S/N 229163). The encapsulant was delaminated in numerous places. Figure 17 shows some of the delaminations on S/N 229163. There was some pitting of the frame of S/N 229163. The plugs in the terminal boxes were corroded on S/N's 229156 and 228138 as shown in Figure 18. The following cells were cracked:

Figure 17  
Delaminations of Encapsulant  
Following Vacuum/Steam/Pressure,  
Solarex Serial Number 229163

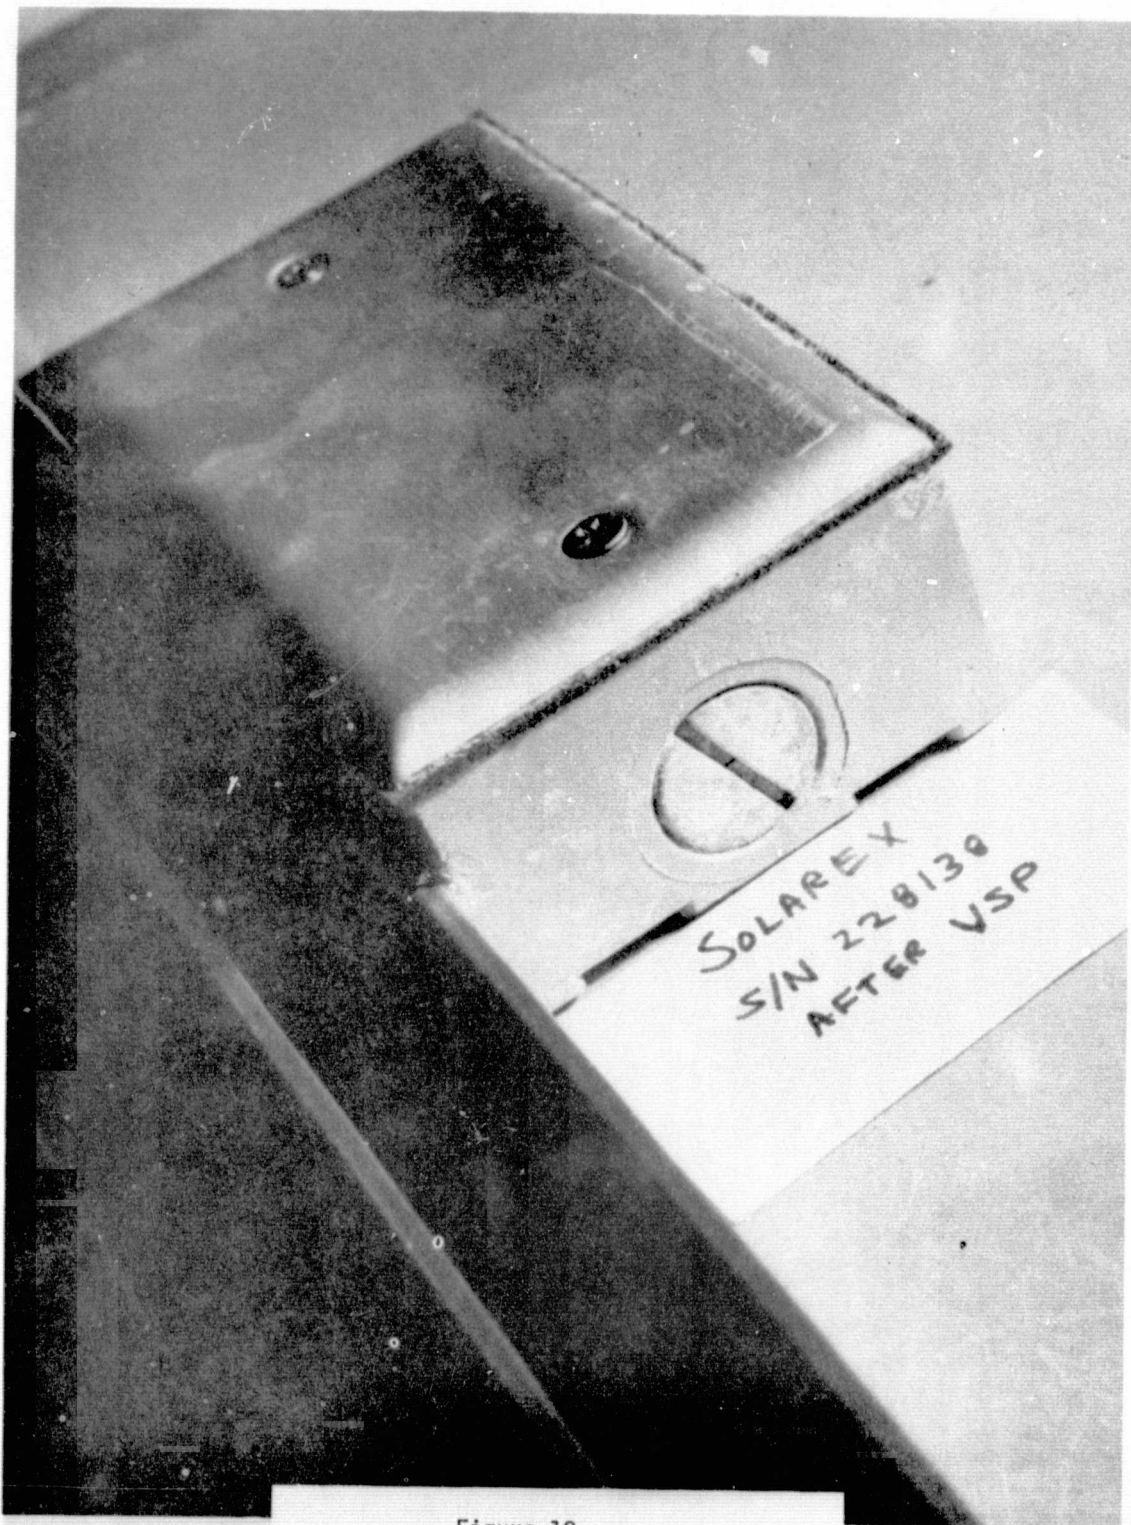
Figure 18  
Corroded Plug in Terminal Box  
of Solarex Module Following  
Vacuum/Steam/Pressure

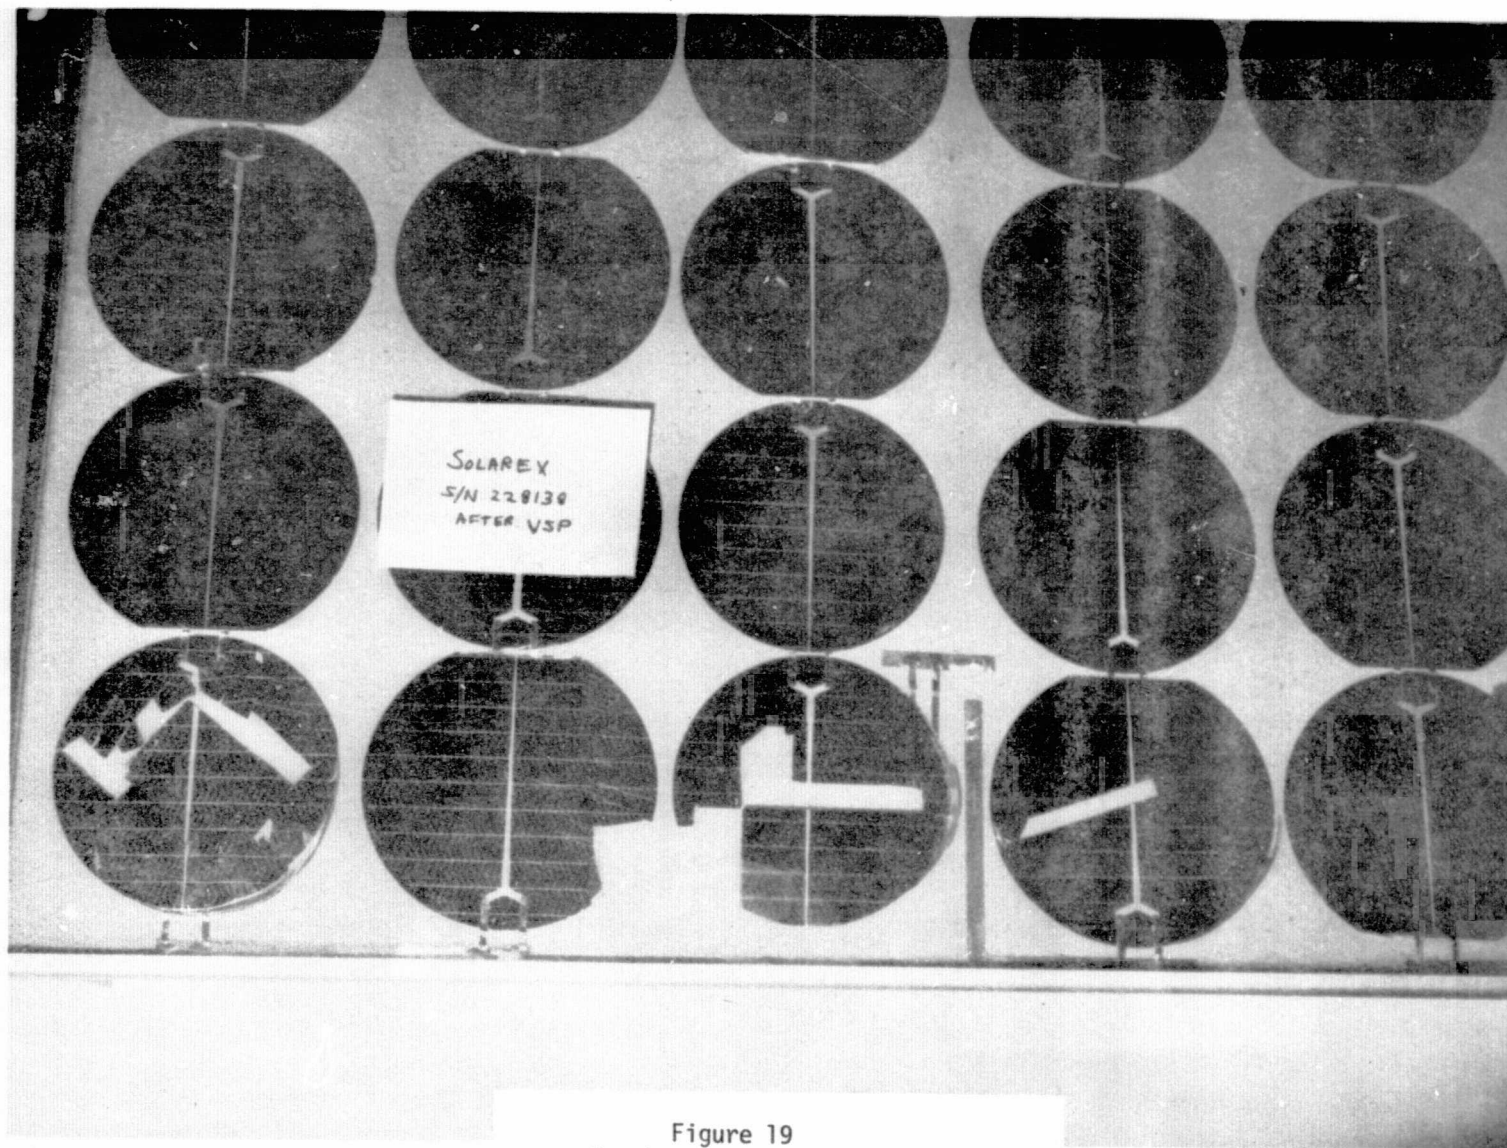
All of the cracked cells on S/N 228138 had pieces which had fallen down behind the rest of the cell as shown in Figure 19 and 20. This was possible because of the delamination of the encapsulant.

Figure 19  
Cracked Cells Following  
Vacuum/Steam/Pressure, Solarex  
Serial Number 228138
