DOE/NASA/1892-78/1  
NASA CR-159393  
WQEC/C 78-224

# **BLOCK II SOLAR CELL MODULE ENVIRONMENTAL TEST PROGRAM**

Kevin L. Holloway  
Naval Weapons Support Center

**October 1978**

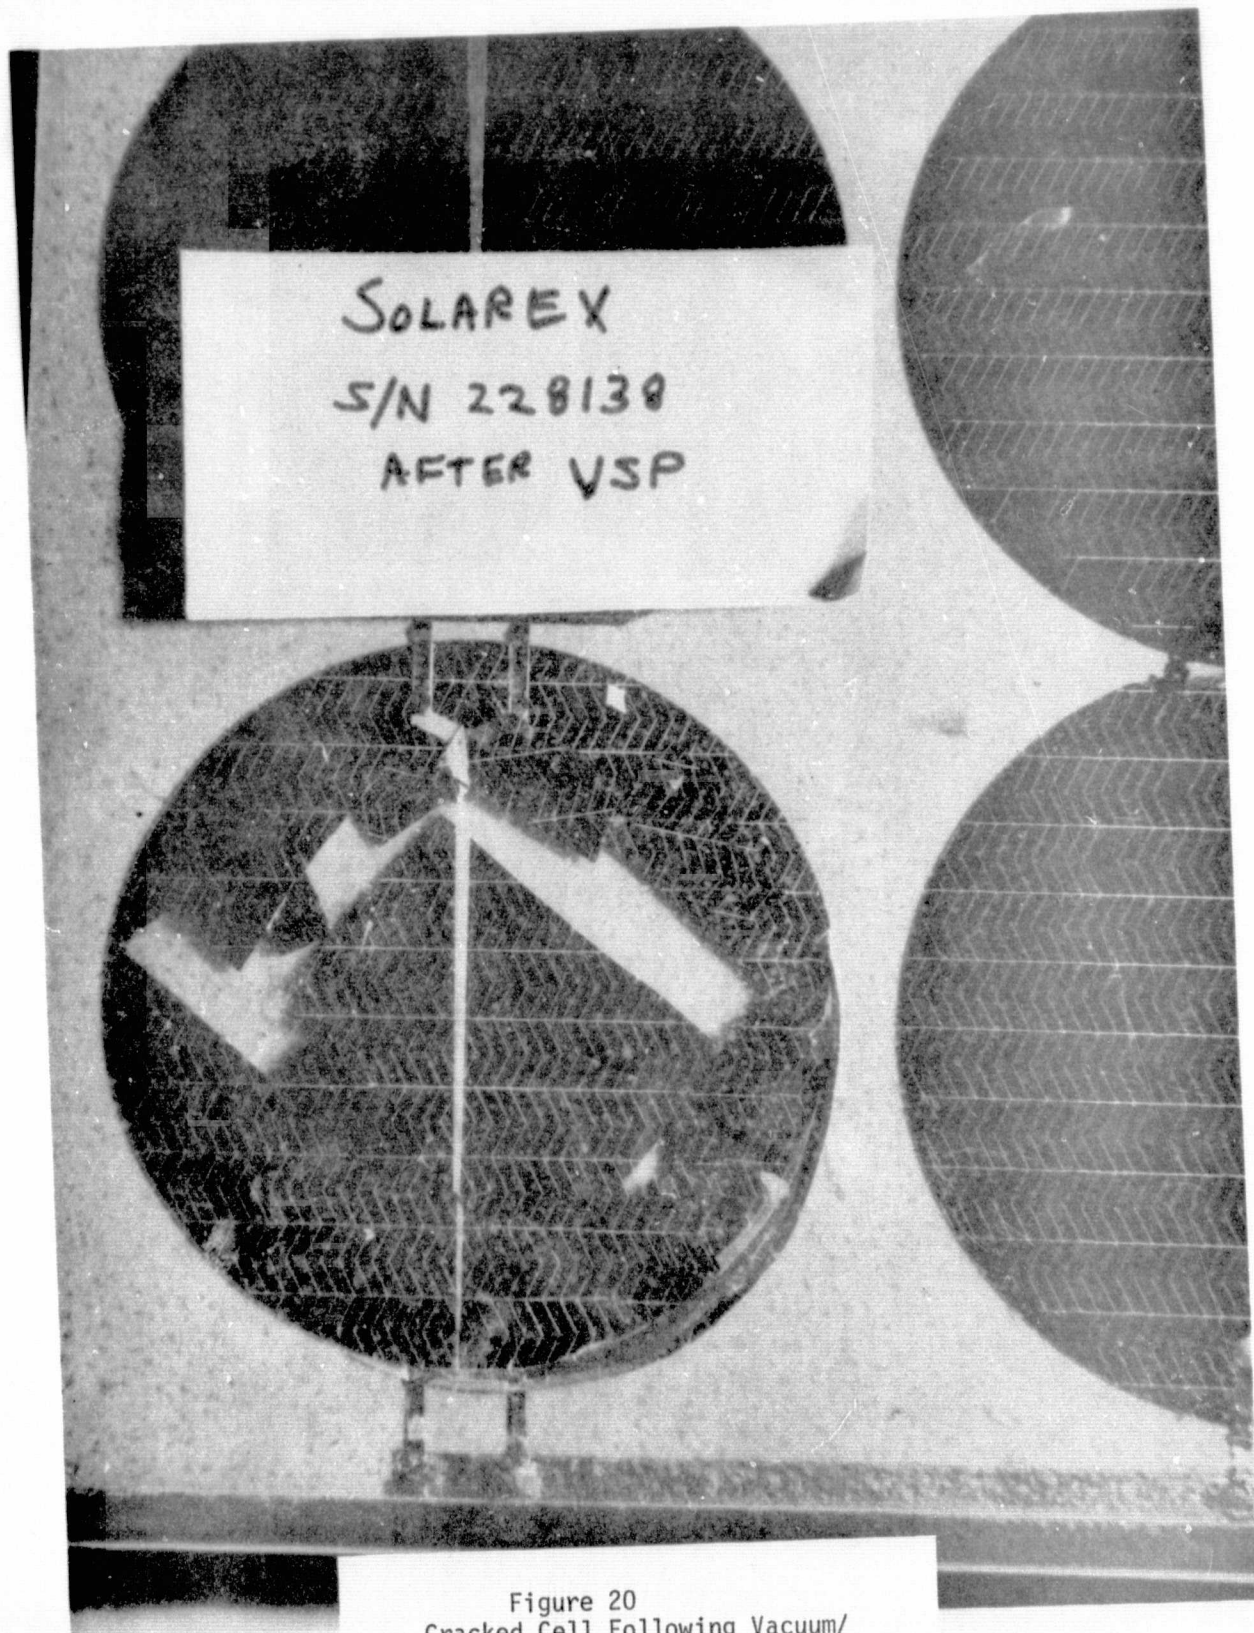
All of the cracked cells on S/N 228138 had pieces which had fallen down behind the rest of the cell as shown in Figure 19 and 20. This was possible because of the delamination of the encapsulant.

Figure 20  
Cracked Cell Following Vacuum/  
Steam/Pressure, Solarex Serial  
Number 228138

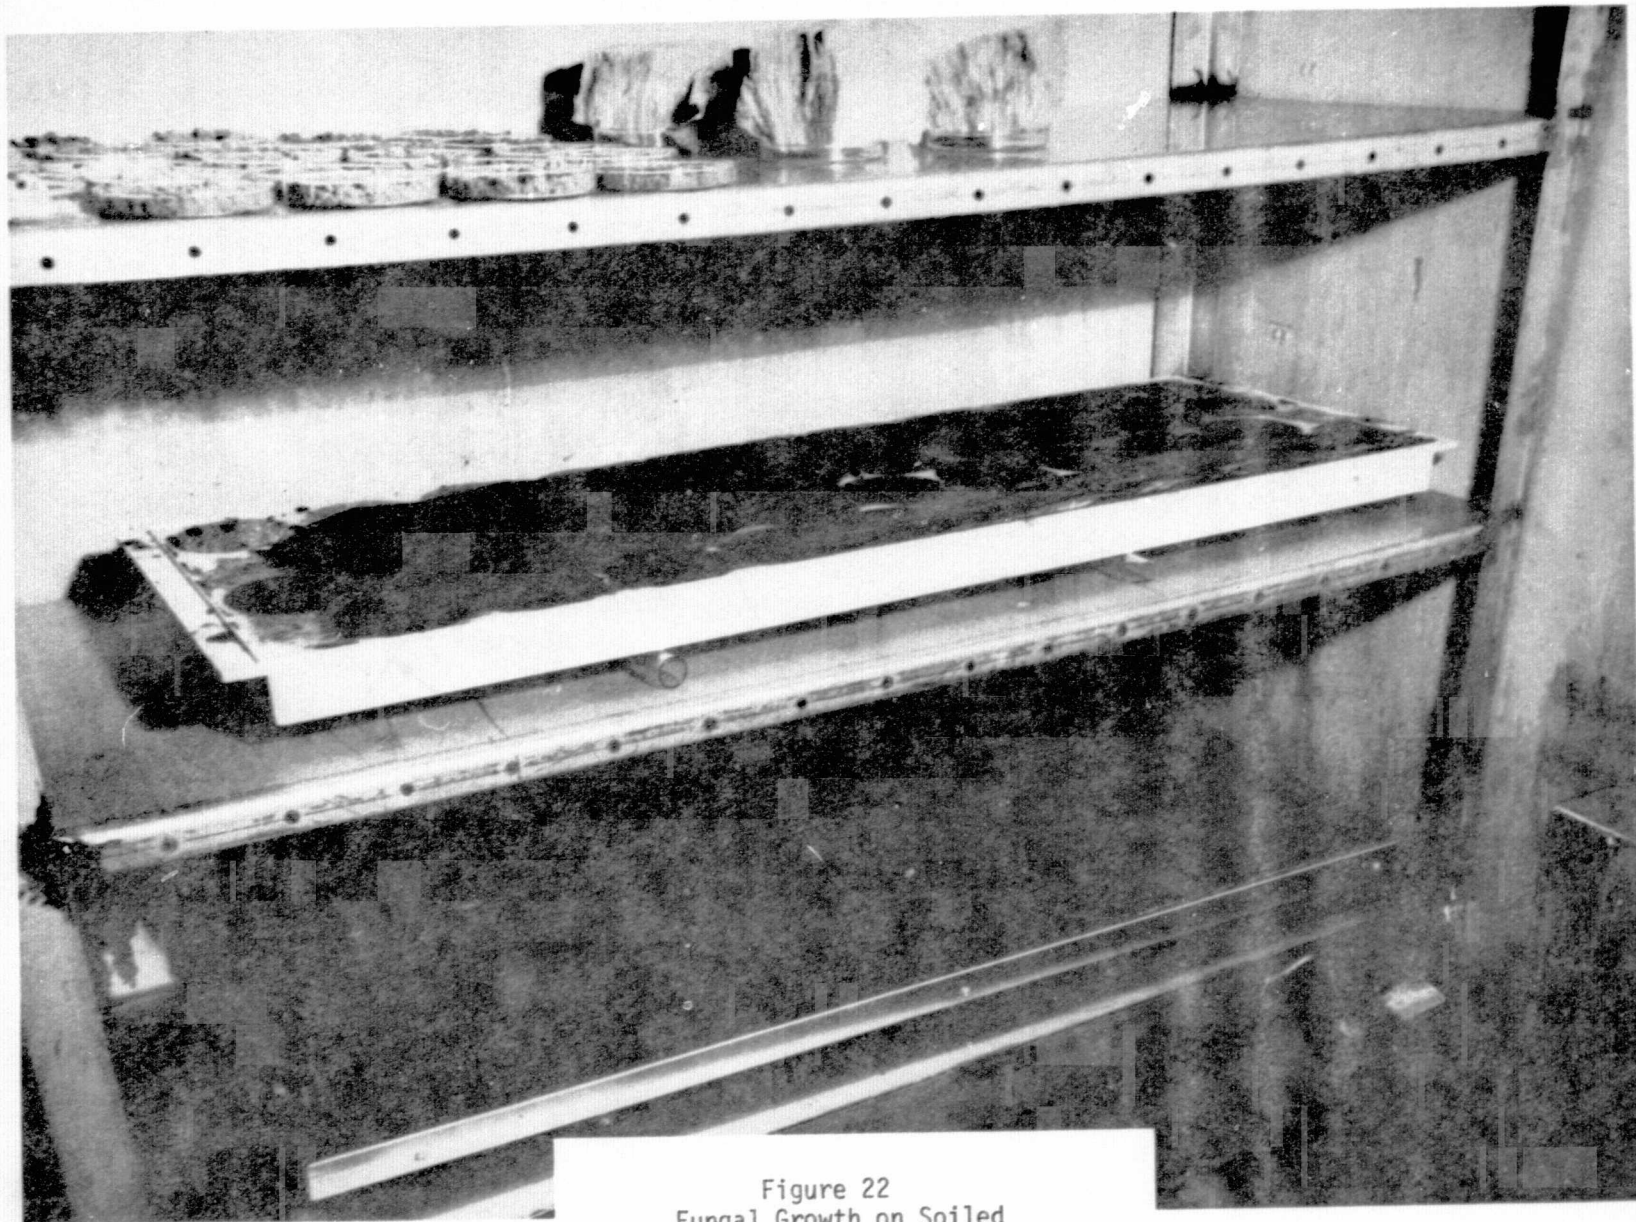
All soiled panels in Group B had heavy fungal growth after 3 days of incubation. This growth persisted throughout the incubation period. Typical growth is demonstrated in Figures 22 through 26. Figures 22 and 23 depict the panels in the humidity chamber. An idea of the overall growth can best be seen on the top panel in Figure 22 and the top right panel in Figure 23. The growth can be seen more clearly in Figures 24 and 25. Figure 25 is magnified approximately two times natural size. Further magnification is provided in Figure 26 (approximately 4X) and 27 (approximately 7X).

Figure 22  
Fungal Growth on Soiled  
Spectrolab and Solar Power  
Modules

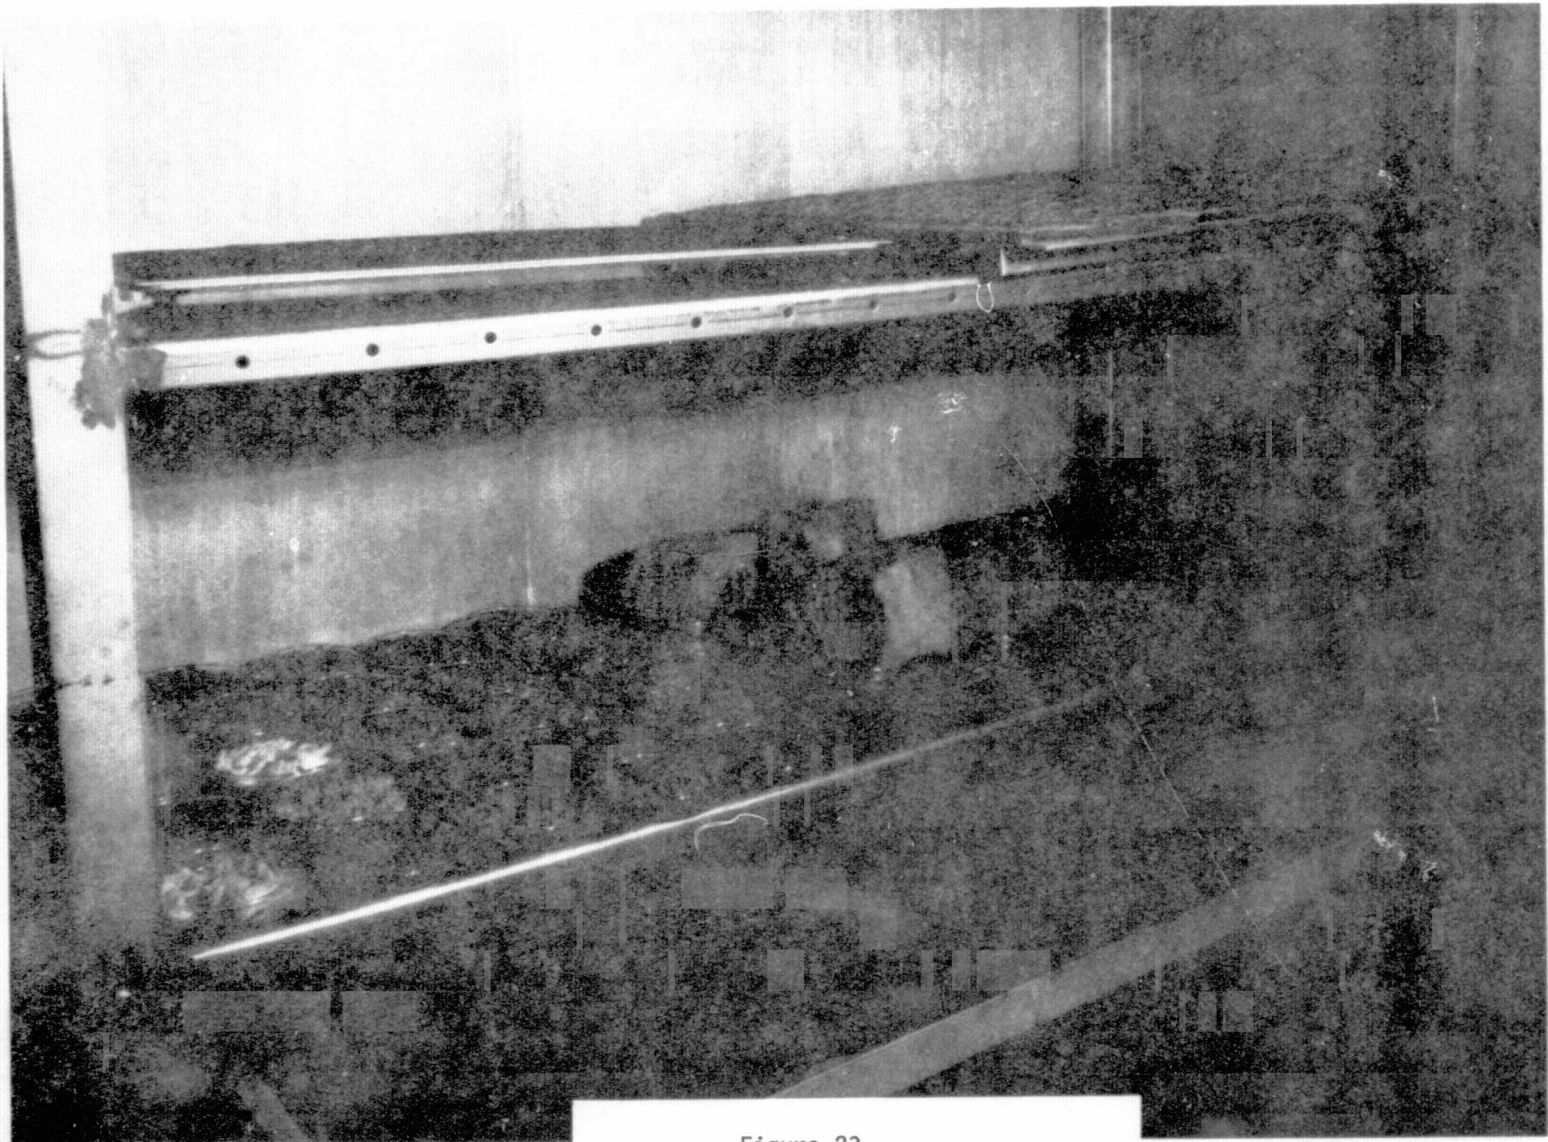
Figure 23  
Fungal Growth on Soiled Solar  
Power, Solarex and Sensor  
Technology Modules

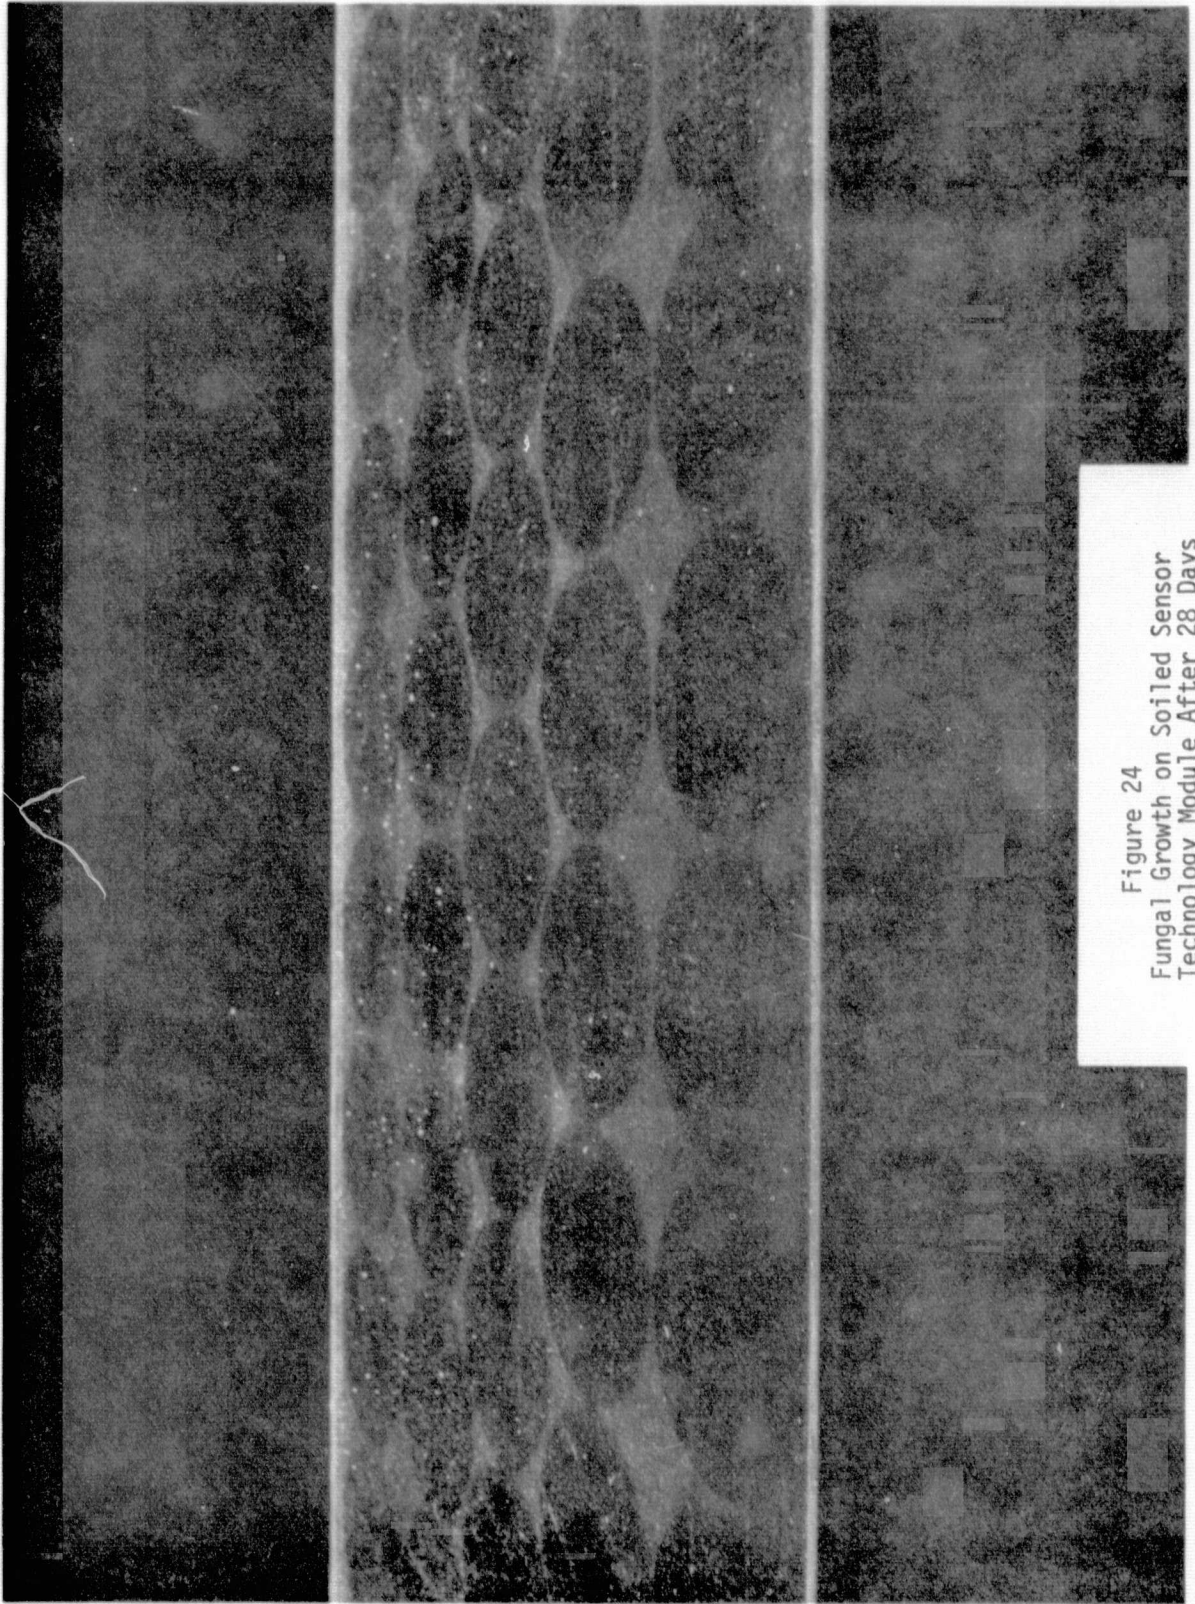
Figure 24  
Fungal Growth on Soiled Sensor  
Technology Module After 28 Days

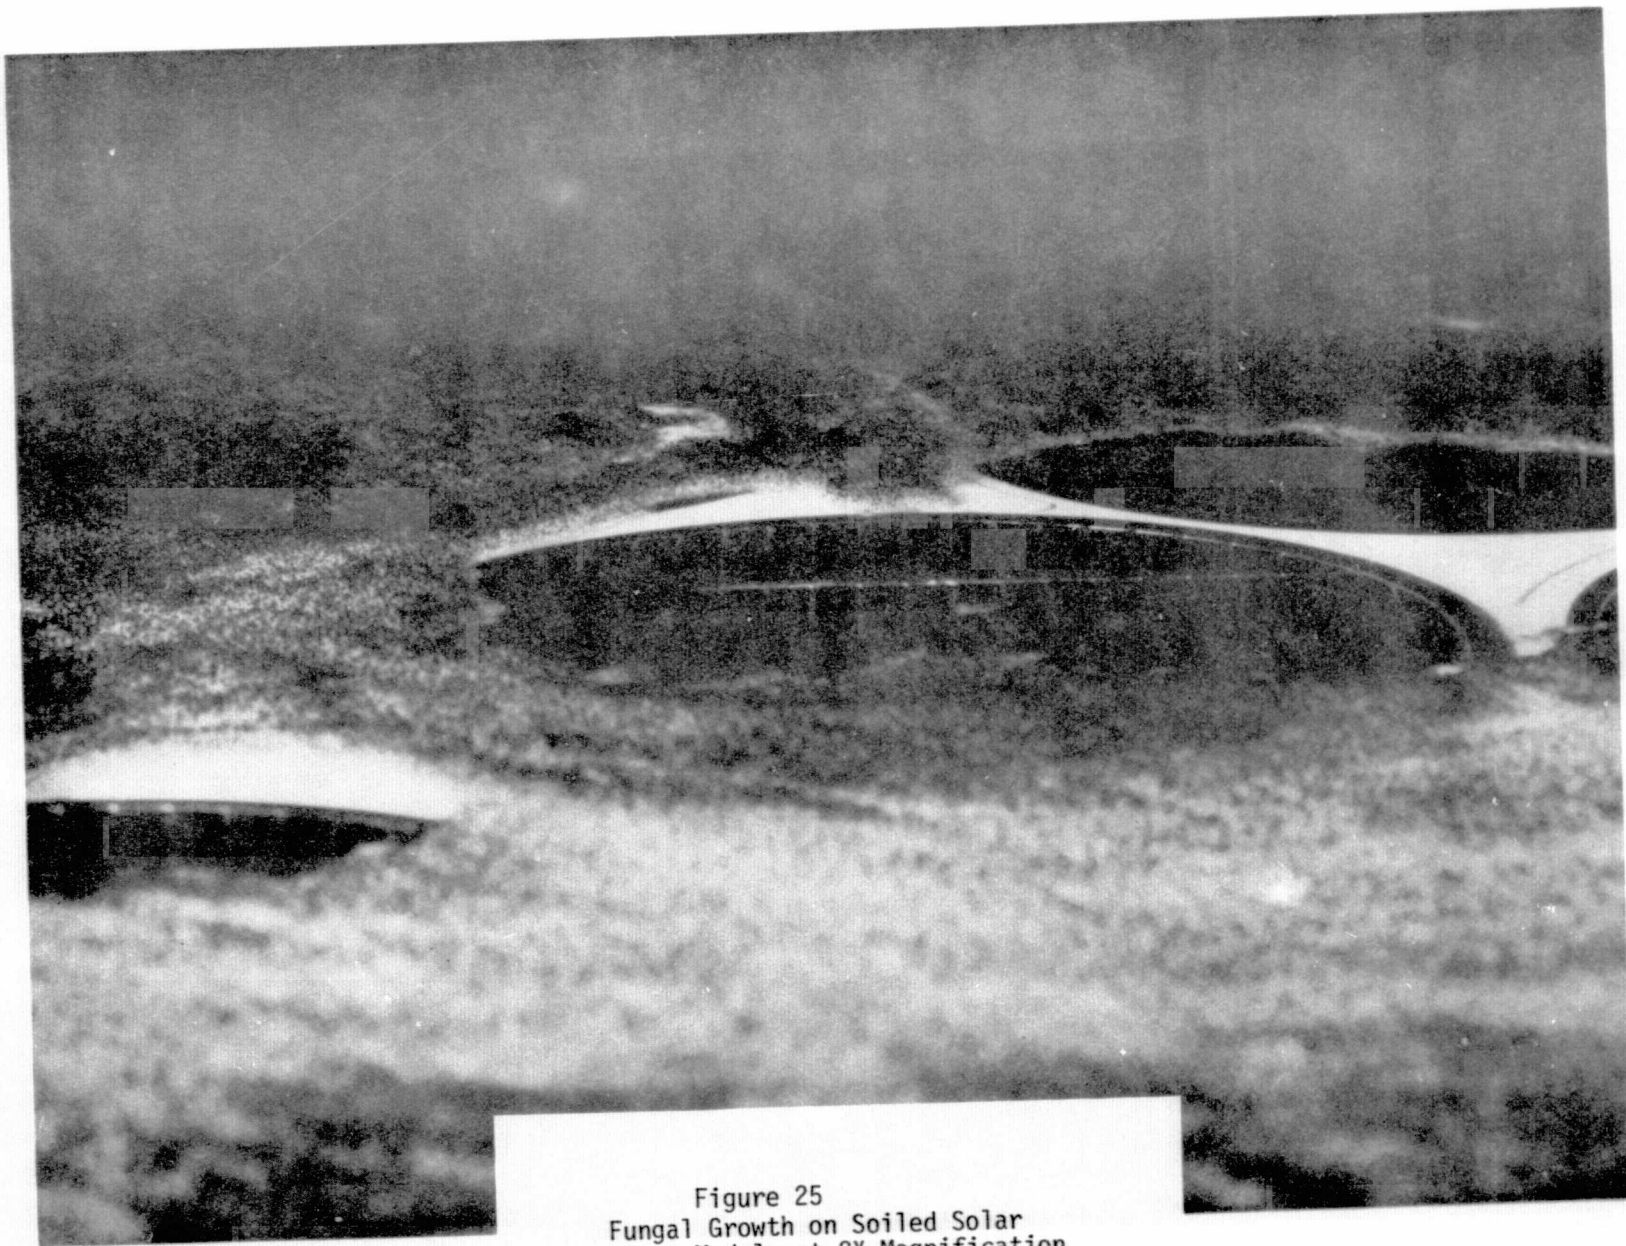
Figure 25  
Fungal Growth on Soiled Solar  
Power Module at 2X Magnification

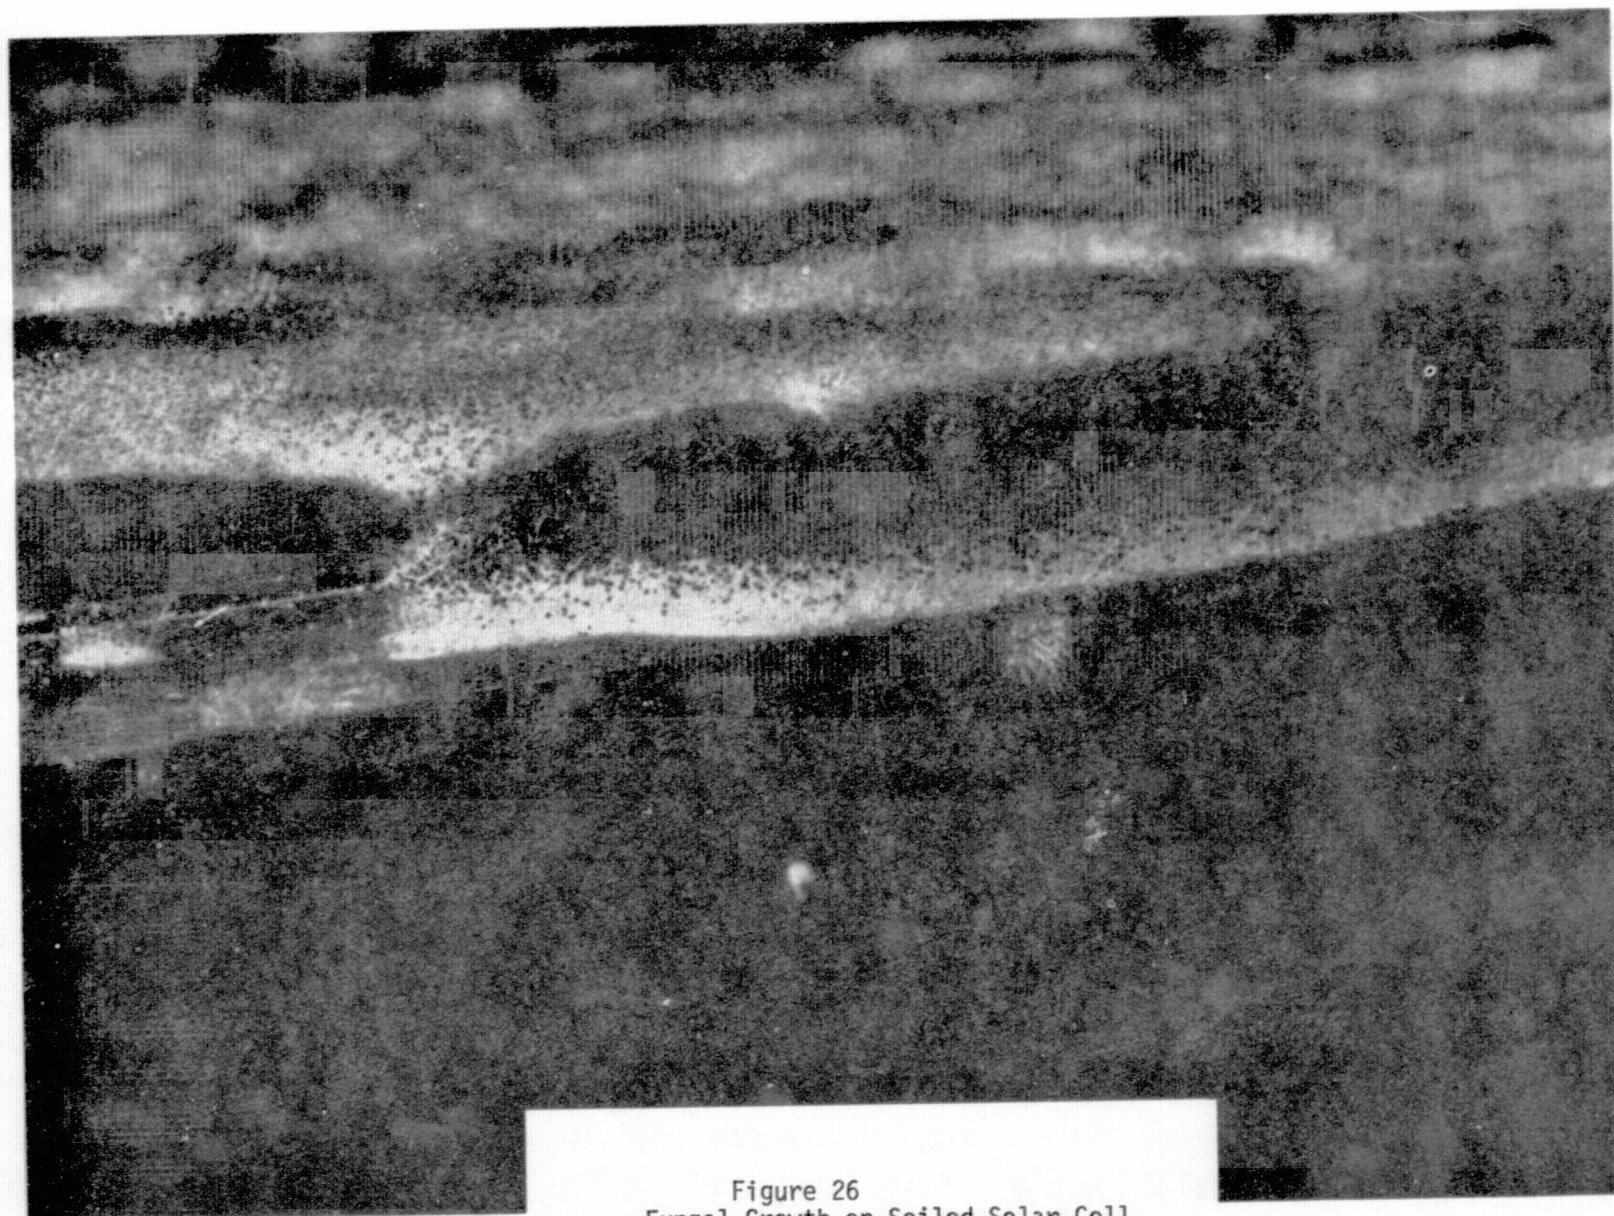
Figure 26  
Fungal Growth on Soiled Solar Cell  
Module at 4X Magnification

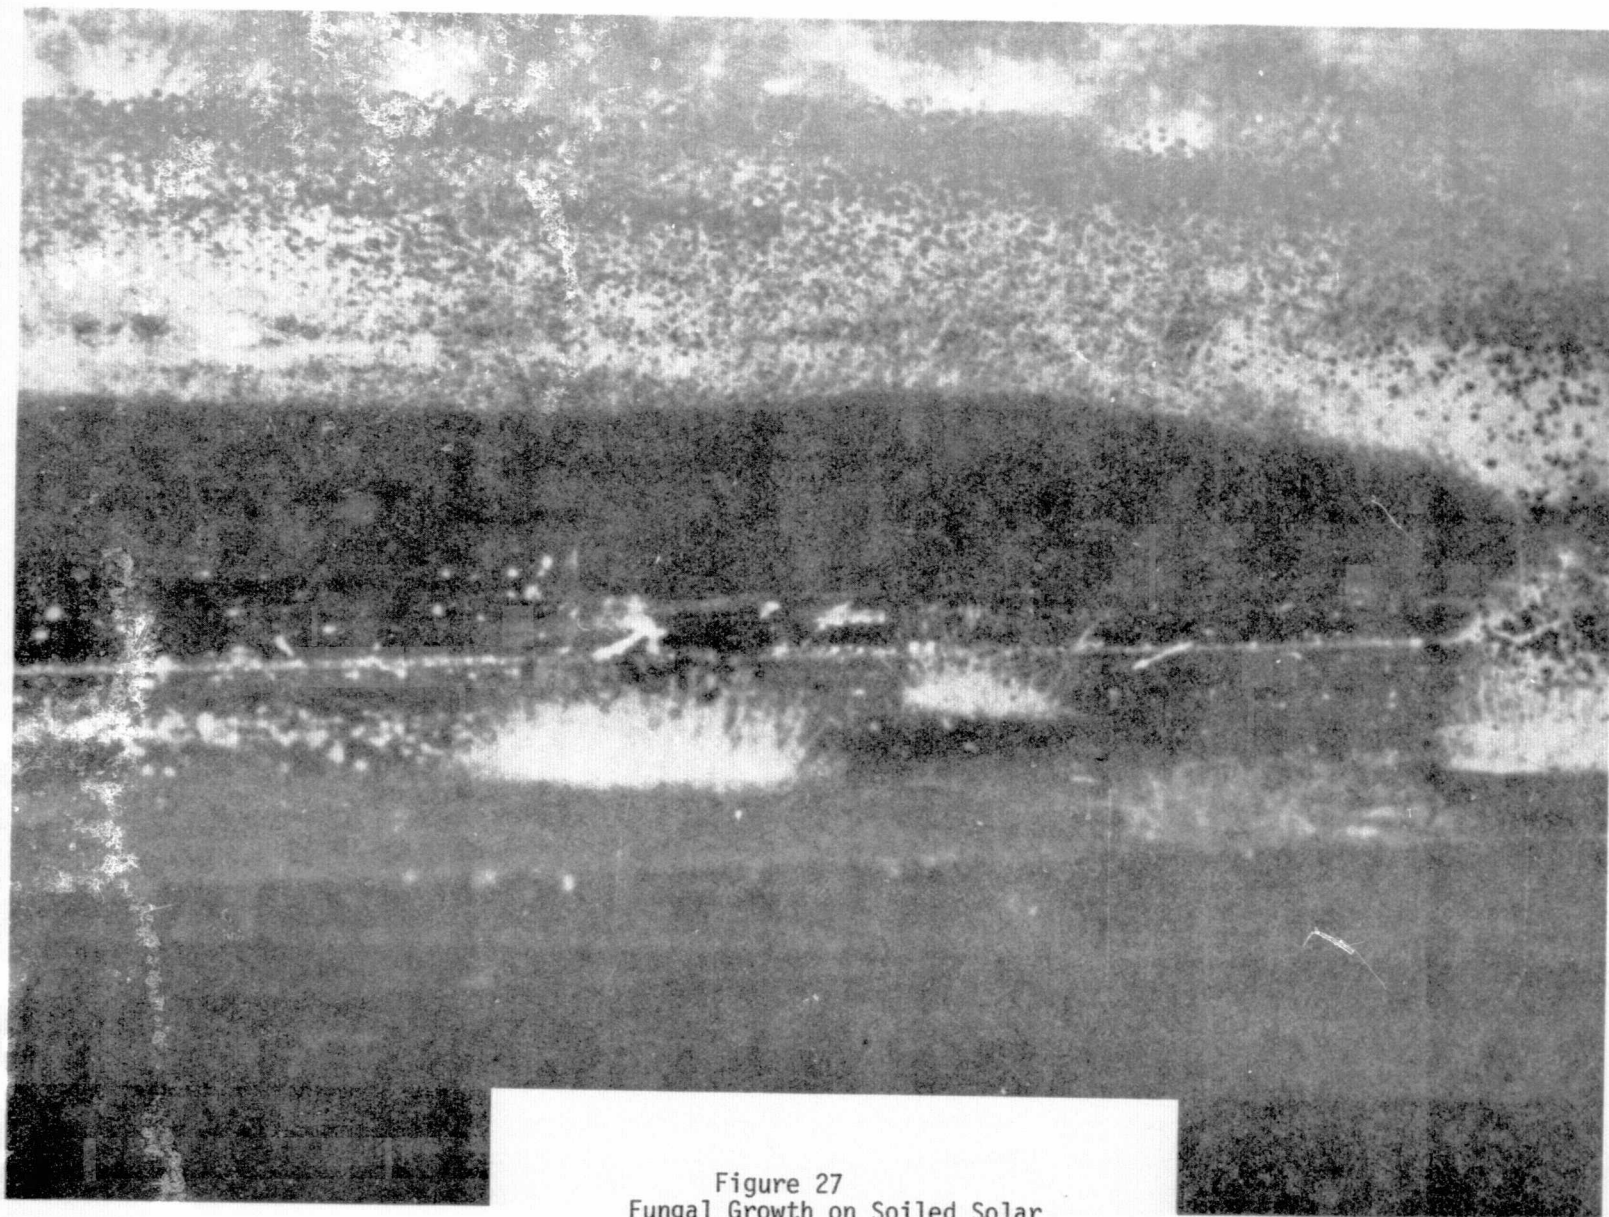
Figure 27  
Fungal Growth on Soiled Solar  
Cell Module at 7X Magnification

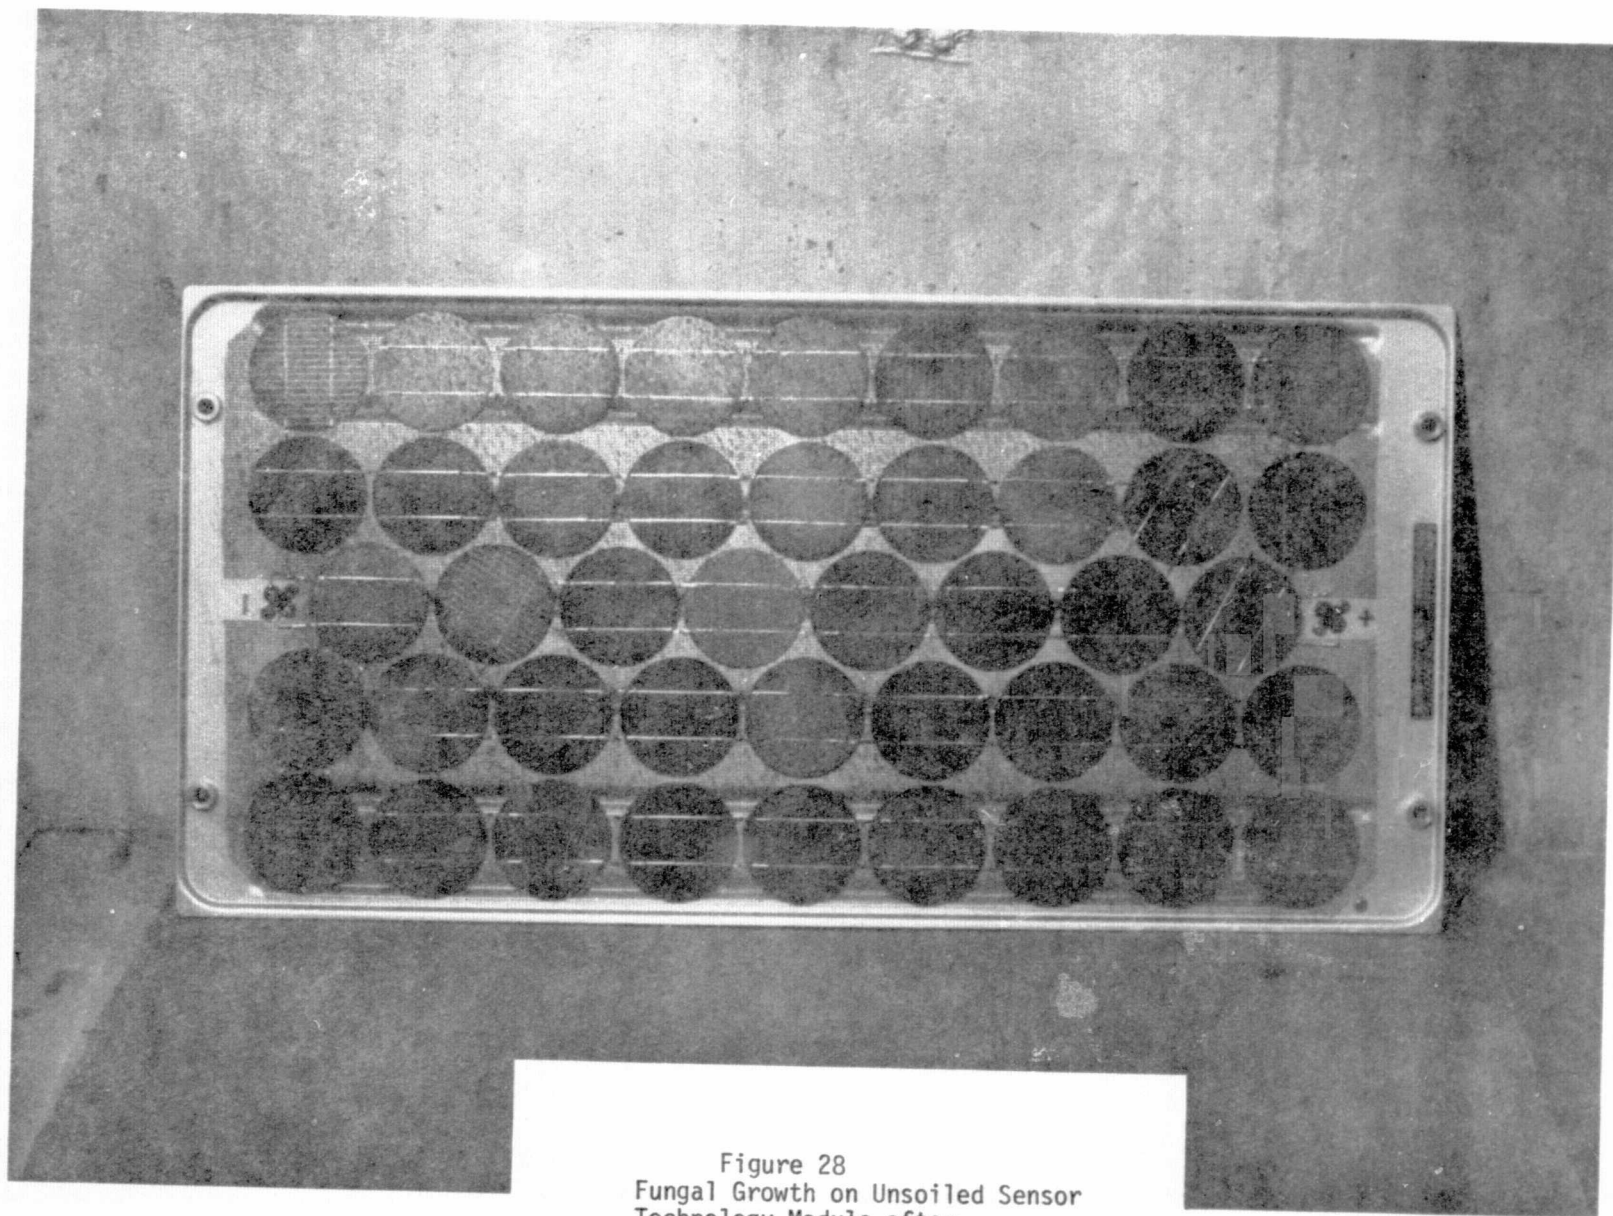
Group A modules were tested in an "as received" condition according to Procedure 1, MIL-STD-810B (reference (3)). After 28 days, Sensor Technology module S/N 1839 supported moderate amounts of fungal growth. The test was continued for an additional 32 days. No growth had occurred on the other three modules after 60 days. Group B modules were "soiled"

Figure 28  
Fungal Growth on Unsoiled Sensor  
Technology Module after  
MIL-STD-810B Fungus Test

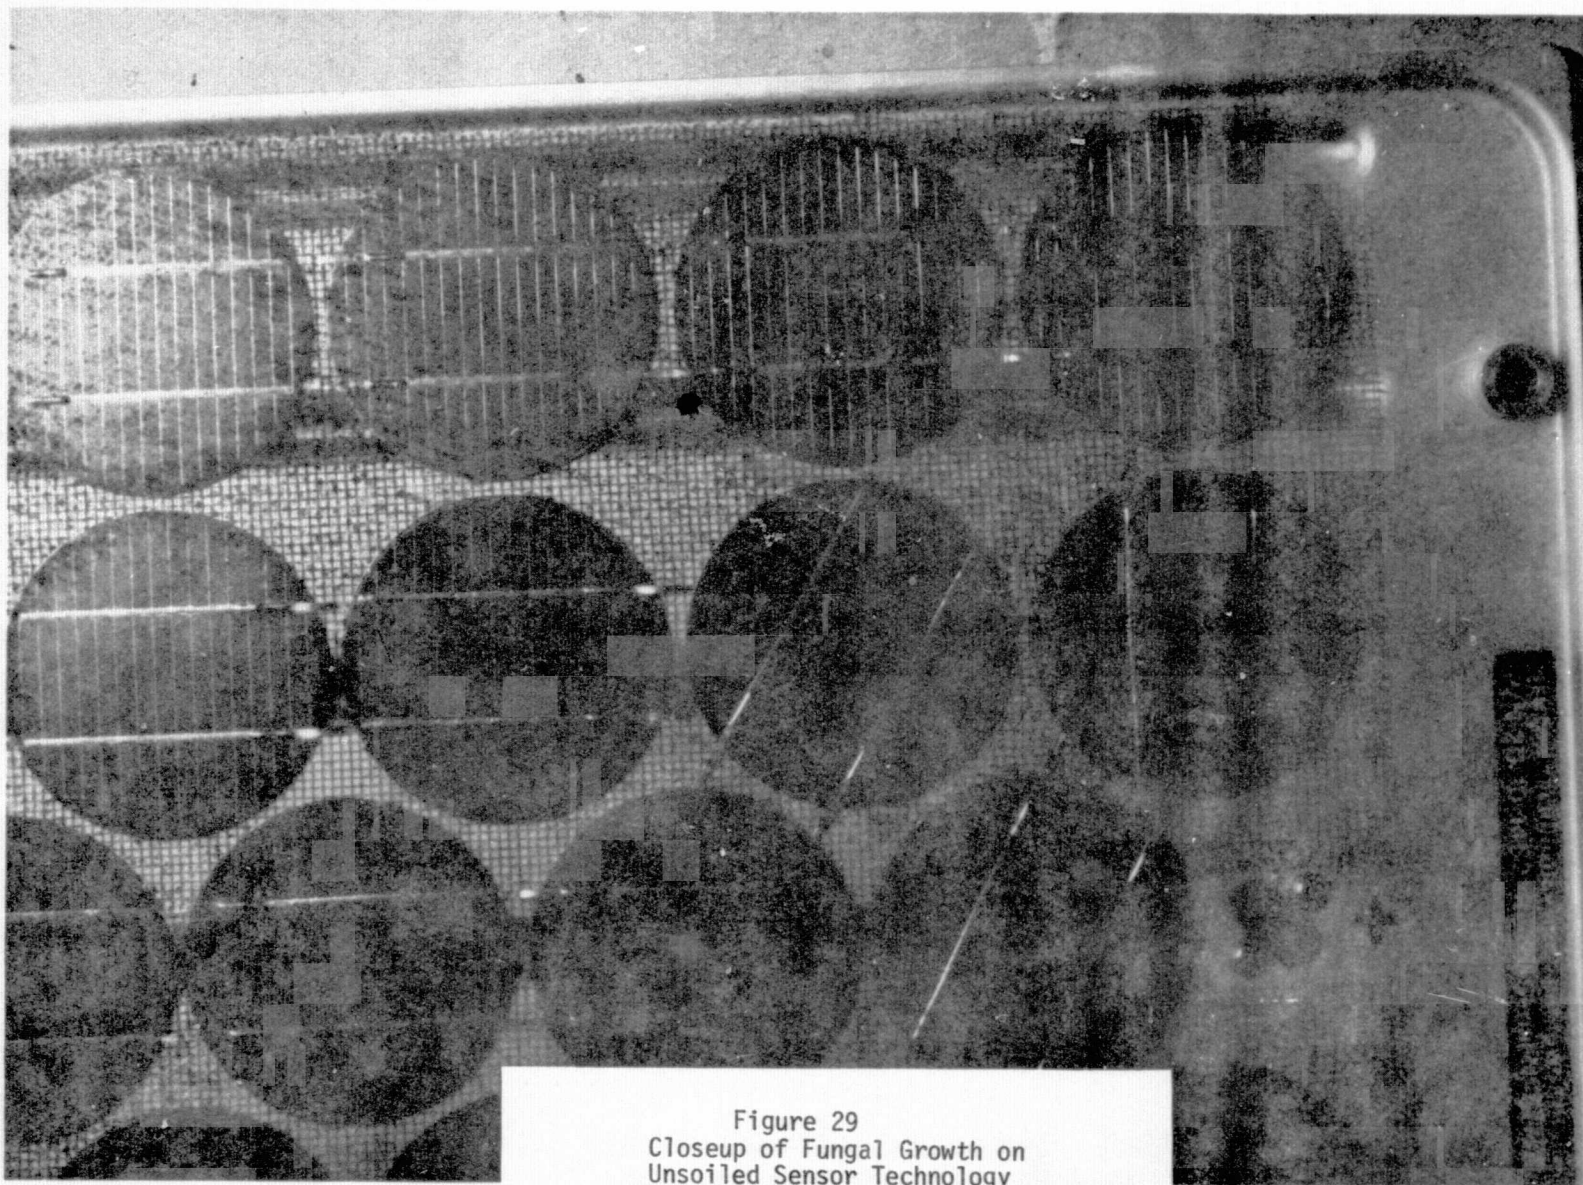
Figure 29  
Closeup of Fungal Growth on  
Unsoiled Sensor Technology  
Module after MIL-STD-810B  
Fungus Test

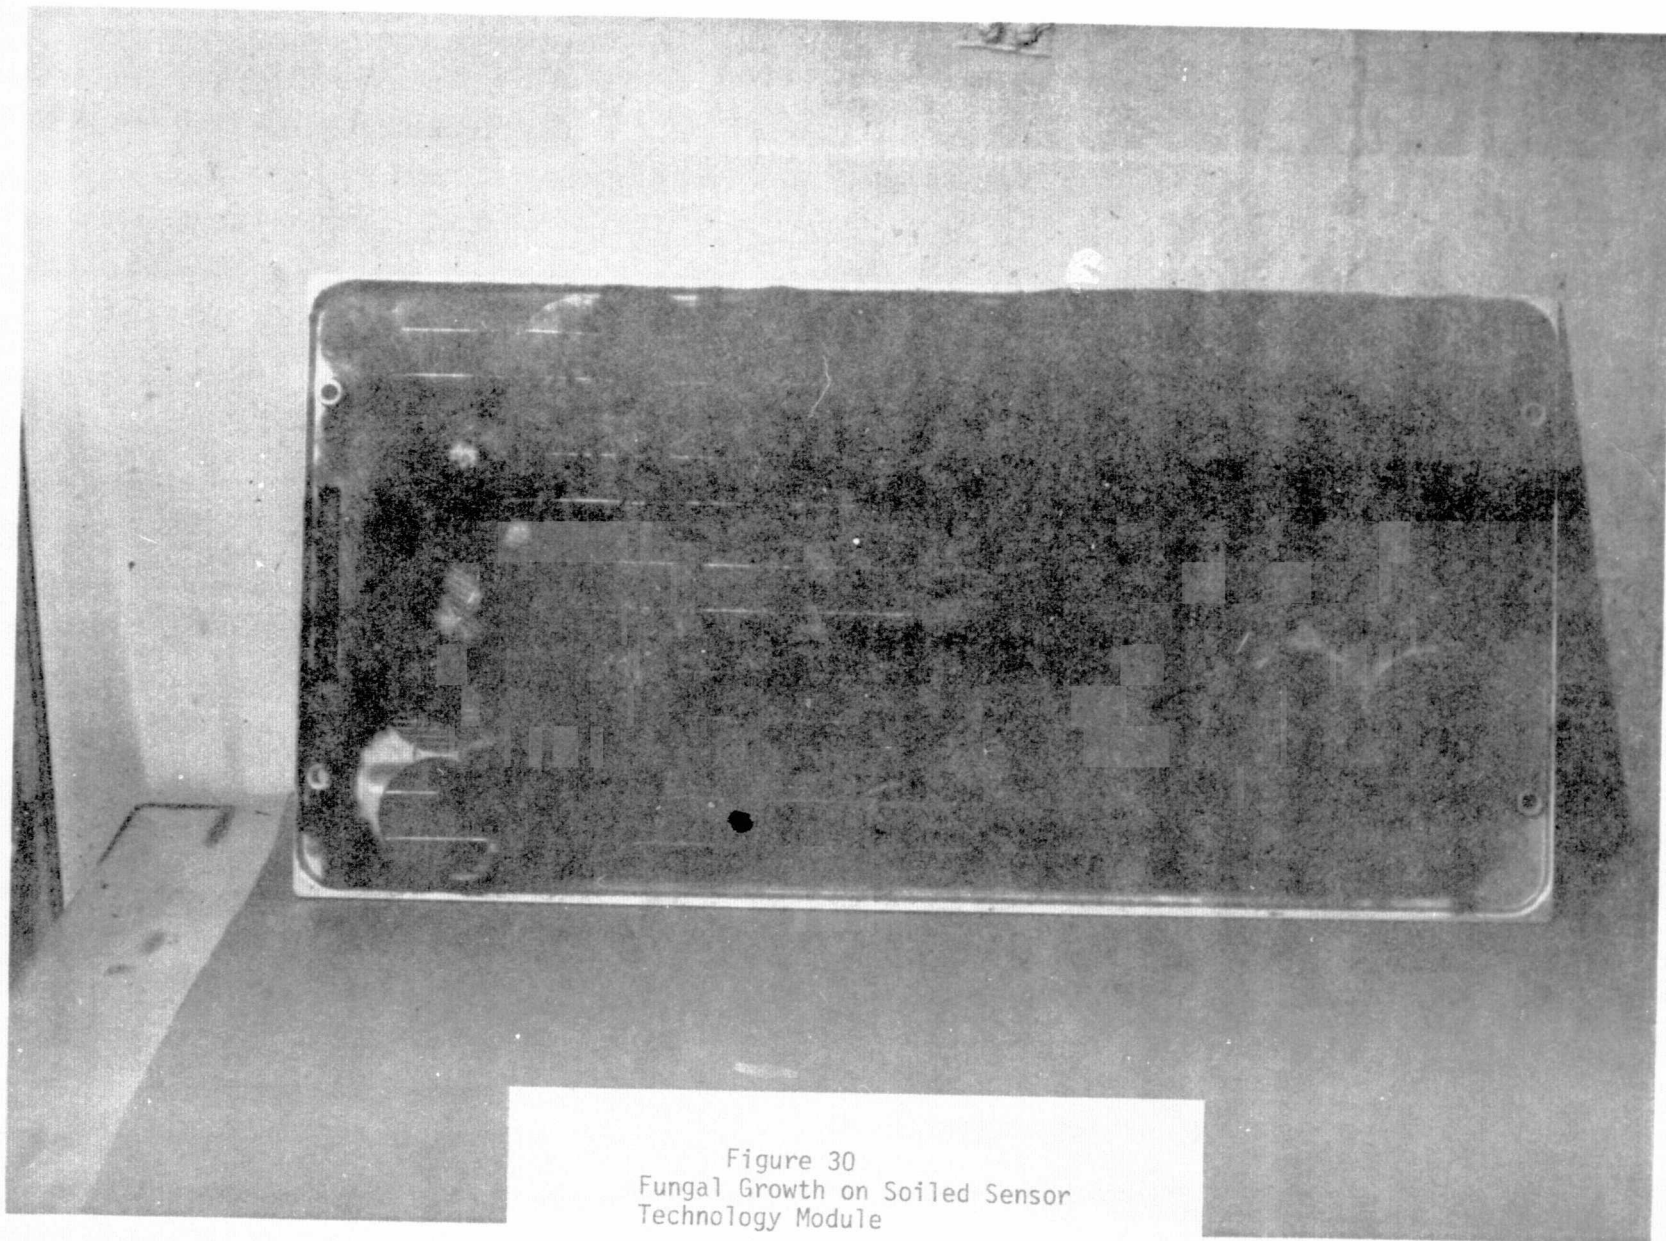
Figure 30  
Fungal Growth on Soiled Sensor  
Technology Module
