NASA Technical Memorandum 79040

HIGH VELOCITY BURNER RIG OXIDATION
AND THERMAL FATIGUE BEHAVIOR OF
Si₃N₄- AND SiC-BASE CERAMICS TO 1370° C

William A. Sanders and James R. Johnston
Lewis Research Center
Cleveland, Ohio

November 1978

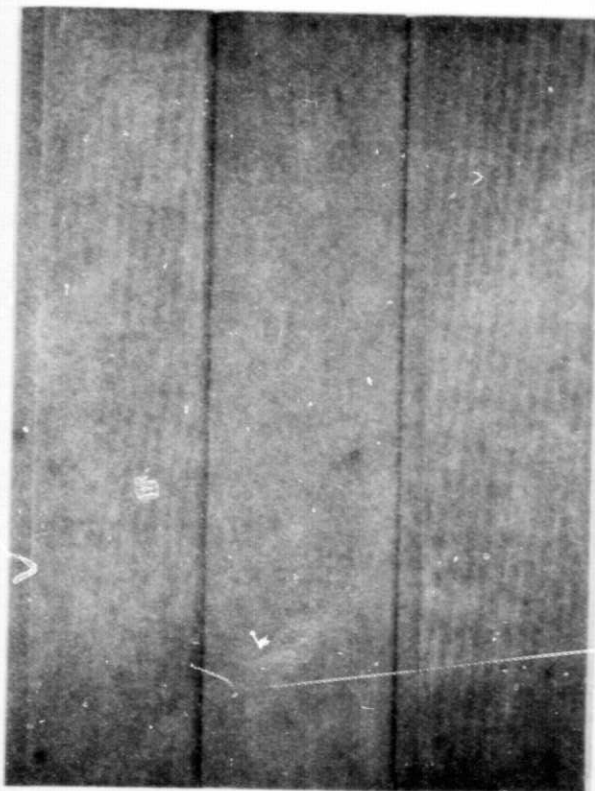
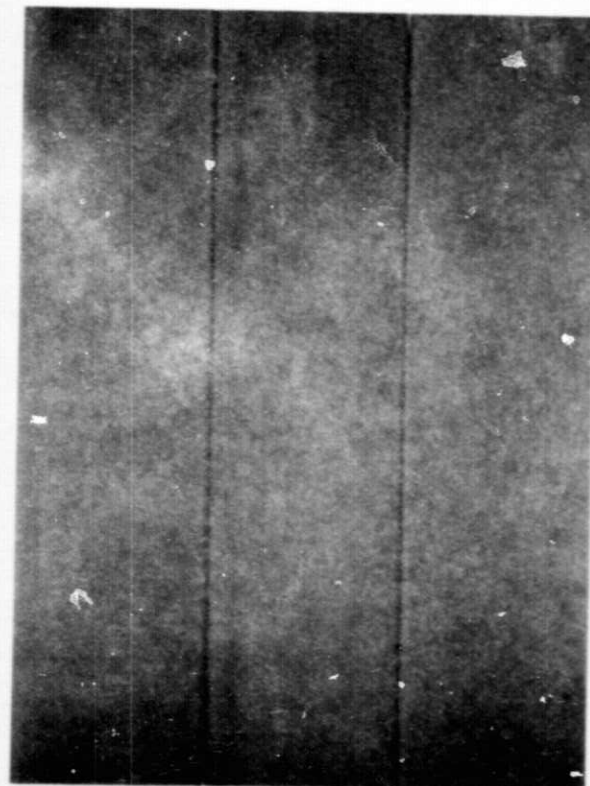
Vane surface appearance. - Low power ($\times 30$) binocular inspection of the NC-132 vanes showed them to be of the best overall surface condition of the four vane test materials. The NC-435 vanes displayed some permanent surface staining but vane surfaces were generally in good condition. The NC-350 vane surfaces were less uniform than the surfaces of NC-132 or NC-435 when batch-to-batch comparisons were made. Although within batches the NC-350 vanes were of uniform gray coloration, there were color differences in the shades of gray between batches as illustrated in figure 2. The Batch 2 vanes were a lighter gray than the Batch 3 vanes. The Batch 1 NC-350 vanes not shown were very similar in appearance to the Batch 3 vanes. The striated appearance of vanes 1 and 3 of NC-350 Batch 2 are believed due to some machining anomaly. At $\times 30$ magnification the texture of the dark and light bands appeared the same. The other side of the striated vanes was a uniform shade of gray the same as vane 2 of Batch 2. The KBI vanes of reaction sintered Si_3N_4 also displayed considerable batch-to-batch color variation, and also within-batch and within-vane color variations as shown in figure 3. For Batch 1, the major surfaces, and particularly the leading edges and the flats opposite the leading edges, were considerably darker than the corresponding surfaces of Batch 3 which were light gray. The KBI Batch 2 vanes not shown were slightly darker than the Batch 3 vanes. Several of the KBI vanes had deep grinding marks and areas of high porosity. These features likely follow from the way in which the KBI vanes were made. The vane shapes were cut from a block of cold pressed silicon powder, and after nitriding were finished by diamond grinding only as necessary to meet required dimensions. Thus, some vane surfaces were in the less perfect as-nitrided condition as opposed to the much smoother surface resulting from diamond grinding.

Figure 2. - Norton NC-350 reaction sintered Si_3N_4 vanes in as-received condition, X1.

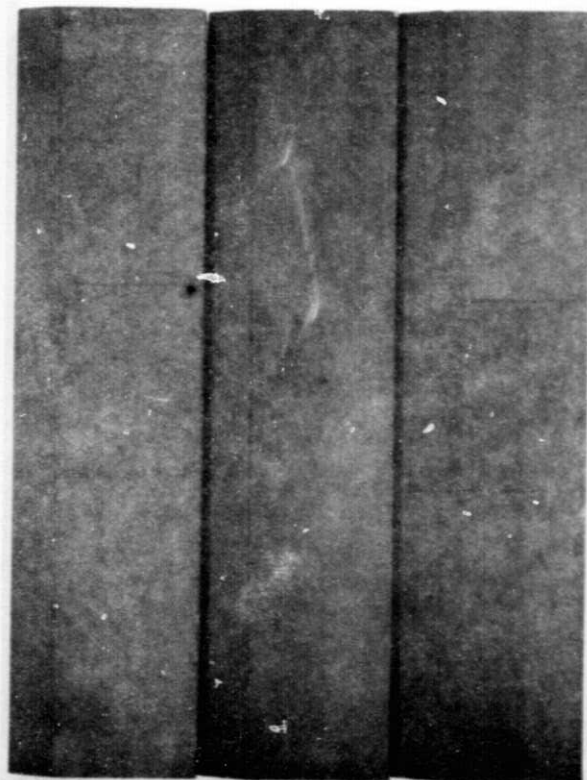
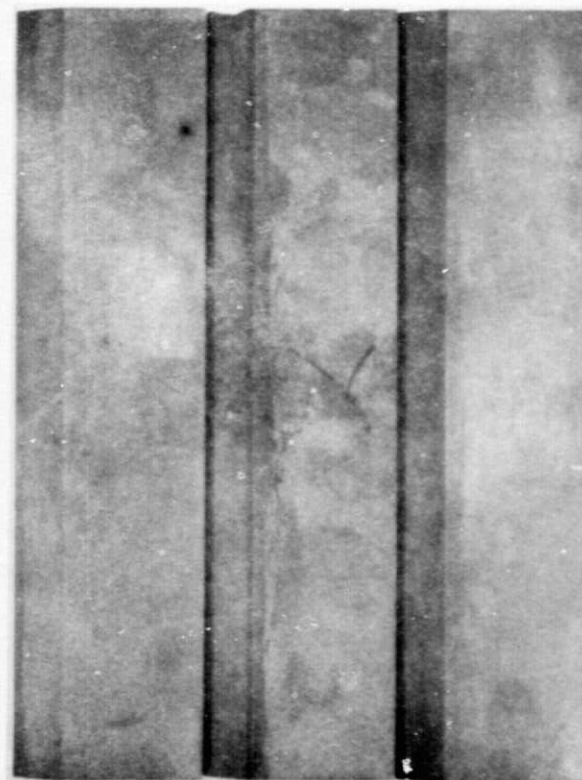
Figure 3. - KBI reaction sintered Si_3N_4 vanes in as-received condition, X1.

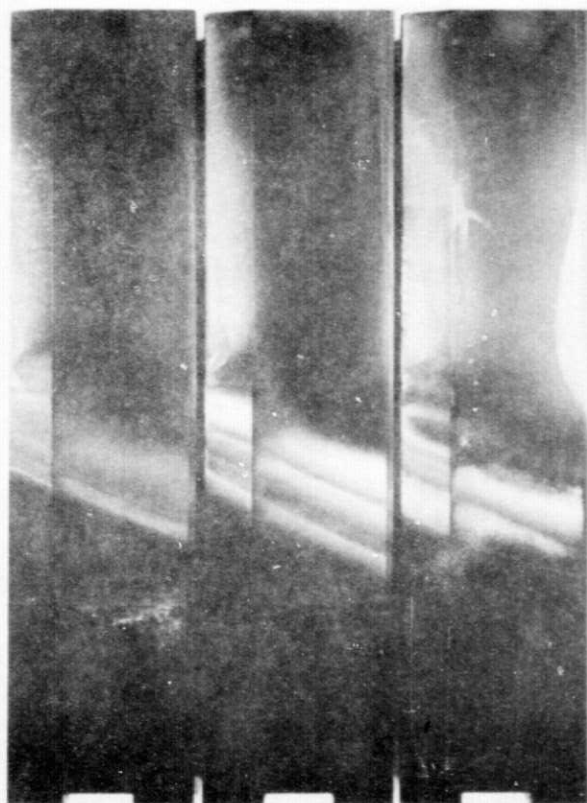
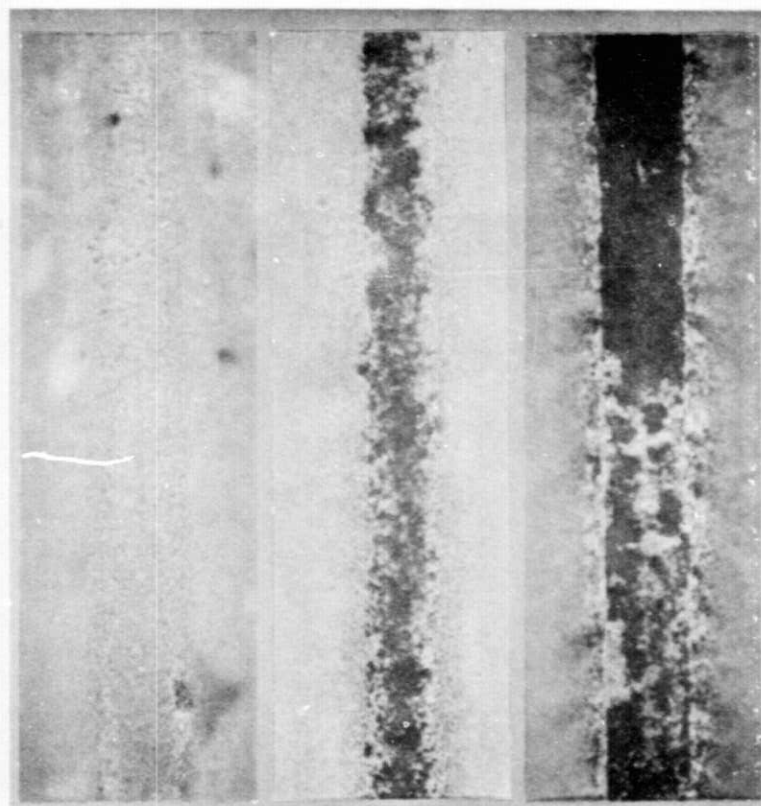
As shown in table V, the weight changes for the six NC-132 vanes tested at 1260° , 1315° , and 1370° C were relatively slight with all vanes surviving 250 cycle exposures. No cracks were found in the vanes by fluorescent penetrant inspection. A plot of weight change versus exposure

duration for the two batches of NC-132 HP Si_3N_4 vanes is presented in figure 5. Batch 2 vanes displayed a more uniform weight change behavior with respect to exposure duration and exhibited less weight change than the Batch 1 vanes. As figure 5 shows, end-point weight loss increased with increasing test temperature. This correlates with the appearance of the vanes which exhibited increased oxide loss for increased exposure temperatures. The only oxide found by X-ray diffraction on NC-132 hot zone leading edges was alpha cristobalite (silica). Figure 6 illustrates the oxide loss-temperature relationship for the Batch 1 vanes. Loss of oxide was not evident at 1260°C , apparent at 1315°C , and very pronounced at 1370°C .

Figure 6. - NC-132 Batch 1, HP Si_3N_4 vanes after 250 cycles exposure in Mach 1 burner rig. Cycle: 12 minutes at test temperature, 3 minute still air cool.

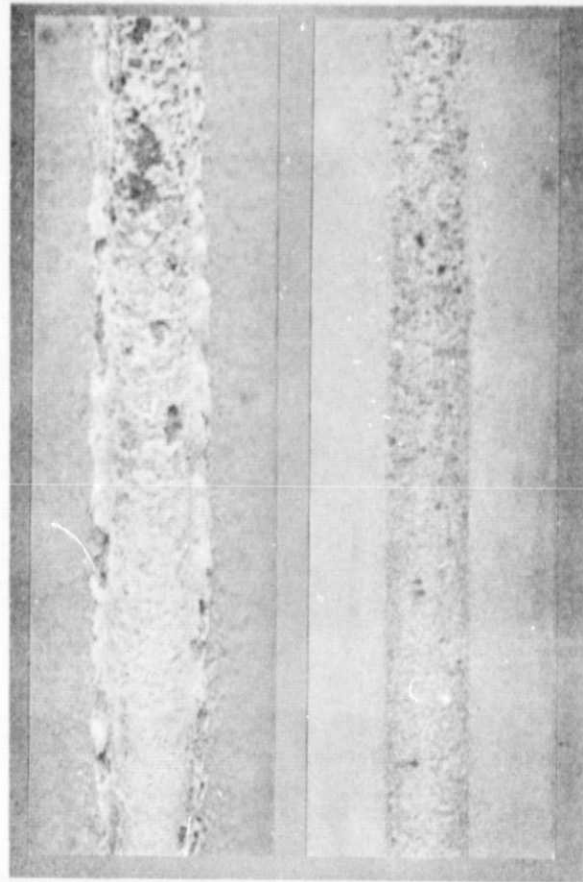
In the 1370°C tests it was observed that, although the Batch 1 NC-132 vane lost more weight than did the Batch 2 NC-132 vane for the total test duration, at first, more oxide formed on the Batch 1 vane than on the Batch 2 vane. This condition was most pronounced after 50 cycles (10 hr) of exposure and is illustrated in figure 7. The reasons for the differences in oxidation behavior of the two batches of NC-132 vanes may be related to some critical differences in impurity levels in the two batches. However, the AFML spectrographic analyses for the two batches of NC-132 given in table II show the level of total metallic impurities to be very

Figure 7. - NC-132 HP Si_3N_4 vane hot zone leading edges after 1370°C , 50 cycle exposure in Mach 1 burner rig. Cycle: 12 minutes at test temperature, 3 minute still air cool, X10.

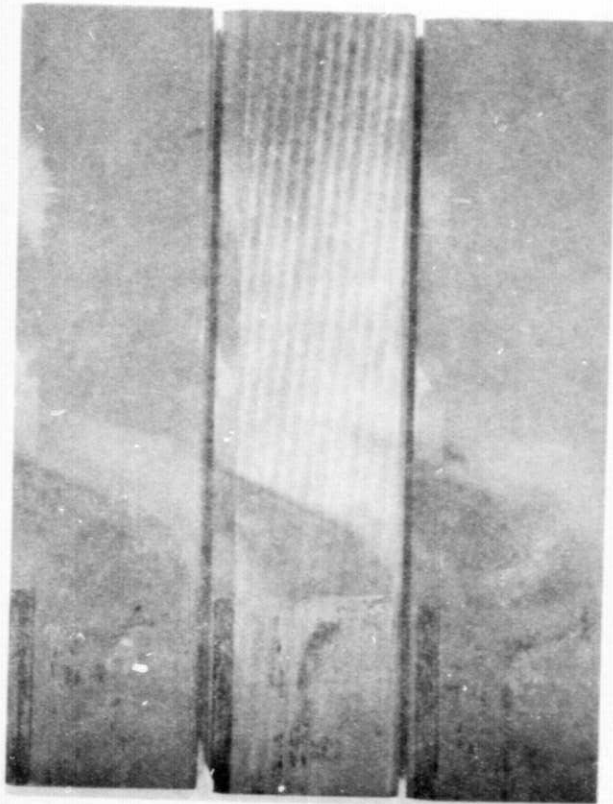
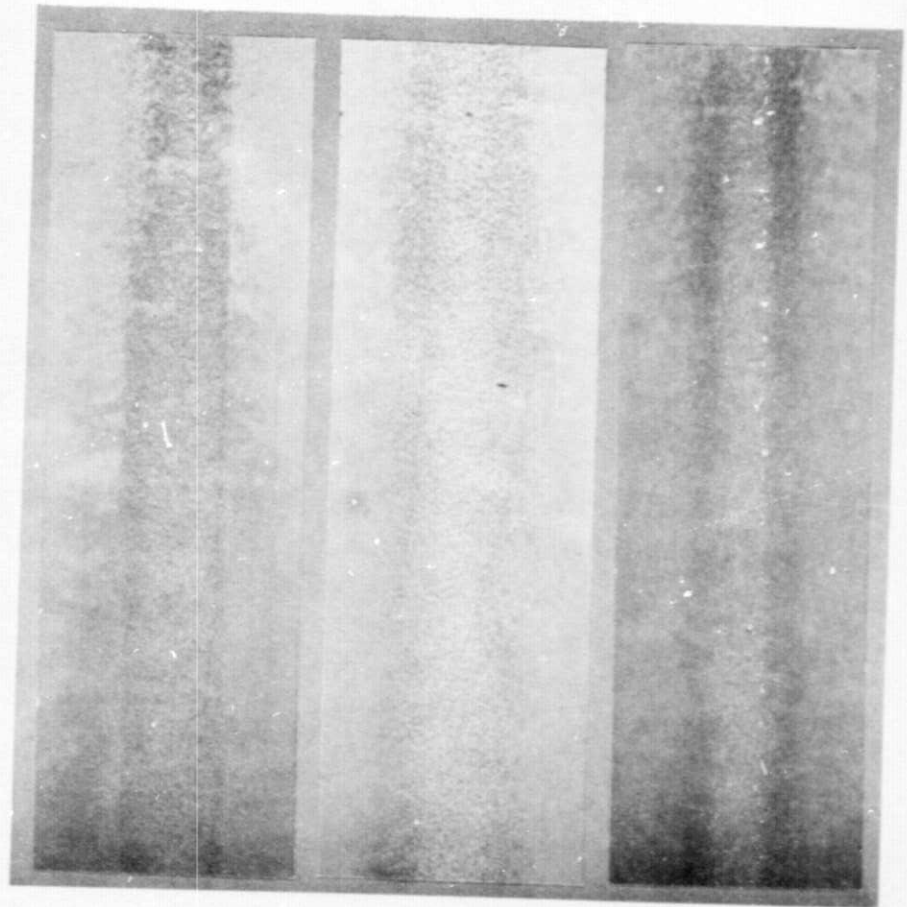
Three vanes of NC-350, each representing a different RS Si_3N_4 batch were successfully tested for 250 cycles (50 hr) at 1370°C . Photographs of these three vanes are shown in figure 9 and plots of specific weight change versus time are presented in figure 10. Figure 9 shows that the general post-test appearance of the vanes from the three different batches is very similar as well as the hot zone leading edges shown at $\times 10$. The white stripes present on the Batch 2 NC-350 vane in the as-received condition (fig. 2) are still present after testing. The vane as a whole is lighter in color as a result of the oxidation exposure, but the stripes do not appear to have had any visual effect on the nature of the oxidation. Figure 10 shows that all three NC-350 vanes lost weight as a result of the first five cycles of exposure. At 1370°C the reason for

these losses is unexplained. The vanes had been oven dried before initial weighing. Beyond five cycles the vanes continuously gained weight at slow rates. Vanes from Batches 2 and 3 with similar starting open porosities of 16.3 and 14.0 percent, respectively showed very similar weight change behavior. The vane from Batch 1 with the lower open porosity of 8.3 percent showed the least total weight gain after the first five cycles and oxidized at the slowest rate. This reflects the benefit of low open porosity so that in a high temperature oxidizing environment, rapid oxide sealing of the RS Si_3N_4 surface occurs with minimal damaging internal oxidation.

Figure 9. - Norton NC-350 reaction sintered Si_3N_4 vanes after 250 cycle exposure in Mach 1 burner rig. Cycle: 12 minutes at 1370°C , 3 minute still air cool.

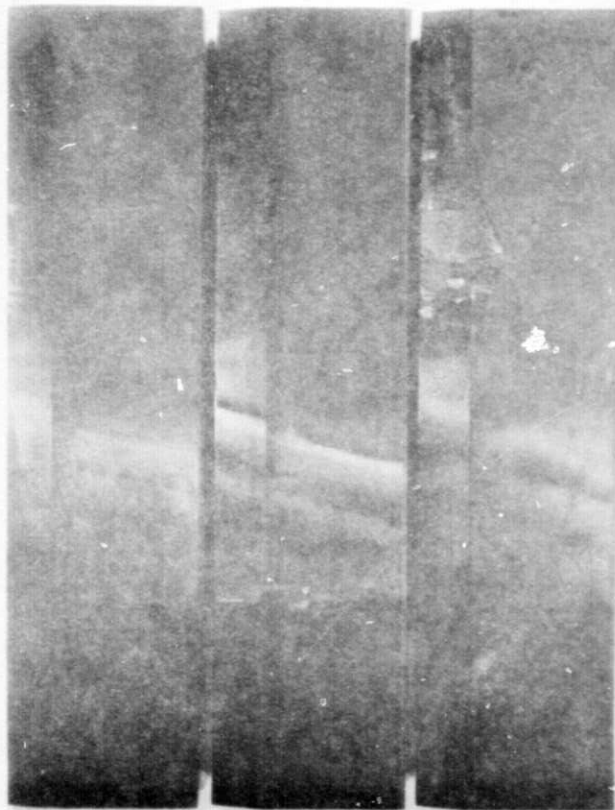
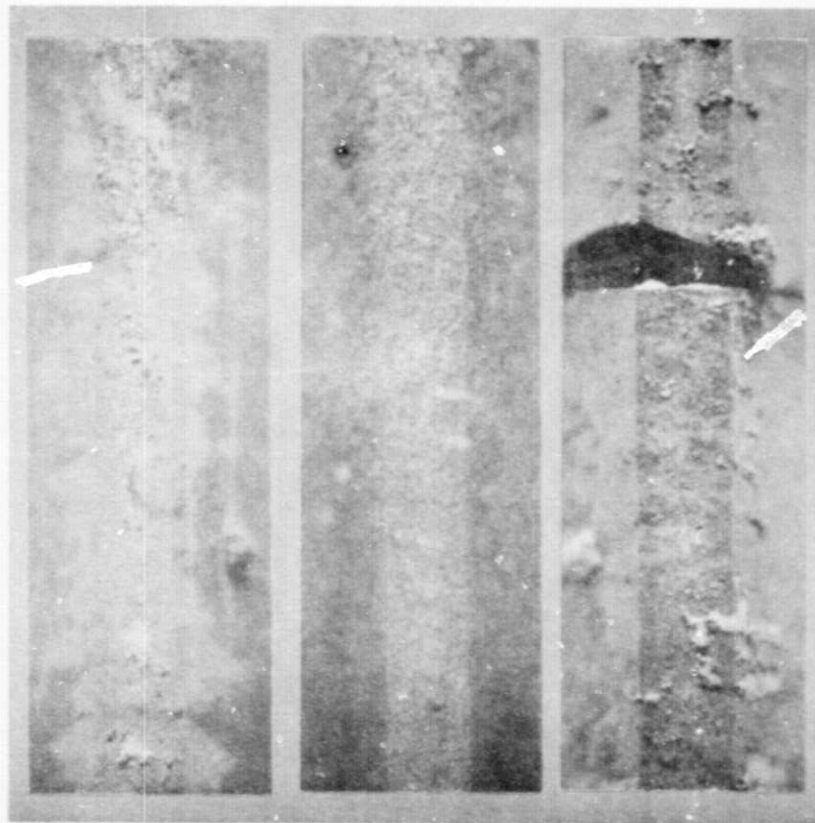
A plot of specific weight change versus exposure duration at 1205° C for three NC-435 vanes is presented in figure 11, and photos of the vanes are shown in figure 12. The weight change behavior at 1205° C was similar for the vanes representing three different batches of material. There was some indication that the Batch 3 vane was beginning to gain weight at a greater rate in the 50 to 125 cycle exposure interval, but then it failed during 126th cycle cooling. The curve for the Batch 1 vane which survived 250 cycles is extrapolated past 125 cycles because a chip in the base of the vane precluded an accurate final weight determination. In the 1205° C testing (and in tests at higher temperatures to be discussed) it was noted that buildups of tiny metallic bead-like particles and glassy oxide took place as illustrated in figure 12. These buildups were most prevalent for Batch 3 NC-435 and least prevalent for Batch 2 NC-435. The Batch 3 vane was pieced together after failure so that the comparison could be made. X-ray diffraction analysis of the buildup material on the Batch 3 vane showed FeSi_2 and Si to be present. And spectrographic analysis on the buildup material showed that the scale material contained between 8 and 12 w/o iron and between 7 and 11 w/o aluminum. These analyses contrast with the 0.58 w/o metallic impurities (iron and aluminum, major) determined for a Batch 3 NC-435 material sample as given in table II. Although silicon melts at 1430° C, iron and aluminum form eutectics with silicon at 1208° and 577° C, respectively. We believe the failure of the Batch 3 vane was due to a flaw which developed during burner rig exposure as a result of a localized heavy exudation of a molten silicon-iron-aluminum eutectic.

Figure 12. - Norton NC-435 siliconized SiC vanes after exposure in Mach 1 burner rig.
 Cycle: 12 minutes at 1205⁰ C, 3 minute still air cool.

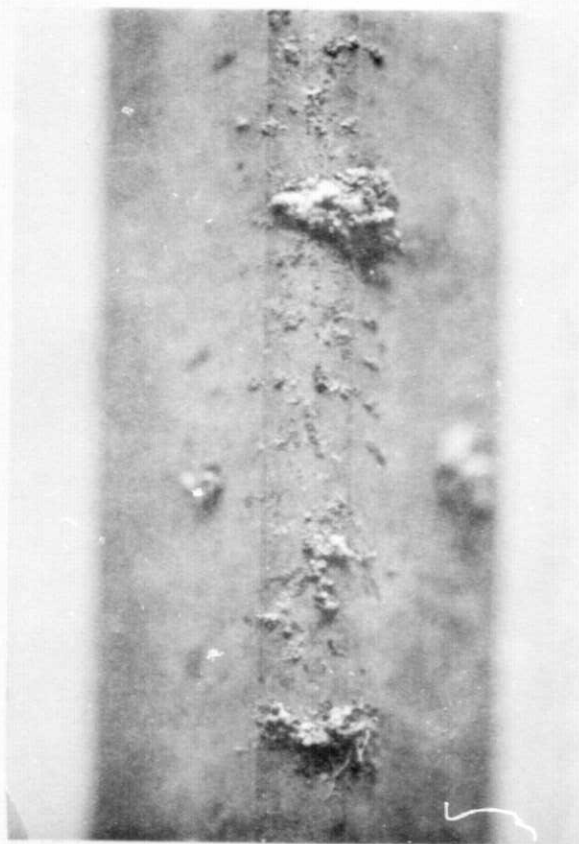
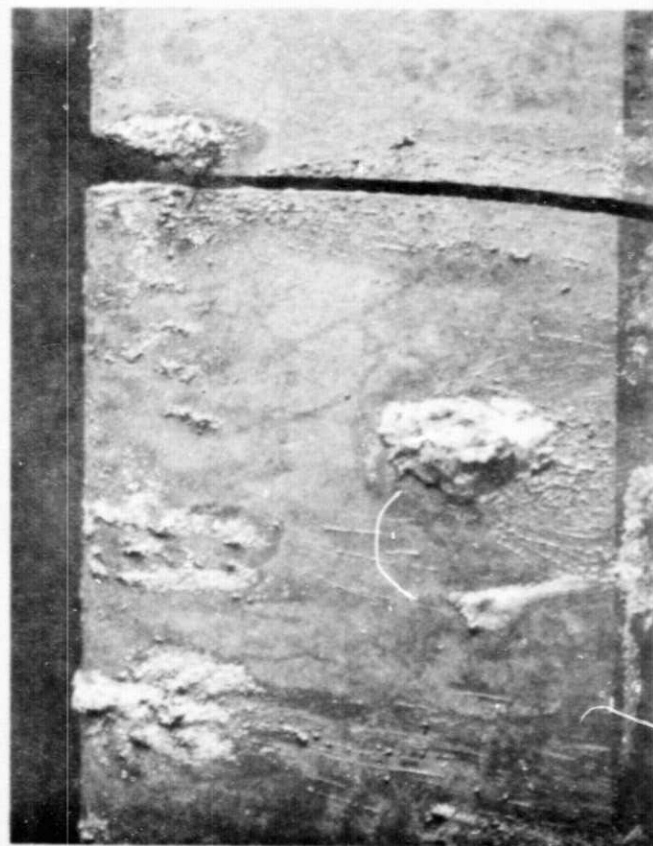
We reason this flaw to be a partial void containing some silicate oxidation product which may well be cracked. Evidence for the heavy exudation of molten material can be seen in figure 13 which shows a front view and a side view of the hot zone leading edge of the Batch 3 NC-435 vane. The front view shows a particularly heavy buildup noted at the 125 cycle inspection. The side view shows the pieced-together vane which failed at the heavy buildup during the 126th cycle cooling. Glassy oxide streaks and buildups can also be noted. Figure 13(a) can likewise be compared with figure 12(b) for noting the coincidence of the failure point and the heavy buildup. We suggest that the Batch 3 NC-435 vane had high near-surface concentrations of silicon, iron, and aluminum resulting in eutectic formation and "sweating out" of the molten eutectic during burner rig exposure. Based on vane appearance in figure 12, such presumed deleterious near-surface concentrations of silicon, iron, and aluminum were considerably less for the Batch 1 NC-435 vane and very slight for the Batch 2 NC-435 vane. This batch ranking, 3-1-2, based upon degree of sweat-out differs from a batch ranking, 2-3-1, based upon highest to lowest concentration of metallic impurities (iron and aluminum, major), given in table II. Apparently, for the metallic impurity levels 0.68, 0.58, and 0.49 percent, chemical inhomogeneties within the vane can override the effects of overall impurity level.

Figure 13. - Norton NC-435 siliconized SiC batch 3 vane hot zone leading edge after 1205⁰ C exposure in Mach 1 burner rig. Cycle: 12 minutes at 1205⁰ C, 3 minute still air cool. X10.

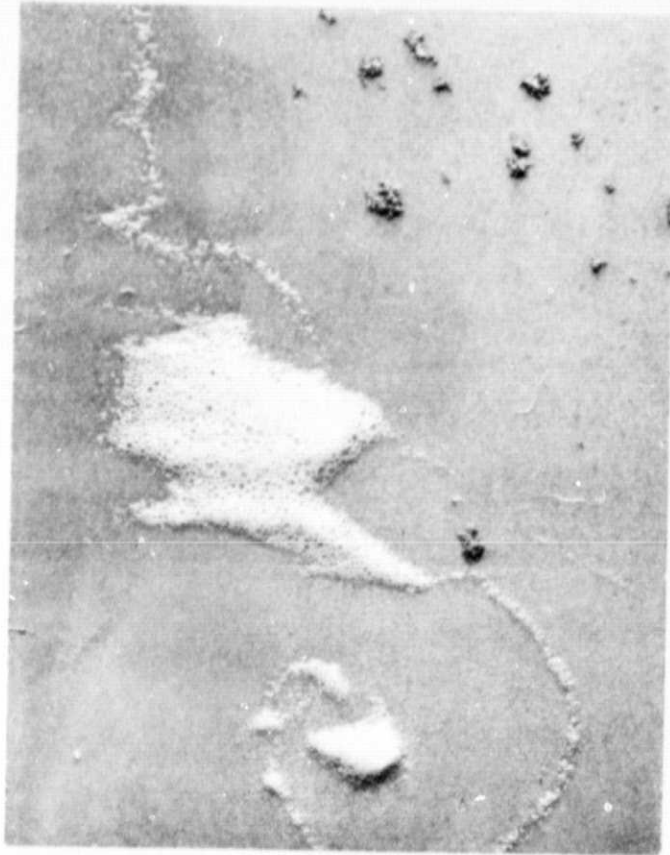
at 1205° C. The photos in figure 15 show the Batch 3 vane after 125 cycle exposure at 1260° C. In addition to the clusters of bead-like particles, there was a large collection of frothy oxide on the vane major flat surface which had been swept back from the leading edge by the Mach 1 hot gas stream.

Figure 15. - Norton NC-435 siliconized SiC batch 3 vane after 1260⁰ C exposure for 125 cycles in Mach 1 burner rig. Cycle: 12 minutes at test temperature, 3 minutes still air cool.

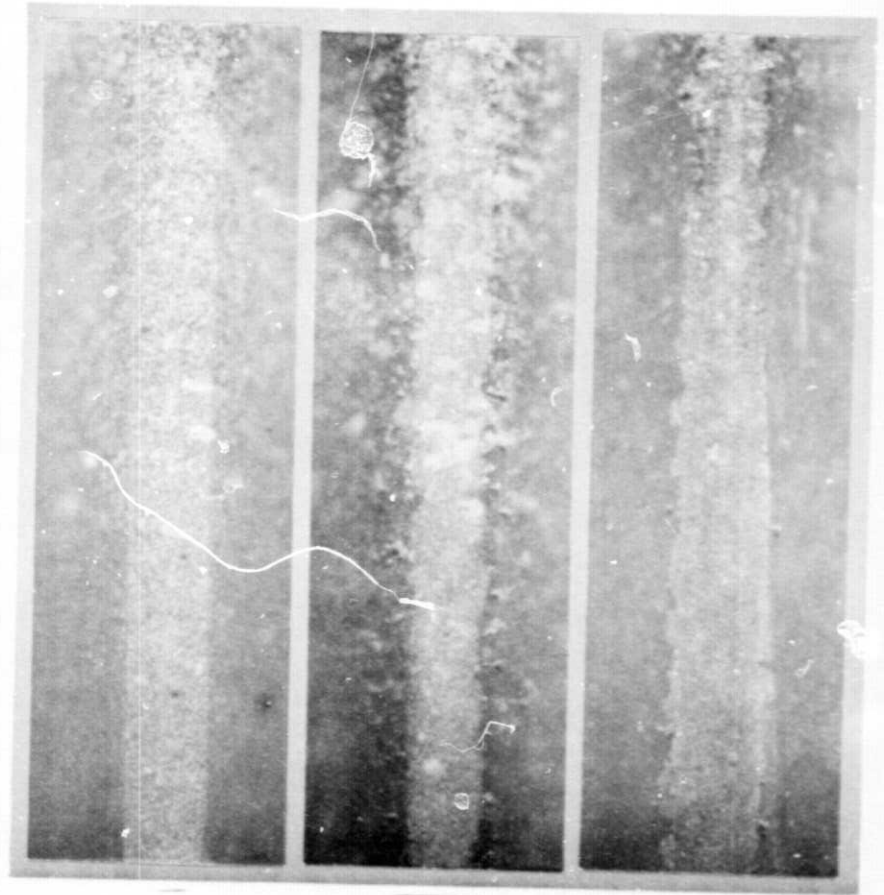
At 1315° C only a Batch 2 NC-435 vane was tested, and it completed the planned 250 cycle exposure. As previously noted, a transverse crack and two longitudinal cracks found by fluorescent penetrant inspection after 125 cycles in this best batch vane healed during subsequent exposure. A plot of specific weight change versus exposure duration at 1315° C is presented in figure 16, and photos of the vane are shown in figure 17. For judging the effect of test temperature on the Batch 2 NC-435 vanes, weight change plots and photos for 1205° and 1260° C tests are included in figures 16 and 17 for comparison with the 1315° C results. Figure 16 shows that after 250 cycles at 1315° C NC-435 has begun to lose weight while at 1205° and 1260° C the material is still gaining weight. The weight loss behavior at the highest temperature, 1315° C, may be due to Mach 1 gas stream erosive action on a less viscous silica oxidation product. It did appear, as can be noted in figure 17, that less bead-like particle clusters remained on the 1315° C test vane than on the 1260° C test vane. There were no particle clusters at 1205° C. The appearance of the 1260° C vane in comparison to the 1205° C vane is regards to particle clusters would be consistent with an assumption that the amount of silicon eutectic bleed out responsible for the particle clusters would increase with increase in exposure temperature. The lesser number of particle clusters remaining on the 1315° C vane in comparison to the 1260° C vane may be due to increased spalling tendency or erosive action at the higher exposure temperature. Such actions on the particle clusters may explain the 1315° C weight loss behavior.

Figure 17. - Norton NC-435 siliconized SiC batch 2 vanes after 250 cycle exposure in Mach 1 burner rig. Cycle: 12 minutes at test temperature, 3 minute still air cool.

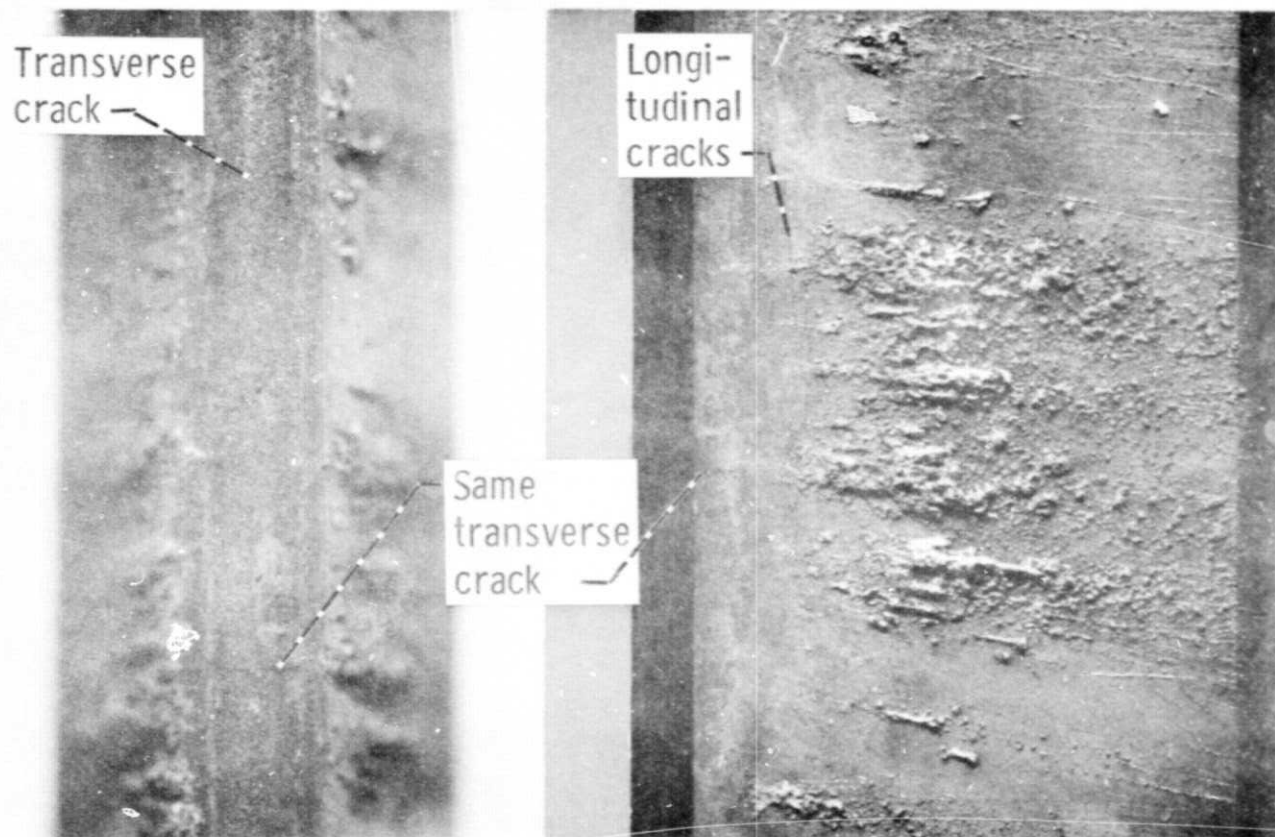
One NC-435 vane of Batch 1 material was tested at 1370° C; it failed after only 19 cycles. The bleed-out of silicon eutectic was very heavy as shown in the figure 18 photos of the front and side views of the leading edge. Failure occurred above the leading edge region shown. The figure 18(a) photo shows two fine transverse cracks in the leading edge. Longitudinal cracks just back of the leading edge can be seen in figure 18(b).

In figure 18(b) the heavy particle clusters back of the leading edge begin just down stream of the longitudinal cracks suggesting that the particle cluster material bled out along the length of the cracks and was swept back by the Mach 1 hot gas stream.

Figure 18. - Norton NC-435 siliconized SiC batch 1 vane hot zone leading edge after 1370⁰ C exposure for 19 cycles in Mach 1 burner rig, X10.
