**NASA CR-150906**

## Final Report

**FINAL REPORT**  
**on**  
**EVALUATION OF SHUTTLE TURBOPUMP BEARINGS**  
**to**  
**GEORGE C. MARSHALL SPACE FLIGHT CENTER**  
**from**  
**BATTELLE**  
**Columbus Laboratories**  
**by**  
**K. F. Dufrane and J. W. Kannel**

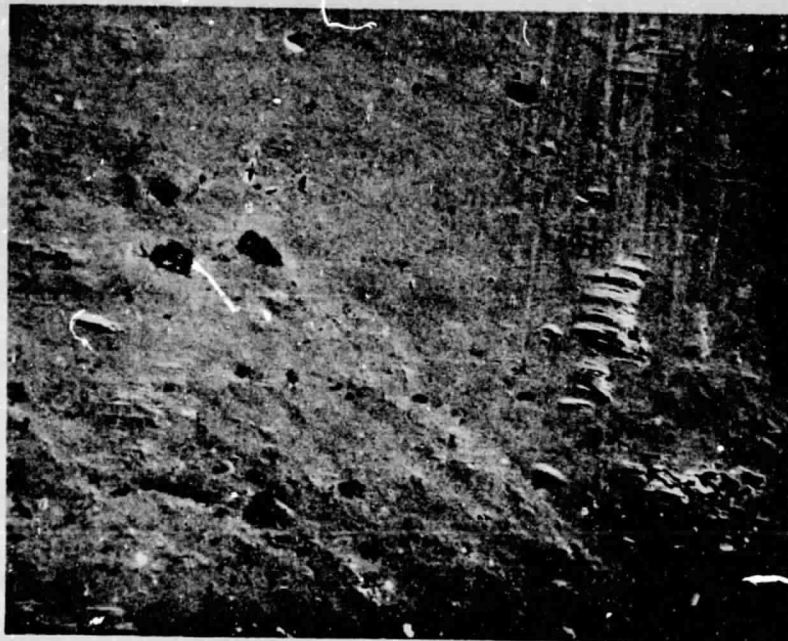
All of the contact paths also had numerous indentations caused by hard debris. The dents were defined by angular sides often reaching sharp points at the bottoms of the depressions. Such dents are typically caused by minerals, such as  $\text{SiO}_2$ , or small carbides. The requirement is that the indenting material be harder than the bearing race. A typical area on the inner race of bearing 8492669 is shown in Figure 1. Numerous small debris dents are visible on the generally featureless ball contact path.

FIGURE 1. SCANNING ELECTRON MICROSCOPE VIEW OF  
INNER RACE OF BEARING 8492669.

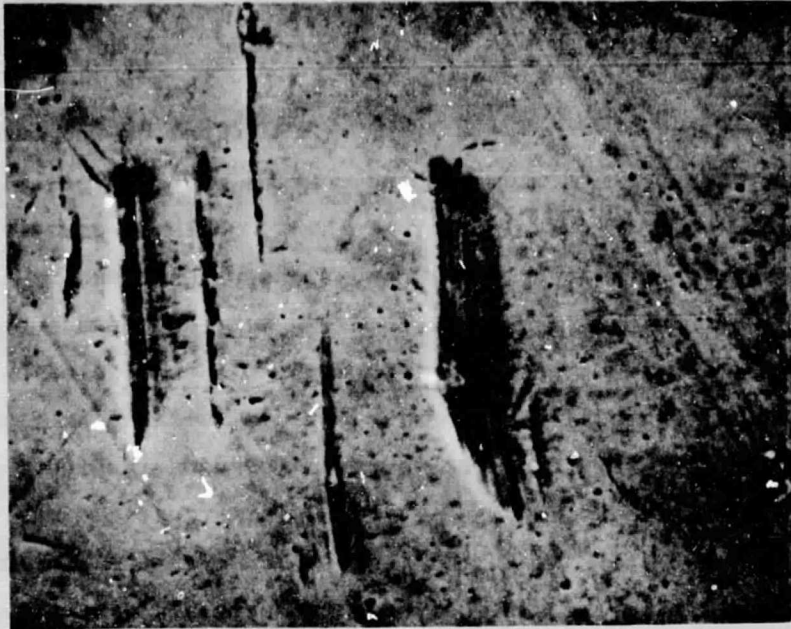
Inspection of the balls showed that they all had a tendency toward banding, which would be expected because of the significant axial load applied to angular-contact bearings. However, the bands were faint and on multiple axes. This indicates that the balls had been unloaded during portions of their orbit in the bearing or that the overall bearing loading had varied significantly during operation. The bands were defined mostly by debris dents of various sizes and a fine frosting of the original ball finish through wear. A typical area showing elongated dents on a ball from bearing 8517901 is shown on Figure 3a.

a. Elongated Dents.

FIGURE 3. DAMAGED AREAS OBSERVED ON BALL  
FROM BEARING 8517901.

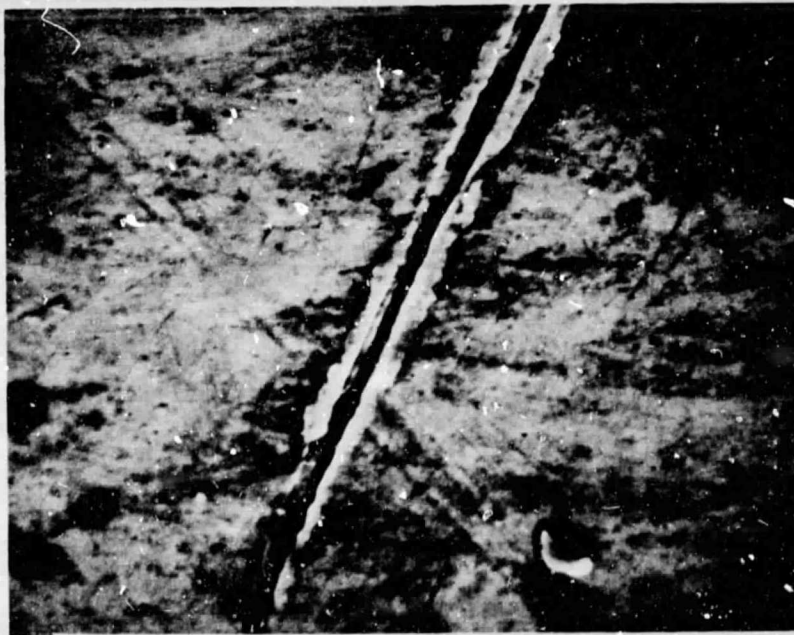
Most of the balls also had continuous small-circle scars on their surfaces, such as shown in Figure 3b. These are normally assumed to be caused by sliding contact with debris embedded in the retainer. If the balls continue to rotate about the same axis, such scars never contact the race, and therefore, are not of significance. However, when operating conditions change the axis of rotation, the scars can be placed in contact with the race and thereby contribute to torque variations (roughness). The flattened material at the edges of the scar in Figure 3b indicate that this portion of the ball had rolled through the race contact area after the scar was formed.

b. Portion of Continuous Small-Circle Scar.

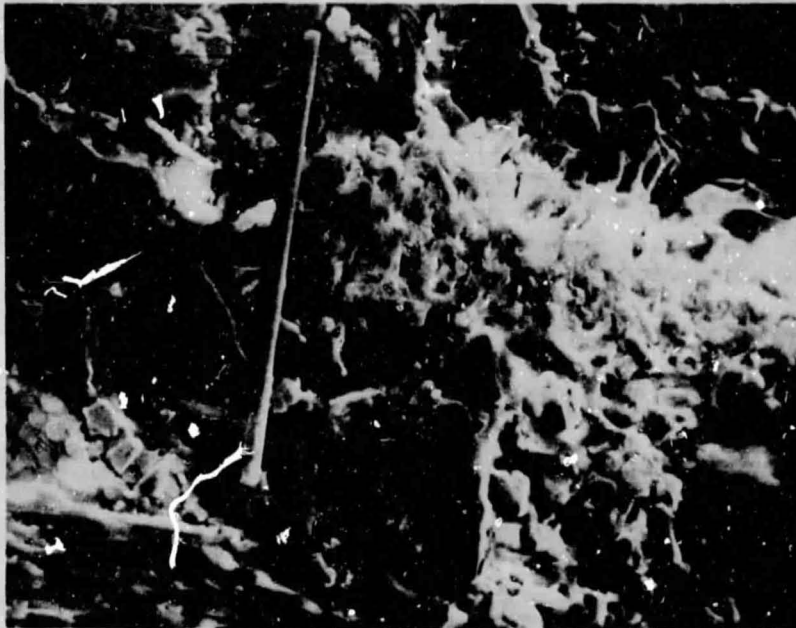
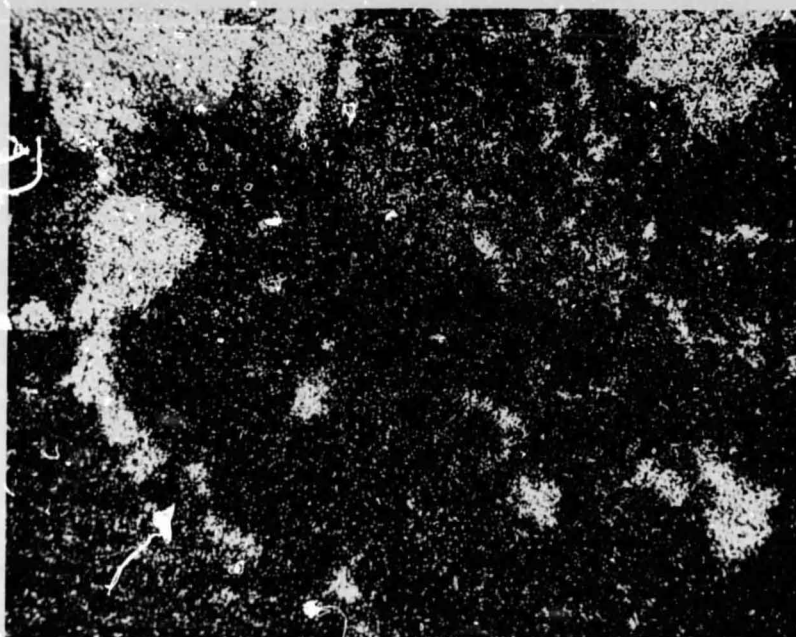
Several of the ball pockets and guiding surfaces had embedded metallic debris observable by low-power optical microscopy. An example of the debris observed in an SEM on the retainer of bearing 849674 is shown in Figure 4a. The X-ray fluorescence pattern of this area for iron is shown in Figure 4b, which identifies the metallic debris in Figure 4a. A similar pattern was developed for chromium, which suggests that the debris is most likely a steel alloy, such as the bearing race steel itself. Since some of the metallic particles protruded from the surfaces of the ball pockets, they may have been responsible for wear scars on the balls.

FIGURE 4. SEM OBSERVATION OF METALLIC DEBRIS IN  
BALL POCKET OF 8492674 BEARING RETAINER.

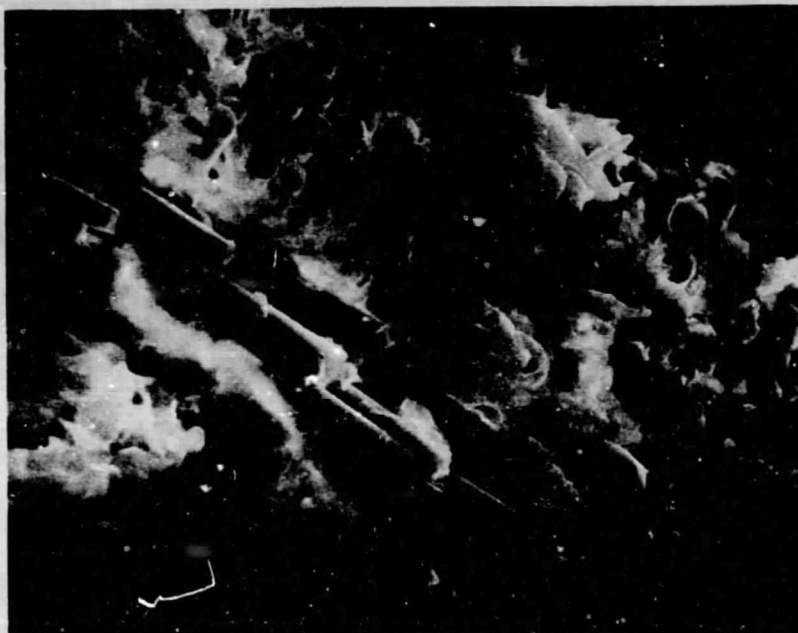
The rod-shaped particle in Figure 4a is a segment of the glass fiber reinforcing used in the retainer. A view of the fibers in another portion of a ball pocket on the retainer from bearing 8492674 is shown in Figure 5. The TFE is visible between the fibers and was often present as the loosely attached particles seen in Figure 5. Since the ball pockets are machined normal to the lay direction of the fibers, the intersection with the ends of the fibers is expected. On a microscale these present a rough surface for the balls and probably are responsible for the mild frosted appearance of the ball surfaces.

FIGURE 5. ENDS OF GLASS FIBERS IN BALL POCKET OF SEPARATOR  
FROM BEARING 8492674.

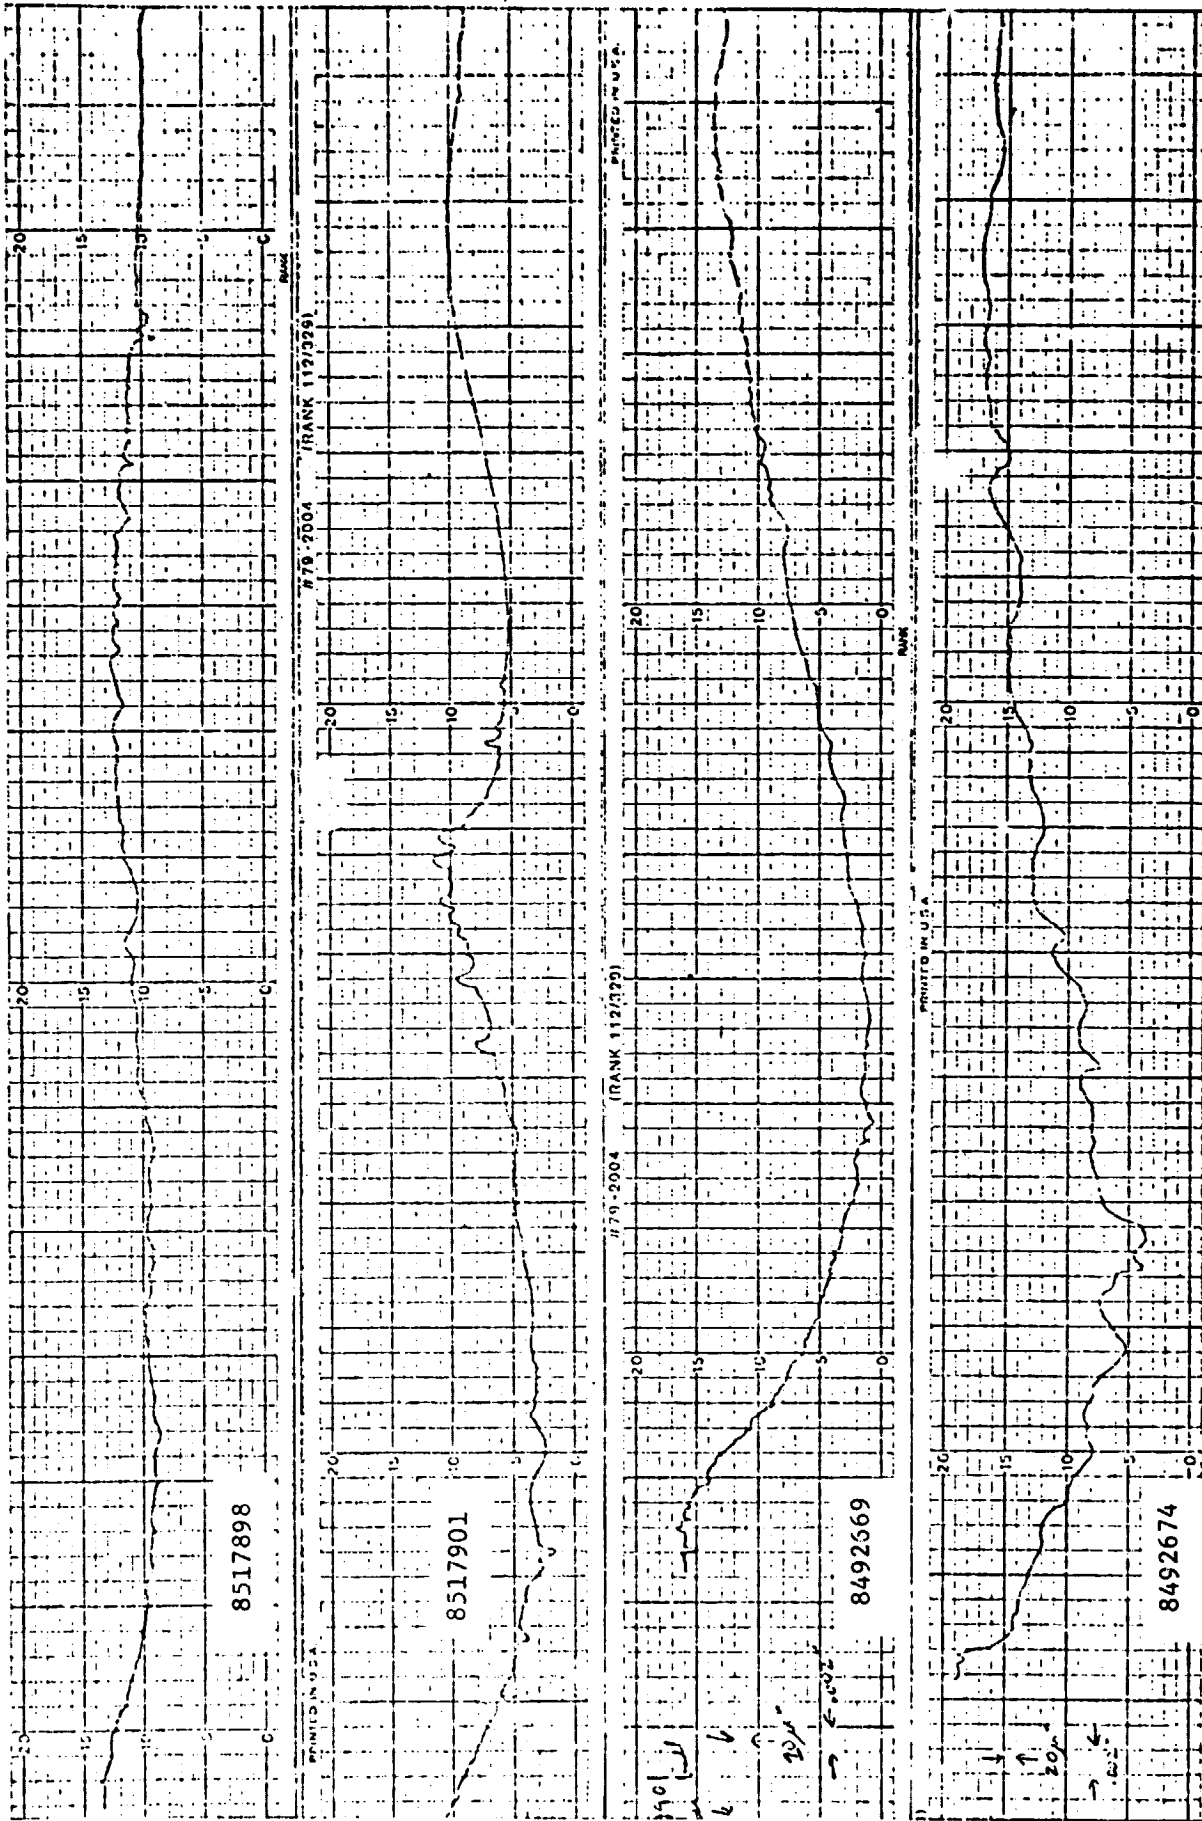
While the Talysurf profilometer cannot reliably measure profile changes over large curved areas without similar before-wear profiles for comparison, it is very useful in assessing the extent of local wear and the depth of indentations. Figure 6 presents traces across the inner race ball-contact areas of all four bearings. The general shapes of the curves are meaningless, but local dents or scratches can be seen ranging in depth from 0.5  $\mu\text{m}$  (20 microinches) to nearly 2.0  $\mu\text{m}$  (80 microinches). The buildup of soft debris on the inner race of bearing 8517901 is seen to have local peaks approximately 0.8  $\mu\text{m}$  (30 microinches) high and a possible general buildup of 2.0  $\mu\text{m}$  (80 microinches) (assuming the central raised area is all part of the deposit). The original surface finishes were probably similar to the uncontacted areas at the right end of the traces.

FIGURE 6. CURVE-MATCHING TRACES ACROSS BEARING INNER RACES. MAGNIFICATIONS, MINOR DIVISIONS,  
 VERTICAL: 0.05  $\mu\text{m}$  (20 microinch)  
 HORIZONTAL: 0.05 mm (0.002 inch)

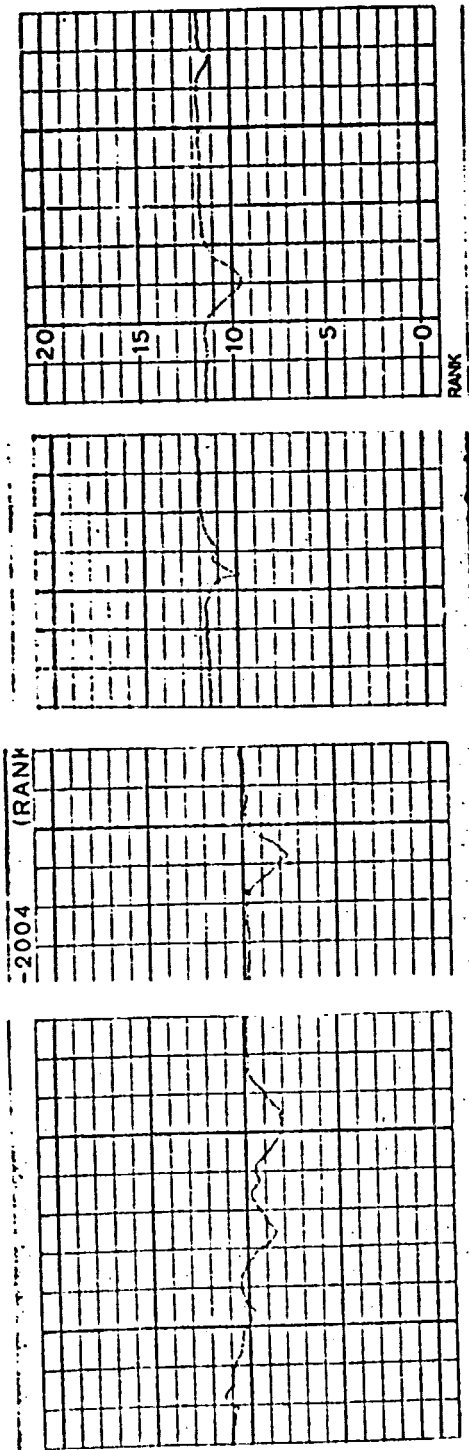
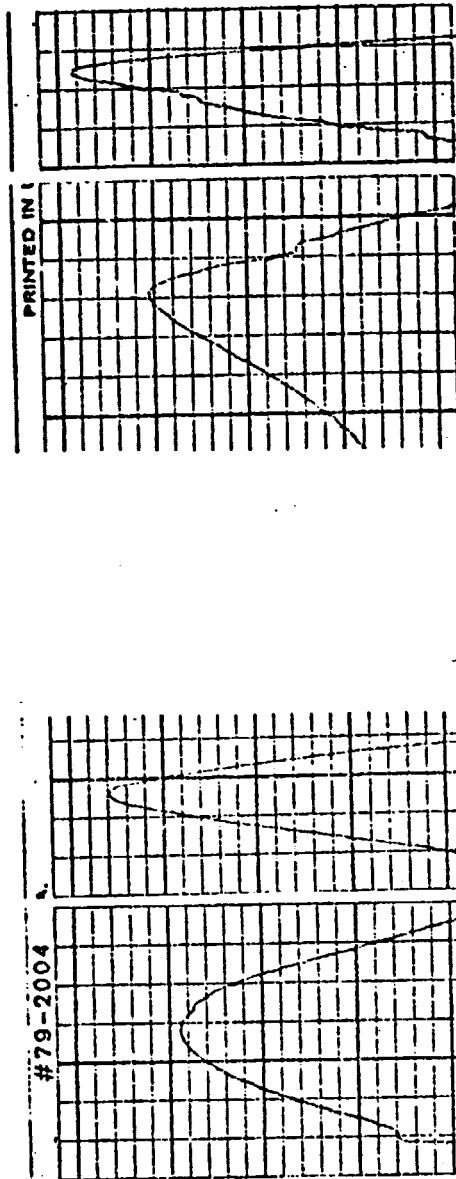
Figure 7a shows profiles of the minor-circle scratches on a ball from bearing 8517901. Scratch depths up to  $1\text{ }\mu\text{m}$  (40 microinches) were measured. Although debris embedded in the ball pockets is generally assumed to cause such scratches, a second possible source may be the result of the sliding/rolling contact on the chamfer of the inner races during periods of very high inner-race contact angles. To explore this possibility, traces of the chamfer corners were made at the same magnification as was used on the balls, shown in Figure 7b and 7c. The radii at the tips of the chamfer corners are seen to match the radii of many of the ball scratches and could, therefore, have caused these scratches. The few scratches with sharper radii were caused by sliding against a sharper object, which was probably embedded debris.

FIGURE 7. PROFILES OF BALL SCRATCHES AND CORNERS OF INNER RACE CHAMFER.  
MAGNIFICATIONS, MINOR DIVISIONS, VERTICAL: 0.5  $\mu$ m (20 microinch)  
HORIZONTAL: 0.005 mm (.002 inch)

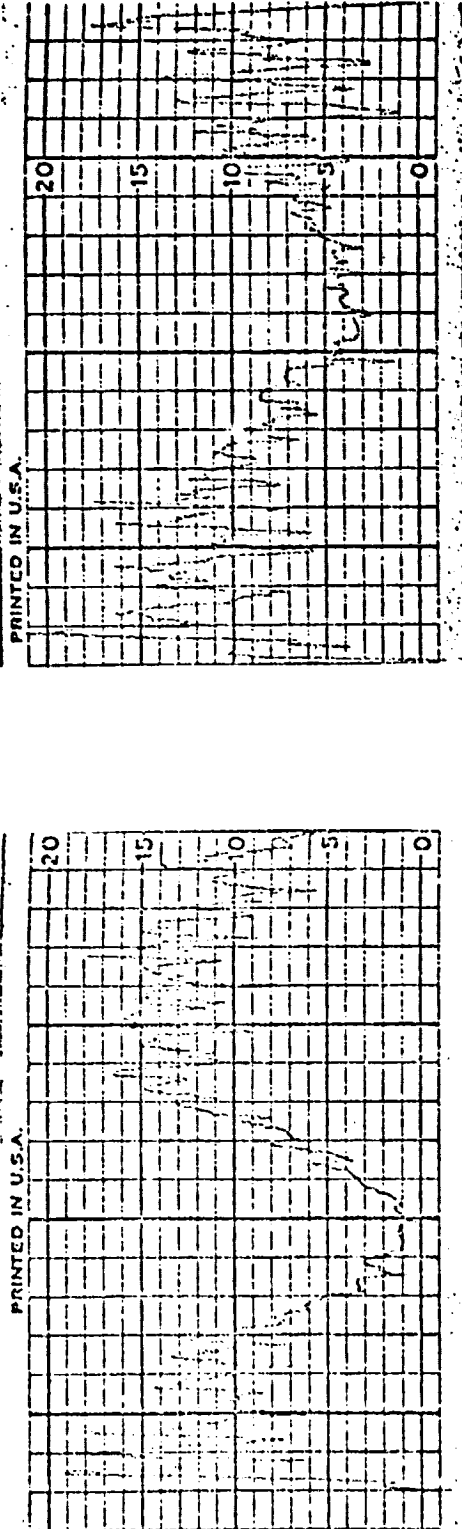
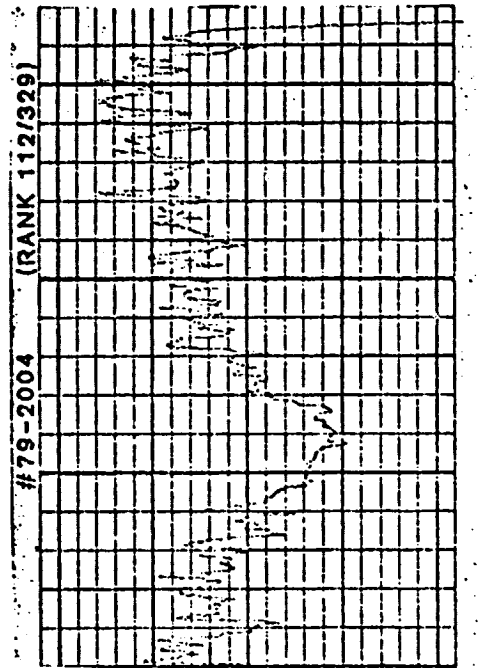
In Figures 8 and 9, the Talysurf was used to measure the extent of retainer wear at the ball-and outer-race contact areas. In figure 8, ball pocket wear depths of approximately 23 to 38  $\mu\text{m}$  (900 to 1500 microinches) were measured on the three retainers provided. The wear on the outer guiding surfaces was less, as seen in Figure 9. Only the peaks of the wrapped structure were worn off in the right portion of the trace where the retainer contacted the race. A wear depth of approximately 13  $\mu\text{m}$  (500 microinches) was measured. Since the lubrication of the bearing is assumed to result from wear transfer of the TFE in the retainer, wear such as that measured is desirable.

FIGURE 8. PROFILES OF MAXIMUM WEAR AREAS OF RETAINER BALL POCKETS.  
 MAGNIFICATIONS, MINOR DIVISIONS, VERTICAL: 2.5  $\mu$ m (100 microinch)  
 HORIZONTAL: 0.25 mm (.010 inch)

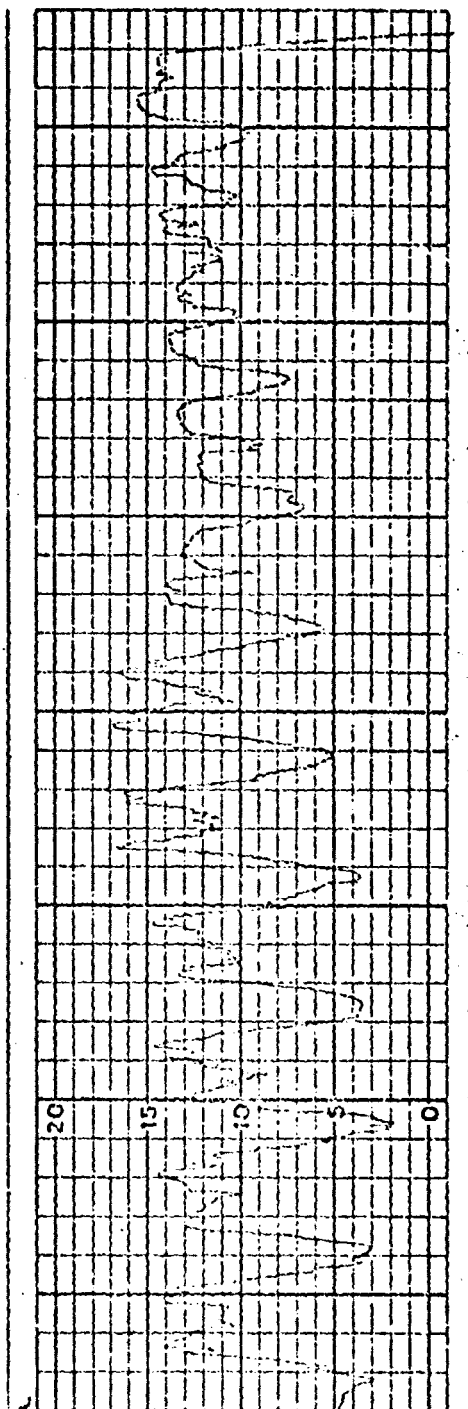
FIGURE 9. WEAR OF RETAINERS ON OUTER DIAMETER FROM SLIDING CONTACT WITH RACE.  
MAGNIFICATIONS, MINOR DIVISIONS, VERTICAL: 2.5  $\mu$ m (100 microinch)  
HORIZONTAL: 0.25 mm (.010 inch)

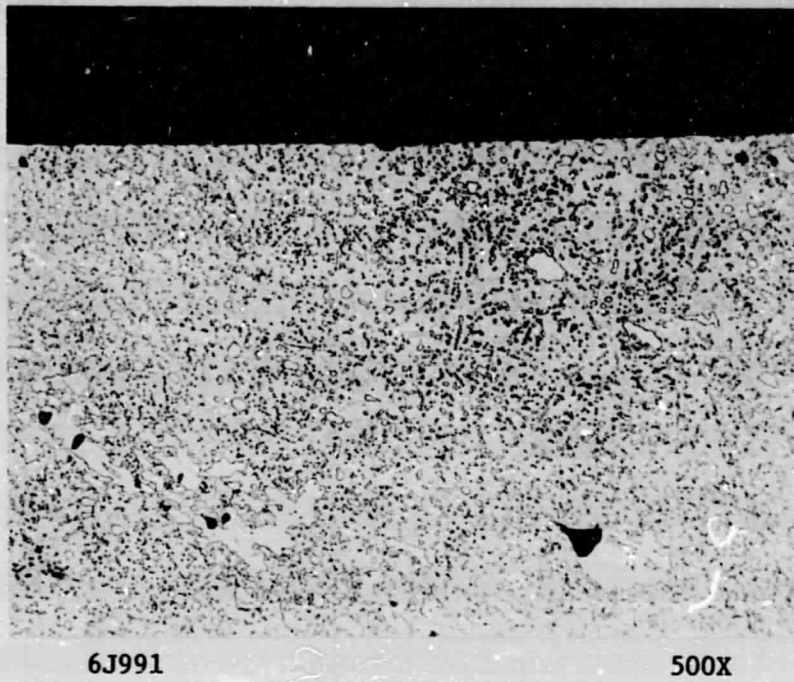
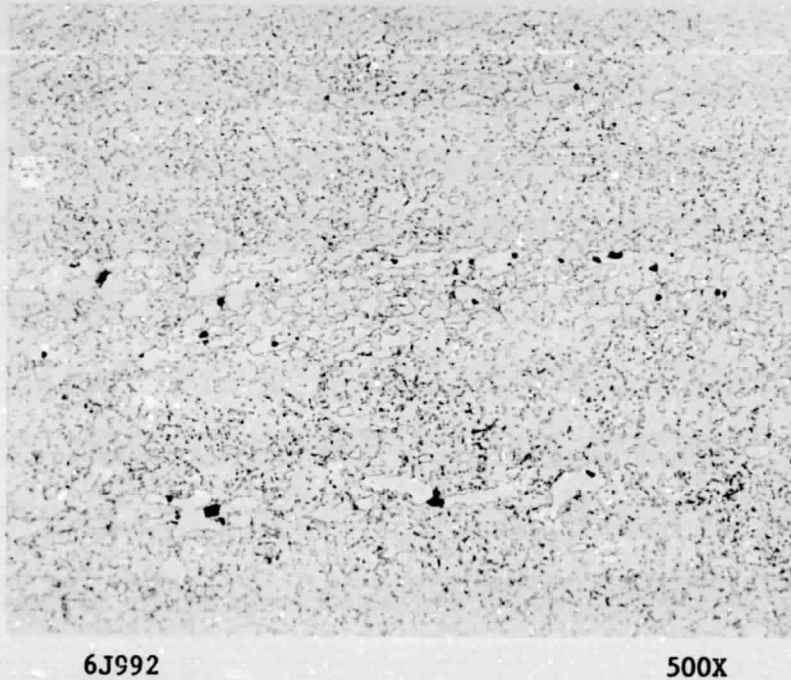
Metallurgical sections were prepared of a race from each bearing to examine the microstructure. A typical area of two bearings is shown in Figure 10. In Figure 10a, taken at the surface, a debris dent was intersected and is visible at the upper surface. The general microstructures are typical of 440C bearing steel, and no evidence of cracking, decarburization, retained austenite, or finishing damage was noted. Hardness readings taken on each of the races are presented in Table 1.

FIGURE 10. TYPICAL BEARING STEEL MICROSTRUCTURE.

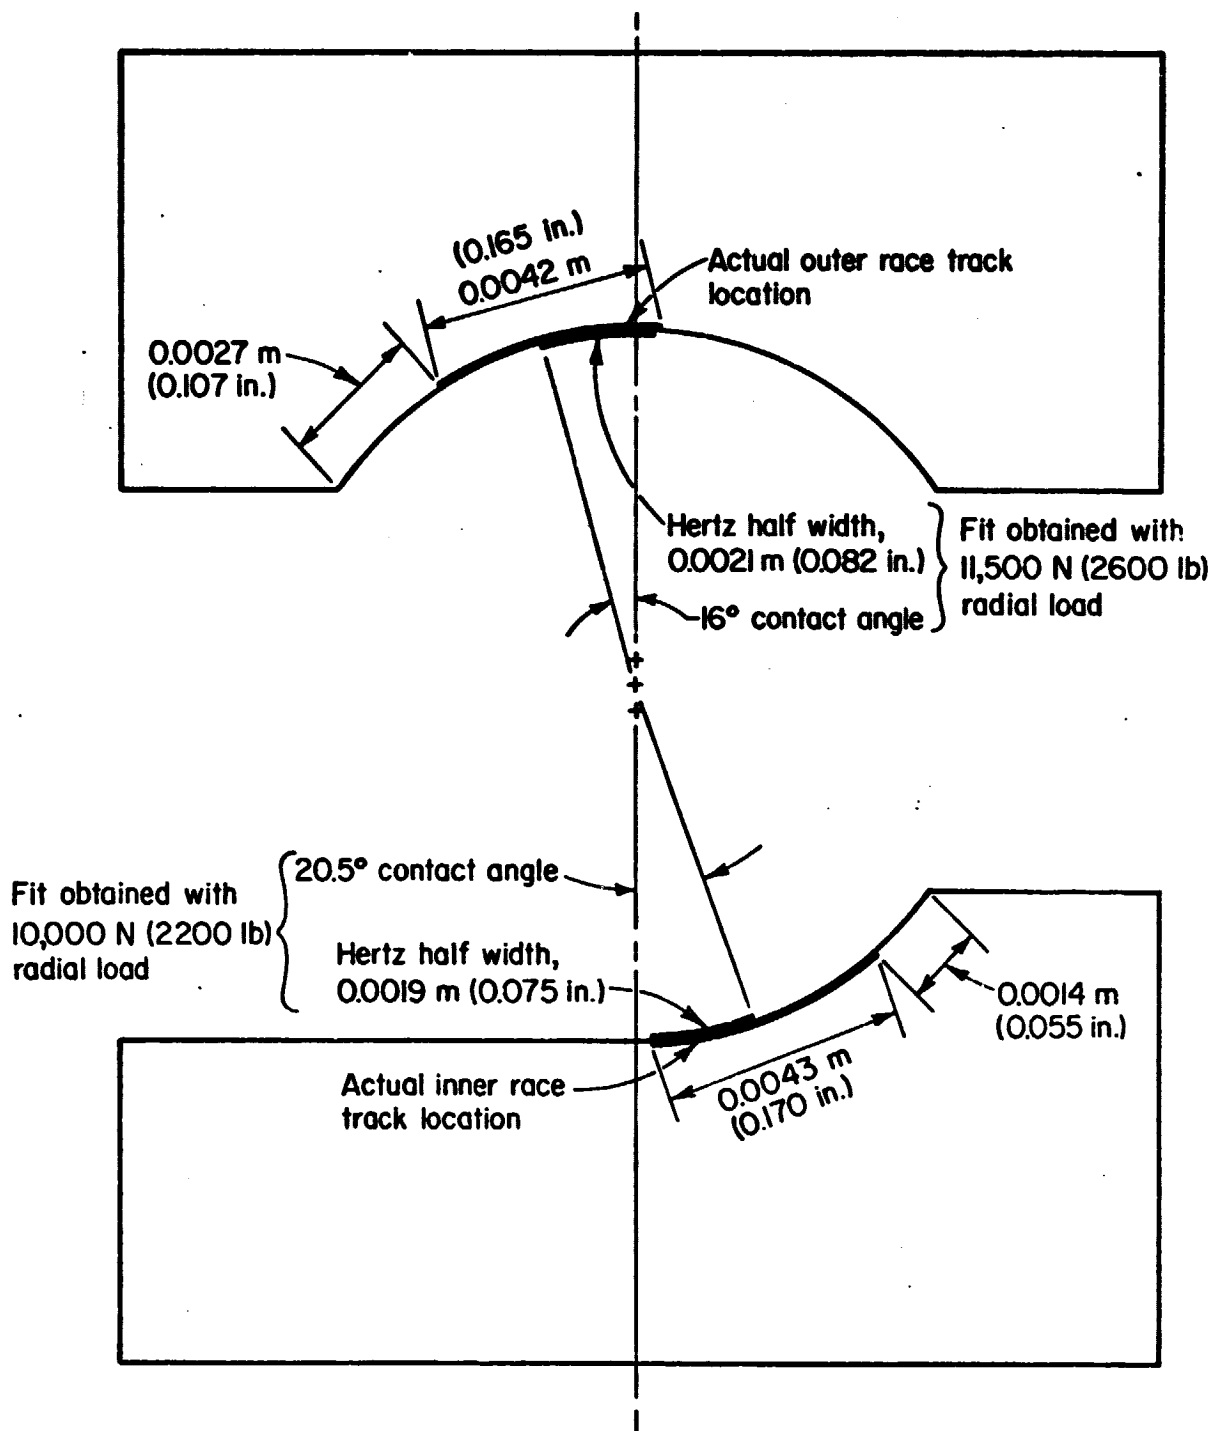
Measurements were made of the location and width of the ball contact paths on the pump bearing races supplied by NASA, by using an optical microscope. The results are shown in Table 3. Using these measurements and the graphs presented in Figures 11 through 14, an estimation was made of the maximum radial load applied to each bearing race. Axial loads were assumed of 2900N (650 lbs) on the type 7522 bearings and 3800N (850 lbs) on the type 7955 bearings. An example of the procedure is shown in Figure 17, which is based on a scale drawing of the bearing races in their nominal position during operation. By graphical iteration, the load was chosen for each race that gave the best simultaneous fit of contact angle and Hertz half width for the extreme edge of the ball contact path (maximum radial load position). The maximum radial loads obtained for each bearing race are presented in Table 3.

FIGURE 17. LOCATION OF ACTUAL BALL CONTACT PATHS ON BEARING 8517901 SHOWING FIT OF CONTACT ANGLES AND HERTZ HALF WIDTHS OBTAINED FROM FIGURES 12 and 14.

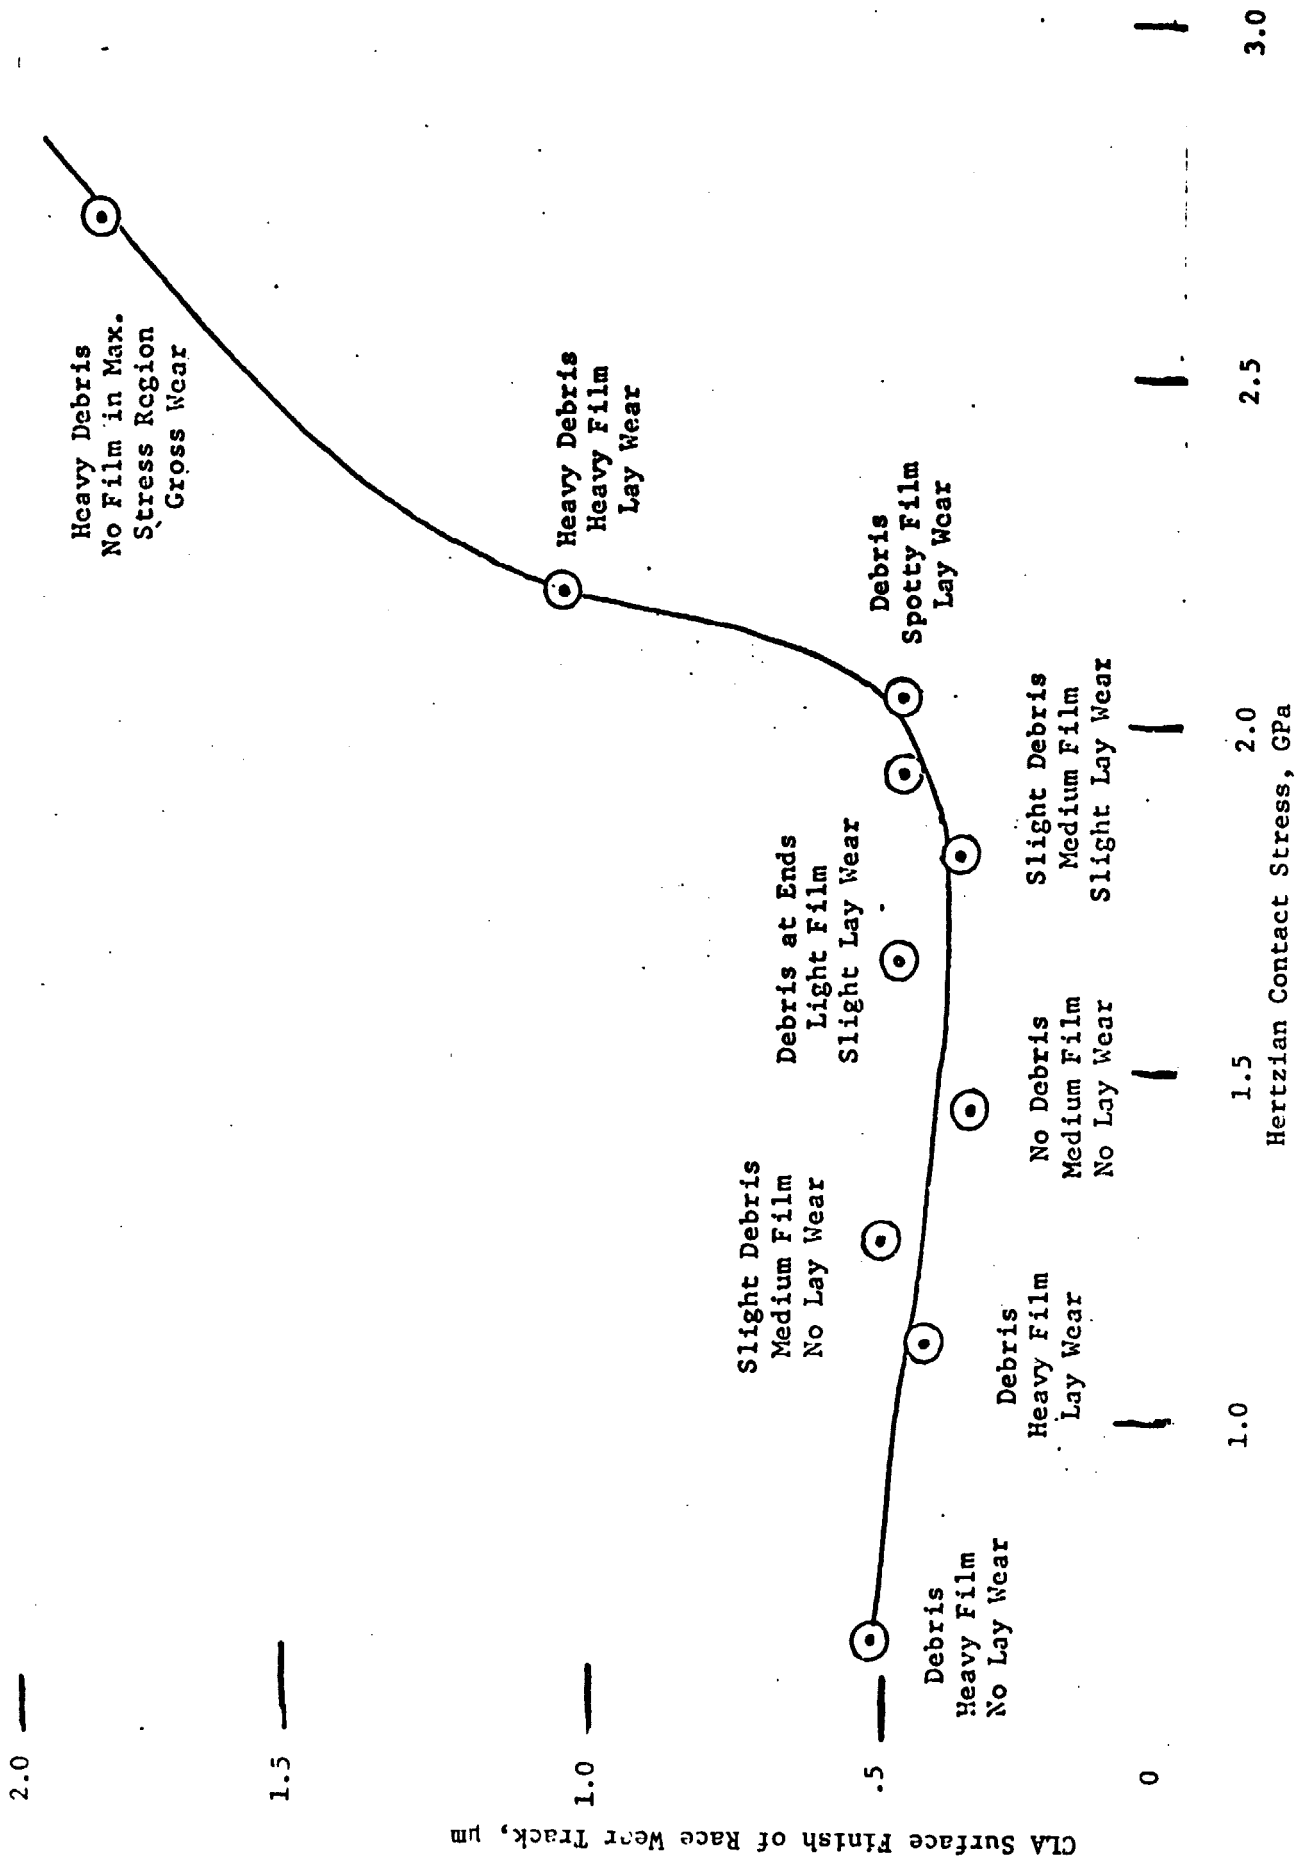
One possible problem with solid film lubrication is in the stress limitation of the film itself. Battelle has conducted some experiments in other projects to characterize solid film strength. Figure 18 shows the result of one such series of tests. It should be noted that these tests were conducted for a different solid film and under much different conditions than being encountered in this project. However, the trends shown in these data are very critical. These data indicate that above a stress of 2 GPa (230,000 psi) solid film failure may occur (as noted previously, the estimated stress for the bearings investigated here was 2.8 GPa (410,000 psi)).

FIGURE 18. ADEQUACY OF TYPICAL TRANSFER FILM LUBRICANT
