**LIGHTNING TESTS OF THE ORBITER PYROTECHNIC
ESCAPE SYSTEM**

R. Cohen, *Johnson Space Center, Houston, Texas*
E. H. Schulte, *McDonnell Aircraft Company, St. Louis, Missouri*

ABSTRACT

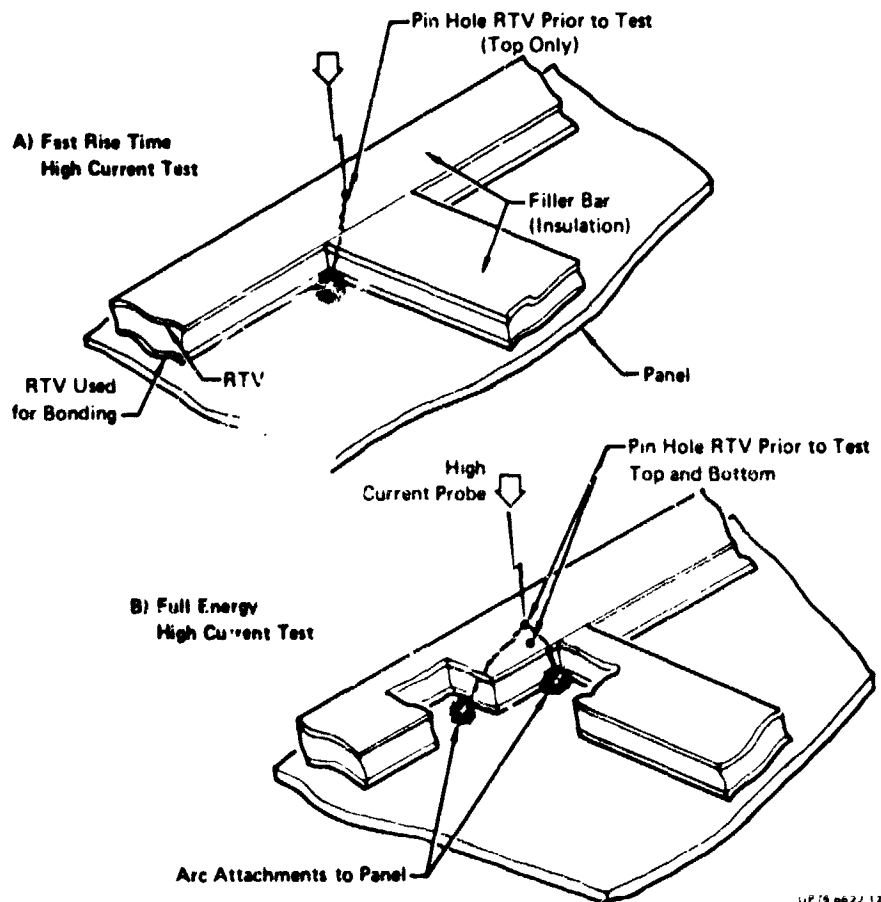
FIGURE 12 – RECONSTRUCTED PROBABLE ARC PATHS TO PANEL DURING HIGH CURRENT SURGE TESTS

The fast rise-time 180-kA current pulse produces the initial fast rising shock effects of a natural lightning strike. However, the actual shock effect on the pyros may have been diminished somewhat because the current attach point to the metal panel was diverted to the side of the filler bar and therefore did not attach directly over the pyros as expected. Although the arc may have penetrated the RTV on top of the filler bar as provided by the pin holes, the arc apparently found a path of less

impedance to the side of the RTV used to bond the filler bar to the panel rather than penetrating thru it; a phenomenon similar to that previously noted for the smooth RTV on the top of the filler bar.
