NASA Technical Memorandum 79112

SOME EFFECTS OF CYCLIC INDUCED DEFORMATION IN ROCKET THRUST CHAMBERS

N. P. Hannum, R. J. Quentmeyer, and H. J. Kasper
Lewis Research Center
Cleveland, Ohio

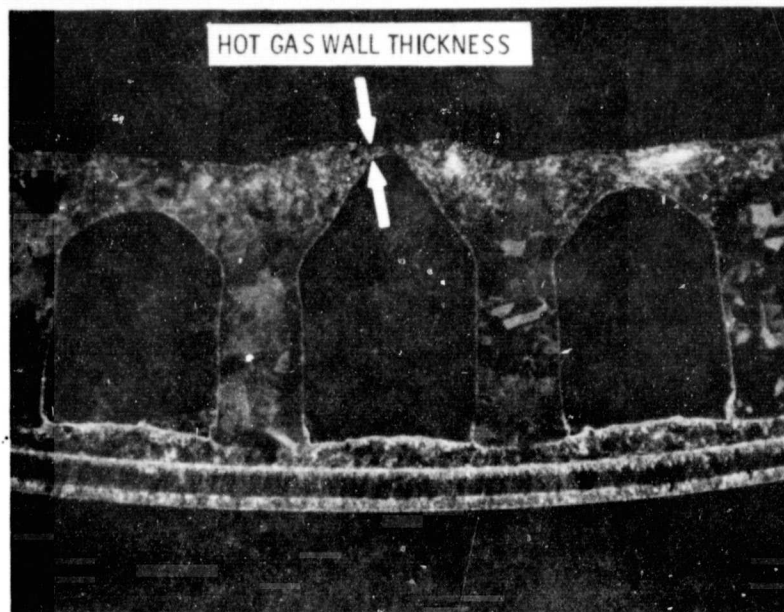
(a) OFHC COPPER THRUST CHAMBER S/N 75.

Cross section views of the failure sites for two different materials are shown in Fig. 4. The failed coolant channel is characterized by a "dog house" shape and a bulge of the hot gas wall toward the centerline of the thrust chamber. Conservation of the wall material was assumed since no hot gas surface melt or erosion was observed. The hot gas wall must thin, therefore, to accommodate the bulge. Because of the progressive thinning, the bulge on the hot gas wall tends to form two bumps per cooling channel. It can be seen in Fig. 4(a) that the bulging and thinning that occurred with the OFHC copper material was much greater than with the

Some metallographic observations were made for the material at the failure sites. It appears that some recrystallization has occurred in the hot gas wall of the OFHC copper chamber S/N 75 (Fig. 4(a)). No recrystallization was observed for the other materials. When hardness surveys were taken across sections similar to those shown in Fig. 4, it was found that hardness adjacent to the failure site was different from hardness away from the failure site (near the electroformed closeout). If it is assumed that the liner material away from the failure site remained in the pretest condition, then a change in hardness occurred at the failure site for all liner materials during cyclic testing. A tabulation at hardness measurements for each chamber are shown in Table I. The as fabricated hardness with OFHC copper was R_B 12-15. At the failure sites there was softening to R_B 0-9. In contrast the heat treated Amzirc and Narloy-Z hardened as cycles were accumulated. Heat treated Amzirc hardened from R_B 10 to R_B 15, Narloy-Z chamber S/N 140 hardened from R_B 33 to R_B 57. Narloy-Z chamber S/N 150 hardened from R_B 45 to R_B 60. An observation can be made that both Narloy-Z chambers failed at about the same hardness, but the one that hardened more (R_B 33 to 57) had longer life (301 compared to 154 cycles). The reasons for these differences in material behavior is not understood.

the cross section photograph (Fig. 4(a)) as local necking of the material adjacent to the crack. The rapid deformation and thinning may have occurred in the final cycle or progressively during the last nine cycles.

As noted in Ref. 4 and as can be seen in Fig. 4(a) of the present work the visual evidence supports the contention of tensile stress failure with OFHC copper. For a tensile stress failure to occur, the ultimate stress for the material must be exceeded at some point in the cycle. The exact point in the cycle when failure occurred is not known since both the stress in the wall and the ultimate stress of the material are changing with time. The stress is nominally the same for all three materials for the same wall thickness and would increase as the wall thickness decreases. Therefore, it is assumed that a wall thickness of approximately 0.475 mm (0.0187 in.) corresponds to a stress in the wall equal to the ultimate stress value of OFHC copper. The result is a tensile stress failure. However, since the published data for heat treated Amzirc and Narloy-Z indicate that the ultimate stress is greater than OFHC copper at similar temperature conditions, the level of stress in a wall 0.475 mm (0.0187 in.) would not produce a tensile stress failure in these stronger materials. Figure 7 shows that these stronger materials possibly failed at stress levels even less than the OFHC copper since the final wall thickness was greater than with OFHC copper. The implication is that the failure mechanism for the heat treated Amzirc and Narloy-Z thrust chambers in the present work is more complicated than simple tensile stress failure.

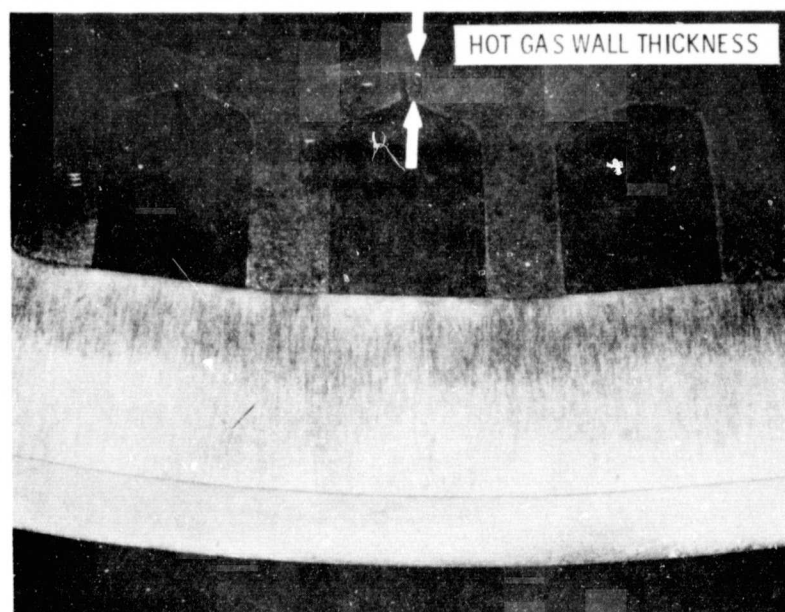
(b) NARLOY-Z THRUST CHAMBER S/N 150.

Narloy-Z (Fig. 4(b)). The failure sites for the other thrust chambers not shown also had the "dog house" shape. Although all materials deformed similarly, an important difference is evident between the two failure sites shown in Fig. 4. In addition to the thinning of the hot gas wall, a necking of the material in a small region on each side of the failure site occurred with the OFHC copper. This is a typical appearance of a tensile failure with a ductile material. Tensile failures were observed in Ref. 4 for OFHC copper, heat treated Amzirc, and Narloy-Z. The failure mechanism was described as stress rupture. In the present work the failure site shown for Narloy-Z in Fig. 4(b) does not show necking of the material adjacent to the crack. Therefore, the visual evidence in the present work supports the Ref. 4 contention of a tensile stress failure mechanism only with OFHC copper. The failure sites for the Narloy-Z and heat treated Amzirc in the present work are different than observed in Ref. 4 because there is no evidence of necking adjacent to the crack with these materials.

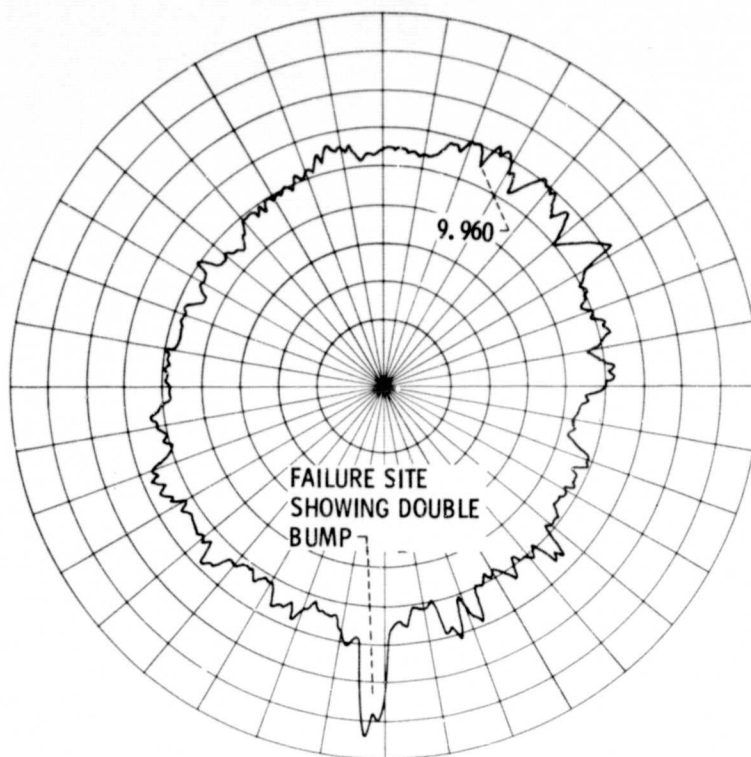
(a) POST FAILURE DATA AFTER 193 CYCLES.

The hot gas side wall deformation was measured nondestructively. Polar plots were made for each of the thrust chambers to document the post test hot gas wall deformation. A typical plot is presented in Fig. 5(a). It can be seen in the figure that the failure site and one or two other channels exhibit the double bump characteristic (each cooling channel covers a 60° arc). The deformation at the failure site is much greater than at other locations in the thrust chamber. This was true for all materials. The deformation data from these polar plots are tabulated in Table I. Deformation at the failure site was defined as the distance from the valley (at approx. the rib center line) to the largest peak. The data tabulated was for the

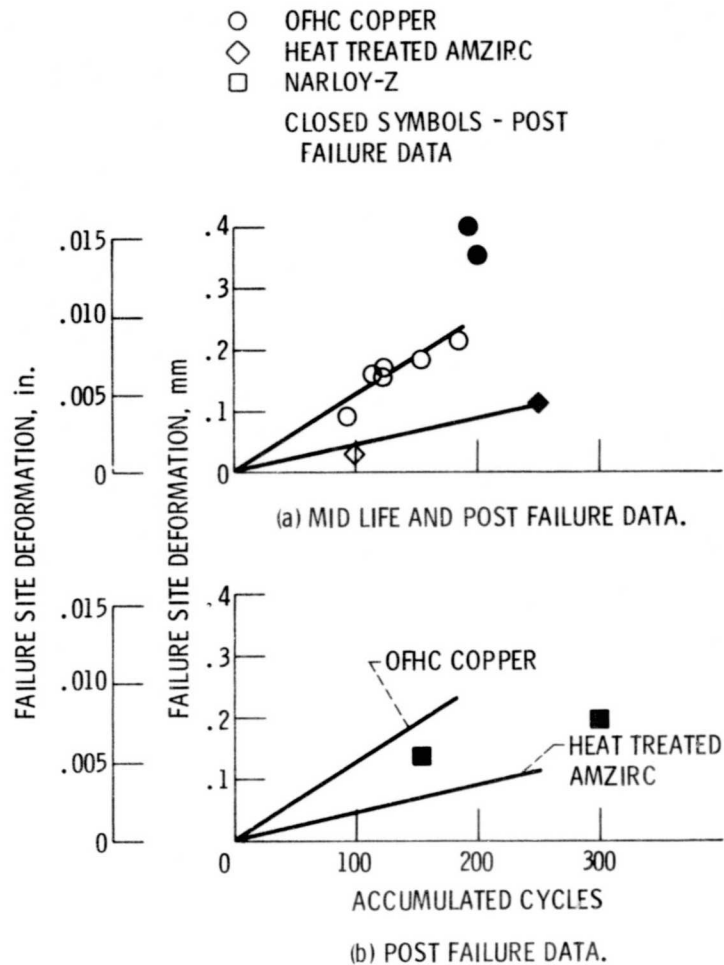
Figure 6. - Failure site deformation as a function of accumulated cycles.

The failure site deformation data for the two OFHC copper chambers (S/N 74 and 75) and for the heat treated Amzirc chamber (S/N 82) are presented in Fig. 6(a) as functions of accumulated cycles. Where available, data using both nondestructive methods, that is, from plaster cast segments and full 360° plots are shown. The closed symbols are the post failure points and represent an average of the nondestructive and the post failure photographic data. Even as the deformation becomes large the failure site bulges out into the chamber in a nearly linear manner as cycles are accumulated. Reference 5 has characterized the failure mechanism as a ratcheting type process. The slope of the deformation histories presented in Fig. 6 could be considered a ratcheting rate. The ratcheting rate for the OFHC copper is nearly 3 times greater than the heat treated Amzirc. As noted in APPARATUS the stiffness of the structural jacket for the OFHC thrust chambers was less than the other chambers. It is reported in Ref. 6 that the low stiffness structure reduced the strain range approximately 10% compared to the thick nickel structure. Consequently, if the OFHC copper chambers had been fabricated with the same stiffness the trend would be toward increasing the ratcheting rate for the OFHC copper.

A rapid increase in the hot gas wall deformation can be seen in Fig. 6(a) just before failure with the OFHC copper. At the onset of failure the material no longer ratchets linearly but becomes unstable and rapidly deforms (thins) until a tensile stress failure occurs. This was seen visually in

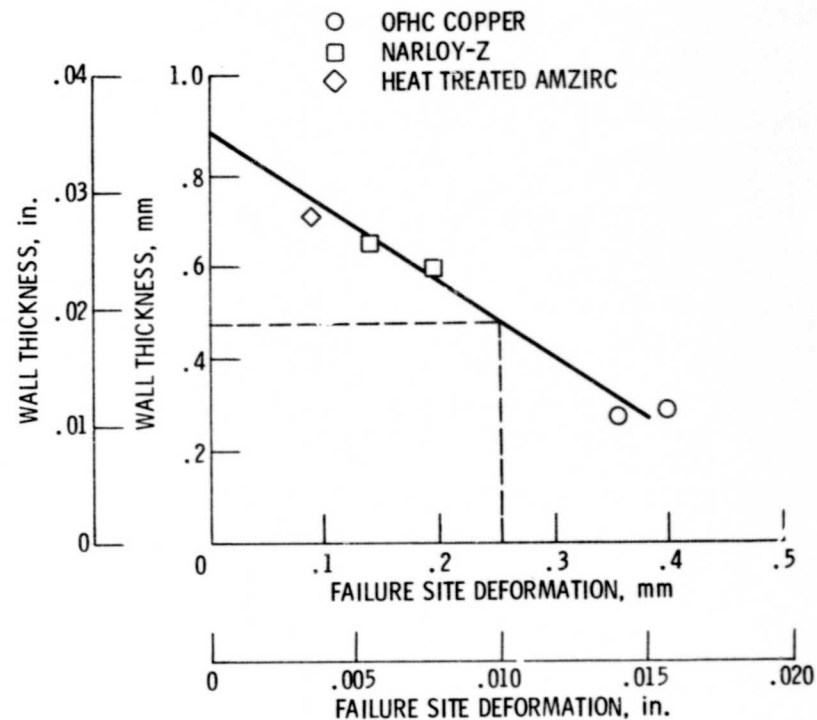
Figure 7. - Relationship of failure site deformation to coolant channel wall thickness for three different thrust chamber liner materials.

Figure 7 shows the final failure site deformation versus the final failure site hot gas wall thickness for three different thrust chamber materials. The data were obtained by measuring cross section photographs. The definition of deformation was the same as used with the polar plots (Fig. 5). The wall thickness was measured as indicated in Fig. 4. As shown in Fig. 7 the wall thickness versus deformation data are correlated by a straight line which extrapolates to the original wall thickness of 0.889 mm (0.035 in.) for zero deformation. Although this correlation was made from post failure data it is assumed that the correlation is also valid at intermediate life. Use of this correlation provides a means for determining wall thickness at intermediate life points from measurements of hot gas wall deformation.
