GEOS Axial Booms

Gunter K. Schmidt, Dornier Systems GmbH, Friedrichshafen, Germany

ABSTRACT

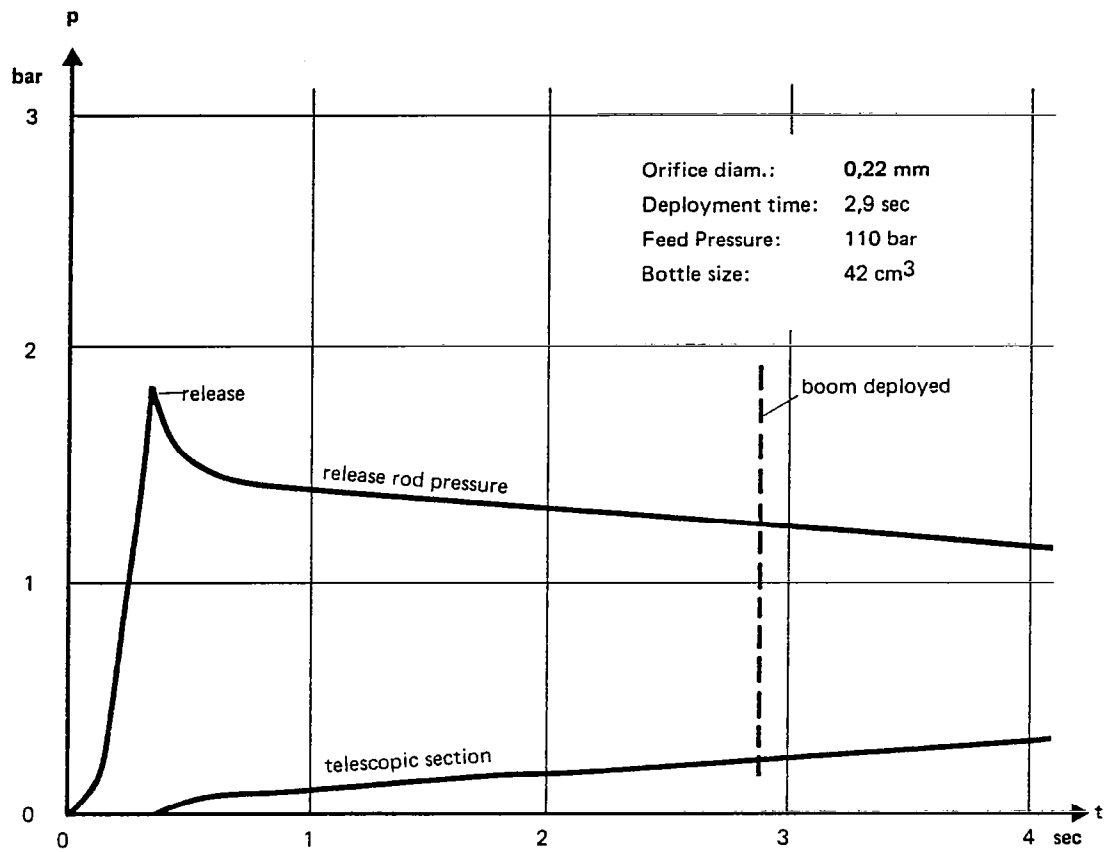
Fig. 3: Long Axial Boom - Pressure Profile

3. In the third test series, an orifice choke was simulated by a thin wire inlay in the orifice channel. During these tests the axial booms were equipped with a special release block which allowed recording of the pressure profiles in the release rod and the telescopic section. A typical pressure profile is shown in Fig. 3.

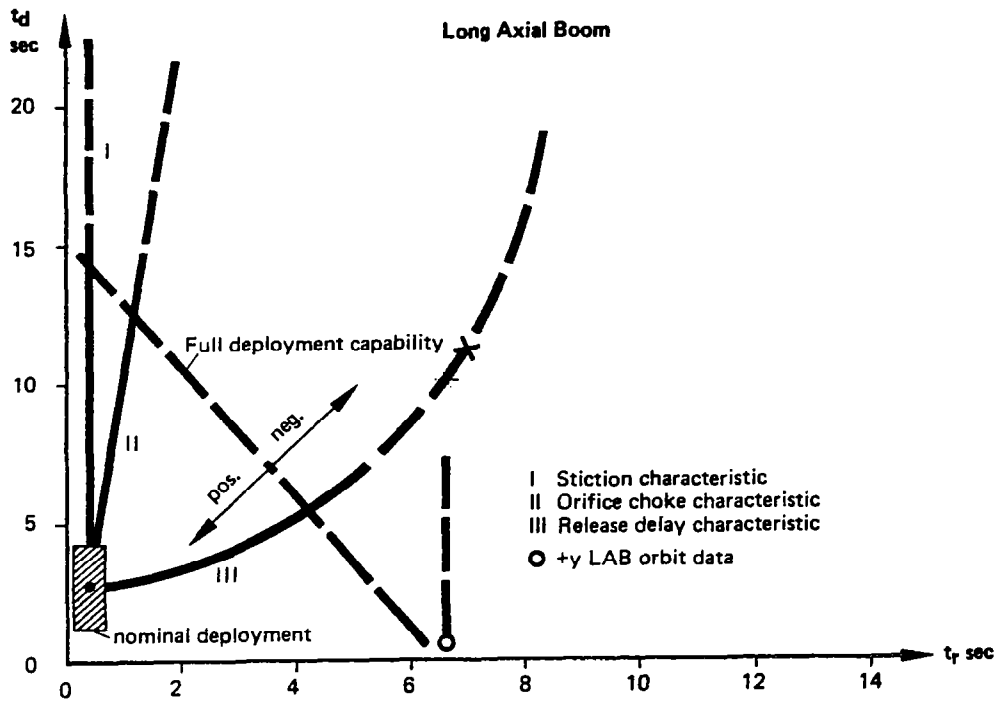
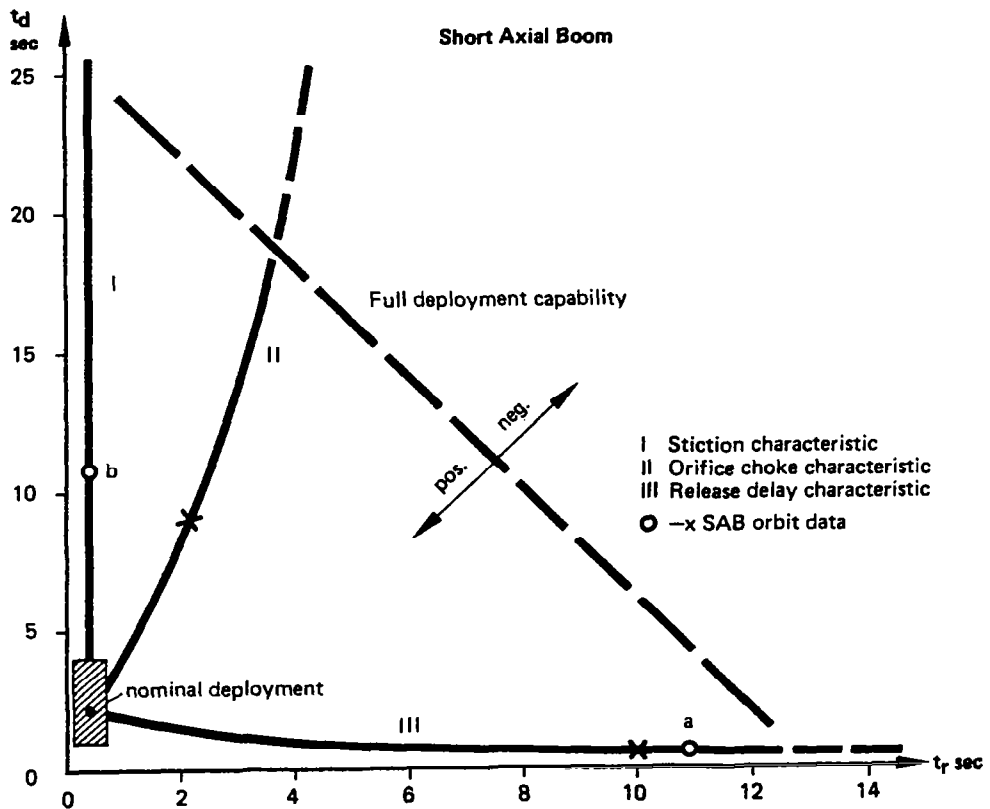
Fig. 6 Axial Booms – Deployment Characteristics

As a result of the above investigations, the release delay t_r and the deploy-time t_d are determined to be the critical parameters. These parameters indicate a characteristic dependency for each of the possible failure explanations. The diagram Fig. 6 illustrates these characteristics.

Curve I shows the relationship attributable to increased friction (1.3). The release delay is not influenced by increased friction in the seal and guide system. Therefore, this failure develops as a vertical line. (see Fig. 6).

Curve II shows the relationship of t_r and t_d for the condition of a reduced gas flow. The reduced gas flow influences the deploy time significantly. Its influence on the release delay is less distinct.

Curve III shows the t_r , t_d dependency for the condition of release mechanism jamming. This failure mode causes the pressure to increase in the release rod and the stowed telescopic sections. When release occurs, there is an increase in deployment speed. This behaviour is more pronounced for the SAB than for the LAB, due to the lower deployed to stowed volume ratio of the SAB.

The SAB data substantiate a position on either curve I or curve III (point b and a), depending on individual interpretation of the orbit data.

There is no substantive evidence from the orbit data that orifice contamination has to be considered. The diagram demonstrates that any partial orifice choking would cause only a small release delay followed by a slow deployment of the SAB. The orbit data does not support this interpretation.

If the delayed release of the Long Axial Boom has to be considered as definite, any friction has to be excluded, since the +Y LAB still deployed about 80 % following the delayed release. Orifice choking can also be excluded as it was impossible, during the tests, to generate release delays of greater than 4 seconds. The release pressure level could not be achieved for the delayed boom at higher choke rates. This condition is valid also during orbit.

Therefore, a malfunction in the release mechanism can be assumed only for the Long Axial Boom. During the first few seconds of deployment, motion following this delayed release was relatively

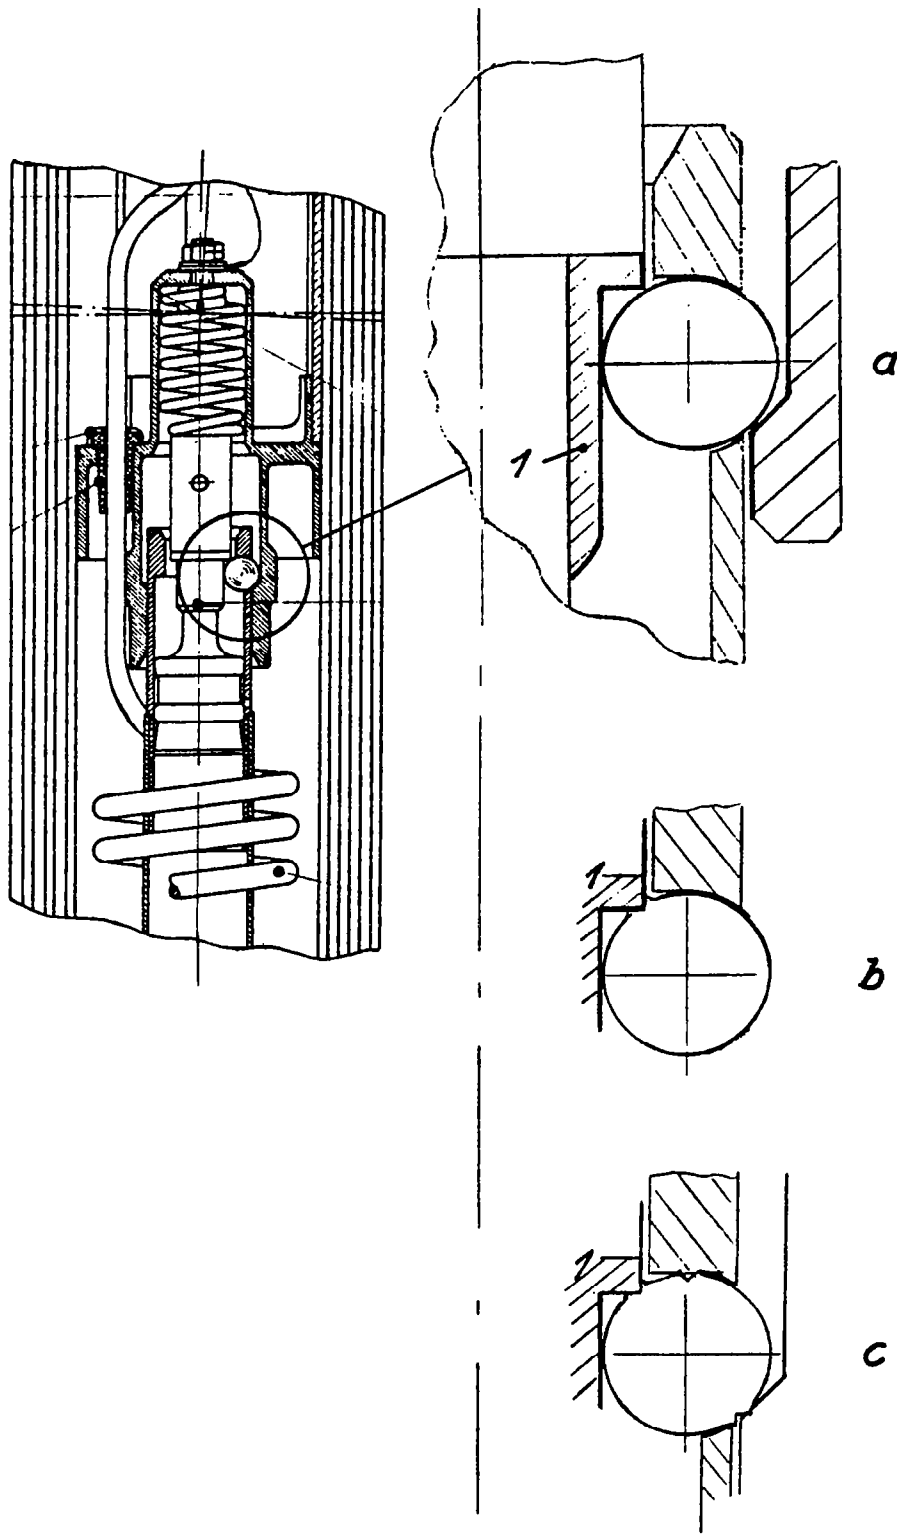
Fig. 7 Release Mechanism — Possible Failure Kinematic

The friction conditions between ball and ball cage had been carefully calculated for GEOS-1. These calculations demonstrated a sufficient safety margin to jamming of 1,5 to 2. However, an indentation caused by the sharp edge of the titanium bushing (Fig. 7 part 1) could have resulted in increased friction, leading to a failure kinematic as indicated in Fig. 7a, b and c.

Inspection of GEOS-1 spare unit release balls proved that the indentations exist. Repeated stowage and release increased the number of indentations and the likelihood of two indentation positions is highly probable; refer to Fig. 7c.

Following actuation of the pyro valves for boom deployment, all four release pistons moved forward and 10 balls moved freely, except for one ball at the +Y LAB and most likely a second ball at the -X SAB may have stuck as shown in Fig. 7c. The gas expanded through the outlet hole into the telescopic sections and decayed as shown by the pressure profile. After some seconds the pressure in the telescopic section nearly equalized to the release rod pressure. At this time, the release spring, which was still compressed may have started to move the release piston in reversed direction due to the reduced pressure differential (see Fig. 2b). It is very likely that due to this piston motion the stuck ball in the jammed mechanism released and movement continued.
