CF6-6D ENGINE PERFORMANCE DETERIORATION

Ray H. Wulf

GENERAL ELECTRIC COMPANY
AIRCRAFT ENGINE GROUP
CINCINNATI, OHIO 45215

1. Report No. NASA CR159786		2. Government Accession No.		3. Recipient's Catalog No.	
4. Title and Subtitle CF6-6D Engine Performance Deterioration				5. Report Date January 1980

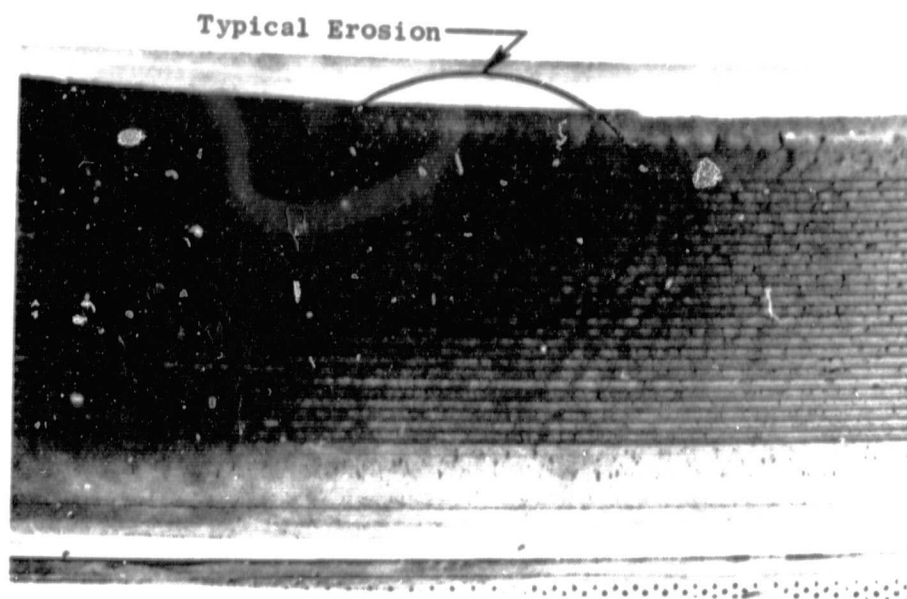
Figure 4-22. Epoxy Microballoon Fan Shroud Showing Typical Erosion Effects After Revenue Service.

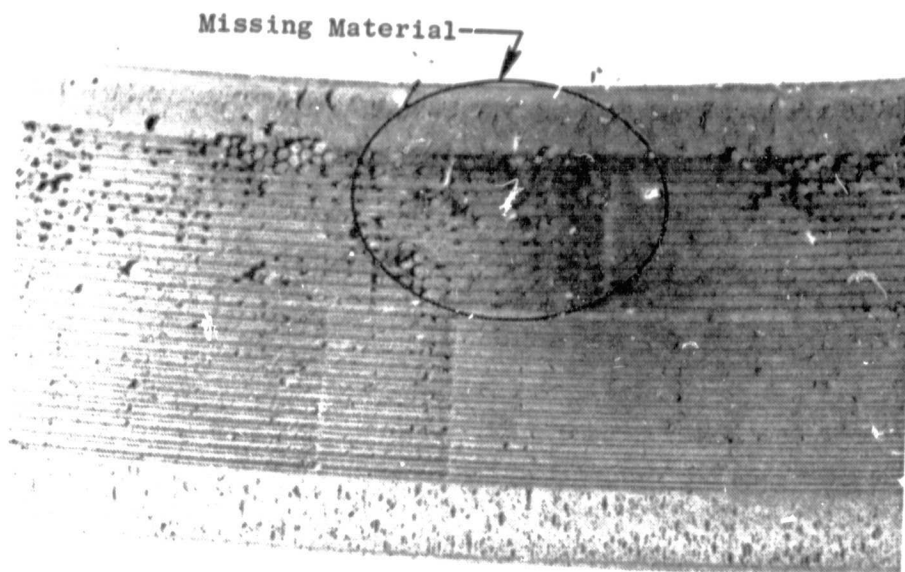
Figure 4-23. Epoxy Microballoon Fan Shroud with Open Cells After Repair.

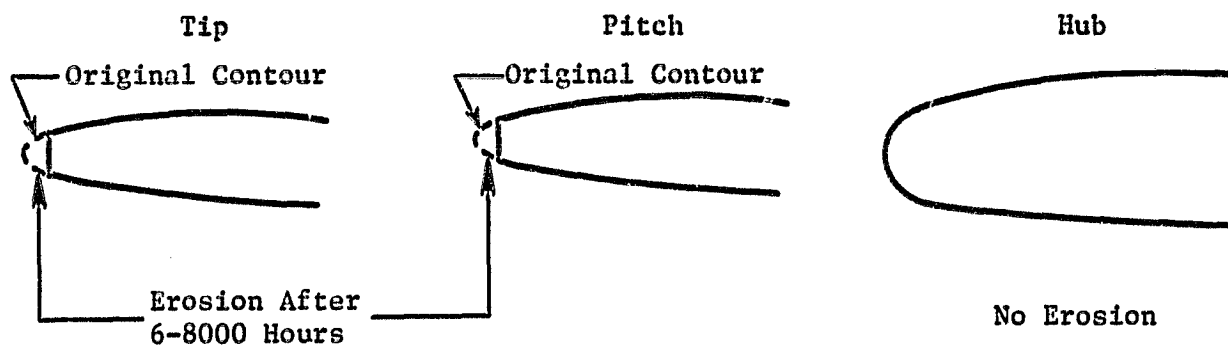
Fan Blade Leading Edge - The physical condition and shape of the fan blade leading edge is extremely important for optimum performance. Erosion of the leading edge in 6000 to 8000 hours of engine operation has been observed to be a significant deterioration mode. This erosion tends to blunt the edge as shown in Figure 4-24. While it is difficult to analytically assess the performance effects of changes to the fan blade leading edge shape, factory and field experience have permitted a reasonable assessment. Based on visual observation, the performance degradation due to fan blade leading edge bluntness was assessed at 0.71 percent fan efficiency or 0.38 percent cruise fuel burn.

Figure 4-24. Results of Erosion on Fan Blade Leading Edge.

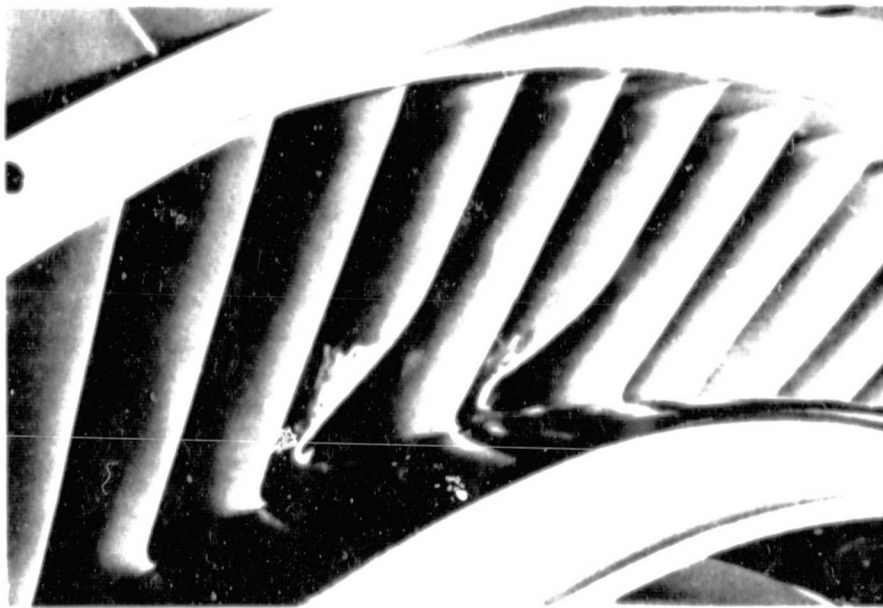
Figure 4-25. Reworked Inner OGV with Incorrect Contour and Blunt Leading Edge.

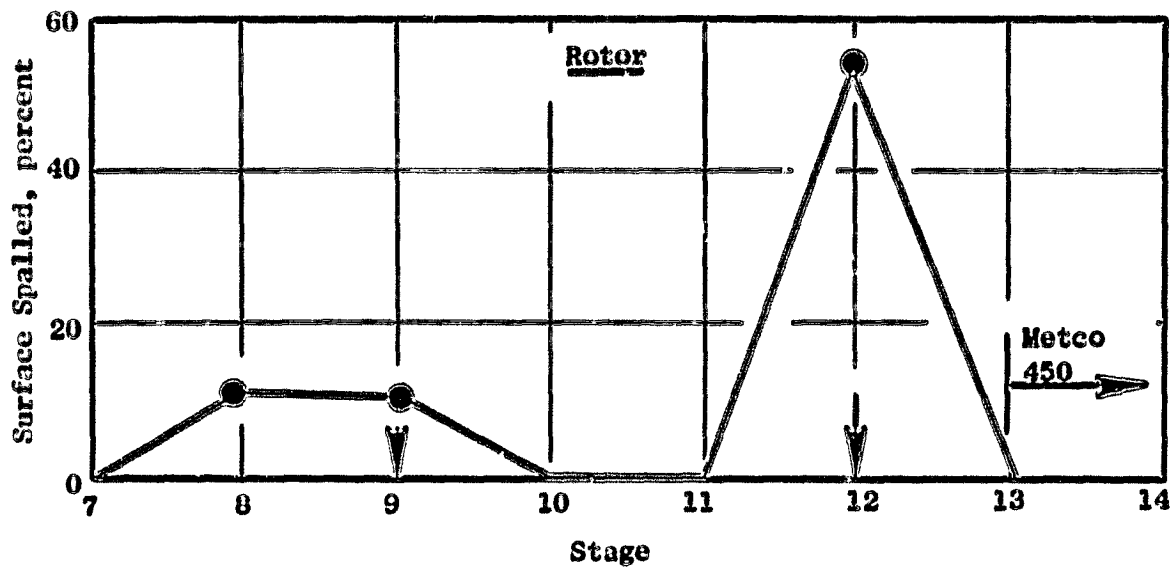
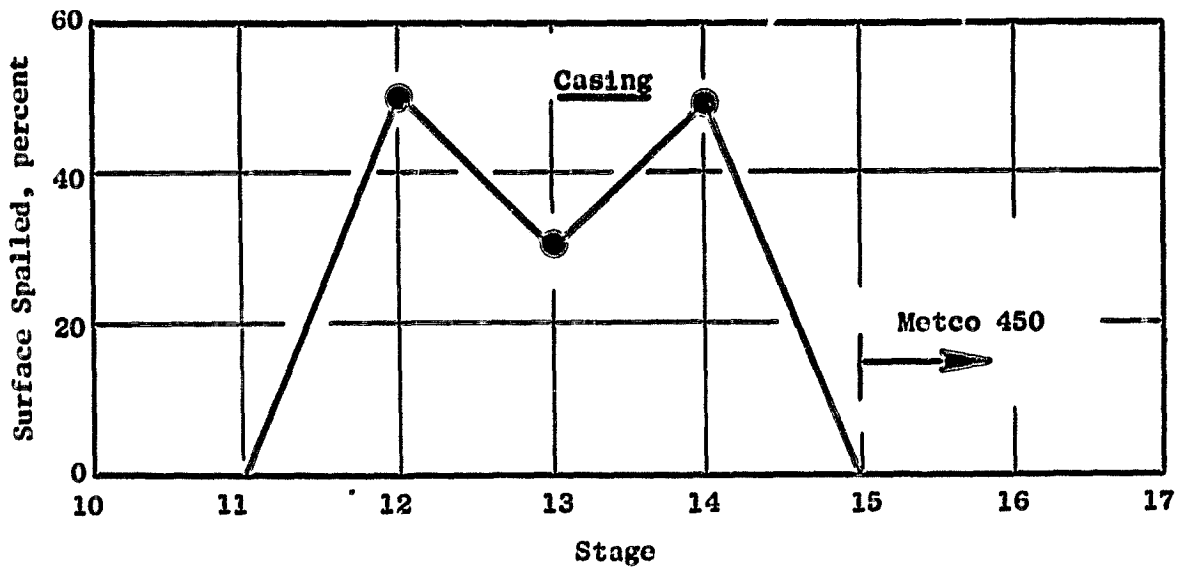
Figure 4-29. CF6-6 High Pressure Compressor - Abradable Aluminum Rub Coating Spalling Deterioration at 6000 Hours.

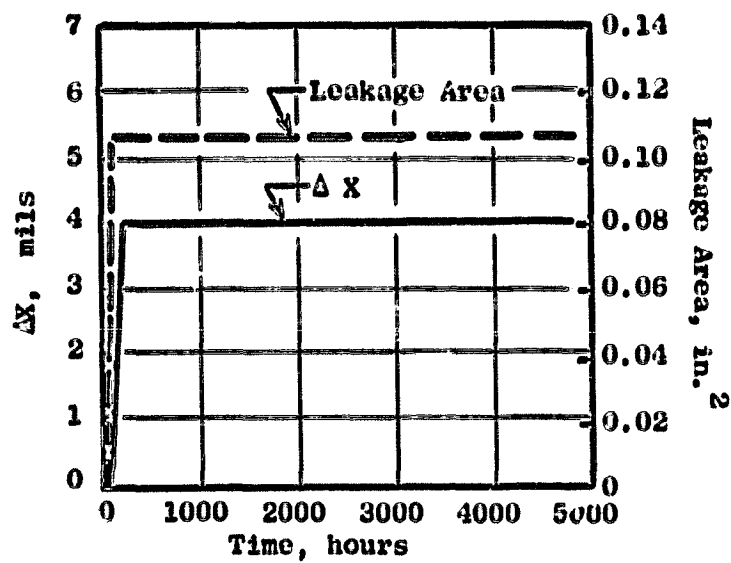
Figure 4-39. Stage 1 HPT Nozzle Vane Outer Band Distortion.
