**NASA Contractor Report 166159**

# **Study of Aircraft Crashworthiness for Fire Protection**

**A. Cominsky, et al  
Douglas Aircraft Company  
McDonnell Douglas Corporation  
Long Beach, California 90846**

**Prepared for  
Ames Research Center  
Under Contract NAS2-10583**

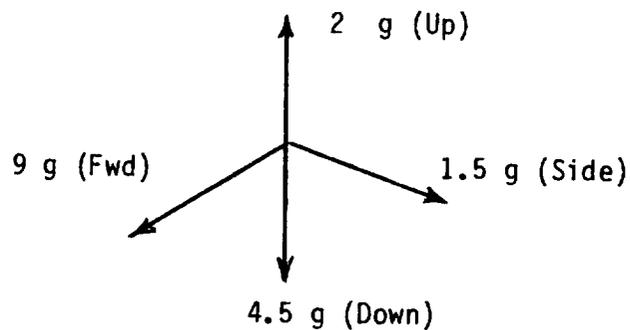
ACCIDENT 2-19

Seat Failures

There were 8 known passenger seat failures. Only one of these seat frames was found. All the legs of the seat were fractured. The entire seat showed a lateral deformation to the left. They were designed for
