Test Evaluation of a Laminated Wood Wind Turbine Blade Concept

James R. Faddoul
National Aeronautics and Space Administration
Lewis Research Center

May 1981

Prepared for
U.S. DEPARTMENT OF ENERGY
Conservation and Solar Energy
Division of Wind Energy Systems

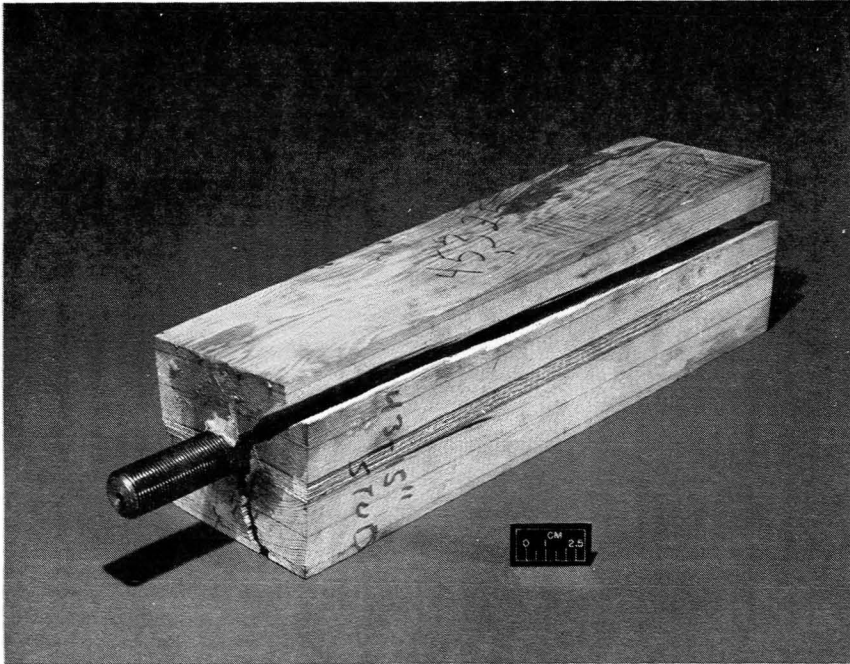
First, because the stud transfers load to the wood through shear in the epoxy resin, high shear stresses develop at the point of entry of the stud into the wood block. These shear stresses cause significant cross grain tensile stresses to develop at the end of the wood block. Since the cross-grain tensile capacity of the wood is less than 500 lb/in.², the result is a splitting failure of the wood with a premature pull out of the stud (see Fig. 6). It was found that bonding a thin layer of birch plywood to the end of the specimens would alleviate this problem. Plates clamped to the top of the specimen and fiberglass wrapping of the top were also tried but with less success. The effect of the birch ply can be seen in Figure 7 where comparative tensile load capacities are presented. As a result, birch ply was added to all subsequent stud test specimens and was also used to cap the end of the 20 ft blade test section.

Figure 6. - Specimen without birch ply - cross grain failure.

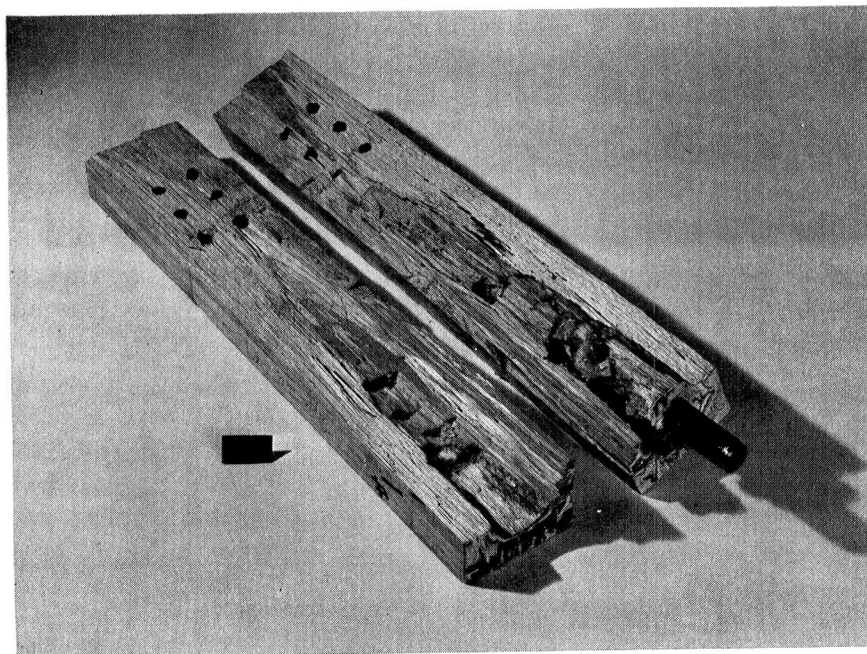
- (3) A step-tapered hole is a method that can be used to increase the load carrying ability of the wood/stud bond. As can be seen in Figure 7, fir veneer specimens with 15 in. stud depths increased in tensile load capacity from about 67,000 lb load to 75,000 lb load when the hole was step tapered (load values are an average of two specimens in both cases). The step-tapered hole causes more tearing to occur during failure (see Fig. 11) than does the continuous diameter hole which generally fails by splitting or shearing the wood.

Figure 11. - Failure typical of stud pull out in specimens using a step tapered hole.

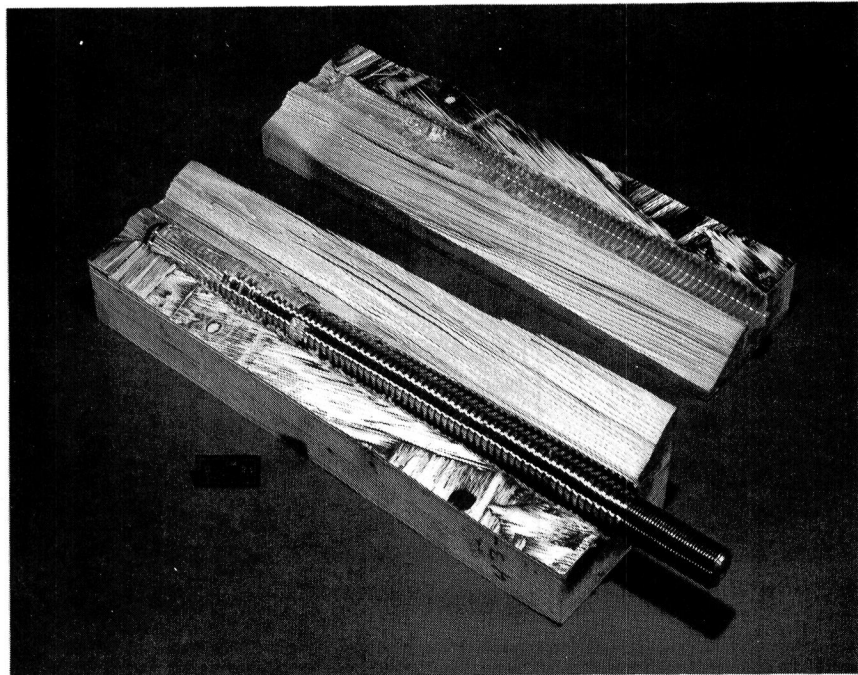
- (7) With reference to the tensile ultimate capability as shown in Figure 7, fir block with plywood core specimens are inferior to fir block or laminated fir in load carrying capacity. The specimens have a tendency to split within the plywood, as shown in Figure 12, resulting in a premature failure of the specimen. Because of this problem, the blade design was modified to eliminate the plywood shear web in the area of the stud bolt-circle blocking.

Figure 12. - Failure of plywood layer.

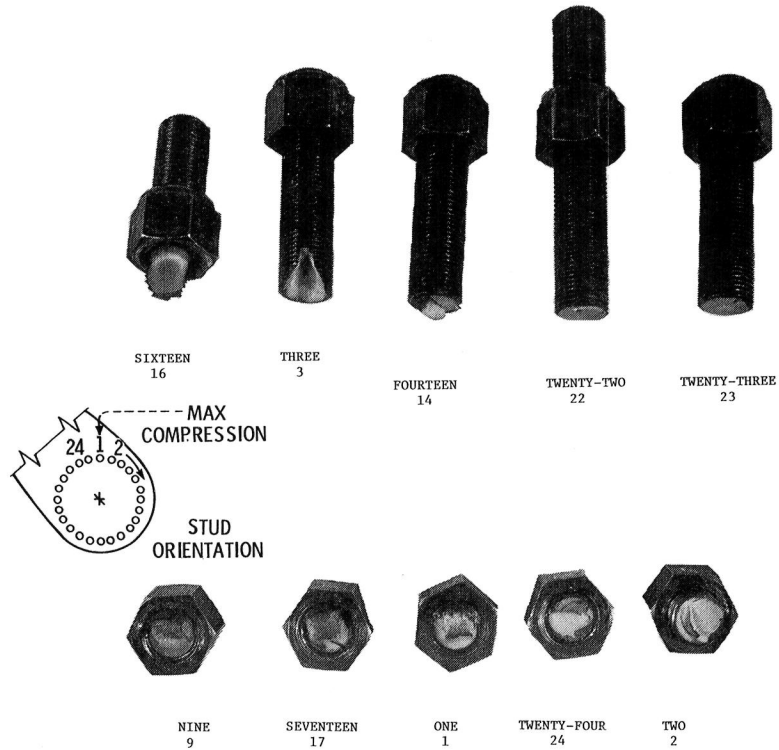
4.2.1 Problem Definition and Resolution. - After running a load/deflection/strain test, the fatigue testing was started by applying a cyclic force between 500 and 4000 lb at the free end of the blade. A cyclic frequency of 4 Hz was used throughout the testing (except for some limited attempts at 6 and 8 Hz operations). This load was equivalent to the rated wind condition on an actual blade. After 370,000 cycles it was found that 10 of the studs had failed in the 5/8 in. diameter threaded length outside of the wood. All but 4 of the failed bolts were on the compression side of the bolt circle and subsequent examination (Fig. 30) indicated that failure of the studs was due to bending and not tensile stresses. Visual observations of the framework during testing corroborated this analysis since the 2 in. thick steel plate could be seen to deflect significantly under load. There was no evidence of any damage to the wood portion of the test specimen.

Figure 30. - Photograph of broken bolts.

Rather than abandon the test, the specimen was sent back to the contractor, Gougeon Bros., Inc., for replacement of the studs. This became an ordeal as it was quickly learned that removal was not easy. A number of staples had been used in the construction of this blade section (a practice which is no longer used) and the staples made the use of a deep hole saw difficult. An attempt was then made to simply unscrew the studs from the epoxy. This resulted in breaking the stud. The unscrewing technique was then tried in combination with application of a high amperage current to heat the stud and soften the epoxy. This was equally unsuccessful. Finally, the hole saw technique was made to work by "brute force" with the result that a rather large and uneven hole was left in the blade as each stud was removed. These holes were subsequently smoothed and tapered by a large boring cutter and were then filled by matching tapered wood plugs made from laminated fir. When all studs had been removed and the holes filled, the root of the test section was redrilled and fitted with 24 new studs having a slightly modified configuration (Fig. 31) featuring a 3/4 in. diameter threaded shank rather than the

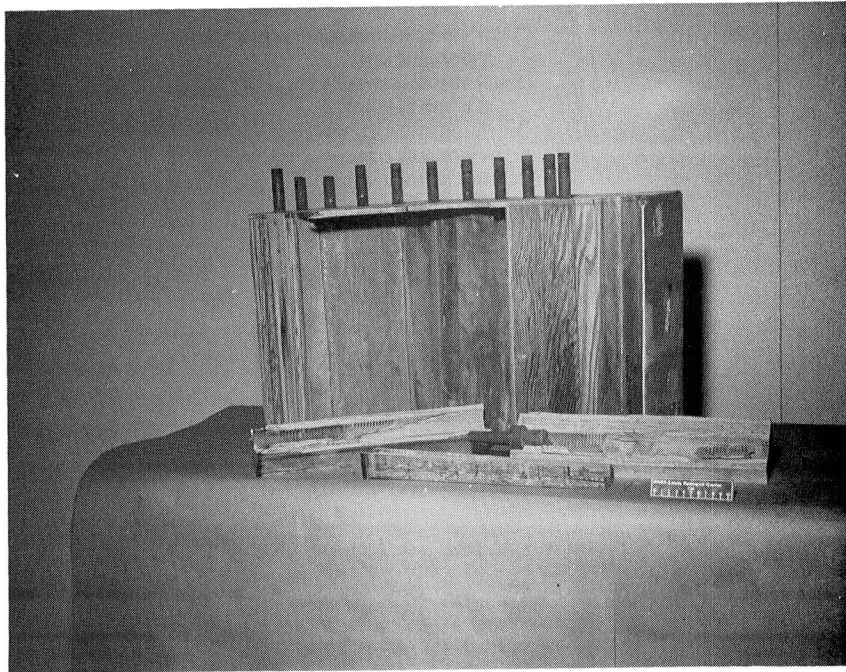
To complete the Phase II testing, the blade section was examined at LeRC. The spool was removed and it was found that, not four, but seven studs had failed. The three studs carrying the highest tensile load had failed at the transition from the 1 3/8 in. collar to the 1 in. acme threaded stud which was imbedded in the wood. Due to an oversight, there was an extremely sharp corner at this point (estimated to have a radius less than 0.002) (see Fig. 31). It was surmised that these three studs had failed due to the stress concentration at that point and had then dumped the additional load into the studs on either side. The two studs on each side had then failed in the 3/4 in. threaded section (and were the ones noticed to have failed at Ft. Eustis), probably due to the increased load the studs were re-

Figure 37. - Root end of sectioned 20 foot blade showing broken studs and integrity of wood laminate.

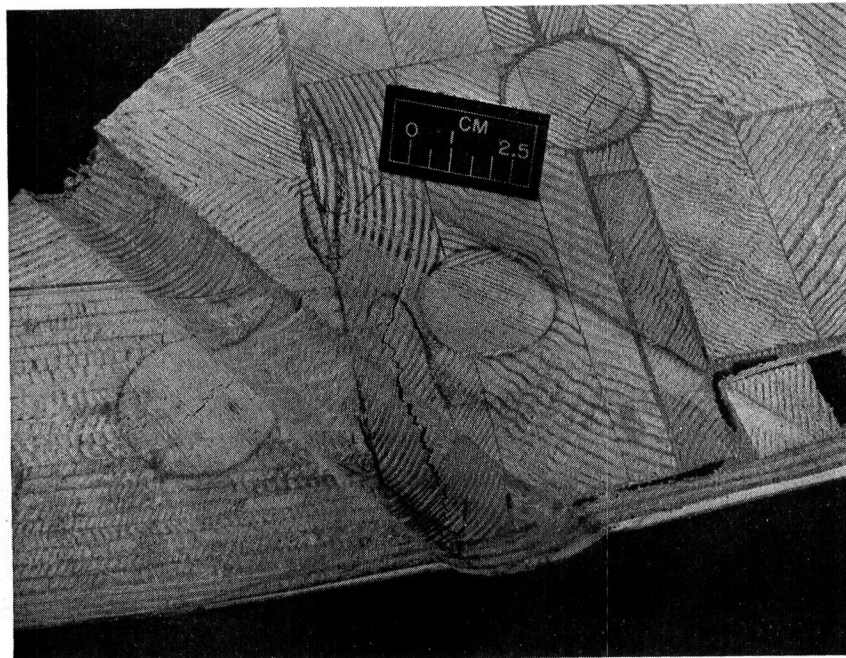
4.3.3. Visual Examination. - After all testing was complete the blade was sectioned for examination. Pertinent photographs are shown in Figures 36 through 43. Only one area of wood cracking was found and can be seen quite clearly in Figure 39. It is not known what caused this crack but it could have come from the work of replacing the studs or from the sectioning operation itself. Due to its location, it is not considered to be a result of the fatigue or ultimate loads.

Figure 39. - Root end build-up for stud installation showing only crack found in entire 20 foot wood test section.

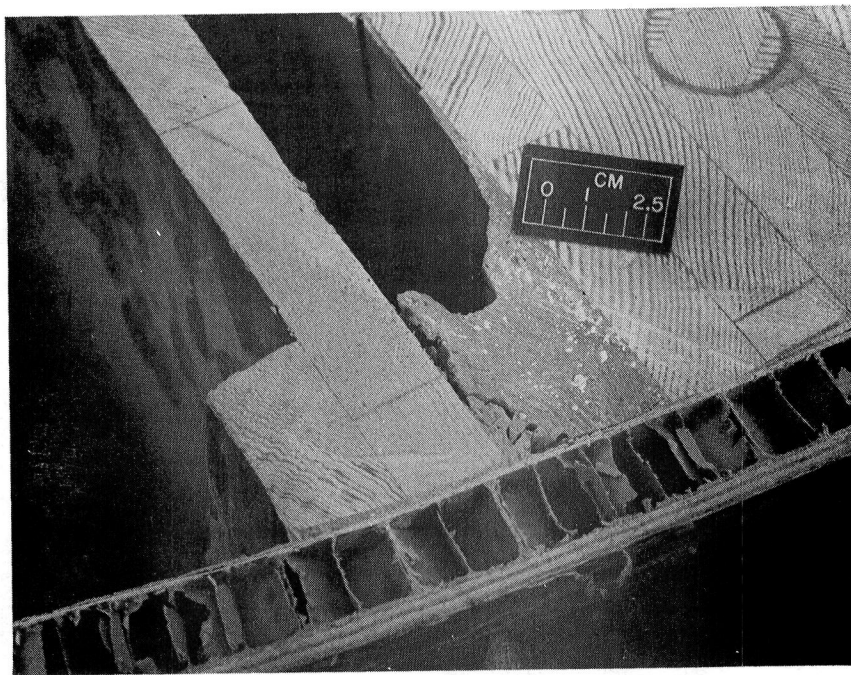
Figure 41. - Excess epoxy between root end blocking and diagonal rib.

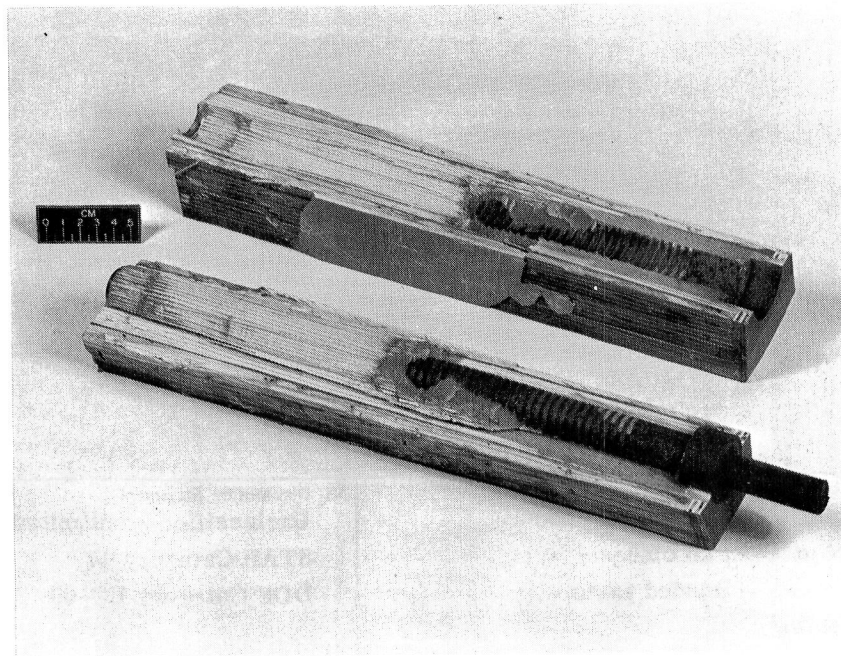
Several studs were removed from the blade and an attempt was made to examine the cast epoxy area. By slicing through wood and epoxy on either side of the stud and then prying the two halves apart, it was possible to visually evaluate the result of the testing on the stud bond. In general, the studs were still well bonded. In local areas, the epoxy was cleanly separated from the stud and in some areas there was evidence of fatigue cracks in the epoxy. None of the damage was as severe as that seen in the individual stud tests discussed in Sec-

tion III. It is therefore believed that the stud-to-wood bond was not close to fatigue failure. A picture of one of the studs with the wood and epoxy broken away is shown in Figure 43.

Figure 43. - Stud removed from root end of 20 foot section after test - wood and epoxy cut and pryed open for examination.
