AN INVESTIGATION OF REPORTS OF CONTROLLED
FLIGHT TOWARD TERRAIN (CFTT)

Richard F. Porter and James P. Loomis

April 6, 1981

BATTELLE COLUMBUS LABORATORIES
ASRS OFFICE
625 Ellis Street, Suite 305
Mountain View, California 94043

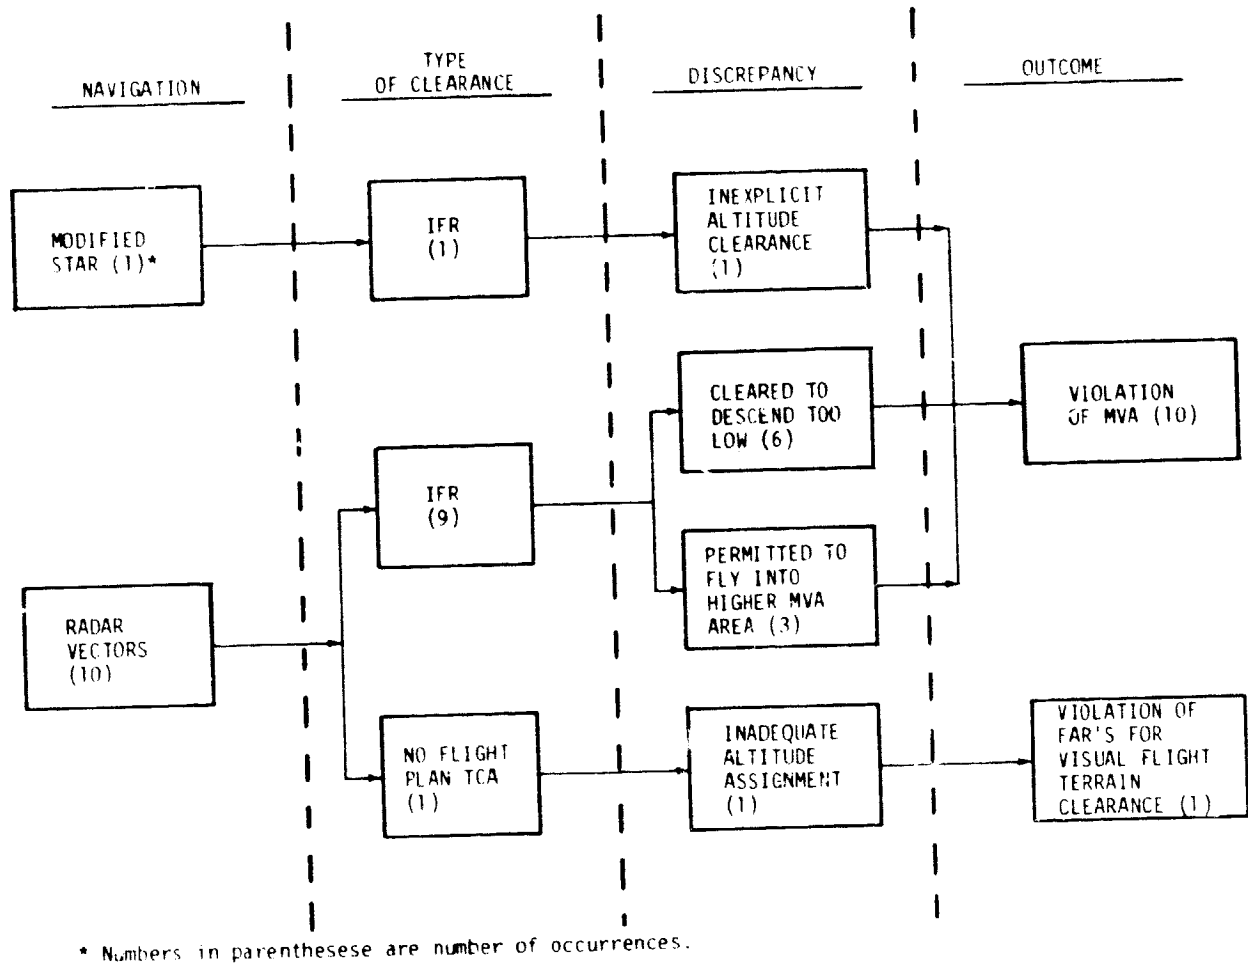
FIGURE 2. OUTLINE OF INITIAL APPROACH INCIDENTS IN WHICH THE AIRCRAFT WAS CLEARED BELOW A MINIMUM LEGAL ALTITUDE

Eleven incidents in this category occurred during the initial approach phase. These events are outlined in figure 2. All but one of the aircraft were being radar vectored at the time of the incident. In the singular case, a military fighter was flying a published STAR approach when instructed by the controller to discontinue and descend to 3000 feet. The clearance was later amended to return to the STAR profile, but the correct altitude was not restated by the controller. As a result, the aircraft flew through an area 1000 feet below the MVA.

As outlined in figure 2, three of the initial approach incidents in this category were initially assigned a proper altitude but were inadvertently vectored into an area with a higher MVA. In one of these, a controller was distracted by radio communications and allowed an air carrier aircraft to violate a 7300 foot MVA area while at 7000 feet. The crew reported a GPWS alert, but the controller did not realize his error until the aircraft was out of the hazardous area. In a similar incident, a military trainer in VMC was kept too wide and violated a 9000 foot MVA at 7000 feet. In the last initial approach incident, a controller underestimated the radius of turn of a fighter aircraft, permitting a transgression 2000 feet below a neighboring MVA and triggering an MSAW alert. A contributing factor in this case was a late hand off to the reporting controller.

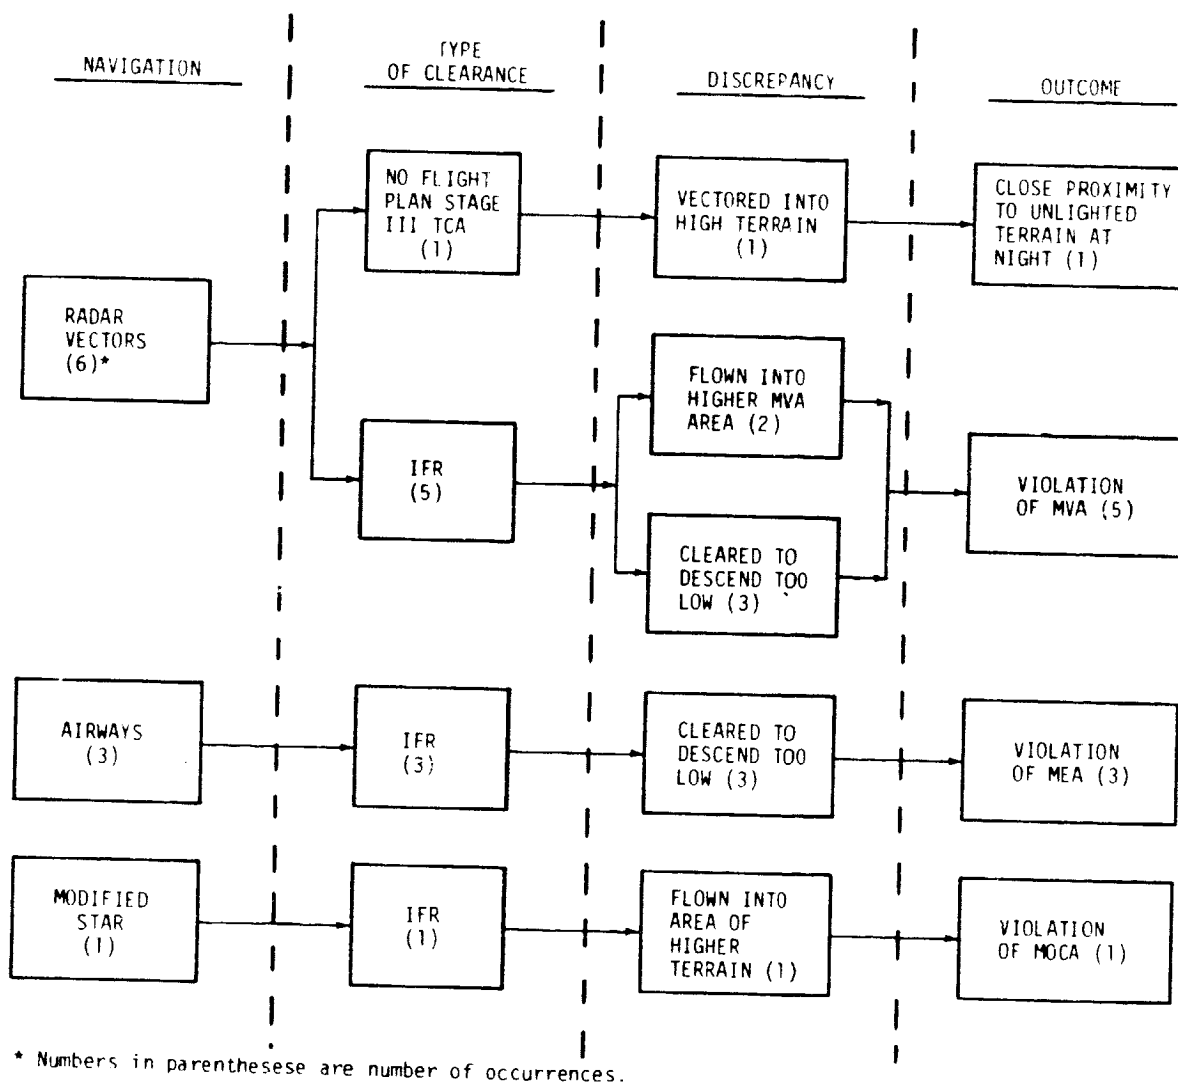
FIGURE 3. OUTLINE OF DESCENT INCIDENTS IN WHICH THE AIRCRAFT WAS CLEARED BELOW A MINIMUM LEGAL ALTITUDE

Ten incidents in this category occurred while the aircraft was in the descent phase. These are outlined in figure 3.

As seen in figure 3, five of the IFR aircraft were on radar vectors and each case culminated in an MVA violation. Three were simply cleared to too low an altitude. One of these incidents was caused by the controller's confusion of two military aircraft with similar call signs; while in another, the flight crew transposed the numbers given for heading and altitude. The crew read back the garbled clearance but were not corrected by the controller. In two cases, a descending aircraft was given radar vectors into a region of higher terrain. In one instance, a controller committed an error in judgement in turning an air carrier aircraft for traffic separation, setting off both a GPWS and MSAW alert. No explanation of the error was given in the other report.

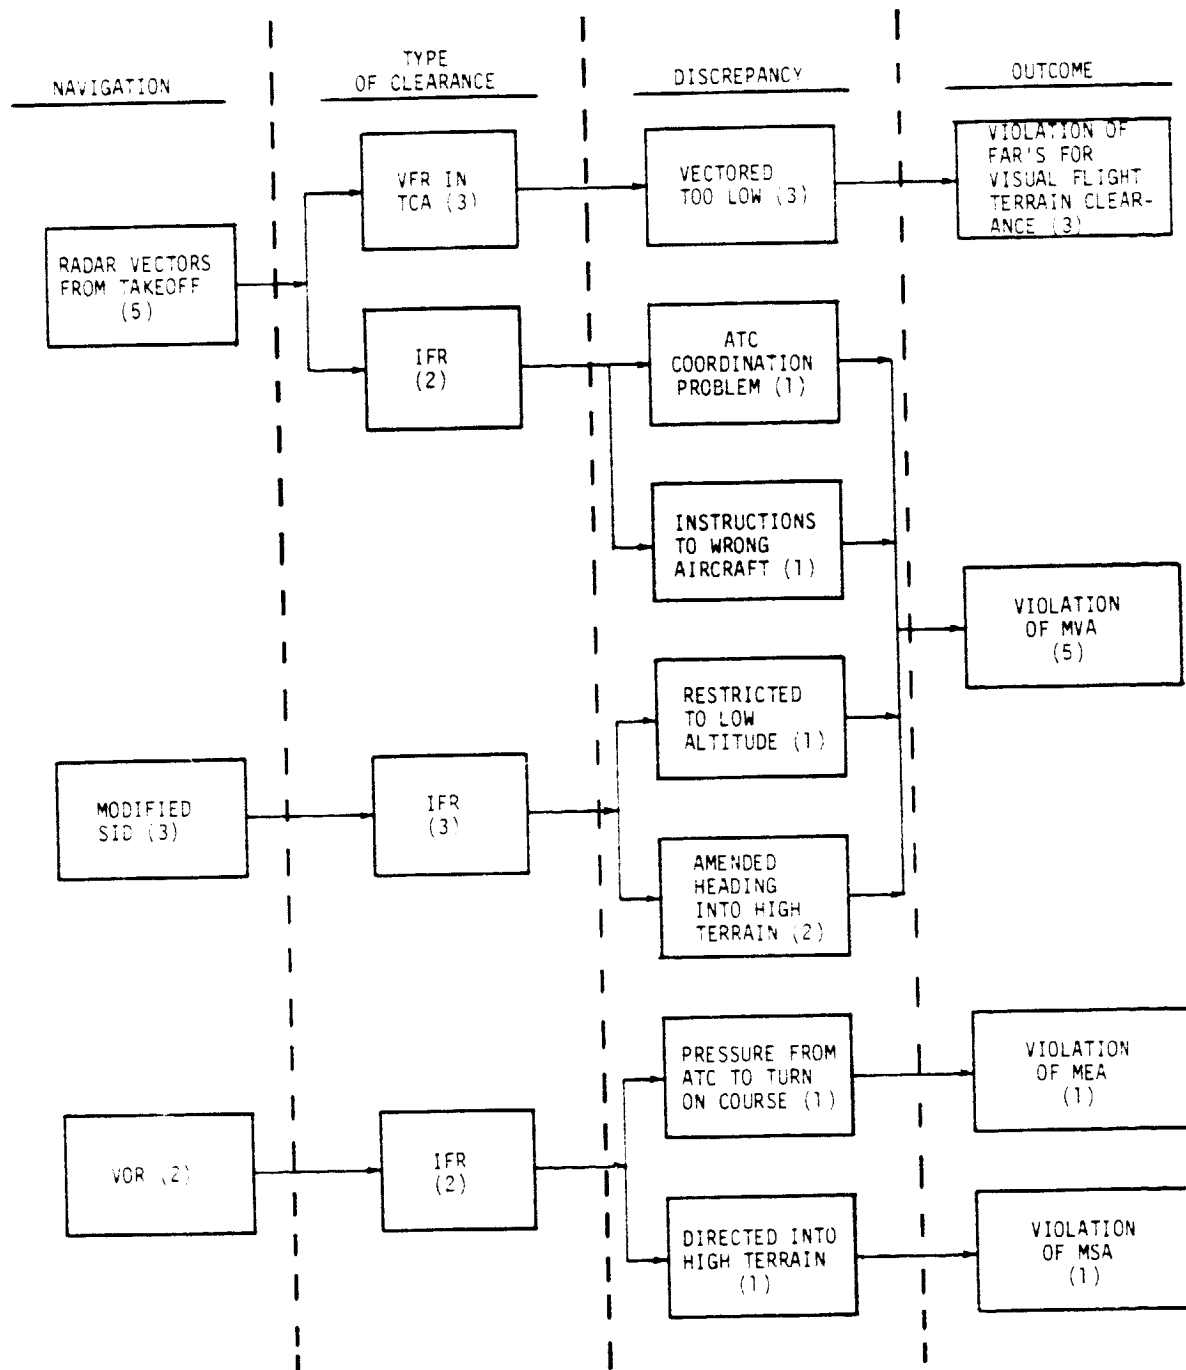
FIGURE 4. OUTLINE OF DEPARTURE INCIDENTS IN WHICH THE AIRCRAFT WAS CLEARED BELOW A MINIMUM LEGAL ALTITUDE

Ten reports in this category described unsafe altitude clearances during the departure phase. These incidents are outlined in figure 4.

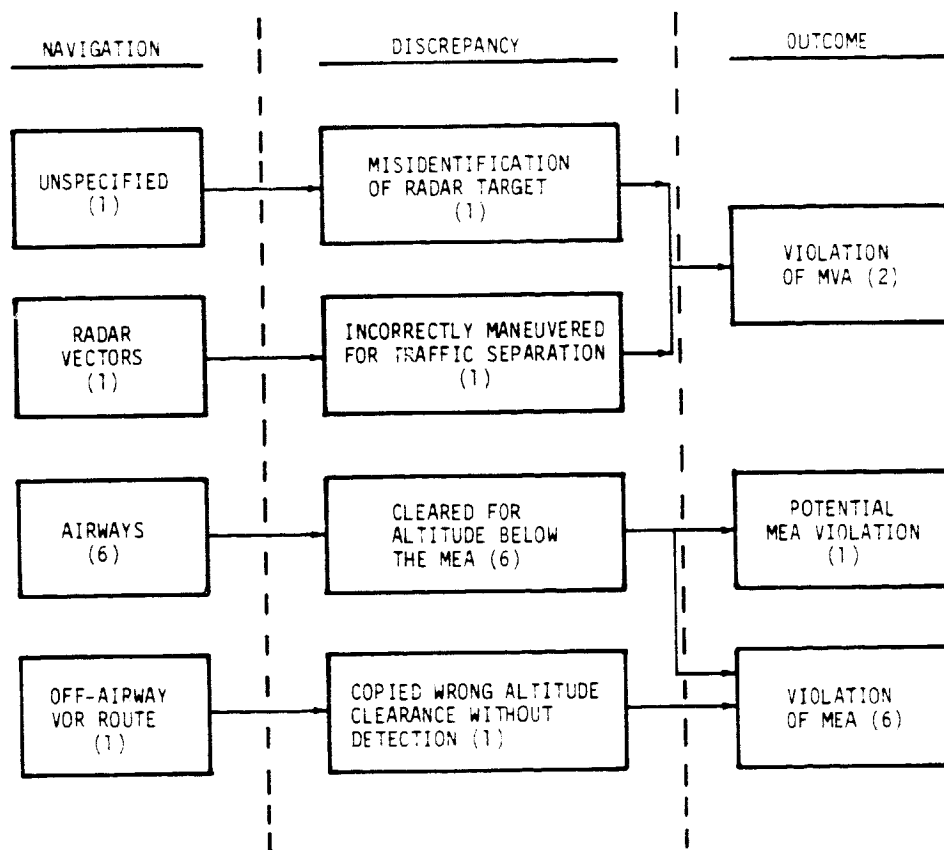
FIGURE 5. OUTLINE OF CRUISE INCIDENTS IN WHICH THE AIRCRAFT WAS CLEARED BELOW A MINIMUM LEGAL ALTITUDE

Nine incidents in this category occurred during cruise flight under IFR clearances. These are outlined in figure 5. In one unusual case, an apparently spurious radar target was identified by the controller as a light aircraft enroute through his sector. When the target subsequently disappeared, the controller called the aircraft and determined that it was 15 miles from the position he had identified and was below the MVA as well. Another MVA violation was reported as a result of radar vectors to ensure separation. Both aircraft were directed into terrain without proper ground clearance.
