TR-1530

LIGHTNING PROTECTION SYSTEM FOR SPACE SHUTTLE

PREPARED BY
PLANNING RESEARCH CORPORATION
Systems Services Company
for
DESIGN ENGINEERING
JOHN F. KENNEDY SPACE CENTER, NASA

August 1977

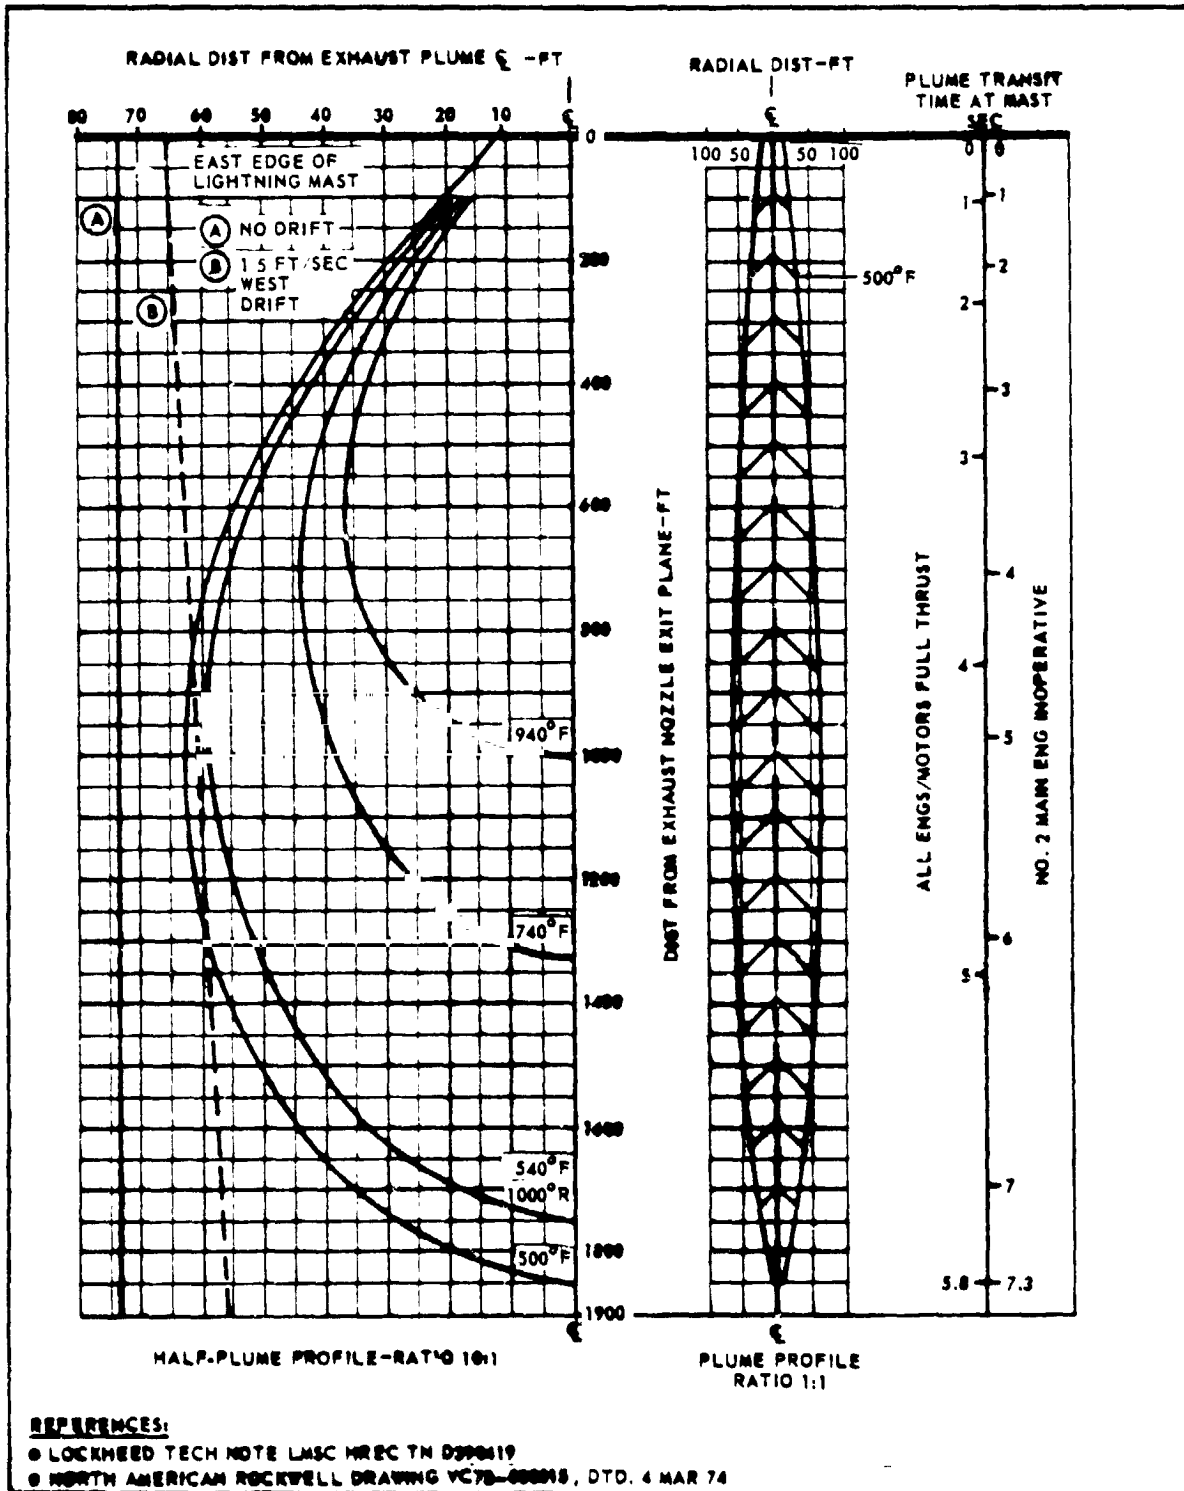
Figure 2-6. Isothermic Profile of a Single Shuttle Solid Rocket Booster Exhaust Plume Showing Projected Flame Impingement on Lightning Mast

Using the aforementioned factors and nominal launch conditions, it is calculated that the Shuttle lightning mast and support structure will experience a minimum of 87 Btu/ft² total radiated heat from the single SRB exhaust plume nearest the SSAT (15 Btu/ft²-s x 5.8 s). Nominal launch conditions are defined as a no-wind, sea-level standard day, with all Space Shuttle propulsion units operating at full thrust. Note that this calculation does not consider the total radiated heat of the combined SRB and main engine plumes, nor the probable increased cross section of the combined plume caused by interaction of gases within the five individual plumes.

Other factors that will significantly increase the level of radiated heat on the lightning mast are: an easterly wind, causing the vehicle to drift towards the mast; the loss of a main engine after liftoff, which would increase mast exposure time to the exhaust plume; and any outward cant to the SRB exhaust plume trajectory, a condition that could envelop the SSAT and lightning mast in flame.

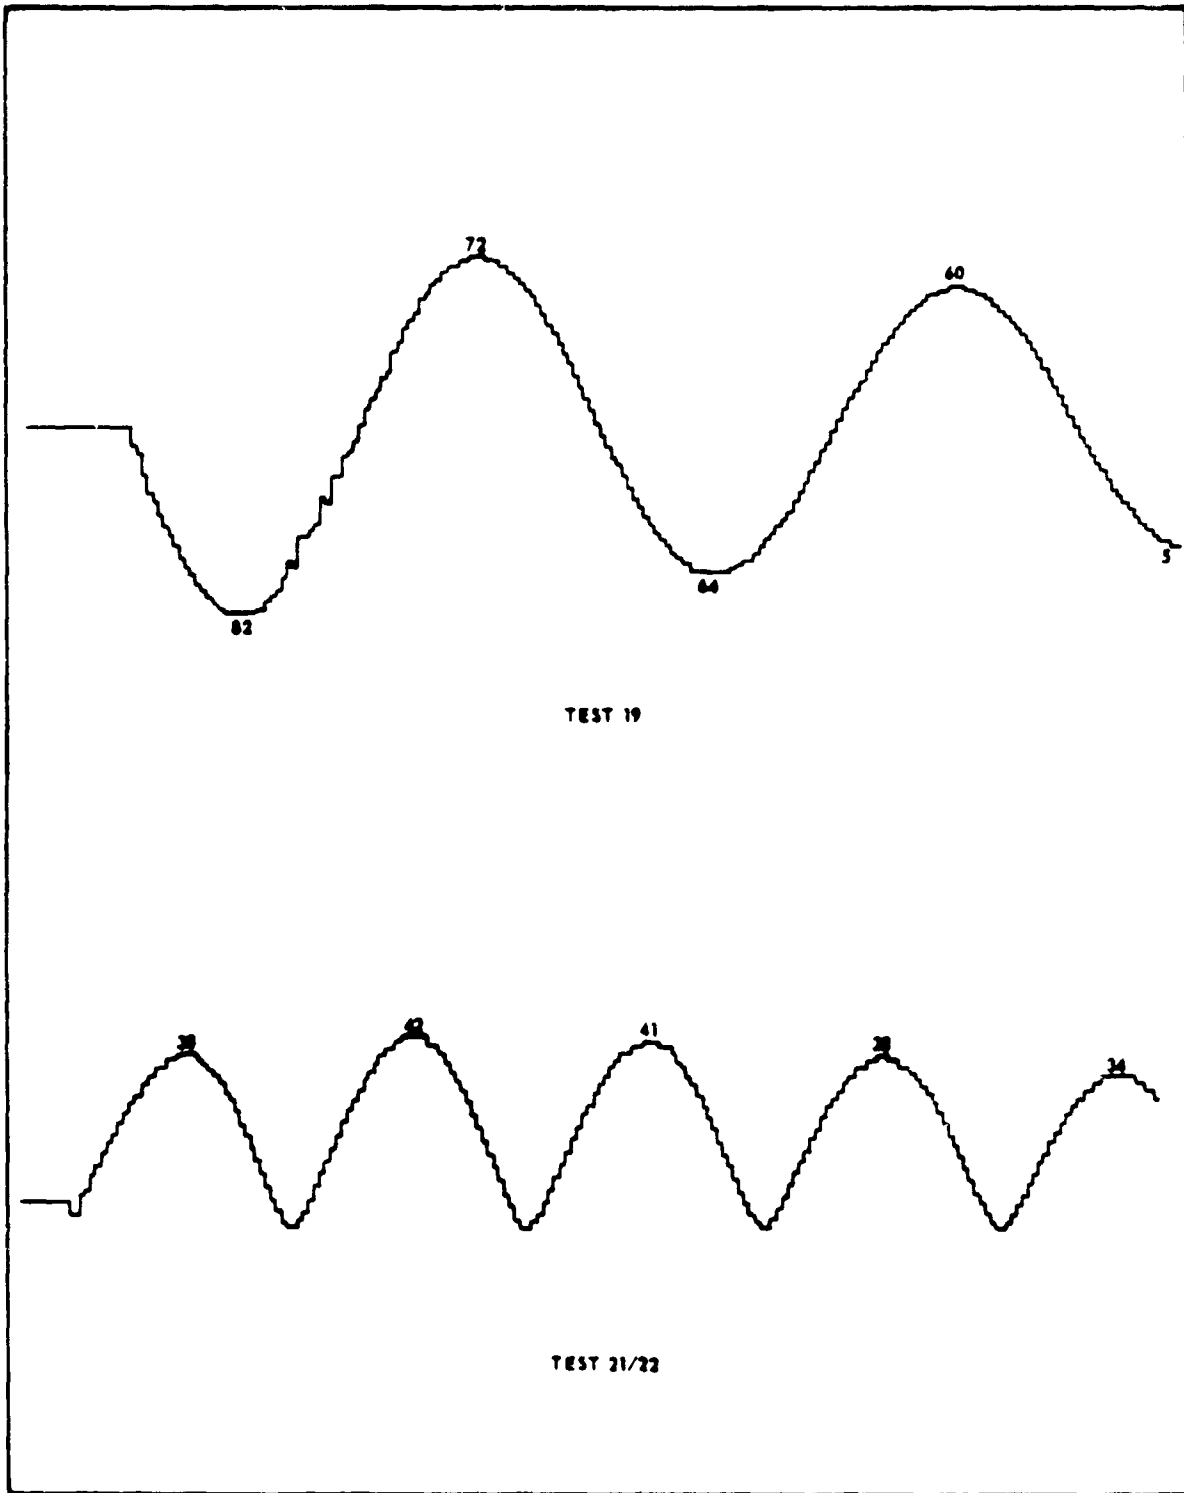
Figure 3-21. Compactor-Acquired Oscillatory Waveforms. Waveform at Top Was Hard-Wired to the Compactor. Bottom Waveform Shows Amplitude Distortion Introduced by Fiber-Optic Coupling.

sensor hard-wired to the compactor. Fiber-optic coupling, used for the waveform shown at the bottom of figure 3-21, introduced an amplitude distortion and polarity was also lost.
