Failure Analysis of a Tool Steel Torque Shaft

John R. Reagan
National Aeronautics and Space Administration
Lewis Research Center

A low design load drive shaft from an experimental diesel truck engine failed unexpectedly during highway testing. The shaft was driven by a turbine used to deliver power from an experimental exhaust heat recovery system to the engine's crankshaft. During design, fatigue was not considered a major problem because of the low operating cyclic stresses. An independent testing laboratory analyzed the failure by routine metallography. The structure of the hardened S-7 tool steel shaft was banded and the laboratory attributed the failure to fatigue induced by a banded microstructure. NASA was asked to confirm this analysis. Visual examination of the failed shaft plus the knowledge of the torsional load that it carried pointed to a 100 percent ductile failure with no evidence of fatigue. Scanning electron microscopy confirmed this. Torsional test specimens were produced from pieces of the failed shaft and torsional overload testing produced identical failures to that which had occurred in the truck engine. This pointed to a failure caused by a high overload an

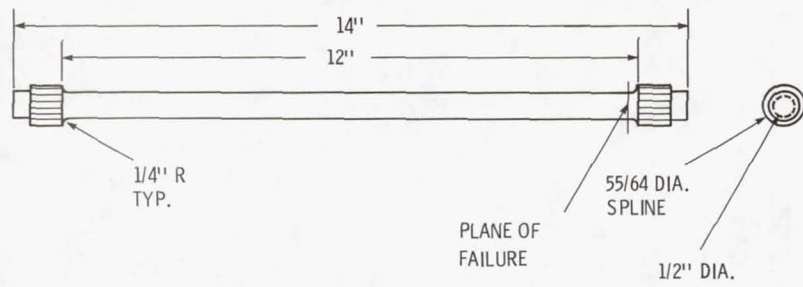
Physically the shaft was 14" long and 1/2" in diameter with 3/4" splines on each end. The shaft had failed at the smallest diameter just as shaft began its transition to the 3/4 diameter spline. The shaft was manufactured from (S-7) tool steel and heat treated to RC 56-58. Figure 1

Figure 1. - Configuration of torque shaft showing the location of the failure.

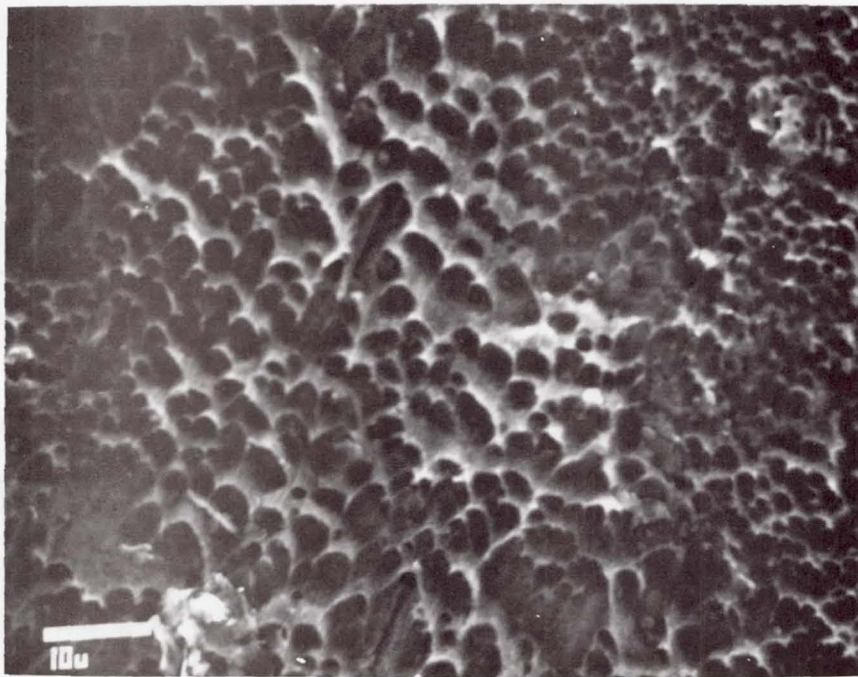
1. The shaft was Zyglo inspected for evidence of cracking.
 - There was no evidence of any flaw being present outside the actual fracture.
 - There was a secondary crack on the fracture surface.
2. A portion of the fracture was placed in the S.E.M. for examination.
 - All areas surveyed showed micro-void coalescence which is indicative of ductile failure. Figure 2.
3. A chemical analysis of the shaft was conducted.
 - The results showed the material to be S-7 tool steel. There was a rather high residual nickel content (0.22 percent), which is not regarded as significant to the failure.
4. Hardness tests were conducted.
 - The shaft hardness was RC 56-57.

Figure 2. - SEM micrograph at 1.5 KX showing microvoid coalescence.

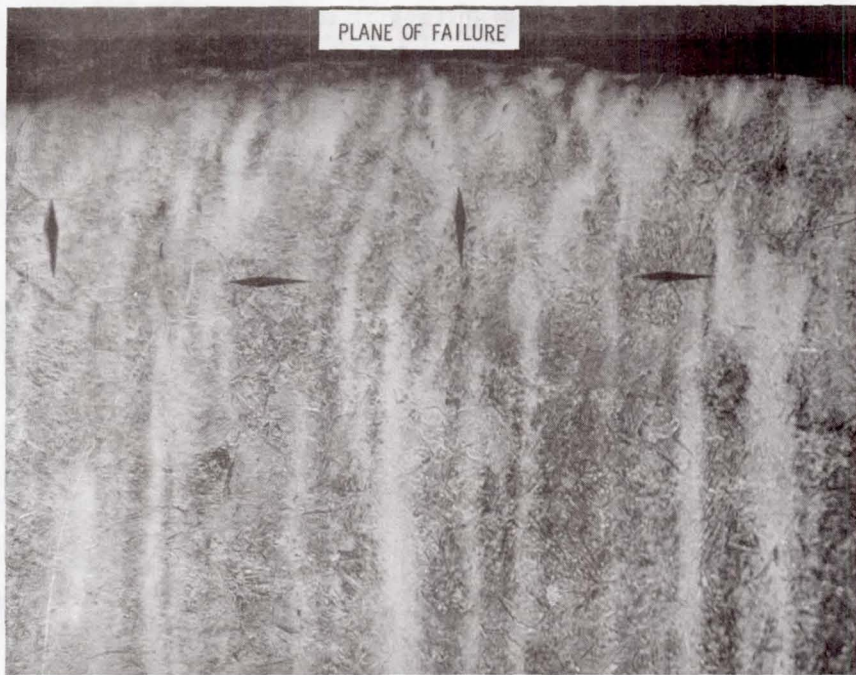
- The microstructure indicated a heavily banded structure. Tukon hardness indicated a possible 3 point difference in the bands (RC 52-55). There was no evidence of carburization or decarburization. Figure 3.

Figure 3. - Banded microstructure at 100X of failed shaft showing failure surface and tukon hardness indentations.

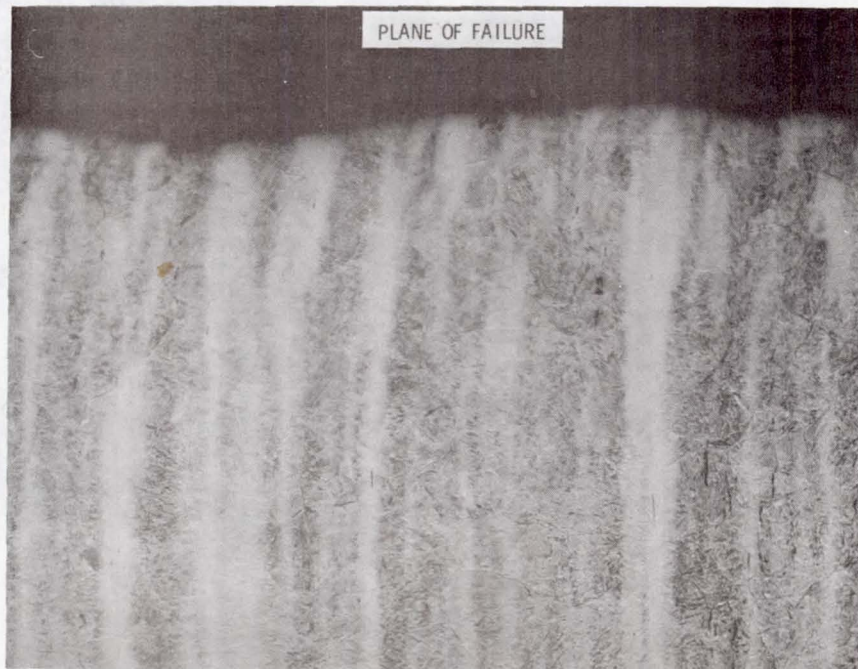
The metallurgical structure of the number one and two specimens examined at the failure sight was shown to be heavily banded. The number three specimen was not examined metallographically. Figure 4.

The banded microstructure could not be related to either the original failure or the test specimen failures.

Figure 4. - Typical banded structure at 100X from No. 1 and 2 test specimen.
