NASA Technical Memorandum 84637

FLIGHT SERVICE EVALUATION OF COMPOSITE COMPONENTS
ON BELL 206L AND SIKORSKY S-76 HELICOPTERS

DONALD J. BAKER

MARCH 1983

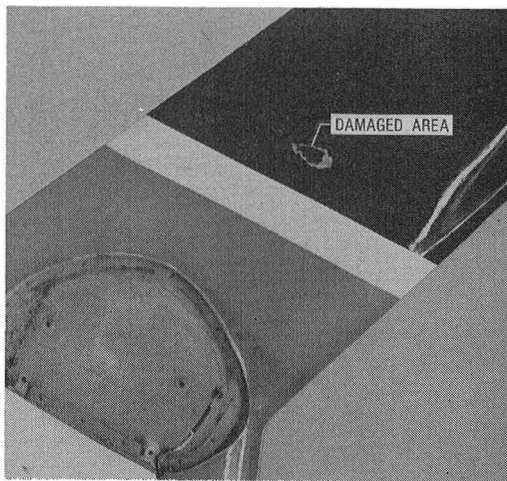
aircraft has 1308 hours of service. The litter doors have not been damaged in service. One baggage door was damaged when closed on an oversize cargo and was subsequently repaired with fiberglass/epoxy. The forward fairings have not been damaged in service. Four vertical fins have been damaged in service. A 5.1 cm x 5.1 cm (2.0 in. x 2.0 in.) area was broken out of the trailing edge of one vertical fin when the aircraft, equipped with floats, autorotated into a river. A second fin was damaged on both the leading and trailing edges and the tail skid was broken when hit by another helicopter while on the ground. The leading edge had cracks over a 30.5 cm (12.0 in.) length and the trailing edge was disbonded over an 45.7 cm (18.0 in.) length. These two vertical fins were repaired with fiberglass/epoxy. The tail skid was removed and replaced with a new skid. Damage to the third vertical fin resulted from wind blown debris while the helicopter was on the ground and is shown in figure 10. The damaged area was removed, an epoxy filler was applied, and an external titanium patch was bonded in place. The fourth fin was destroyed in a ground transportation accident.

Figure 10. Damaged Bell 206L Graphite/Epoxy Composite Vertical Fin.

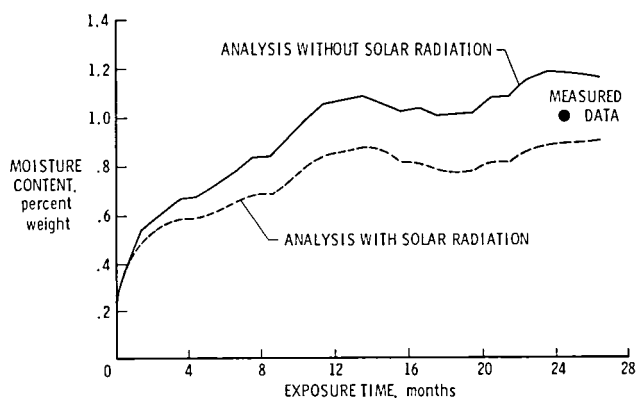
The environmental panels were removed from the Stratford, CT and West Palm Beach, FL (WPB) locations after 2 years of exposure. Data on moisture absorption are presented in Table 8 and figure 16. The 5-ply Kevlar-49/epoxy panel absorbed the most moisture (1.6 percent) whereas a 33-ply graphite/epoxy panel absorbed the least amount of moisture (.18 percent). The average monthly weather data for both locations and predicted moisture content are given in reference 3. Moisture absorption data for the 6-ply graphite/epoxy specimens are compared with predicted moisture absorption in figure 16.

The measured data is approximately midway between the two predicted curves which differentiate the effect of solar radiation.

Figure 16. Moisture Absorption of a 6-ply Graphite/Epoxy Panel Exposed At West Palm Beach FL.

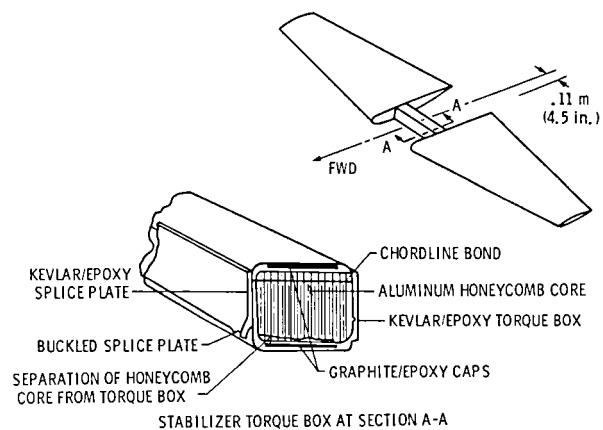
The first horizontal stabilizer removed from service had accumulated 1600 flight hours over a 17 month period in the Lake Charles, LA area. No defects were found during inspection of the stabilizer. Deflection from the proof load was the same as in the initial acceptance test. Plots of strain as a function of limit load are shown in figure 17. The tension strain response was linear up to 160 percent of design limit load (DLL) and then increased at a reduced slope until the maximum applied load of 220 percent of DLL was reached. The compression strain response was linear to 120 percent of DLL and then increased at a reduced slope until 170 percent of DLL was reached. There was no increase in compression strain after 170 percent of DLL. At 220 percent of DLL a loud "snap" was heard and the load dropped to 150 percent of DLL. Attempts to increase the load beyond the 150 percent DLL resulted in deflection until the test fixture limit was reached. Visual inspection of the stabilizer indicated a buckle in the splice plate on the left hand leading edge of the spar. Teardown of the component indicated a loss of shear transfer capabilities between the composite material and the metal honeycomb (figure 18). At 220 percent of DLL, the shear load had been transferred to the Kevlar/epoxy torque box and eventually buckled the splice plate. The structure still supported 150 percent of DLL but with reduced rigidity. The stabilizer tested for certification did not fail but reached the maximum deflection allowed by the fixture at 268 percent of DLL. Additional tests will be necessary to determine if the change in failure mode is the result of environmental degradation of the composite

Figure 18. Schematic of S-76 Composite Stabilizer Static Fracture Modes.

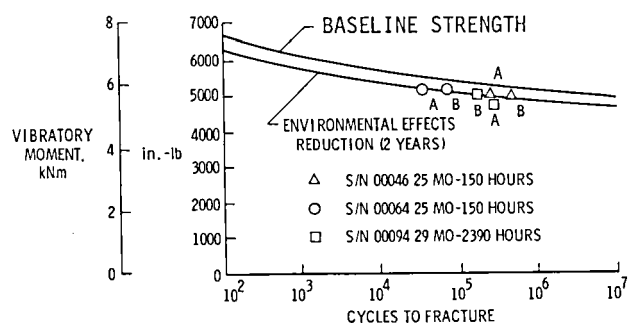
The first tail rotor spar (Serial Number 00094) removed from service had accumulated 2390 flight hours over a 29 month period in the Lake Charles, LA area. No defects were found during the inspection of the spar. The spar was fatigue tested and the results are given in figure 19 along with data from spars labeled serial numbers 00046 and 00064 (reference 3). These spars were removed from a Sikorsky flight test aircraft that was at West Palm Beach, FL. The points designated "A" represent the first fracture on one side of the spar. Testing was continued on the other side until fracture occurred and the results are designated "B". The data indicate a 94 percent retention in fatigue strength for the spars exposed 2 to 2 1/2 years compared to the strength of dry spars tested at room temperature for FAA certification. Four coupons were machined from the failed spar (No. 00094) and dried. The average moisture content was 0.26 percent. The two spars (S/N 00046 and 00064) removed from a flight test helicopter had 150 hours of service each and contained .29 percent (S/N 00046) and .32 percent (S/N 00064) of moisture, respectively. The 94 percent strength retention for the spars with 2 to 2 1/2 years service compares well with the 95 percent strength retention projected from laboratory conditioned specimens (reference 3).

Figure 19. S-76 Tail Rotor Spar, Moment-Cycle Fatigue Curve.
