Support and Power Plant Documentation for the Gas Turbine Powered Bus Demonstration Program

D. N. Nigro
R. G. Stewart
S. A. Apple

Detroit Diesel Allison
Division of General Motors Corporation
P.C. Box 894
Indianapolis, IN 46206

March 1982

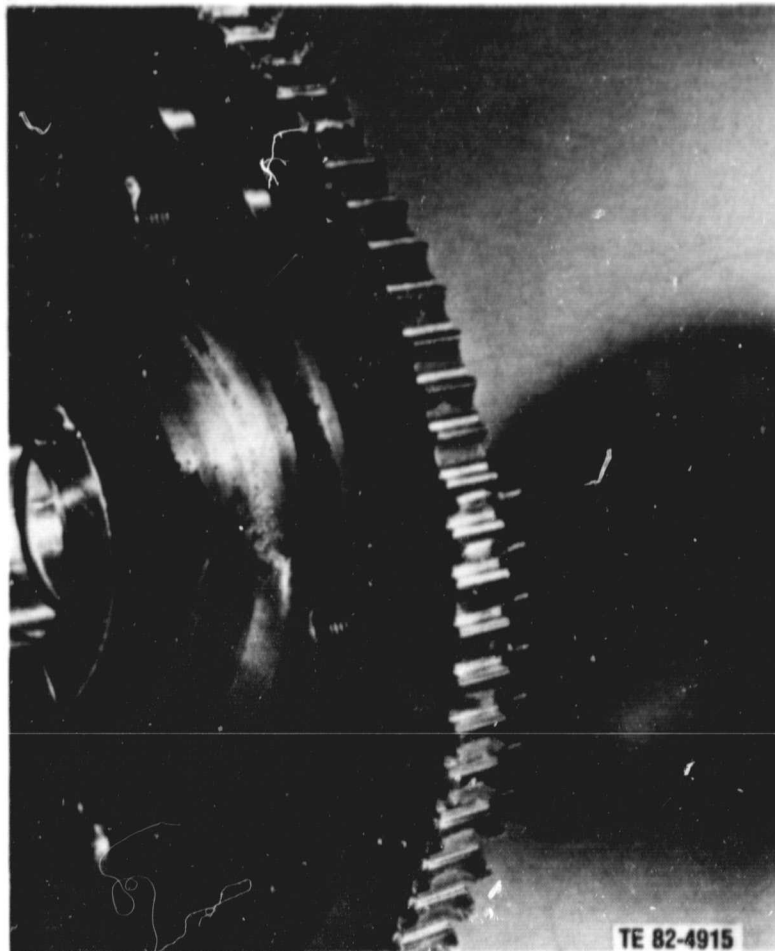
Heavy wear occurred on the cast iron No. 2 accessory gear teeth (Figure 6) at the mesh with the power turbine accessory drive gear after 3870 mi (6228 km) of operation on Greyhound engine S/N T5. This mesh experiences the highest tooth loading of the accessory drive gears, a calculated hertz stress of 112,800 psi (777.7 MPa) from the impact of combined peak accessory loads and the relative diameters of the gears.

As in the GT404-3 engine design, pearlitic malleable cast iron accessory gears were used in the GT404-4 engine. Casting porosity at the surface significantly reduced the load-carrying capacity of the gear, which resulted in wear and subsequent fatigue failure at the tooth root. In order to avoid an expensive and time-consuming redesign effort, case-hardened SAE 8620 steel gears were substituted for the cast iron gears in all of the Greyhound engines. Since the accessory gear problem occurred early in the Greyhound program, the steel accessory drive gears were subsequently subjected to considerable field operation without further incident.

Figure 6. Failed accessory drive gear from Greyhound engine S/N T5 (149 total engine hours).

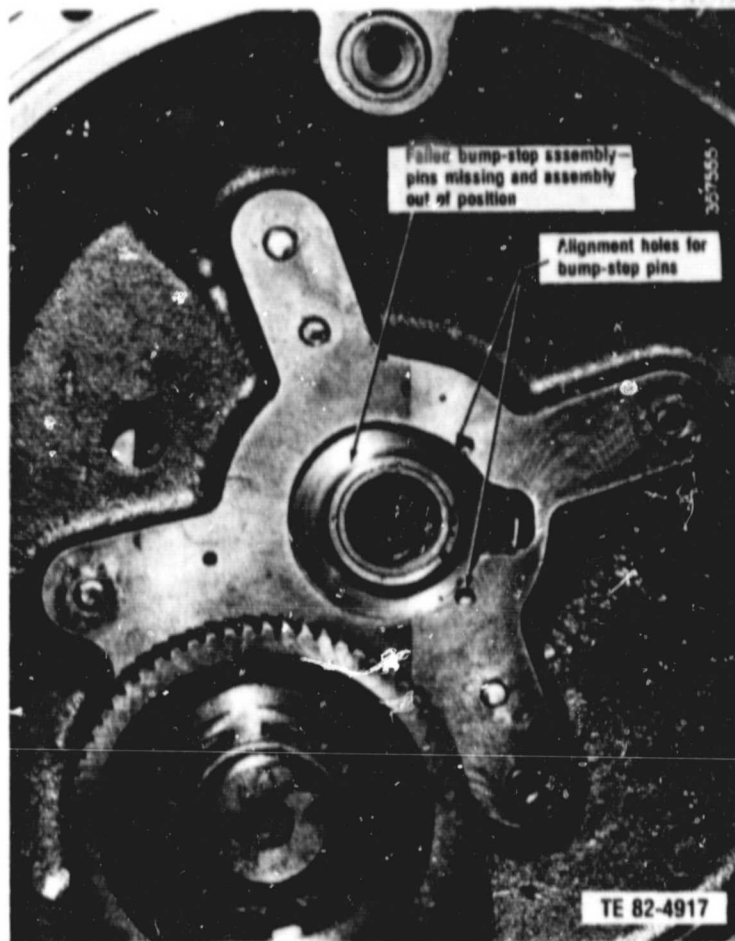
The quill shaft bump-stop assembly is located along the gasifier main shafting and is shown in the engine cross section (see Figure 7). A failure occurred after 16,740 mi (26,940 km) of Greyhound operation on engine S/N T5 and was initiated by the loss of the bump-stop orientation pins, which permitted the bump-stop assembly to creep circumferentially, reorienting itself to create a significant lubrication leak from the bump-stop outer diameter to the gearbox cavity. This leak essentially terminated the supply of pressure oil to the bump-stop bushing and greatly reduced the oil supply pressure in the passages that provide lubrication to the power turbine pinion gear mesh and the power turbine bearings. Figures 8 through 10 show the failed bump-stop assembly and gasifier quill shaft.

Figure 8. Gearbox front housing from Greyhound engine S/N T5 showing misoriented bump stop and pins missing (508 total engine hours).

the coach engines suggested that all pins were suspect. Factory inspection of the coach engines revealed that all of the bump-stop assemblies contained undersize pins. Table III shows the results of these inspections. In the case of one of the operational Greyhound engines, one of the pins had fallen into the gearbox but with no damage to the engine. Proper pins were provided for all of the coach engines and no further incident occurred.

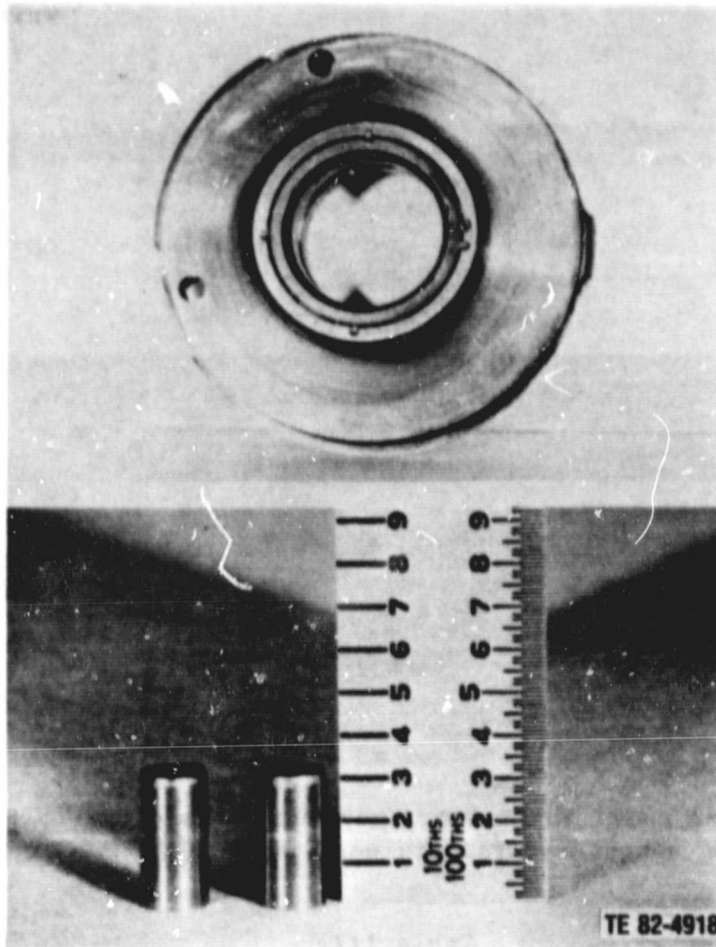
The pins lost from the bump-stop assembly were found to be totally undamaged (Figure 9), which indicated that they were disengaged prior to any of the failure events. Dimensional inspection disclosed that the pins were undersize and a review of the manufacturing history of the bump-stop assemblies used in

Figure 9. Bump-stop assembly and undamaged orientation pins from Greyhound engine S/N T5 (508 total engine hours).

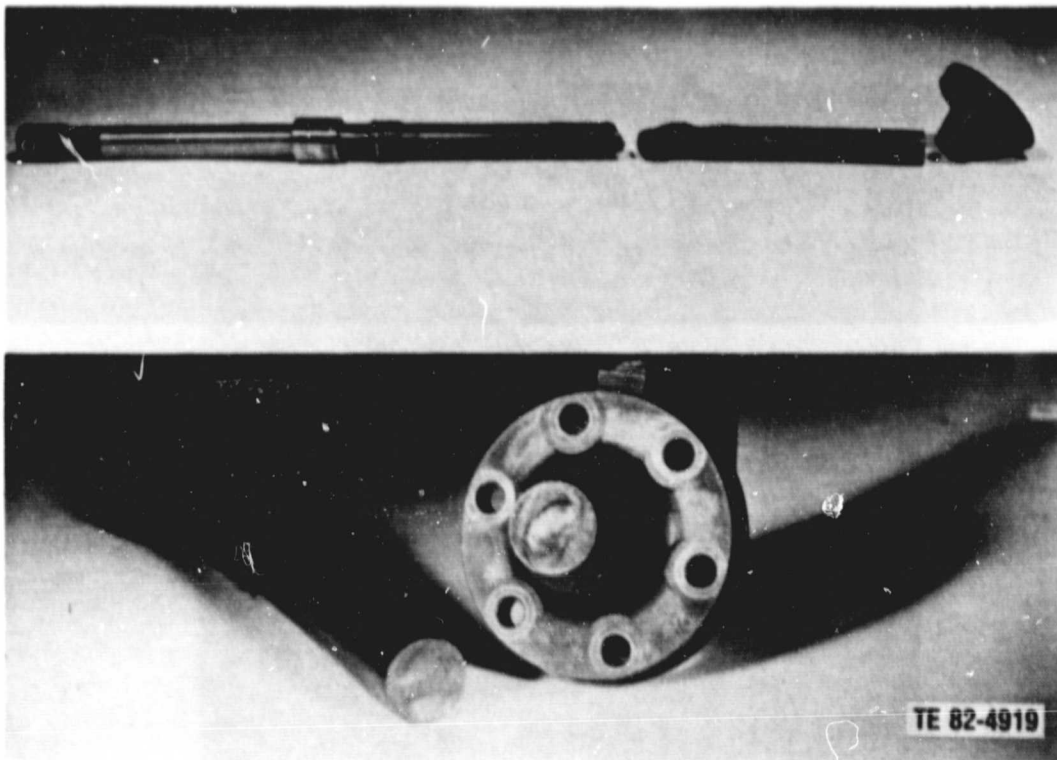
The quill shaft provides the mechanical connection between the gasifier rotor system and the gasifier gear train. The dynamic modes with major quill shaft bending are positioned outside the engine operating regime with acceptable margin. Thus, the quill shaft passes through a bending critical speed during engine starting and thereafter operates in a supercritical mode with the quill shaft mass center on the rotational center. Shaft inversion (phase change) occurs during the transition from subcritical to supercritical operation and to restore the gasifier quill shaft to stable supercritical operation after a disturbance such as throttle position change, initiation of dynamic braking, or change from power transfer to free shaft operation moves the shaft mass center off the rotational center. Loss of supply oil to the bump-stop bushing terminated the ability of the bump-stop to provide viscous damping to the quill shaft at the critical bending frequency and the viscous force required to promote shaft inversion without large shaft deflections. The quill shaft therefore achieved excessive deflection, exceeding the yield strength of the shaft, contacting the bore of the counterrotating power turbine rotor, and progressing to failure of the quill shaft and power turbine shaft.

Figure 10. Gasifier quill shaft from Greyhound engine S/N T5 showing central rubbing failure and secondary fracture near flange (508 total engine hours).

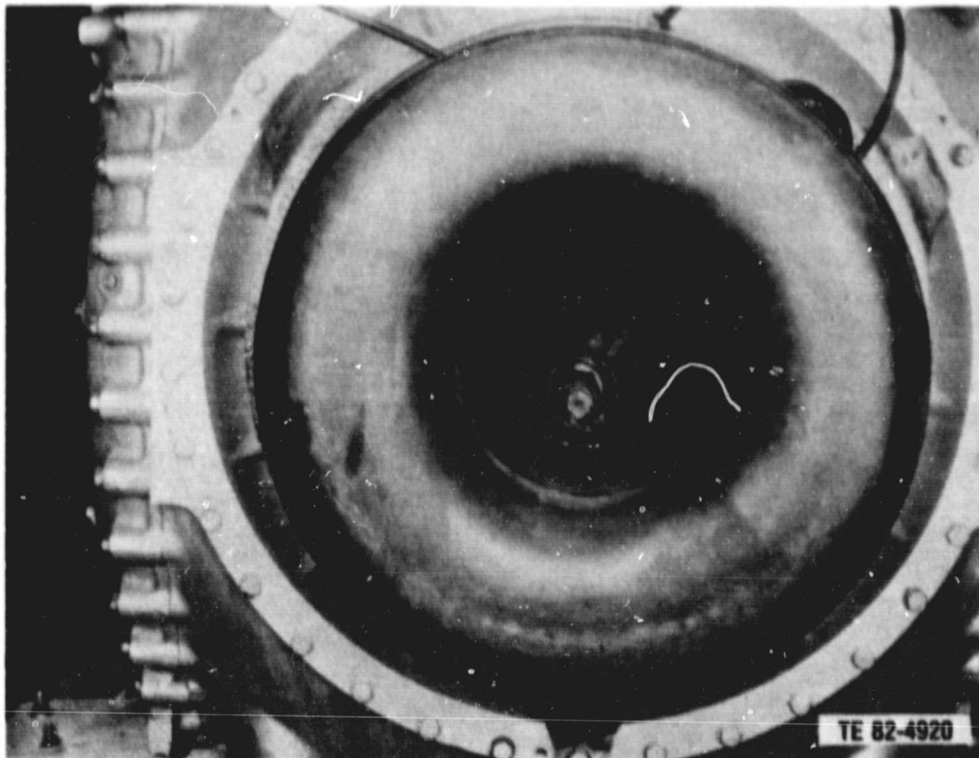
A failure of a compressor impeller was encountered after 27,240 mi (43,839 km) of Greyhound operation on engine S/N T9 and resulted from a subsurface inclusion in the casting. The compressor impeller failure is shown in Figures 11 and 12.

The material of the GT404-4 engine compressor impeller is cast aluminum 201 (KO-1). Investigation revealed that failure occurred in fatigue which initiated at a subsurface film type casting defect. The inclusion was found to contain increased amounts of base metal alloying elements. Due to the compact structure of the inclusion and subsurface location, the routine nondestructive inspections of X-ray and fluorescent penetrant inspection (Zyglo) failed to identify the defect. The alloys, added to the molten aluminum for enrichment, did not disperse completely and collected to form the subject inclusion.

Figure 11. View of Greyhound engine S/N T9 inlet showing failure of compressor impeller (768 total engine hours).

The inclusion problem was corrected by filtering the alloy-enriched molten aluminum during the pouring operation. Both ceramic and fiber screen filters were evaluated and found to be effective in diluting the alloy concentrations in the aluminum prior to entering the mold, thus preventing the formation of inclusions in the finished casting. This was verified by inspection sampling of a number of finished castings. The procedure involves machining through the casting in small increments with Zygl inspection of the machined face after each cut. No discrepancies were found and filtering was added to the casting process.

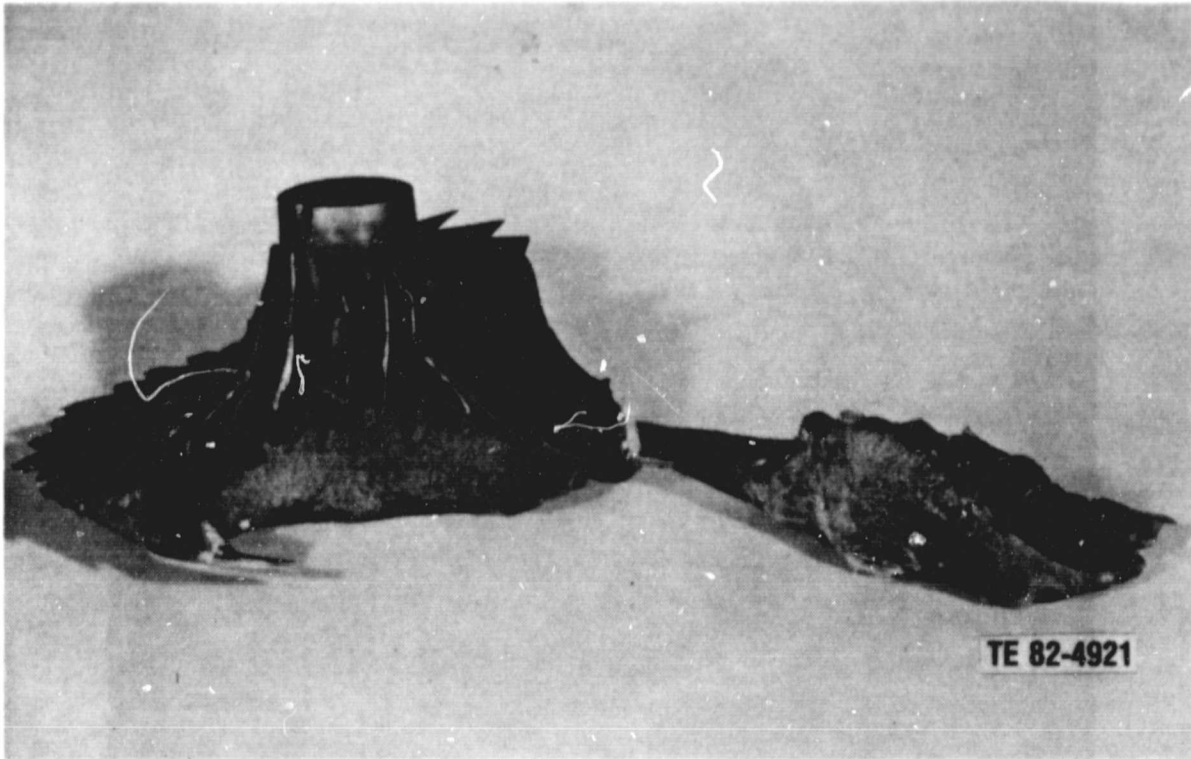
Figure 12. Failed compressor impeller from Greyhound engine S/N T9
(768 total engine hours).

The filtered casting compressor impellers were installed on all of the coach engines and no subsequent impeller failures were encountered.

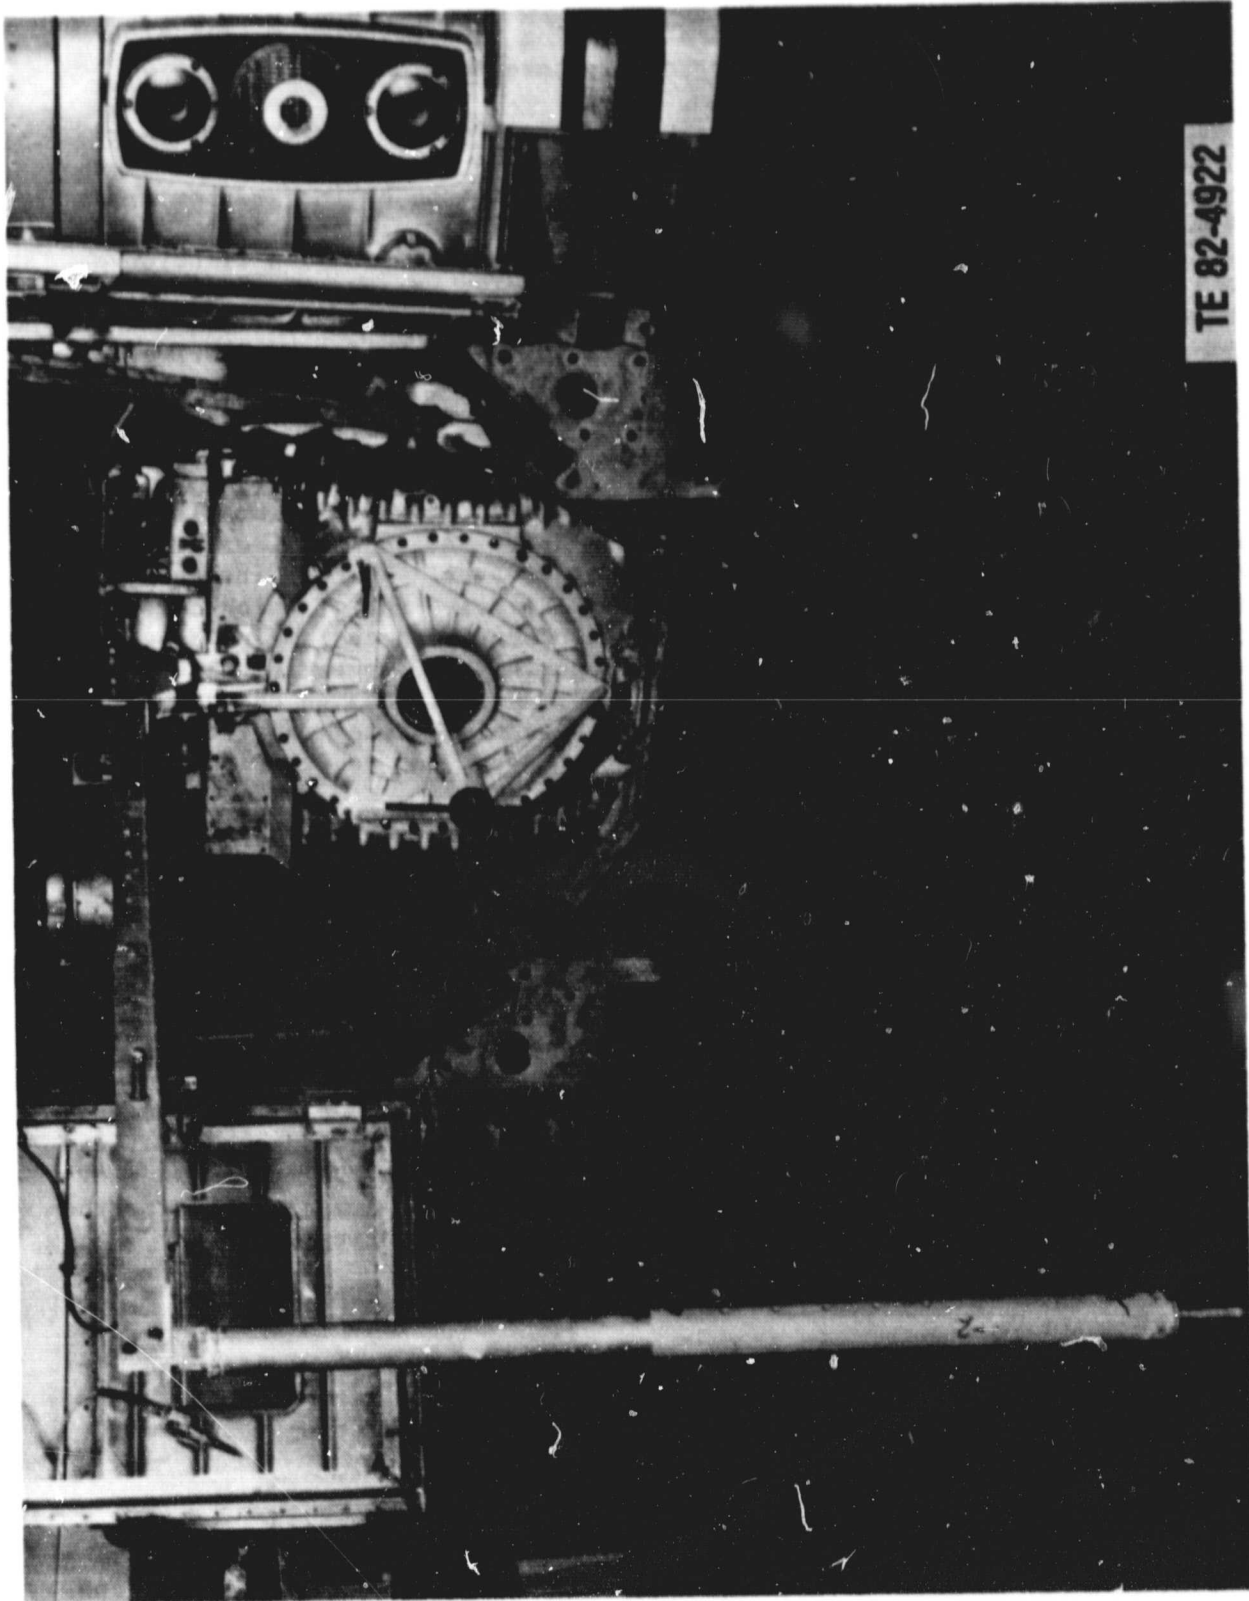
Figure 13. Engine compressor impeller replacement tooling.

In order to expedite compressor impeller replacement on all of the coach engines, special tooling was designed and fabricated to allow proper removal and installation of the parts without engine removal from the coach. Figure 13 shows the tooling being used on a Greyhound engine installed in the coach.

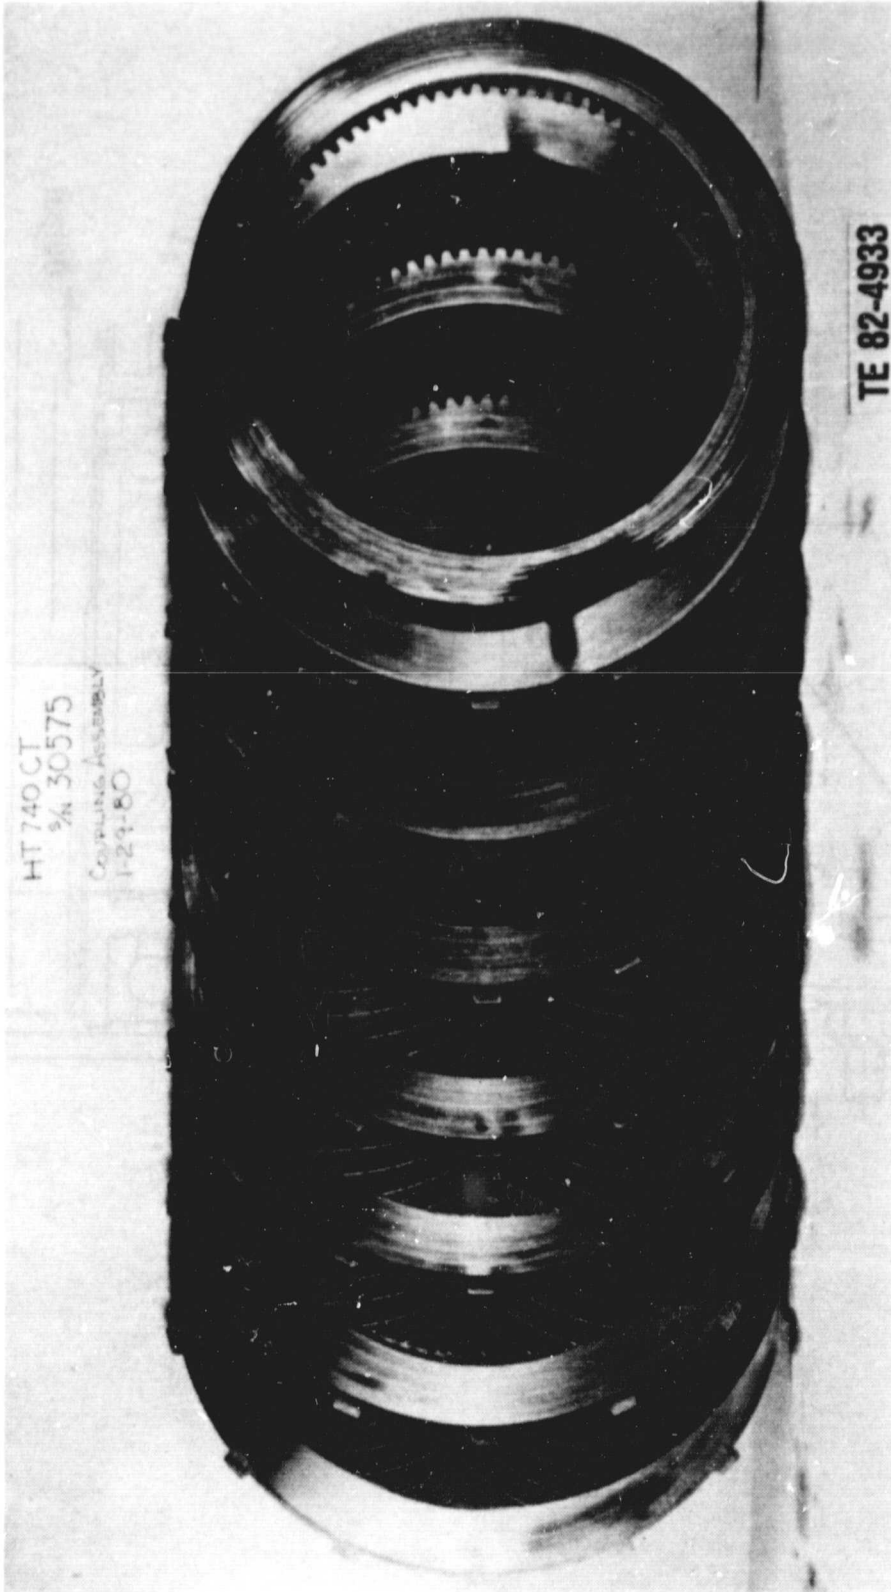
Figure 24. HT740CT transmission S/N 30575 coupling clutch plate failure.

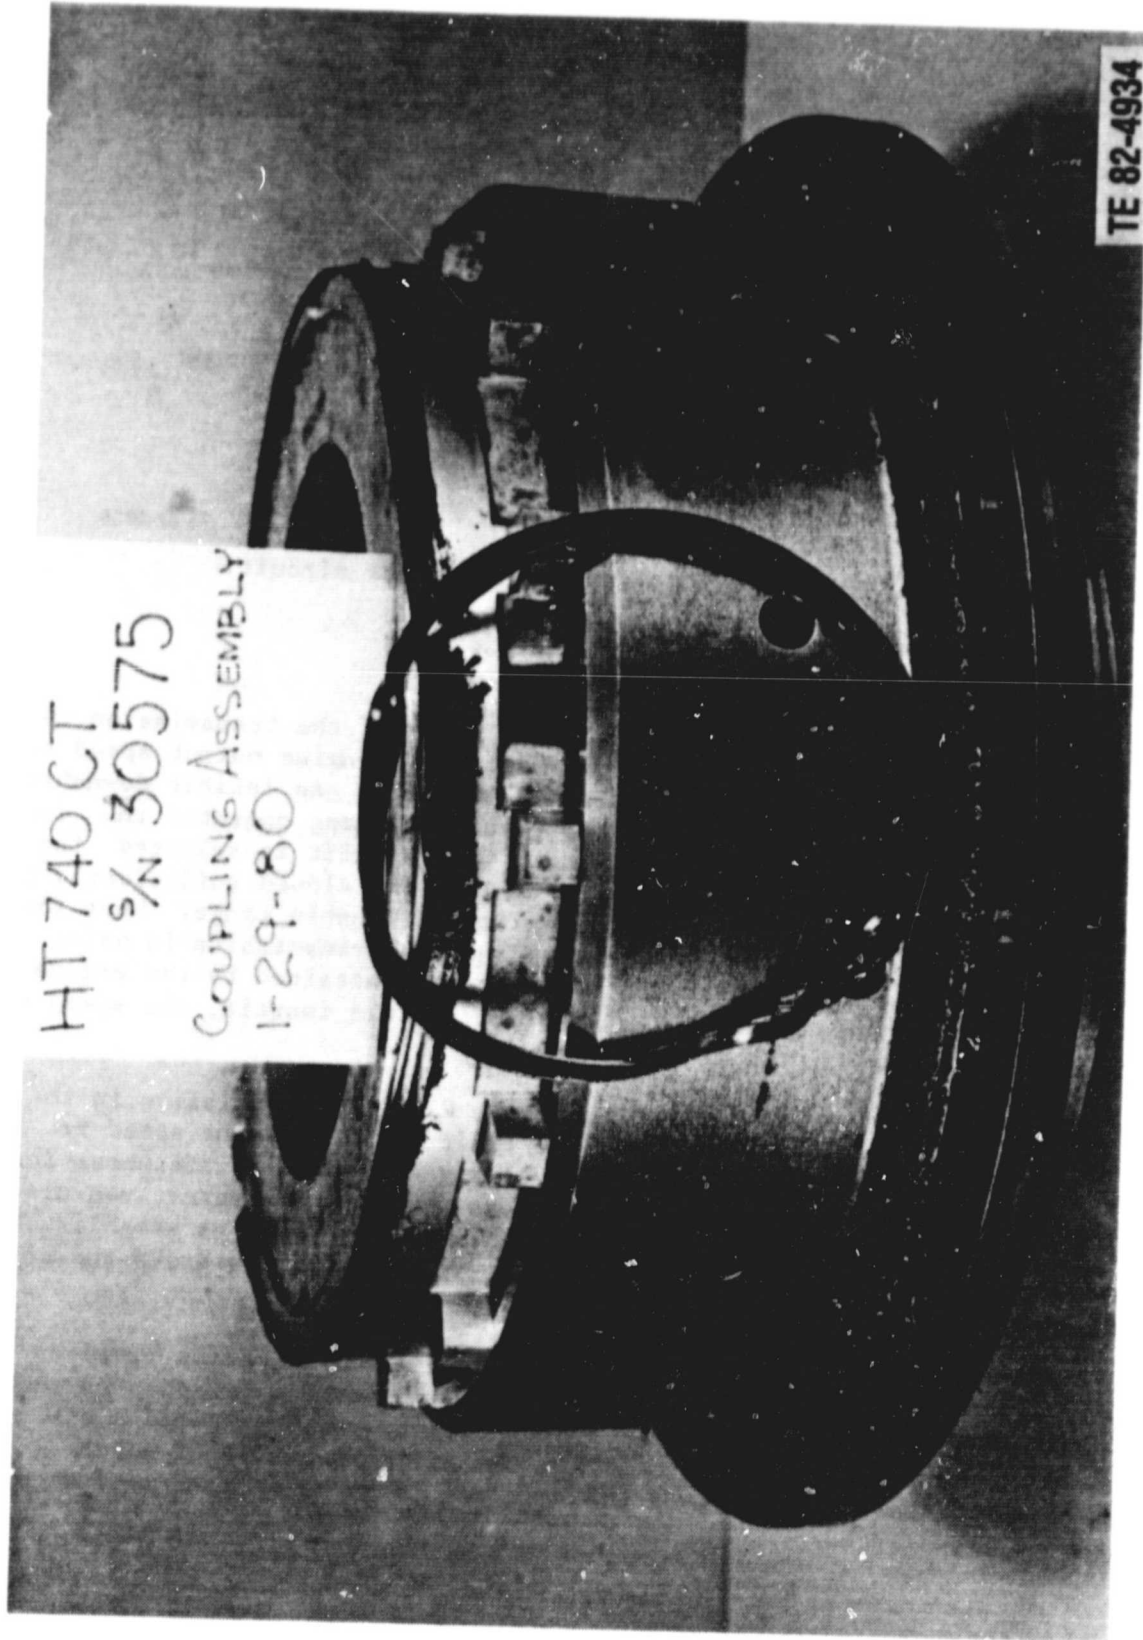
Figure 25. HT740CT transmission S/N 30575 coupling assembly showing seal damage.

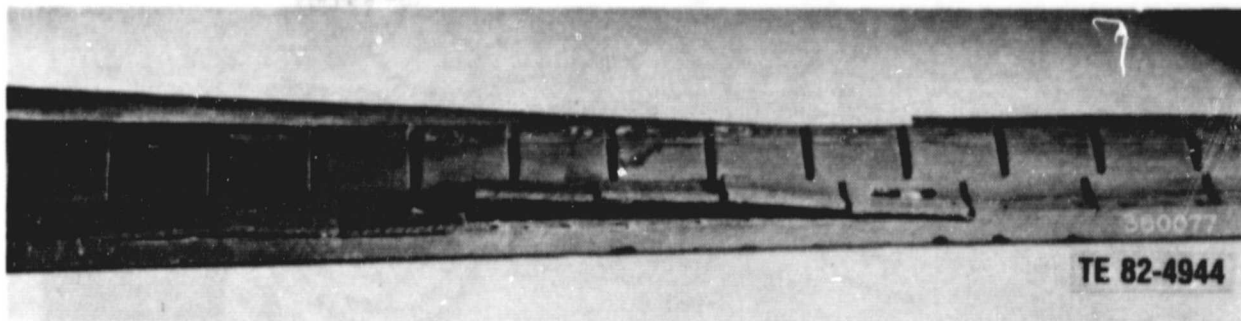
created by the separation and the resultant high-velocity impingement directed against the edge of the sheet metal insulation retainer in the power turbine exhaust cavity caused distortion of the retainer (see Figure 36). Subsequent retainer contact with the disk caused surface damage. Improved control of weld quality corrected the problem.

Figure 35. Regenerator inboard seal showing seal leaf retainer separation from platform.

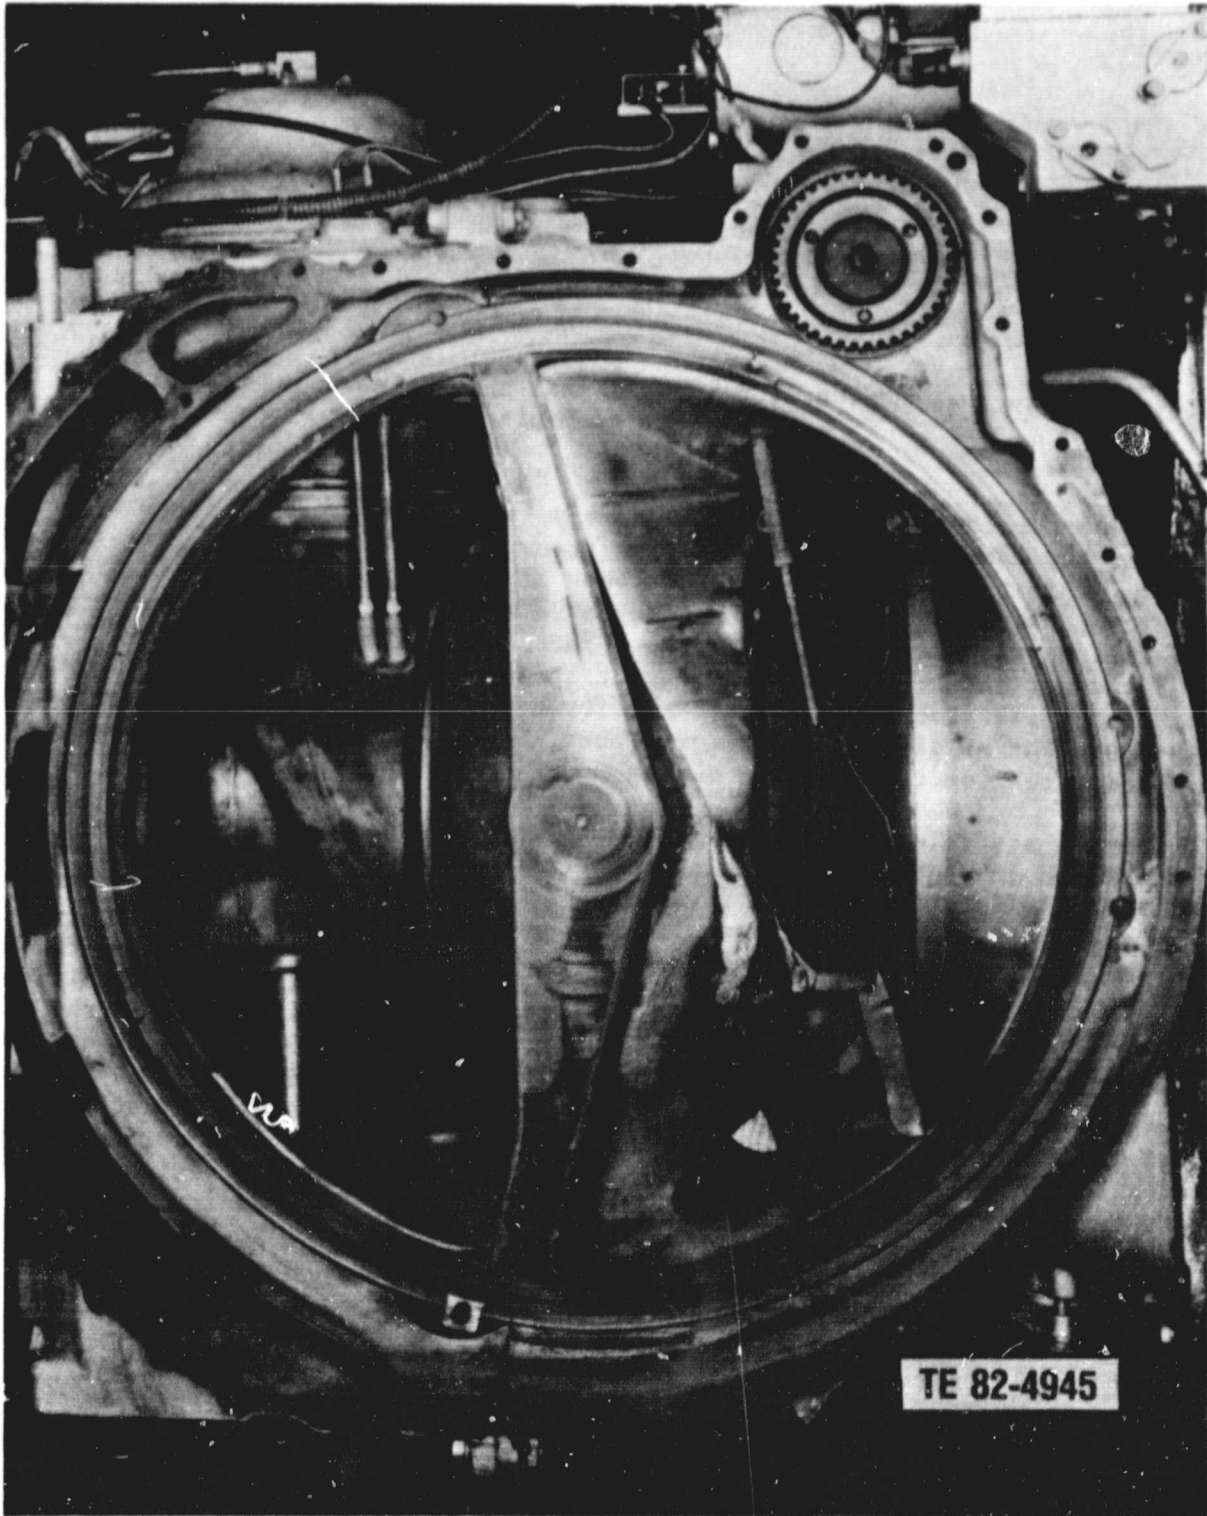
Figure 36. Left side of engine showing sheet metal
insulation retainer distortion.

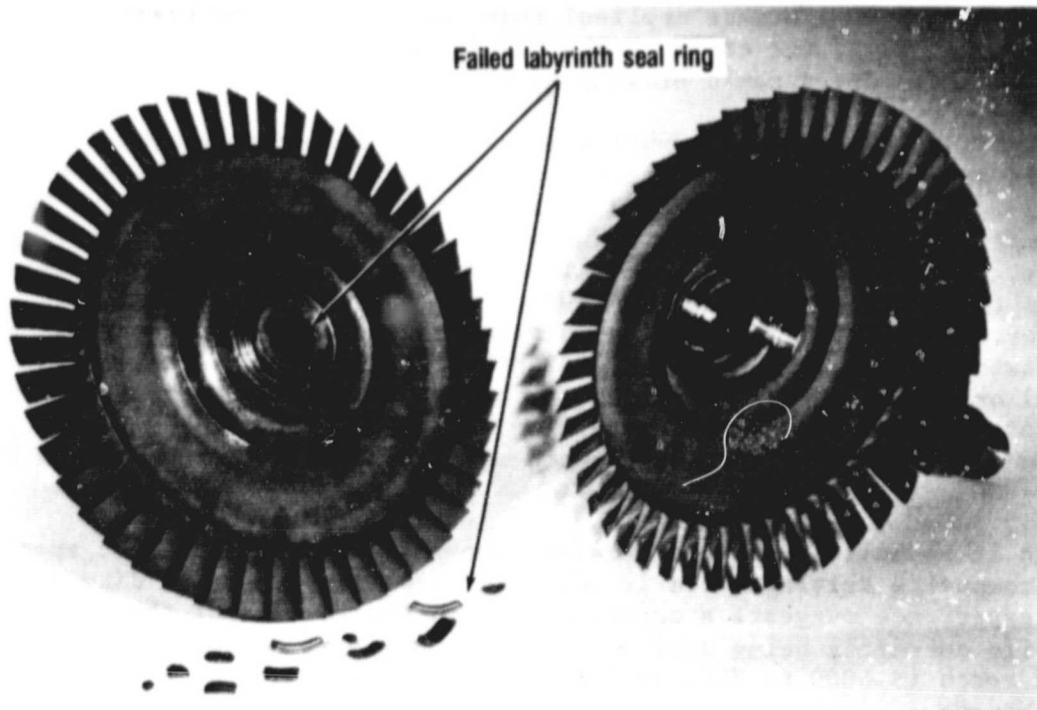
Figure 37. Power turbine rotor and shaft assembly showing failed labyrinth seal ring in comparison with new like part.

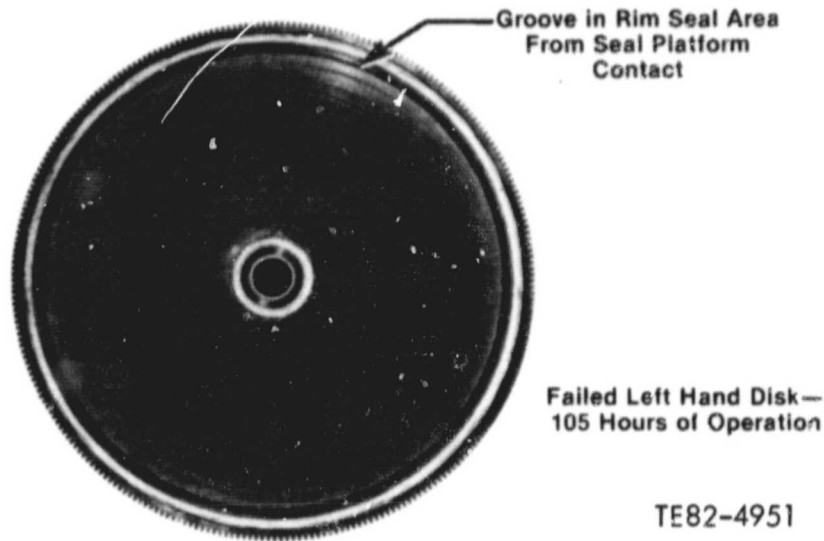
Figure 42. Ceramic regenerator disk showing surface damage.
