THEMATIC MAPPER

Prepared for
GODDARD SPACE FLIGHT CENTER
Greenbelt, Maryland 20771
CONTRACT NAS 5-24200

FLIGHT MODEL
PRESHIPMENT REVIEW
DATA PACKAGE
VOLUME II - SUBSYSTEM DATA
PART C
Article IV - 3A

THEMATIC MAPPER
FLIGHT MODEL
PRESHIPMENT REVIEW
VOLUME II
SUBSYSTEMS
TABLE OF CONTENTS

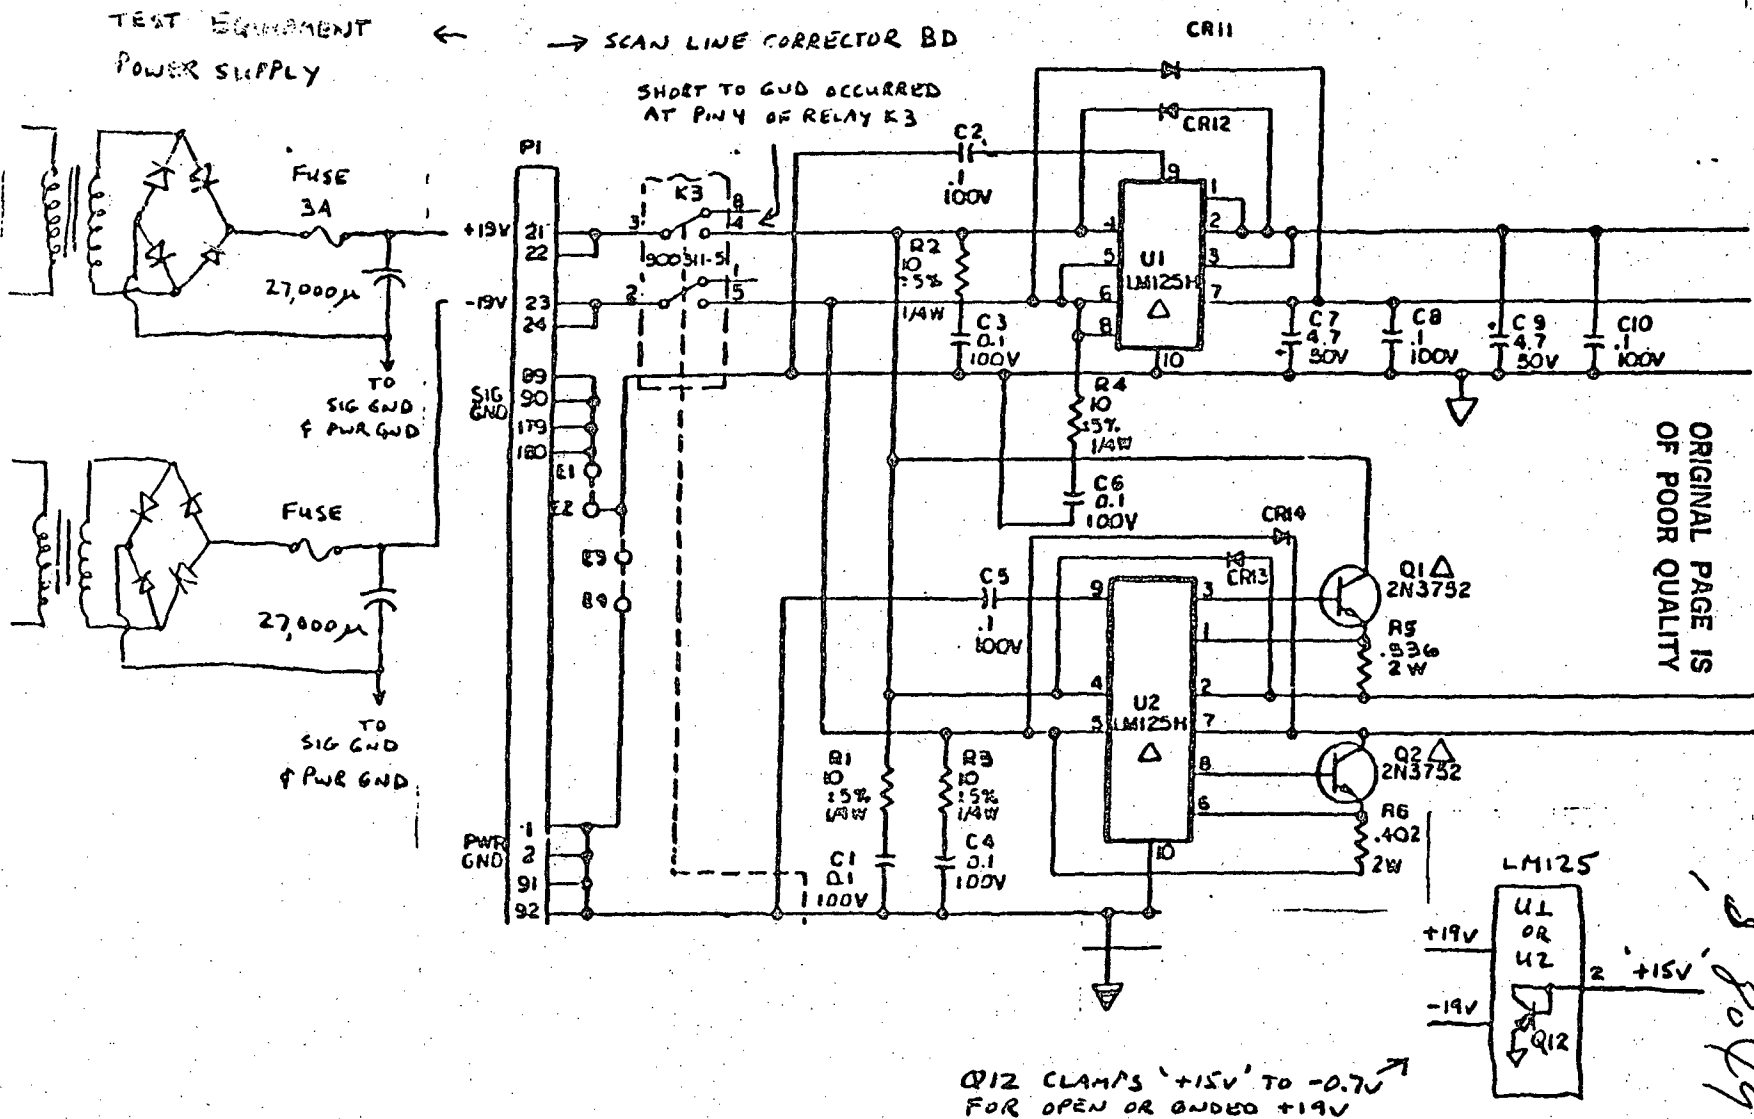
FIGURE 1. SLIC ±19V POWER INPUT CIRCUITRY, ILLUSTRATING POINT AT WHICH FAILURE OCCURRED

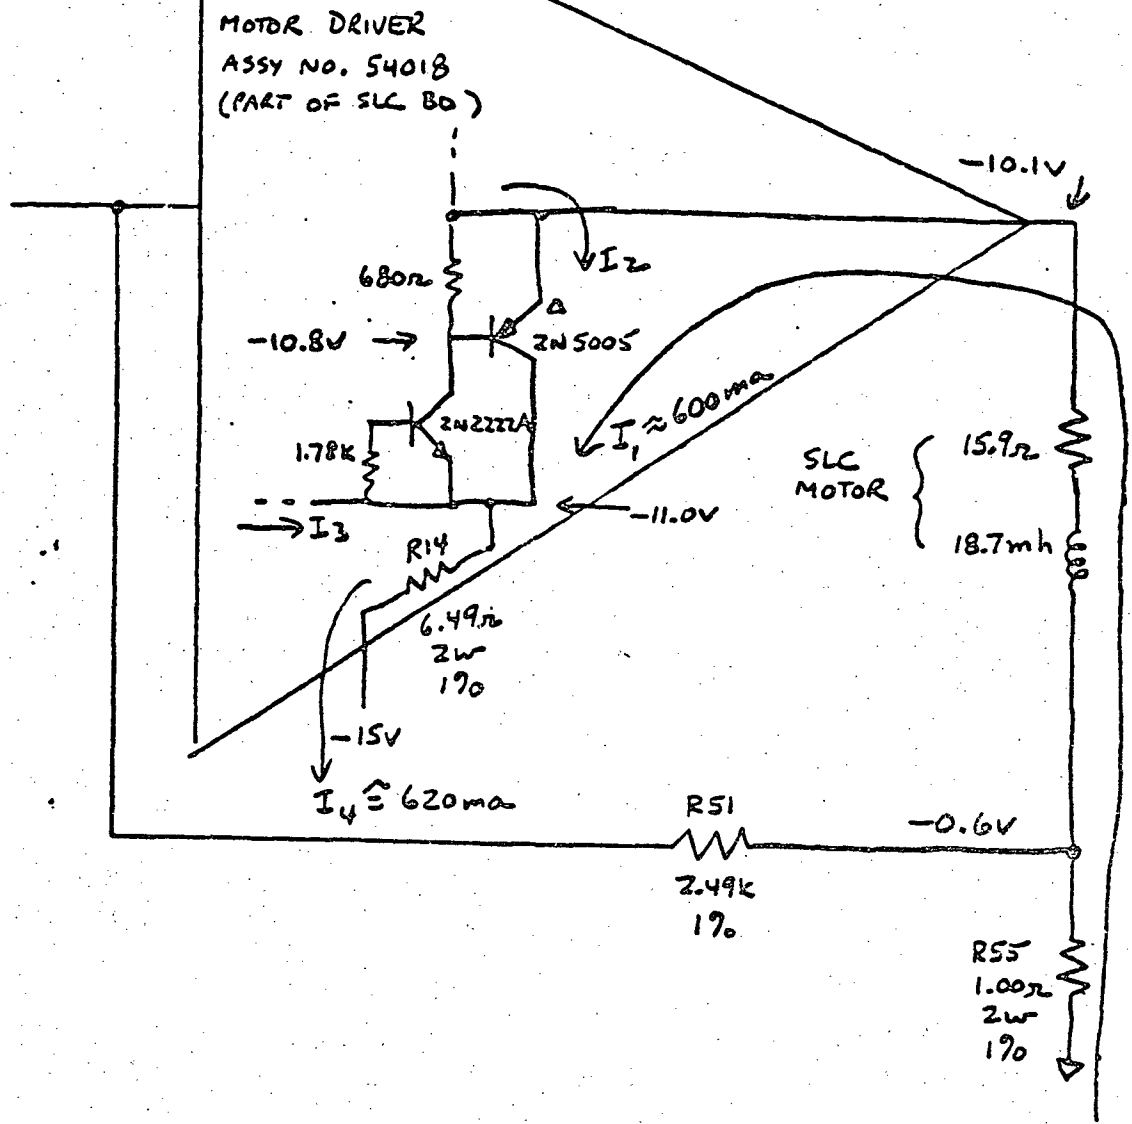
FIGURE 2. MOTOR DRIVER STEADY-STATE OUTPUT FOR
+14V SHORT TO GND

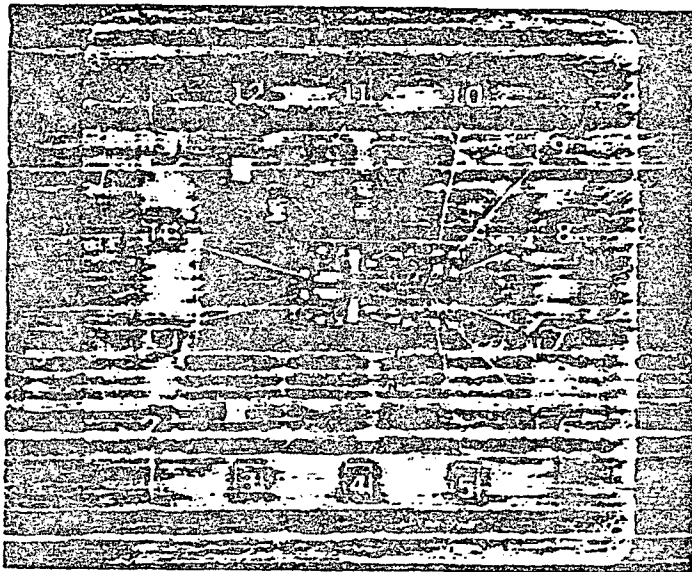
Figure No. 3

Photomicrograph of the cavity
showing the driver circuitry
(center die) and the four
JFET switches on separate
substrates.

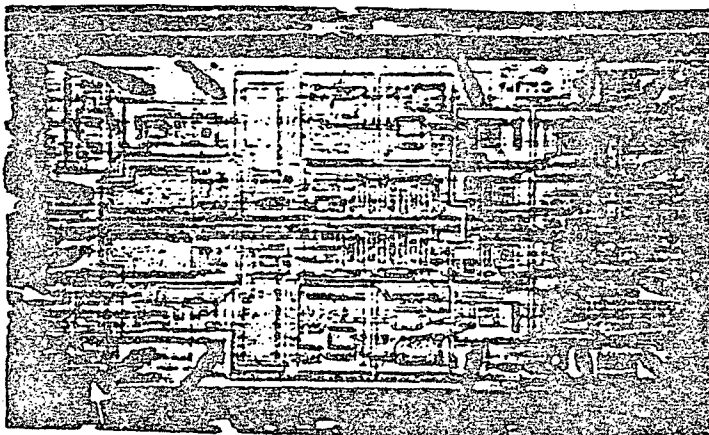
Figure No. 4

Overall view of the center die
showing the location of the
crack shown in Figure 5 (be-
tween arrows).

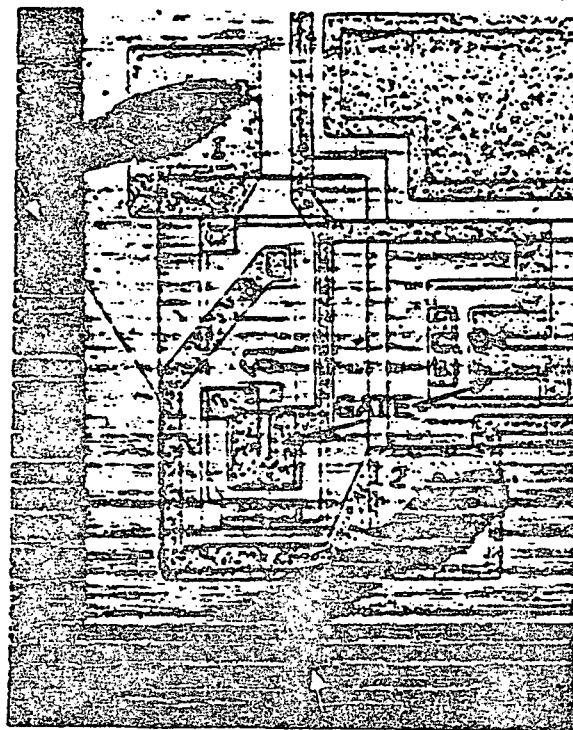
Figure No. 5. Detailed view of the crack across MOSFET Q5 of the driver circuitry. Note that the crack extends to the scribe surface at the edge of the die (between arrows). (182X)

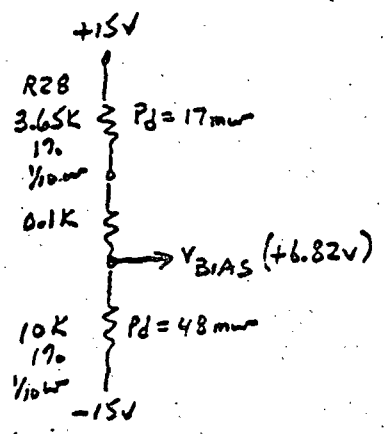
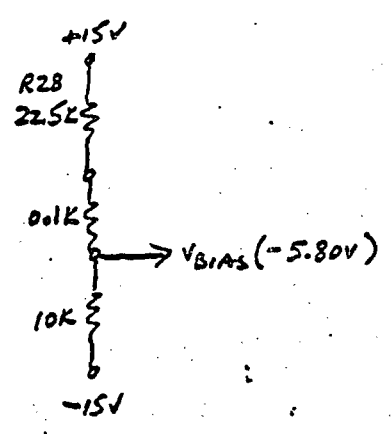
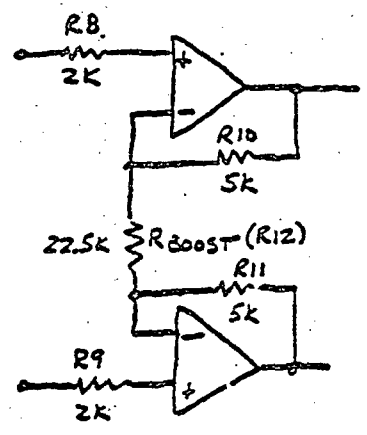
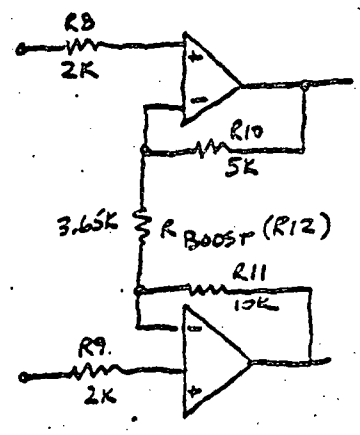
FIGURE L : OFFSET AND BOOST CIRCUITS RESULTING FROM INTERCHANGE OF R2B AND R12.
