# THEMATIC MAPPER

Prepared for  
**GODDARD SPACE FLIGHT CENTER**  
Greenbelt, Maryland 20771  
**CONTRACT NAS 5-24200**

FLIGHT MODEL  
PRESHIPMENT REVIEW  
DATA PACKAGE  
VOLUME III - SYSTEM DATA  
PART C

#### 4.0 SUMMARY OF LIENS

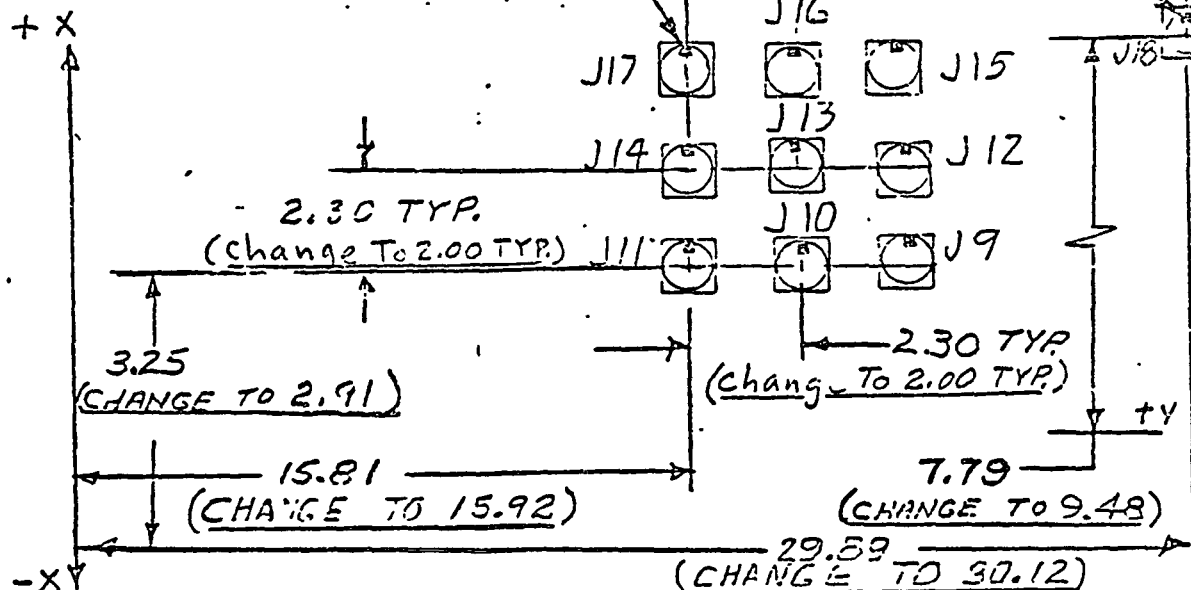
*3533000-400 Page 3**PATTERN SHRINKS IN SIZE**[30] Master Polarizing Key  
(Typical J9 thru J24)*

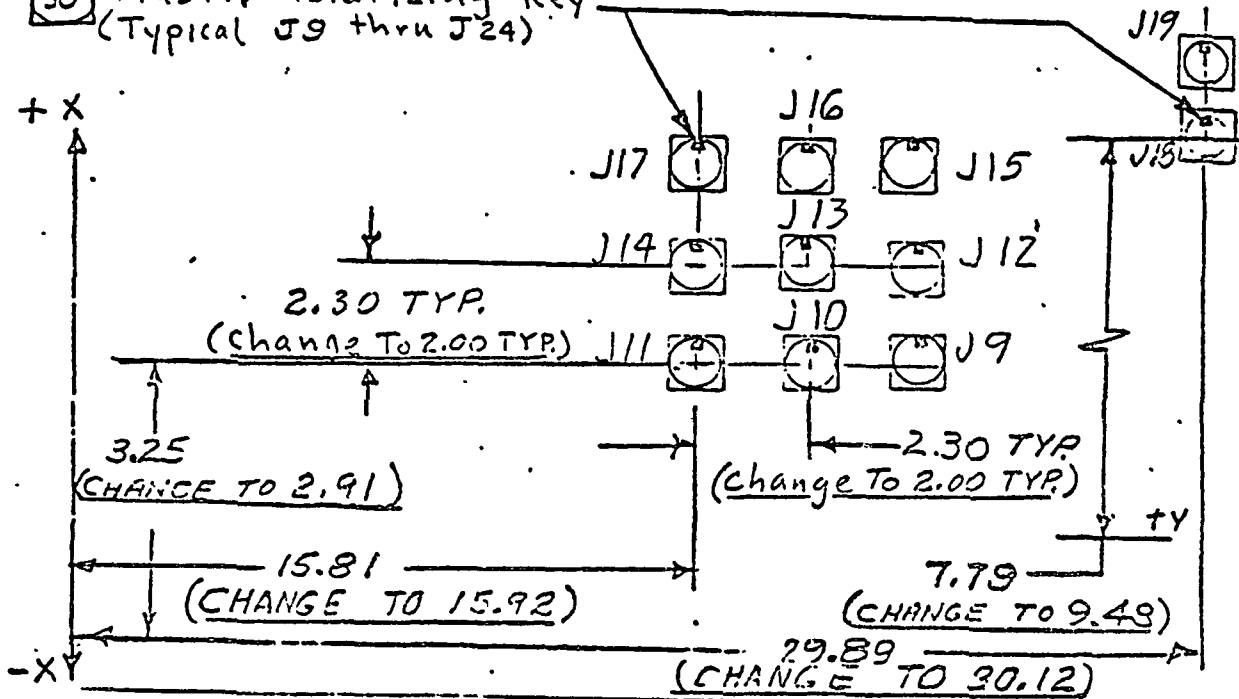
3533000-400 Page 3 As shown

30 Master Polarizing key  
(Typical J9 thru J24)
