# Examination, Evaluation, and Repair of Laminated Wood Blades After Service on the Mod-0A Wind Turbine

James R. Faddoul  
National Aeronautics and Space Administration  
Lewis Research Center

Prepared for  
National Conference of the American Wind Energy Association  
San Francisco, California, October 16-19, 1983

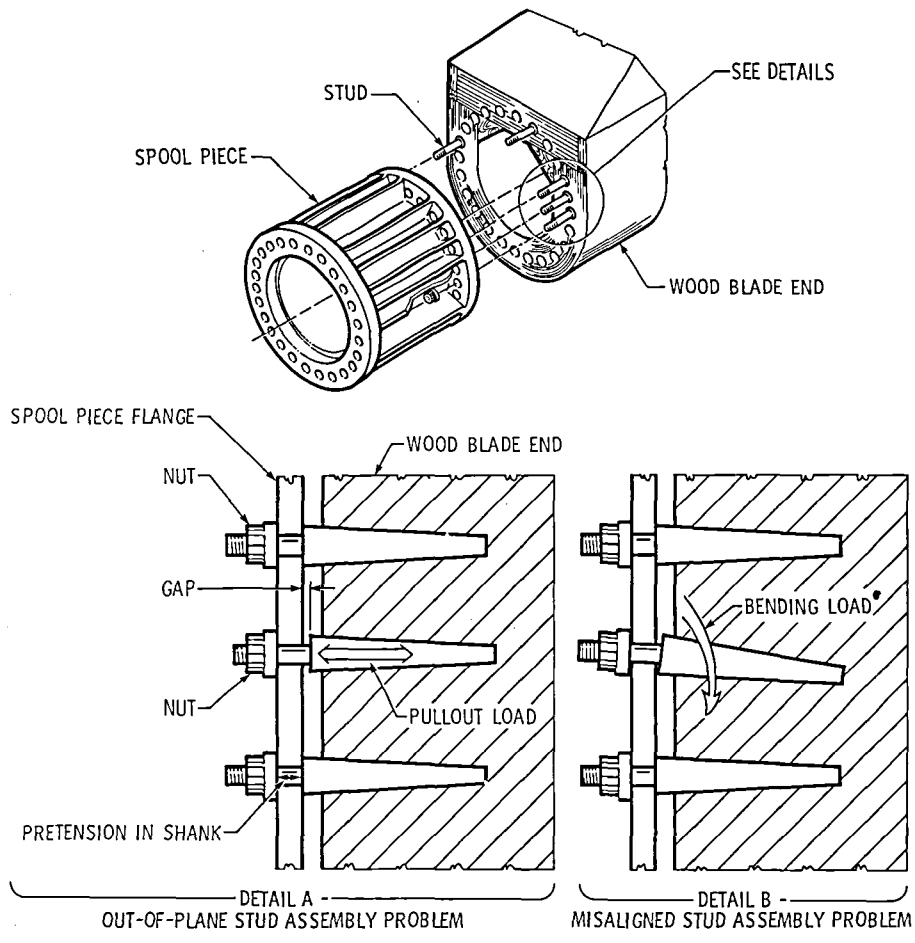
allowable weight by 1.4 kg (3 lb) and the allowable gravity moment by 5152 N-m (3800 ft-lb). The other deviation involved a misalignment of the blade retention studs on blade 1011, shown schematically in figure 1. Special shim washers were manufactured and were used to correct the out-of-plane condition of the stud faces of blade 1011. The out-of-plane condition of blade 1010 was found to be within design limits and the shim washers were not used on that blade. Some of the more important events in the history of the blade set are as follows:

Figure 1. - Wood blade root end/stud/spool-piece assembly.

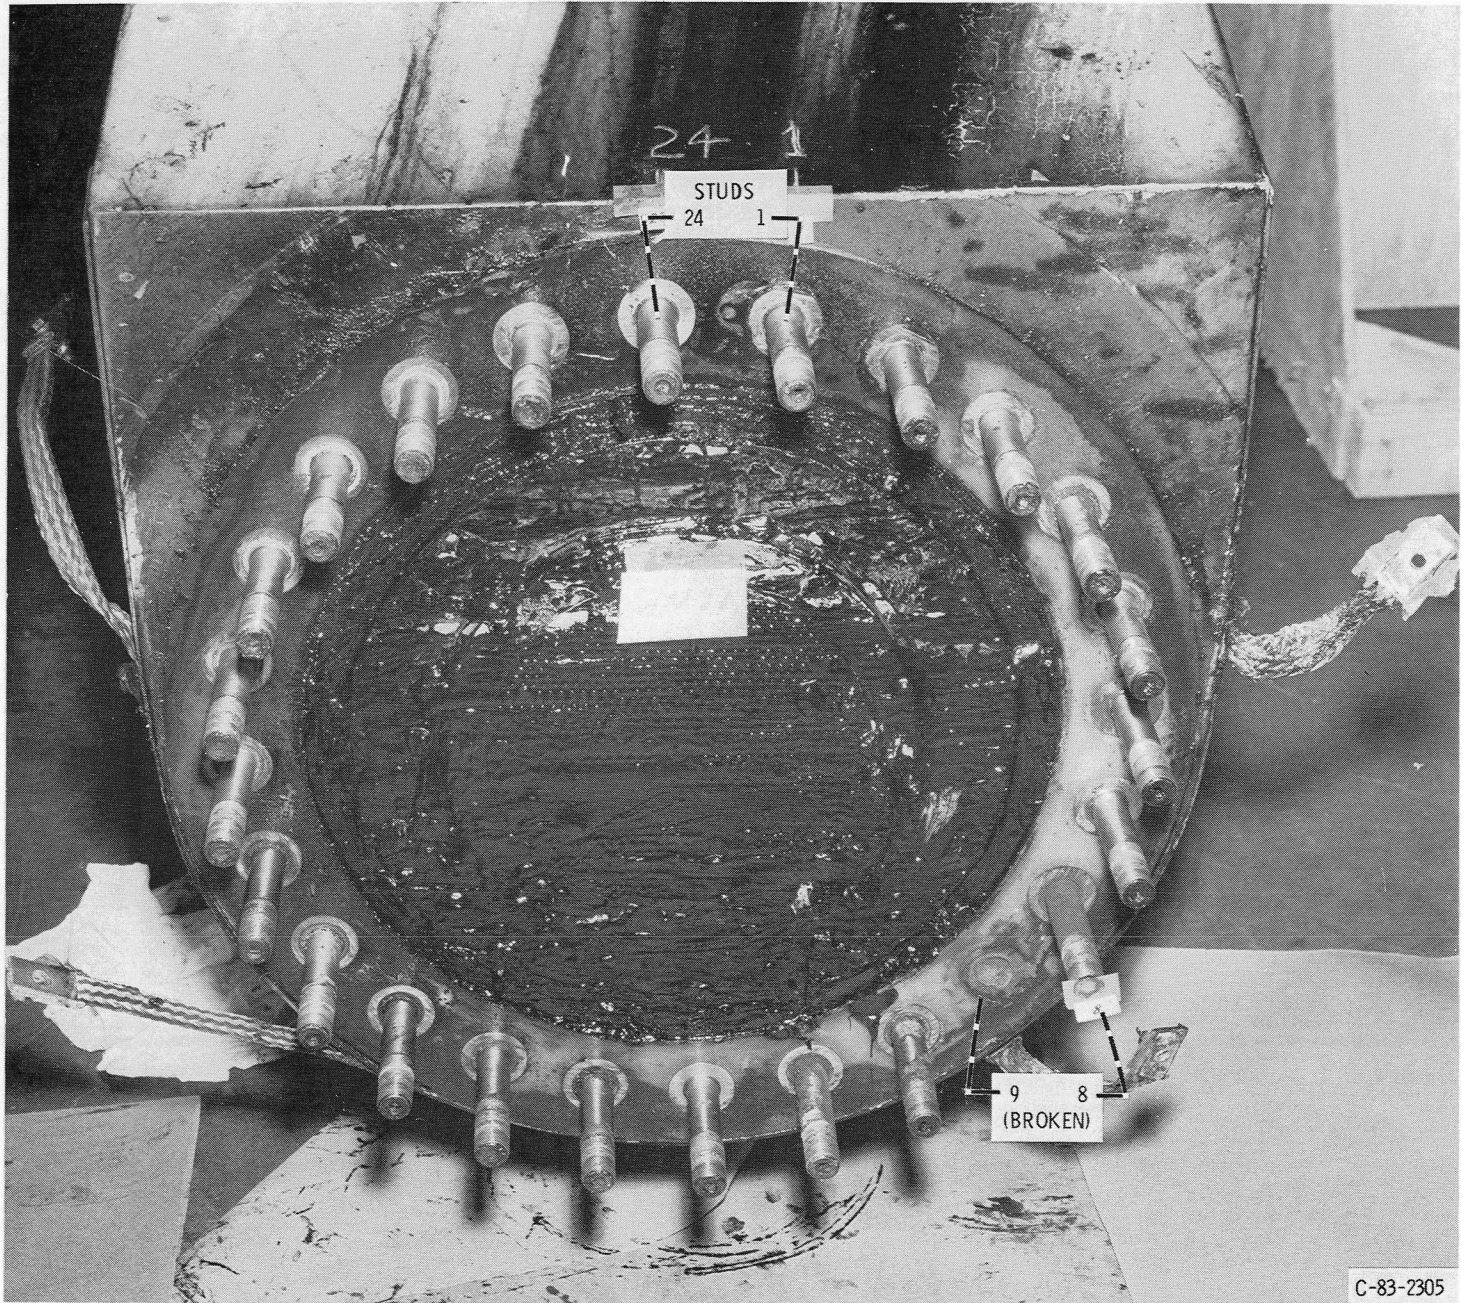
Once the visual and "rough" weight checks were made, the spool pieces were removed from both blades, and the stud/spool piece interface was visually inspected. During removal of the spools the torque on each nut was checked and none were found to have loosened. Observation of the studs indicated that significant corrosion had taken place on blade 1011 only and only on a stud-selective basis (figs. 2 to 4). Blade 1010 (figs. 5 and 6) had no serious corrosion.

Figure 2. - Root end of blade 1011 showing bolt circle and stud numbering sequence.

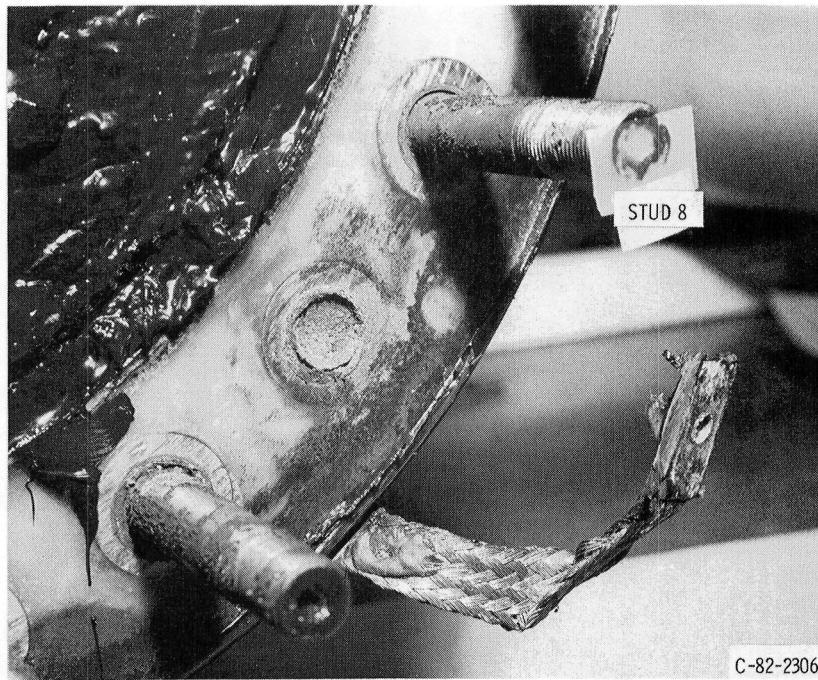
(a) Studs 8 and 10 plus remains of 9.

Figure 3. - Corrosion of and around stud 9 on blade 1011.

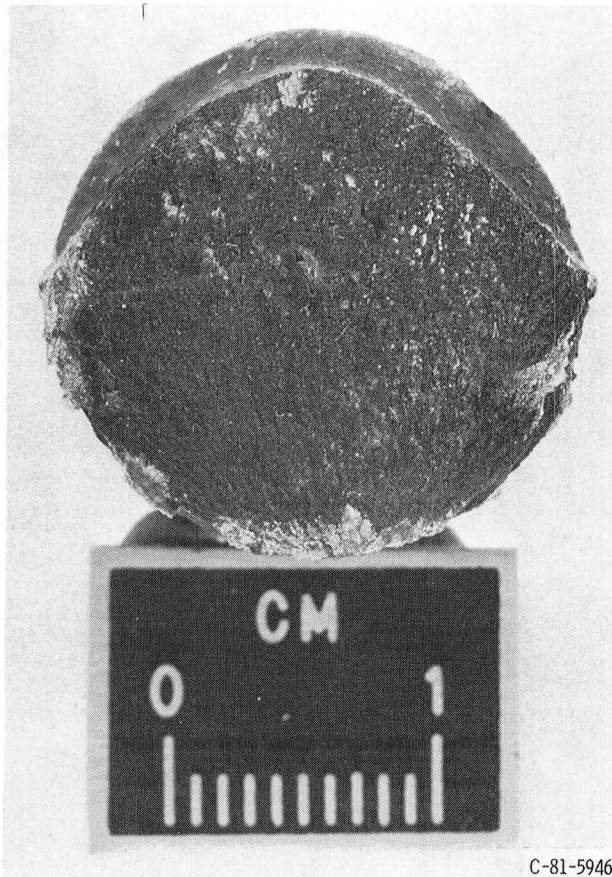
(5) The cause of failure was stress corrosion fatigue.

(b) Fractured face of stud 9 blade 1011.

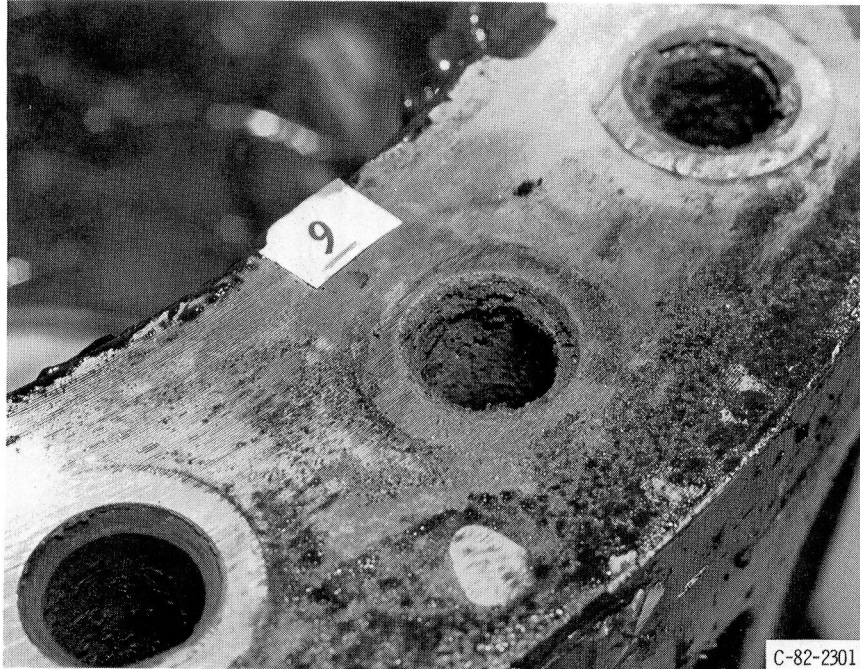
(2) Metal-to-metal contact between the stud shoulder and the spool was not consistent. When full contact was achieved, little or no rusting or corrosion had occurred. The broken stud had less contact and more corrosion than any other stud.

(c) Corrosion of spool piece in location of stud 9, blade 1011.

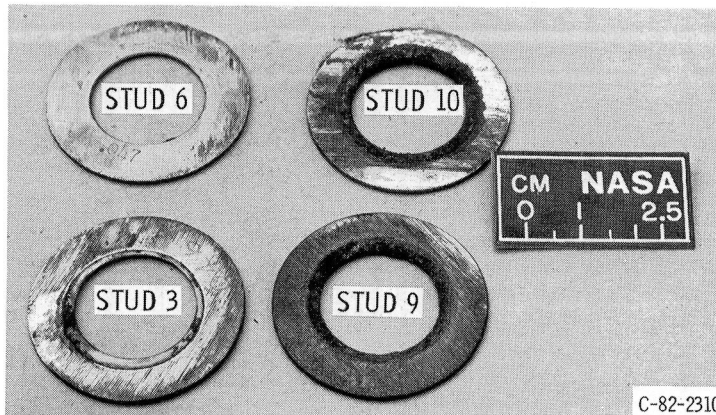
(4) Although the shim washers on blade 1011 had corrected the out-of-plane condition of the stud shoulders, there was evidence that a nonperpendicular condition (misalignment) also existed that could not be corrected with shims. This condition led to lack of metal-to-metal contact between the stud shoulder and the spool. This, in turn, created two problems. First, the misalignment prevented the preload of the stud from being fully effective in reducing the cyclic component of the applied load. And, second, the absence of full metal-to-metal contact allowed the corrosive moist salt air to attack the radius area of the stud, where failure ultimately occurred.

(d) Shim washers removed from four studs on blade 1011.

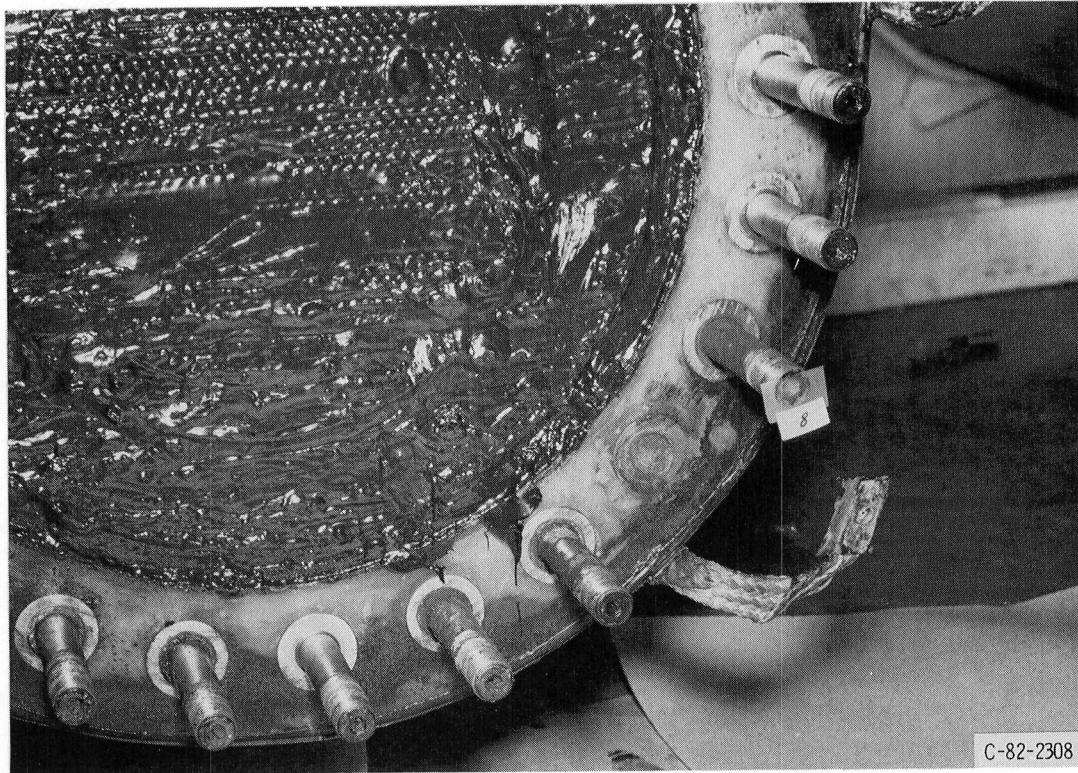
Figure 4. - Variability of corrosion of blade 1011.

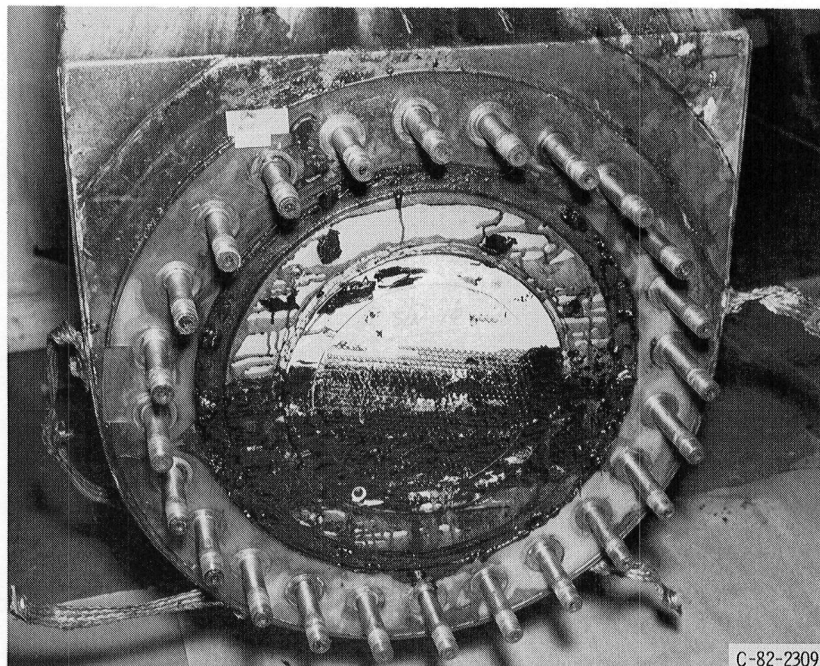
Figure 5. - Root end of blade 1010 showing very little significant corrosion.

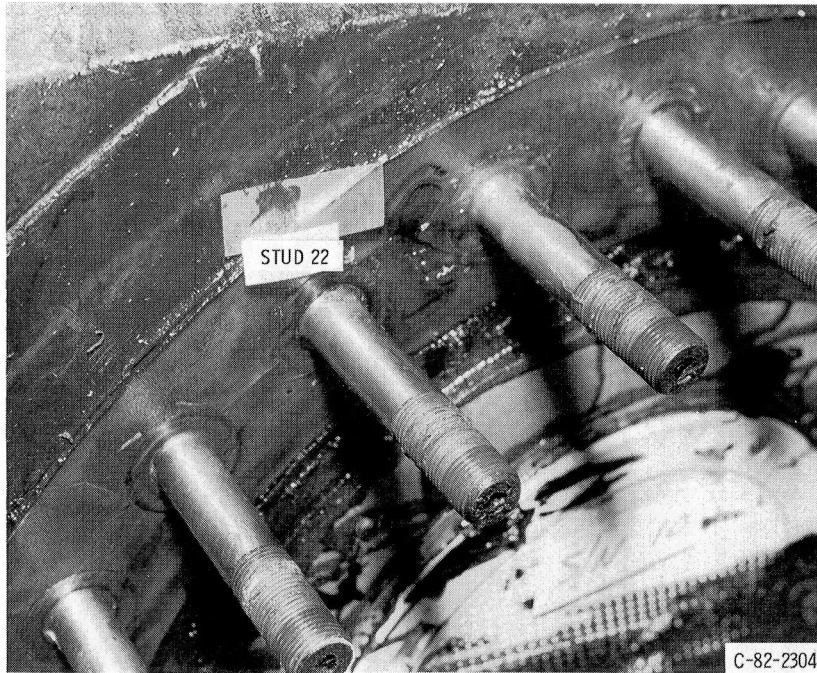
Figure 6. - Section of blade 1010 showing worst area of corrosion.

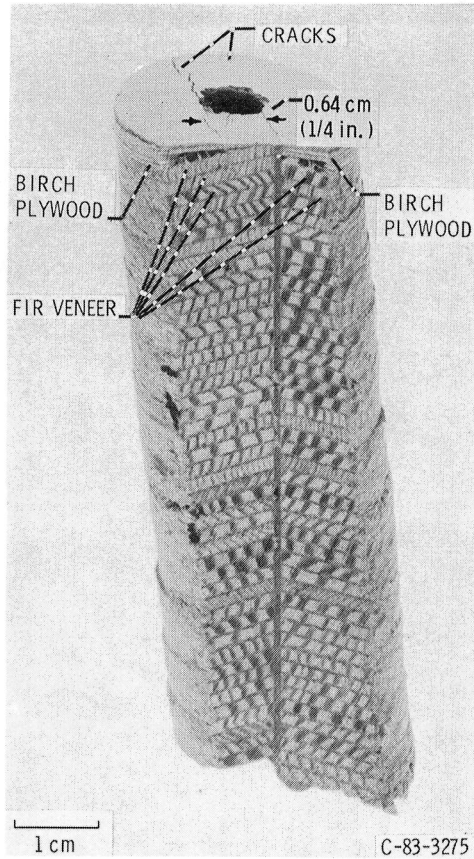
Also evident on blade 1012 was the leading-edge crack, which ran the entire length of the blade and seemed to be in the joint between the upper and lower blade halves. Figure 12 shows a plug section from blade 1012 that has two cracks separated by about 0.64 cm (1/4 in.). Less than 10 percent of the blade had this condition, but there were areas where the crack was discontinuous and would jump back and forth from one location to the other. Depth of the crack was estimated by inserting a thin "feeler gage" and proved to be less than 0.64 cm (1/4 in.). In some areas the crack appeared to be only superficial. At the tip of the blade from station 700 to 750, there was also a great deal of pitting and erosion of the leading edge (fig. 13). Both the leading-edge crack and erosion at the tip were unique to blade 1012. Neither of the Hawaii blades nor the other Block Island blade showed any signs of similar problems.

Figure 12. - Plug section from blade 1012 showing two leading-edge cracks.

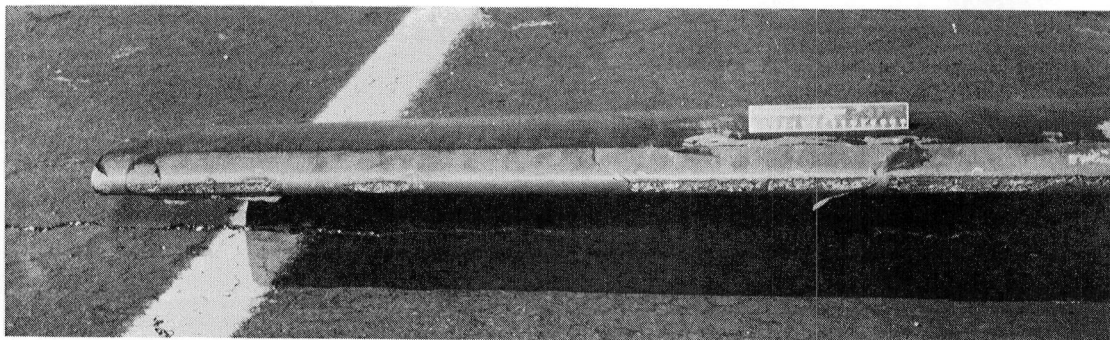
**Tip erosion:** Erosion and cratering at the tip of blade 1012 were very severe, as shown in figure 13. Unfortunately, since the machine was operating at a reduced power level, it is impossible to determine the effect on aerodynamic performance, but it would, of course, be expected to be a large (5 percent minimum) penalty. When sections were cut through the blade at the tip, the cause of the erosion problem was easily visualized. Figure 28 shows that neither the plywood blade exterior nor the fir veneer conformed to the mold surface in the outboard sections of the blade. Consequently an epoxy filler material was used to provide the exterior airfoil surface. This condition is not unique to blade 1012, however; so it is not sufficient to cause the erosion. What is unique about blade 1012 is that a leading-edge crack developed because of other manufacturing problems. The crack eventually grew large enough at the blade tip to cause splitting of the leading-edge protection tape, a 7.6-cm (3-in.) wide self-adhesive polymeric material. The tape splitting (cracking) was promoted by embrittlement caused by ultraviolet and weathering effects. Once the tape had split, direct impingement of wind and rain at high velocity quickly eroded the epoxy filler. The erosion process was further accelerated by the epoxy filler being a low-density material as a result of the frothing and bubbling created by the vacuum bag manufacturing process. The erosion process removed only the epoxy filler and stopped when a wood surface was reached.

Figure 13. - Leading-edge erosion and pitting of blade 1012 after return from Block Island (7564 operating hr.).

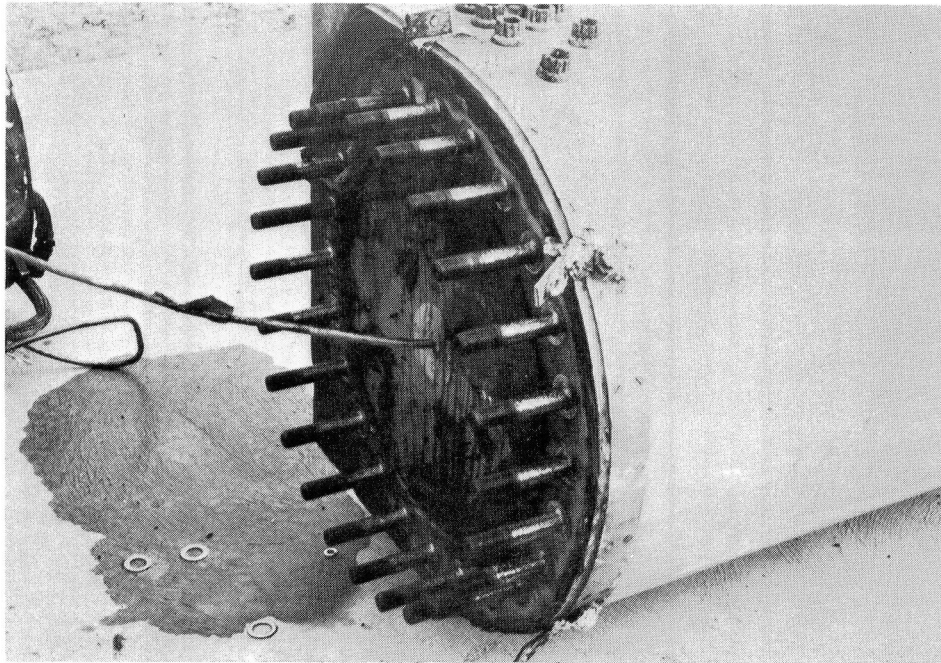
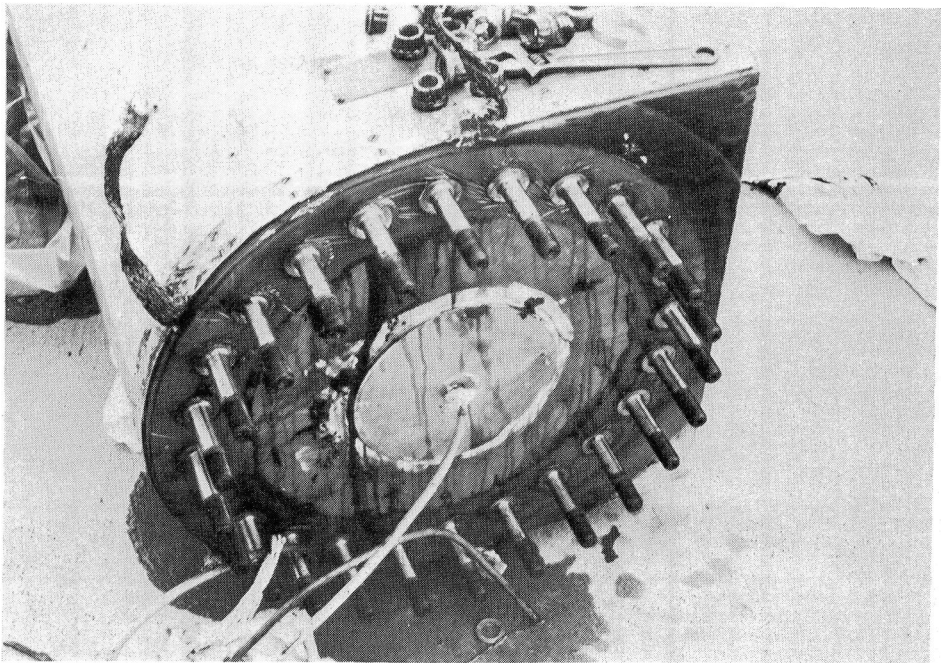
Spool pieces were then removed from both blades to determine the amount of corrosion that had occurred on the studs. As shown in figures 14 to 17, there was light-to-moderate rust but no significant pitting as had been found on blade 1010 from Hawaii. Stud-to-spool contact appeared to be complete and uniform, indicating that the studs had been installed properly with correct alignment and depth of insertion. No cracking or evidence of structural fatigue could be found by visual examination.

Figure 14. - Root end studs of blades 1012 and 1013 after return from Block Island.

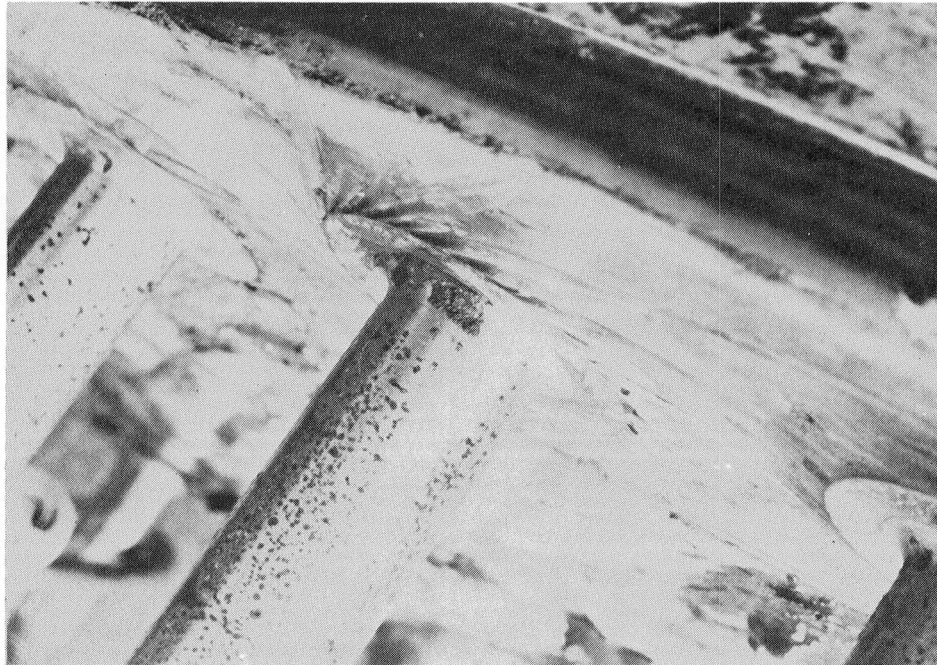
(a) Corrosion and pitting at radius of stud.

Figure 15. - Most corroded stud and matching spool piece position for blade 1013.

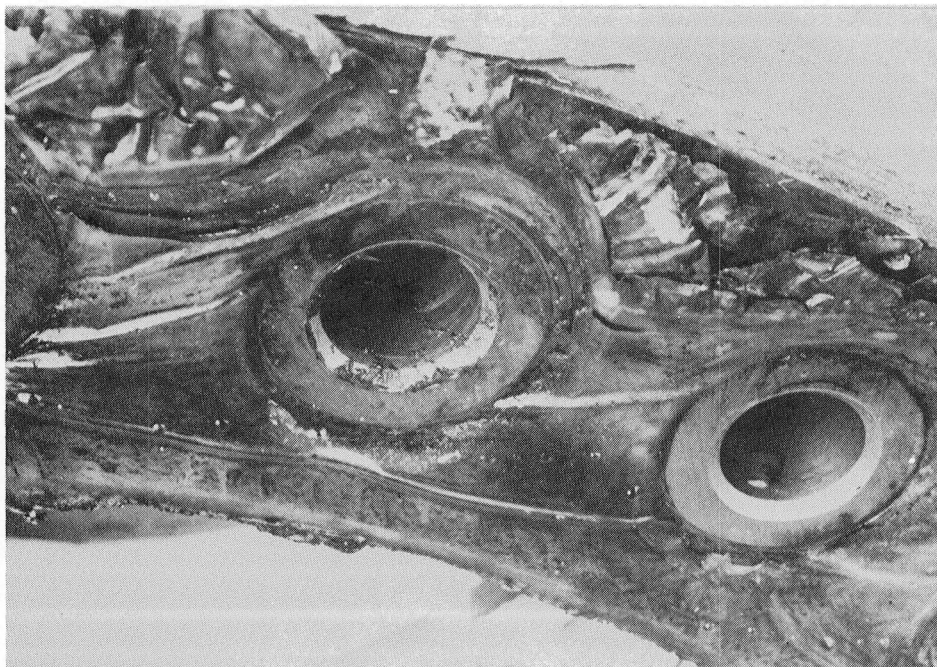
(b) Corrosion of face of spool piece.

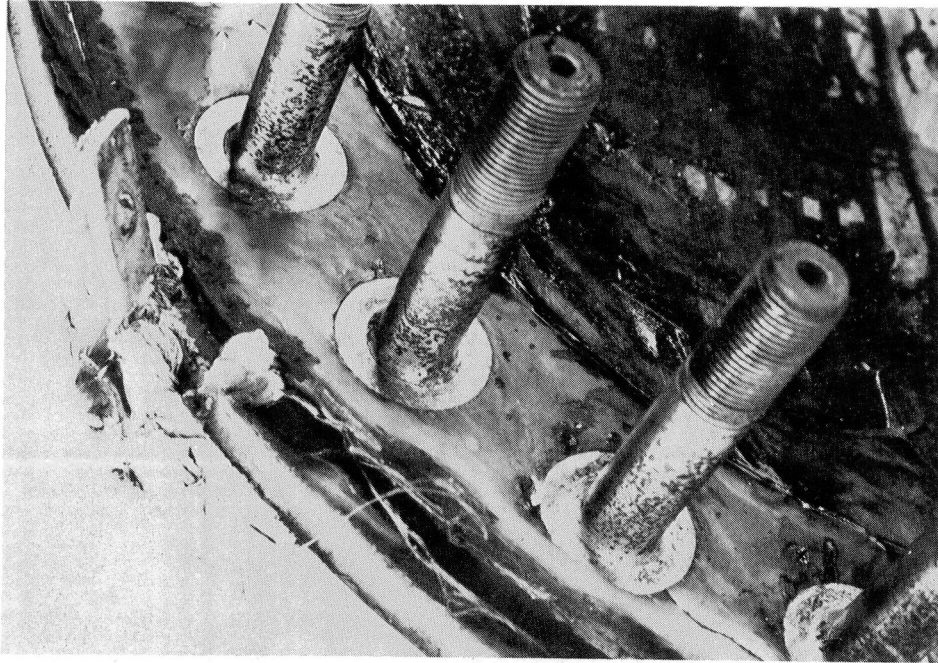
Figure 16. - General condition of moderate corrosion of studs from blade 1013.

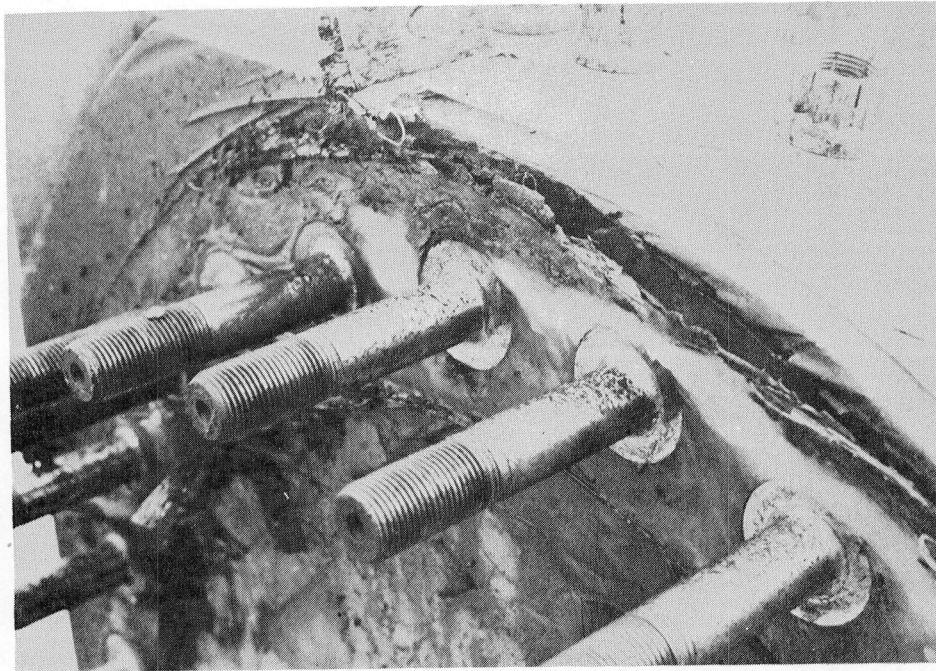
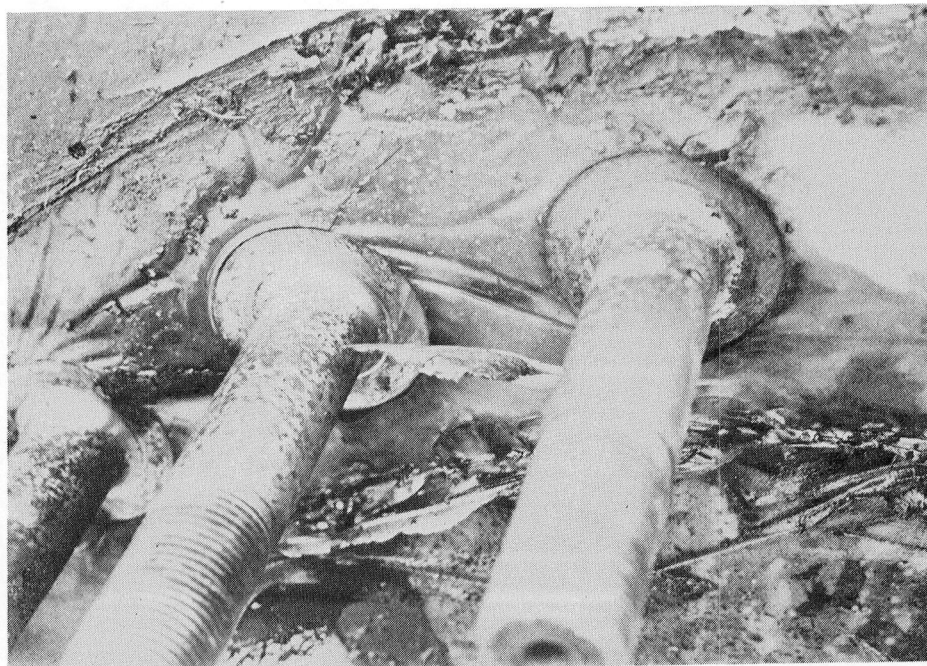
(a) Overall view of stud condition.

(b) Closeup of general corrosion.

Figure 17. - Corrosion of studs from blade 1012.

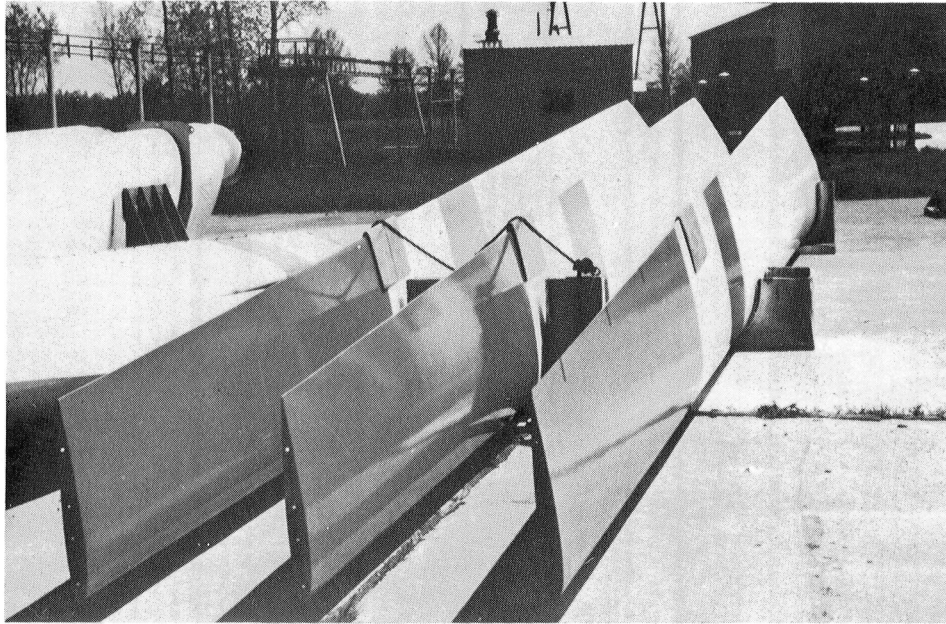
Blade cleaning and weighing. - The Block Island blades were cleaned by using the same techniques as used for the Hawaii blades and achieved the same result. No staining or discoloration remained (fig. 18) and, after cleaning, the blades were in the "like new" condition. Both blades were then weighed on December 14, 1982, by GBI personnel, who again had brought their own scale with them. Results of this weighing are as follows:

Figure 18. - Laminated wood blades after cleaning.

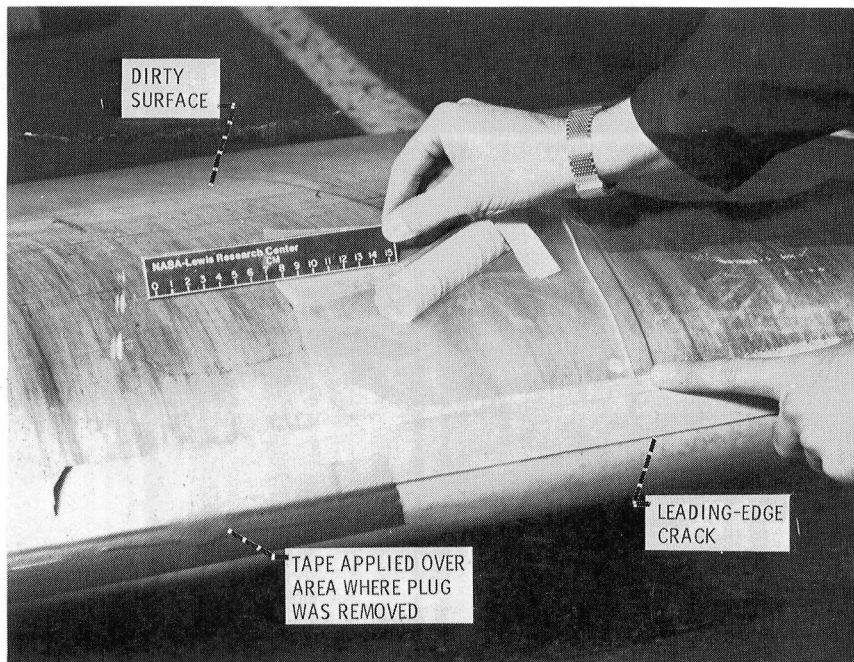
Figure 19. - Wood core specimen for blade 1012 and leading-edge crack. (Note condition of surface finish.)

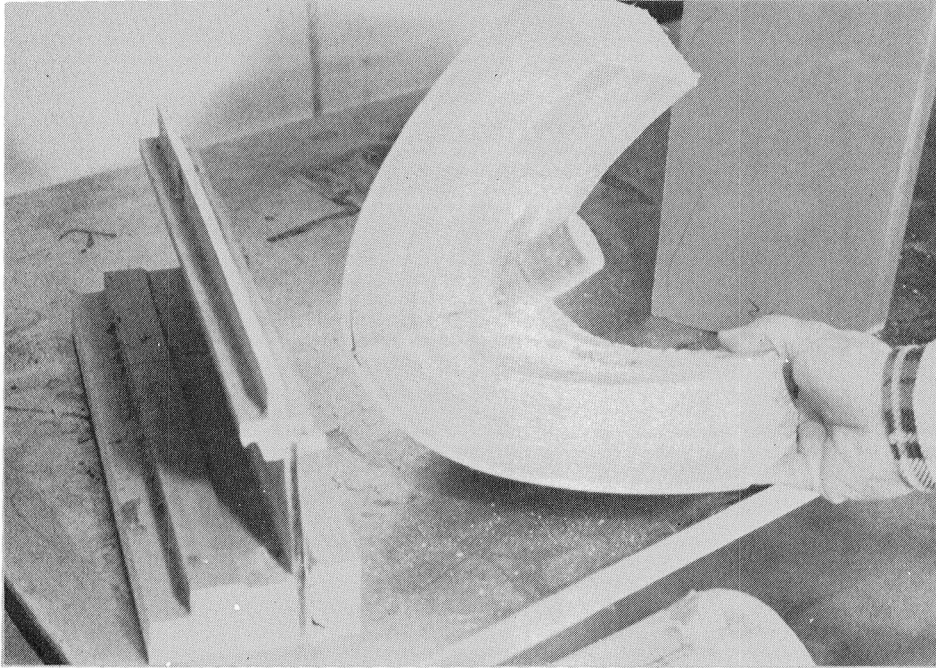
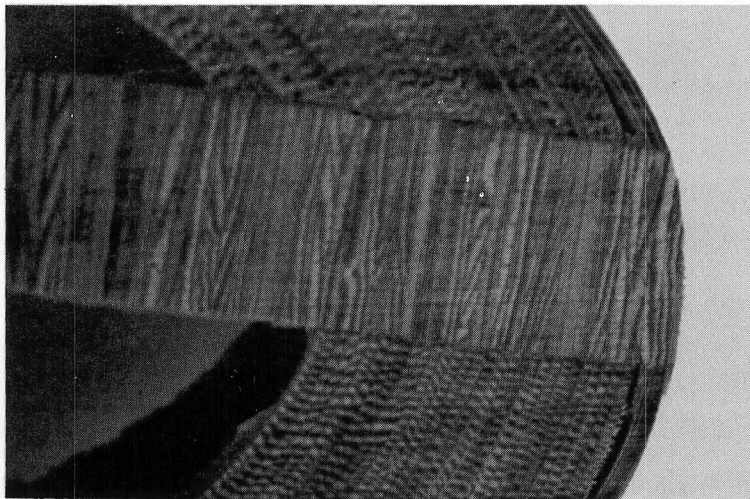
Figure 20. - Sections from repaired blade 1012.

Plug studies. - To evaluate what had happened in the cracked area of the leading edge and to investigate any pattern of moisture absorption, a special plug cutter similar to the tool used to remove cores from the Hawaii blades was developed. This tool removed plugs approximately 2.5 cm (1 in.) in diameter, as shown in figure 19. This technique proved valuable in quickly determining what had happened to blade 1012. In addition, it was found that the holes could be easily repaired by tapering the hole with a tapered reamer and bonding in a properly oriented plug of material with a matching taper. A repaired and sectioned plug is shown in figure 20.

(a) Plug repair cut from leading edge.

(b) Cross section cut through bonded-in plug repair.

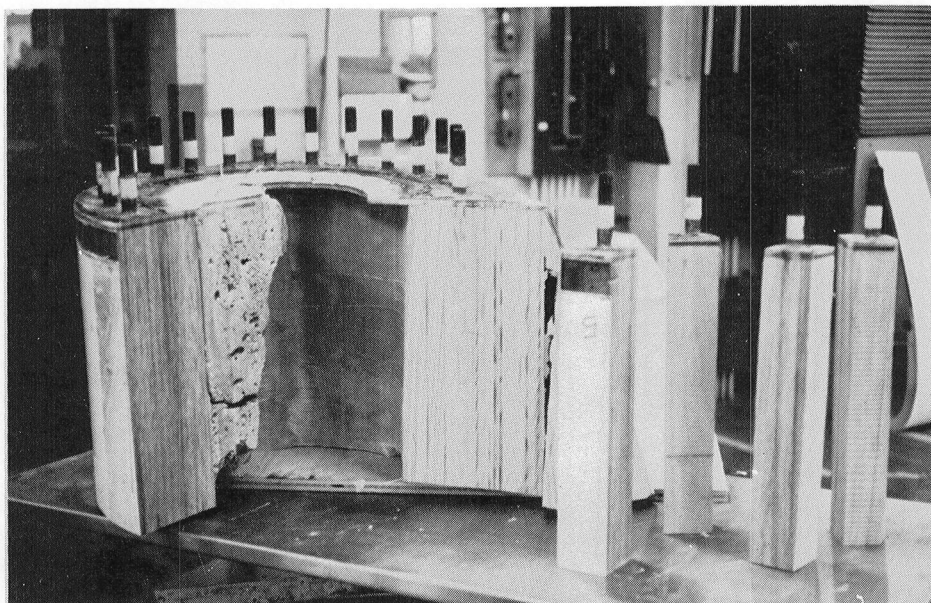
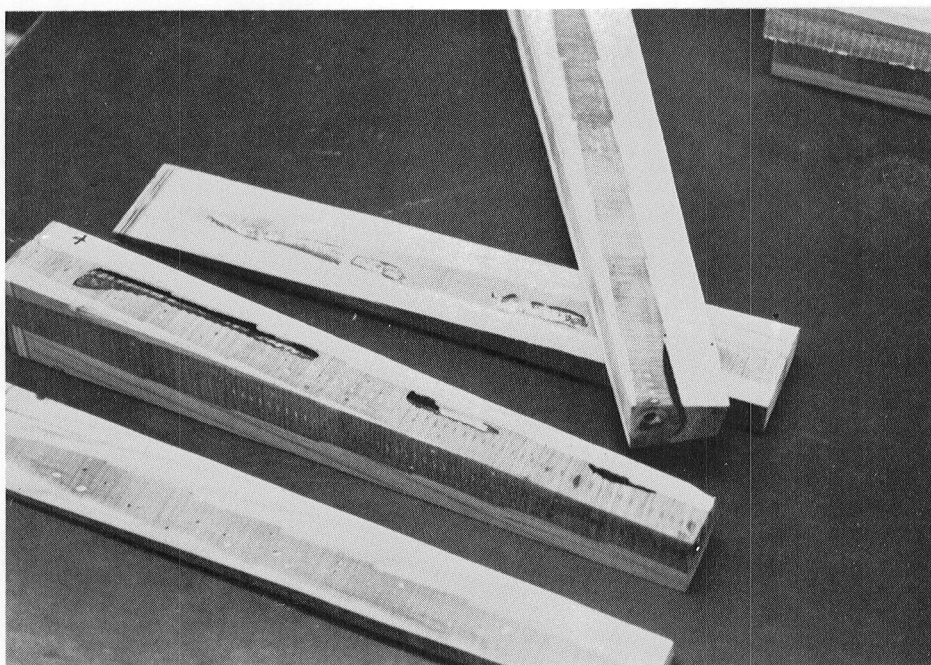
Stud bond: The four most highly loaded studs were removed from the root of the blade by cutting out the stud and an accompanying block of wood, as shown figure 23(a). Each of the four stud/wood block specimens was then cut on two sides with a band saw that followed the stud taper and exposed the tip of the thread tooth and the epoxy bond. It was immediately obvious that two studs had been poorly bonded as major voids were found in the epoxy (figs. 23(b) and (c)). The other two studs were reasonably void free. The voids, however, did not seem to have an adverse effect on the structure. No cracking or crazing of the epoxy matrix could be found at any stud location. Figure 23(d) shows a stud taken from a fatigue test specimen that had failed (in the wood away from the stud area) after more than a million high-load cycles. As can be seen, the extent of cracking of the epoxy matrix around the stud is quite evident, albeit inconsequential to the performance of the stud. From the evidence, it can be concluded that while a very undesirable situation (large voids in the stud bond) existed in blade 1012, failure of the structure had not resulted nor was it imminent. However, it is also obvious that more care must be taken and nondestructive inspection techniques must be developed to assure that good stud bonds exist in future laminated wood blades.

(a) Stud blocks as cut from root.

(b) Voids in stud bonds.

Figure 23. - Studs removed from blade 1012.

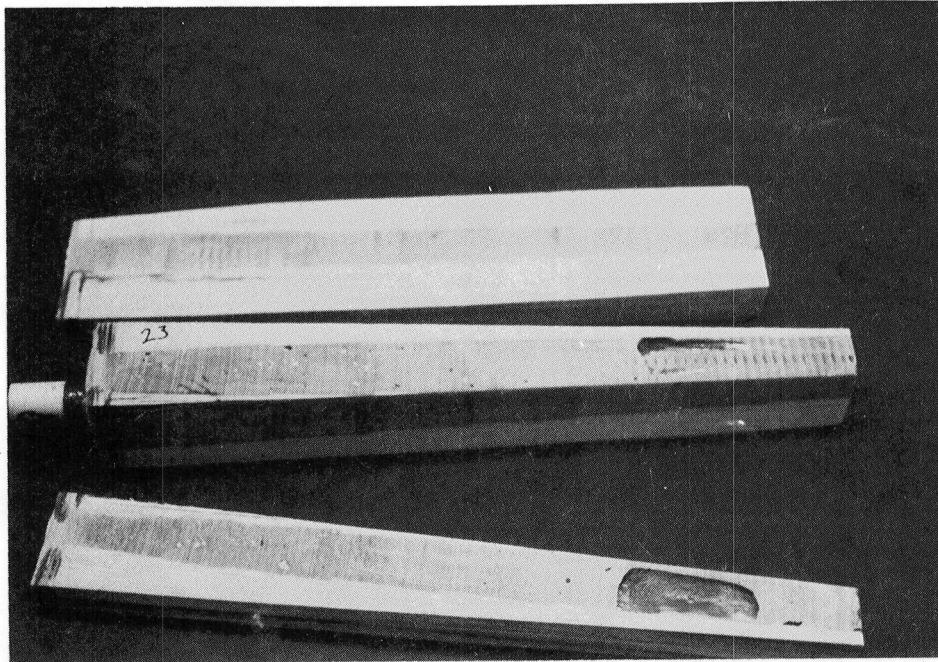
(c) Void in bond for stud 23.

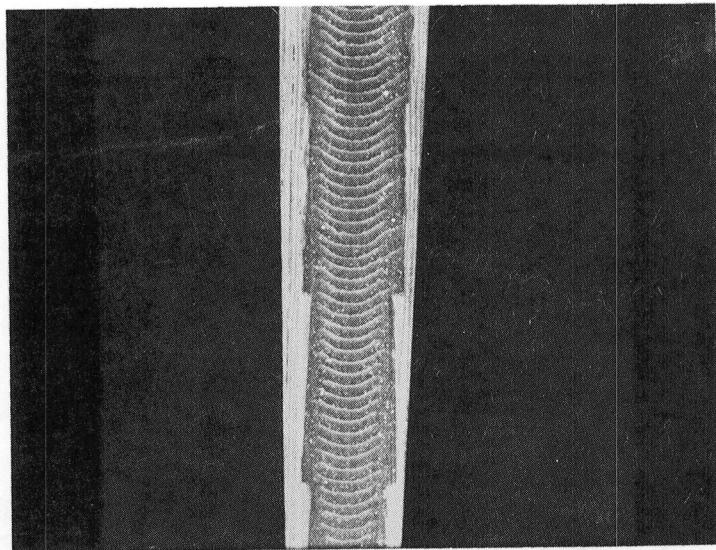
(d) Stud from wood-fatigue test specimen showing complete cracking of epoxy matrix.

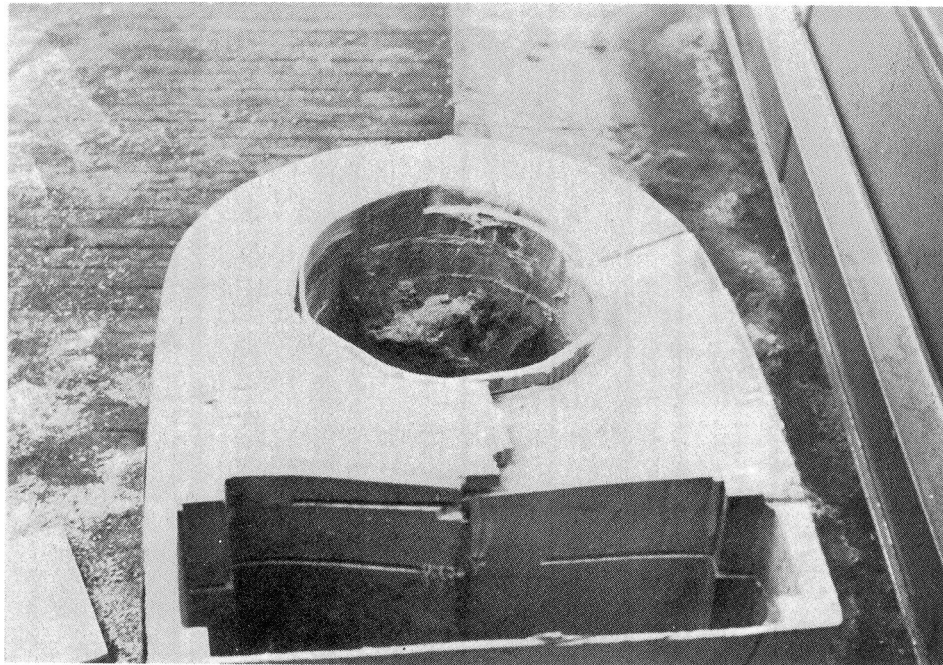
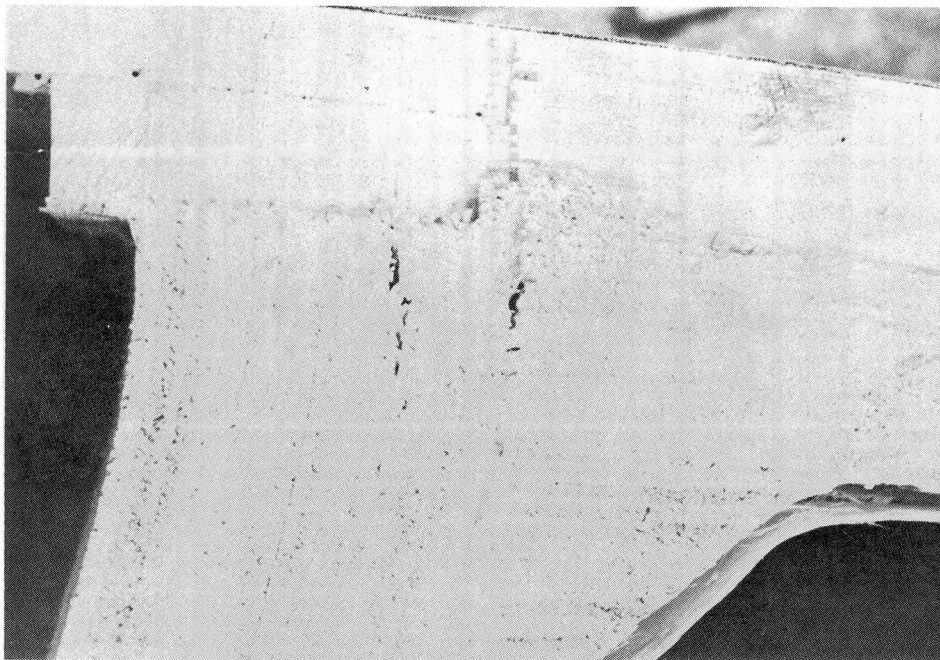
Root blocking: Visual examination and evidence from the stud blocks removed from the root end indicated that the ply-to-ply compaction and bonding was excellent. No gaps or unbonded areas were found in this area of the blade. Some curvature of the laminated root blocking was noted previously in the plies that made up the back side of the "D." This can be seen in figure 24. This problem had been identified during fabrication, and subsequent blades used a premolded, thick, flat panel to build up the blade root.

Figure 24. - Curvature of root blocking from blade 1012.

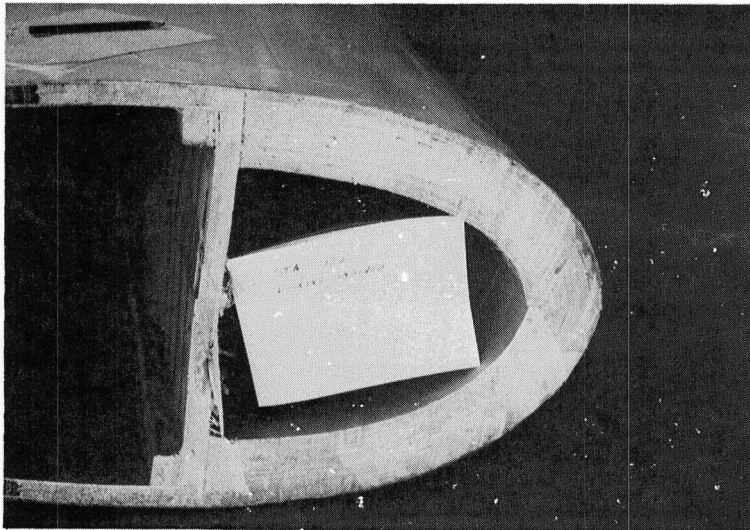
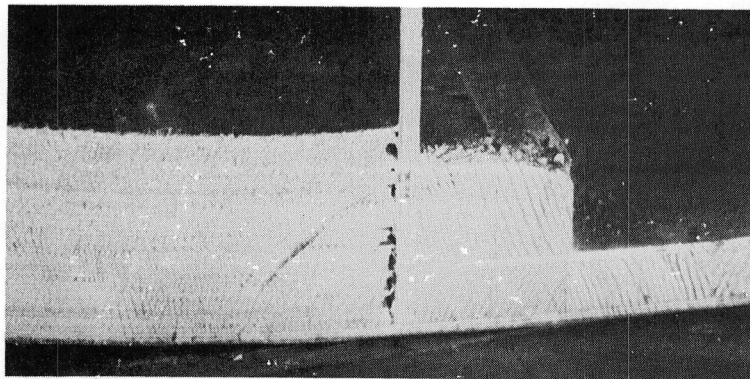
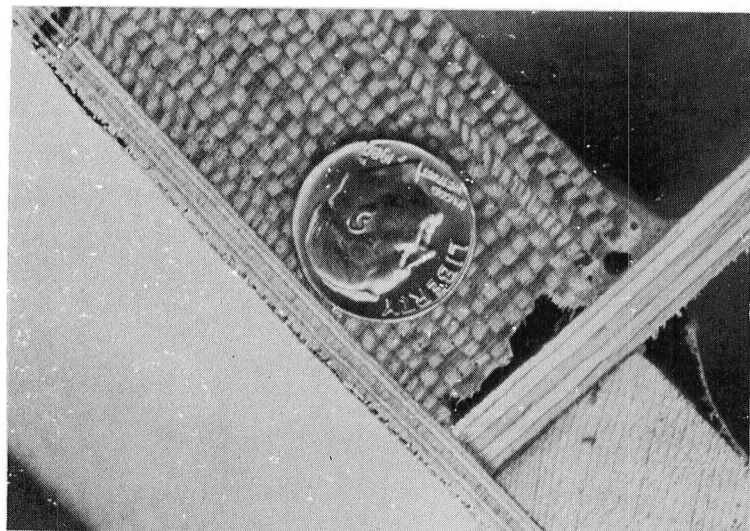
Shear web bond: As shown in figure 25, the bond of the shear web to the D-spar plies on the high-pressure surface was extremely porous. This condition existed from station 240 all the way to the tip (station 750). Inboard of station 240, and on the low-pressure side, the bond was satisfactory. It had been noted during fabrication that there was a potential problem in obtaining good adhesive fill in the shear web to the D-spar point. On at least one blade, an attempt was made to fill voids by drilling into the area and injecting epoxy resin. However, this technique was either not used on blade 1012 or was totally ineffective. Why the bond problem occurred on only one side of the blade is unknown. And, although structural failure had not occurred, nor was there evidence of any significant structural effect, the degree and extent of the problem is such that new procedures would be required for future blade fabrication.

(a) Good bond at station 132.

(b) Poor bond area on one-half of station 252.

(c) Voids at station 612.

Figure 25. - Shear web bond problem.

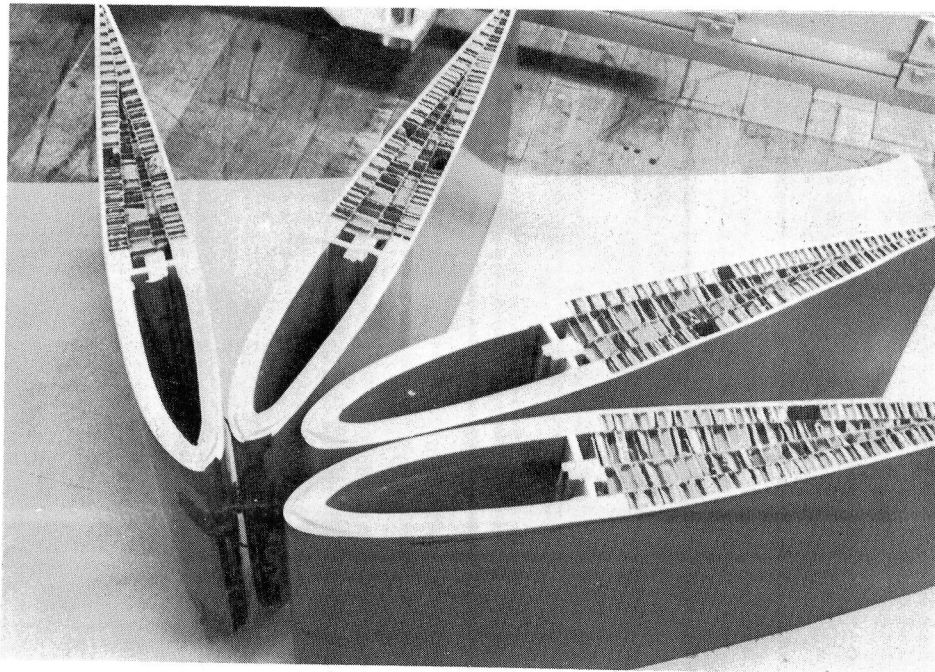
required four different honeycomb pieces to be bonded together to achieve the proper thickness. Thus, one piece of honeycomb was bonded to the outer plywood layer and a second piece of honeycomb was bonded to the first by sandwiching a fiberglass cloth impregnated with resin in between. When the blade halves were bonded together, another resin-impregnated fiberglass cloth layer was placed on top of the honeycomb layer in the bottom half to provide for the center bond line, as shown in figure 26. When sections were cut from this area, it was found that the bond lines between the two honeycomb layers in each blade half were very weak and that the section could be easily pulled apart. Little or no "footprint" was left on the fiberglass cloth, and no fillet of epoxy was found attached to the honeycomb cell edges. Thus it was concluded that the vacuum pressure used during the bonding operation was probably inadequate. As with other areas of the blade, however, the problem with the fabrication process had not caused any structural damage and there was no loss in the skin panel's ability to carry load.

Figure 26. - Honeycomb layers as assembled in blade trailing edge.
