# Examination, Evaluation, and Repair of Laminated Wood Blades After Service on the Mod-0A Wind Turbine

James R. Faddoul  
National Aeronautics and Space Administration  
Lewis Research Center

Prepared for  
National Conference of the American Wind Energy Association  
San Francisco, California, October 16-19, 1983

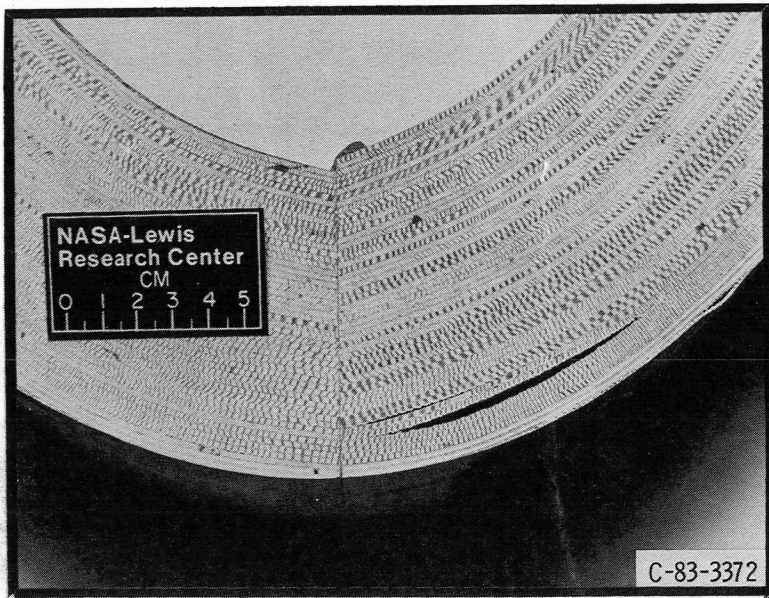
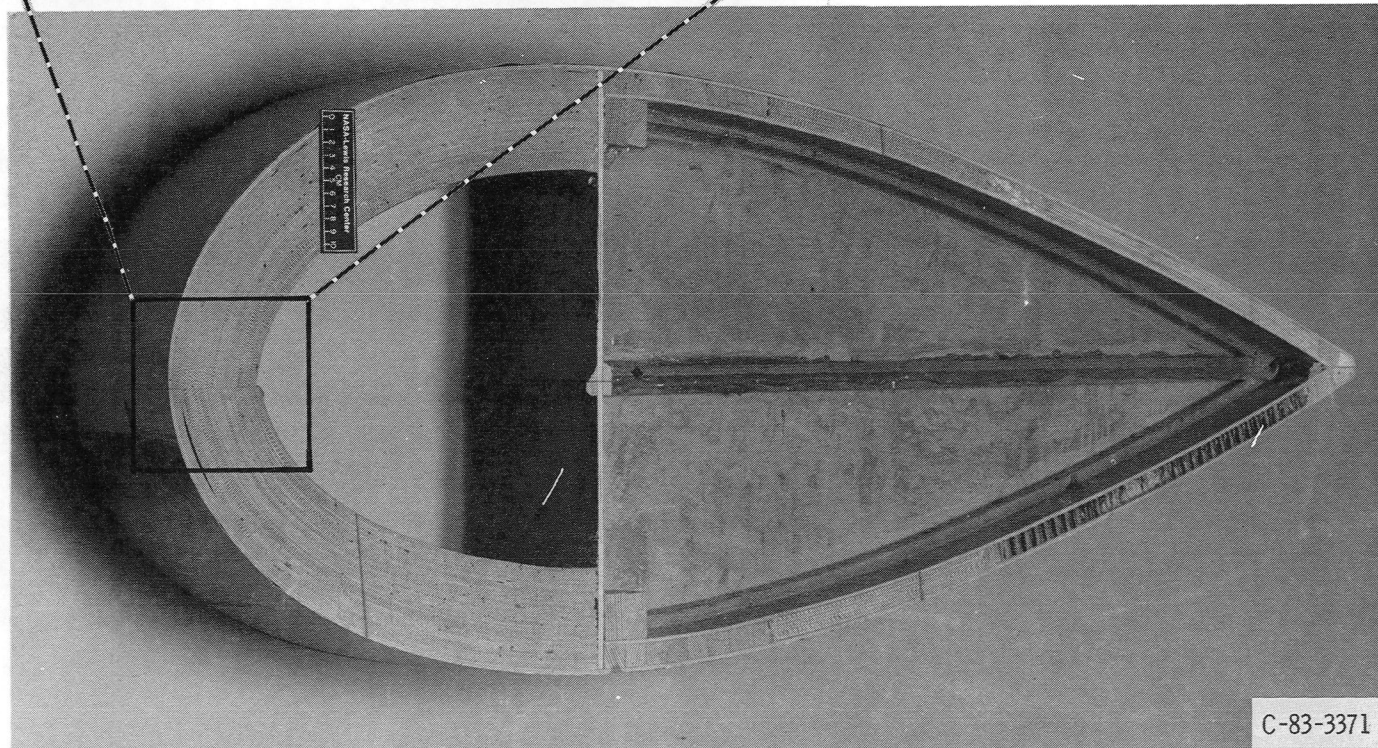
**Leading-edge crack:** As determined from the plug studies, the leading-edge crack was due to a mismatch in the alignment of the upper and lower blade halves. This conclusion was further supported by the cross sectioning of blade 1012, as shown in figure 27. In addition, it was evident that the crack had not contributed to any significant loss in structural capability and that the crack did not progress past the external plywood nor did it turn and run along the layers. Even in areas where the ply-to-ply bonding was of poor quality the crack showed no tendency for enlargement. Preventing the crack is expected to be as simple as maintaining the alignment of the leading edges of the two blade halves during bonding.

Figure 27. - Mismatch of leading edge (manufacturing defect) on blade 1012.

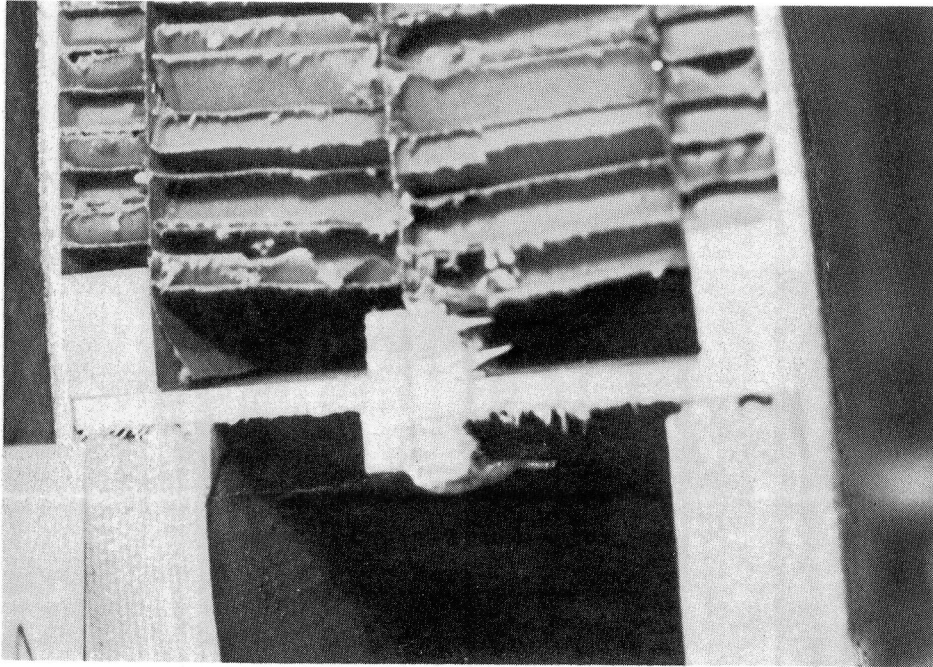
Figure 28. - Closeup of four-section honeycomb assembly.

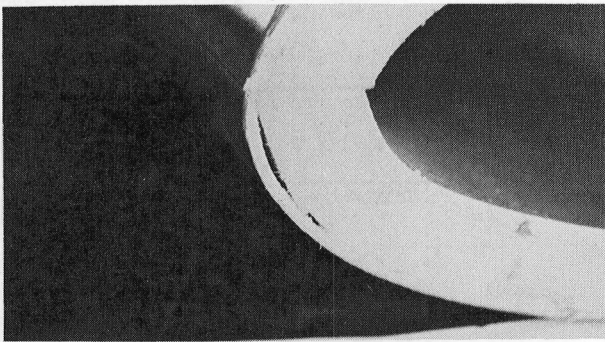
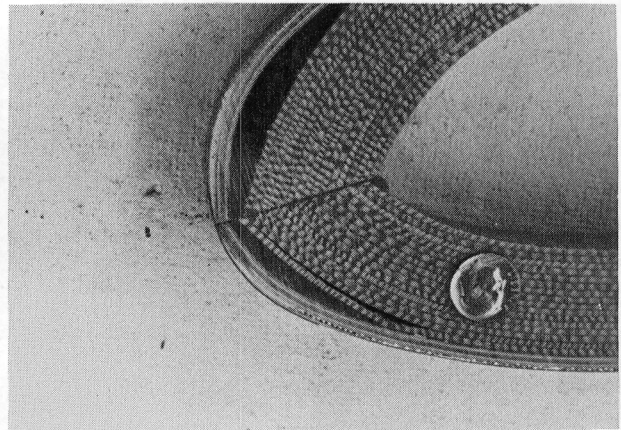
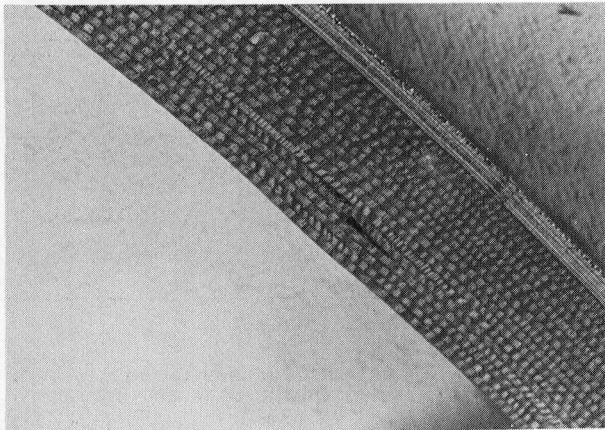
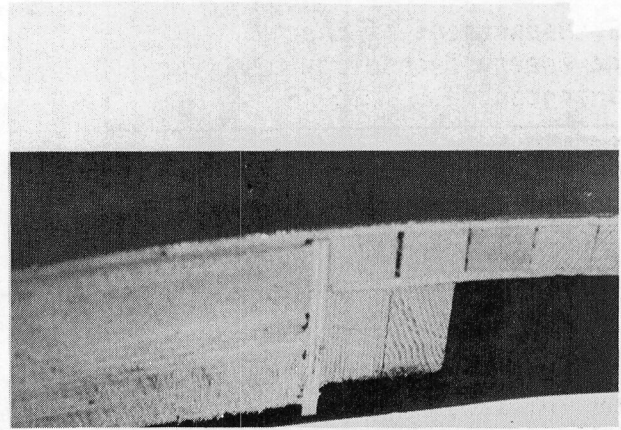
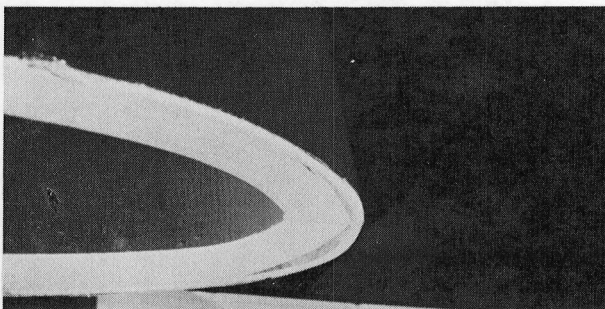
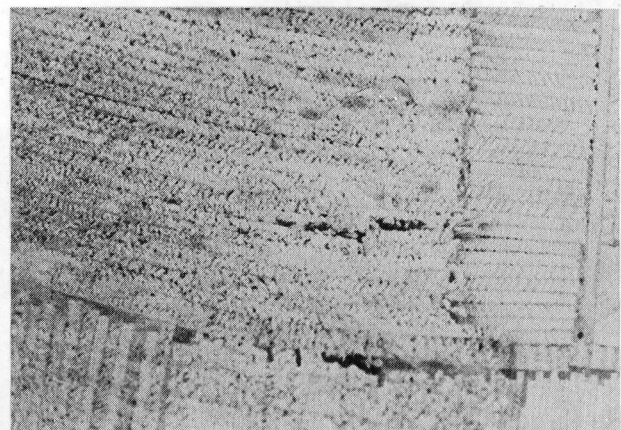
**General laminate bond quality:** In a number of areas of the blade individual plies had not bonded together, and in a few places plies had split or overlapped. A sequence of these events is shown in figure 29. As a percentage of volume, however, the defects were minimal and in no case was there any evidence that a structural failure had occurred, or would result, because of

(a) Nose delamination at station 492.

(d) Leading-edge crack, disbond, and nonconformance to mold at station 650.

(b) Veneer overlap from sections near top.

(e) Gaping between blocking at station 252.

(c) Lack of ply conformance to mold from station 550 outboard.

(f) Curvature and voids in root blocking area.

Figure 29. - Minor fabrication problems of blade 1012.

the defect. In most cases, the problem could be eliminated in future production by using a slightly thicker (15 percent) epoxy coating on the wood. The extra epoxy would assure that layers were bonded together and would tend to flow and fill the few void areas that were found. In general, the wood laminate quality was considered to be excellent.
