OBSERVATIONS OF SOLAR-CELL METALLIZATION CORROSION

G.R. Mon

Jet Propulsion Laboratory
California Institute of Technology
Pasadena, California

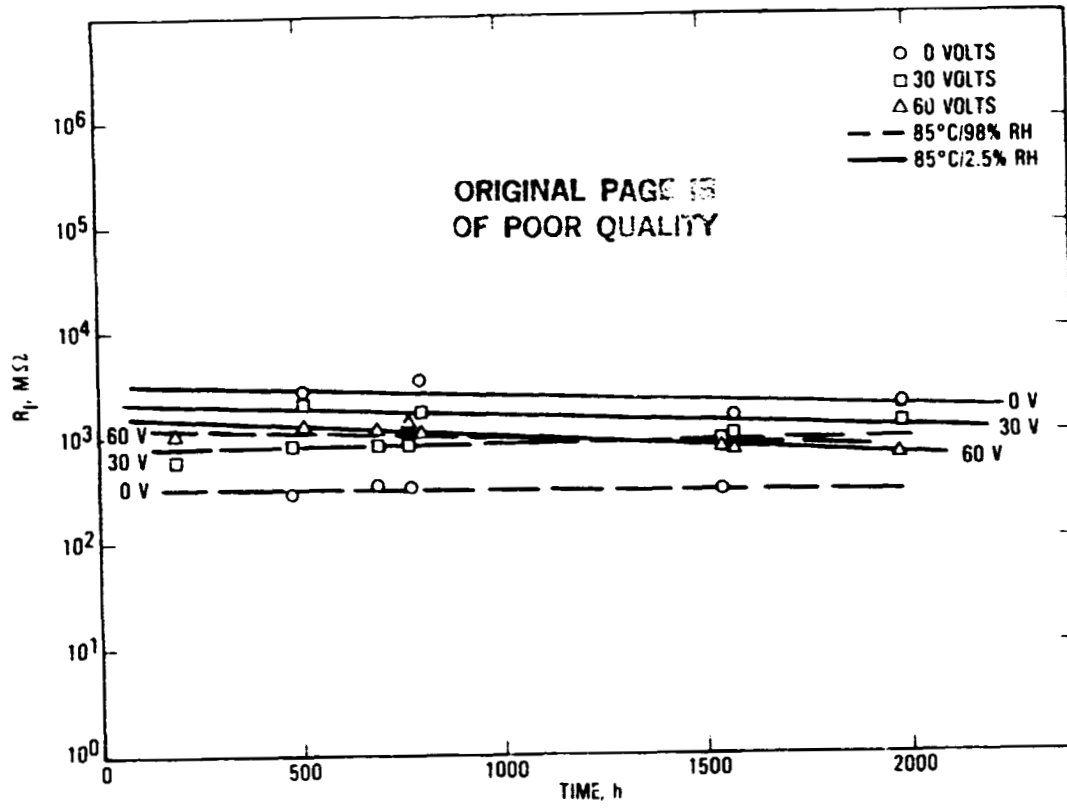
Insulation Resistance vs Time: EVA-Ag Paste

Other electrical parameters monitored included insulation resistance (decreased significantly), dissipation or loss factor (increased significantly) and cells-to-frame capacitance (generally unaffected).

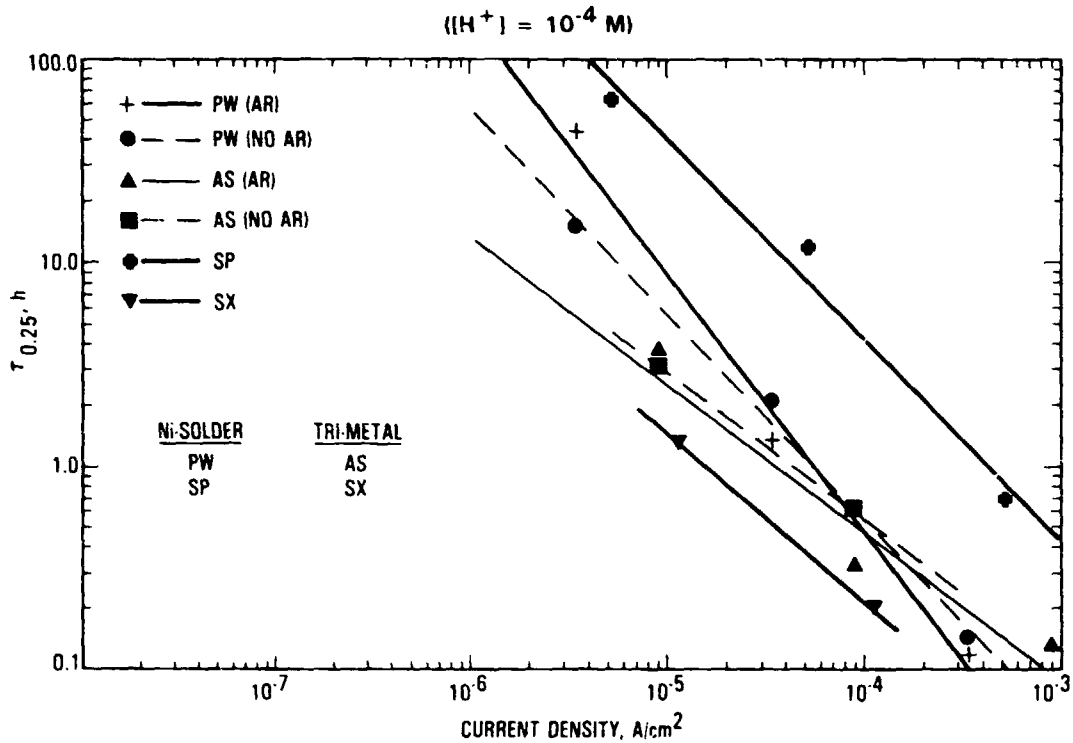
Time to 25% Maximum Power Degradation vs Current Density

- (1) Ni-solder metallization is extremely stable in the sense that, unlike systems containing silver, no migration has been observed.
- (2) For silver-print metallizations, the power loss observed after 100 hours in an 85°C/85% RH test chamber is equivalent to about 30 years of real-time exposure at 60°C/40% RH daytime conditions.
